COWBAR COASTAL CLIFF MONITORING STAITHES, N. YORKSHIRE

April 2014

University of Durham

Redcar and Cleveland Borough Council

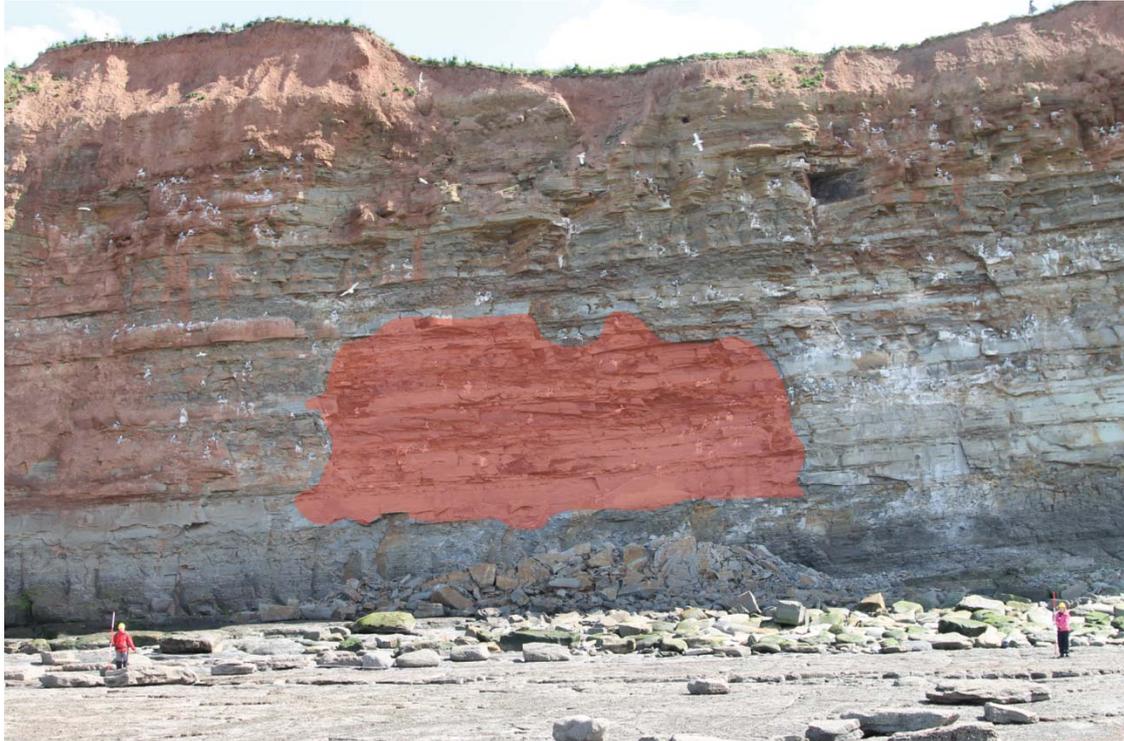
Figure 4: Photograph (14/04/13) showing the location and extent of the rockfall observed between 14th March and 14th April, with debris pile below. Note people for scale.

- i. Approximately 27 m in cross-shore width, up to 17 m in height and up to 2.8 m in depth was released from the cliff between March 12th and April 14th (Figure 1(1), & Figures 4 – 6).

- iv. The initial volume of material lost during as a result of this rockfall was identified as 687.1 m³. Further subsequent analysis revealed that this event multiple failures which span the 2012 – 2013 and this monitoring period as shown in Figure 3 and 6 which describe the evolution of this failure. The failure reported here was 325.5 m³.
- v. The period since this event has been quiet, with fewer rockfalls than have been observed in previous months. As a result the monitored erosion rate for years 1 – 3 is reduced as compared to that for years 1 – 2. The modelled rate is more stable as this accounts for the possibility of larger events such as this.
