COASTAL CLIFF MONITORING - COWBAR NAB, STAITHES, N. YORKSHIRE

August 2018

N Rosser
University of Durham

Scarborough Borough Council
c/o Robin Siddle

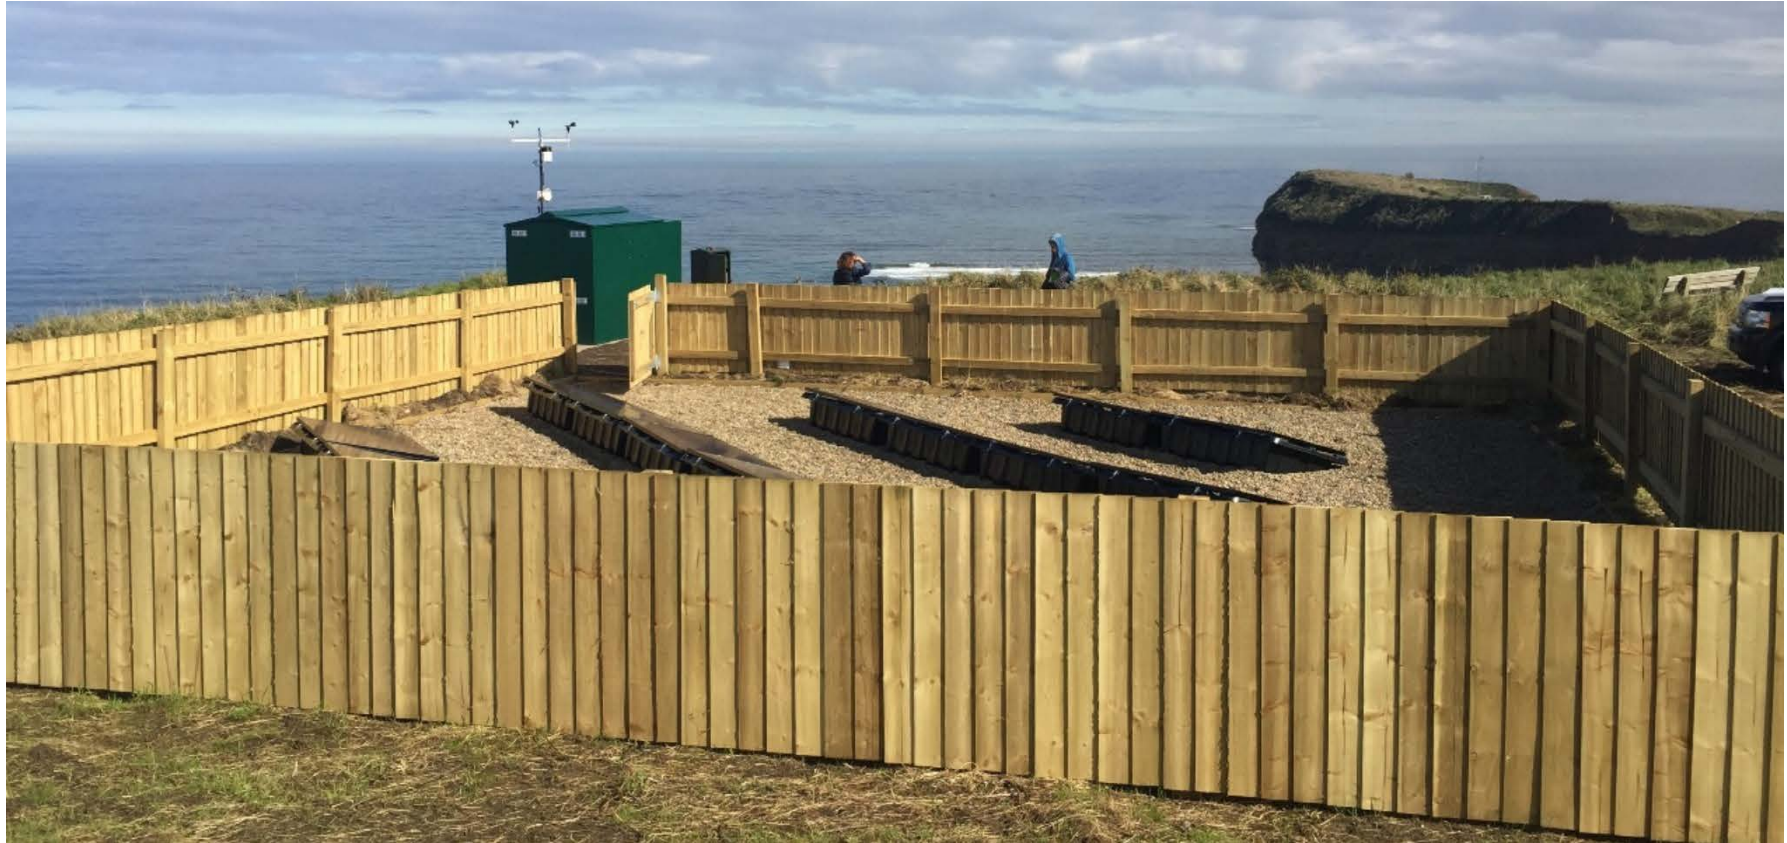
Figure 1. Completed installation of the fixed monitoring system at Cowbar Nab. In the foreshore is the solar power enclosure, providing off-grid power to the monitoring system. The larger green shelter houses the power control system, and the small green enclosure the monitoring instrument.

- In October 2017 testing was completed on a permanently installed laser scanning system at Cowbar Nab, which provides near real time data on cliff erosion (Figures 1 - 4). The system captures data every hour (Figure 2) and posts the calculated hour by hour erosion to a web-based interface, detailed below. The approach is described in detail in the following doctoral thesis, available online:

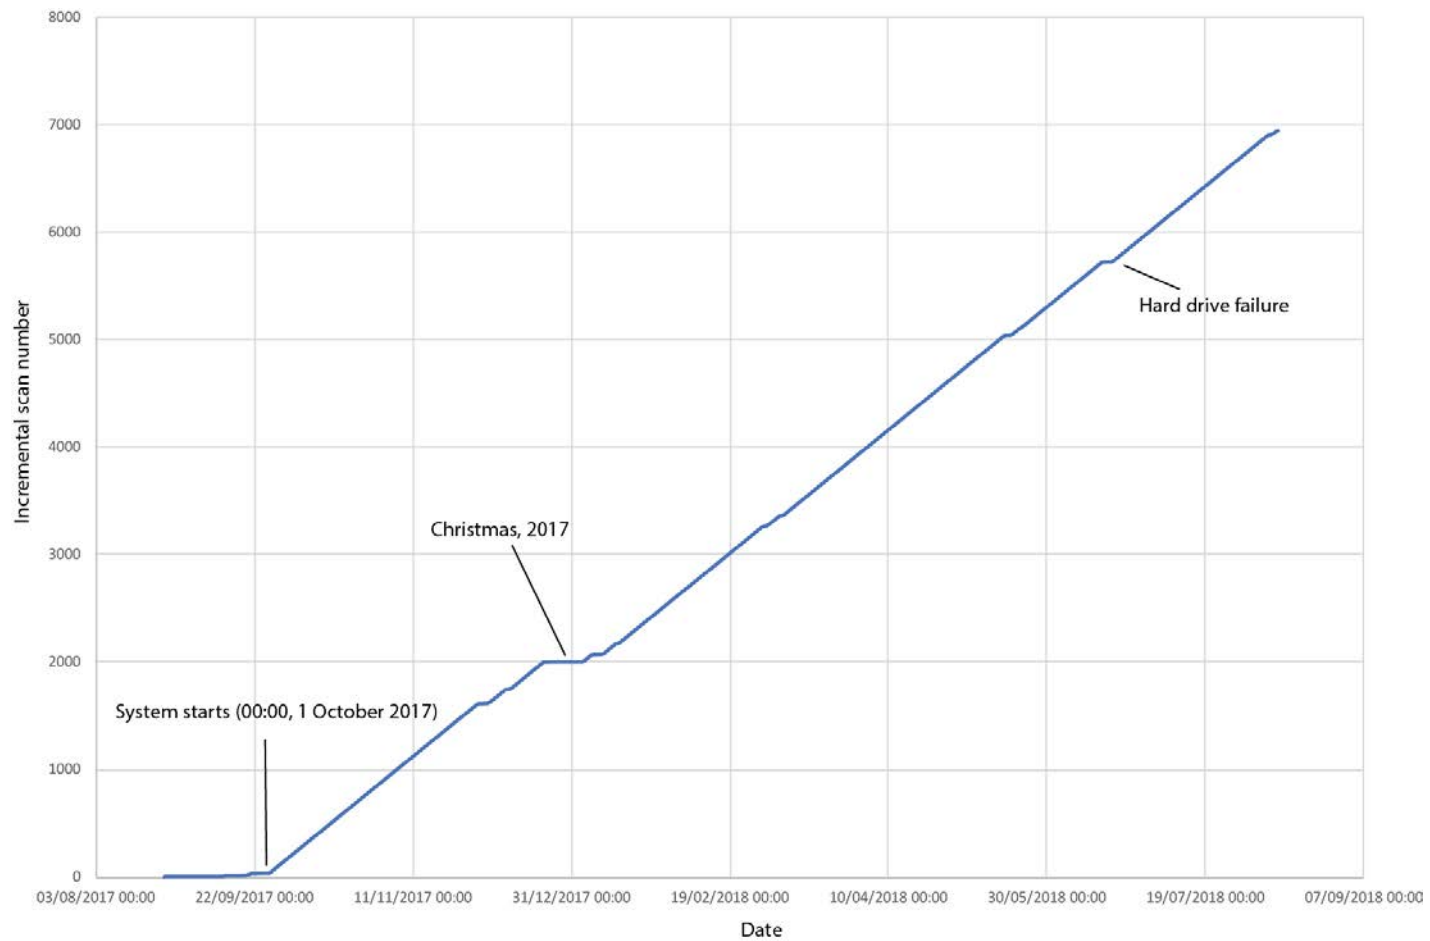
Figure 2. Hourly scan rate record, from start of systematic monitoring (1 October 2017 @ 00:00), with interruptions annotated, included snow cover on the solar array over Christmas 2017, and a hard drive failure within the monitoring instrument in June 2018. Monitoring has otherwise been continuous with data loss only occurring during poor weather conditions, such as fog obscuring the scanner.

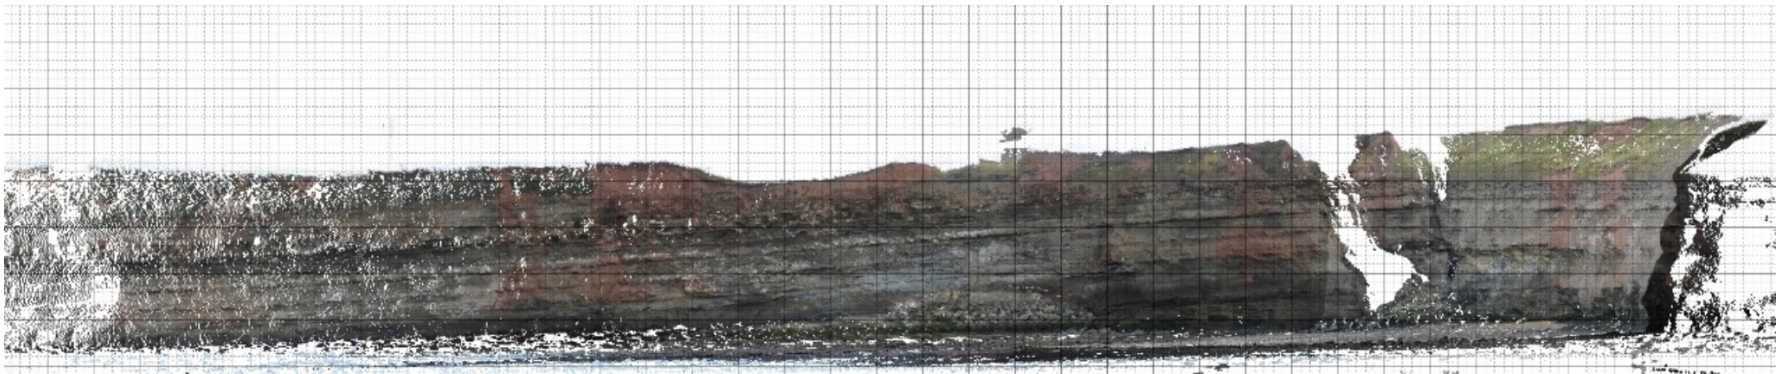
Figure 3. Example of data captured from the cliff top scanner. White areas are occluded (invisible from the scanner position).

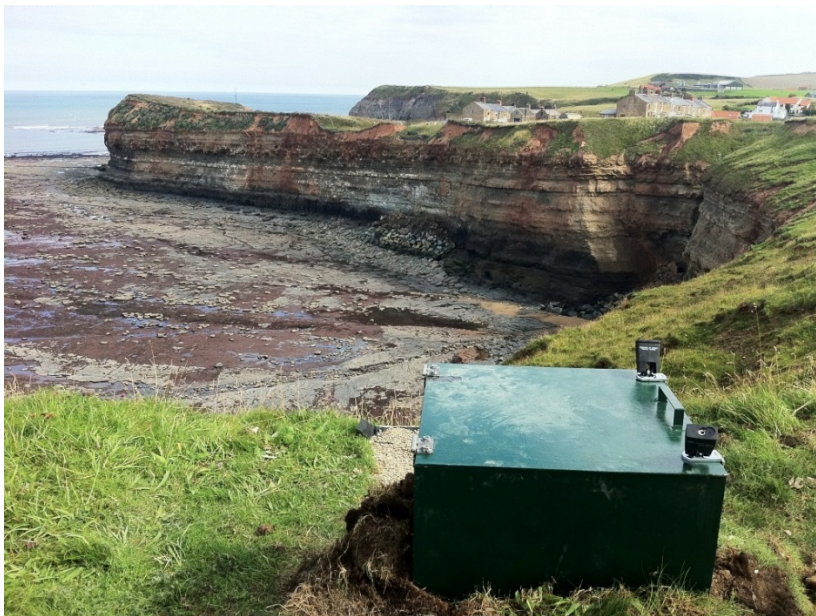
Figure 4. View of the instrument cabinet at Cowbar, showing the view onto the Nab.

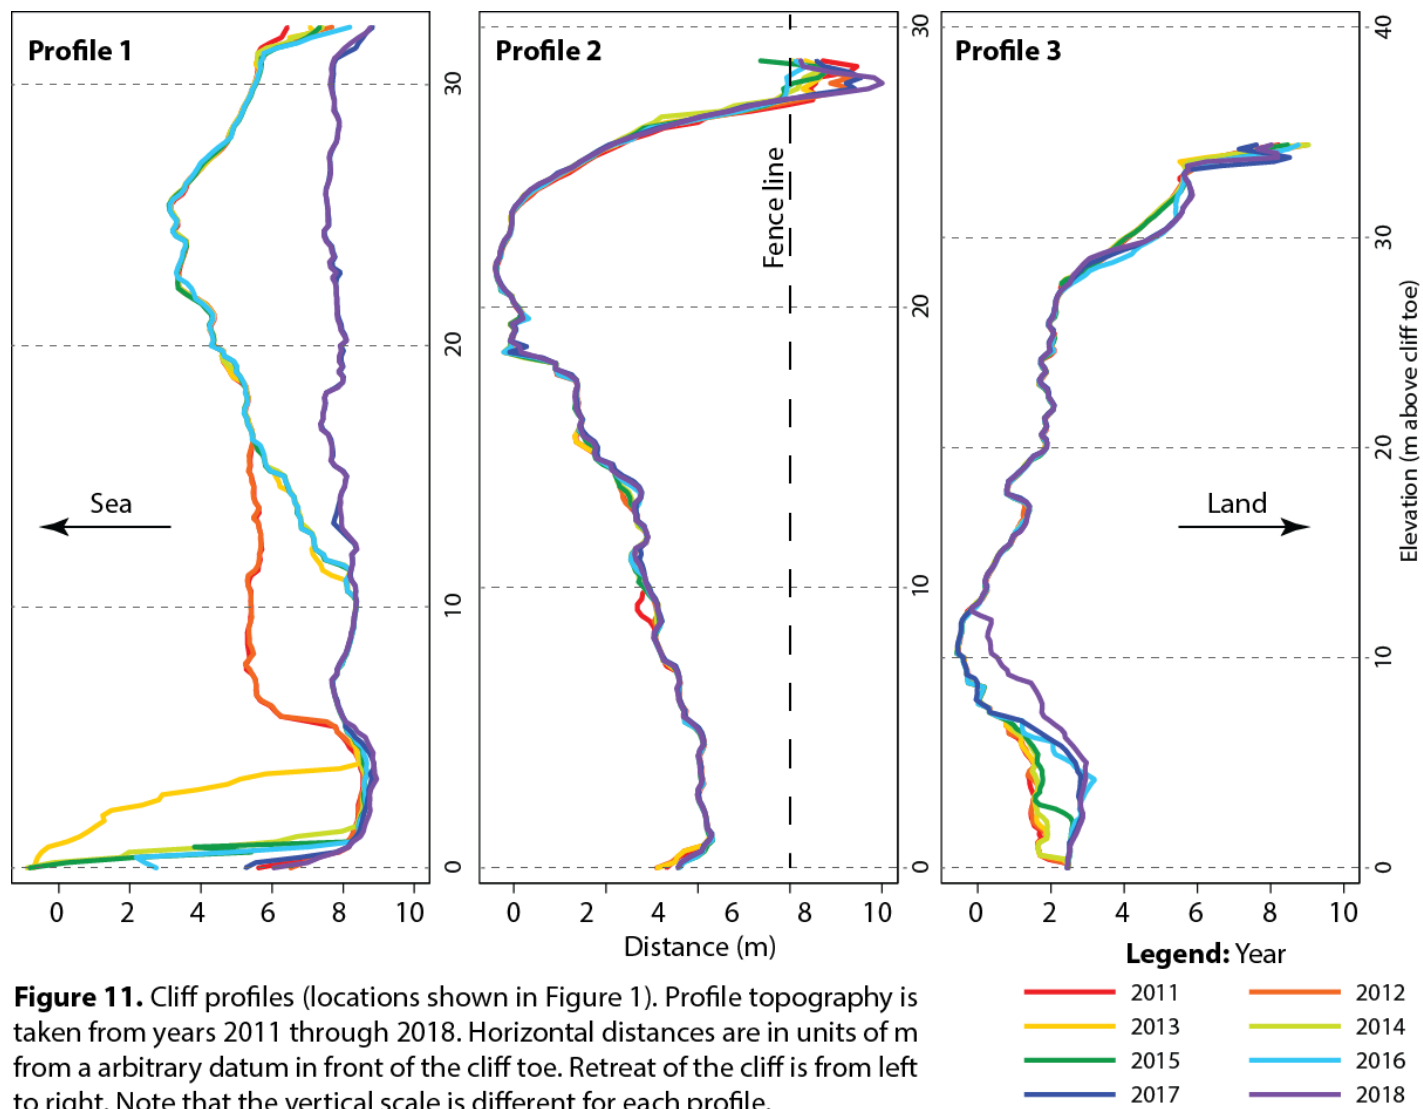
- Profile 1 underwent significant change in May 2016 due to the large rockfall discussed above, and illustrated in Appendix 1. We note that this rockfall resulted in the loss of a previously overhanging section of the cliff face, removing rock to the cliff top.

- We note that Profile 2, positioned immediately above the rock armour, has a convex form, with an overhang of up to 4 m. Notably this is very similar to the cliff form at Profile 1 prior to collapse. Whilst the exact line of this profile has undergone little change between May 2015 and August 2018, we note in Figure 9 and 10, rockfalls in the zone immediately adjacent to the most protruding section of this overhang recently, which are likely to continue to propagate laterally over coming months. As a result, whilst this profile has remained little changed in this monitoring period, we anticipate that the rock above this section will fail next. The timing of this remains unknown, and our data to date shows no sign that this is imminent. Importantly, based on the style of previous failures of this type at this location, the rockfall will likely remove the overhang, rather than retreat the cliff edge back substantially.

- Profile 3 shows loss of material close to high water level at the cliff toe. We anticipate that this area of failure will develop over coming months, to eventually over-steepen and collapse the cliff face above. The cliff line at this point is some 5.5 m seaward of the fence line, and so based on the style of previous failures, this would be unlikely to impact upon assets at the cliff top.

Figure 11. Cliff profiles (locations shown in Figure 1). Profile topography is taken from years 2011 through 2018. Horizontal distances are in units of m from an arbitrary datum in front of the cliff toe. Retreat of the cliff is from left to right. Note that the vertical scale is different for each profile.

- Observed rockfall indicate how this process may occur. We note that larger failures tend to remove convex cliff sections (overhangs), leaving a near-vertical profile, as was the case in May 2016. It is likely that a similar style of failure will occur at the overhang currently immediately above the rock armour (Profile 2). There is no indication that a failure of a similar nature is imminent, but failure and retreat of the cliff in this location is inevitable. We observe some evidence of smaller rockfalls exaggerating this overhang at present. Given the rates and spatial coverage of rockfall that has been observed at Cowbar to date, it is possible that the next large rockfall will change the position of the cliff line. Planning for this eventuality should be considered.

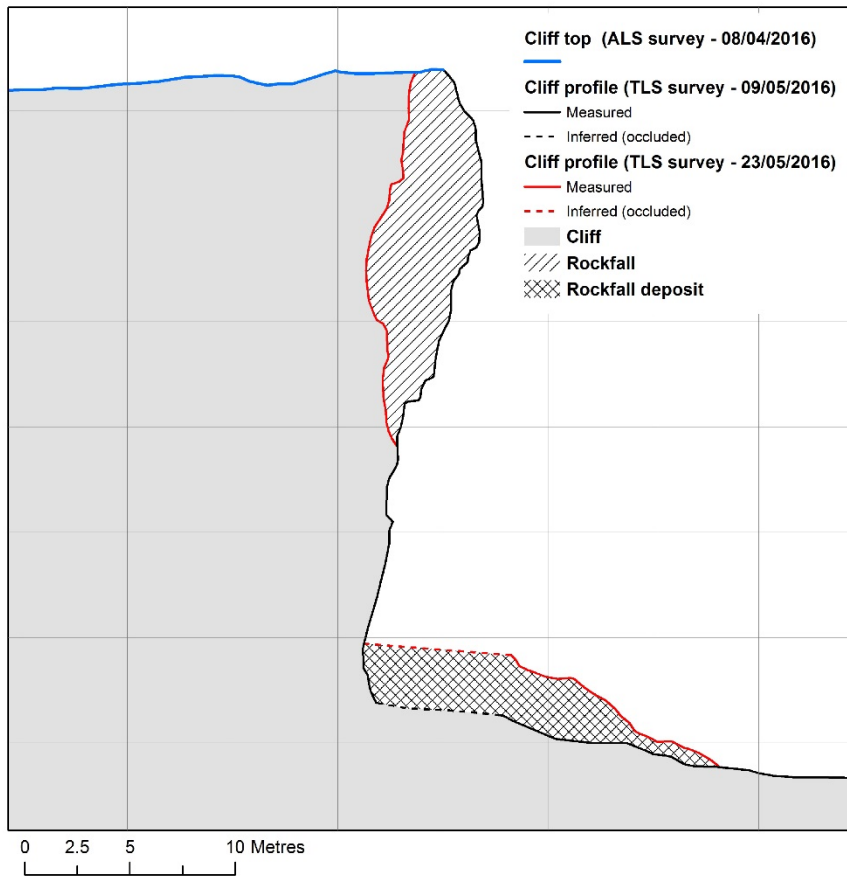
Figure Appendix 1.2 (Top): Cliff profile showing section through the deepest part of the rockfall, the deposit on the foreshore, and the position of the rockfall relative to cliff top. **(Bottom)** 3D render of the rockfall scar.
