Whitburn Coastal Footpath Adaptation Strategy

Client: South Tyneside Council

Reference: PC1950

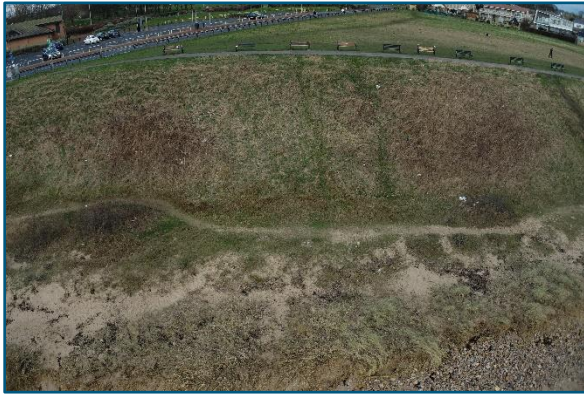
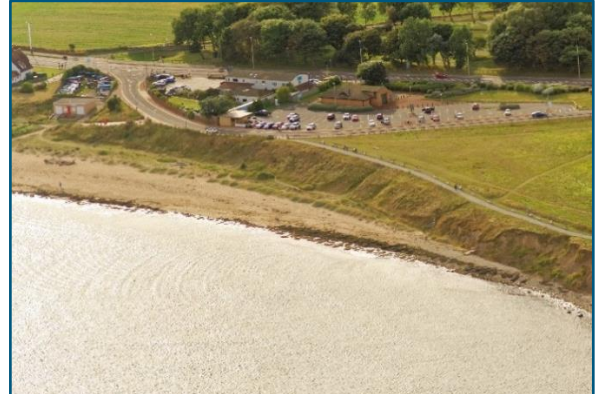
Area A – Well vegetated sloping cliff fronted by dune of increasing width.
(Left) Image from drone survey (Right) Oblique Aerial Image from Cell 1 monitoring programme

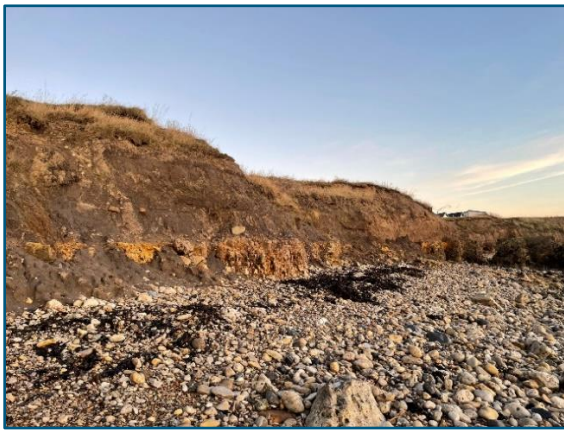
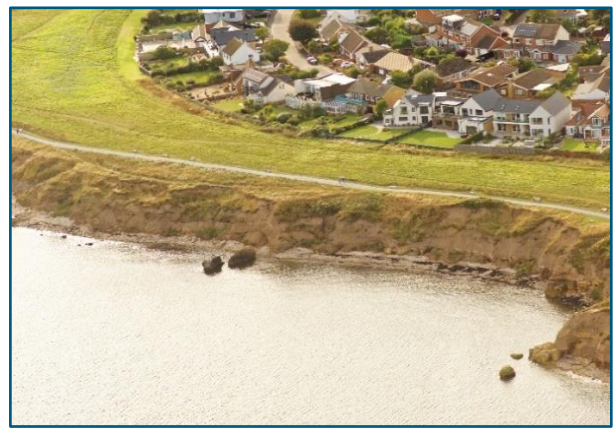
Area B – Thick glacial till deposits mantled on thin limestone shelf.
(Left) Image from site walkover (Right) Oblique Aerial Image from Cell 1 monitoring programme

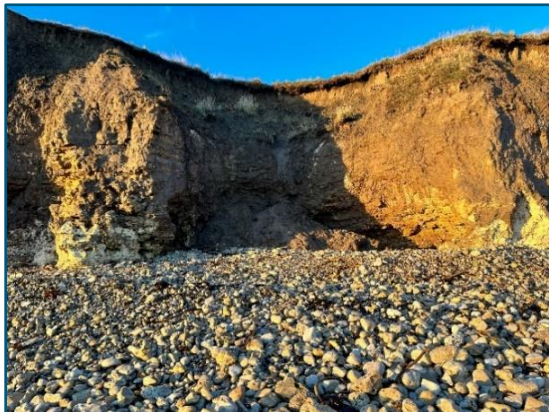
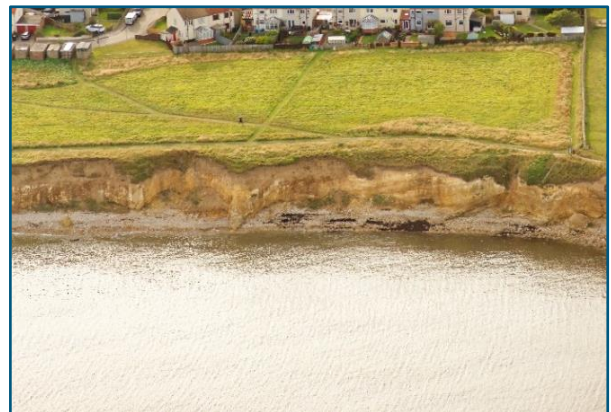
Area C – Magnesian limestone rising in elevation, resulting in steeper, harder cliffs.
(Left) Image from site walkover (Right) Oblique Aerial Image from Cell 1 monitoring programme.

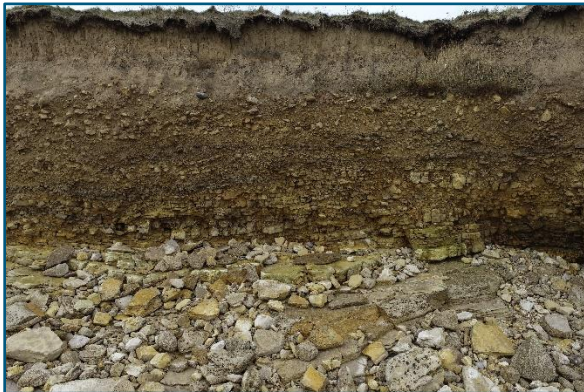
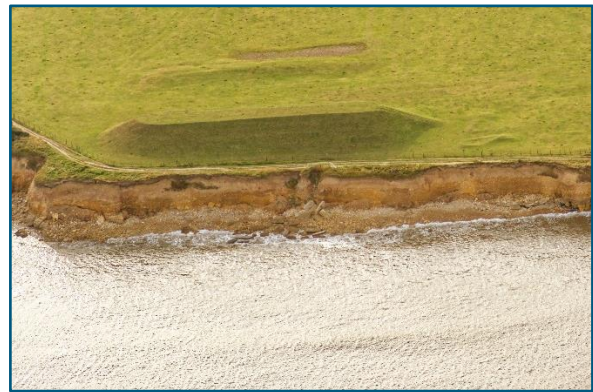
Area D – Decreasing cliff heights fronting firing range, stratum of weathered rock present
(Left) Image from drone survey (Right) Oblique Aerial Image from Cell 1 monitoring programme

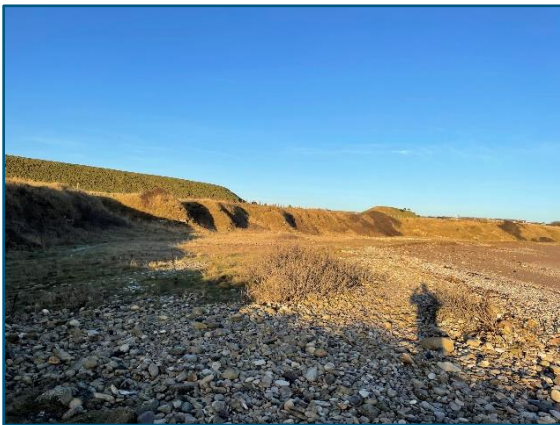
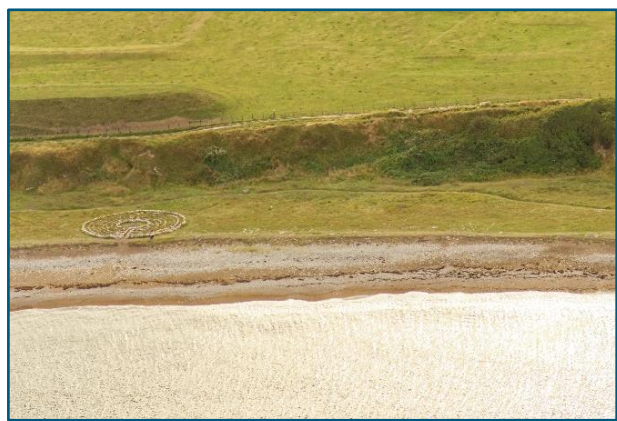
Area E – Well vegetated sloping cliffs backing Whitburn (Jackies) Beach, detached from marine processes by grassed platform.
(Left) Image from site walkover (Right) Oblique Aerial Image from Cell 1 monitoring programme

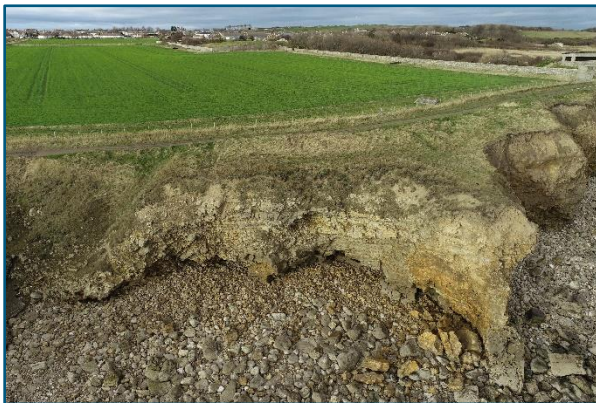
Area F – Undercutting Magnesian limestone cliffs
(Left) Image from drone survey (Right) Oblique Aerial Image from Cell 1 monitoring programme

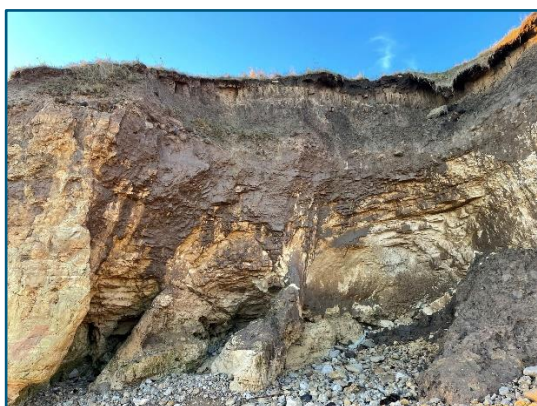
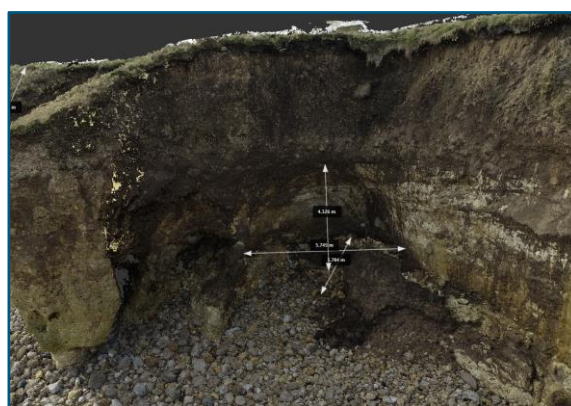
Cave 2 (Area C) – Approximately 4m wide, 4m high and 2m deep
(Left) Image from drone survey (Right) Annotated RGB point cloud

As discussed above, only a limited number of caves were observed along Phase 1. Along the majority of Areas A and B, the limestone strata is too thin for caves to form. More caving was observed in Area C, as the limestone strata increased, however the caving was largely limited to the protruding rocky headlands and so posed limited threat to the coastal footpath. A general overhang in the order of 1 to 2m was observed along the length of Area C. *Figure 2* shows two of the most notable caves observed in Phase 1, the position of the caves are marked on the drawings PC1950-0001 and PC1950-0002 found in Appendix B.

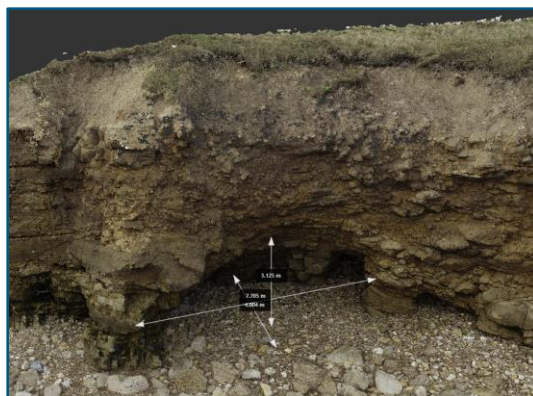
Cave 3 (Area C) – Approximately 8m wide, 3m high and 4m deep
(Left) Image from drone survey (Right) Annotated RGB point cloud

Similarly, in Phase 2, the caving was largely limited to Areas C and F where the magnesian limestone strata was at its highest. *Figure 3* shows a selection of the most notable caves observed in Phase 2, the position of the caves are marked on the drawings PC1950-0001 and PC1950-0002 found in *Appendix B*.

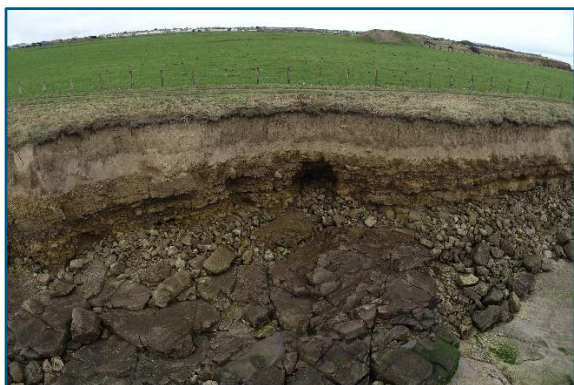
Cave 4 (Area D) - Approximately 2.5m wide, 2m high and 3m deep
(Left) Image from drone survey (Right) Annotated RGB point cloud

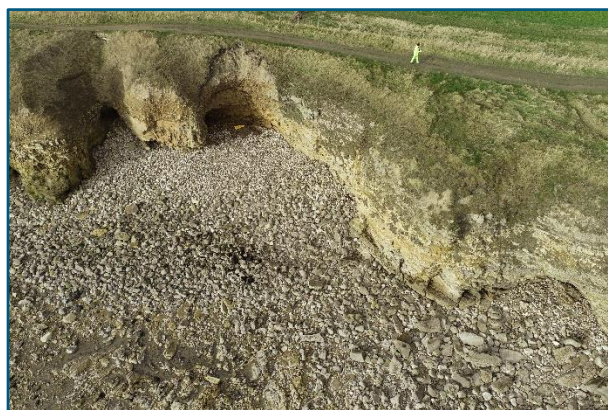
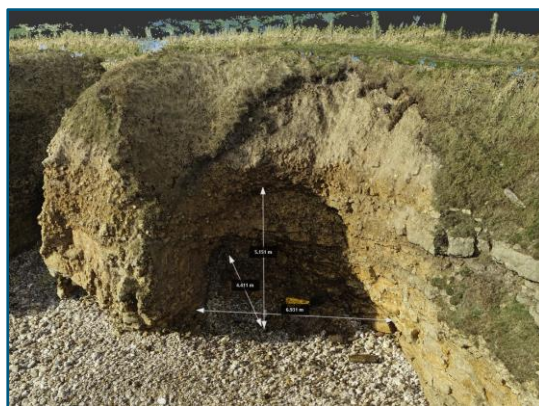
Cave 5 (Area F) – Approximately 7m wide, 5m high and 4.5m deep
(Left) Image from drone survey (Right) Annotated RGB point cloud

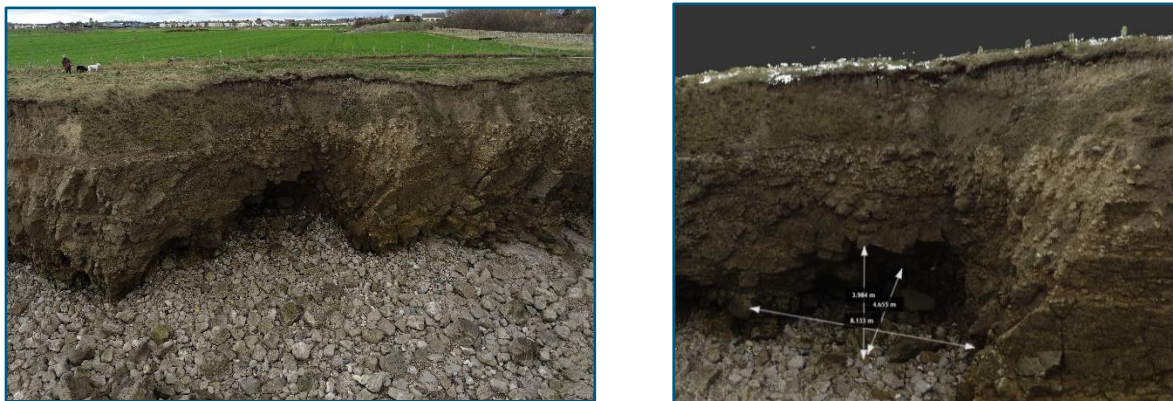
Cave 6 (Area F) - Approximately 8m wide, 4m high and 4.5m deep
(Left) Image from drone survey (Right) Annotated RGB point cloud

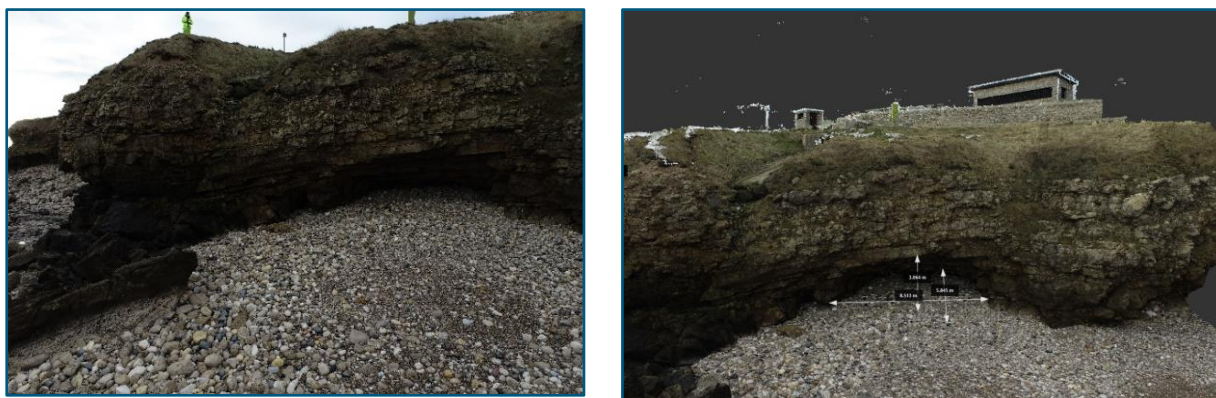
Figure 4 – Significant cave observed outside of study area

Cave 7 (Out of Study Area) - Approximately 8.5m wide, 3m high, 6m deep.
(Left) Image from drone survey (Right) Annotated RGB point cloud

One of the most significant caves noted during the walkover survey is shown in *Figure 4*. The large cave is located just north of the southern boundary of Whitburn nature reserve and therefore falls outside of the current study area. It is recommended the council undertake a similar study in this area to assess the risk of undercutting to the English Coastal Footpath.

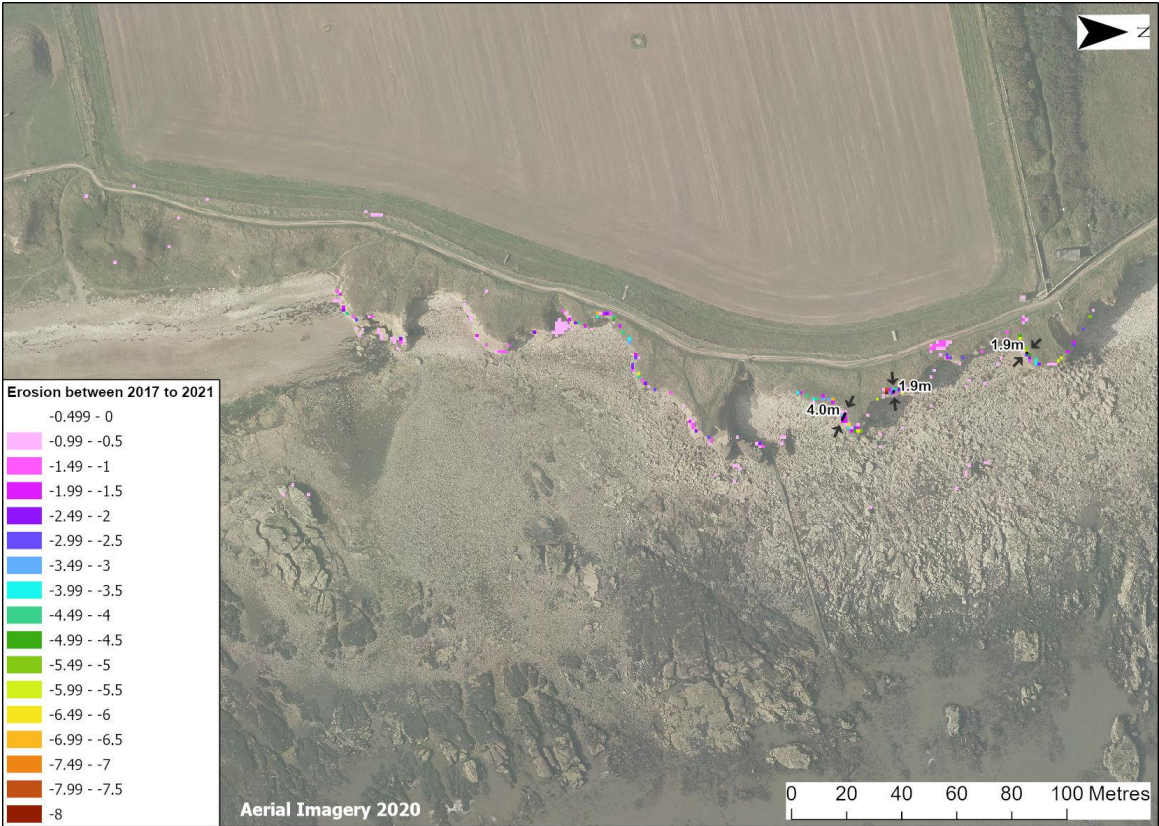
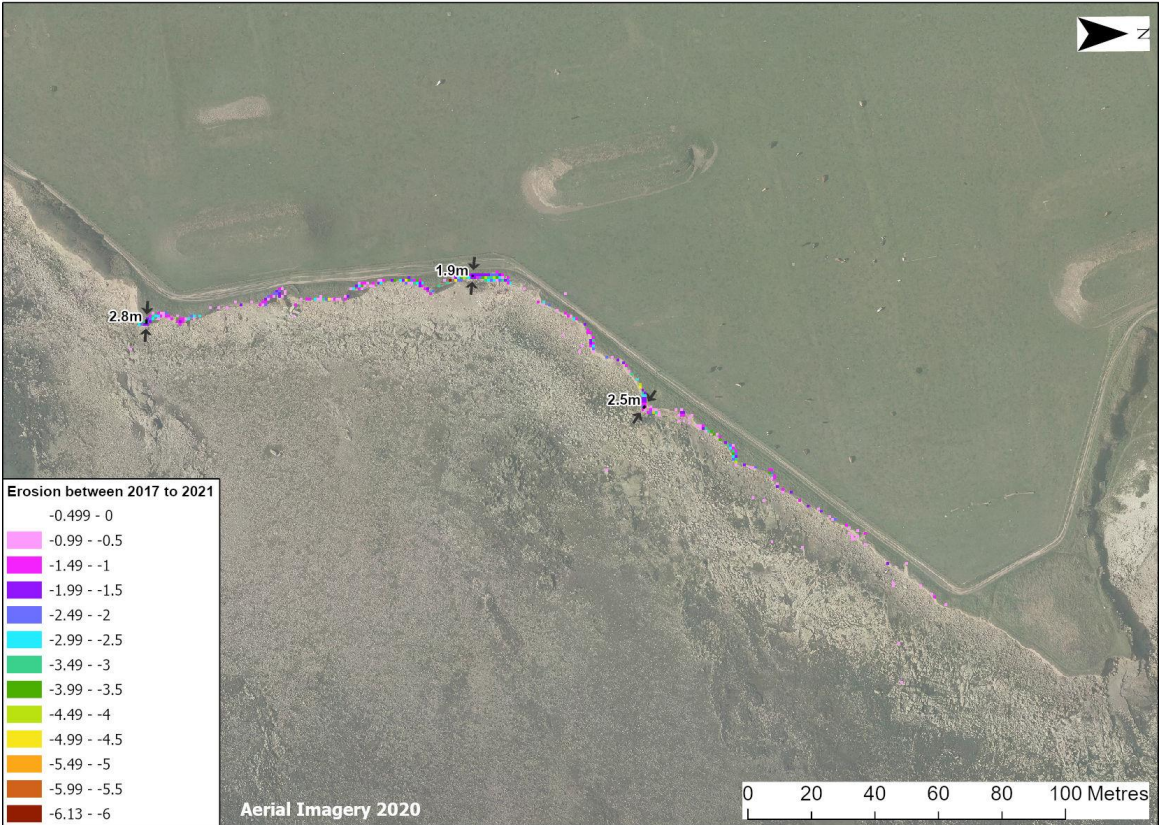
Figure 7 – Lidar comparison plot between 2017 and 2021 for Area D and F.

Figure 4 shows a comparison plot between Lidar data from 2017 and 2021 in an attempt to estimate the maximum magnitude of failure. This plot shows that the magnitude of loss in Area D varies in plan form distance between 1.9m to 2.8m. As this loss incorporates all the changes over a 4 year monitoring period and due to the episodic nature of failure mechanism in this location (discussed further in section 5), it is estimated that the maximum magnitude of loss in a single failure is likely in the order of **1.5m**.

Figure 4 shows a comparison plot between Lidar data from 2017 and 2021 in an attempt to estimate the maximum magnitude of failure. This plot shows that the magnitude of loss in Area D varies in plan form distance between 1.9m to 4m. As this loss incorporates all the changes over a 4 year monitoring period and due to the episodic nature of failure mechanism in this location (discussed further in section 5), it is estimated that the maximum magnitude of loss in a single failure is likely in the order of **2m**.

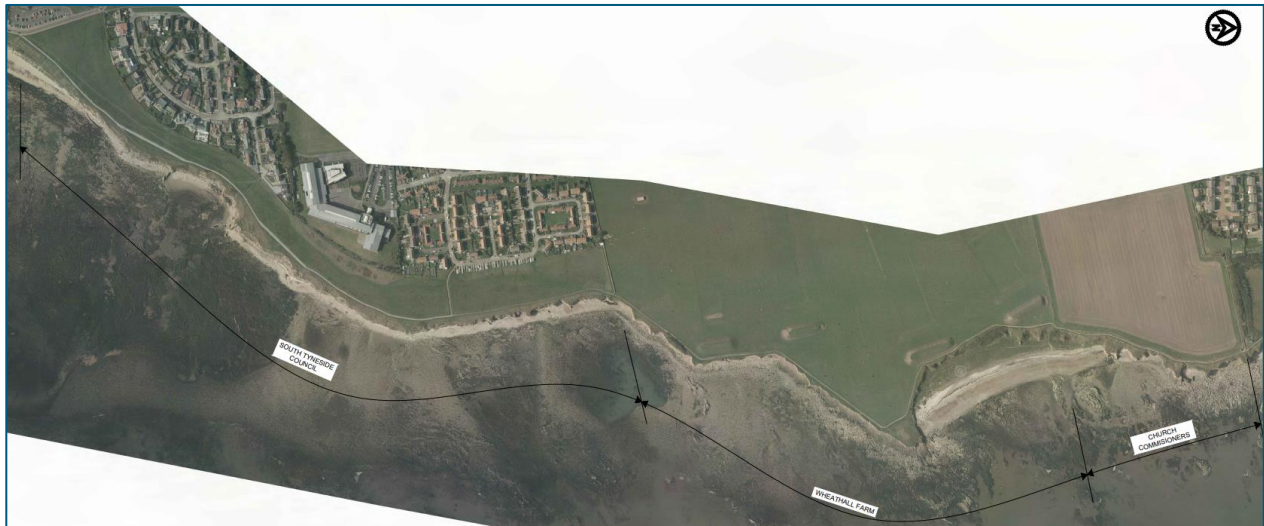
Figure 14 – Land Ownership along study area

Within the study area, there are a number of owners along the coastal footpath. As shown in *Figure 14* the grassed buffer zone in Phase 1 is believed to be owned by South Tyneside Council (TBC). In Phase 2, the former rifle range is owned by a local farmer (Wheatall Farm), the field north of the ranges is owned by the Church Commissioners and the land further north of the range is owned and managed by the National Trust.
