## Changing coastlines in NE England: a legacy of colliery spoil tipping and the effects of its cessation

**Abstract:** Historical tipping of vast quantities of colliery spoil at various foreshore locations in NE England has changed the morphology and sedimentology of large areas of the shoreline and nearshore sea bed, and has impacted adversely upon the ecology and amenity use of the area. Tipping started early in the 20th Century, well before statutory controls to regulate impacts of activities on the marine environment came into force in the UK in 1974, and ended with the closure of the last colliery in 2005. The spoil tipping acted as a form of artificial sediment recharge to the foreshore, akin to conventional beach recharge schemes that use sand or shingle to replenish foreshores for coastal defence and amenity purposes, but creating a legacy of contaminated beaches and prograding (advancing) shores. Since closure of the collieries, however, the foreshores have received no artificial supply of material, and the shoreline in all former tipping areas has since been in retreat due to natural erosion. This has caused problems where assets are present at the rear of the spoil bea

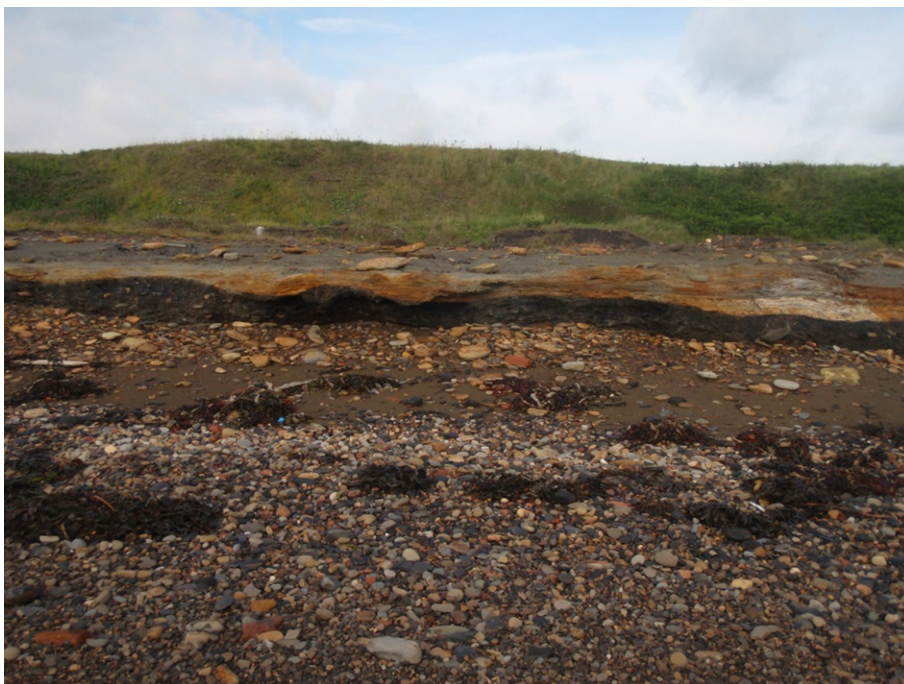
**Fig. 2.** Colliery spoil beach to the north of the River Lyne in Lynemouth Bay, Northumberland.

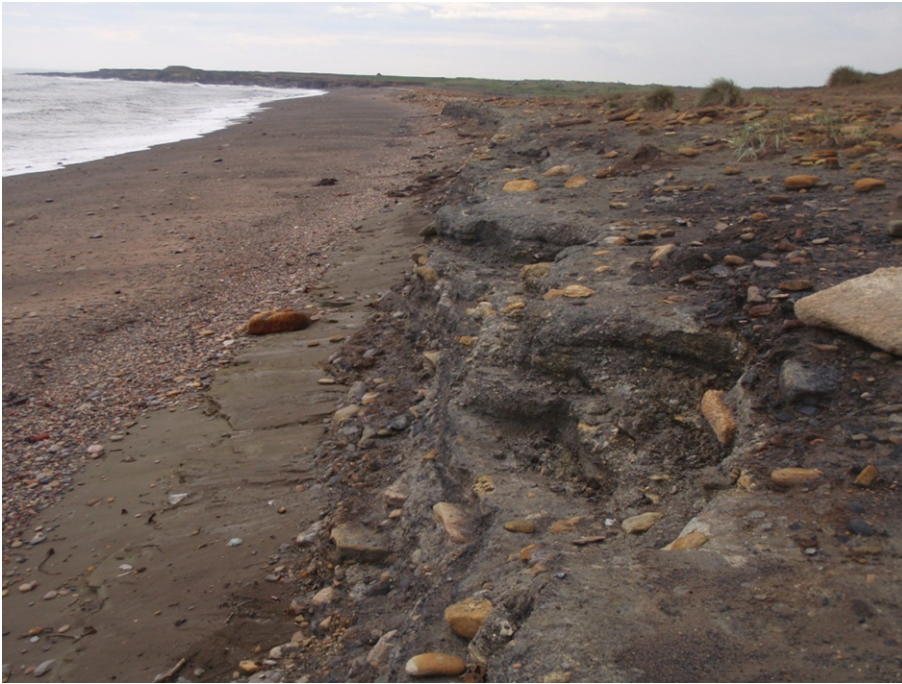
**Fig. 3.** Colliery spoil beach at Lyne Sands in Lynemouth Bay, Northumberland.

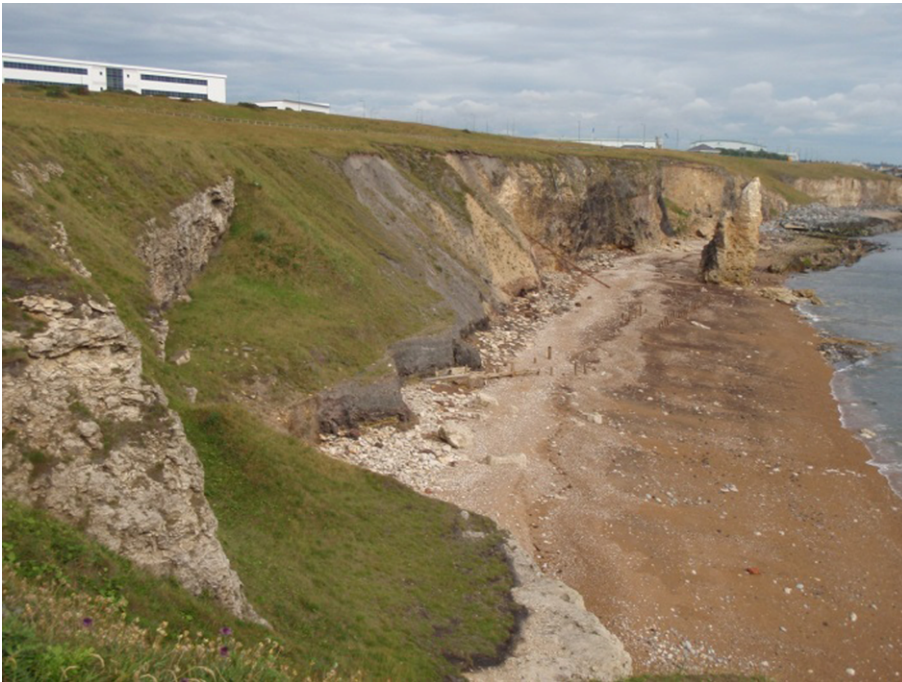
**Fig. 5.** Dawdon Bankside (Seaham Fleet Rock sea stack in distance). Note the small slippages starting to occur in the sea cliffs as the spoil beach has now all but disappeared due to erosion.

Colliery waste at Dawdon was dumped at both Dawdon Bankside (Fig. 5) and Dawdon Blast Beach (Fig. 6). The accumulation of spoil formed an artificial beach in both locations, with the spoil beach at Blast Beach being some 140 m wide. This material effectively arrested coastal erosion of the sea cliffs at both sites, but also had undesired aesthetic and environmental impacts.

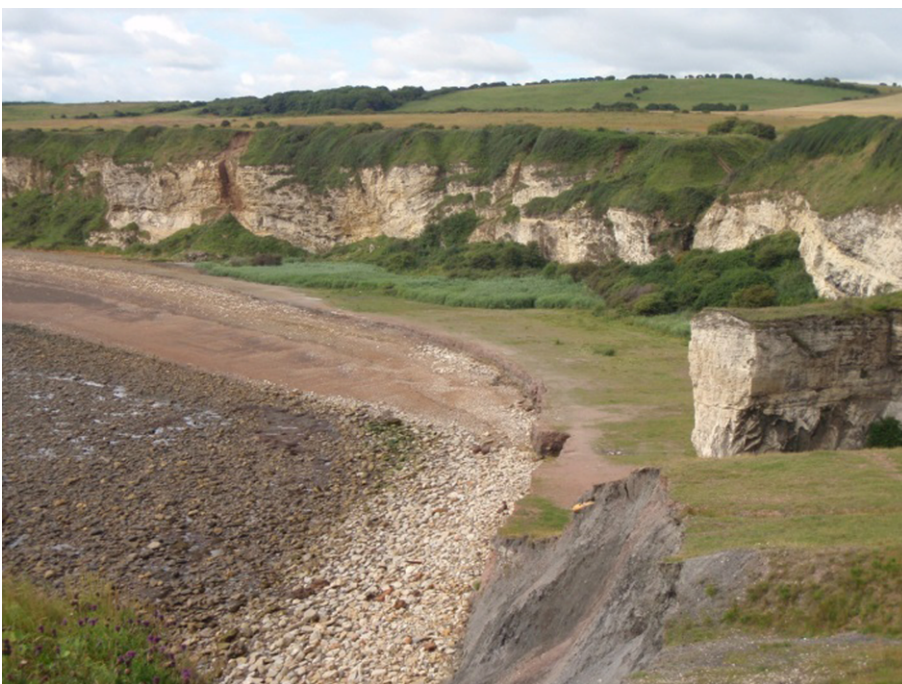
**Fig. 6.** Dawdon Blast Beach. Note the stable sea cliffs to the rear of the wide but retreating spoil beach.

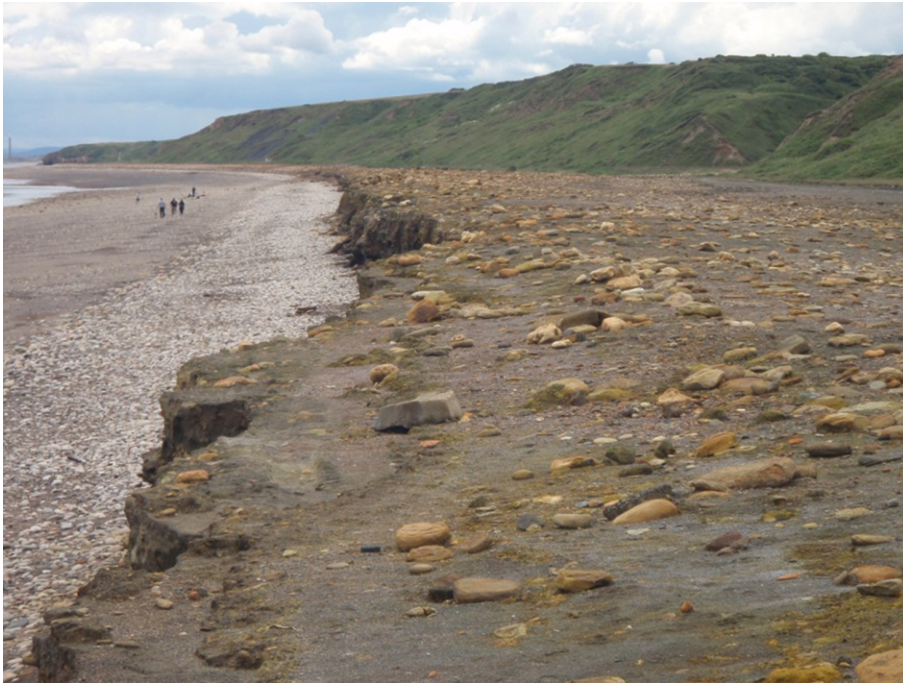
**Fig. 7.** Horden Spoil Beach. Note the wide spoil beach at the toe of the sea cliffs.

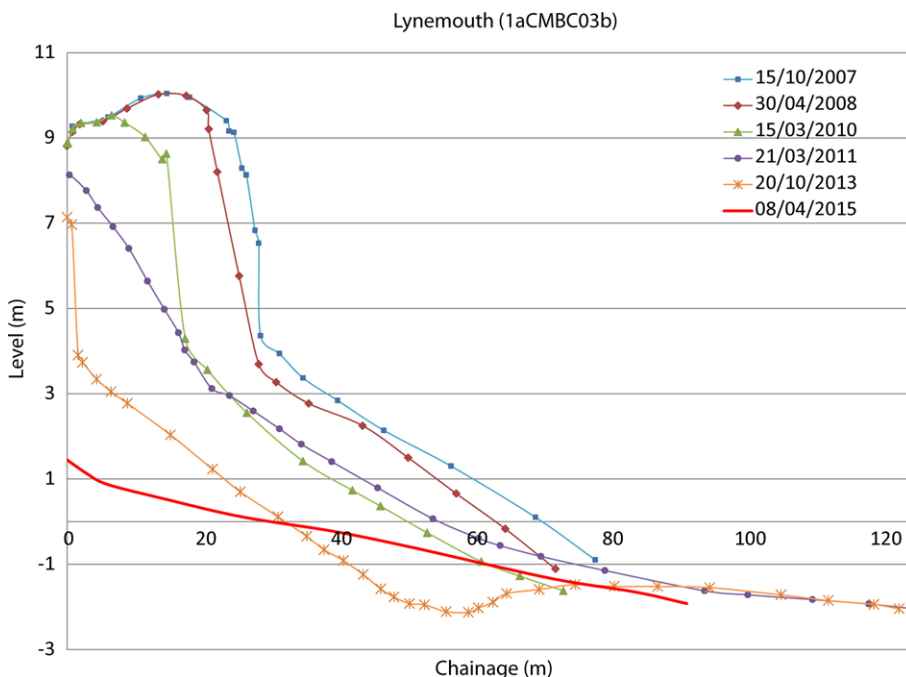
**Fig. 10.** Changes along a beach profile transect in Lynemouth Bay, 2007–2015. Note how each successive survey shows a progressive landward retreat of the spoil 'berm'.

Transect 1aCMB03b in Lynemouth Bay was first surveyed in 2007 and is located in the area of most recent colliery spoil tipping, just to the north of Lynemouth Power Station (Fig. 1). The successive surveys have shown a progressive landward retreat of the 'berm' of the spoil beach of almost 30 m since 2007 (Fig. 10).

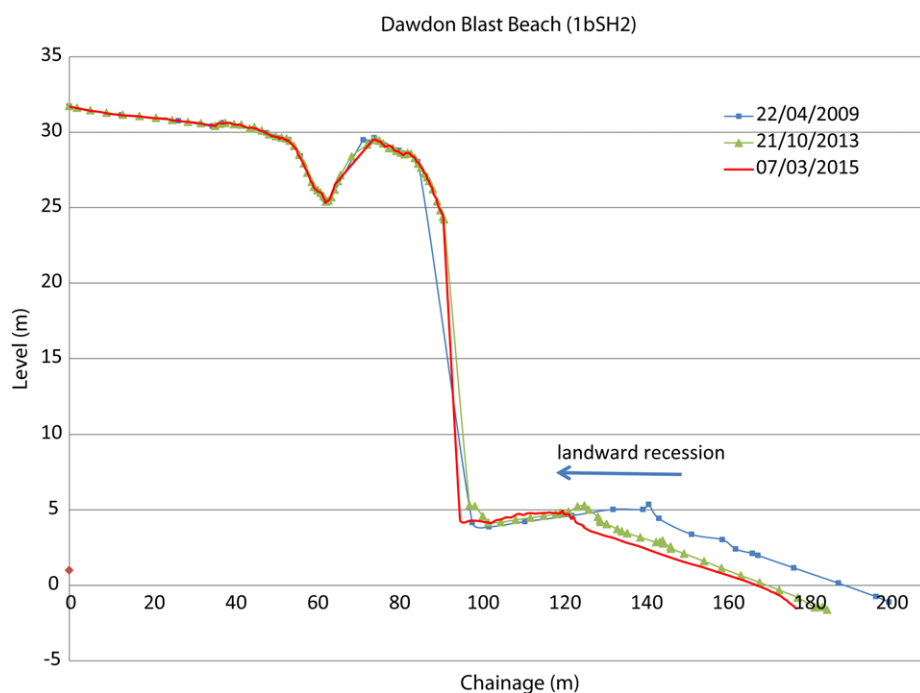
**Fig. 11.** Changes along a beach profile transect at Dawdon Blast Beach, 2009 – 2015. Note how each successive survey shows a progressive landward retreat of the spoil ‘cliff’.

Similar recessional trends have been observed along the County Durham coastline. At Dawdon Blast Beach, for example, the survey transect 1bSH2 (Fig. 1) has exhibited measurable change. The width of colliery spoil has retreated by around 20 m between 2008 and 2015 (Fig. 11). The trend has been of persistent retreat over a number of years, rather than losses due to any single storm event. There is a remaining width of around only 25 m in front of the (present-day) relict cliffs.

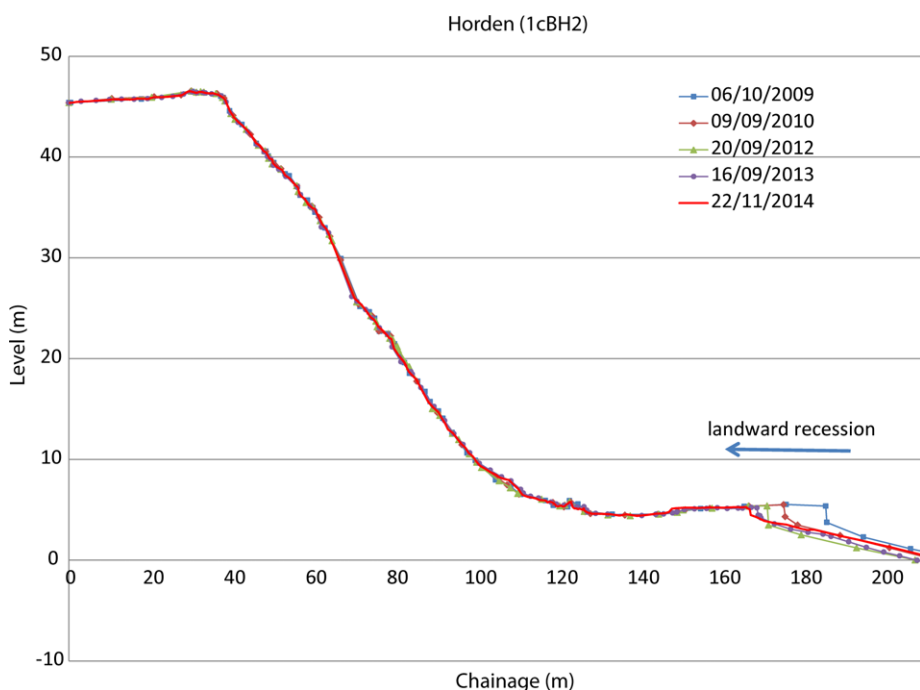
**Fig. 12.** Changes along a beach profile transect at Horden, 2009 – 2014. Note how each successive survey shows a progressive landward retreat of the spoil ‘cliff’.

Similarly, transect 1cBH2 at Horden (Figs 1 and 12) has also shown measurable change in the width of colliery spoil, persistently retreating between successive surveys since records began in 2009. In total, the edge of the spoil has retreated by around 20 m between 2009 and 2014. There is a remaining width of spoil of around 50 m at this point along the frontage.
