COASTAL GEOMORPHOLOGICAL CHANGE IN NORTHEAST ENGLAND: THE ROLE OF REGIONAL-SCALE MONITORING

Nick J. Cooper¹, David S. Brew¹, Greg Guthrie¹, Tanja Cooper¹, Alix Scullion¹, Ewan Richardson¹, Tom Ward¹ and Robin Siddle²

SUMMARY

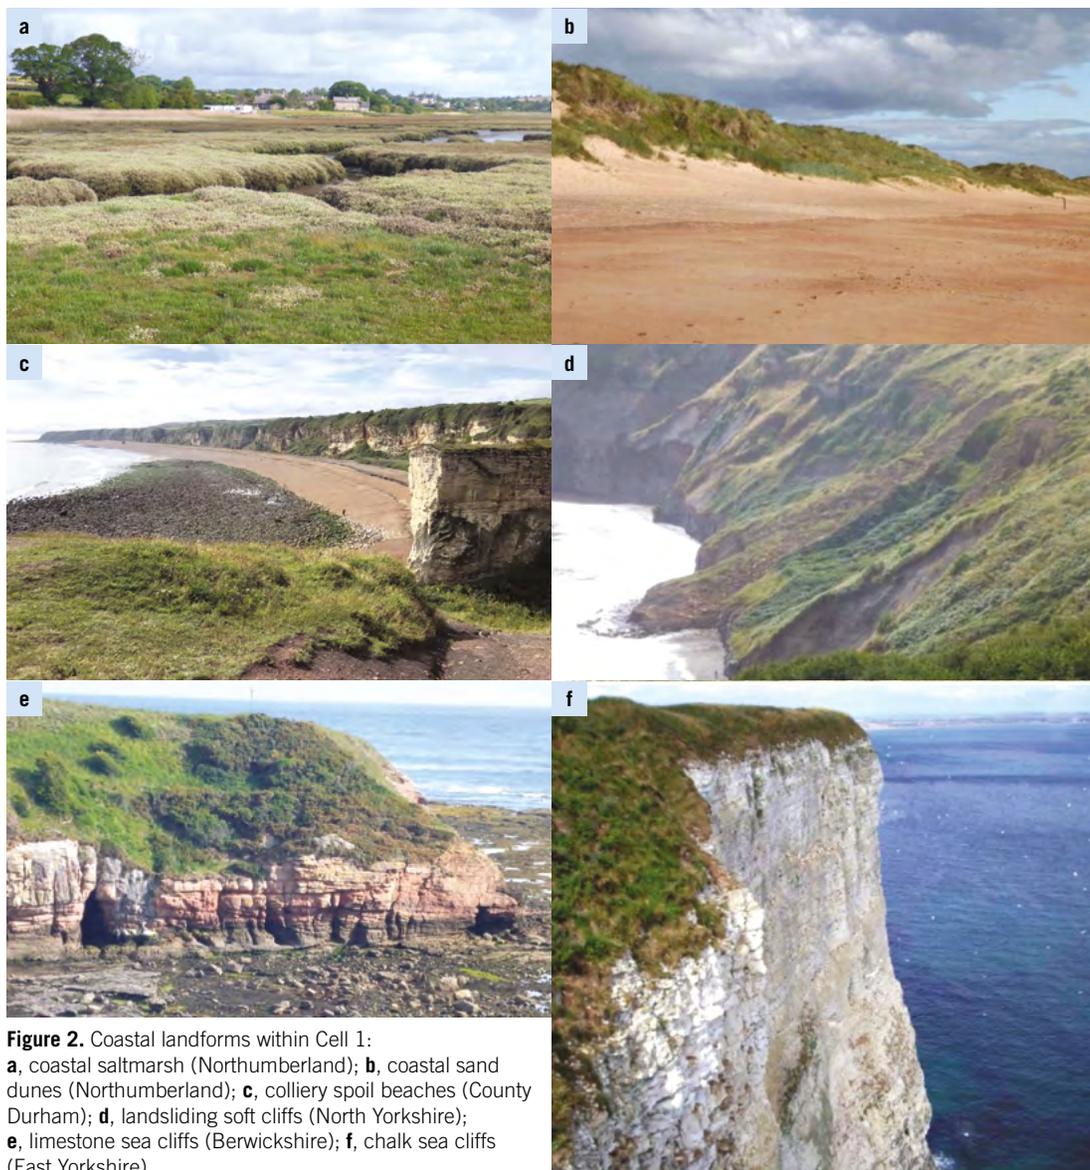
Figure 2. Coastal landforms within Cell 1: **a**, coastal saltmarsh (Northumberland); **b**, coastal sand dunes (Northumberland); **c**, colliery spoil beaches (County Durham); **d**, landsliding soft cliffs (North Yorkshire); **e**, limestone sea cliffs (Berwickshire); **f**, chalk sea cliffs (East Yorkshire).

Within Cell 1, the coastal landforms vary considerably (Figure 2). They variously comprise: low-lying tidal flats with fringing saltmarshes; wide, sweeping sandy beaches backed by coastal dunes; hard rock cliffs that are mantled with glacial till of varying thicknesses; and softer rock cliffs prone to extensive landslides.

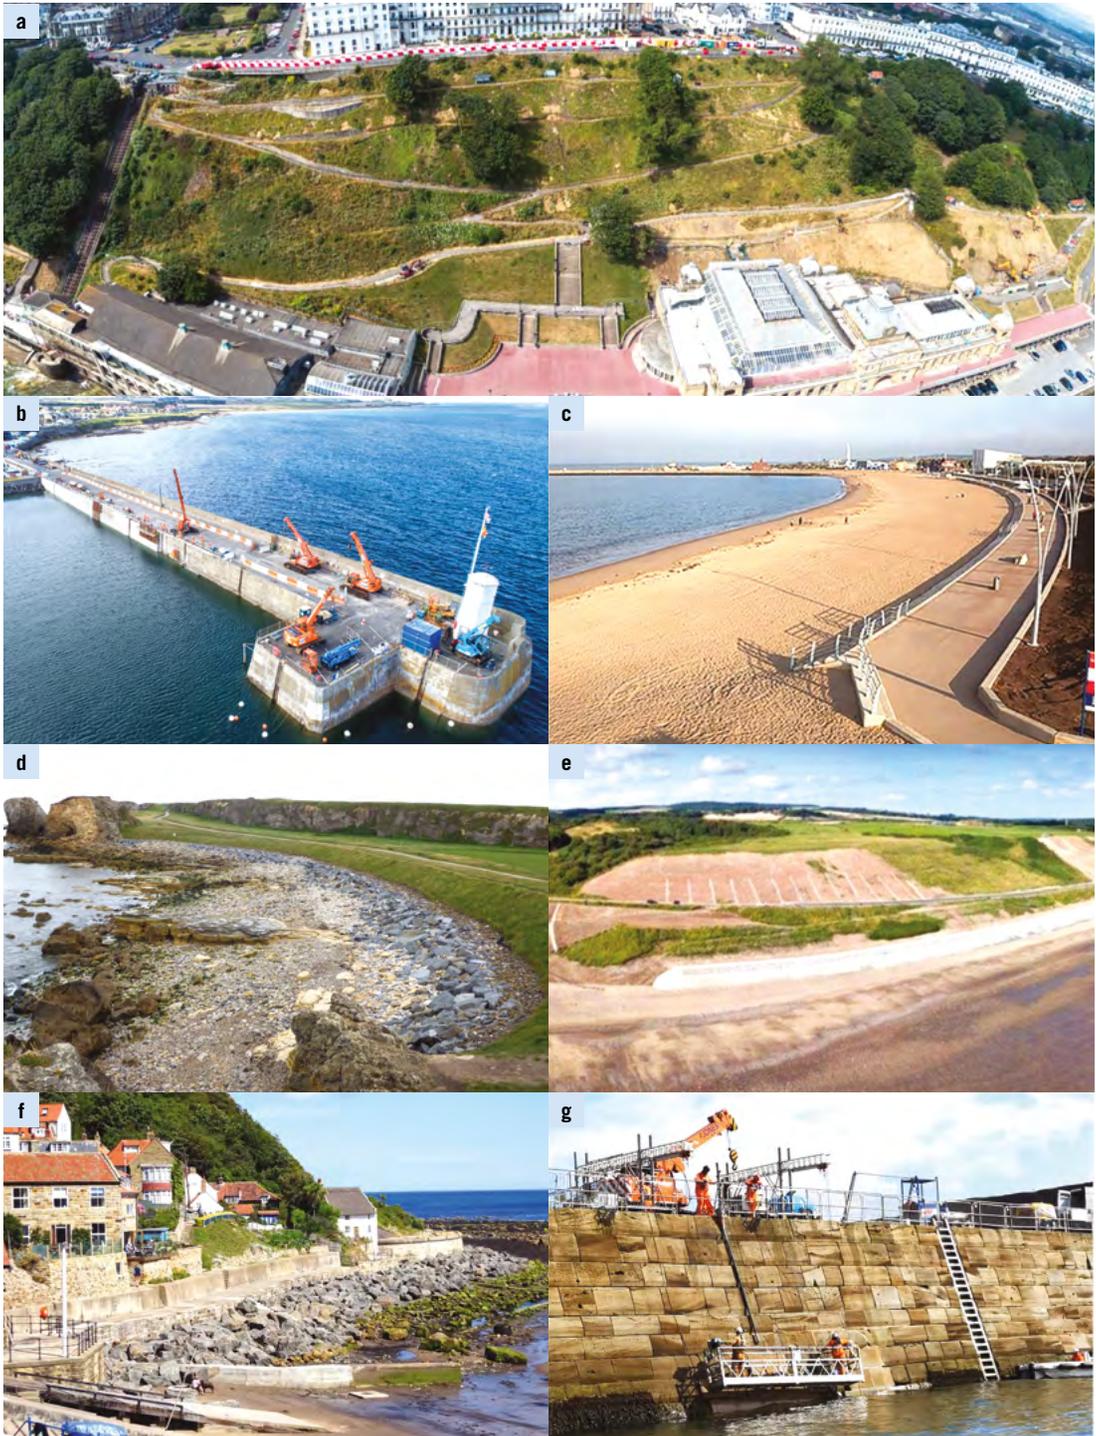
Figure 3. Coastal defences within Cell 1:

a, Scarborough Spa coastal slope stabilisation, North Yorkshire; **b**, Seahouses main pier, Northumberland (image courtesy Balfour Beatty); **c**, Littlehaven Promenade & seawall, South Tyneside; **d**, Trow Quarry, South Tyneside; **e**, Sandsend Road, North Yorkshire; **f**, Runwick Bay, North Yorkshire; **g**, Whitby Harbour Piers, North Yorkshire (image courtesy Balfour Beatty).

There are also many different forms of coastal defence (Figure 3), including offshore breakwaters, revetments, sea walls, harbour piers, and quay walls, as well as different management activities such as beach recharge and sediment recycling, dune management, and adaptation to coastal change (e.g. abandonment and re-wilding, roll-back of coastal footpaths, etc.). Some areas in Northumberland, and through much of County Durham, have been significantly affected by historic tipping of colliery spoil, leading to 'artificial' spoil beaches and cliffs. Cell 1 monitoring commenced in its present form in September 2008 and is managed by Scarborough Borough Council on behalf of the North East Coastal Group. Prior to 2008, coastal monitoring was undertaken on a consistent basis across Northumberland and North Tyneside as part of the (then) Northumbrian Coastal Authorities Group's monitoring programme which commenced in 2002, whilst several authorities elsewhere within Cell 1 undertook their own local monitoring programmes.

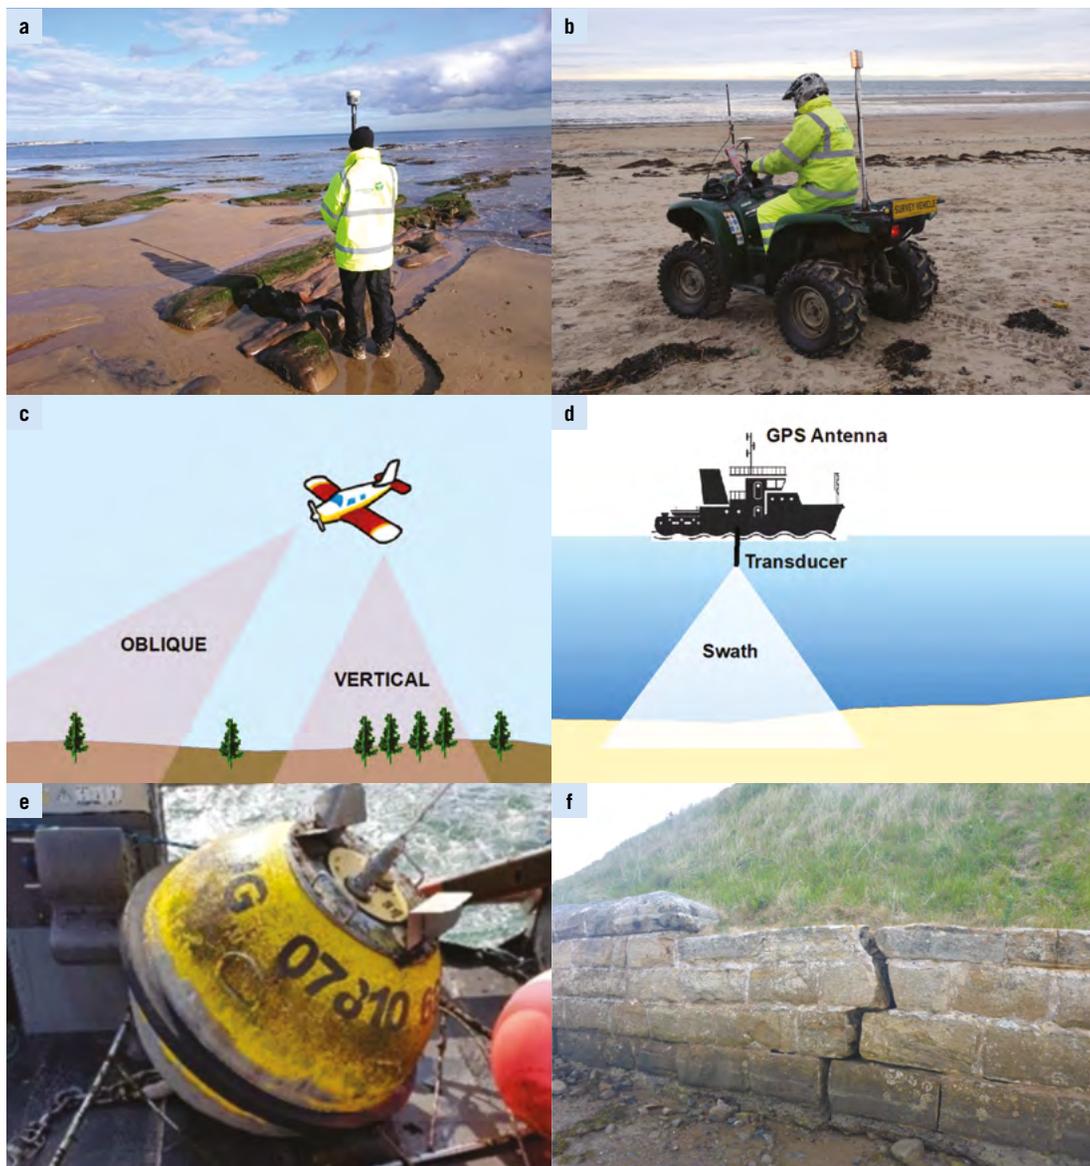
Figure 4. Survey types forming the Cell 1 monitoring:

a, beach profile survey using hand-held GPS (image courtesy Academy Geomatics); **b**, beach topographic survey using quad-bike mounted GPS (image courtesy Academy Geomatics); **c**, vertical and oblique aerial photography; **d**, multi-beam echo sounder bathymetric survey; **e**, wave buoy (image courtesy Fugro); **f**, walkover inspections.

The main elements of the Cell 1 monitoring are (Figure 4):

- beach profile surveys;
- beach topographic surveys;
- cliff-top recession surveys;
- real-time telemetered wave and tidal level data collection;
- bathymetric and sea bed characterisation surveys;
- vertical and oblique aerial photography;
- Light Detection and Range (LiDAR) surveys;
- ecological habitat mapping; and
- walk-over visual inspection surveys of built and natural assets

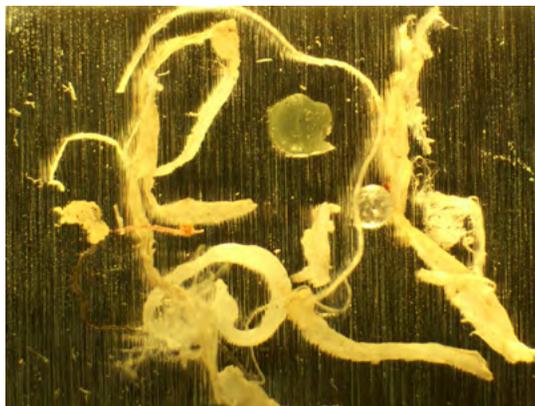
Figure 5. Microplastic fibres, fragments and beads. Image courtesy SOCOTEC.

- The Cell 1 Microplastics Study analysed sea bed sediment samples collected as part of the bathymetric and sea bed characterisation surveys for the quantity and type of microplastics (Figure 5) in the marine environment (See *et al.* 2020).

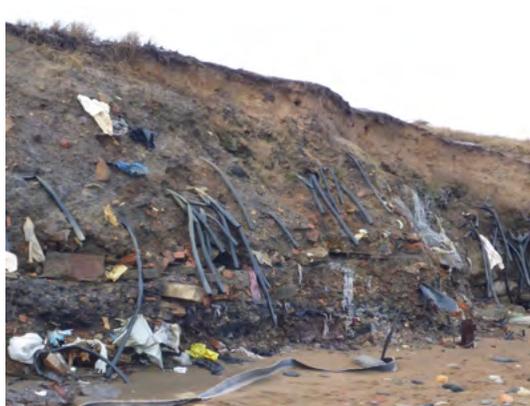
Figure 6. Eroding refuse amongst colliery spoil cliffs at Lynemouth Bay in Northumberland.

- The Cell 1 Coastal Landfills Study (Royal HaskoningDHV, 2019) assessed the risks from coastal change to identified historic landfill sites within the region (Figure 6), leading to development of a capital scheme to manage eroding refuse at Lynemouth Bay in Northumberland.

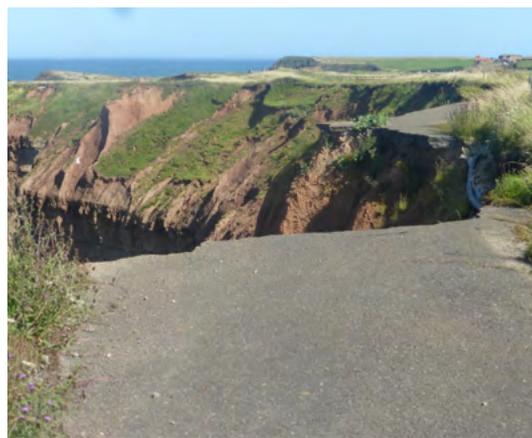
Figure 8. Coastal erosion in superficial (drift) geological deposits at Cowbar in Redcar & Cleveland.

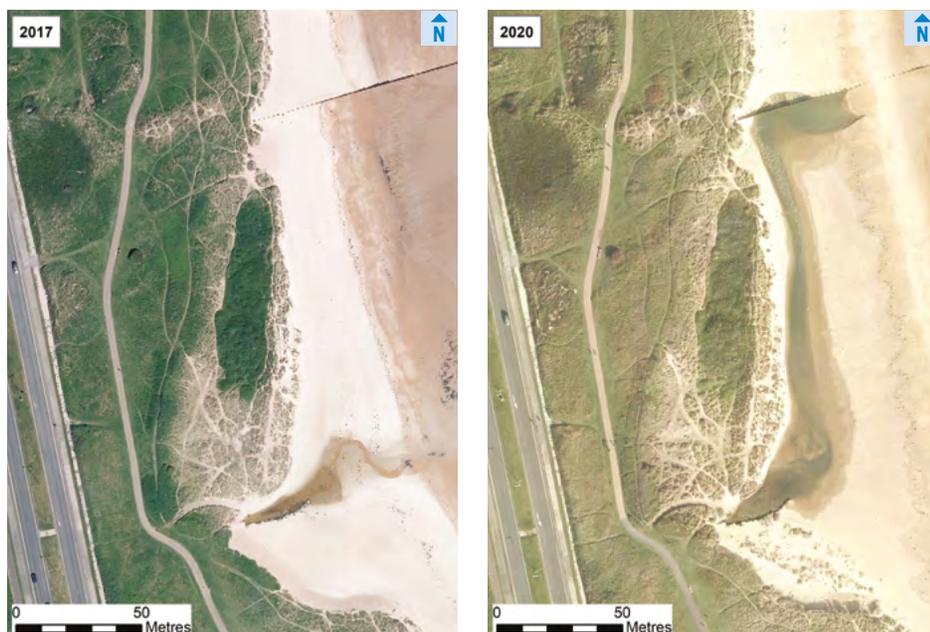
Figure 9. Changing course of a small beck across the foreshore at Meggies Burn in Northumberland, between 2017 (left) and 2019/20 (right).

The captured aerial photography is also useful in understanding ongoing morphological changes. Whilst the larger estuaries of the Rivers Tweed, Tyne, Wear, Tees and Esk have breakwater and pier control structures at their mouths, many of the small river channels and becks which drain into the North Sea within Cell 1 are unconstrained at their mouths and can adopt differing courses dependent upon preceding physical conditions such as rainfall (affecting river spate) or sea storms (affecting beach changes). In some locations the changing course of these channels across the foreshore can increase, or conversely reduce, exposure to erosion processes along the toe of adjacent dunes or lead to undermining of nearby coastal structures. An example is shown in Figure 9, where the course of small beck has change alignment along a beach at Meggies Burn in Northumberland.

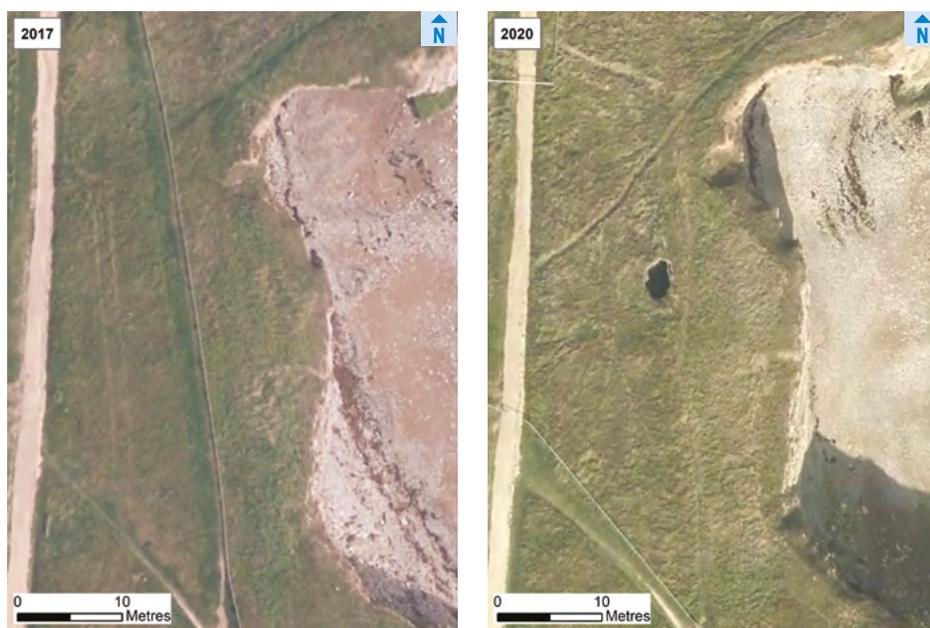
Figure 10. Opening of a 'sink hole' in the cliff top at Whitburn Coastal Park in South Tyneside, between 2017 (left) and 2019/20 (right).

In some areas, the cliffs are experiencing cave formation at their bases and when these caves penetrate deep into the rock structure, it can lead to wash-out of softer material behind and the

formation of 'sink holes' in the cliff top land. Figure 10 shows an example from Whitburn Coastal Park in South Tyneside, where a sink hole opened between 2017 and 2019/20.

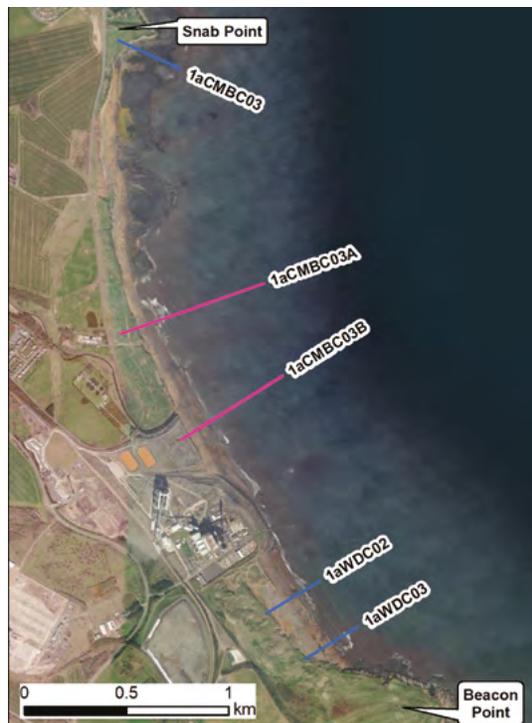
Figure 15. Beach profile survey locations in Lynemouth Bay.

Lynemouth Bay extends between Snab Point in the north and Beacon Point in the south, and is intercepted by the narrow, unconstrained channel of the River Lyne (Figure 15). The beaches in Lynemouth Bay experienced extensive tipping of colliery spoil from 1934 to 2005, resulting in an artificially advanced shoreface, which led to subsequent land-claim and development of the Lynemouth Power Station and coal stocking yard.

Monitoring of coastal change in Lynemouth Bay has been undertaken as part of the Cell 1 monitoring (or its predecessor programme across Northumberland) since 2002, with aerial photography and beach profile surveys. Various profiles have been added or removed over time and the location of these profiles is shown in Figure 15. Annual average erosion rates, based upon the most up to date data, are shown in Table 1.
