## **Cell 1 Regional Coastal Monitoring Programme**

Halliwell Banks

Reference: PC9150-RHD-ZZ-XX-RP-Z-0001

Document title: Cell 1 Regional Coastal Monitoring Programme

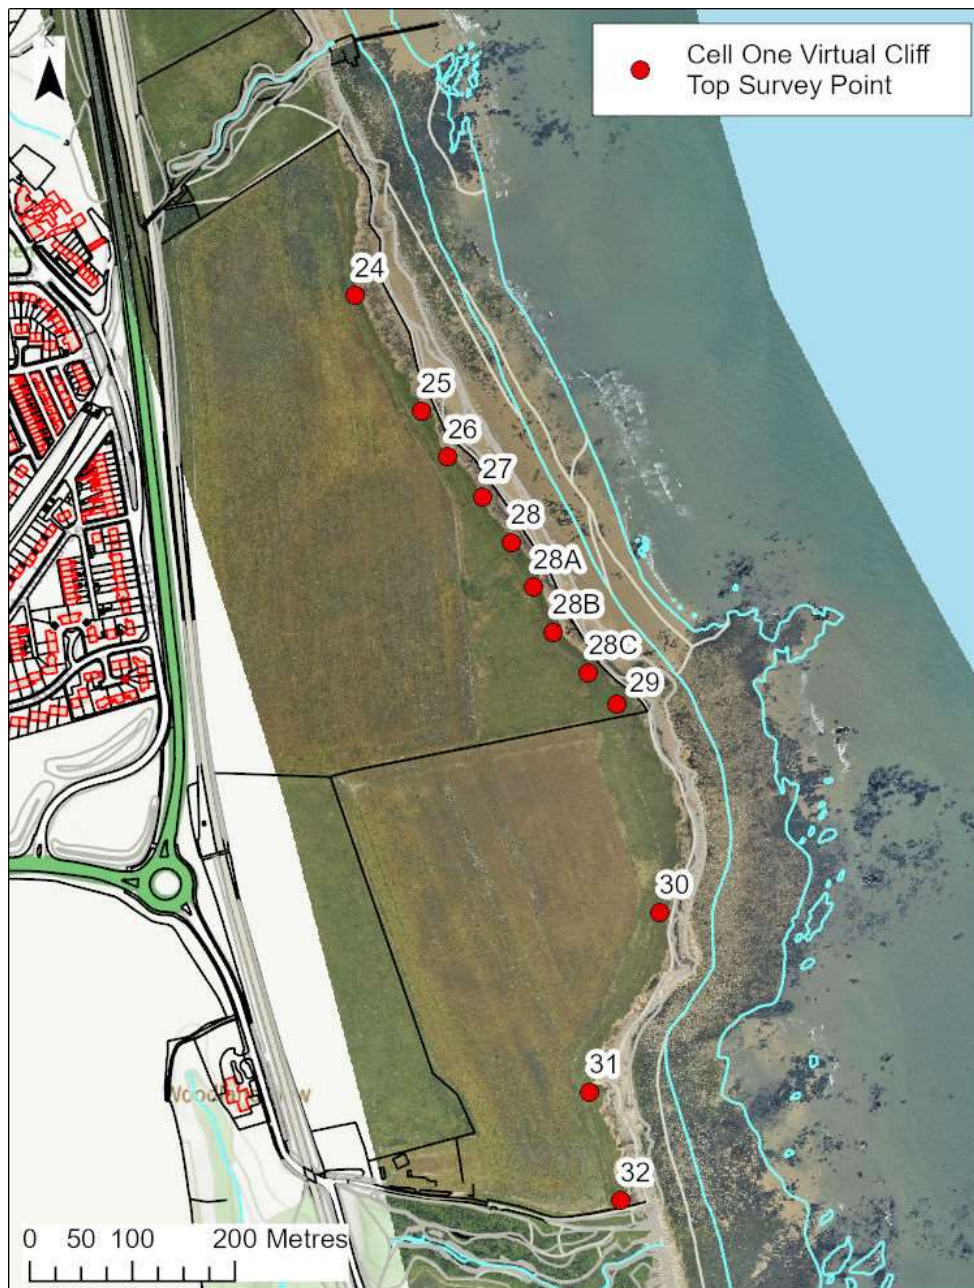
**Figure 5.3 - Cell One Virtual Cliff Top Survey Points**

There are twelve Cell One Virtual Cliff Top Survey Points that fall into the area of interest near Halliwell Banks, namely points 24 to 32, as shown in Figure 5.3. Each of these points is being surveyed twice a year, the first survey was carried out in Spring 2009 (with the exception of points 28A to 28C that were surveyed for the first time in Autumn 2009), and the most recent survey has been undertaken in Spring 2022.

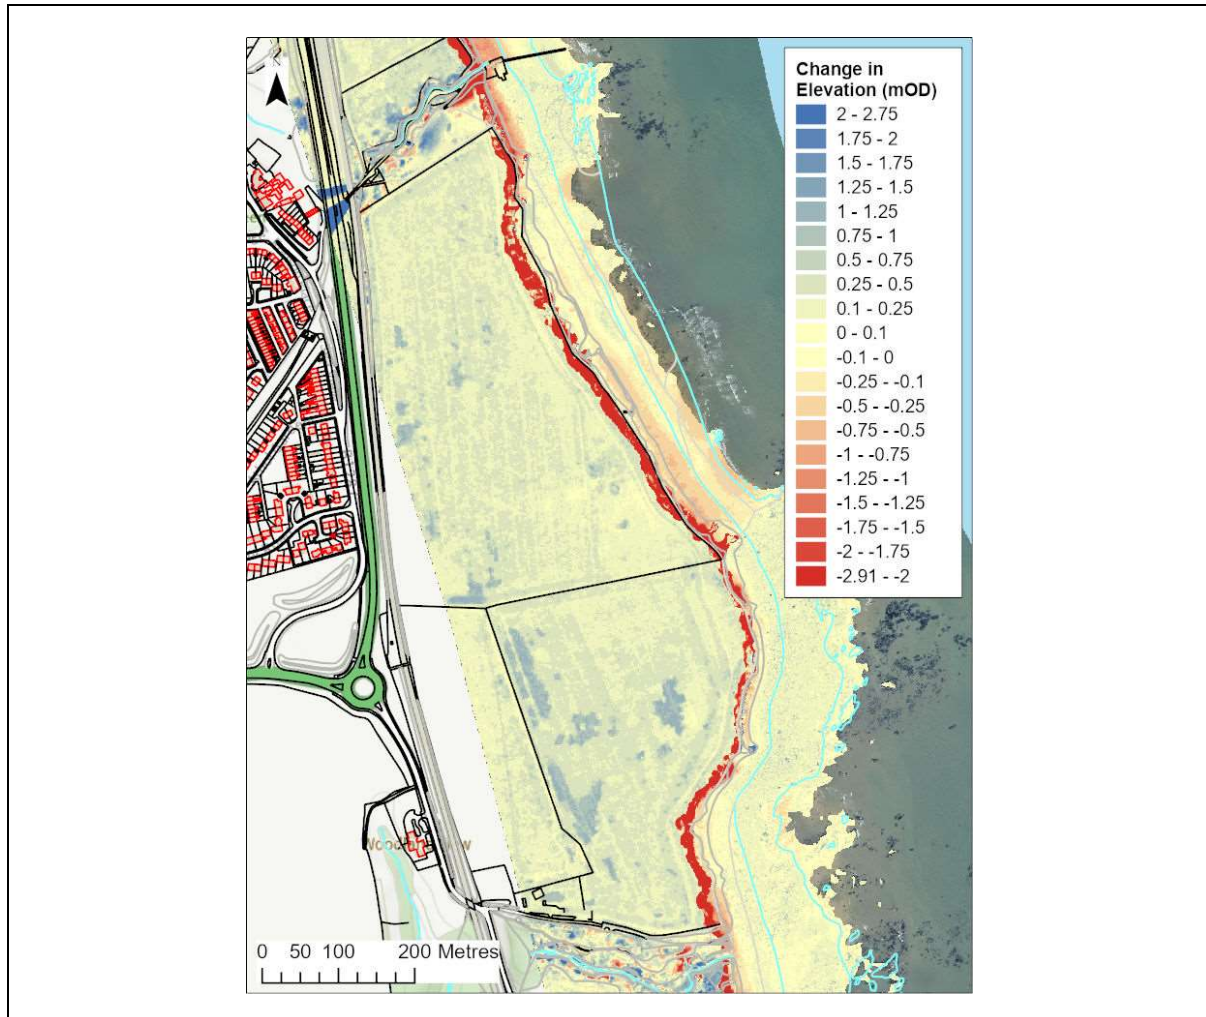
**Figure 5.5 - Change in elevation between 2010 and 2021**  
(areas in red = erosion, areas in blue = accretion)

A difference in the topography between each survey is shown in Figure 5.5. Note the band of erosion (red) all along the cliff edge, indicating ongoing recession over this period of time.

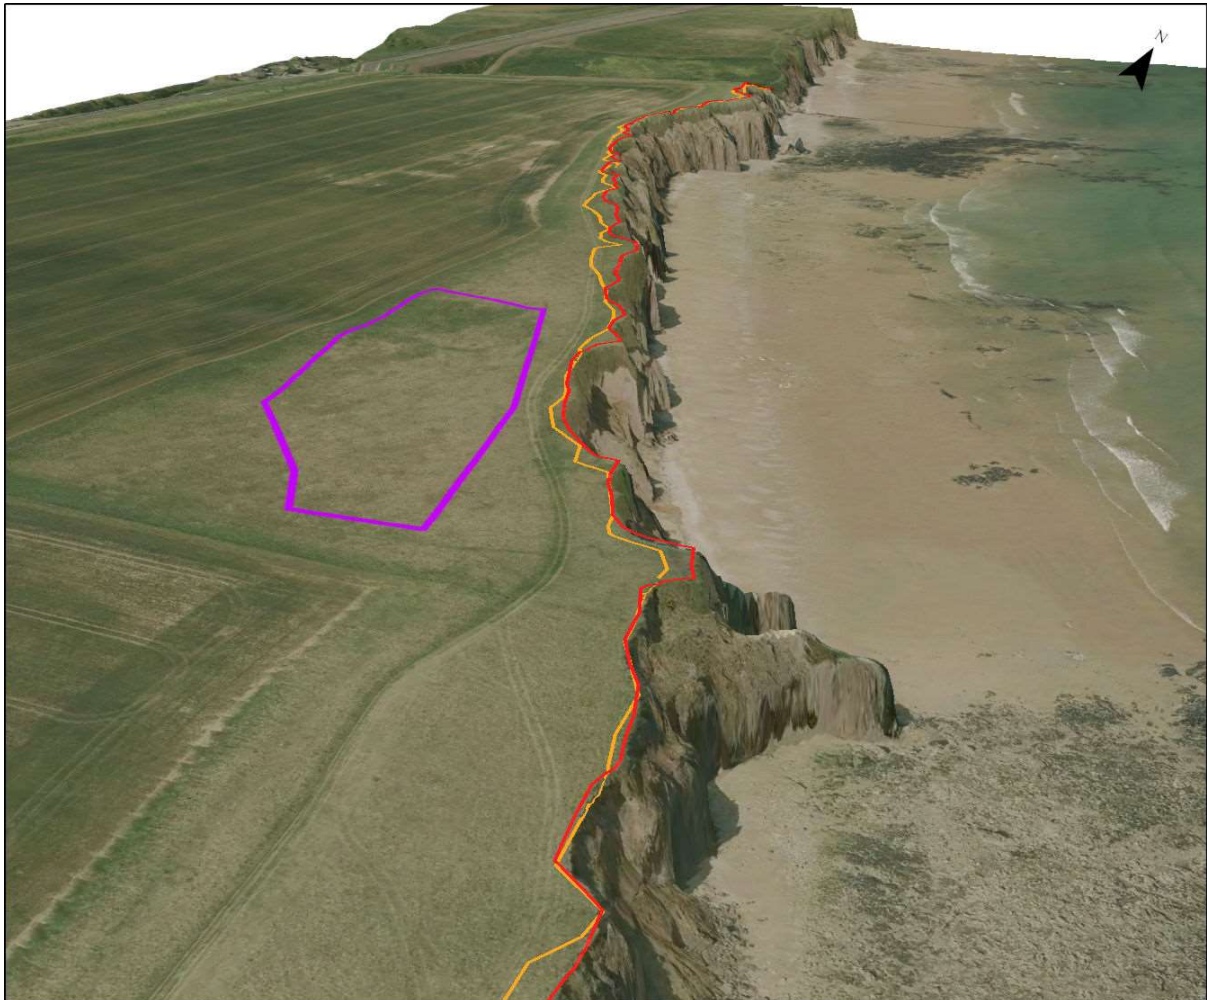
**Figure 5.8 – Cliff top position in 2010 (red) and 2021 (orange) superimposed upon 2010 aerial imagery**

The 2008 study's assumed landfill area of investigation can also be plotted in association with the aerial imagery and an oblique view created. This is done for 2010 and 2021 in Figure 5.8 and Figure 5.9, respectively. Note that changes between the images can best be viewed by opening and scrolling between the provided JPG images of the plots.

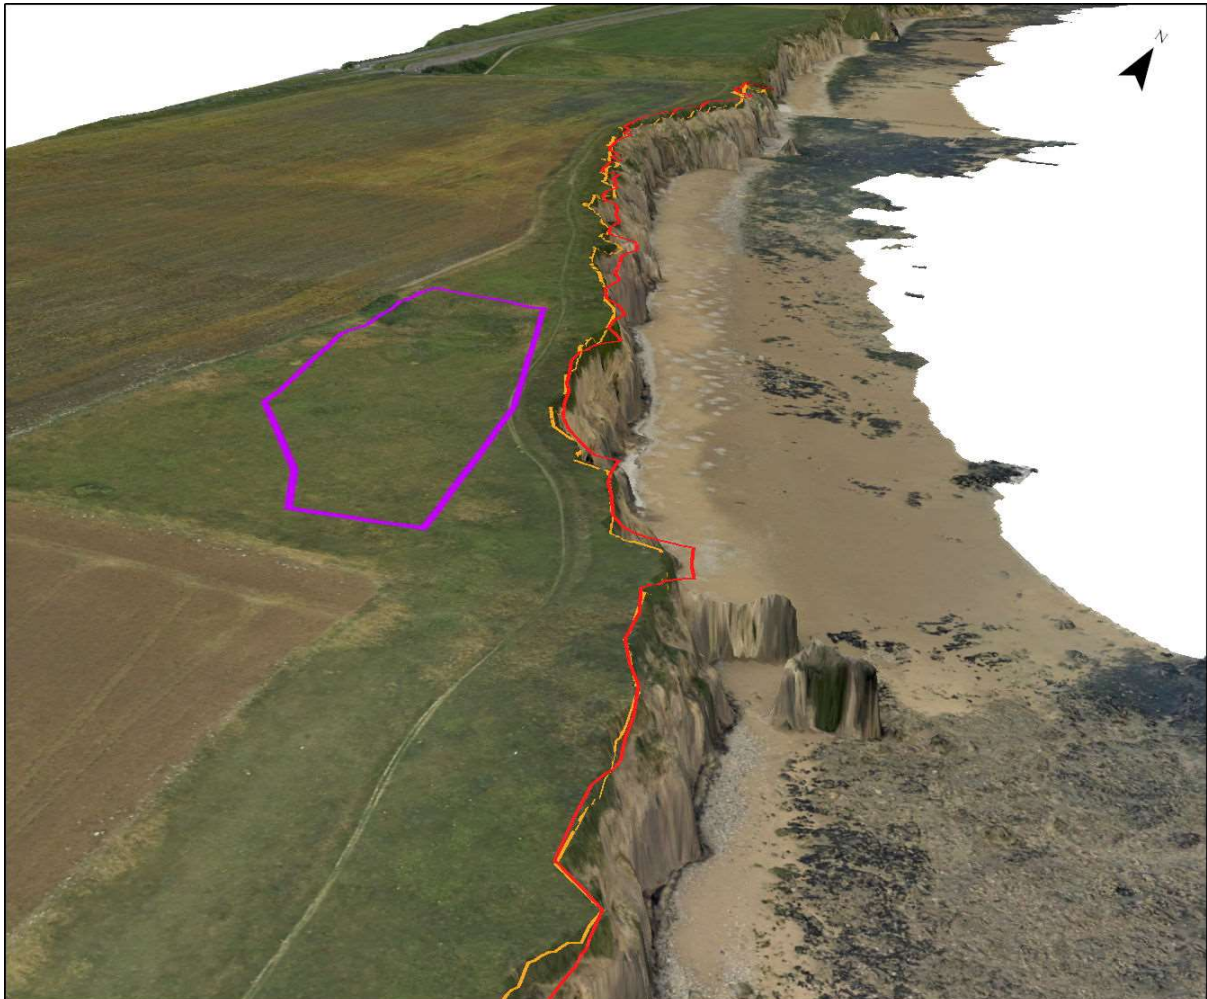
**Figure 5.9 – Cliff top position in 2010 (red) and 2021 (orange) superimposed upon 2021 aerial imagery**
