Cell 1 Regional Coastal Monitoring Programme Lynemouth Laserscan Surveys 2018-19

This report relates to the laserscan surveys of Lynemouth Bay in Northumberland from 2018 and 2019.

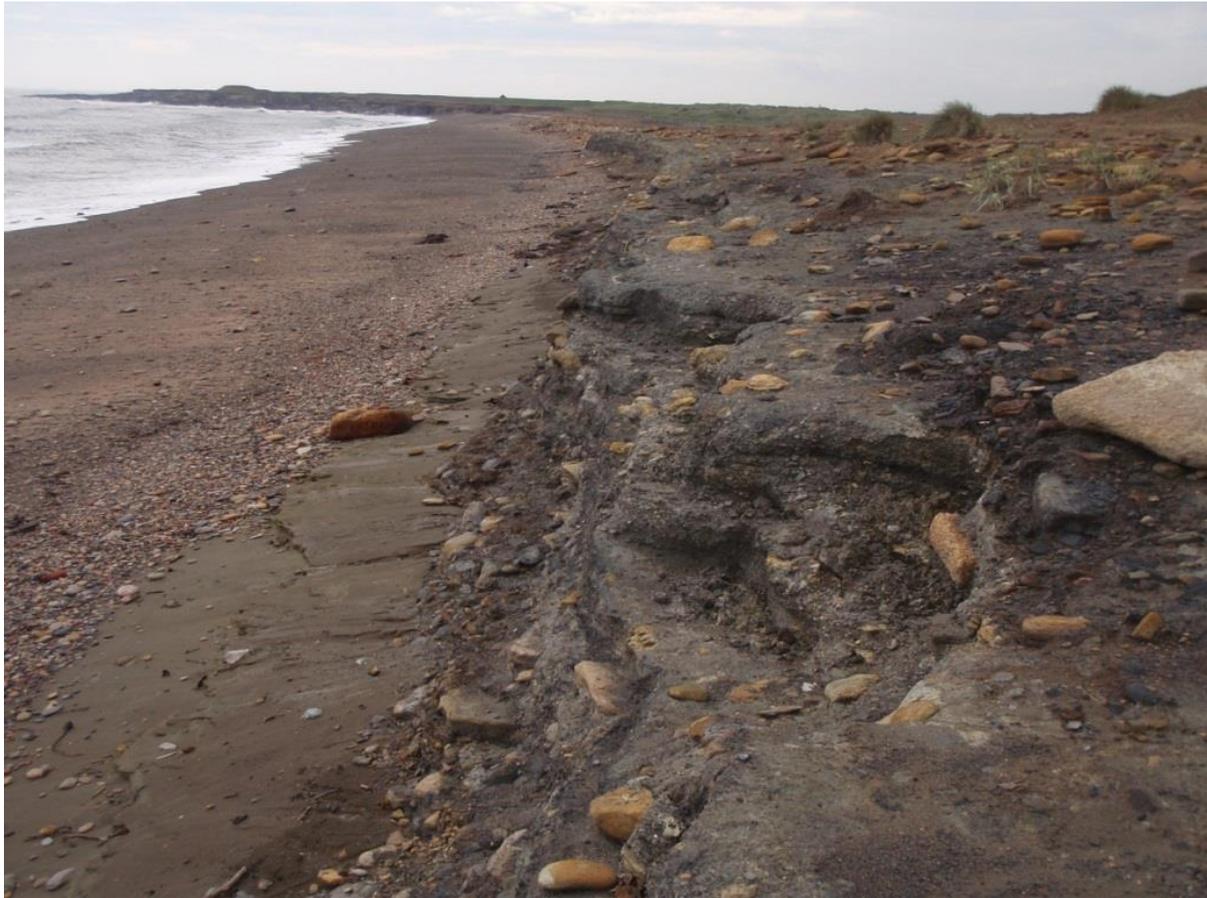
It is important to note that in undefended sections of the bay, erosion of the artificial beaches continues to the present day at measurable rates (Figure 2). The Cell 1 Regional Coastal Monitoring Programme is capturing these changes through walkover inspections, aerial photography and beach surveys, whilst the Cell 1 Landfill Study (Royal HaskoningDHV, 2019) has also considered the erosion of the colliery spoil and other associated wastes within the Bay.

Figure 2 – Erosion of colliery spoil beach, Lynemouth Bay

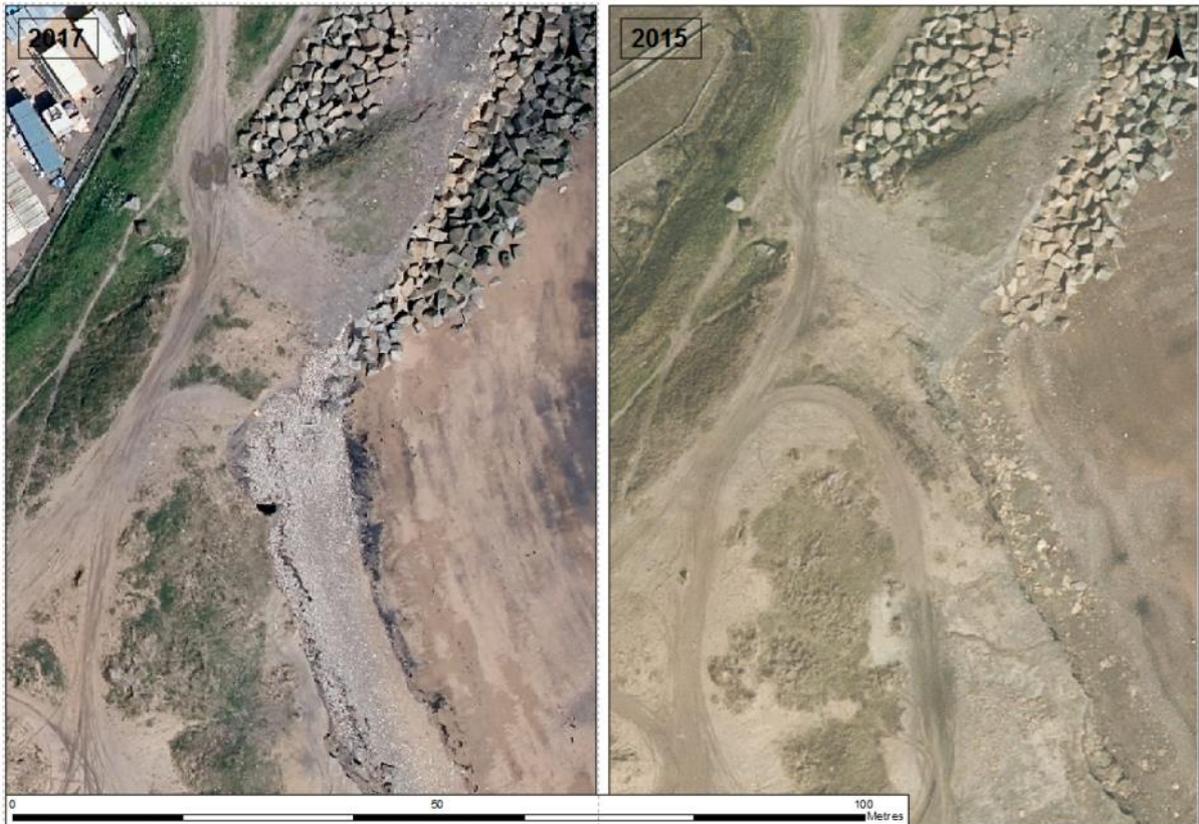
Over the winter of 2017/18, considerable erosion of the cliff line of colliery spoil to the immediate south of the Power Station was observed. The aerial photography captured as part of the Cell 1 Regional Coastal Monitoring Programme clearly shows that erosion at this location was measurable between 2015 and 2017 (Figure 3). Across this area, typically 15m of spoil was lost over those 2 years. Initially this presented concerns about potential outflanking of the revetment protecting the Power Station but subsequent investigations revealed that when the revetment was built, a tie-in section of revetment was also constructed, but this subsequently became buried by continued colliery spoil tipping. Ongoing erosion of the spoil will eventually expose the original tie-in structure, which would then provide continued defence to the Power Station. Notwithstanding this, a decision was made to monitor any erosion of the cliff line of colliery spoil adjacent to the revetment over the winter of 2018/19 to determine if any further erosion had occurred. This report covers the findings of two laserscan surveys over this period.

Figure 3 – Coastal erosion at the southern end of the Lynemouth rock revetment

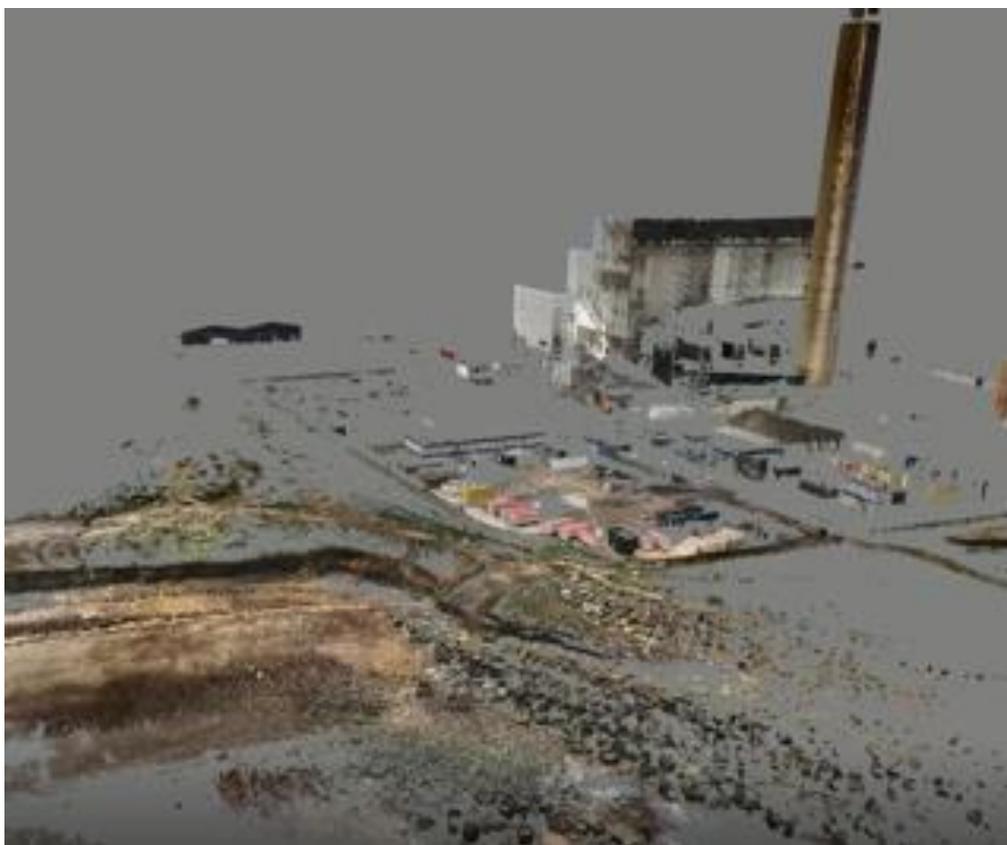
A Scanimation showing a visualization flyover of the 13/09/2018 survey was provided at the time of that survey.

Figure 4 – Scanimation of the 2018 survey

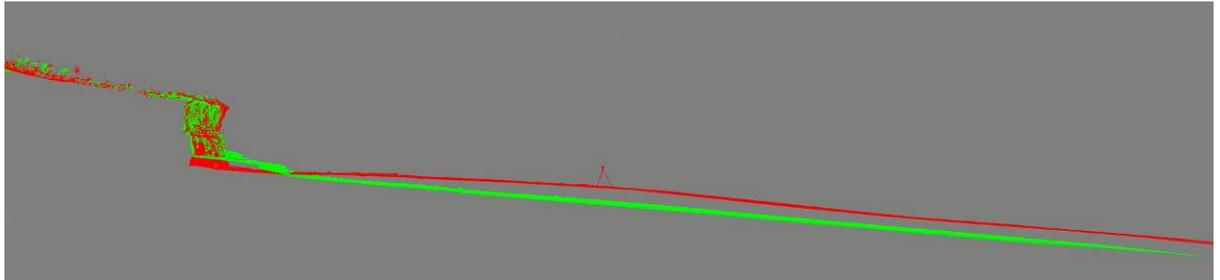
Results show that there was an accumulation of a small volume of material generally along the colliery spoil beach to the south of the Power Station across a short cross-shore width of upper beach, but a more widespread trend of beach lowering over the winter of 2018/19 (Figures 5 and 6). The scale of change is consistent with previous beach surveys and is likely to be caused by storm waves over the winter reducing the beach profile in level and volume. It is envisaged that over the summer of 2019, beach levels will rebuild slowly but progressively back towards September 2018 levels.

Figure 5 – Cross-section comparison of September 2018 (red) and April 2019 (green) laserscan surveys

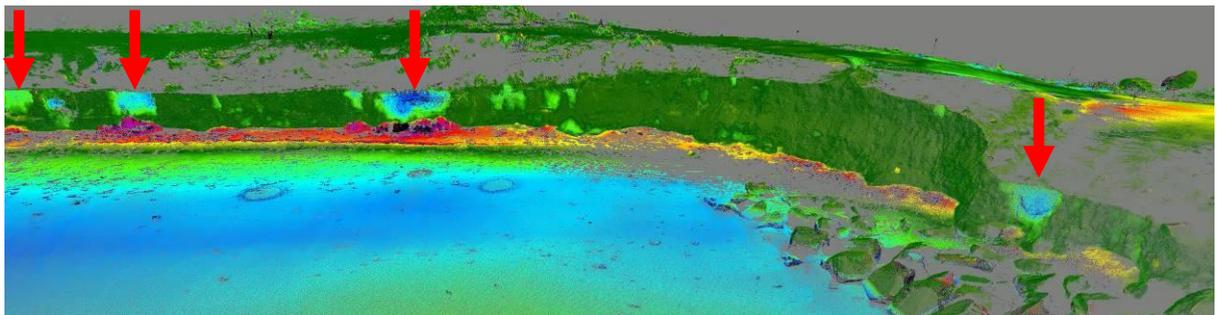
There were also four areas south of the Power Station where cliff collapses occurred over the winter of 2018/19 (Figure 6). One of these areas was immediately behind the existing revetment but involved only a small local collapse of cliff and is not compromising the integrity of the defence. The other collapses, one larger and two very small, were located further south of the revetment along the undefended colliery spoil cliff line. In all cases, areas of distinct material loss can be seen from the cliff face (green and blue areas in Figure 6), with debris accumulating at the cliff toe (red and purple areas in Figure 7). It is anticipated that this debris will be relatively quickly washed away by marine action, suggested that the collapses occurred relatively shortly prior to the April 2019 survey.

Figure 5 – Orthophoto of changes over winter 2018/19 (blue and green = erosion; yellow, orange, red and cerise = accretion)
