Cell 1 Regional Coastal Monitoring Programme
Update Report 12: 'Partial Measures' Survey 2020

South Tyneside Council

South Tyneside Council
June 2020

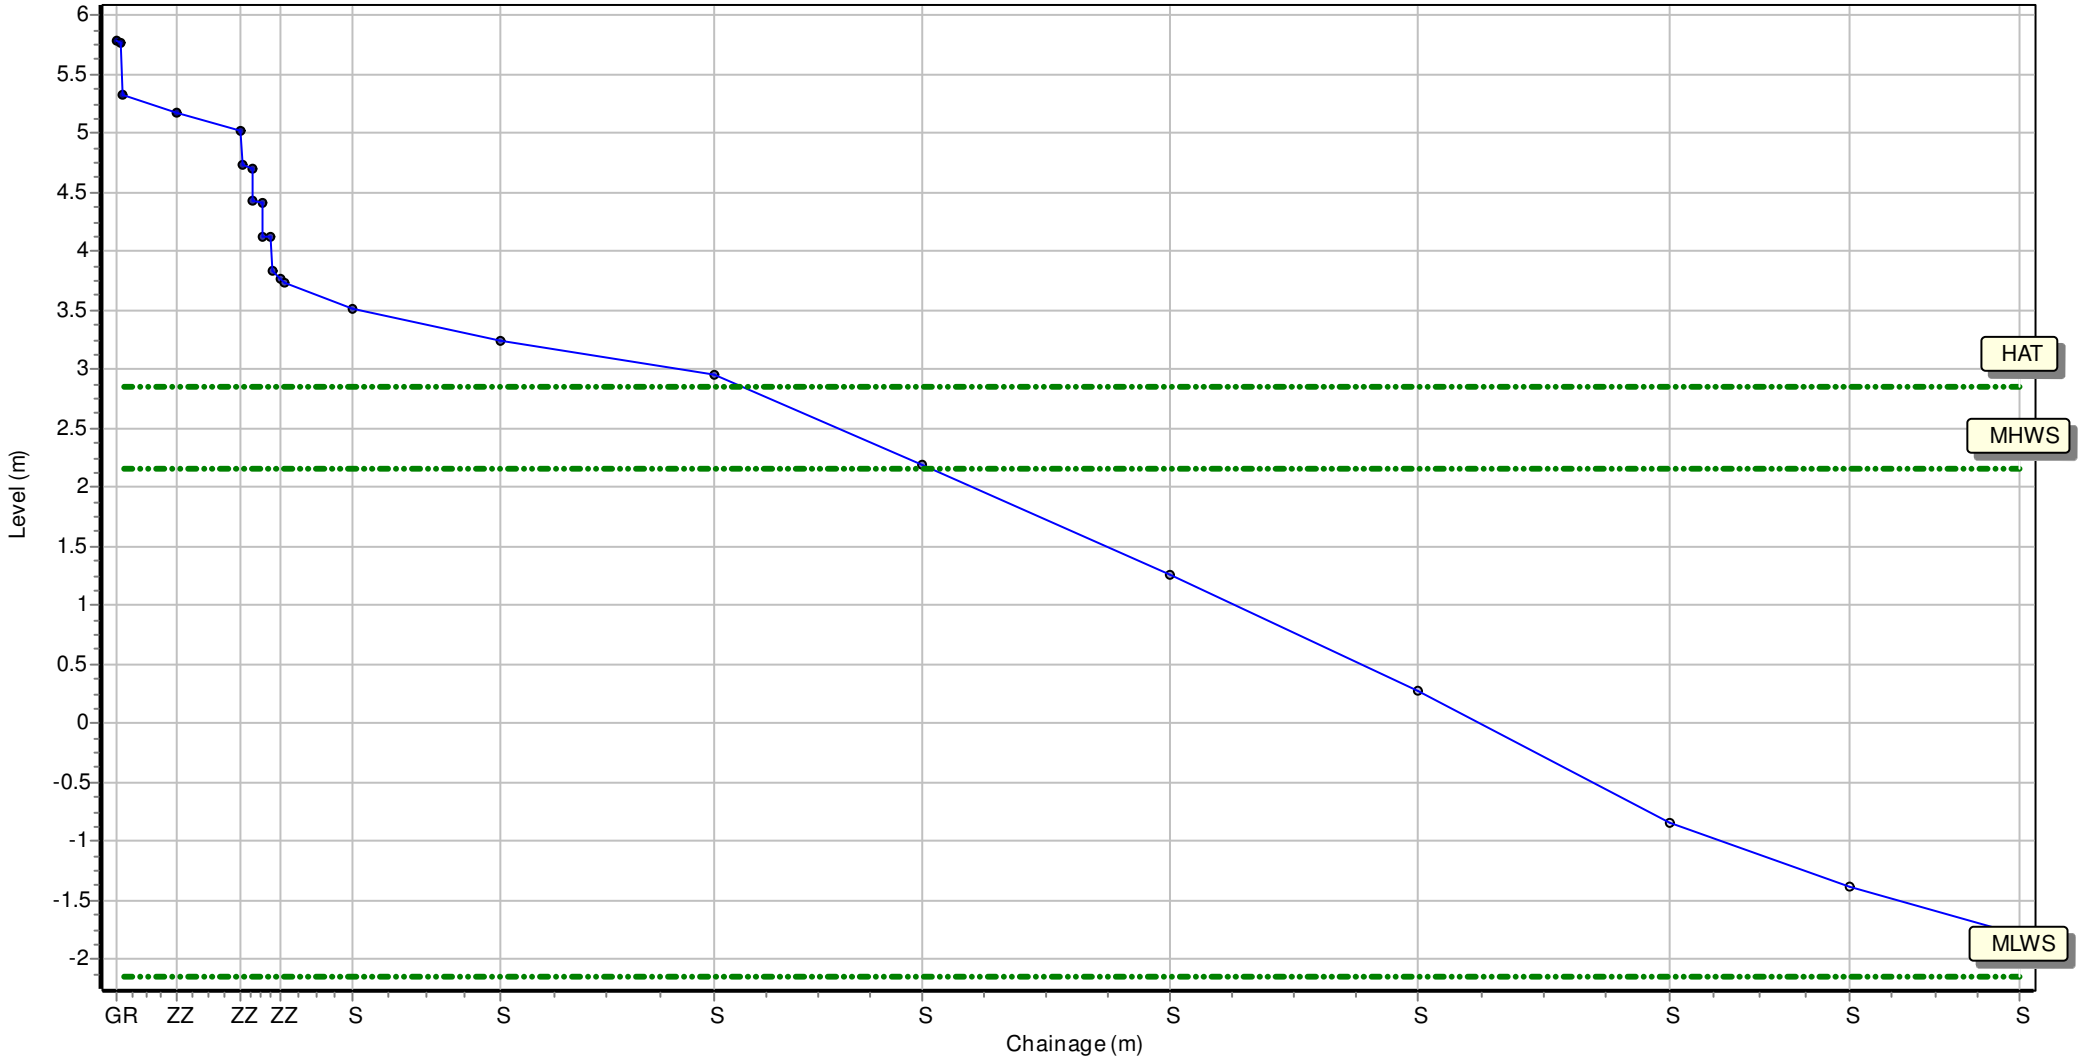
Location: **1bSS2**

- A section of cliff face could not be surveyed at profile 1bSS14 due to ground conditions being unsafe.
- There was an area that could not be surveyed at profile 1bSS2 due to regrading of the beach.
