Cell 1 Regional Coastal Monitoring Programme Analytical Report 15: 'Full Measures' Survey 2022

Sunderland City Council

February 2023

(*) The present report is **Analytical Report 15** and provides an analysis of the 2022 Full Measures survey for Sunderland City Council's frontage.

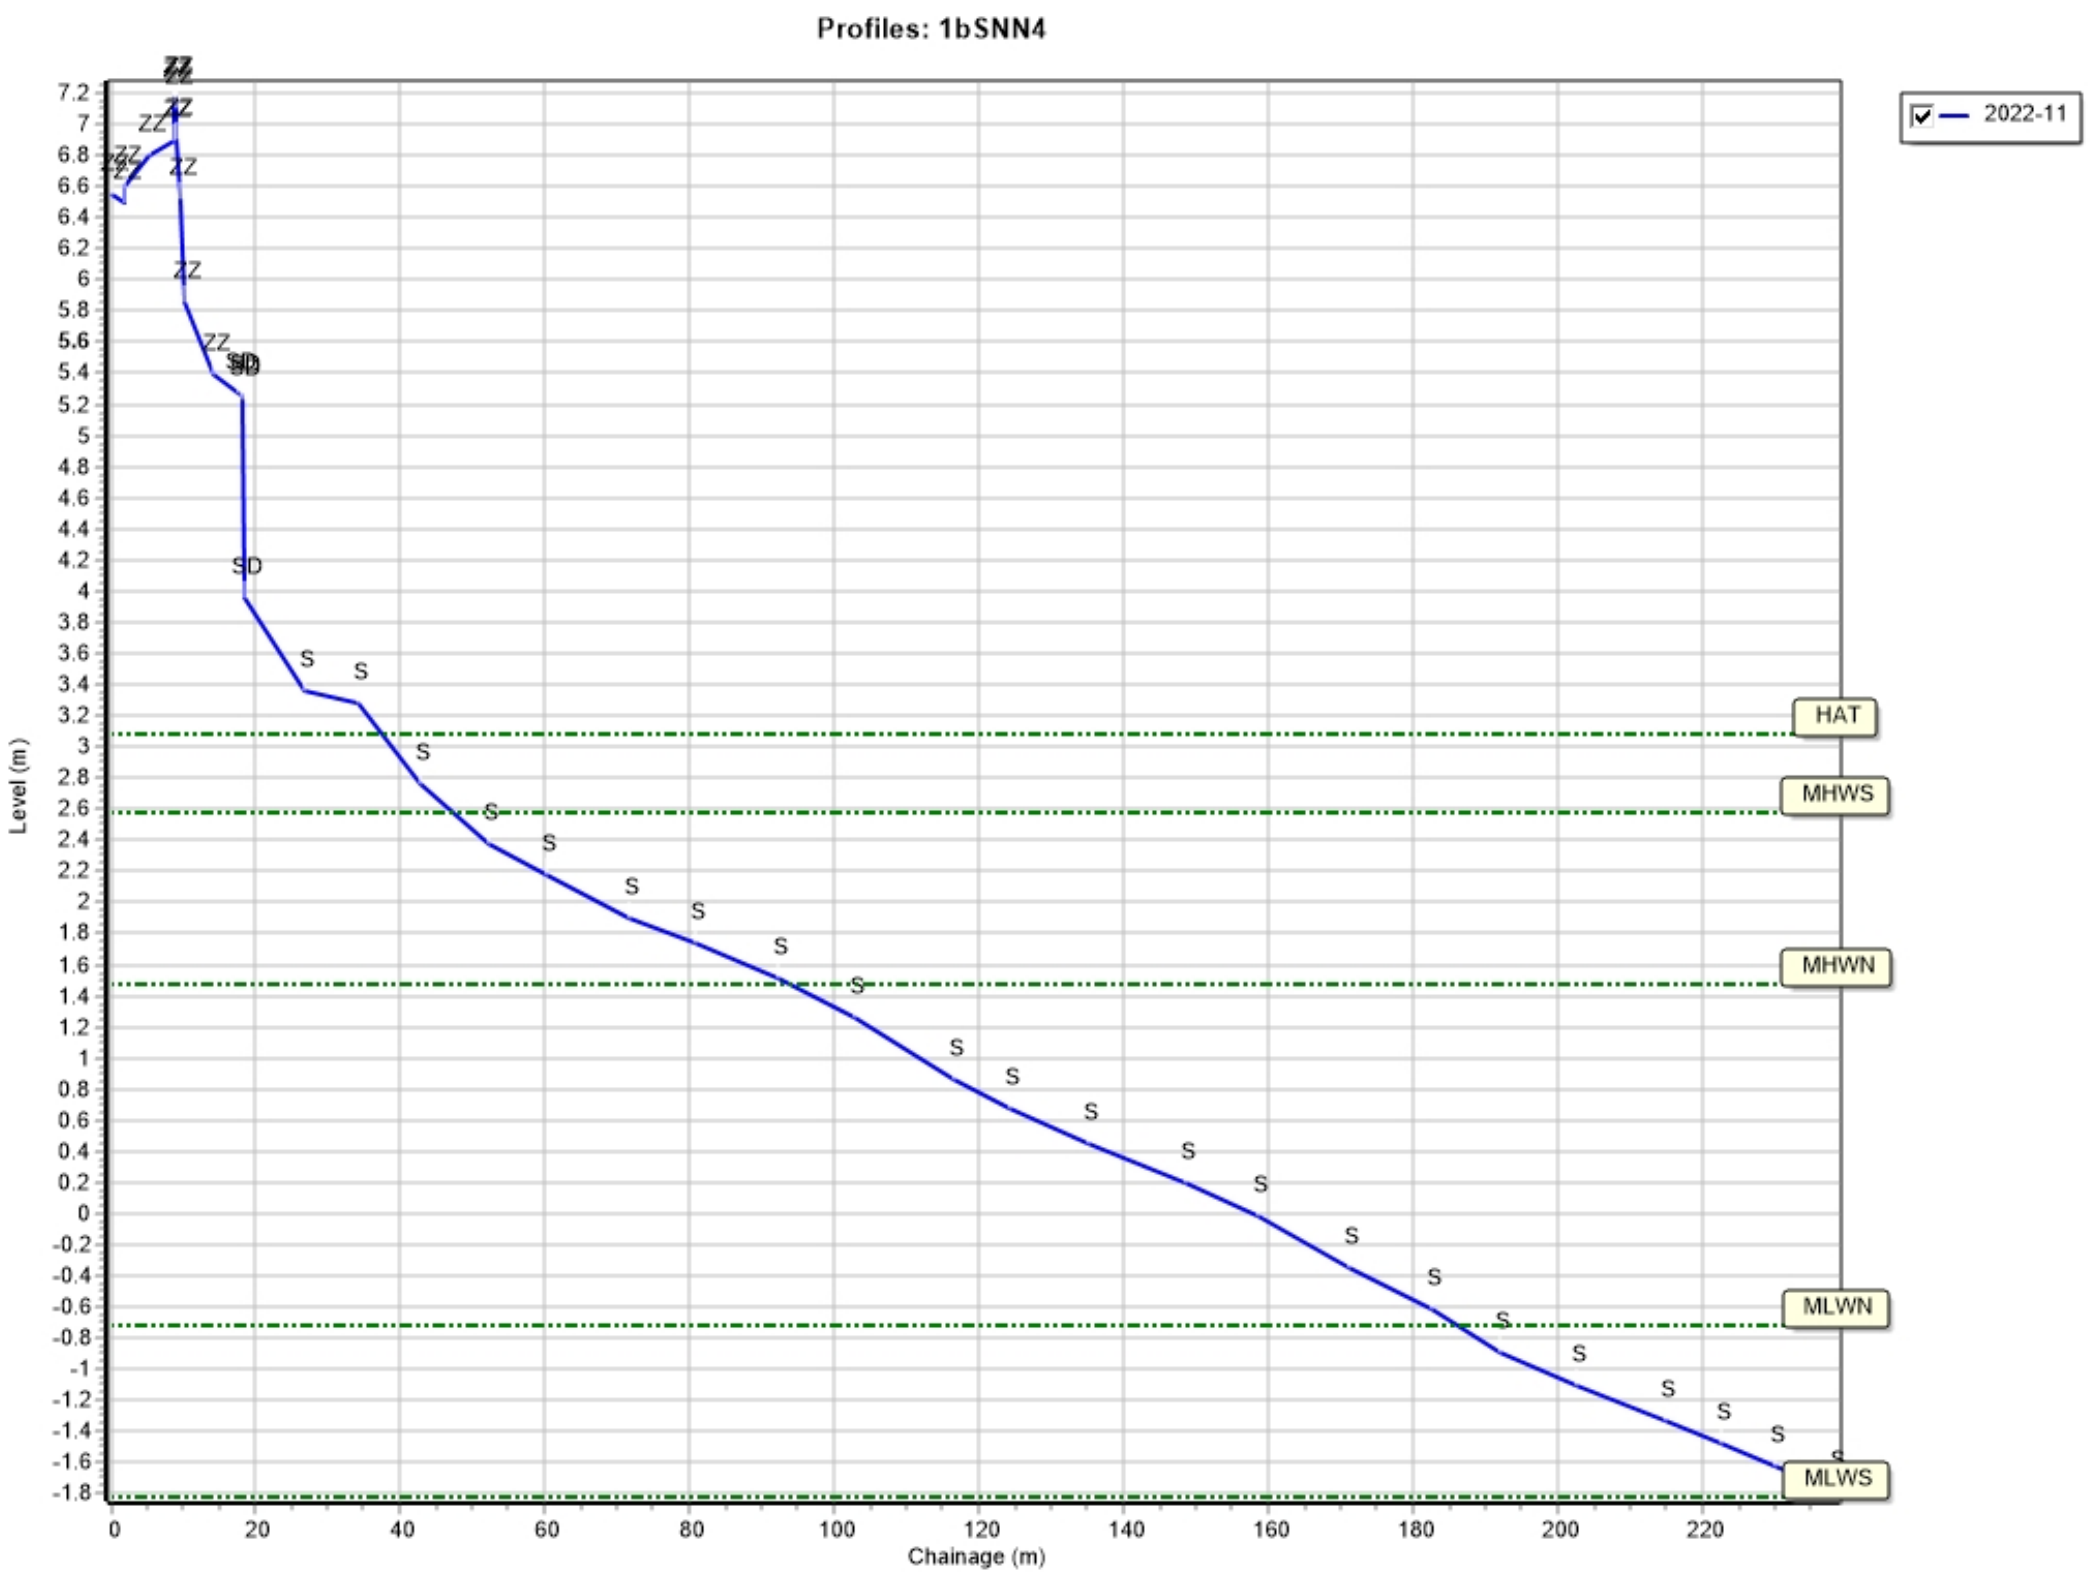
Profiles: 1bSNN4
2022-11
HAT
MHWS
MHWN
MLWN
MLWS
Level (m)
Chainage (m)
7.2
7
6.8
6.6
6.4
6.2
6
5.8
5.6
5.4
5.2
5
4.8
4.6
4.4
4.2
4
3.8
3.6
3.4
3.2
3
2.8
2.6
2.4
2.2
2
1.8
1.6
1.4
1.2
1
0.8
0.6
0.4
0.2
0
-0.2
-0.4
-0.6
-0.8
-1
-1.2
-1.4
-1.6
-1.8
0
20
40
60
80
100
120
140
160
180
200
220
ZZ
SD
S

Survey Date	Description of Changes Since Last Survey	Interpretation
	Profile **1bSNN4** shows the beach has generally lowered by 0.1m across the profile, except between chainage 216-232m which has risen by up to 0.1m. The majority of the beach is at a medium level compared to the range recorded from previous surveys. At profile **1bSNN5**, from the toe of the sea wall to chainage 140m the beach has risen by up to 0.3m, switching to a lowering of the beach profile by up to 0.2m to the end of the beach profile at chainage 238m. Overall, the beach is at a medium-low level when compared to the range recorded from previous surveys. At profile **1bSNN6**, the beach from the toe of the sea wall to chainage 36m has lowered by up to 0.4m which now exposes the toe of the sea wall. The middle beach between chainage 36-152m has alternated between accretion / erosion by ±0.1m. The beach sewaward of chainage 152m has risen by up to 0.3m. The profile is at a high level compared to the range recorded from previous surveys, particularly from chainage 35-70m which is at its highest level recorded. Profile **1bSNN7** is at Seaburn, just to the north of Parson's Rocks. The beach profile has generally arisen across the profile by up to 0.3m, except on the middle beach between chainages 55-100m which has undergone little change (<0.1m). Overall, the profile is at a high level compared to the range recorded from previous surveys Profile **1bSNN8** extends across Parsons Rocks. The beach profile remains stable and has exhibited little change except for differences in rock location between the two surveys.Overall, the profile is at a medium level compared to the range recorded from previous surveys. Profile **1bSNN9** drops from the cliff top to the foreshore at Roker. The upper beach from the toe of the cliff to chainage 38m has lowered by up to 0.5m, switching to a rise in beach profile of up to 0.1m to chainage 115m. The middle beach between chainage 115-157m has lowered by up to 0.1m whilst the lower beach seaward of chainage 157m has risen by up to 0.2m. Overall, the profile is at a medium level compared to the range recorded from previous surveys. Profile **1bSNN10** is located approximately mid-way between Parson's Rocks and Roker Pier. Between the toe of the seawall and chainage 85m the beach has risen by up to 0.2m. The middle beach between chainages 85-134m the beach has lowered by up to 0.2m.The lower beach seaward of chainage 134m has risen by up to 0.4m. Overall, the beach is at a medium-high level compared to the range recorded in previous surveys.

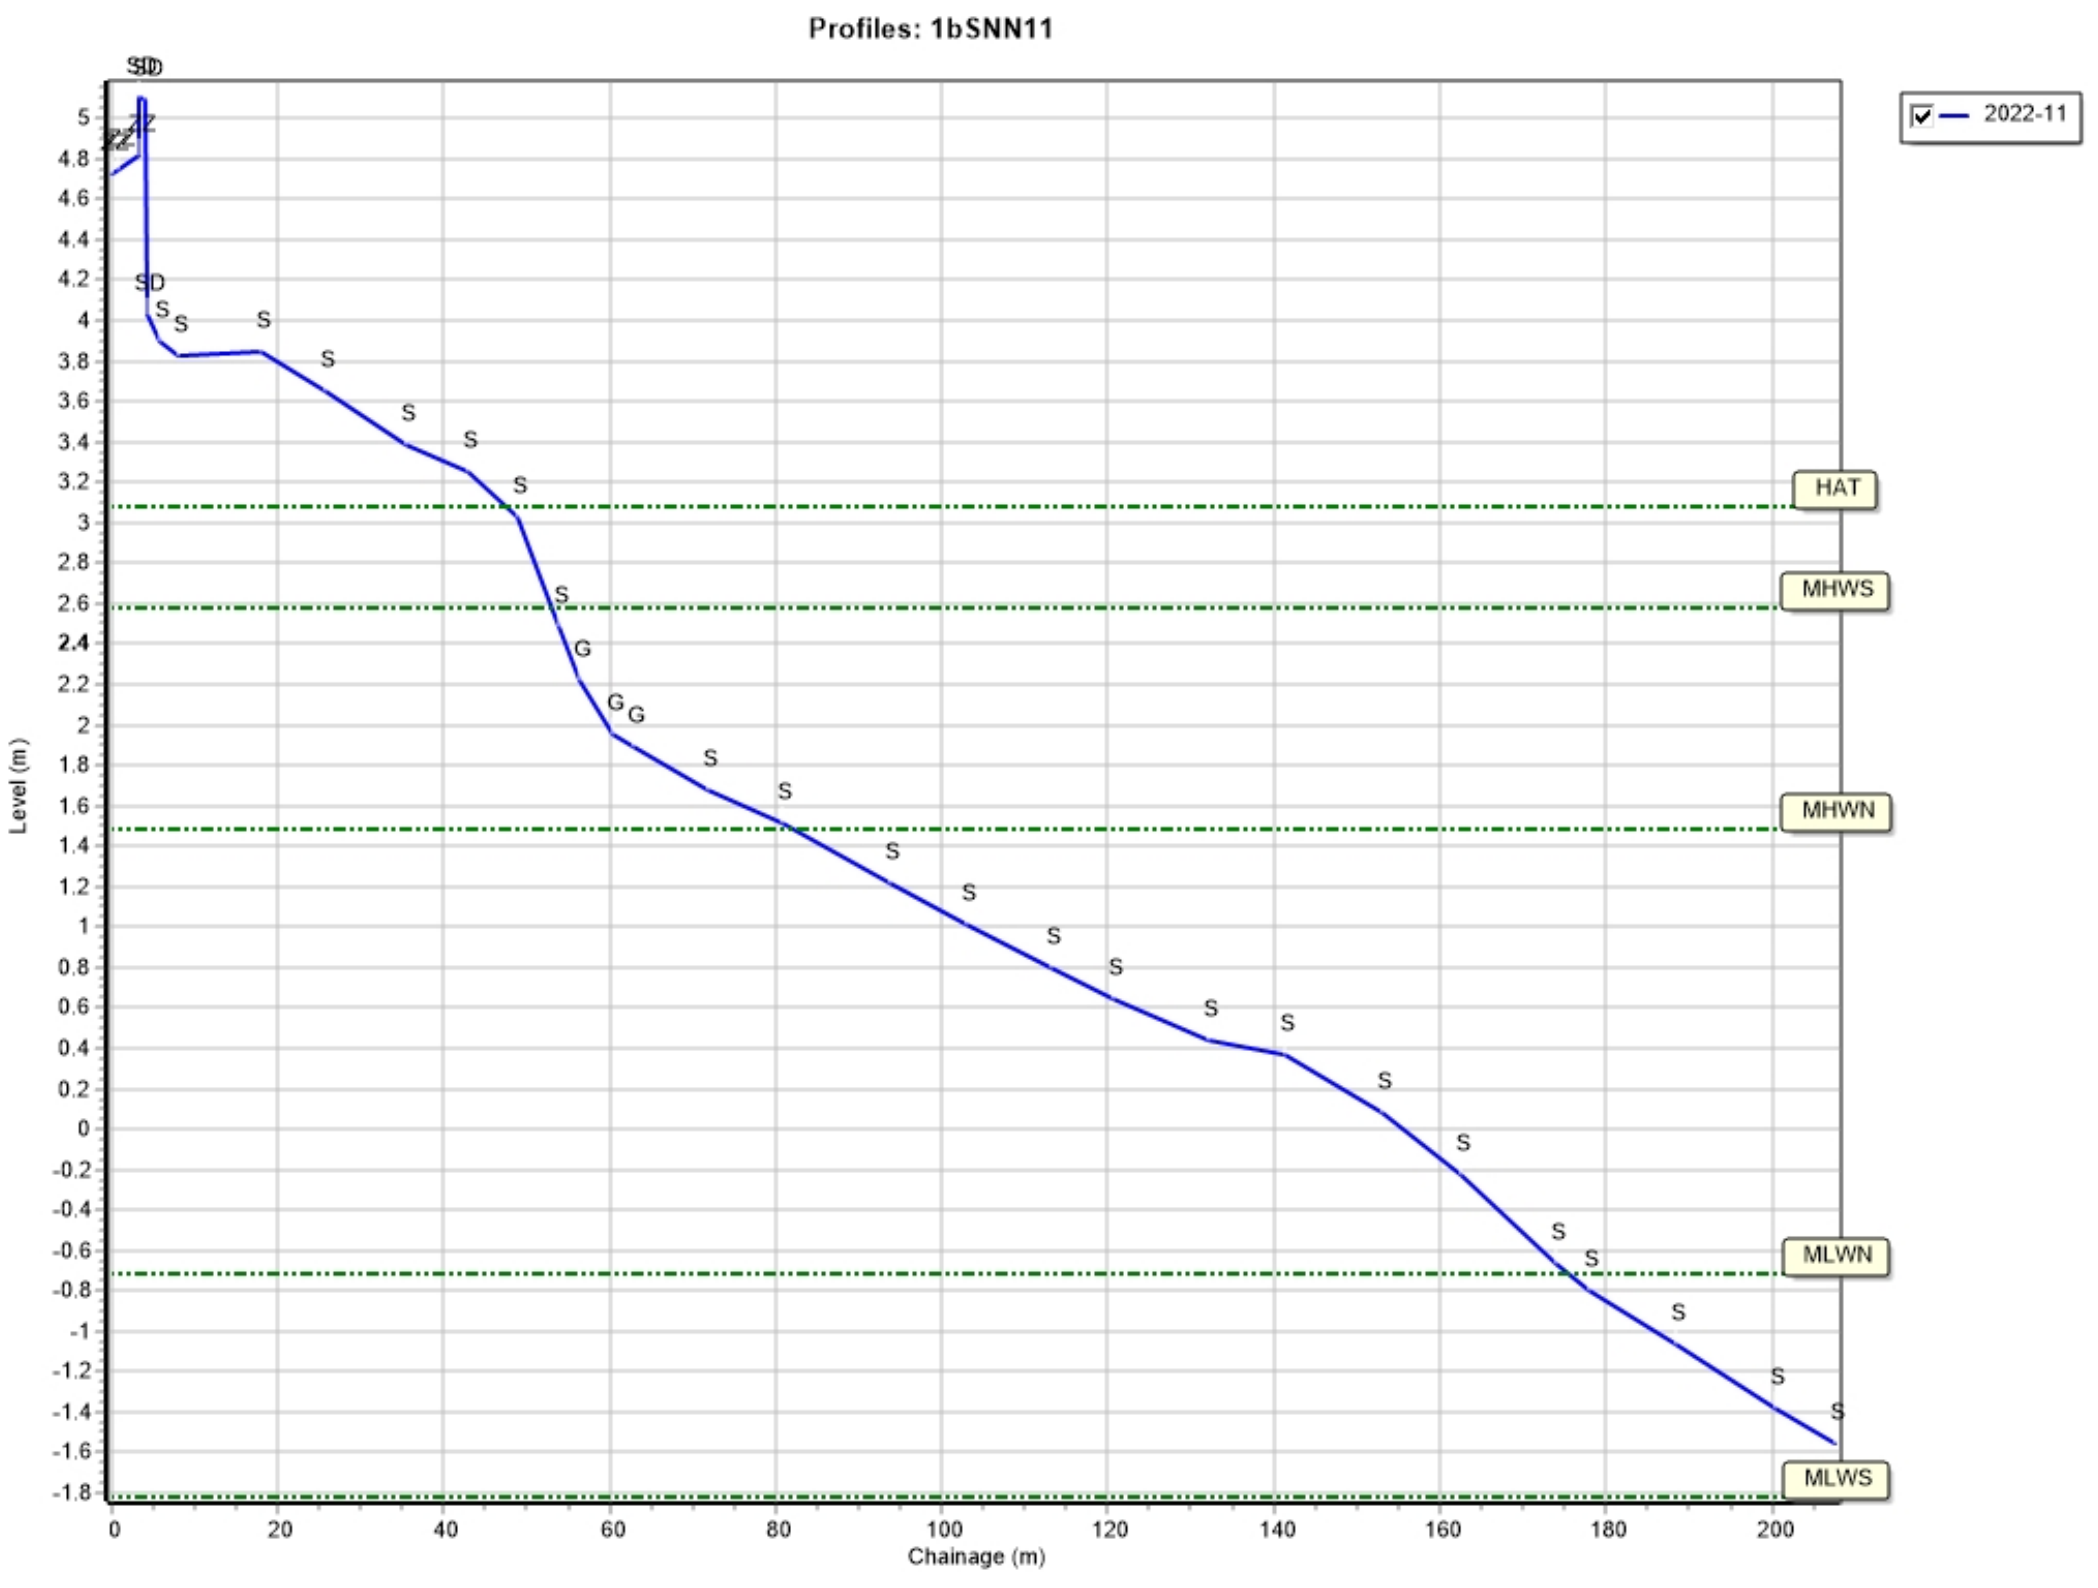
Profiles: 1bSNN11
2022-11
HAT
MHWS
MHWN
MLWN
MLWS
Level (m)
Chainage (m)
0
20
40
60
80
100
120
140
160
180
200

Survey Date	Description of Changes Since Last Survey	Interpretation
	Profile **1bSNN11** is located to the south of Whitburn. The beach level has alternated between erosion and accretion, but has generally lowered by up to 0.1m at the toe of the sea wall (between chainages 4-13m) and 0.5m on the lower beach (seaward of chainage 142m). The beach between chainage 38-56m has risen by up to 0.4m. The beach ranges between a low-high level compared to the range recorded from previous surveys.	
Nov 2022	**Topographic Survey:** Whitburn Bay, between the Bents and Roker Pier, is covered by an annual topographic survey which commenced in September 2009. Data from the most recent topographic survey (Full Measures, autumn 2021) have been used to create a digital ground model (DGM) (Appendix B – Map 1) using GIS. A difference plot has also been produced using the DGM (Appendix B – Map 3) produced from the last produced topographic survey (Full Measures, autumn 2021) and the present survey. The most northerly survey extent has undergone patchy erosion and accretion, with accretion dominating by up to 1.25m. To the south of this, there has been high magnitude erosion on the upper beach (0.75-1.5m), with accretion/little change (±0.1m) on the middle and lower beach. The central survey area is dominated by accretion (0.5-0.75m) and little change (±0.1m). The south of the survey area has generally undergone little change, with only a narrow band of accretion on the upper beach and a patch of erosion on the lower beach. There are isolated patches of erosion and accretion around Parsons Rocks.	The topographic survey shows that since the last survey, accretion and little change (±0.1m) has dominated across the bay, with erosion generally found on the upper beach in the north of the survey. **Longer term trends:** The most recent topographic survey is in line with topographic trends seen since autumn 2009, showing a dominant trend of accretion with isolated areas of erosion in the north and south of the bay and around Parsons Rocks.

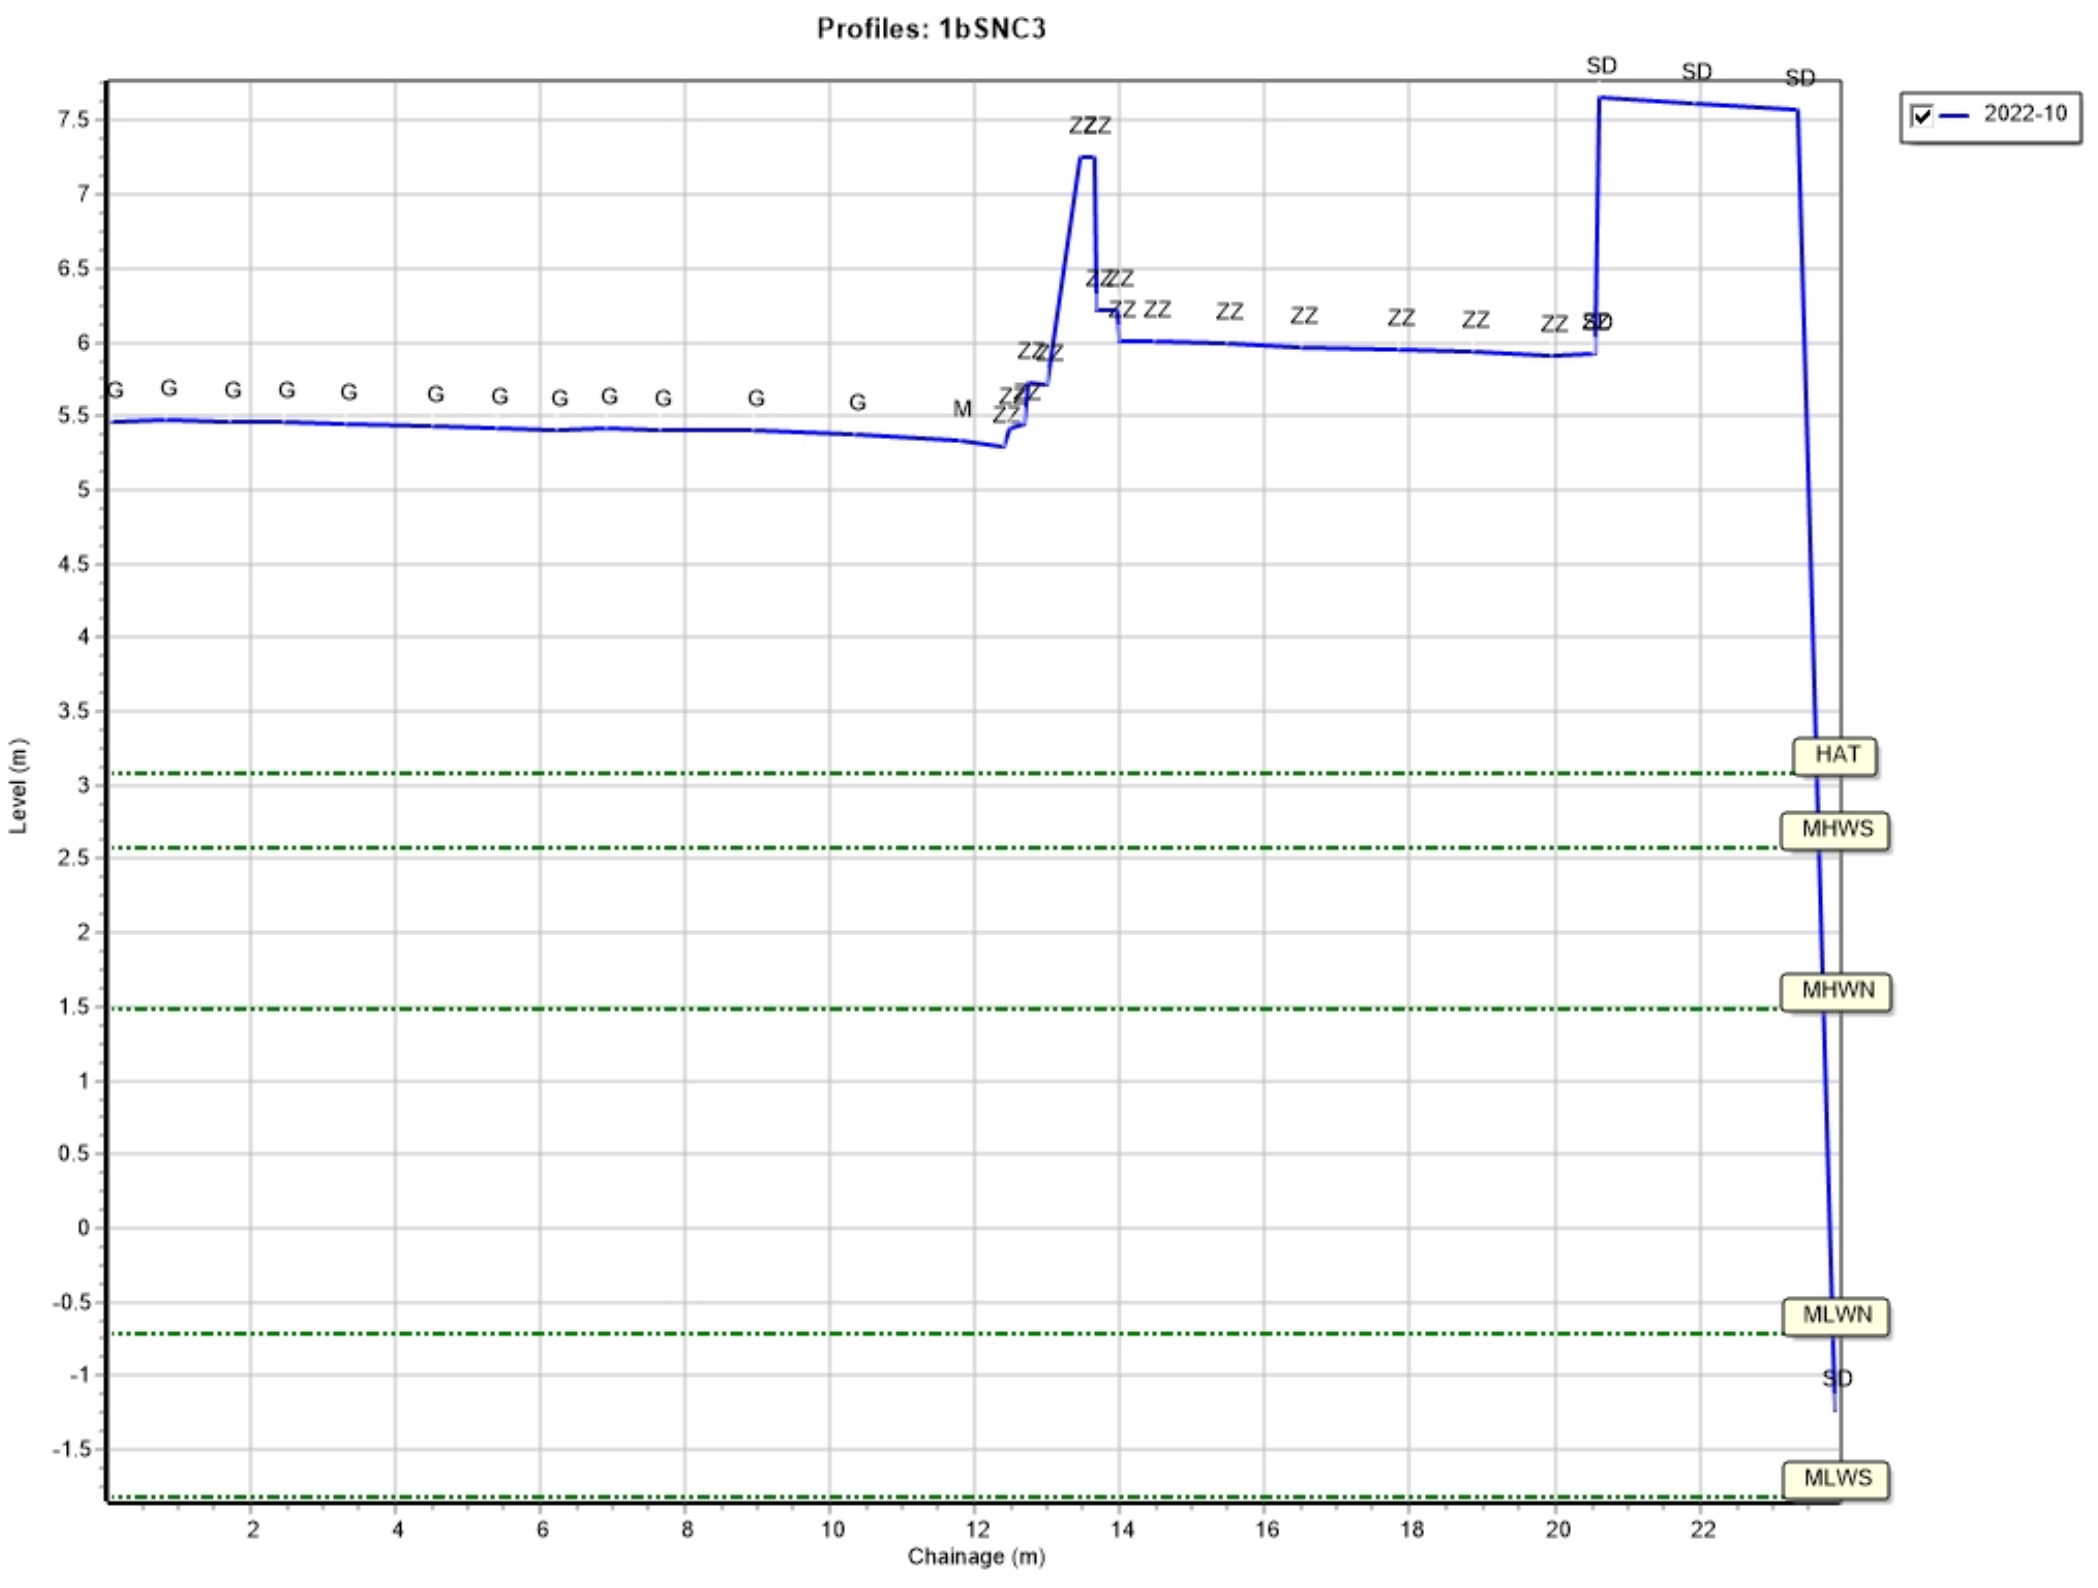
Profiles: 1bSNC3
2022-10
Level (m)
Chainage (m)
HAT
MHWS
MHWN
MLWN
MLWS
7.5
7
6.5
6
5.5
5
4.5
4
3.5
3
2.5
2
1.5
1
0.5
0
-0.5
-1
-1.5
2
4
6
8
10
12
14
16
18
20
22
G G G G G G G G G G G G
M
ZZZ
ZZ
SD SD SD
SD

Survey Date	Description of Changes Since Last Survey	Interpretation
	1bSNC3 to **1bSNC6** are on the seaward face of the dock. Profile **1bSNC3** extends from the dockyard across a back flood wall, which has a crest level of around 7.2mOD, and promenade to the main seaward dock wall, which has a crest level of 7.55mOD. The profile then extends down the seaward face of the wall into deep water. As there is no beach present, this profile has not been analysed. The survey report notes that construction work is being carried out next to this profile to extend the revetment. This is part of the ongoing Stonehill Wall scheme. Profiles **1bSNC4** and **1bSNC5** extend from the rock armoured revetment across the short width of foreshore down to low water. At profile **1bSNC4**, the beach level has risen across the majority of the profile by up to 0.9m on the upper beach to 0.4m on the middle and lower beach. A small extent of the survey seaward of chainage 34m has lowered by up to 0.1m. Overall, the beach is at a medium level compared to the range recorded from previous surveys. At profile **1bSNC5**, there has been some movement in boulder position on the upper beach to chainage 4m. The rest of the beach profile has risen by up to 0.4m on the upper beach to 0.7m on the middle and lower beach. This has covered previously exposed boulders at chainage 11m and 17m. Overall, the beach is at a high level compared to the range recorded from previous surveys. Profile **1bSNC6** extends across the revetment and seawall. The beach level has lowered across the entire profile by up to 0.5m from the toe of the sea wall to the middle beach, reducing to 0.1m on the lower beach. The beach levels are at a medium-high level compared to the range recorded from previous surveys. Profiles **1bSNC7** to **1bSNC9** are within the shelter of North East Pier and South West Breakwater in the former South Outlet, parts of which have been in-filled with tipped rubble. Profile **1bSNC7** is a section across North East Pier. There has been no discernible change in the overall profile. Small apparent changes will be artefacts of the placement of survey points along the profile. Profile **1bSNC8** crosses the boulders and rubble. From chainage 35m seaward of the boulders and rubble, the beach level has risen across the profile by up to 0.5m. Overall, the profile is at a medium level.	at 1bSNC7 and 1bSNC9. At profile 1bSNC8, the long-term trend has been lowering beach levels since surveys began in October 2009, however the most recent survey shows signs of recovery with a rise in profile of up to 0.5m across the profile.

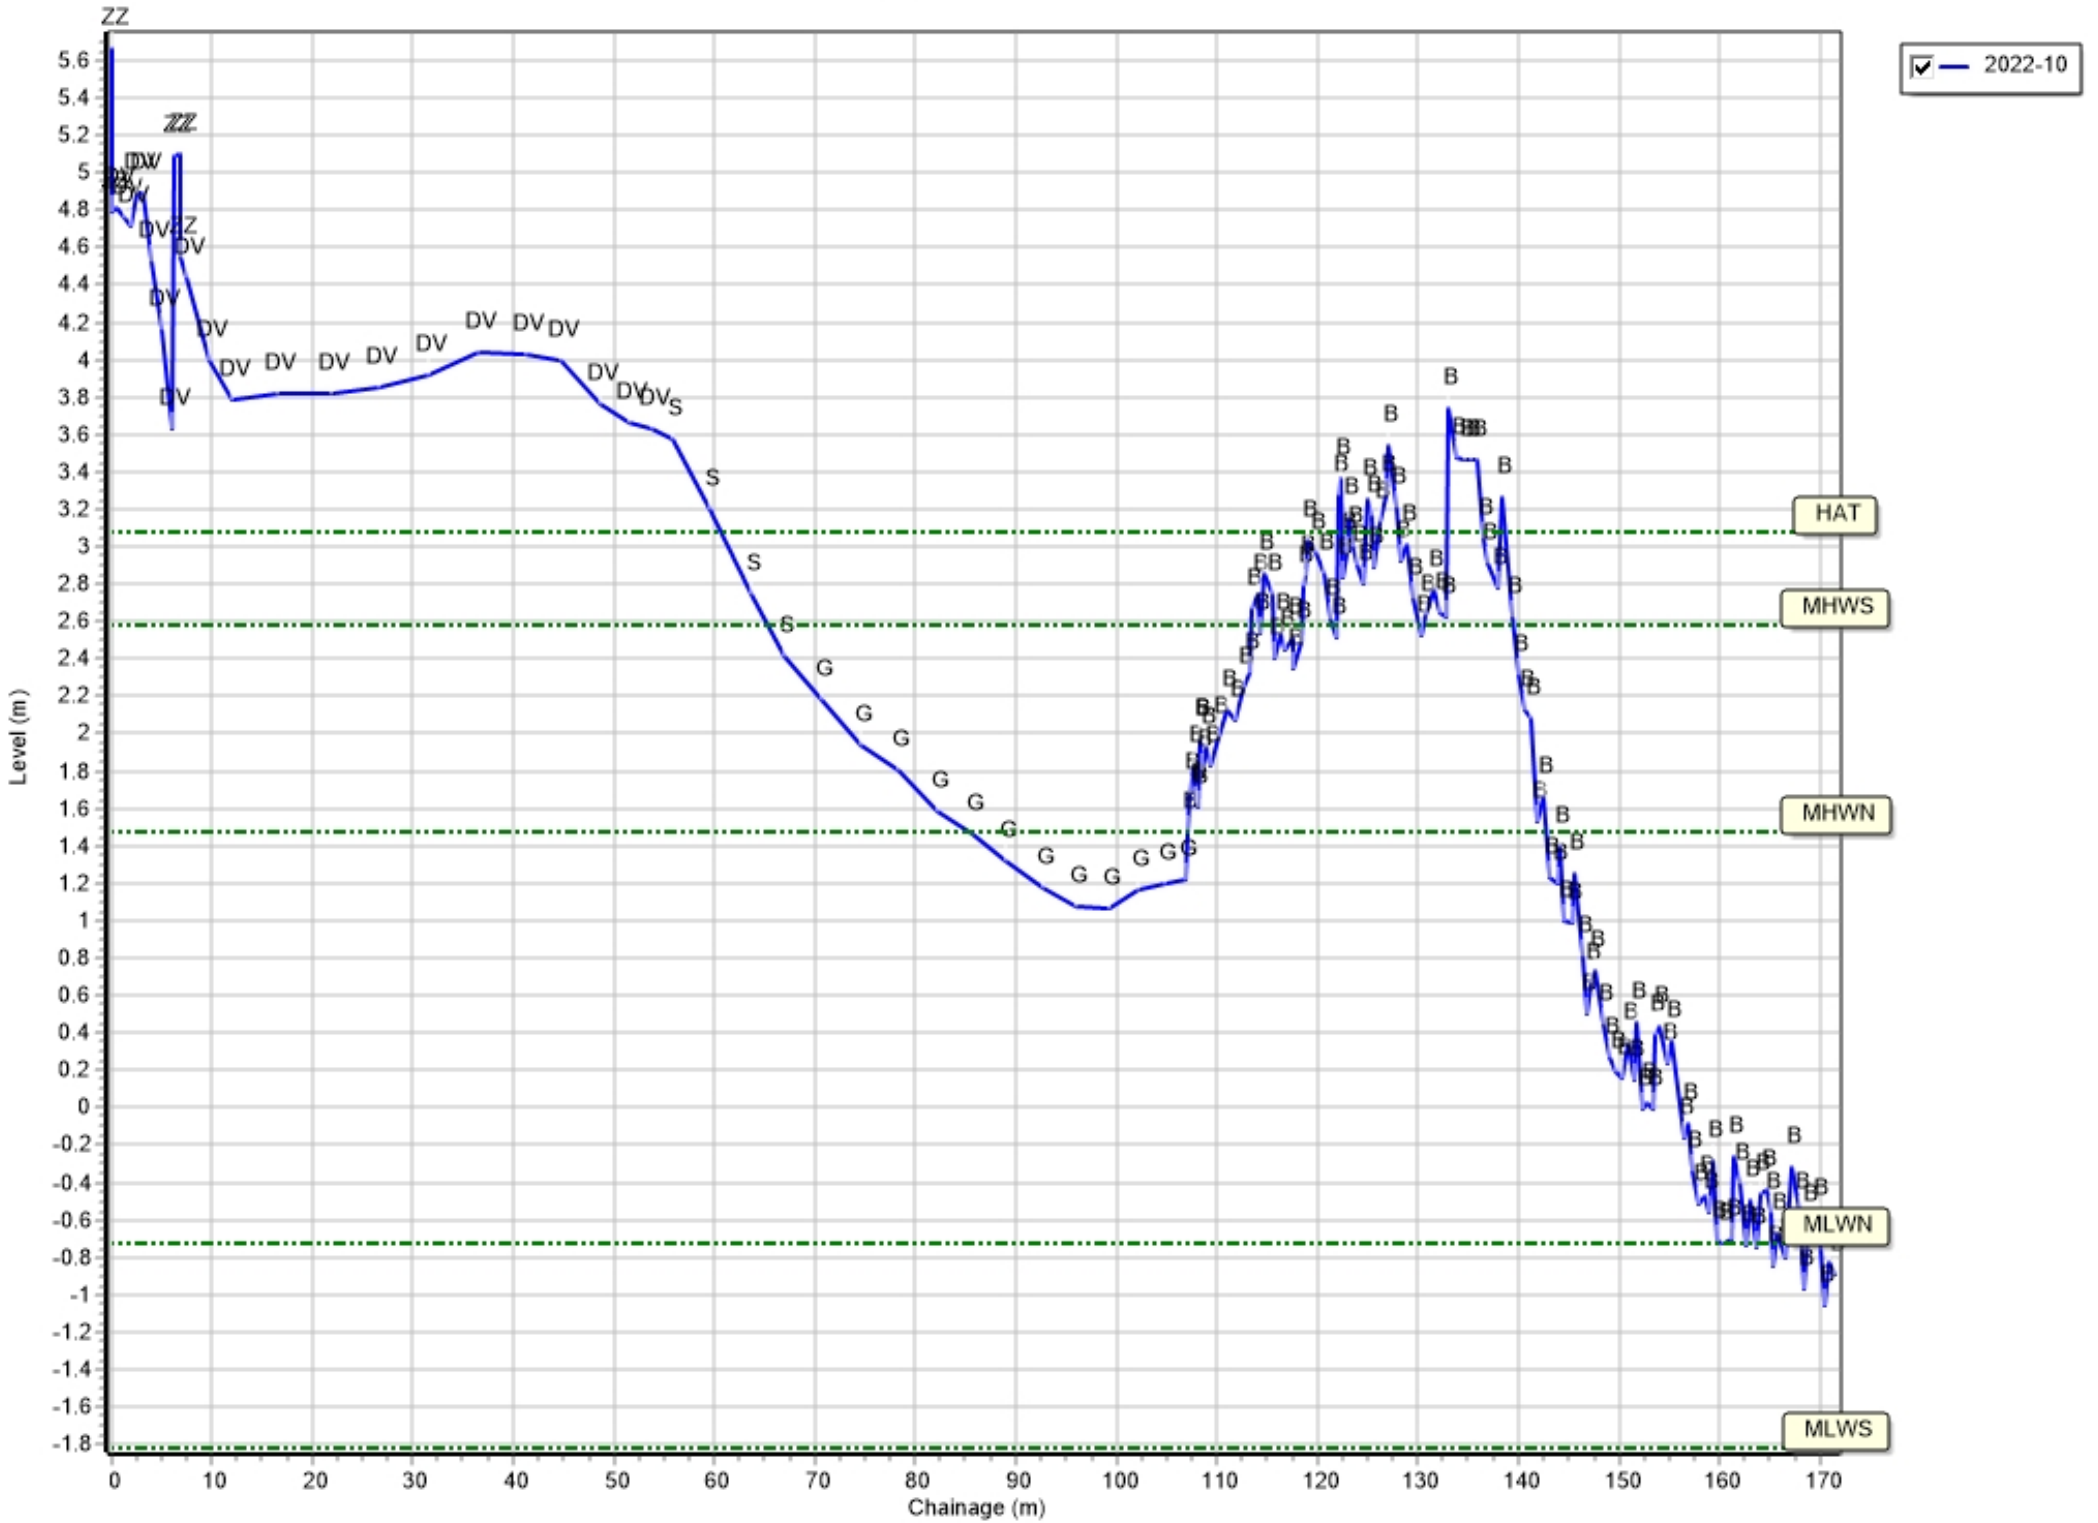
Profiles: 1bSNC9
2022-10
HAT
MHWS
MHWN
MLWN
MLWS
Level (m)
Chainage (m)

Survey Date	Description of Changes Since Last Survey	Interpretation
	Profile **1bSNC9** extends from the dock facilities and crosses a short length of concrete wall and sheet piling before extending across the sand and gravel backshore and foreshore to reach and cross a boulder mound that is towards the seaward end of the south west breakwater. The report notes the start of this profile was not surveyed as it is unsafe to access. The profile has risen across the gravel backshore by up to 0.2m. The beach between chainages 63-80m has lowered by up to 0.1m.There are apparent changes in height of the boulder mound in places. The profile remains high compared to earlier surveys, particularly between 16-63m and 100-105m which are at their highest level recorded.

- The survey report notes that the beginning of profile 1bSNC9 was unsafe to access at the time of the survey.
