Cell 1 Regional Coastal Monitoring Programme
Analytical Report 8: 'Full Measures' Survey 2015

County Durham Council
Final Report

February 2016

(*) The present report is **Analytical Report 8** and provides an analysis of the 2015 Full Measures survey for County Durham Council's frontage.

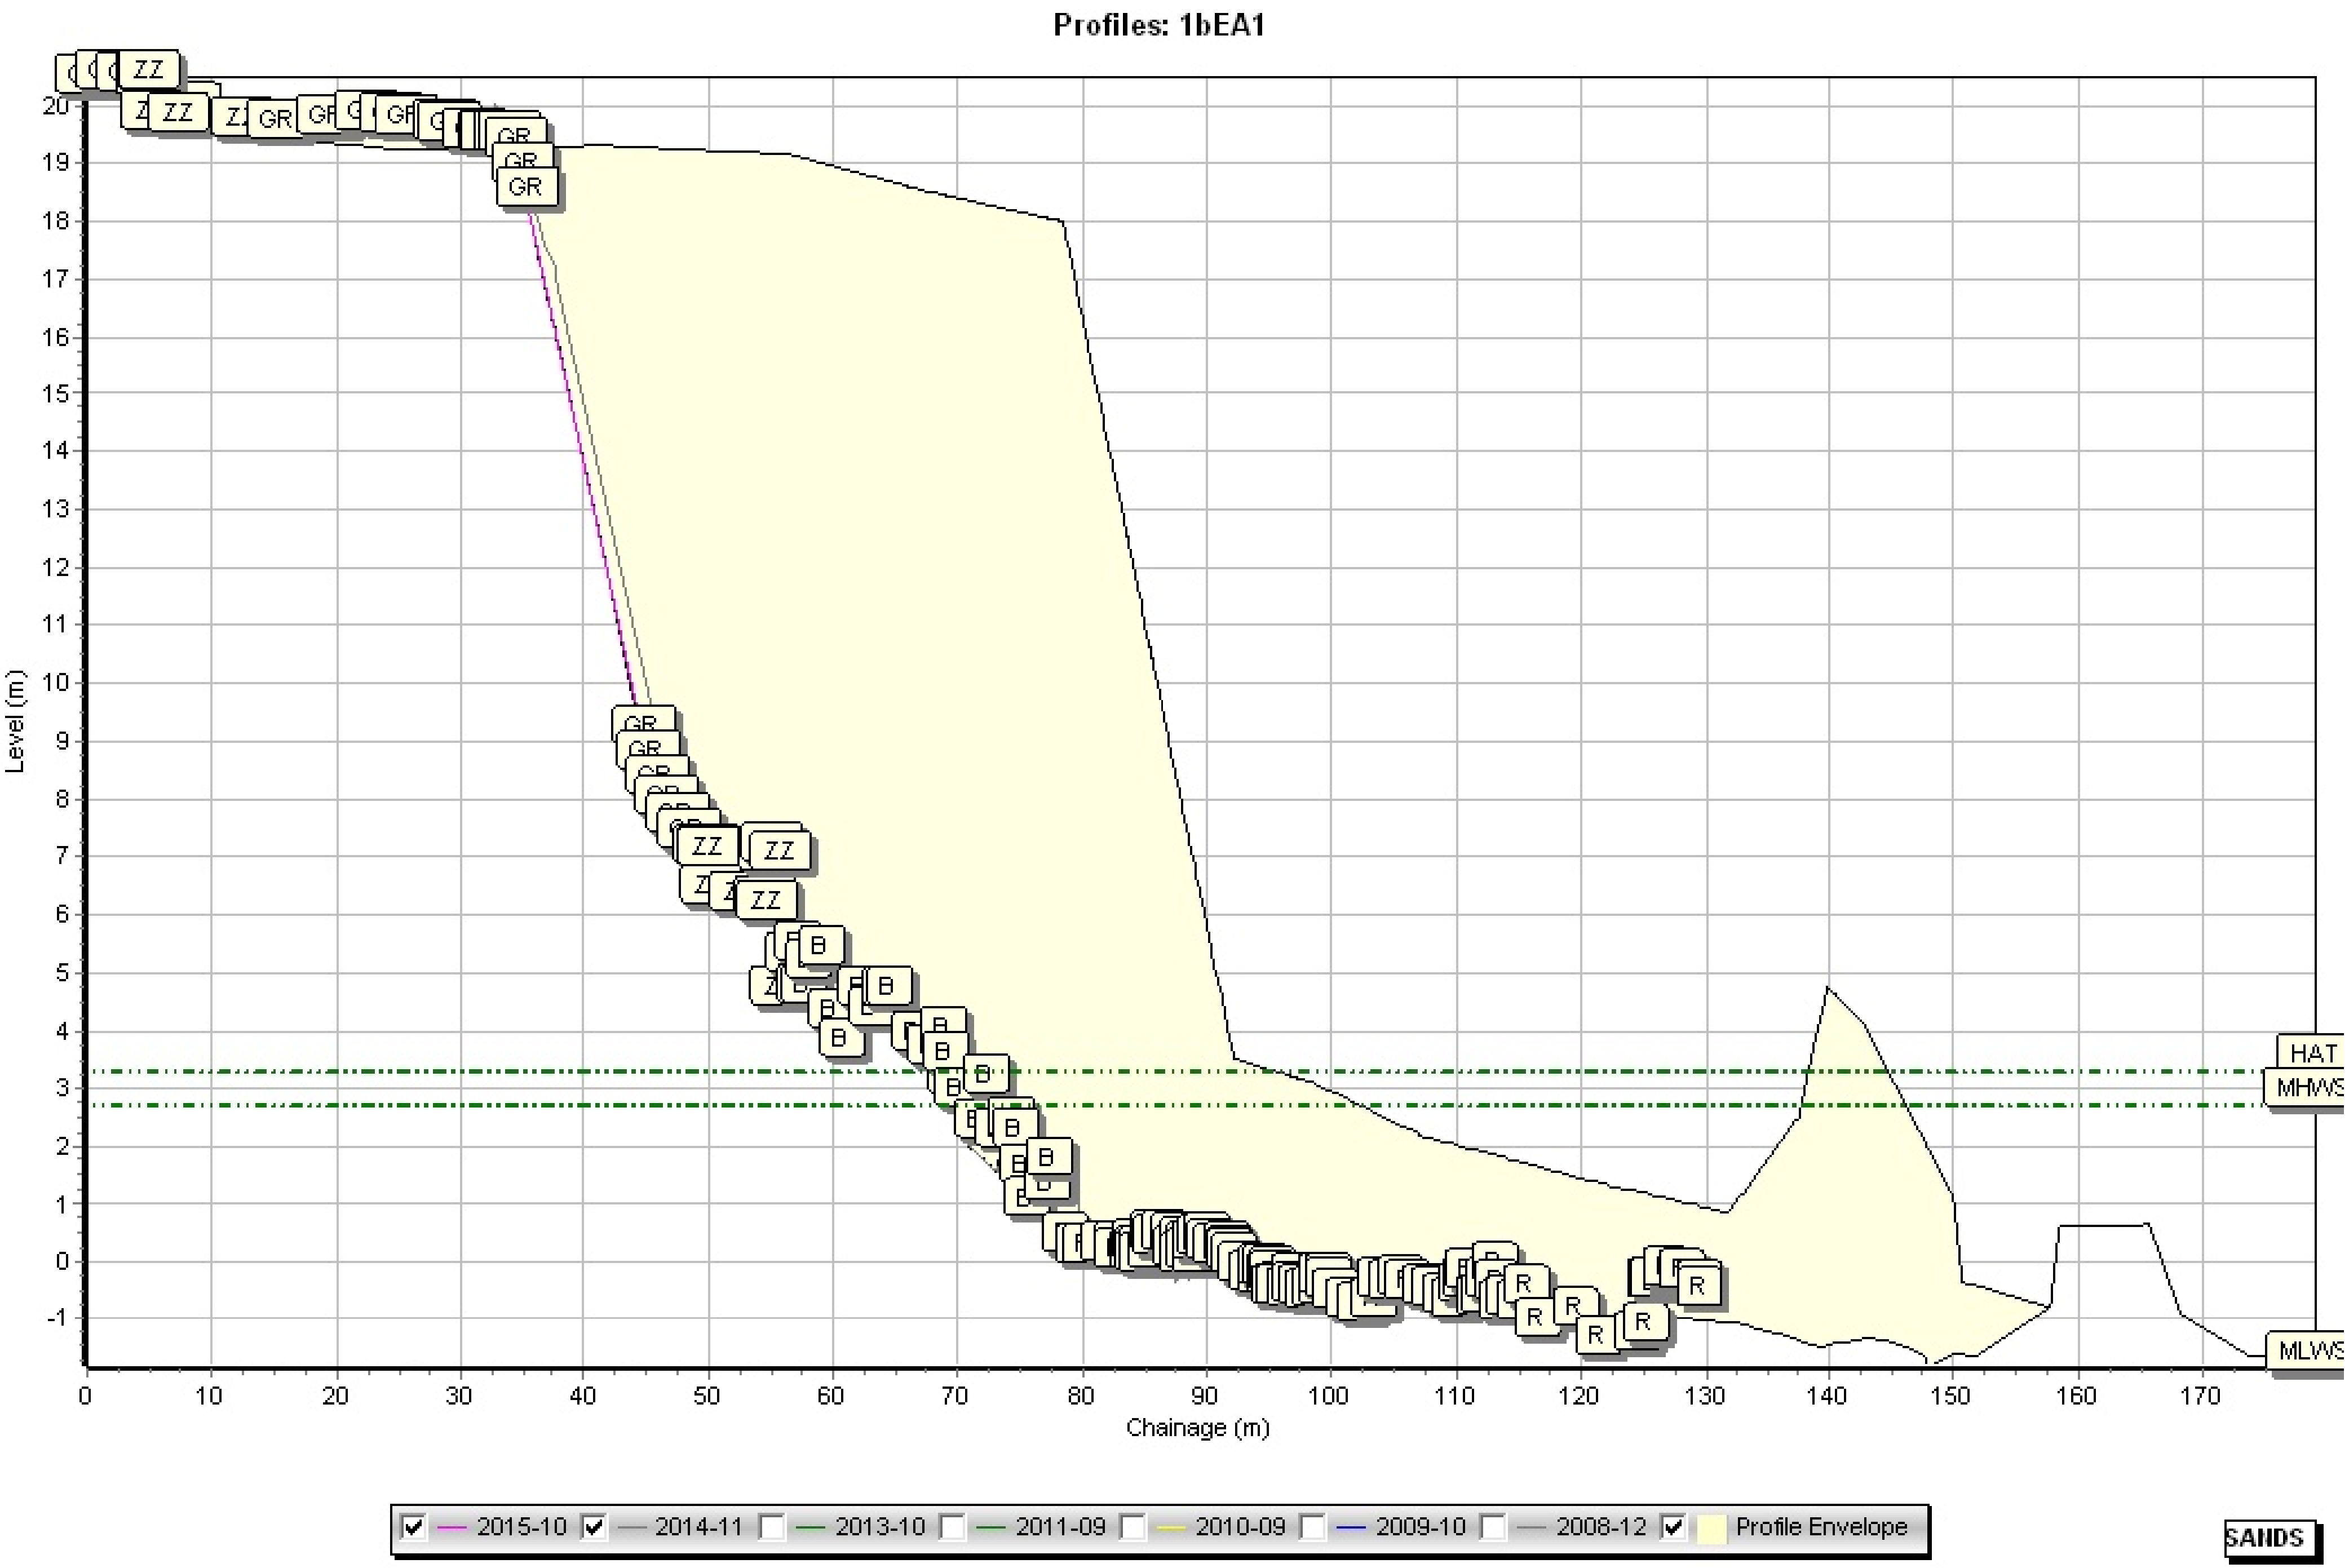
Profiles: 1bEA1
Level (m)
Chainage (m)
HAT
MHWS
MLWS
2015-10
2014-11
2013-10
2011-09
2010-09
2009-10
2008-12
Profile Envelope
SANDS

Survey Date	Description of Changes Since Last Survey	Interpretation
16th Oct 2015	**Beach Profiles:** One beach profile line **1bEA1**, located at Featherbed Rocks (Appendix A), has been monitored since March 2009. The profile extends across the cliff top and cliff face then extends across the promenade, rock armour sea defence and beach. At the base of the sea wall rock armour extends as far as 80m chainage. Previous surveys have shown accumulations of material at the base of the revetment but this has not been present since the 2012 Full Measures survey.	The rocky nature of this foreshore means it is unlikely to undergo significant changes in morphology unless sediment is deposited upon it. A veneer beach has previously been present here but has not been recorded since the 2012 Full Measures survey. **Longer term trends:** The profile for November 2014 and October 2015 are two of the lowest recorded and exposed the rocky shore platform along much of its length. Between 2010 and 12 a thin veneer beach was present.

- At Featherbed Rocks the rocky shore platform continues to be exposed and the veneer beach present in earlier surveys has not been present since autumn 2012.

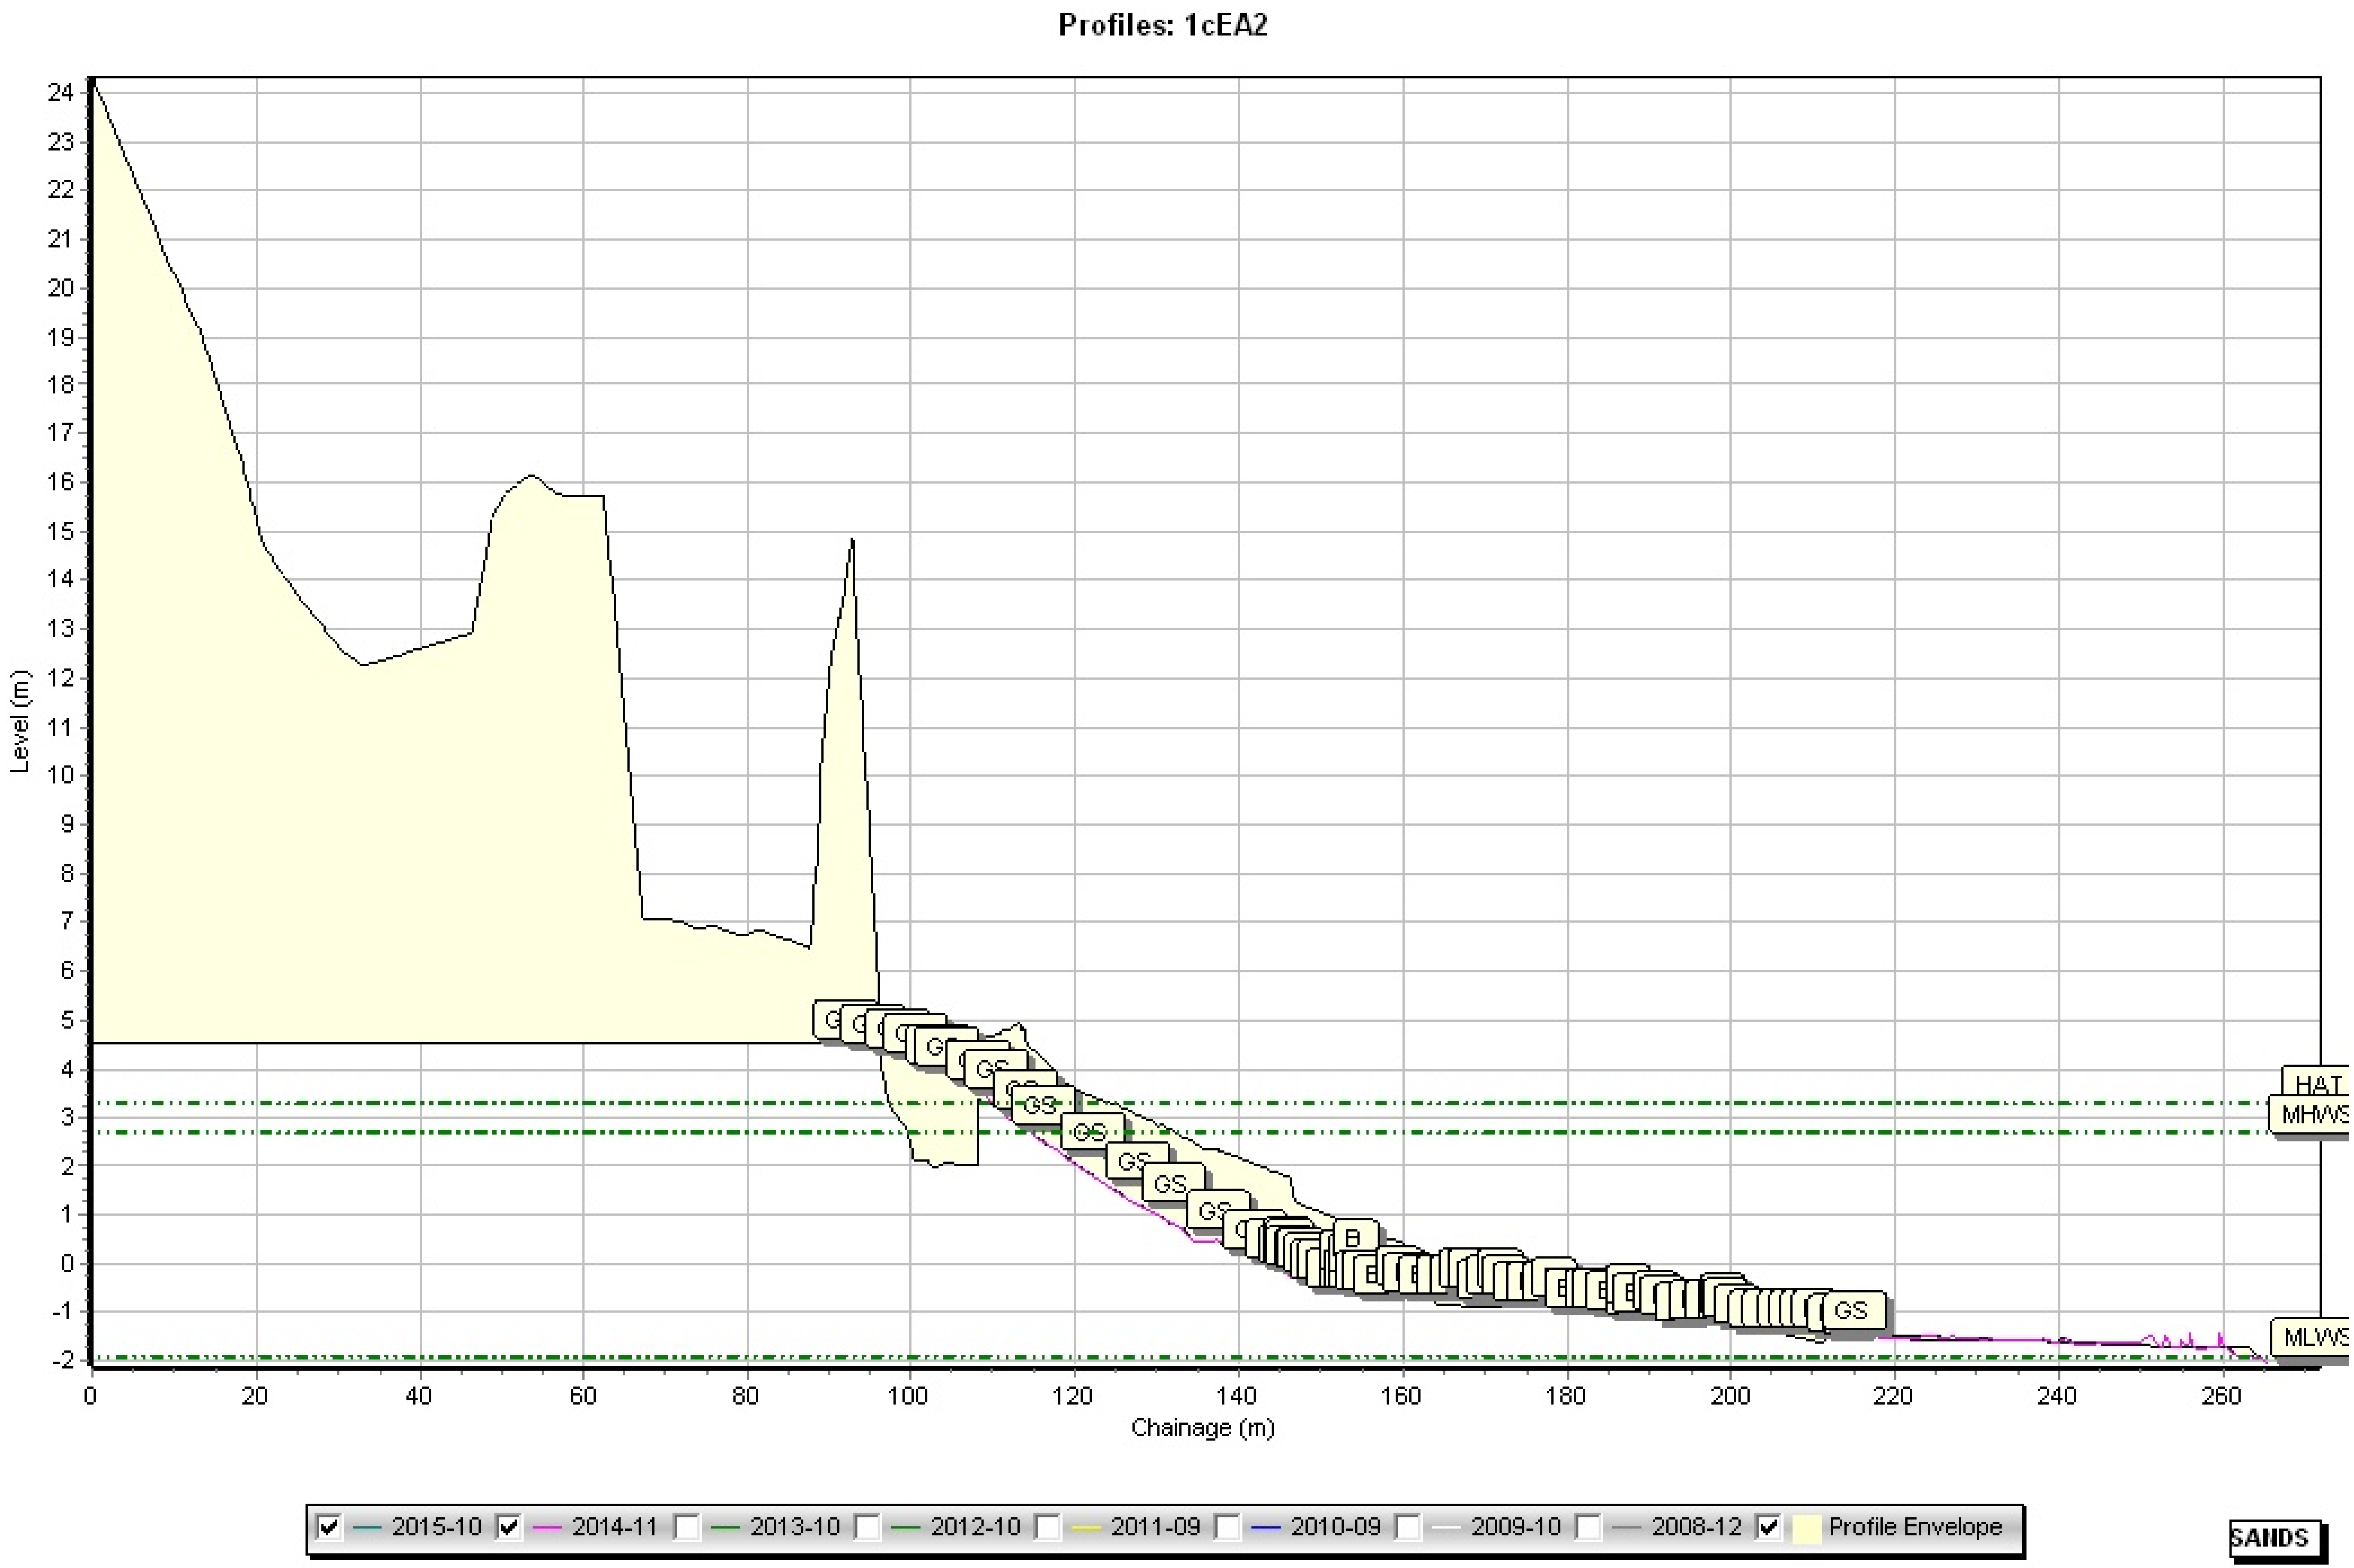
Profiles: 1cEA2
Level (m)
Chainage (m)
HAT
MHWS
MLWS
2015-10
2014-11
2013-10
2012-10
2011-09
2010-09
2009-10
2008-12
Profile Envelope
SANDS

Survey Date	Description of Changes Since Last Survey	Interpretation
16th October 2015	**Beach Profiles:** Hawthorne Hive is monitored by beach profile **1cEA2** (Appendix A). Dense vegetation meant that the start of this profile could not be surveyed and as a result it starts was at 95m chainage. In previous years there was a channel which crossed the profile. The survey photographs show that the channel is now north of the survey profile line and does not cross it. The majority of the beach, particularly between 95m and 145m chainage had remained at a similar level to the March 2015 profiles, although slightly steeper. The rest of the profile between 145m and 220m chainage have the rocks exposed at the bottom of the beach. The beach as a whole is 0.4m above the November 2014 profile.	The beach has recovered since the lowest levels recorded in April and November 2014, and is near the middle of the range of historical levels recorded since 2008. The beach has steepened since March 2015, which is likely to be due to erosion caused by storm events during the autumn of 2015. **Longer term trends:** The beach level has recovered since the lows of 2014. Limited cliff erosion occurs in this section and therefore sediment supply is limited to erosion of colliery spoil. Storm events which may block the channel and varying flows in Hawthorne Burn are likely to continue to episodically block the channel and change its course across the beach.

- At Hawthorne Hive the levels on the foreshore have recovered since April and November 2014 and are now near the middle of the range of recorded beach levels. The channel on the beach continues to be slightly north of the profile line, but can still be seen in photographs.

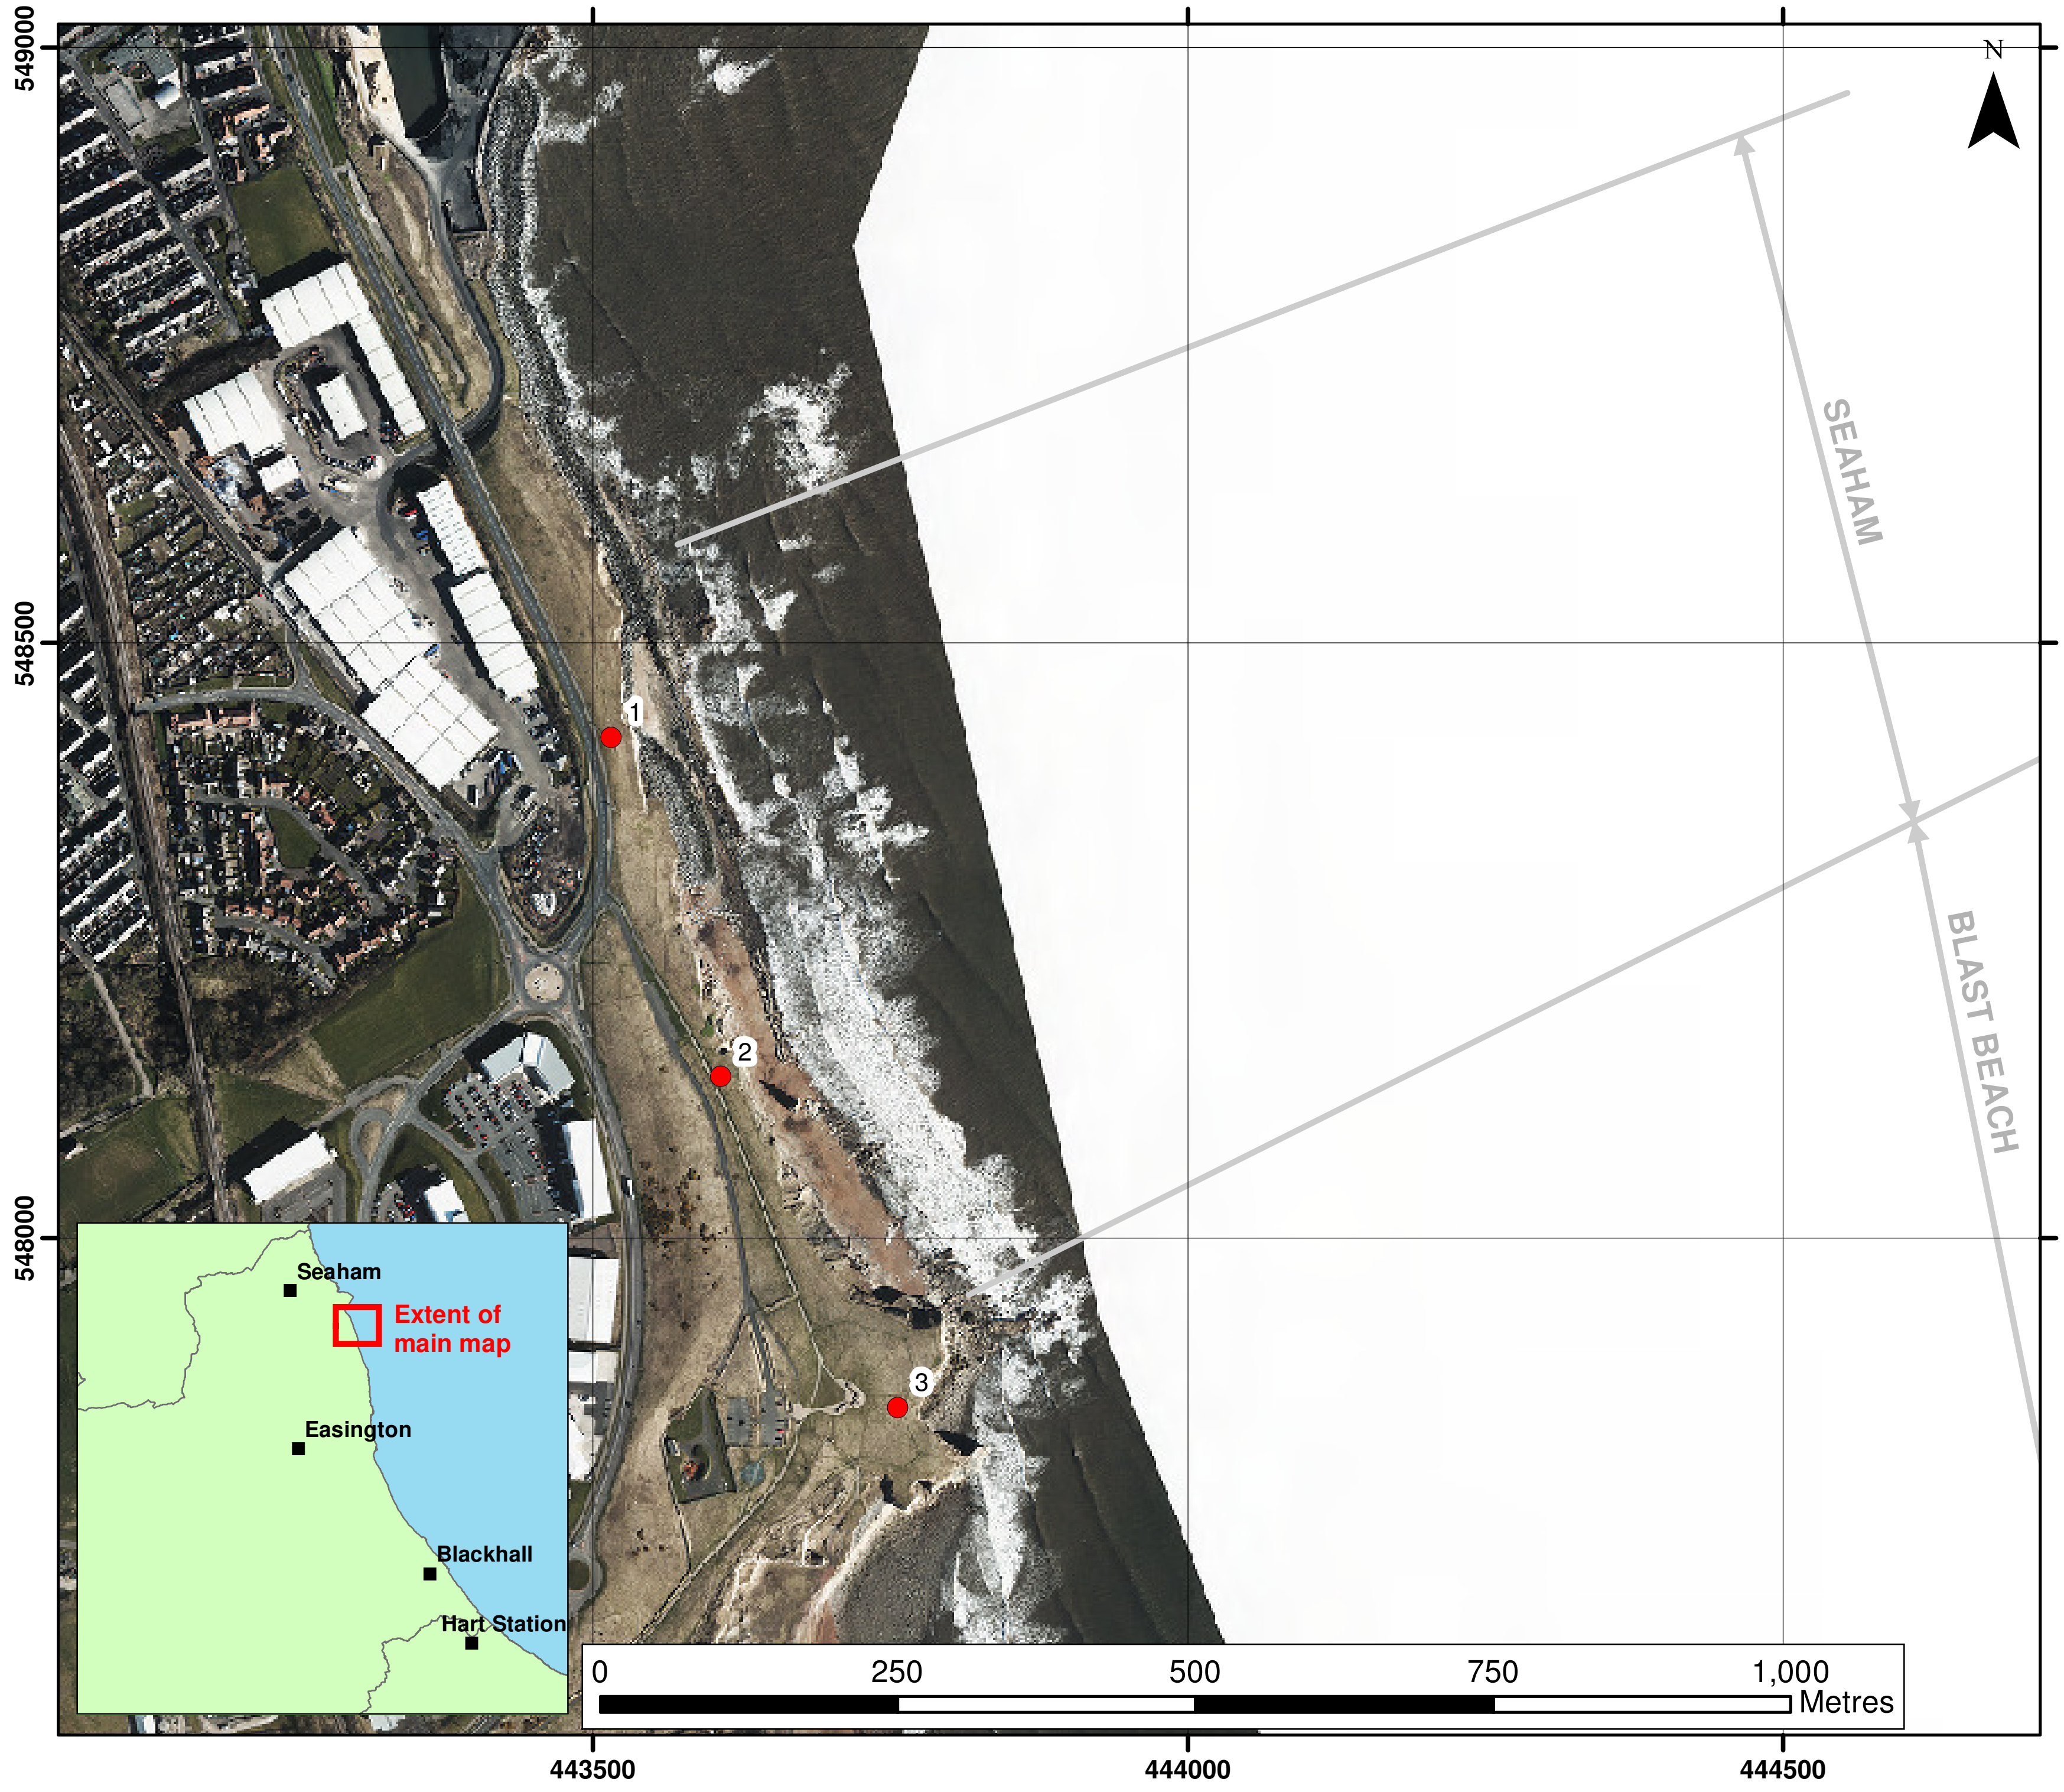
Appendix B - Map 1
Ground Control Points
Seaham
Durham County Council

- At Seaham cliffs there has been recession along ground control points 1 and 3 of 0.2m/yr since the records began in November 2008. No significant change has occurred at ground control point 2. Further years of data collection will help to understand the long term trends on these cliffs and the stability of the bay.

Ground Control Point Details				Distance to Cliff Top (m)			Total Erosion (m)		Erosion Rate (m/year)
Ref	Easting	Northing	Bearing (º)	Baseline Survey (Nov 2008)	Previous Survey (Mar 2014)	Present Survey (Oct 2015)	Baseline (Nov 2008) to Present (Oct 2015)	Previous (Mar 2015) to Present Oct 2015)	Baseline (Nov 2008) to Present (Oct 2015)
1	443515.4	548421.7	70	16.1	15.2	15.0	-1.1	-0.2	-0.2
2	443607.8	548136.3	90	13.3	13.3	13.3	0.0	0.0	0.0
3	443756.1	547858.5	95	14.8	13.5	13.6	-1.2	0.0	-0.2
