**Cell 1 Regional Coastal Monitoring Programme
Update Report 5: 'Partial Measures' Survey 2013**

**South Tyneside Council
Final Report**

June 2013

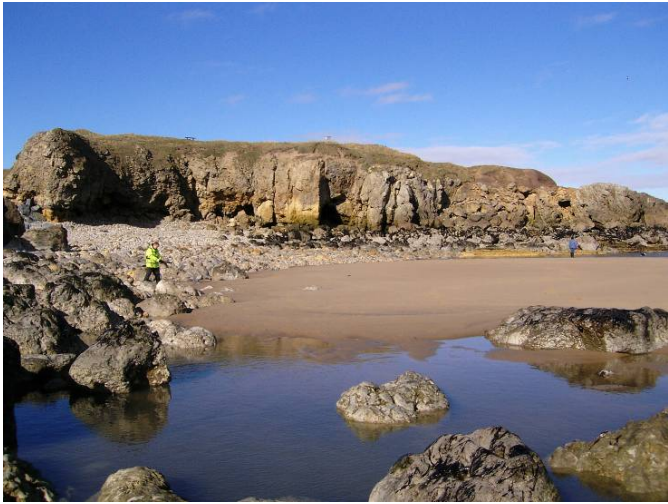
Plate 7 – Survey photograph 1bSS10_20130312_N5.JPG

Survey Date	Description of Changes Since Last Survey	Interpretation
	<p>anticipated to have an accuracy of $\pm 0.2\text{m}$ due to the technique used.</p> <p>The results from the cliff top survey are presented in Appendix C – Table C1, showing the position from the ground control point to the edge of the cliff top along a defined bearing. Also shown is the change in measurement since the baseline (autumn 2011) and current (spring 2013) cliff top surveys.</p> <p>Results show that erosion or an amount of movement greater than the survey error has occurred has two ground control points since surveys began in September 2011. However, points 3 and 4 are calculated to have advanced by 0.3m and 0.7m respectively, which is interpreted as error associated with problems in precisely locating the cliff edge. All other points show no movement.</p> <p>Since the last survey in November 2012, erosion greater than the survey error has not occurred at any locations and it has not been possible to identify any trends. Review and analysis of the 2012 aerial photography will allow the nature of cliff recession to be better understood.</p>	<p>survey was completed in Sept/Oct 2012 and a second repeat survey is planned for 2014. These data will be analysed to give more accurate information on the behaviour of the cliffs in a separate report.</p>

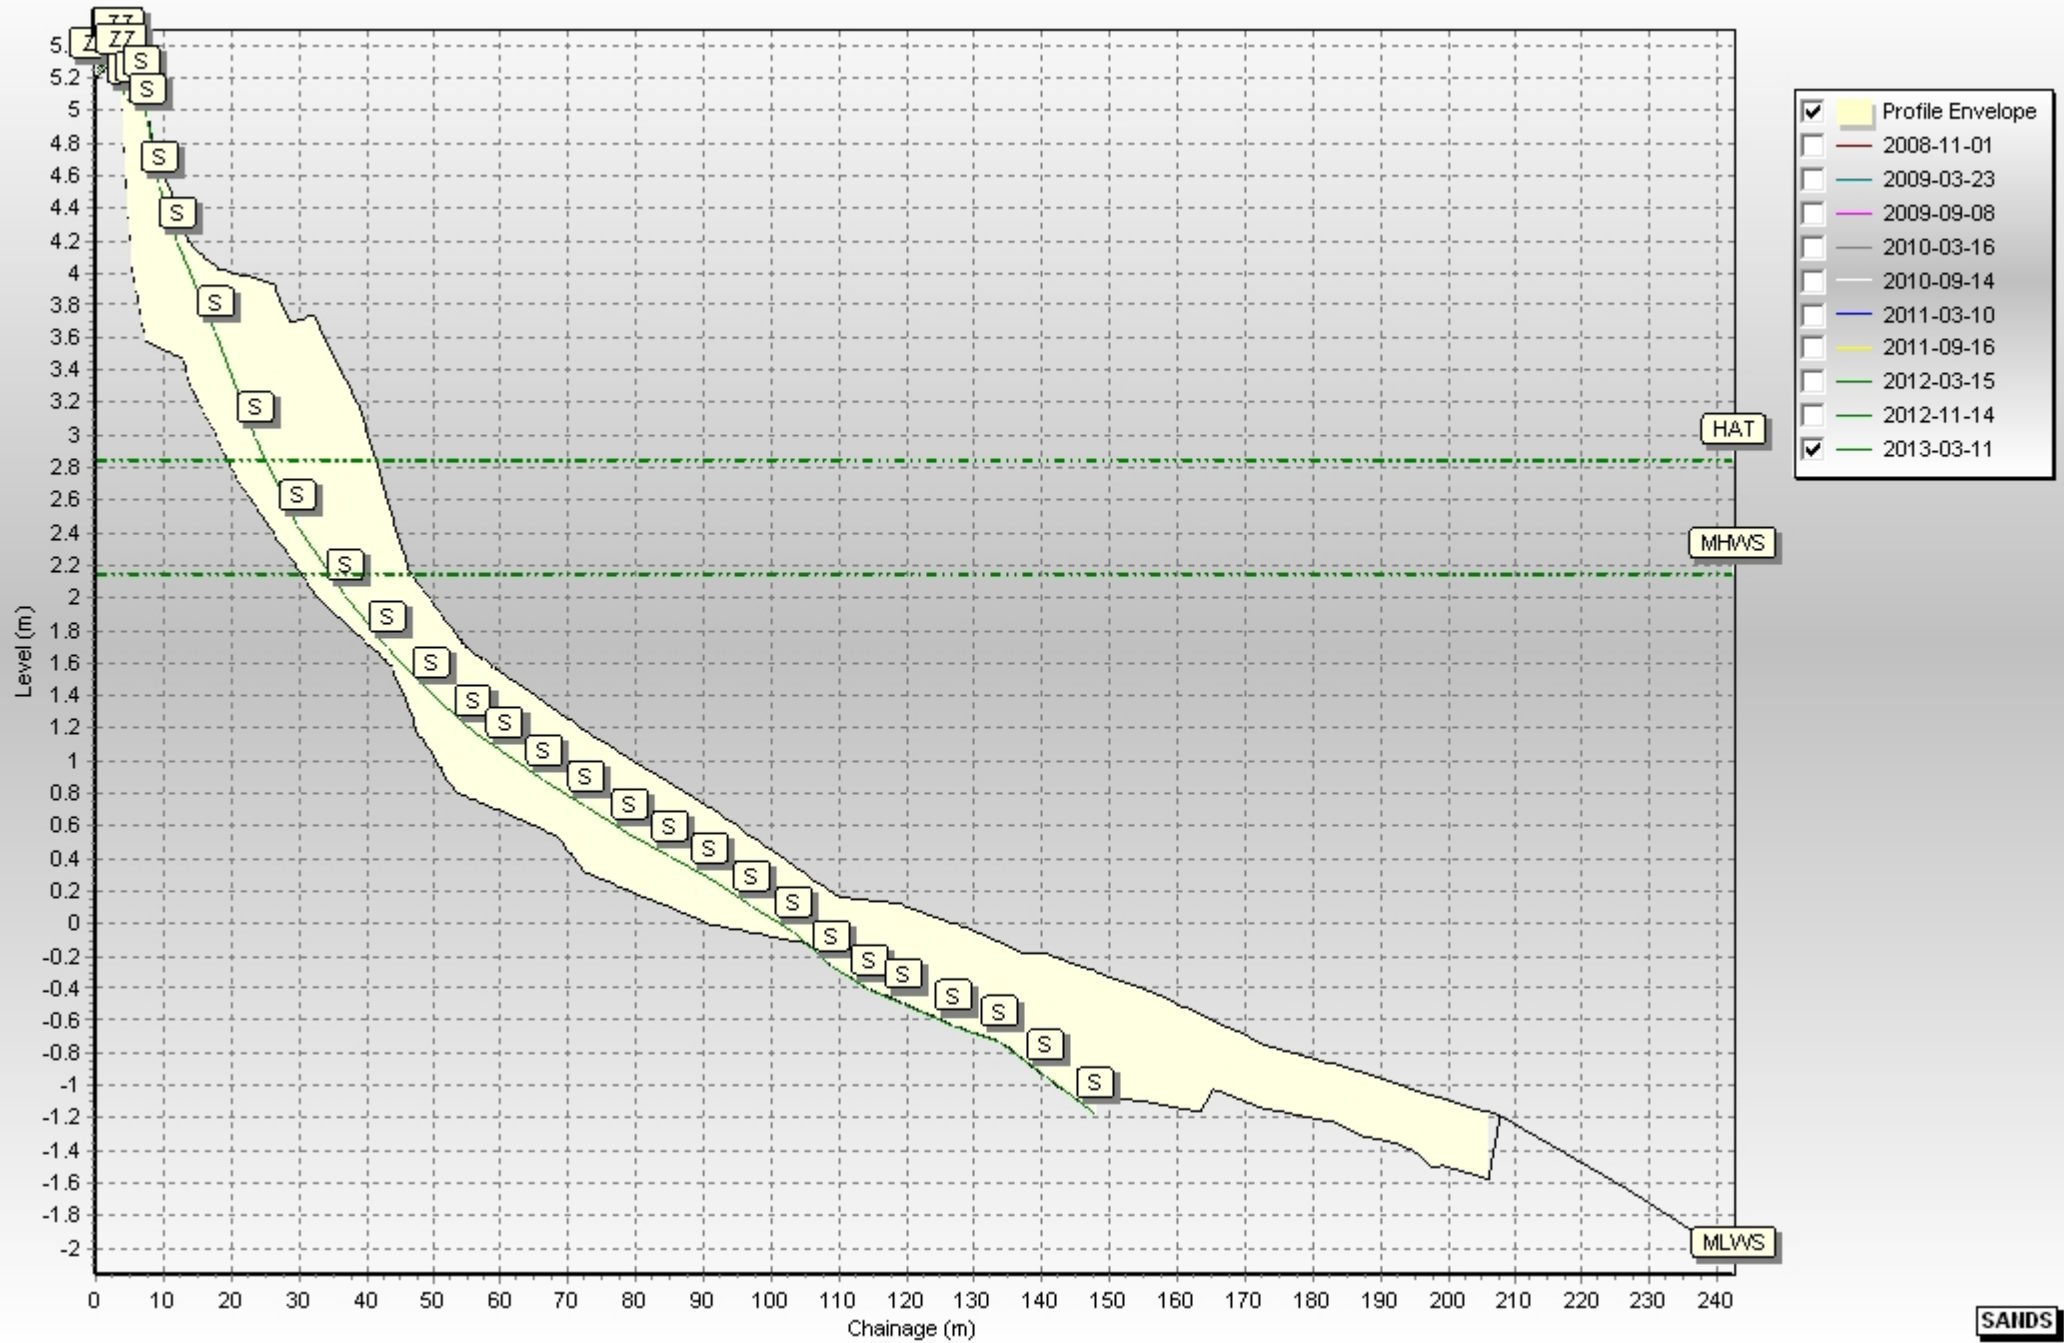
Profiles: 1bSS8

It is noted from the survey photograph for profile 1bSS8, that sand has been blown onto the promenade and road behind, which may create a maintenance issue. Any wind-blown sand should be returned to the beach to assist in maintaining a healthy beach.
