**Cell 1 Regional Coastal Monitoring Programme
Coastal Walkover Inspections 2010**

**Northumberland County Council
Final Report**

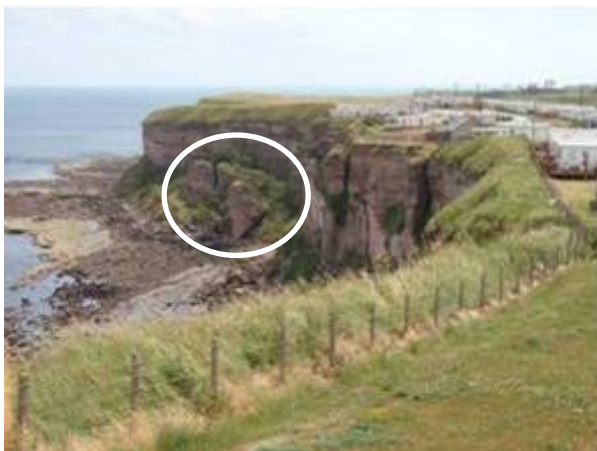
At Marshall Meadows Bay, however, there are signs of more activity, with some slumping in the softer material which overlays the hard rock base. This has cut the cliff top back close to the footpath in a small number of places along the cliff section that extends north to Marshall Meadows Point. Also, directly at the Caravan Park, there are previous large rock falls (below left) and visible signs of fracturing in the rock directly in front of the building (below right). Some further rock falls are therefore anticipated.

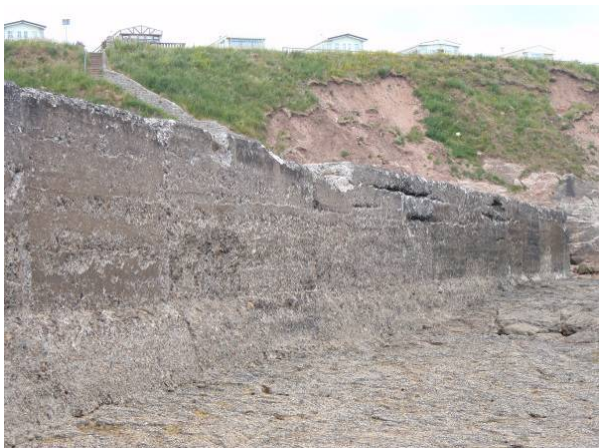
The Green's Haven breakwater itself is in a poor condition. The northern-facing (seaward) side is highly abraded and the crest is significantly damaged (below left). There is a void in the crest at the change in the structure's plan form alignment (below right) and extensive cracking nearby. It is likely that more of the crest will fail along the line of the existing cracking. The seaward end of the breakwater is extensively abraded and somewhat undermined. The southern-facing (haven) side is also highly abraded.

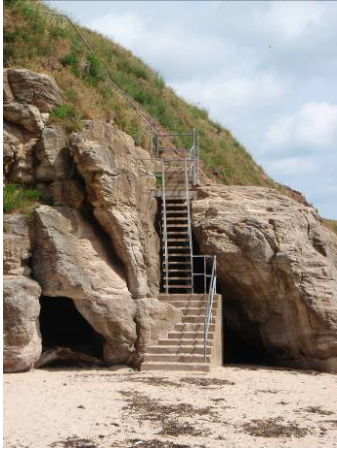
The cliffs to the south of the breakwater have two caves at the toe of the wooden (upper) and concrete (lower) access steps (below left). There has also been one rockfall and occasional slumps in the softer overlaying material along this cliff section, including one to the immediate north of the retaining wall to the access path (below right). There are various lengths of concrete apron and wall at the southern end of this frontage, but there are still occasional slumps in the cliffs behind.

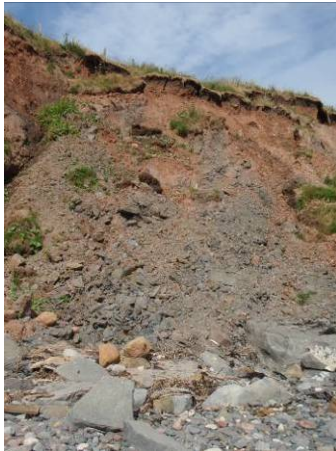
Along the cliffs from Fisherman's Haven southwards to Meadow Haven there is evidence of recent slumps which have left the cliff top overhanging in places. Along one 10m length in particular the cliff top recession has cut back to the fence posts (below left). Elsewhere smaller local slumps are in evidence. The foreshore is characterised by swirling rock outcrops called Bucket Rocks (below right).

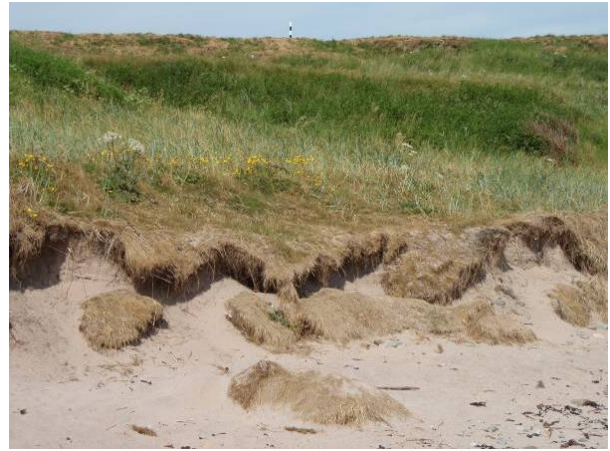
To the north of the Berwick Pier (breakwater) is a wide foreshore backed by generally healthy, well-vegetated and stable dunes (below left). Towards the north of this section, the dune edge starts to exhibit signs of erosion (below right).

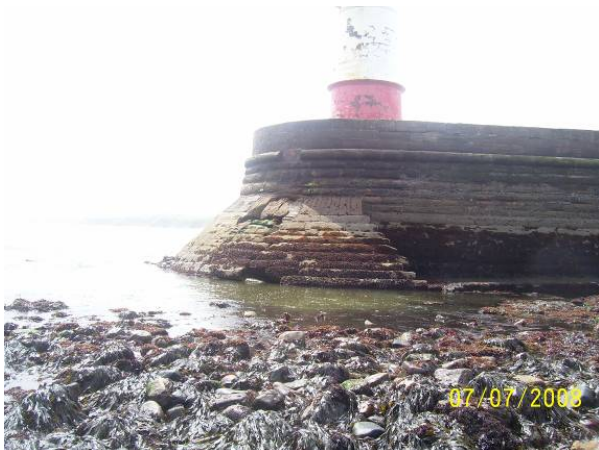
The north face of the main breakwater remains in good condition, although there are local areas where a masonry apron has been constructed in the past and where there might be slight indications of outwash beneath the apron. This will need to be further monitored. The head of the breakwater has been repaired (below right) following the damage identified in 2008 (below left).

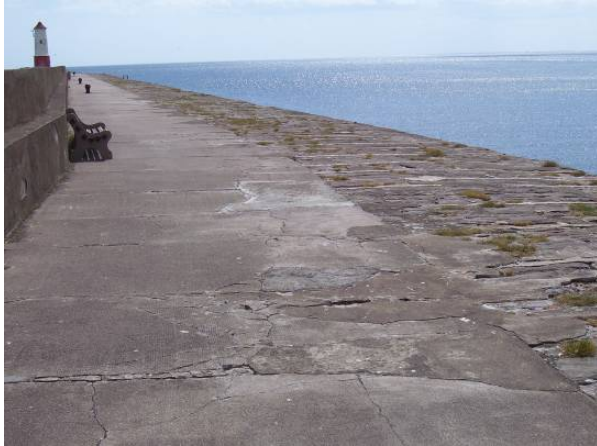
In general the deck and main inner face of the breakwater is in reasonable condition. There continues to be some spalling along the deck (below left). However, locally the inspection has identified a significant hole developing in the face of the breakwater and this requires urgent attention (below right). Reference should also be made to recommendations within the detailed inspection report under taken in 2008.

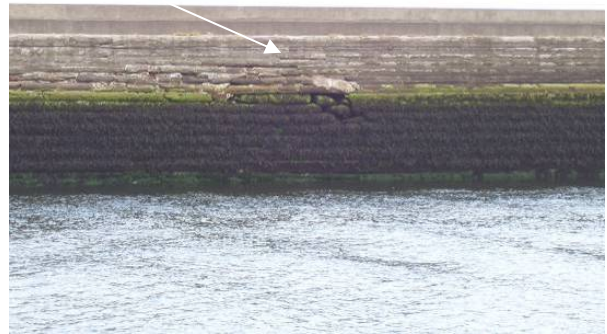
- **Tweed Breakwater** – Whilst important repairs have clearly been undertaken since the 2008 inspections towards the head, there is a void developing in the inner face of the structure which requires urgent attention.

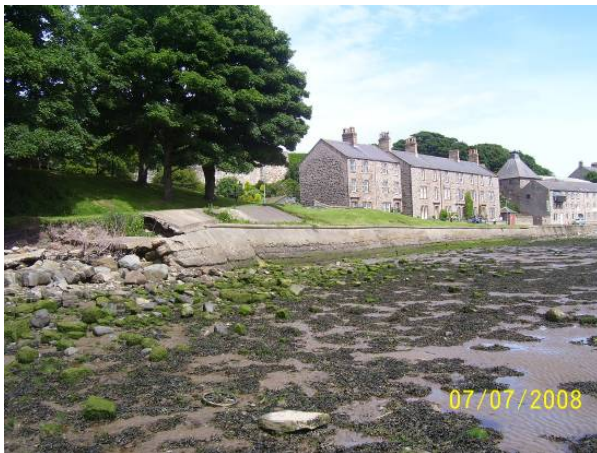
- **Berwick Town Walls** – One fronting sloping revetment remains in poor condition at its western end, but has not visibly deteriorated significantly since the 2008 inspections.

The section of seawall between the breakwater and the main walls has changed little although there is continuing damage to the old slipway. At the western end of this structure the revetment section is still in poor condition (below right). However, this has not deteriorated significantly since 2008 (below left).

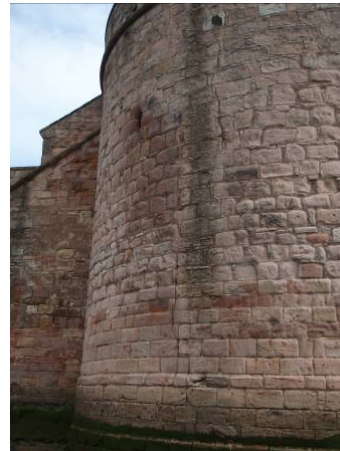
The main town walls remain in relatively good condition with no significant change over the foreshore. Monitoring of the vertical crack in the main tower (below right) shows no movement and it is concluded that this is an old feature of the wall. It is noted from the description of the history of the walls that the early extension seaward of the tower in this area was endangered by the sea. Potentially the crack is associated with the subsequent modifications.

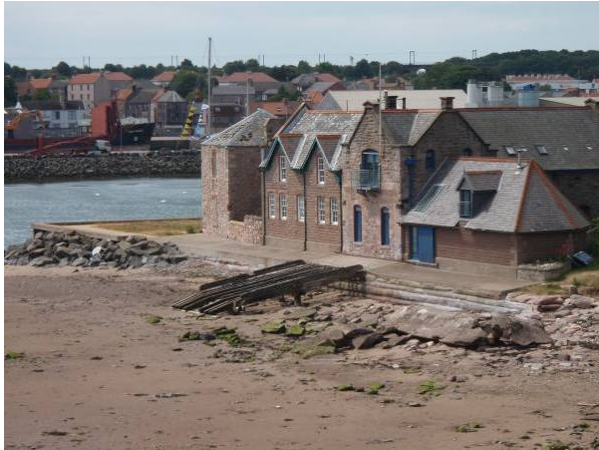
The existing defence in this area is in poor condition (below left). The short section of existing revetment further west does seem to have allowed accretion of sand (below right).

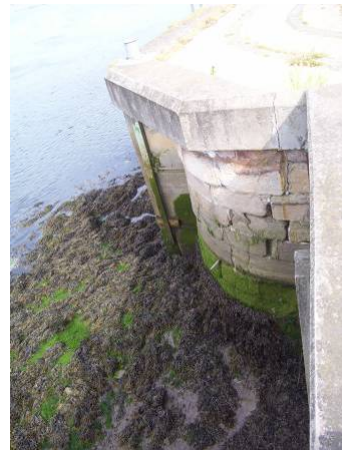
The main Berwick Quay wall appears in good condition although some of the older masonry sections will require further repointing. There some concern noted from 2008 that a local corner of the old wall showed signs of movement. The cracks in this area have not become worse (below right).

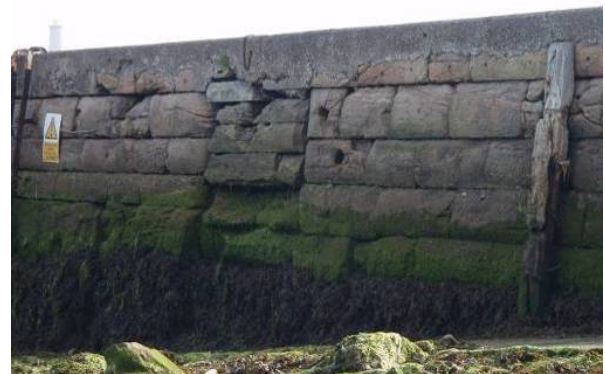
Minor routine maintenance is needed to infill gaps in the low masonry wall (below left) to the east of the gabions, and to Spittal Pier (below right).

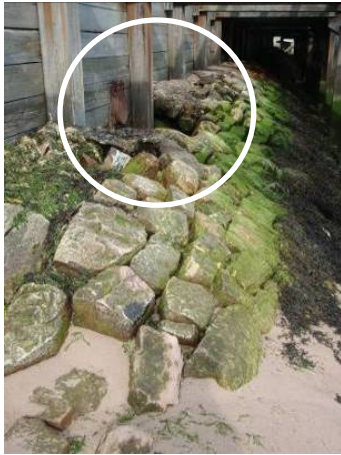
- **Spittal Quay** – High beach levels have mostly masked the significant damage previously identified in 2008 to the masonry underneath the timber jetty, while some outflanking at the tie-in to the dunes is now occurring.

Routine maintenance would also benefit the masonry toe underneath the timber jetty at Spittal Quay, where some stones are missing (below left) and where there is some outflanking at the tie-in to the dunes (below right).

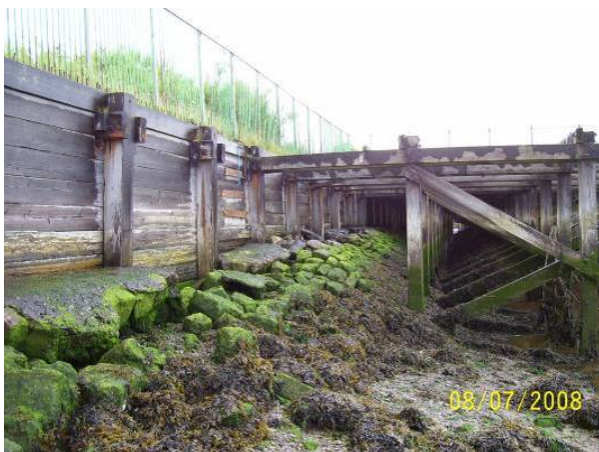
However, there has been a significant build up of sand at the downstream end (below right 2010, below left 2008). The revetment beneath the level of sand remains in a precarious state. The change along this section relates to the erosion pattern noted to the dunes further downstream and it suggests that the frontage does act as a controlling feature of this whole area. This needs to be considered as part of the current strategy being developed for the area.

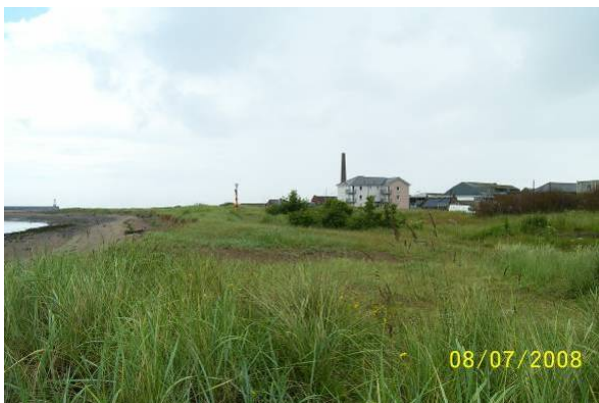
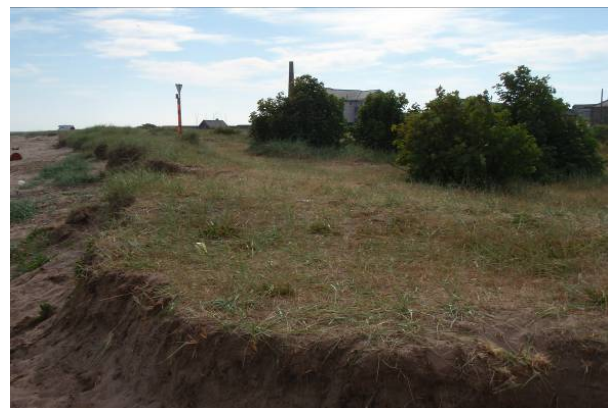
- **Spittal Dunes** – The dunes have actively eroded, linked to changes in position of the main estuary channel and evolution at Sandstel Point spit.
- **Spittal Point** – The foreshore has notably eroded but the revetment remains providing protection. The timber groynes along the frontage are effectively obsolete, and the gabions behind part of the revetment are missing or broken in some places and would benefit from replacement or maintenance.

The dunes at Spittal are actively eroding along their entire length and a suitable buffer zone should be allowed in any development proposals for this area to reflect this ongoing change. (below left 2008, below right 2010).

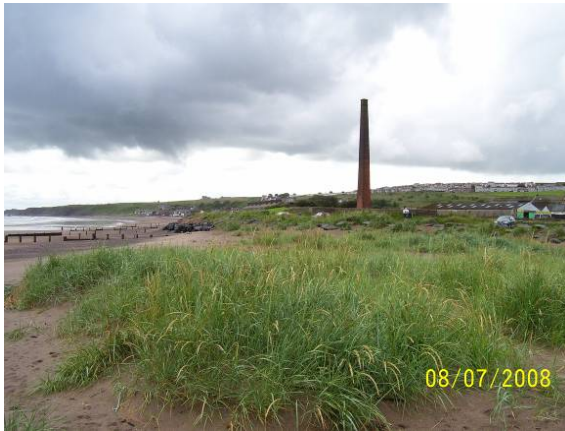
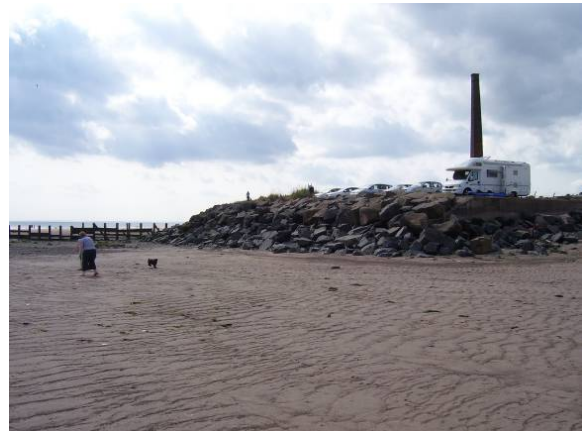
The headland defence at Spital has suffered significant erosion, by up to 2m in front of the revetment (below left 2008, below right 2010). The change in this area, while dramatic, is at present addressed by the revetment and similar changes have been experienced in the past.

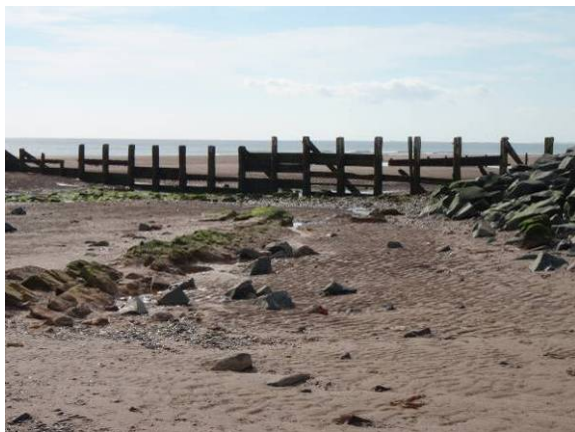
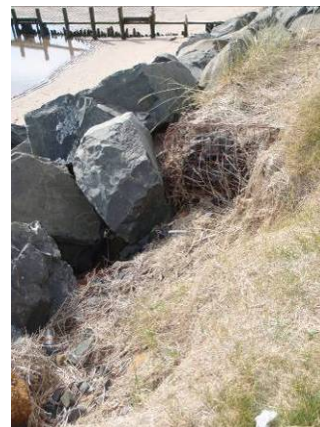
The revetment running south of Spittal Point is in good condition, but the timber groynes are obsolete (below left) and some of the gabions above the revetment are broken. Where there are no gabions present, or where they are broken, the grassland above the revetment is eroding (below right). These gabions provide a useful filter to the back of the revetment and should be repaired or replaced through routine maintenance.

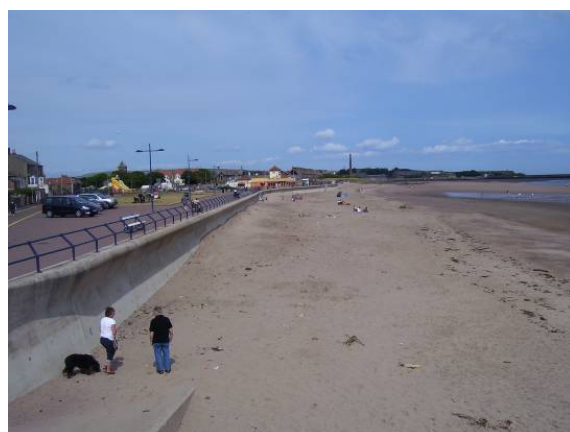
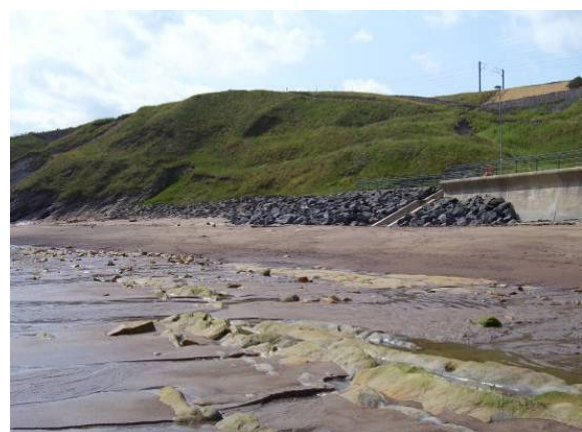
At the southern end of the revetment there has not been the same degree of erosion. The beach along Spittal Promenade remains quite healthy (below left) and the level of the beach is maintained through to the steps at the southern end of the promenade (below right).

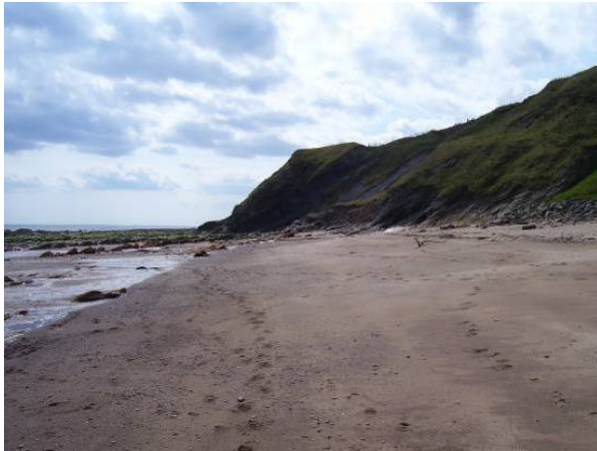
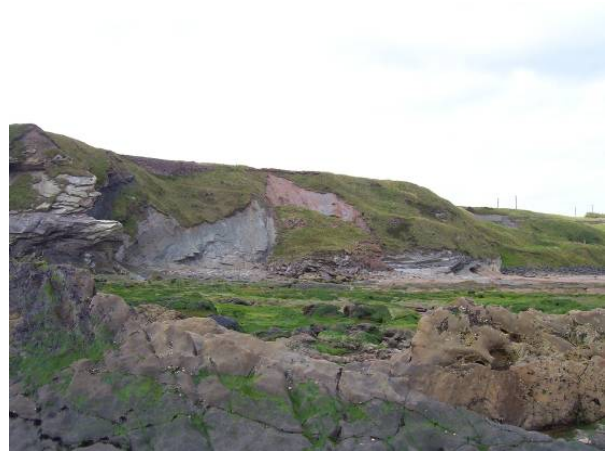
To the south of the promenade there has been a significant local landslip (below left). This has exposed the underlying rock (below right). This tends to confirm the assessment made in the SMP2 that despite the underlying instability of the cliff in this area, the railway line is unlikely to be affected over the short to medium term and probably even in the long term.

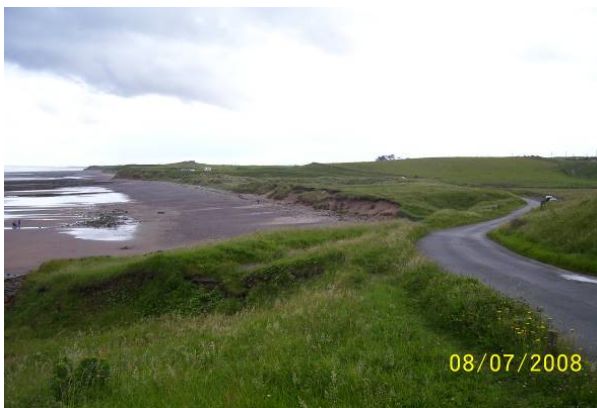
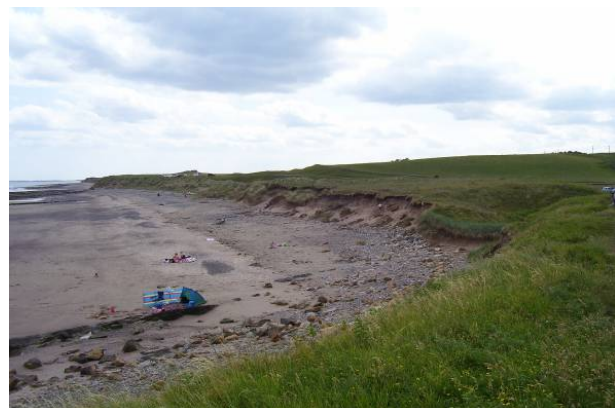
South Scremerston: increased erosion of dune face with higher foreshore.

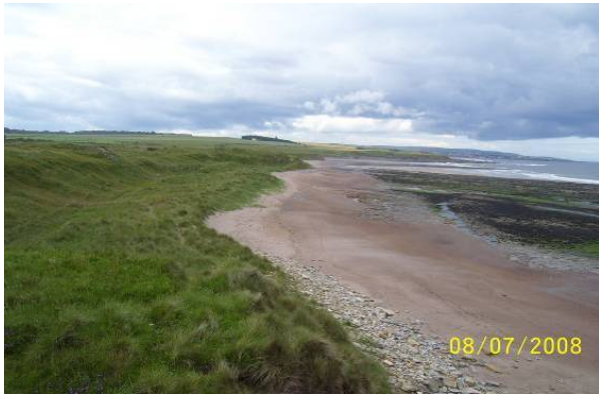
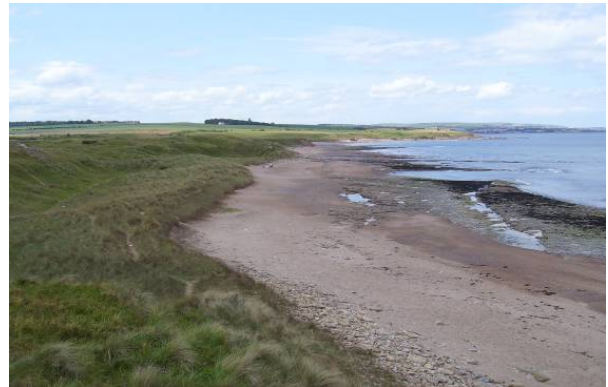
Slight erosion at the dune face, loss of upper beach but similar lower foreshore.

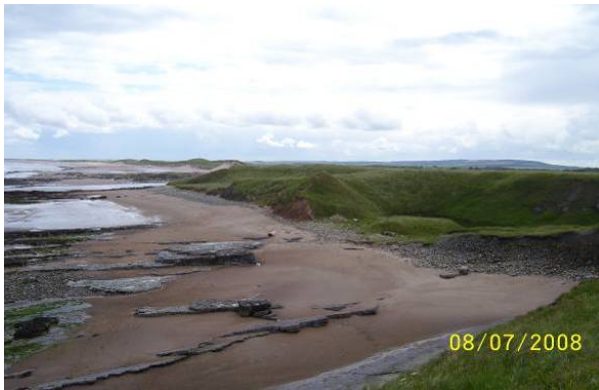
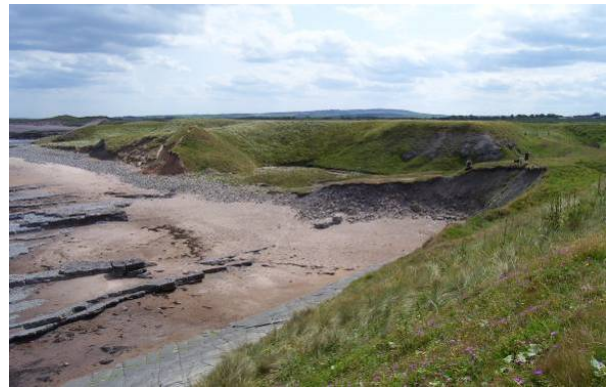
The Skeers: Slight erosion to the dune cliff line, increased exposure of shingle to the upper beach and similar levels over the lower foreshore.

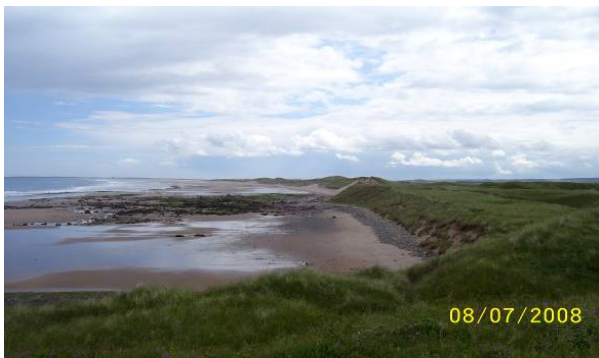
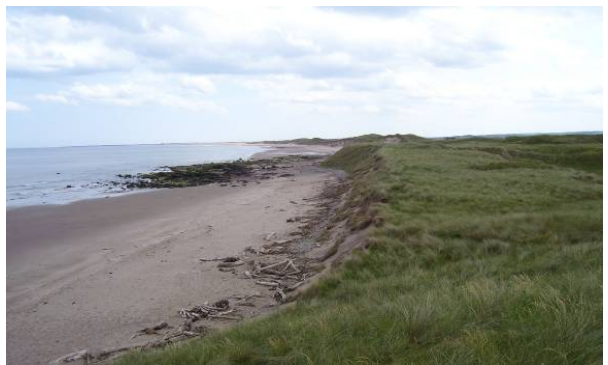
Significant storm debris and high upper beach sand level, covering shingle, significantly greater erosion of the back dune.

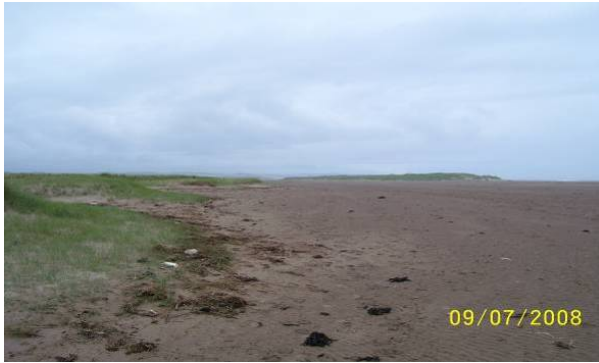
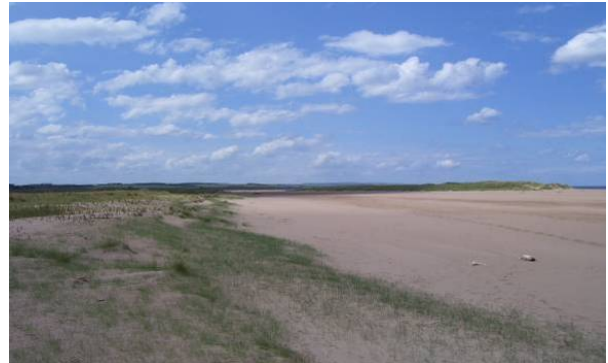
Cheswick and Goswick: Over this frontage, through to the South Low, there has been a general increase in sediment over the low lying upper beach. This has allowed rapid development of embryo dune vegetation. This is further evidence of the area tending to be a sediment sink.

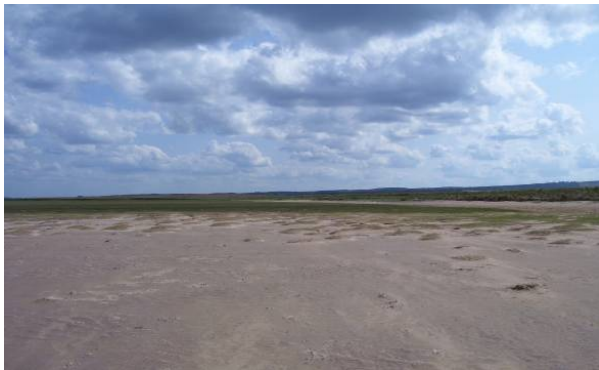
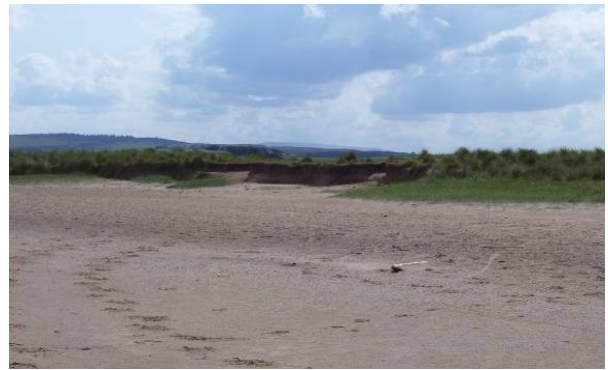
There is evidence of accretion up against the swath of salt marsh around the entrance to the South Low, but also local erosion of the dune line to the rear.

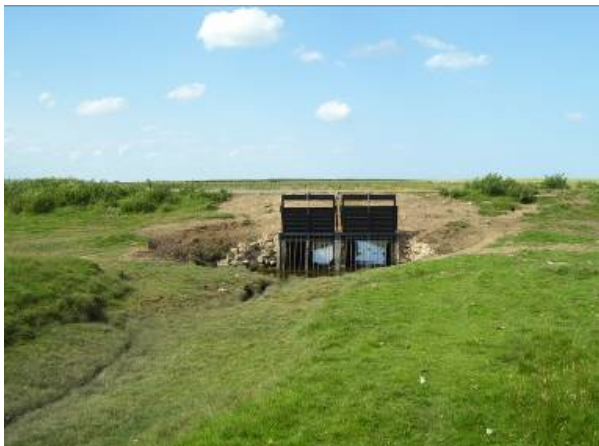
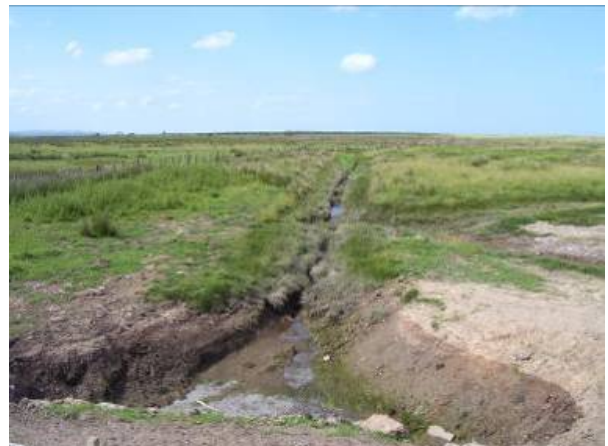
A new sluice has been constructed at South Low (below left), opening land behind to tidal flooding (below right) as part of the Northumberland 4shores project.

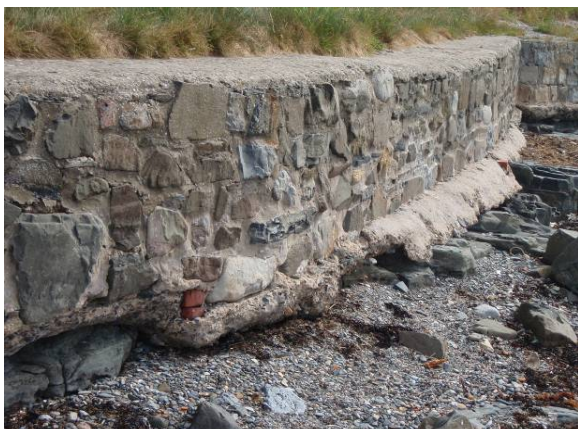
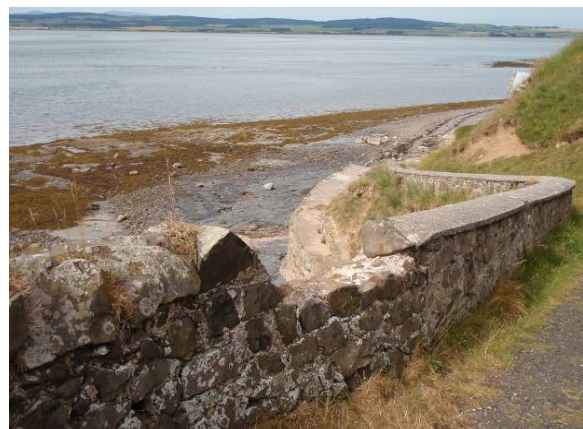
At the toe of the foreshore access ramp from The Heugh headland, there is a cobble berm on top of which sit three boathouses (two combined in one building and the other separate) and the distinct black shed named Maggie's Shed. The shed is becoming notably undermined and may need relocating. More significantly, however, there is the onset of outflanking at the southern end of the wall that protects the access ramp. This wall also has become increasingly undermined since 2008 (below left) and now requires maintenance. This is not presently a significant activity, but some missing masonry and voids should be infilled to avoid further deterioration. It is noted that this area has previously been repaired and some areas are holding up well. Other previous repairs, however, are themselves becoming undermined. During maintenance activities, attention could also be paid to more 'cosmetic' issues such as missing coping stones along the access ramp wall (below right).

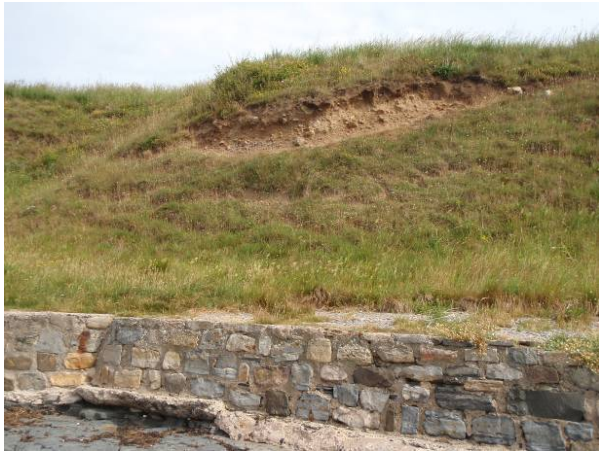
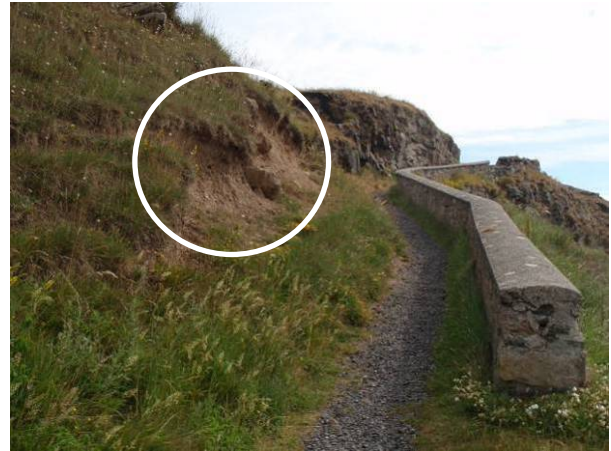
In the softer material above the wall, some previous localised slumps are identifiable (below left). In one area along the access ramp, the softer material remains slightly overhanging and may therefore be subject to further slumping (below right).

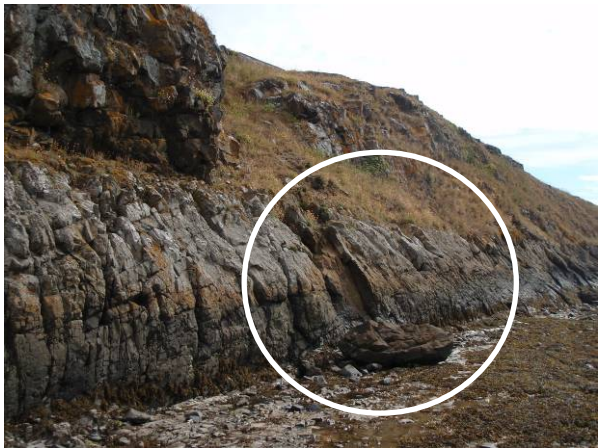
Extending from The Heugh access ramp to Steel End, at the harbour pier, the hard rock cliff is once again highly fissured. In one location a single rock has fallen (below).

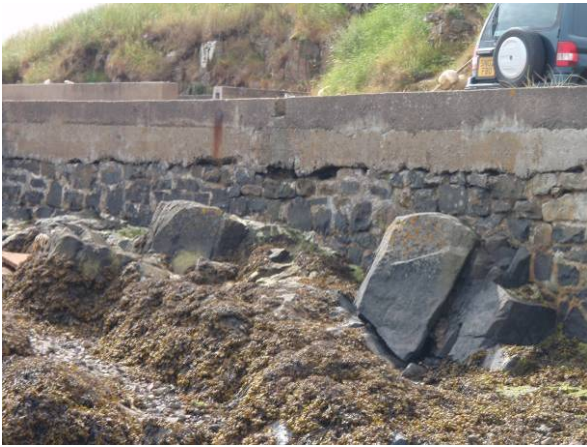
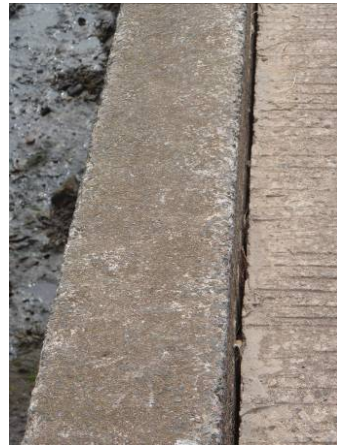
Along the harbour pier and the trunk-wall leading to the pier, there are some gaps between the coping and the side-facing stones which need filling on the 'inner' side of the pier (below left). Along the pier there is also a slight gap opening between the coping and the pier deck (below right).

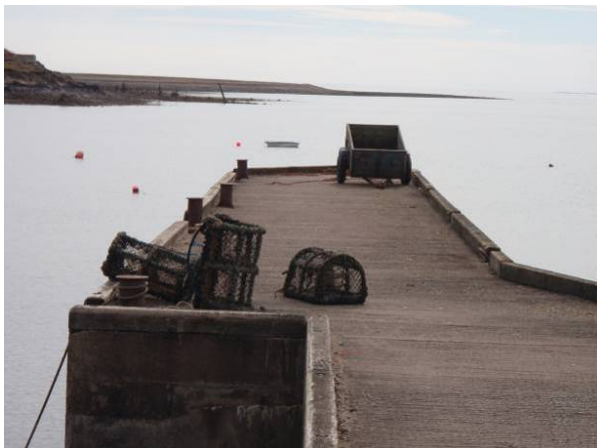
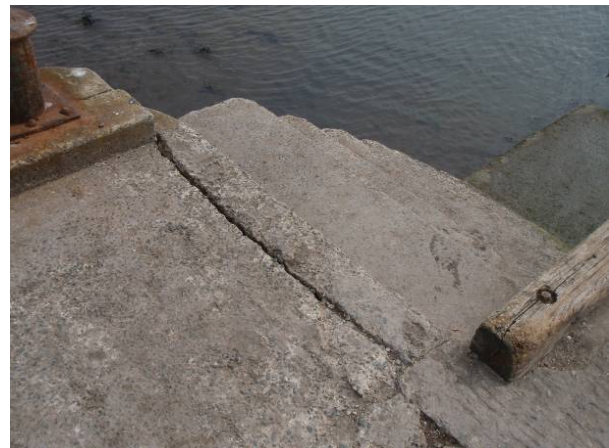
There is apparent liting of the seaward end of the pier (below left) and a crack at the top of the fishermen's steps on the inner side (below right) which both need continued monitoring for signs of worsening.

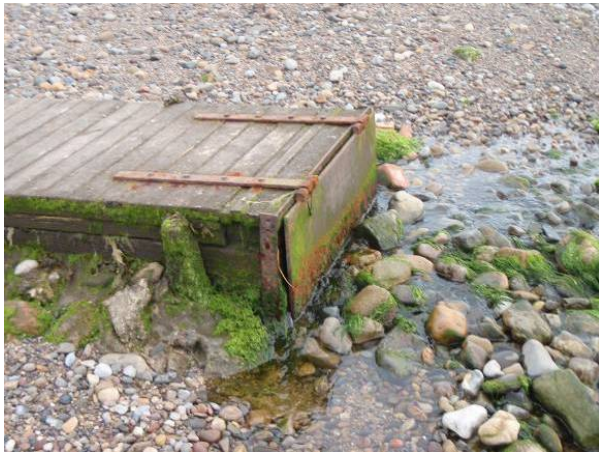
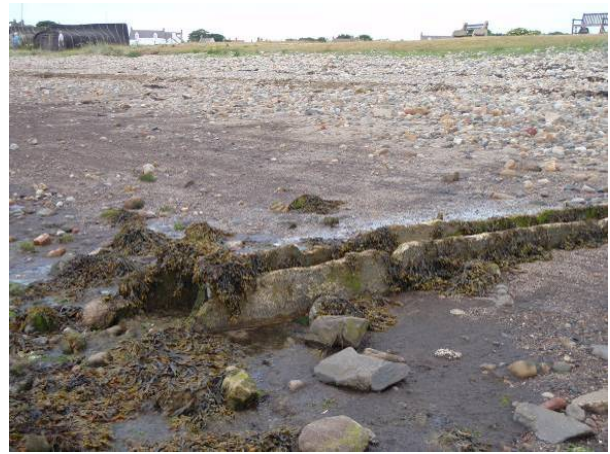
Within the harbour itself, the sandy beach and dunes remain stable, with beach levels quite high at the time of the inspections. The broken hinge on the flap valve of the outfall in the centre of the beach has been repaired since 2008 (below left), but the obsolete outfall remains deteriorating (below right).

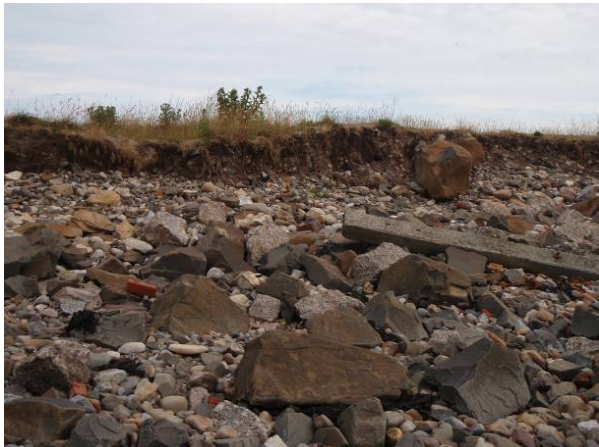
The section fronting the footpath that extends towards Lindisfarne Castle is eroding at its western end, although there remains a suitable buffer to the footpath. Some rubble has been placed to slow this process in the west (below left), but ongoing erosion here results in boulders being released onto the foreshore (below right).

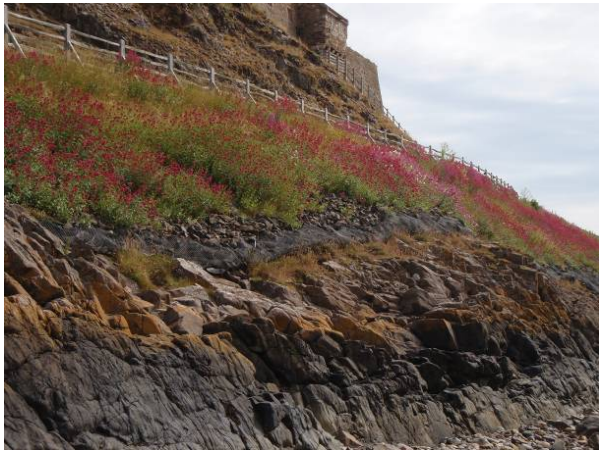
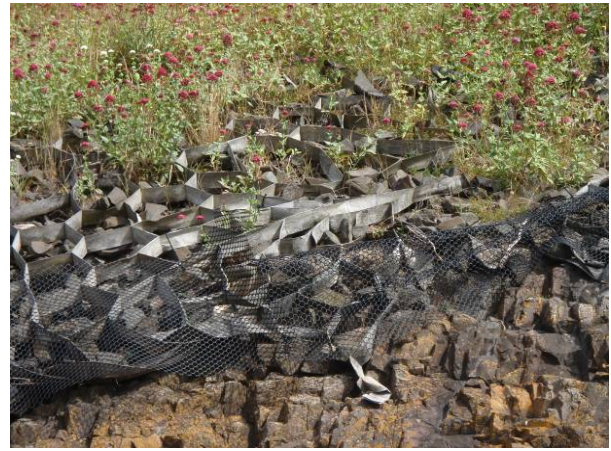
At the castle itself, the hexagonal netting does seem to have been highly effective in stabilising the soft cliffs which mantle the harder rock base, resulting in good vegetation cover and preventing slumping (below left). In places, however, the rock is now spilling out of the netting (below right) and this should be replaced if slumps are to be avoided.

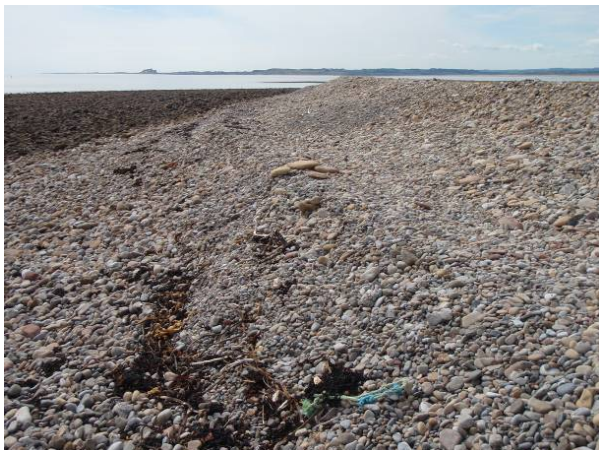
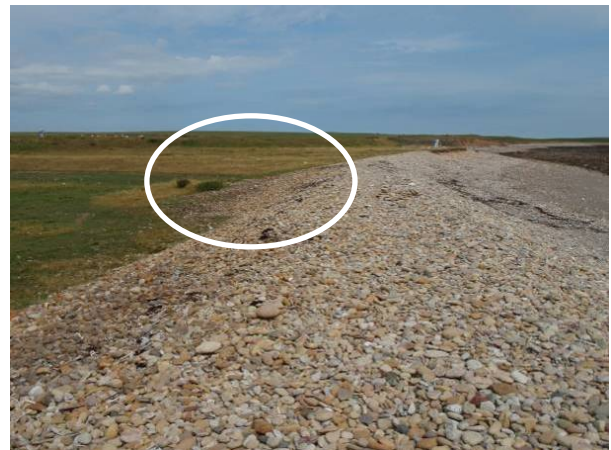
The 'ness' at Castle Point remains in a very healthy condition, with text-book examples of storm ridge formation (below left) and pebble barrier overwash fans (below right) exhibited.

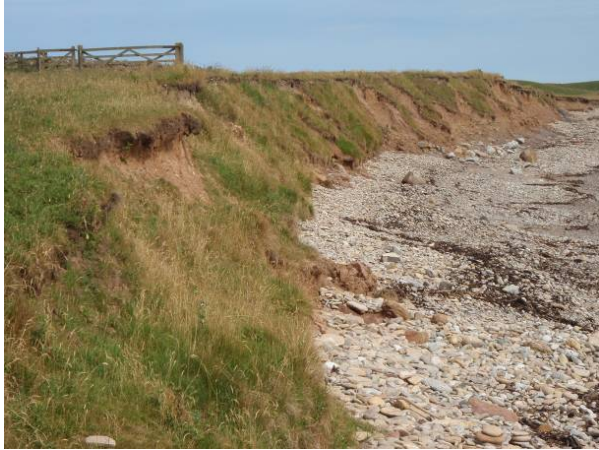
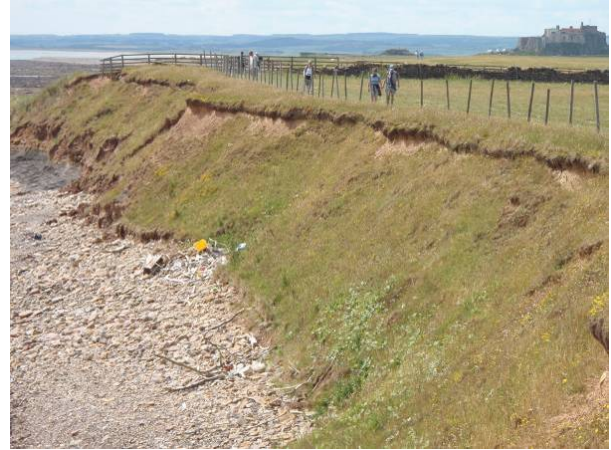
The frontage between Castle Point and Emmanuel Head comprises soft cliffs fronted by rocky platforms, often with a cobble berm at the toe of the cliff, interspersed with lower areas fronted by more extensive cobble berms. Erosion of the cliffs throughout parts of this section remains ongoing, but at a relatively low rate through local slumps (below left). In one area fencing has been erected to keep the public away from the eroding cliff edge (below right), but no significant further erosion has been noted here since 2008 and the cliff face is well vegetated, indicating that some stability has been retained.

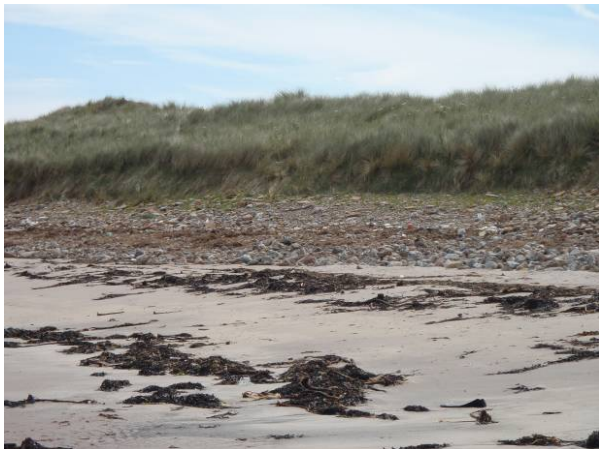
At Sanham, the dunes in the south and north of the bay are relatively stable due to the sheltering effect provided by Emmanuel Head and Castlehead Rocks, respectively (below left). In the centre of the bay, however, slumping remains active down the dune face (below right), although this is fairly modest and presents no risks to assets.

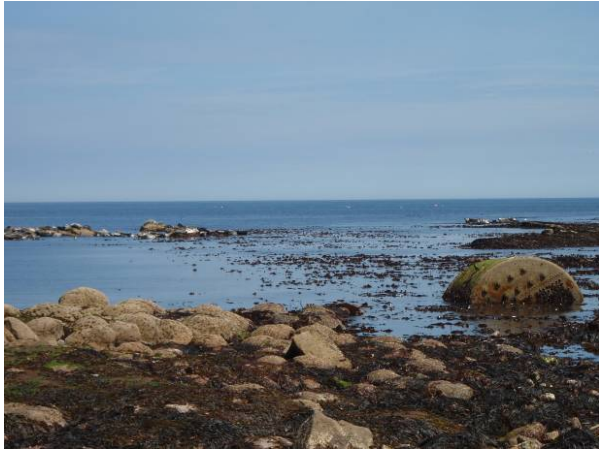
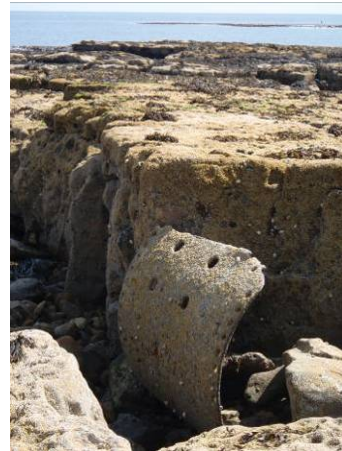
The metallic object observed in 2008 along the foreshore by Castlehead Rocks remains present (below left) and a further piece of metal debris was identified (below right). Checks should be made with the Nature Reserve Warden that they are aware of this and that it is not unexploded ordnance. A tall refrigerator was also observed along the foreshore here, which should be removed.

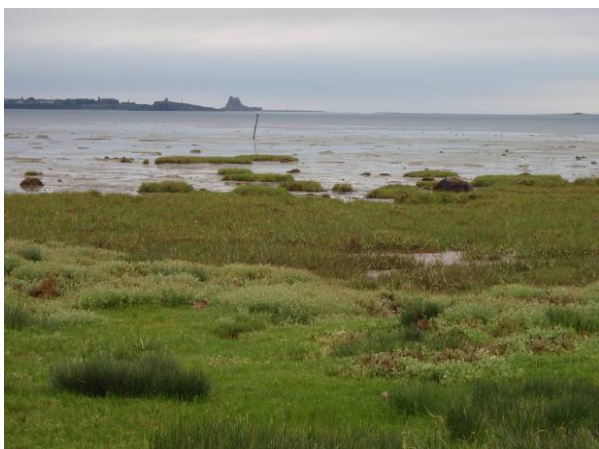
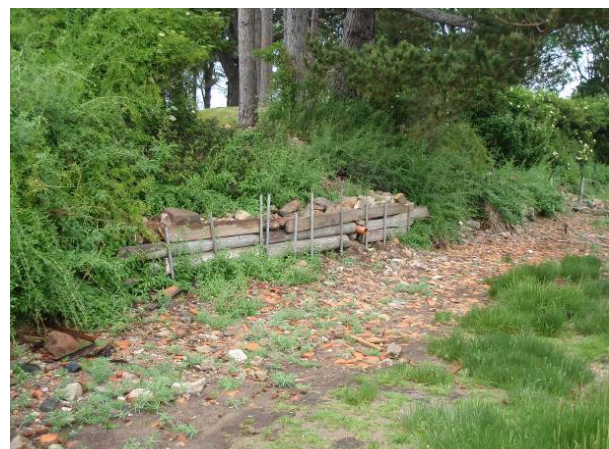
From the landfall of the Holy Island causeway, near Beal, south to Fenham Burn, the shoreline is characterised by a good fronting width of salt marsh and mud and sand flats (below left). The marsh becomes narrower and patchier towards Fenham Mill, where there is a small timber retaining wall in front of the house (below right), before becoming wider again towards Fenham-le-Moor. The shoreline itself is comprised of a coastal slope which is not experiencing erosion.

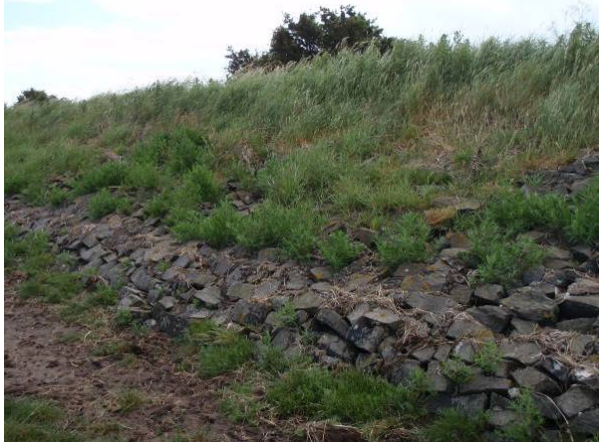
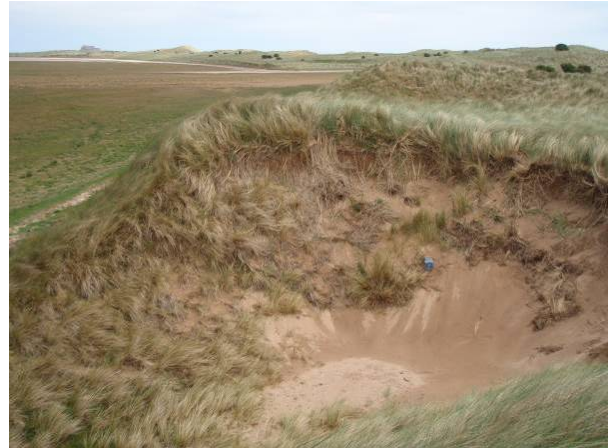
East of the bird hide at Elwick, there is a flood embankment, fronted by salt marsh, which was not originally depicted in the National Flood and Coastal Defence Database (NFCDD). A new asset length has now therefore been created to cover the embankment. The embankment is protected along its toe by an asphalt and stone 'revetment' (below left) and currently is effective in preventing sea flooding to a local low-lying band of farmland across Ross. There are a few areas where routine maintenance would be of benefit to fill gaps between stones. Further along Cockly Knowes is a bracken-covered coastal slope leading to the Ross Links dunes. This is mostly stable, although there is one large blow-out at the coastal margin (below right).

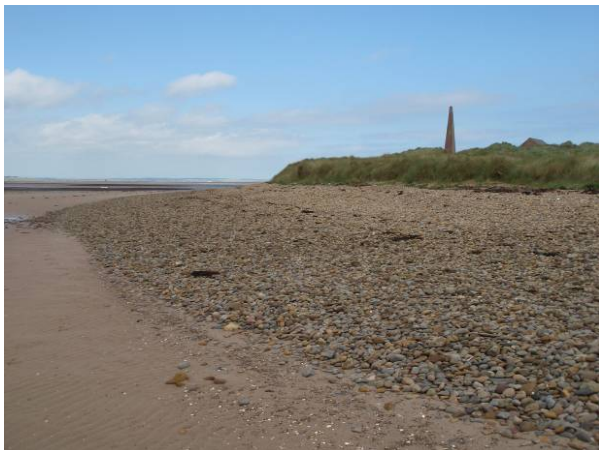
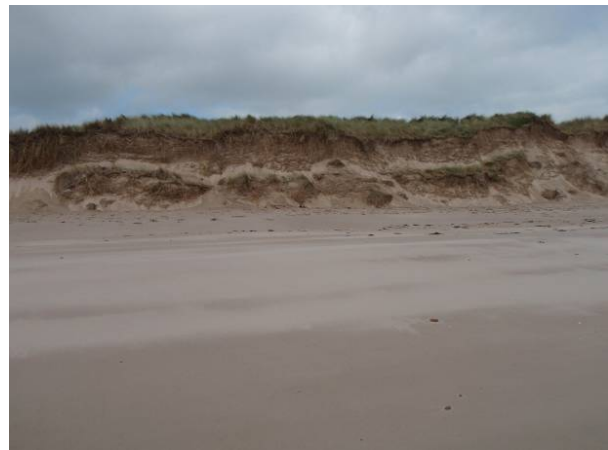
The 'spit' of dunes along Old Law, extending seawards to Guile Point, were not previously included in NFCDD but now have been included as a new asset length. The inland-facing side of the spit is fronted by a cobble berm and is highly stable (below left). Two navigation beacons are present at Guile Point, one directly on the foreshore and the other on the dunes. The seaward side of the spit is more exposed to wave action and is actively experiencing storm-related erosion along its length (below right).

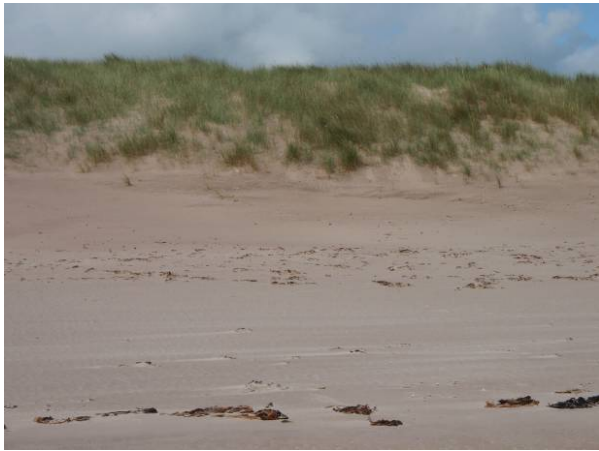
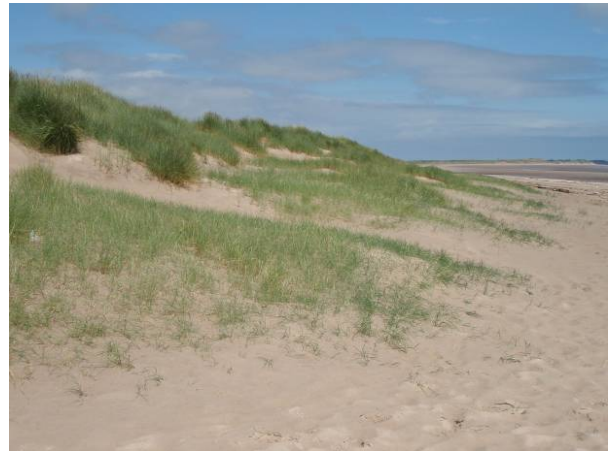
The dunes along Ross Back Sands (below) are very stable and are known to have been accreting historically. Within this, however, there is one area of about 10m in length and another of about 20m in length where toe erosion has occurred. The dunes extend around Ross Links towards Links End, where they are fronted by salt marsh and mud flat.

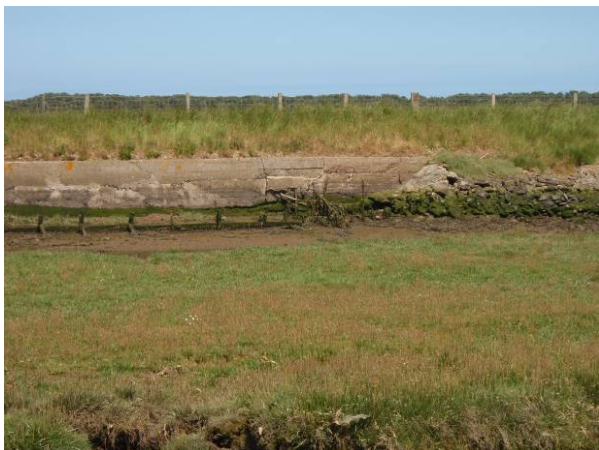
Various walls and mortared rock revetments (below left) extend around Links End towards the sluice at Ross Low (below right). These appear to remain in need of maintenance although their condition has not significantly deteriorated further since 2008.

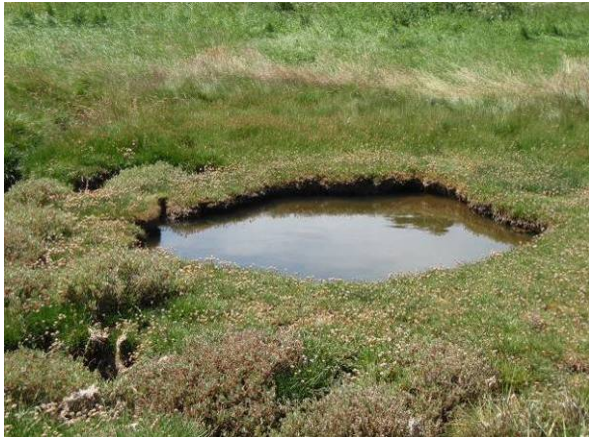
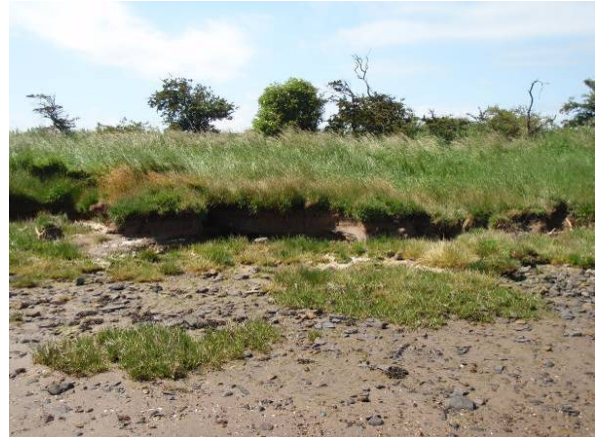
Along the Chesterhill Slakes in Budle Bay, the salt marsh is generally healthy, although some salt pans (below left) and marsh edge erosion (below right) was noted. Generally, seaward of a distinct marsh edge cliff, the upper mud flat is colonised by *Spartina* (also shown below right). At the point where the shoreline turns westwards to head inland to Ross Low, loosely tipped rocks are present to offer some protection at this vulnerable point.

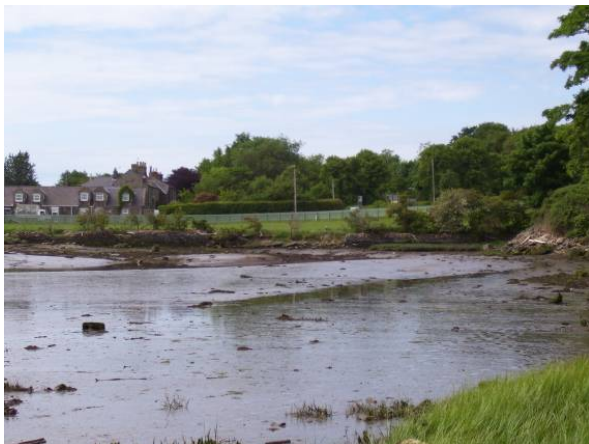
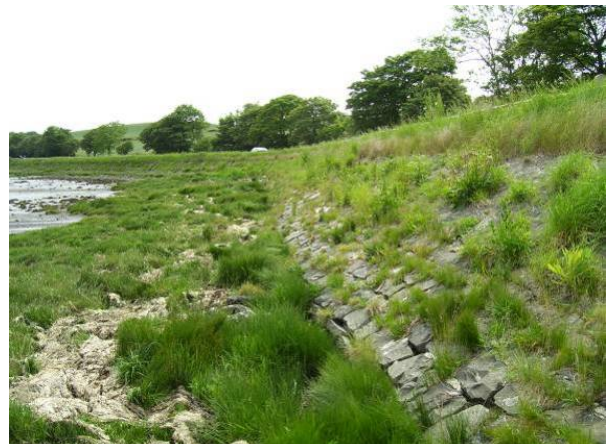
At Waren Mill (below left), the wall at the head of the bay is in poor condition but is not critical. The revetment fronting the road needs some minor maintenance to fill gaps between blocks (below right), although this has a low priority at present.
