**Cell 1 Regional Coastal Monitoring Programme
Coastal Walkover Inspections 2010**

**Northumberland County Council
Final Report**

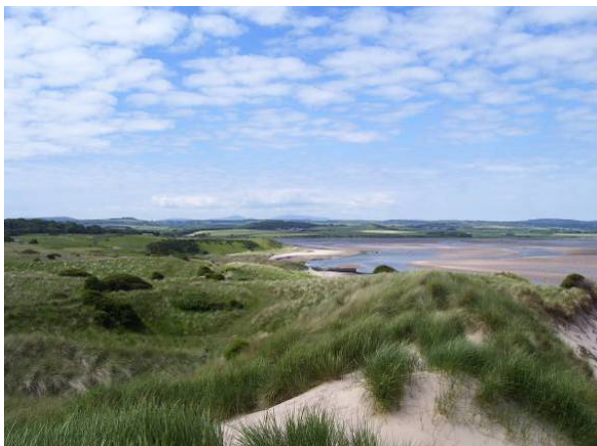
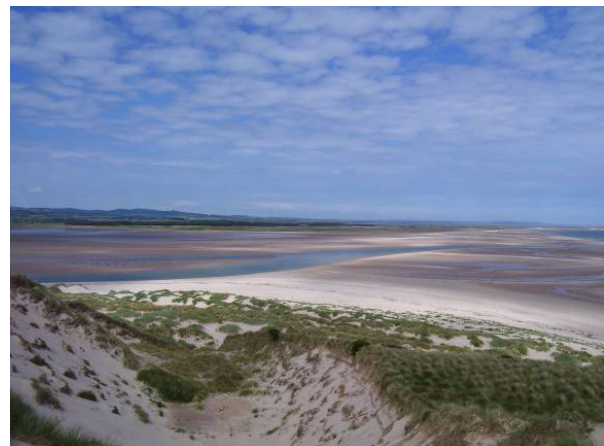
The southern side of Budle Bay is relatively healthy with no significant issues. The old jetty acts to control the sediment along the frontage (below right). There has been some growth in the spit from this southern side (below left) and this forms an outline shoreline to the bay.

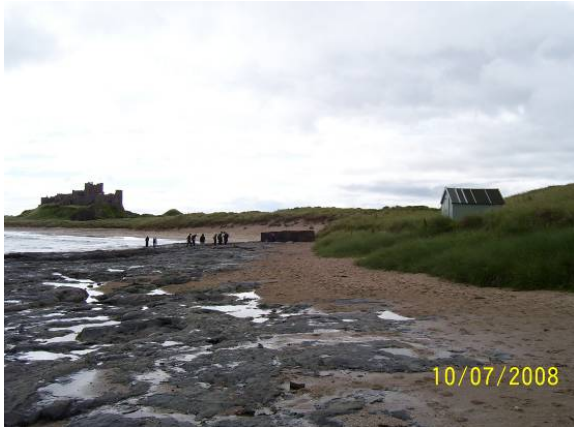
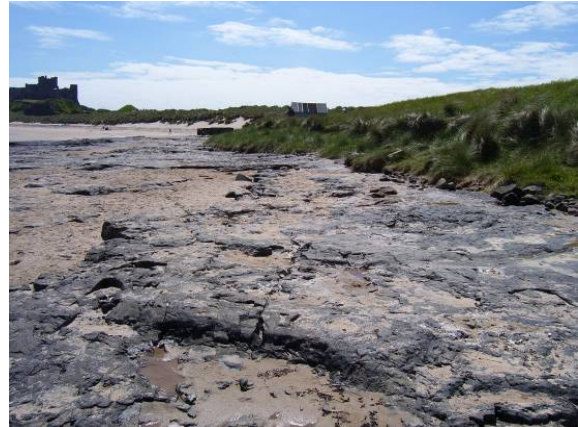
Bamburgh: local erosion to the backshore but beach levels high (below left 2008, below right 2010).

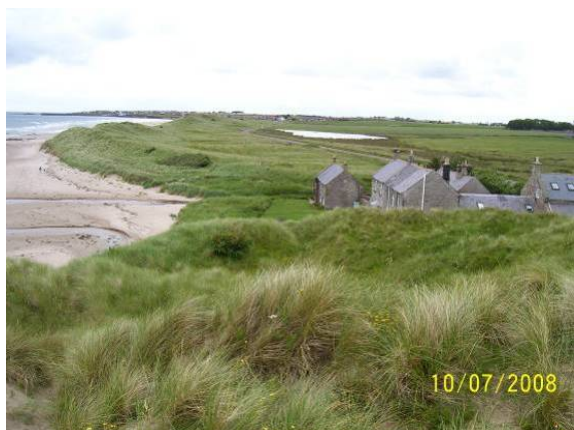
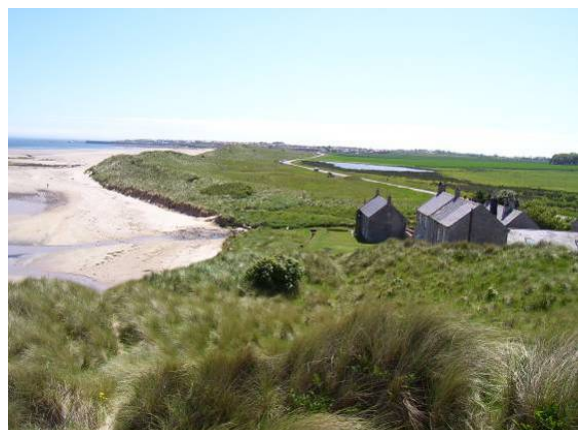
Monks House: general erosion to the dune but beach levels remain stable (below left 2008, below right 2010).

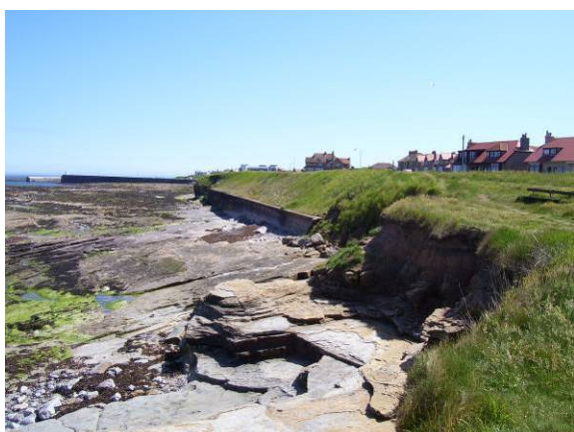
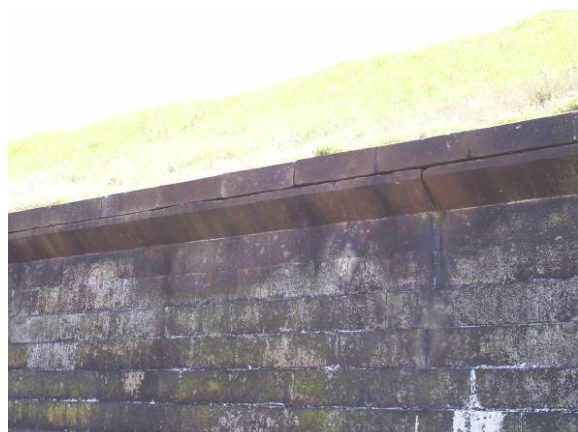
There has been little significant erosion north of Seahouses (below left). The road wall is still in reasonable condition. There are coping stones loose and these need to be repaired to maintain the integrity of the wall (below right)

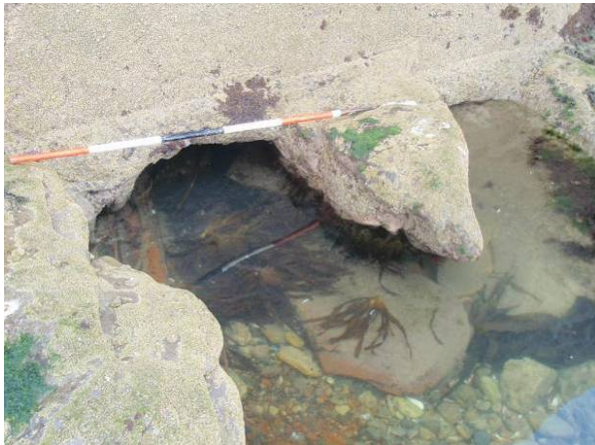
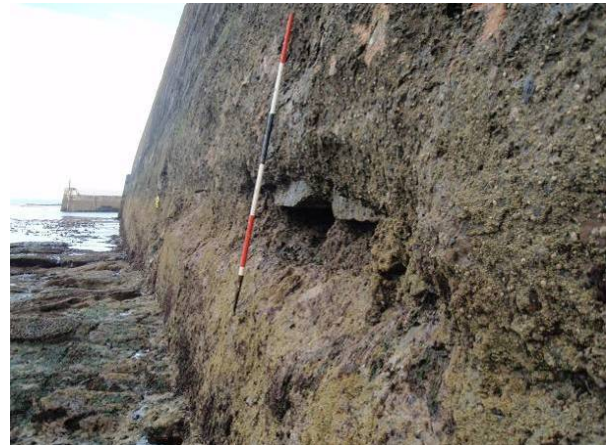
Detailed inspections carried out in 2010 by Royal Haskoning for Northumberland County Council along the Main Pier have identified some very significant defects with the structure. A number of scour holes (below left) have been located along both the seaward face and the inner face and it is believed that the core of the structure is being lost via these scour holes. Intrusive investigations have discovered voids existing between the deck and the core material that should be supporting the deck. This has resulted in settlement and cracking of the deck. A significant amount of material (in places over 500mm) has also been lost from the face of the pier walls due to abrasion and general degradation of concrete (below right). Concrete strength tests have indicated that the strength of the concrete, especially on the inner face is extremely poor. Tests also confirmed the remaining thickness of the structure walls varies from in excess of 3m to as little as 0.6m and in one area divers reported the wall sounding 'hollow'. The concrete has become very porous and in one location water can be viewed seeping from the structure at a significant rate.

A full options appraisal report has been produced for Northumberland County Council and the recommendations of the report are that the pier walls should be encased, with increased protection also provided at the toe. It is proposed that the deck is removed and the core material excavated to investigate whether there are any voids at depth and then the structure backfilled and a new deck cast.

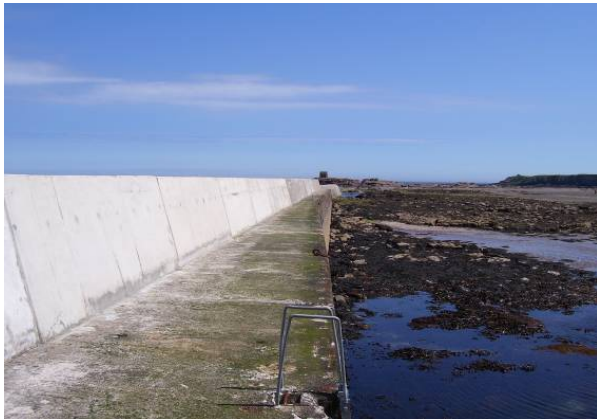
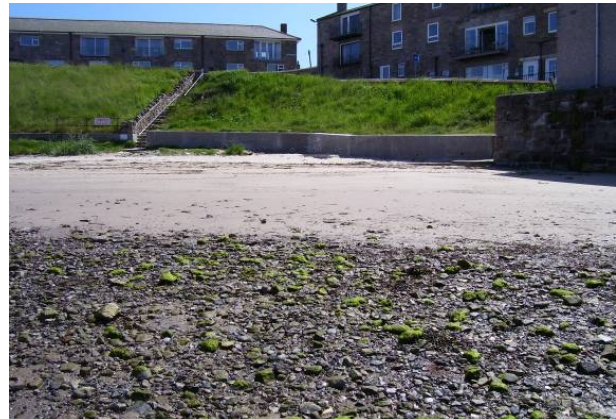
Work was on-going during the last inspection (in 2008) to the Outer Breakwater (below left) and to local walls to the back of the harbour below the work sheds on Harbour Road (below right). These works are now fully completed and the structures are now in good condition and providing increased protection to the Harbour.

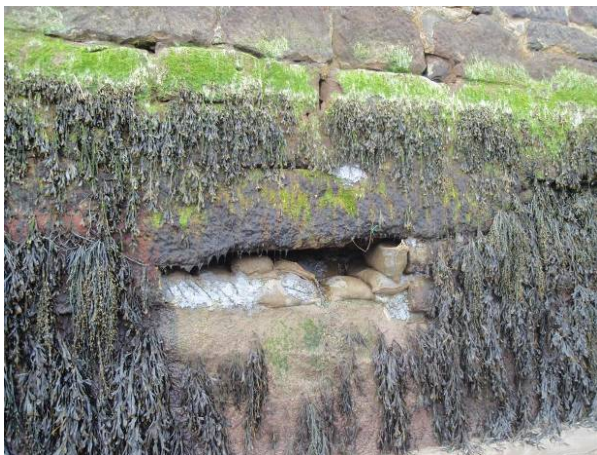
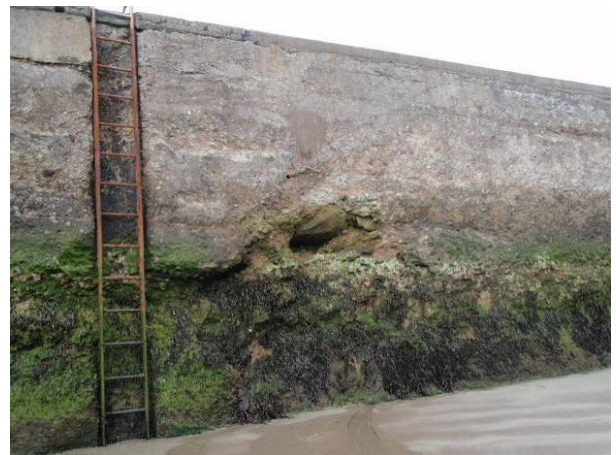
North Sunderland Harbour Commissioners are in the process of applying for permission to install rock armour on the beach between the Main Pier and the Inner Arm. This purpose of this is to reduce the wave reflections inside the harbour and protect the back wall from further erosion. Currently a void is opening up in the face of the wall (below).

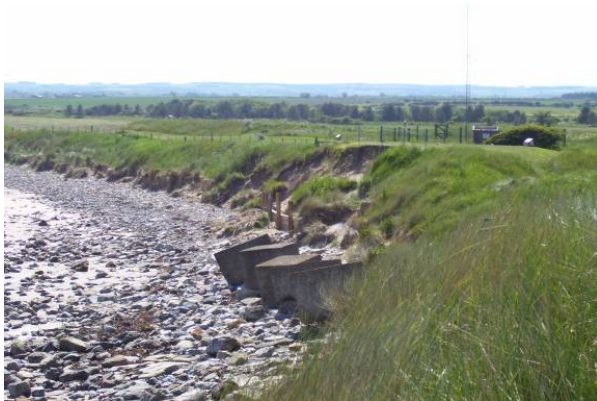
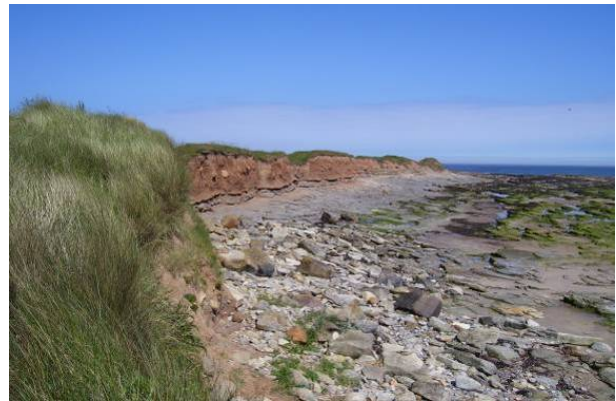
To the south of Seahouses there has been further local erosion to the dune line in the area of the golf course. While the main dune line has suffered slightly, more severe erosion has occurred in the corner between the dunes and the cliff line that runs seaward (below right). It is noteworthy that the thin ridge making up this cliff suffered very little erosion (below left). This seems to confirm the specific nature of the storms that hit the area earlier in the year. Waves will have tended to run along the cliff face, rather than against it, and more directly against the main alignment of the dunes. Where the two frontages meet the waves would be concentrated into the corner. As with other areas of the coast, the general foreshore level has not been significantly reduced. Any further defence of the frontage could be counter to the intent set out in the SMP.

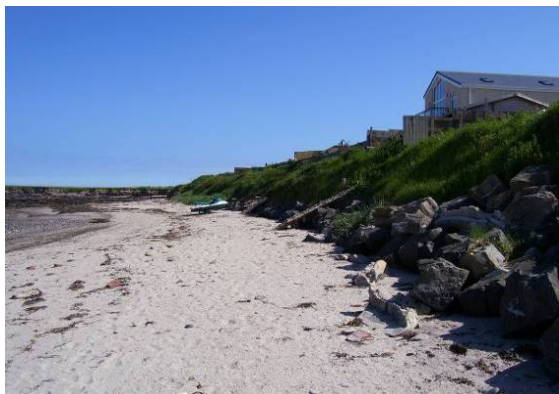
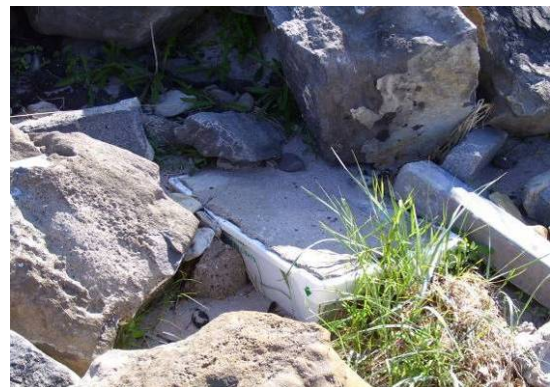
Some additional defence seems to have been undertaken to properties to the north of Beadnell (below left). This has been carried out in a haphazard manner, including use of building rubble (below right). This does not provide a secure defence of the frontage and should be improved. It is understood that this is private defences.

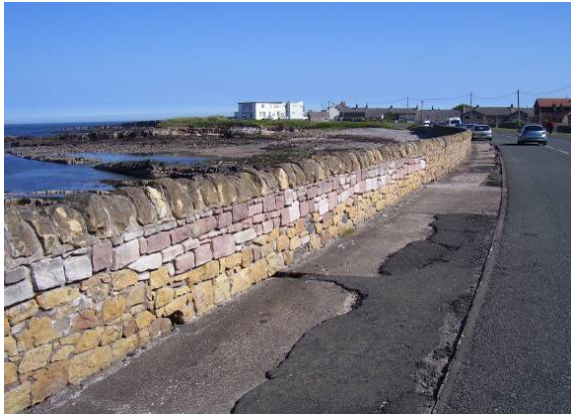
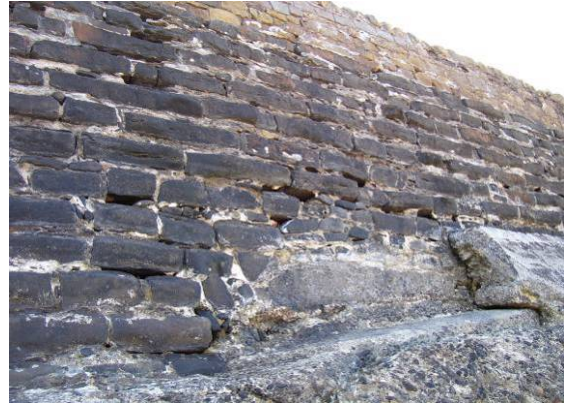
The main bay to the village has suffered significant overtopping, with damage to the road and further deterioration to the main sea wall. Some pointing and repair has been undertaken to the crest wall on the landward side (below left). However, this does not address the more serious deterioration of the seaward side of the wall (below right). There is need for repointing and concern now over general undermining and potential loss of the concrete toe works.

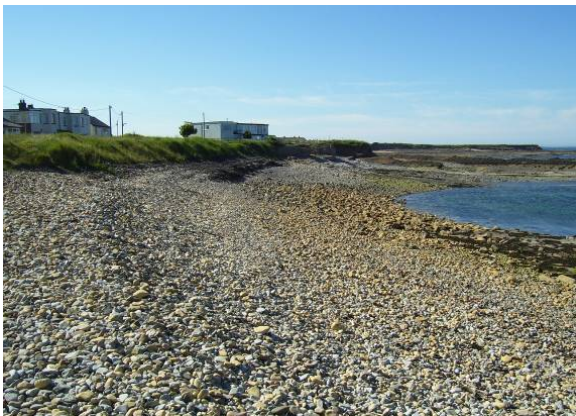
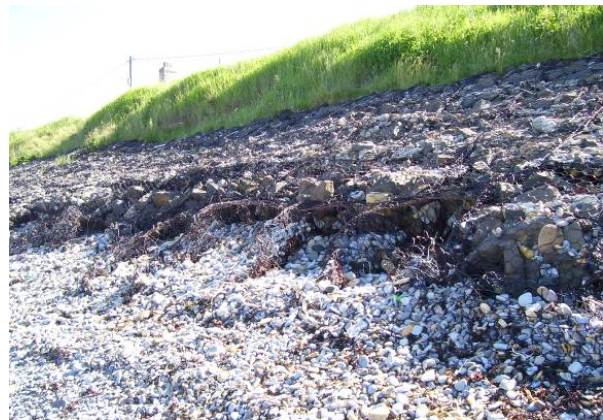
Further south, the gabion revetment has suffered further damage and is in need of repair (below). This frontage and that above are linked in terms of access to the village and harbour and it may be sensible to undertake a review of defence needs as a strategy.

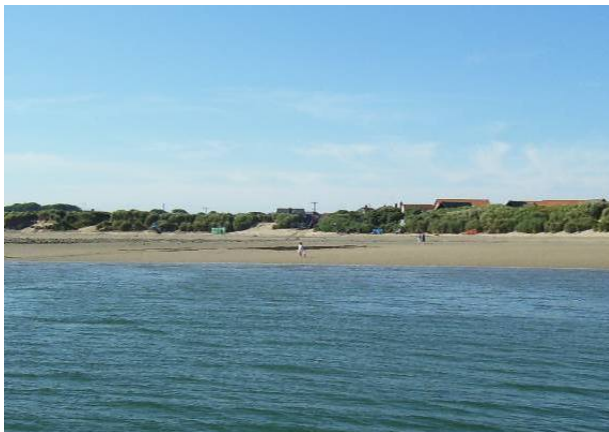
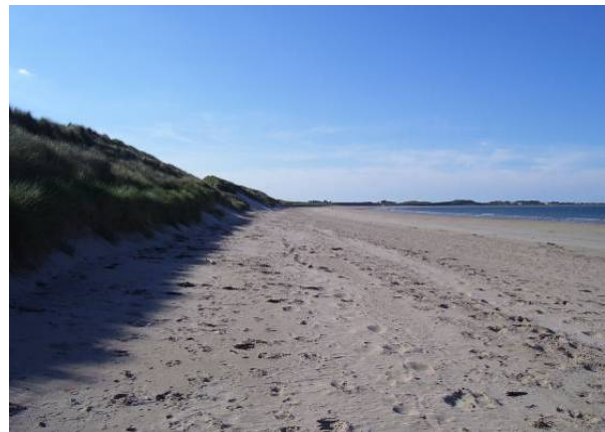
The harbour works are in reasonable condition and maintain the protection to the dunes in the north of Beadnell Bay. There has been local erosion to the dunes by the entrance to the car park and recreational area (below left). There has been little significant erosion elsewhere around the bay (below right).

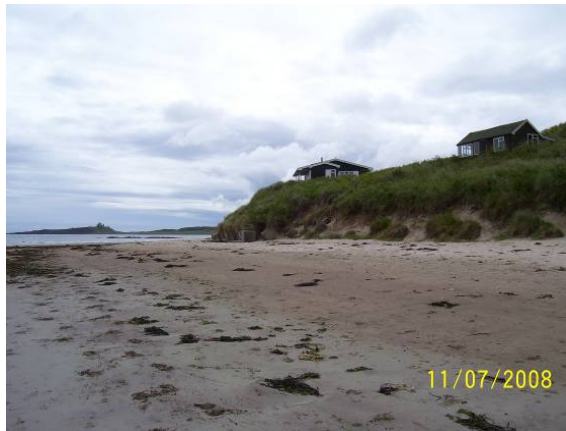
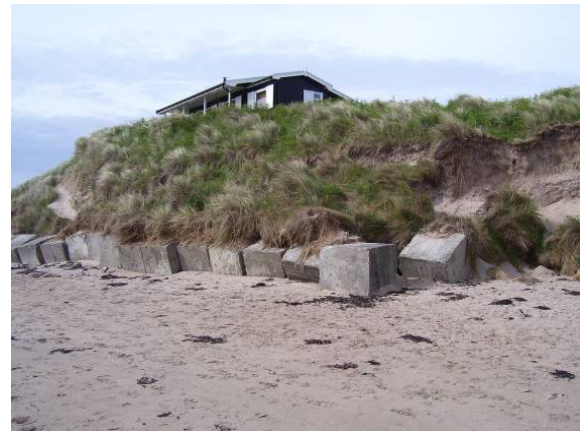
Despite erosion to the face of the dunes, there has been little set back of the toe to the frontage to the south of Low Newton (below left 2008, right 2010).

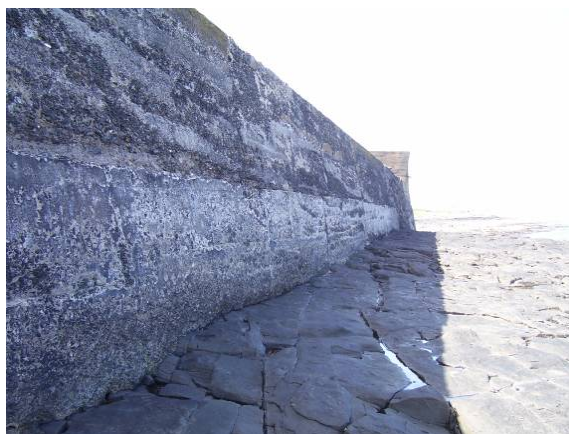
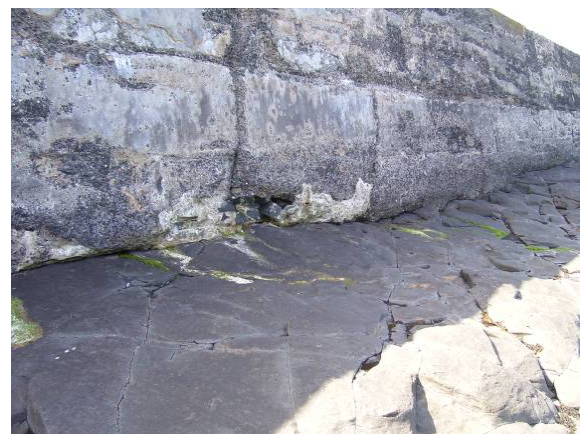
There has been no significant change at Craster. Along the outer face of the South Pier, there is very minor abrasion and undercutting (below). This will be monitored but no action is required at this time.

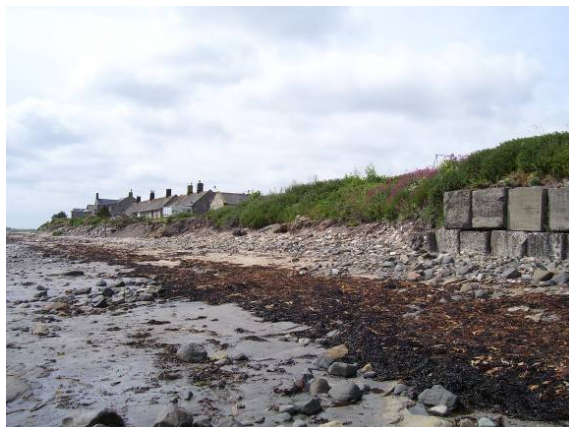
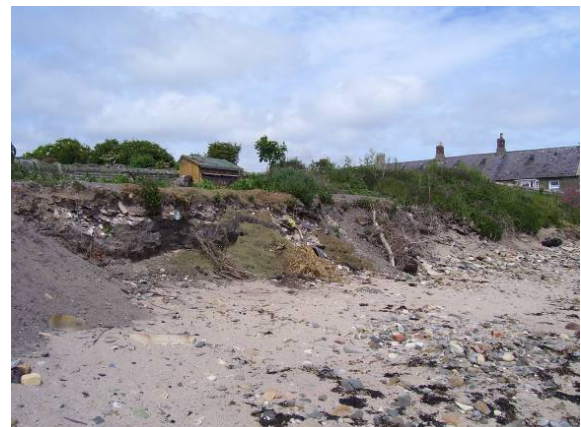
At Boulmer there has been some further erosion to the village frontage and the local response has been to tip material on the face of the bank (below). This provides little protection. An outline strategy has been developed for the frontage and further consideration should be given to implementing the recommendations to improve management in the area.

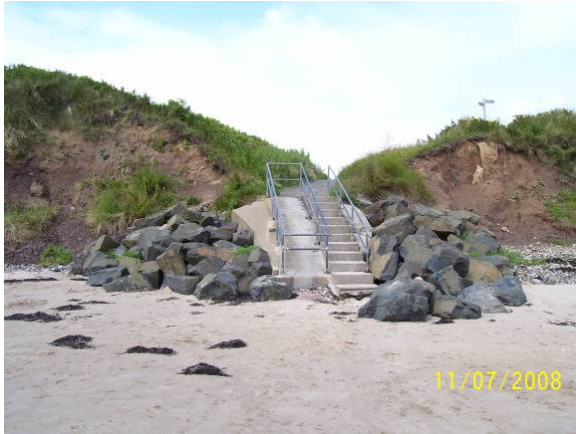
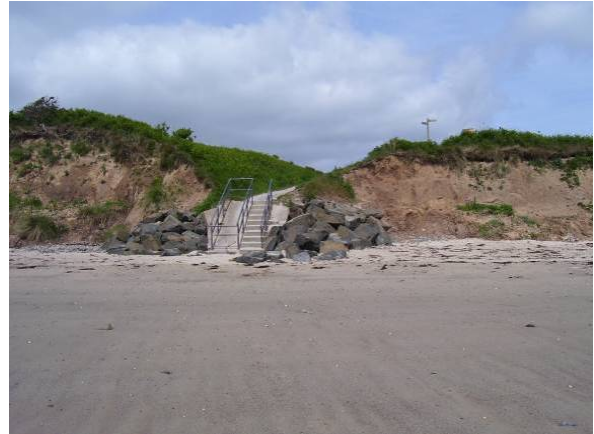
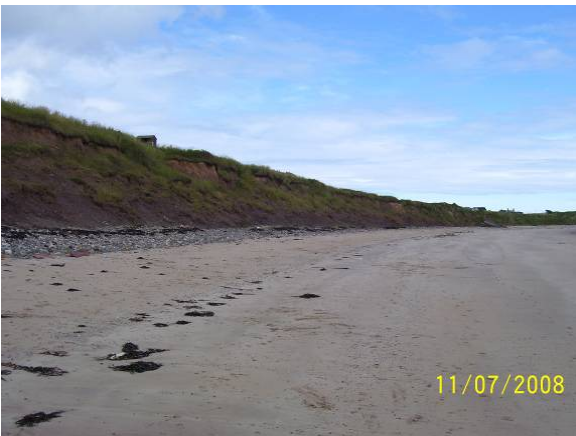
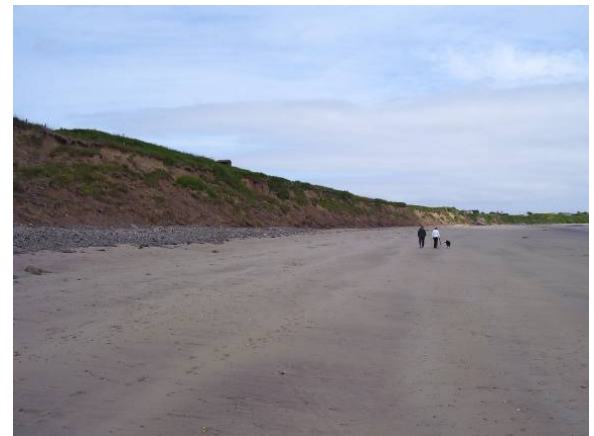
At Foxton Bay, the cliff line continues to show signs of slippage although there has been no significant erosion at the toe and in comparison to the inspection in 2008 the beach level has risen (comparison at access steps and along the cliff shown below; left 2008, right 2010). It is recognised that the beach in this area can change in level depending on specific wave conditions.

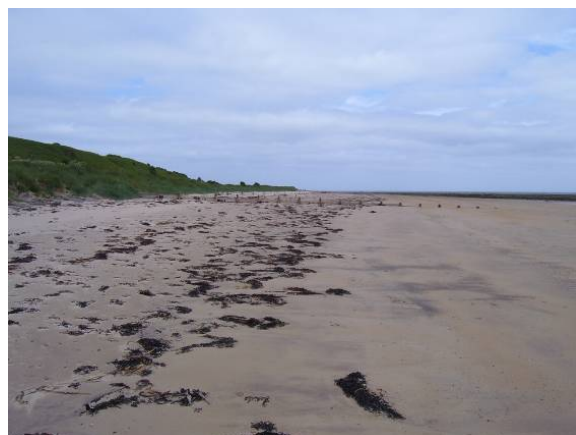
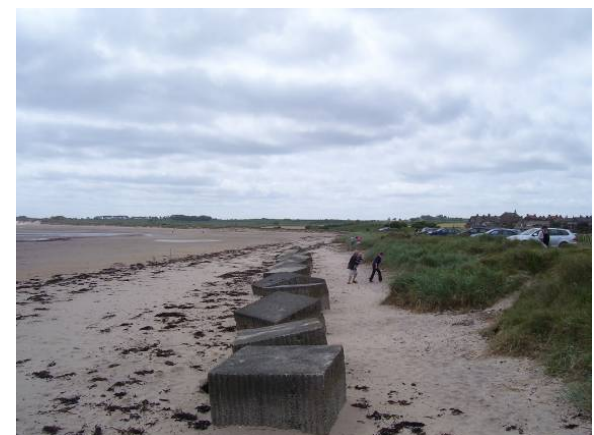
Over the northern section of the Alnmouth frontage, beach levels remain high, with the groynes largely buried (below left). The bank vegetation works also remain healthy and there has been little change along the car park frontage (below right). The access management works have reduced damage to the vegetated dunes and have increased resilience to the frontage despite the recent storms. This management would not provide substantially greater protection in the event of a major storm.

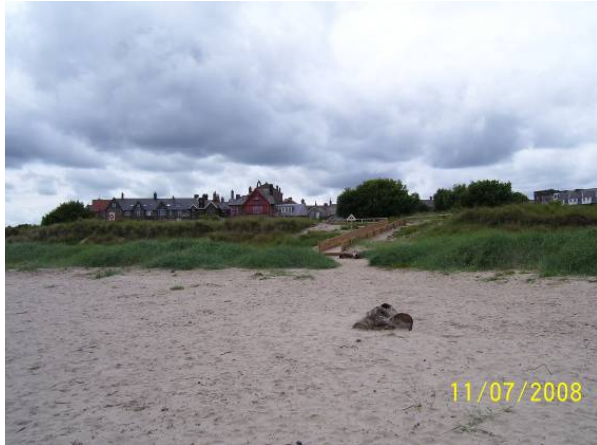
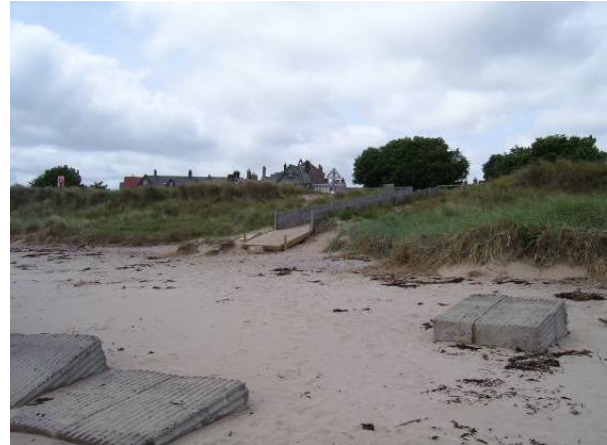
It is also noted that the coast to the south has suffered significant erosion (below left 2008, right 2009). This has reduced the width of new dune growth seen over the last 6 years, but has not cut back as far as the old eroding dune line of the 1990s. Again dune access management may have helped retain new dune width. There is the possibility that the erosion may have altered the alignment of the AIn and this may result in changes further north along the frontage. These potential changes will be monitored and picking up how the overall system now response will be important in understanding the long term behaviour of the whole frontage. The erosion to the north of the estuary is matched by erosion to the northern end of the dunes to the south (discussed below).

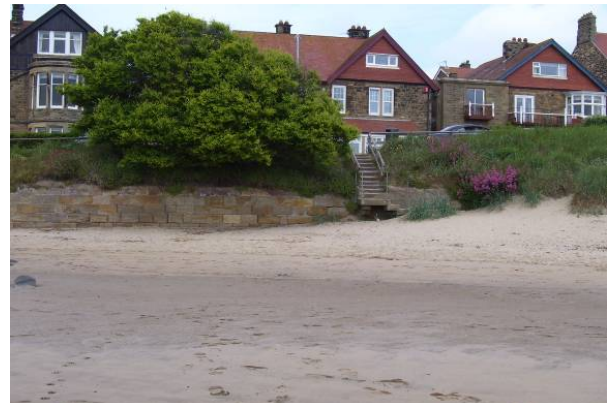
Some of the eroded sand from the open coast has been taken into the mouth of the estuary and beach levels are healthy to either side of the entrance channel (right).

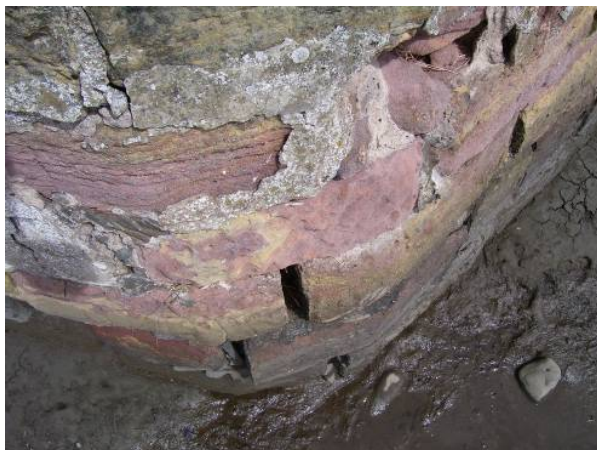
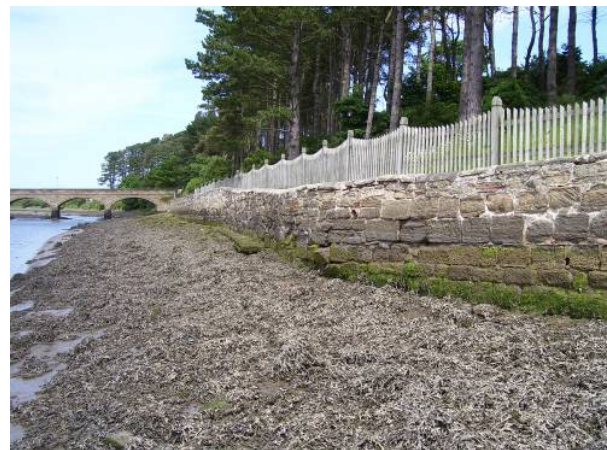
There has been little change to the walls within the estuary. There is still some concern over the cracking and lack of pointing to the corner of the pathway wall (below left) and the wall through to the road bridge may still suffer damage, despite recent repairs (below right).

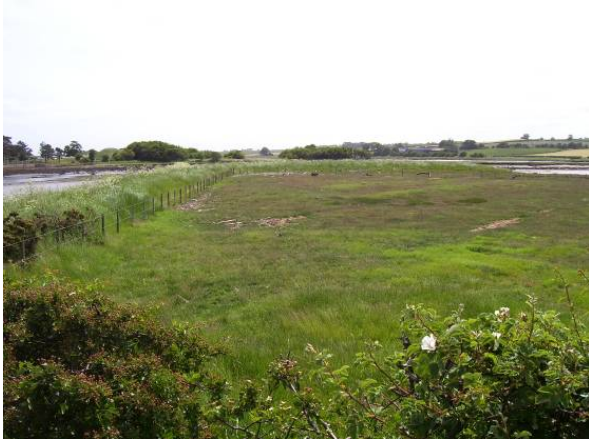
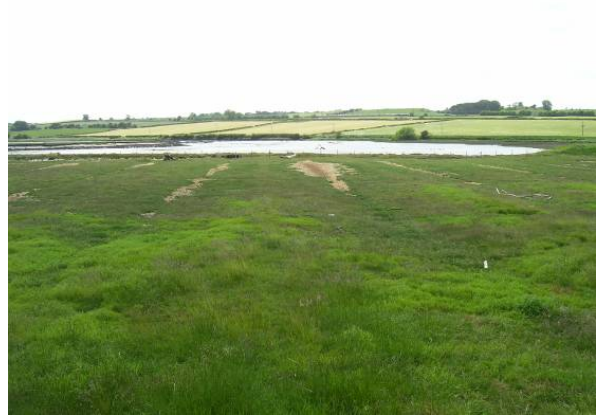
The affect of flooding is seen to the area where defences have been removed to the northern side of the inner estuary as part of the Northumberland 4 shores project (below) and this will continue to be monitored.

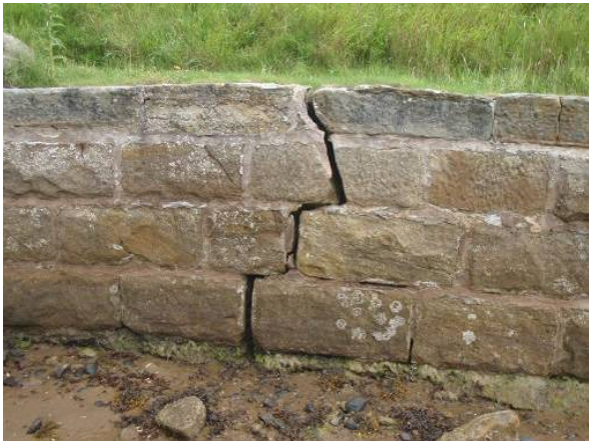
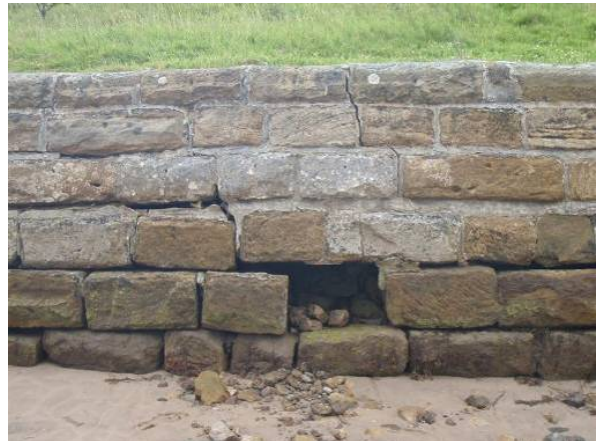
The low masonry wall at the toe of Church Hill is in poor condition with several major full-height cracks along mortar joints (below left) and one area of missing blocks (below right), which looks set to worsen further. This wall would benefit from some maintenance to prevent further unravelling and local collapse which could lead to localised erosion of the backing slope.

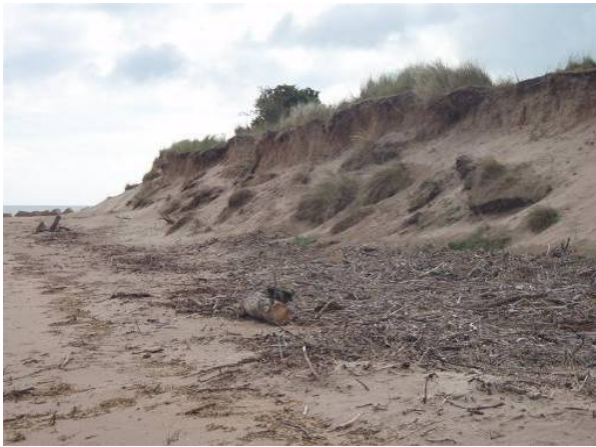
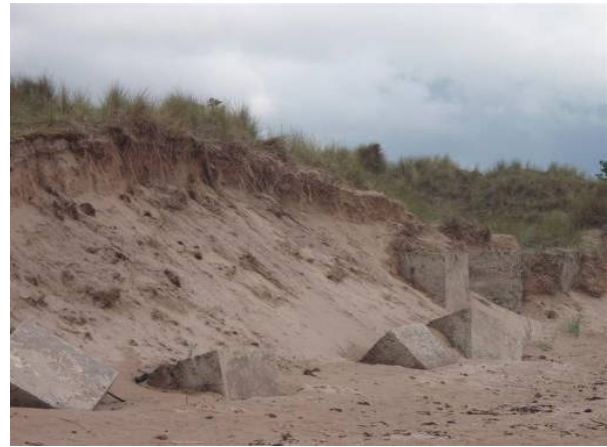
Dunes along the south bank of the River Aln (below left) and further south towards Birling Carrs (below right) have suffered from some slumping on their face despite the quite frequent presence of concrete anti-tank blocks. These blocks are becoming abraded and on some of them reinforcement bars are starting to protrude.

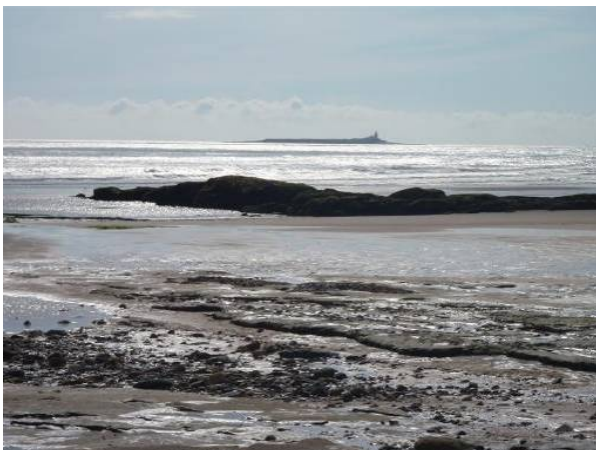
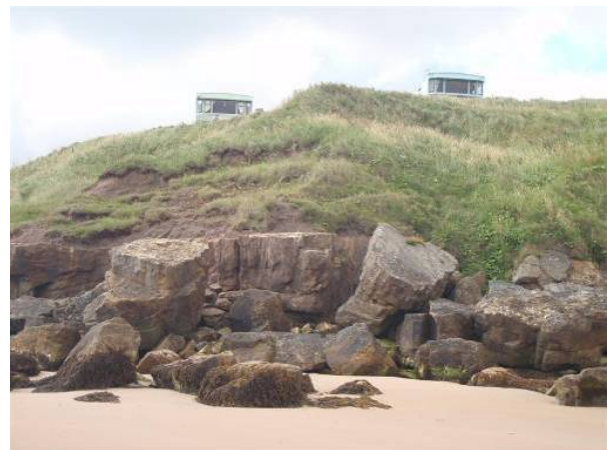
Immediately in the lee of the rocky outcrops at Birling Carrs (below left), the backing dunes or slopes are somewhat more stable. The hard rock that outcrops in places at the base of the coastal slope has suffered from local rockfalls and very minor slumping behind (below right).

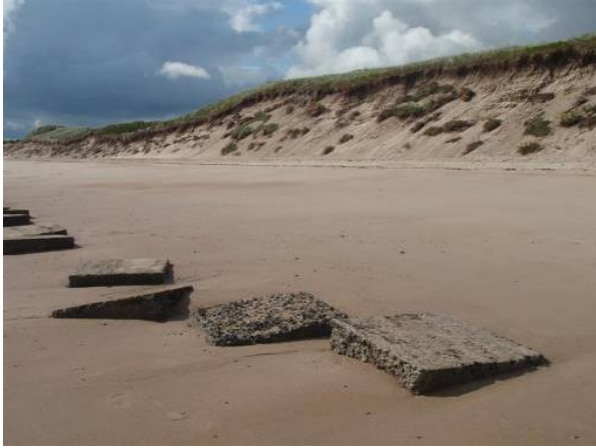
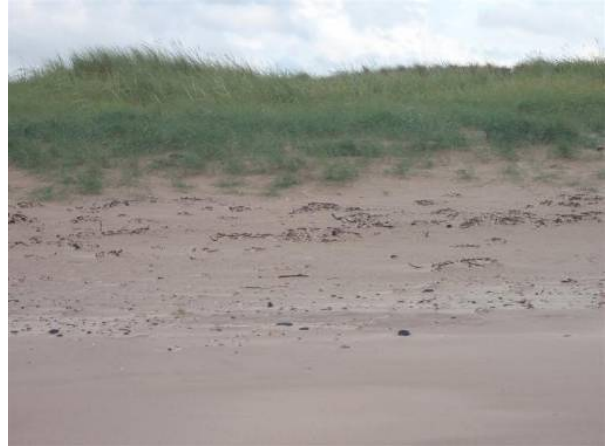
South of Birling Carrs, the dunes again are suffering from slumping (below left), although on a lesser scale to those located further north. However, with progression south, towards Warkworth Harbour's North Pier, the dunes become much more stable (below right) and the beach widths greater as sand is trapped from migrating alongshore by this major harbour structure.

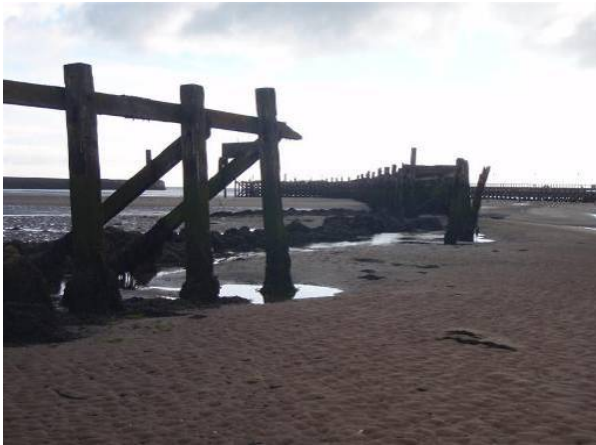
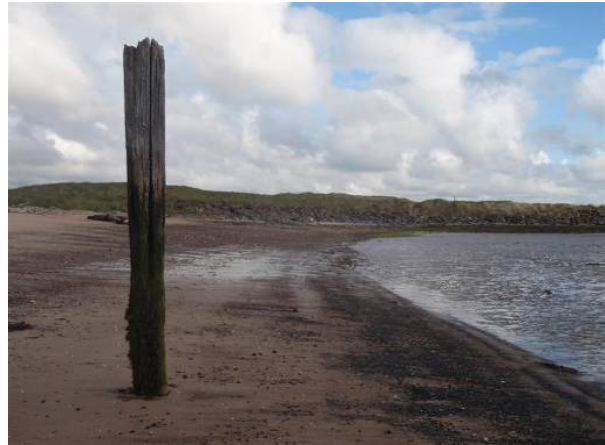
The North Jetty at Warkworth Harbour remains in a dilapidated state (below left) and is fairly ineffective as a river training structure since a bar of sand has built up adjacent to the jetty, pushing the river channel towards the southern bank. The northern Wave Basin continues to possess a healthy beach and stable backing dune system (below right).

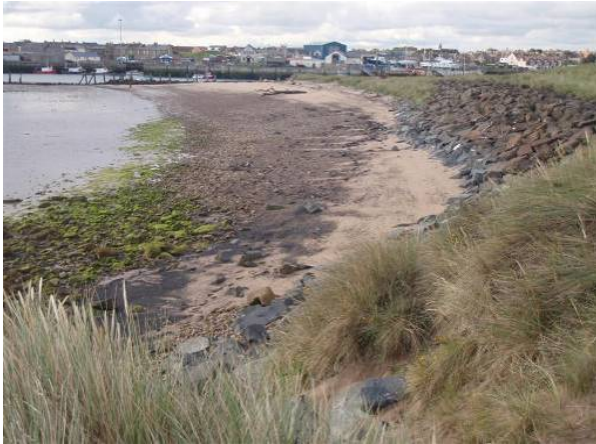
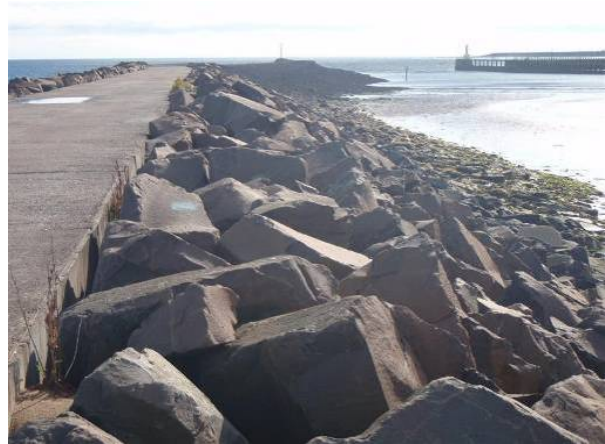
The rock revetment connecting the inner-facing root of the North Pier to the northern Wave Basin remains in fair condition (below left). This is also the case for the rock revetment at the landward end of the pier itself on both the inner-facing and seaward-facing sides of the pier (below right).

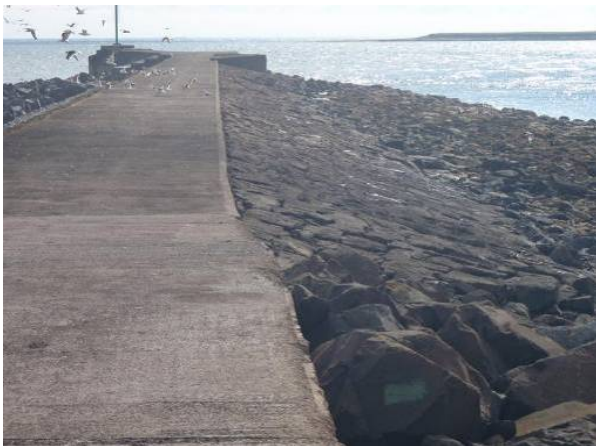
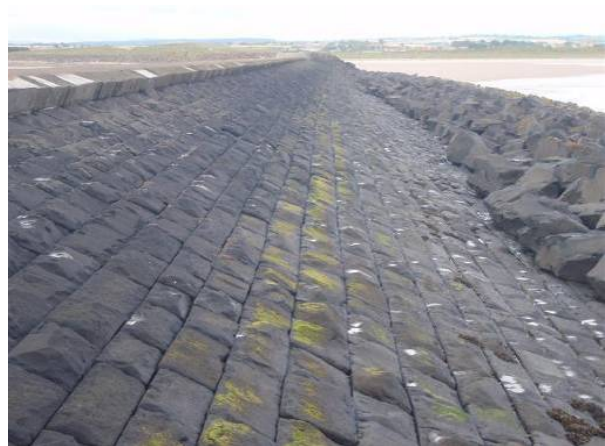
The central section of pier comprises a sloping blockwork face which has a few gaps on the inner face (below left) and some signs of damage on the outer face (below right) but generally is in good condition. The concrete deck of the pier has some minor cracks along this section. The seaward-facing side is heavily armoured with rock.

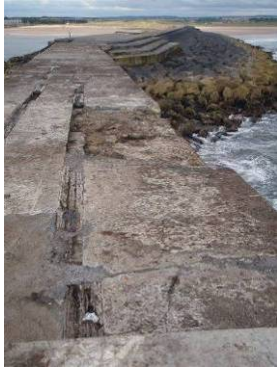
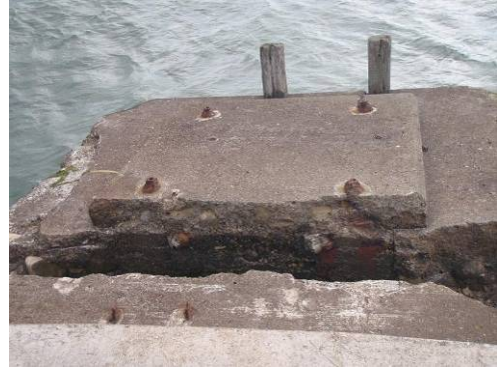
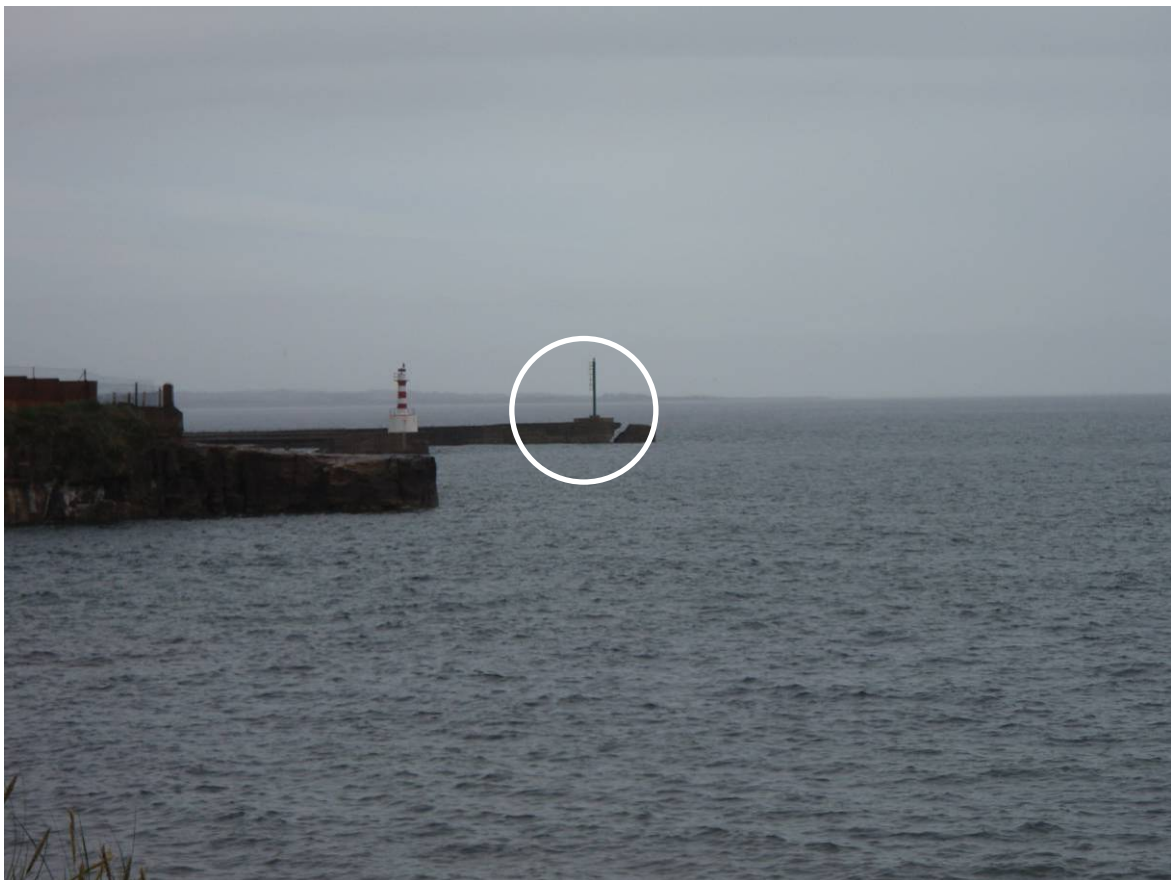
The seaward end of the North Pier remains in very poor condition. There is extensive abrasion of the concrete areas, including the deck (below left), and it appears that the cracked tip of the pier has fallen further away from the main structure, widening the gap at this end (below right).

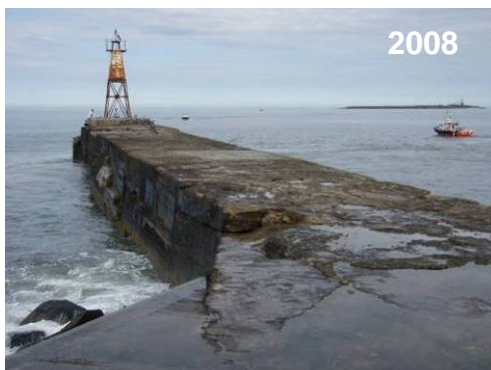
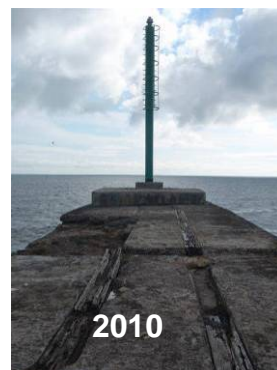
The superstructure to the navigation beacon has (presumably) been removed since the 2008 inspections to prevent it falling into the sea as the end of the pier worsens in condition (below).

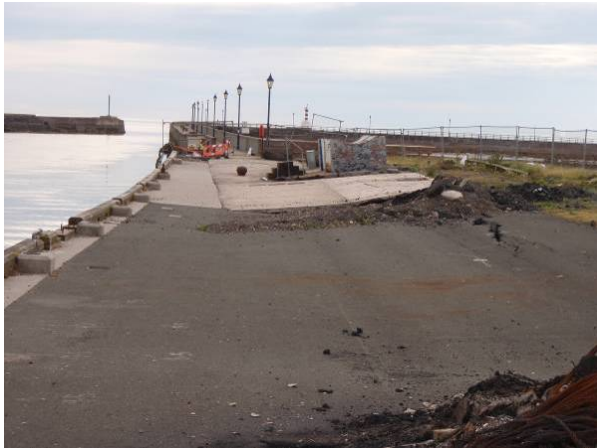
Subsequent to the 2008 walk-over inspections, part of Broomhill Quay failed during a period of intense rainfall and high river flows in September 2008 (below). This was caused by the high currents in the river channel causing undermining of the quay and subsequently washing-out the core fill material, leading to settlement, deck cracking, voiding and collapse in areas. The failed section of quay is now closed to public access and a capital investment is needed to improve the situation. Investigations have been undertaken to consider creating a new dock in the damaged area to provide a catalyst for regeneration of the quayside, rather than simply repairing on a like-for-like basis. The remaining unaffected section of quay has been re-designed to allow continued public access and fishing use.

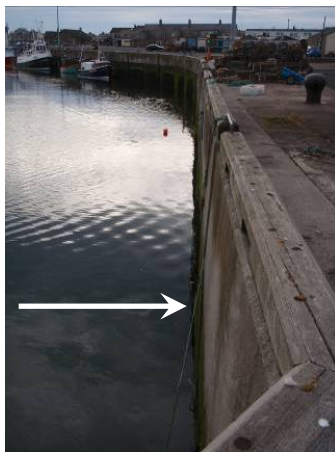
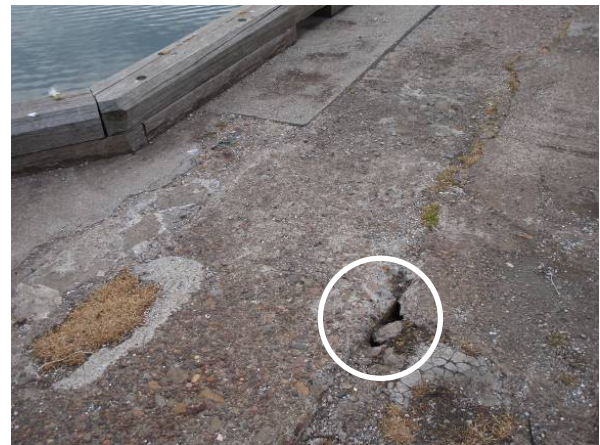
Of some concern is some apparent (presently slight) bulging in the seaward face of the quayside further upstream along the south bank (below left), between the dock and the lifeboat station, where a small hole has opened in the deck (below right). This area should be considered further from the river using a vessel-based survey at an appropriate stage of the tide.

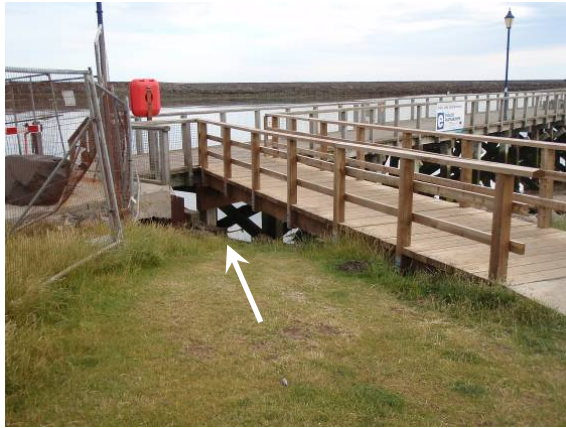
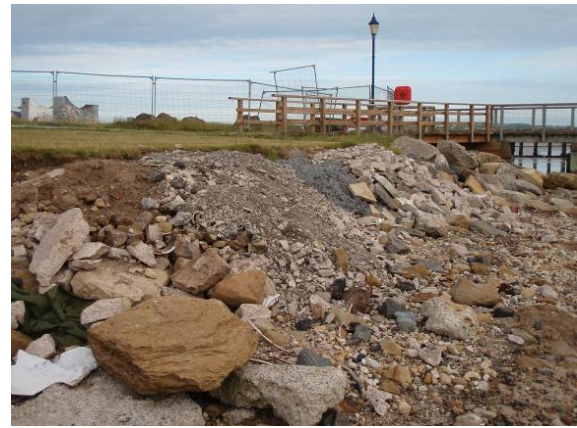
At the eastern end of the failed section of quayside, a new timber linkspan bridge has been erected to enable continued public access to the South Jetty (below left). A section underneath the new timber linkspan bridge remains exposed and vulnerable to outflanking, with undercutting of the failed section of quay deck now also observed. The previously-observed outflanking of the rock revetment here (placed to protect the corner of the amenity land against erosion) has been addressed by the infilling and protection of eroded land with tipped rubble, tipped soil and a small section of poured concrete (below right), which not only looks unsightly but has also simply deflected the outflanking problem further into the Little Shore Wave Basin. The timber South Jetty itself remains in a good condition and the half-tide barrier remains effective in retaining water during the ebbing tide.

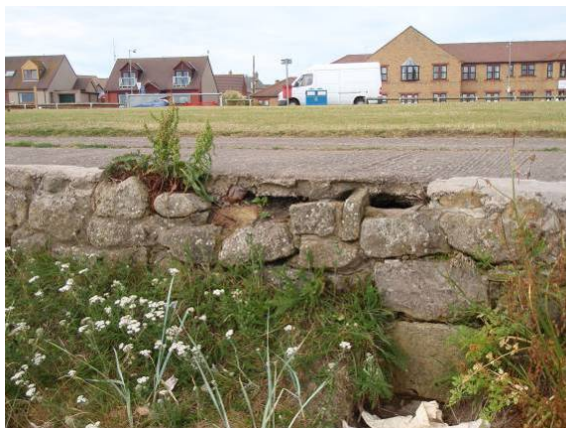
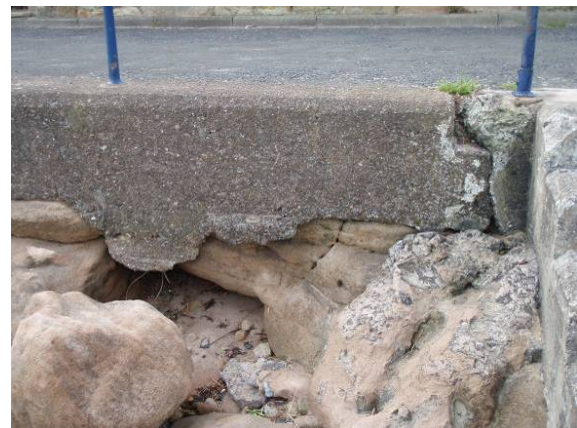
Within the Little Shore Wave Basin, some minor maintenance repairs are required to the small masonry wall at the rear of the dunes along the Harbour Road shore (below left), but more significantly, wide vertical cracks, occasional undermining due to loss of 'plumb' stones (below right), and cracking in the capping beam need attention along the sea wall fronting Bay View.

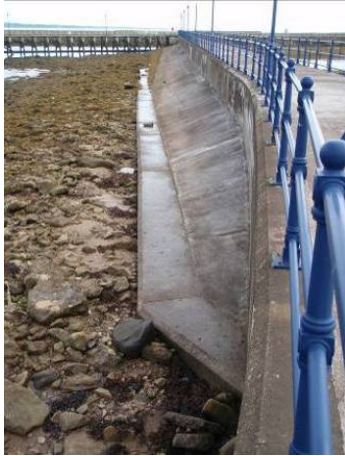
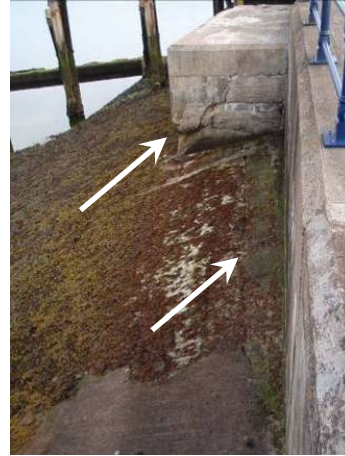
The inner facing section of the South Pier appears in fair condition along most of its length (below left), although there remain unaddressed local problems with abrasion and cracking at the junctions where the structure joins both the Bay View sea wall and the South Jetty (below right).

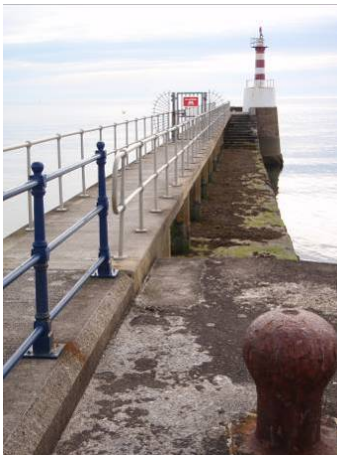
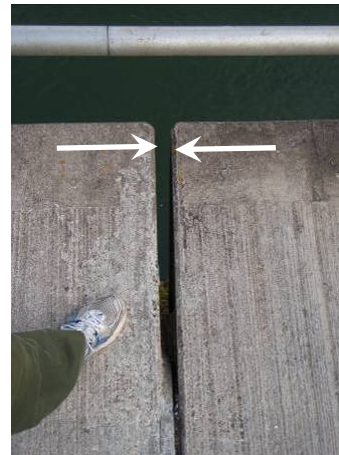
The South Pier Head is not open to public access, but appears highly abraded (especially at the access steps to the lighthouse; below left) and at the landward end there are large gaps between concrete blocks (below right). At the seaward-facing junction with the South Pier, there is extensive abrasion and cracking in the structure which requires maintenance attention.
