**Cell 1 Regional Coastal Monitoring Programme
Coastal Walkover Inspections 2010**

**Northumberland County Council
Final Report**

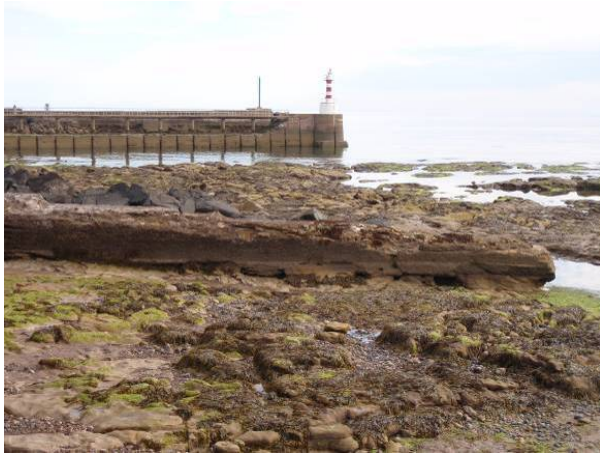
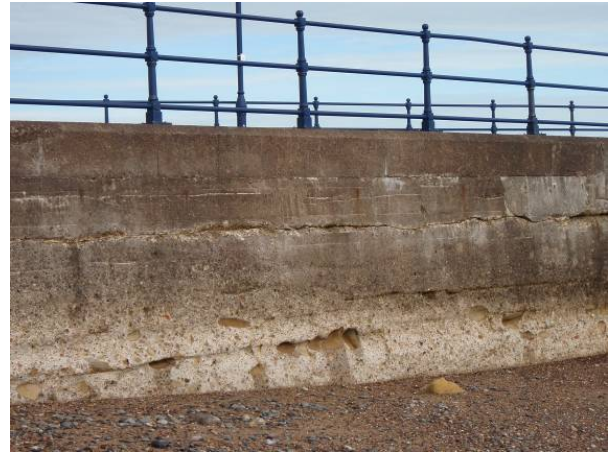
The seaward face of the South Pier appears generally fair in condition, although the concrete stub groyne is highly abraded (below left) and there is frequent evidence of cracking in the seaward face of the Pier towards its southern end, and then further along the adjacent short length of sea wall which extends to Pan Point (below right), which requires maintenance attention.

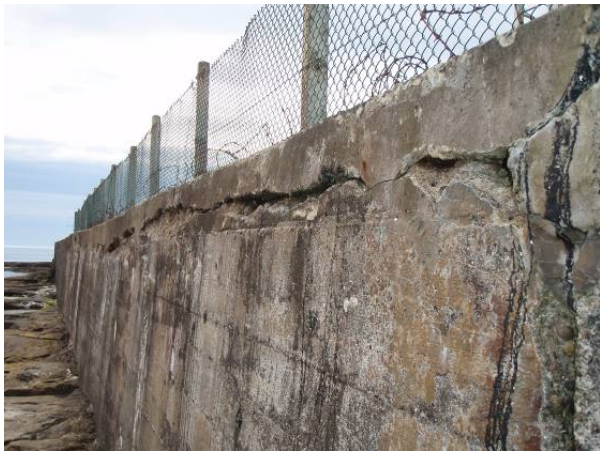
The concrete wall protecting Cliff House at Pan Point has deteriorated in condition since 2008, with numerous cracks throughout (below left), some of which expose corroded and broken reinforcement bars, and toe undermining still observed at the western end (below right). The access steps are also dilapidated and present a public safety hazard. These defects could be addressed through targeted maintenance.

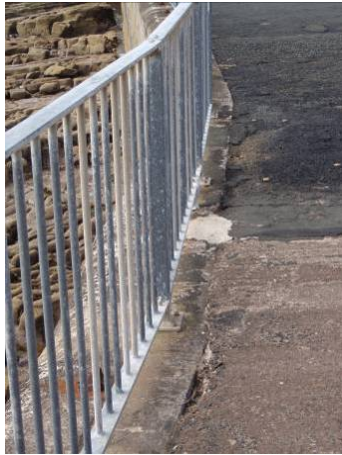
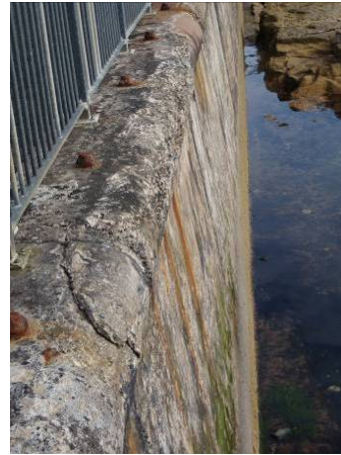
The seawall fronting the children's play area is in overall fair condition, although some minor unravelling of the tarmac on the promenade (below left) and some abrasion of the wave return wall at the southern end (below right), where previous patch repairs had been made, were noted.

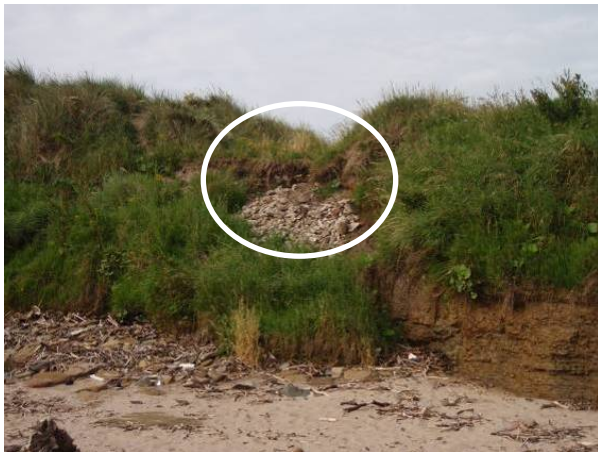
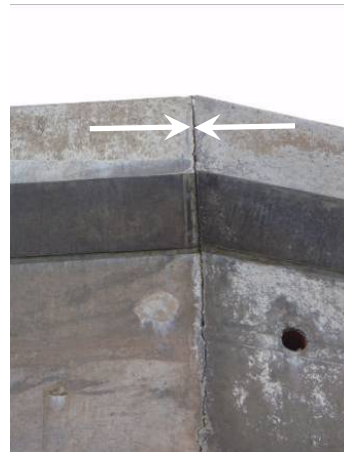
Along Amble Links the dunes appear to have recently been slightly more active than they were in 2008, with minor slumping in areas unprotected by rocky shore platform or hard rock cliff base, although the northern section remains stable. There was evidence of fly-tipping of rubble down the seaward face in one area (below left). The concrete sea wall encasement around the Island View headland (completed in 2003) is still in good condition, although there is a gap at one construction joint (below right) and there remains erosion to both the north and south where rock armour has been placed over short lengths.

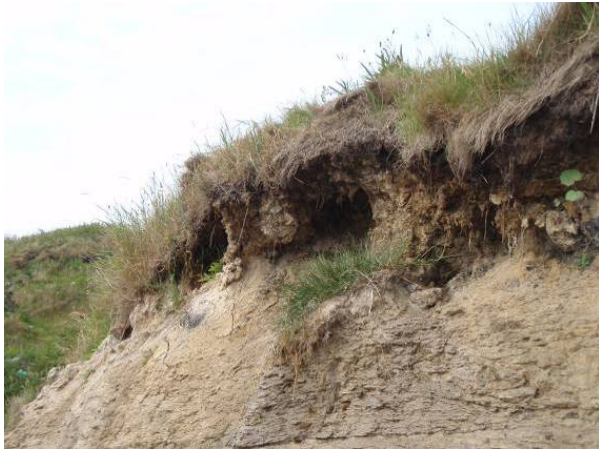
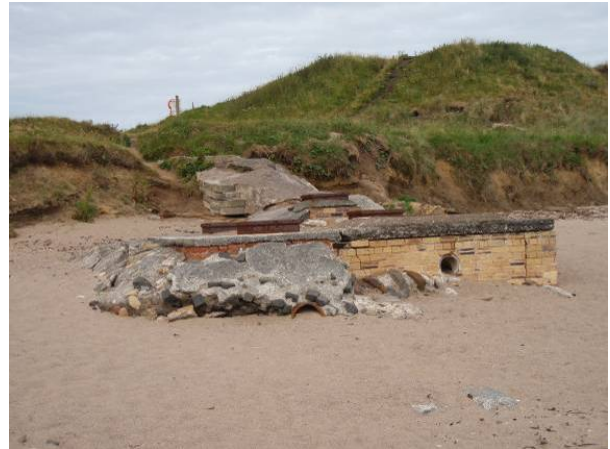
The severe winter of 2009/2010 has caused some minor change along the low vegetated cliffs, causing local slumping and leaving overhangs and cracks in the softer material (below left) that are likely to lead to future further minor slumps. The outfall structure remains in a dilapidated condition ideally requiring either removal or repair (below right), although the dunes extending south to Wellhaugh Point remain stable.

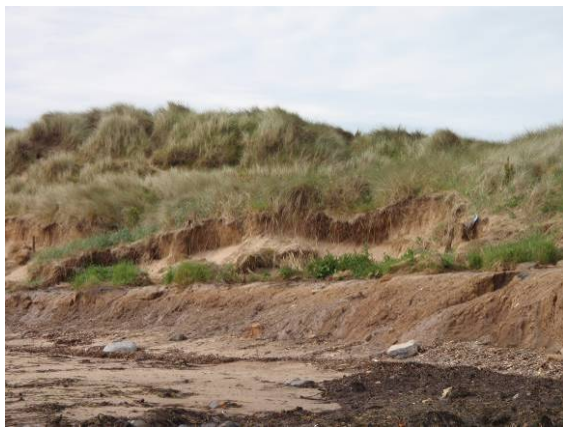
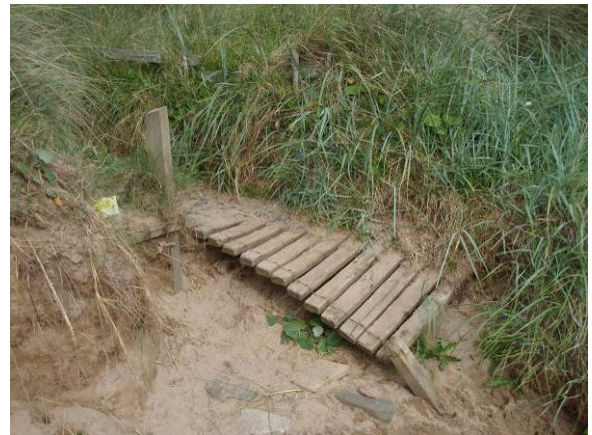
The short, low, masonry wall backed by a rock revetment and the cliffs at Wellhaugh Point remain in good condition, but the dunes extending between Wellhaugh Point and Beacon Hill experienced notable erosion. In the northern-most section of dunes, this has exposed underlying clay at the toe of the dunes along a reasonable length of frontage, often creating distinct 'clifflet' in the clay (below left). There is damage, through erosion, to an access boardwalk towards the north of this frontage which presents a public safety hazard (below right).

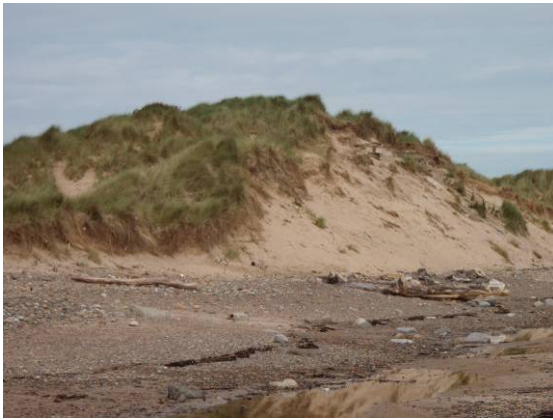
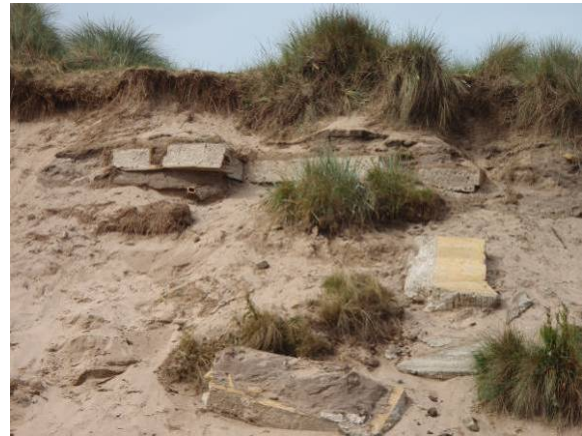
Immediately south of the damaged access boardwalk, the dunes reach their greatest height. Along this section the dune face has experienced slumping and recession to the crest (below left). Rubble has been released down the dune face through this erosion, including bricks and the remnants of a dilapidated structure (below right).

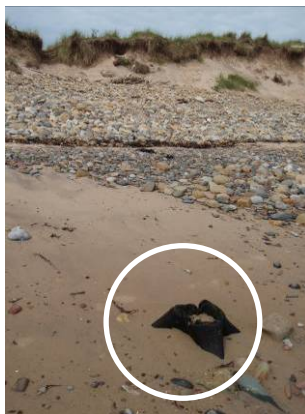
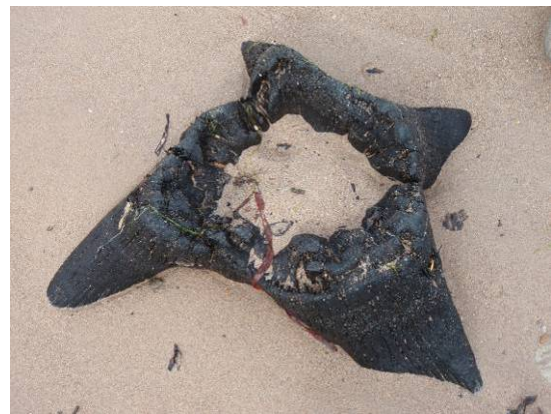
The dune crest level then dips with southwards progression and rises again just to the north of Beacon Hill. In this section of dune, the entire seaward face has been recently active, revealing several fossilised tree stumps on the foreshore (below).

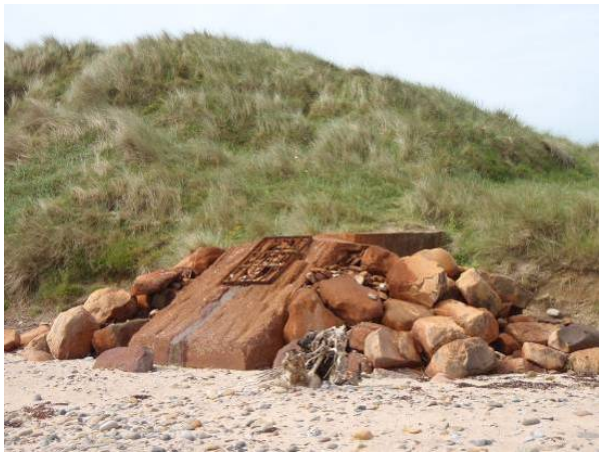
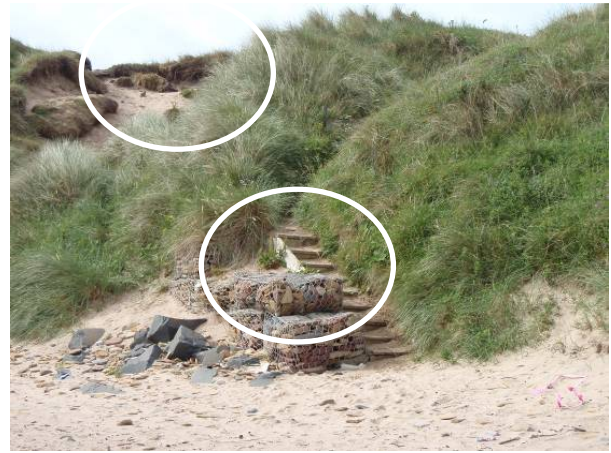
Further south still, near Beacon Hill, the dunes become more stable and well vegetated, with a cobble berm formed at their toe offering protection. The highly rusted outfall structure remains in need of repair or removal (below left), while the gabions by the access steps are become slightly deformed (although they remain intact and functional; below right). To the immediate south of these access steps is a large dune blow-out (also below right).

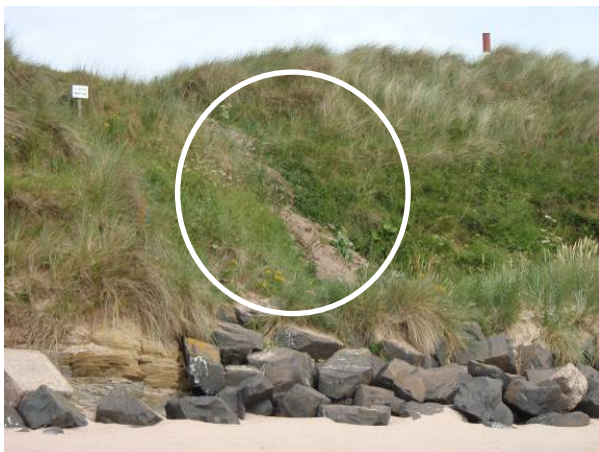
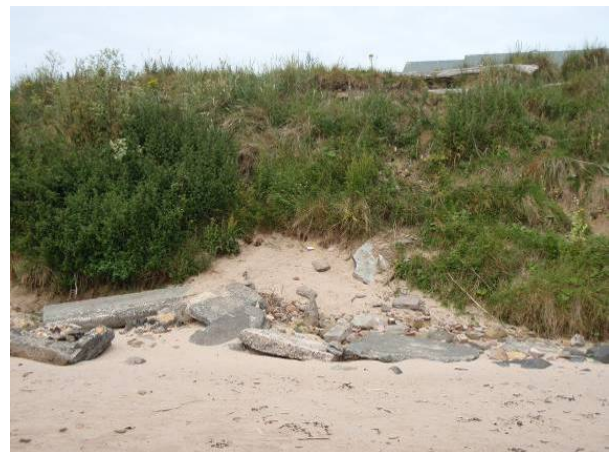
South of Beacon Hill, there is a section of rock armour, somewhat informally placed, that appears to have mostly stabilised the backing vegetated cliff, although one small section of minor movement in the cliff was noted (below left). Where the cliff then cuts back at the southern end of the revetment, some rock, stone and brickwork has been placed (below right), presumably to counter potential outflanking of the revetment. More rubble has been tipped further south still, prior to the frontage where the dunes naturally become more stable once again. Overall this frontage is less active than was observed in 2008.

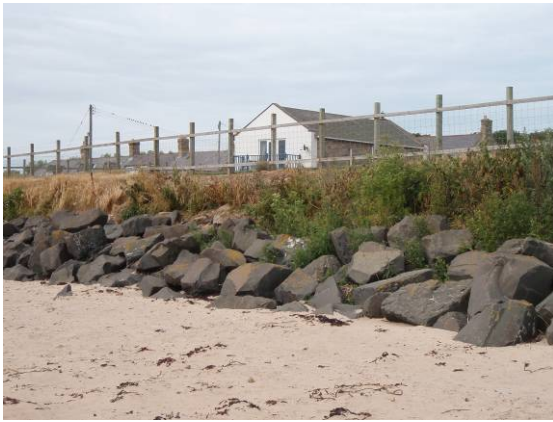
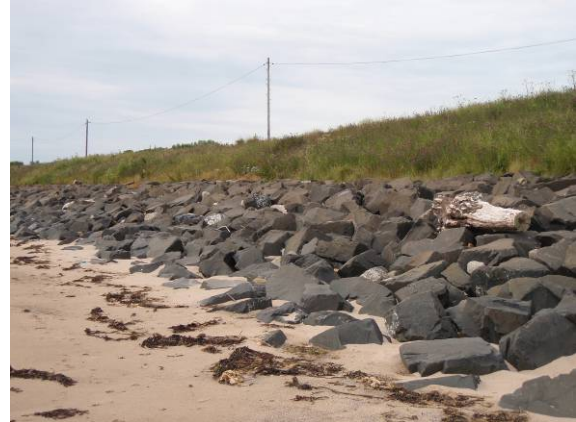
The northern section of rock revetment fronting Low Hauxley (south to the access ramp) remains in fair condition (below left). The wider revetment south of the access ramp remains in good condition (below right), with less evidence of fly-tipping than was recorded in 2008 (although two patches of rubble remain at the southern end). A rusted bicycle frame has become lodged in the revetment by marine action.

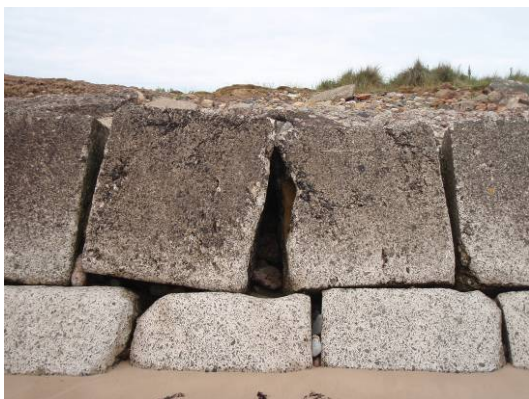
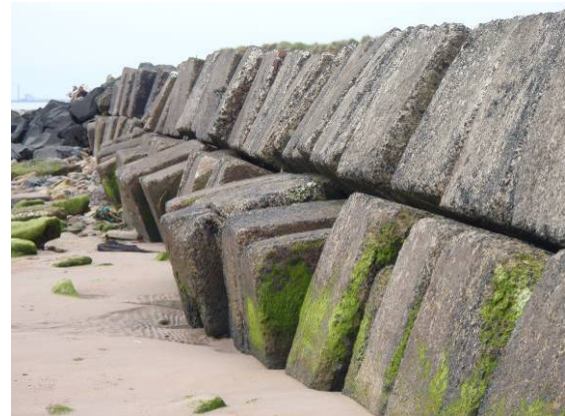
The 'wall' made from large concrete blocks, located just to the north of Hauxley Nature Reserve, has large gaps between blocks where mortar is missing (below left) and at the southern end has considerable block displacement (below right). Despite these defects, which have been present for many years, the wall is still holding.

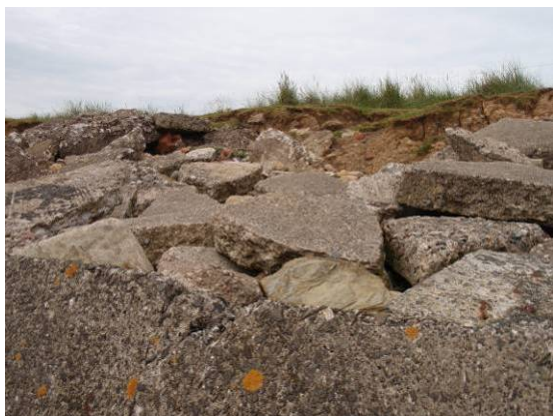
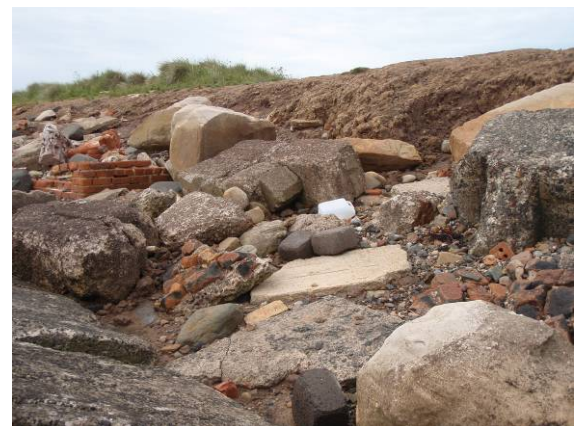
There does, however, seem to have been notable erosion of the rubble-strewn land behind the wall, presumably caused by storm wave overtopping of the wall (below).

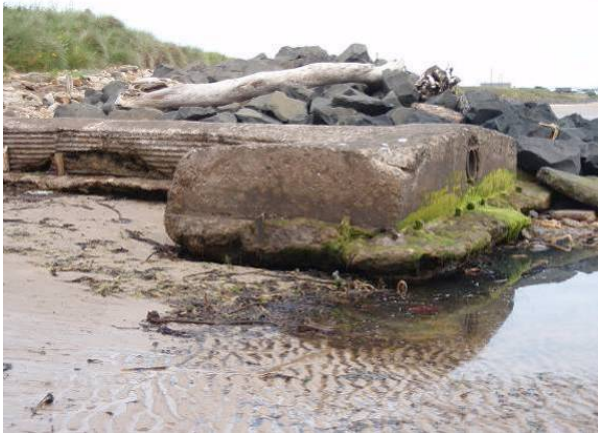
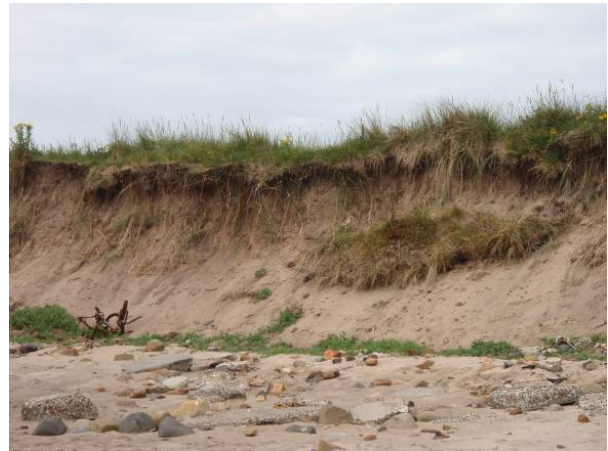
The outfall along the shore at the northern boundary of Hauxley Nature Reserve is in a poor condition, with undermining and concrete damage, especially around the southern side and head (below left). There is then ongoing active, but small-scale, slumping throughout the length of dunes southwards to Bondi Carrs (below right).

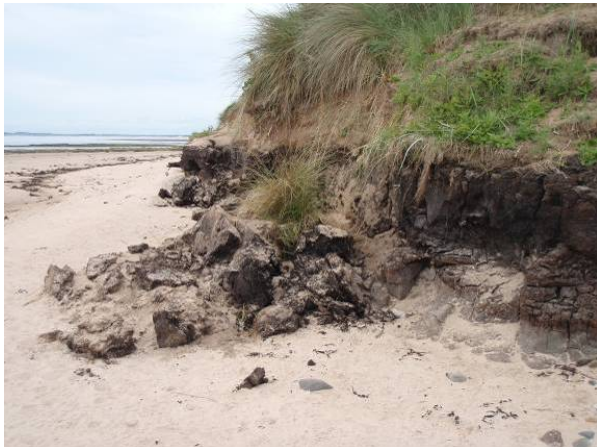
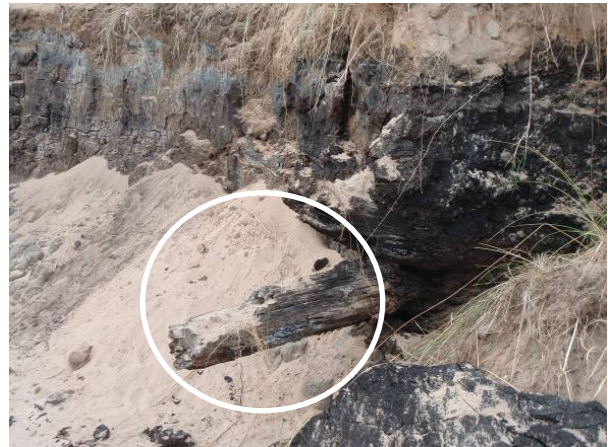
Along the dunes at the southern end of Hauxley Nature Reserve, erosion of the lower peat layer has occurred, leaving clumps deposited on the foreshore (below left) and exposing fossilised tree stumps in five separate areas (below right). The dunes have then cut back landwards across this underlying peat base, with many areas of slumping and oversteepening of the remaining dune face. This frontage has clearly suffered notable erosion since the 2008 inspections.

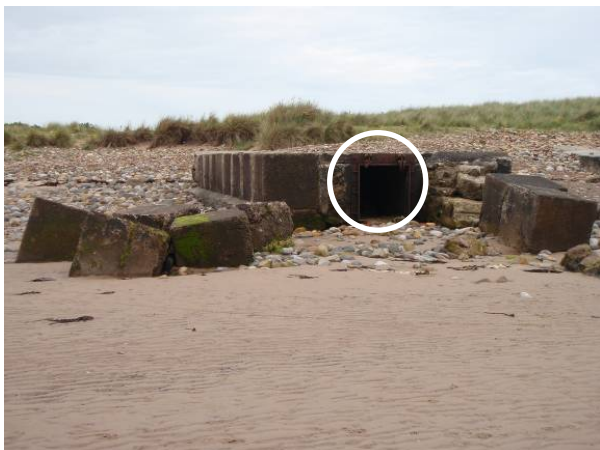
The outfall at the northern end of Druridge Bay has its hinged cover missing, making man-entry possible (below left). This should be replaced to maintain public health and safety. The dunes along Togston Links have eroded since the last walk-over inspections in 2008, with a distinct near-vertical face now cut into the underlying clay layer at their base. The dune face has experienced ongoing slumping, leaving small overhangs in the crest. Close to the car park by the piped outlet, further erosion has occurred and a clear 'dog-leg' exists where erosion has continued south of the short length of rock armour (below right). Attempts have been made to prevent this outflanking using rubble, but the 'step-back' erosion continues to the south, with the underlying peat layer exposed. The dunes become more stable towards Hadston Carrs, where a cobble berm is present at the toe and the rock outcrop affords some shoreline protection.

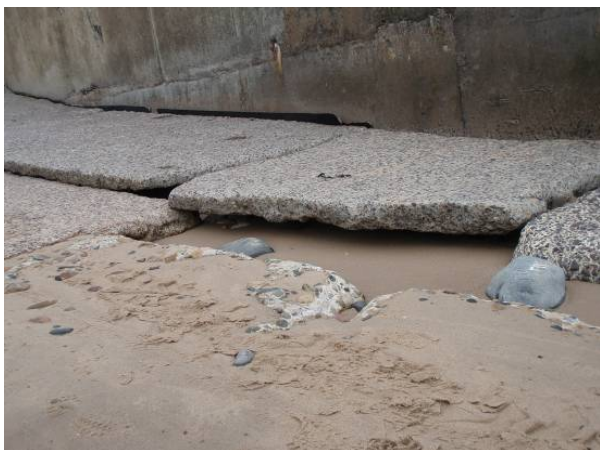
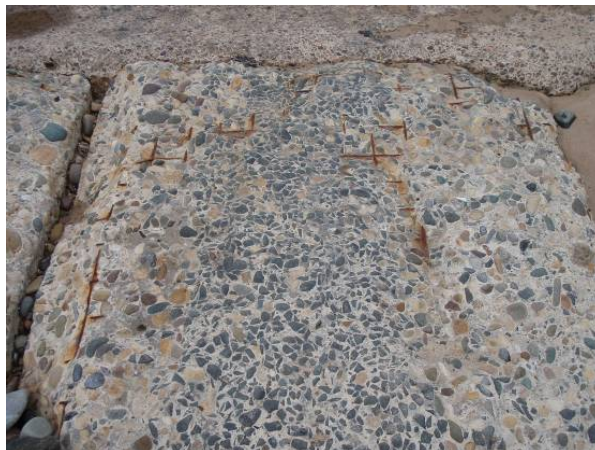
The outfall structure through which Ladyburn Lake discharges to sea remains in good condition, although the concrete fill between the outfall's south wall and the Hadston Scours Boat Club's concrete slipway is breaking up, with gaps evident and one slab cantilevered (below left). The four concrete blocks at the toe of the slipway are heavily abraded and the reinforcement mesh is starting to show (below right).

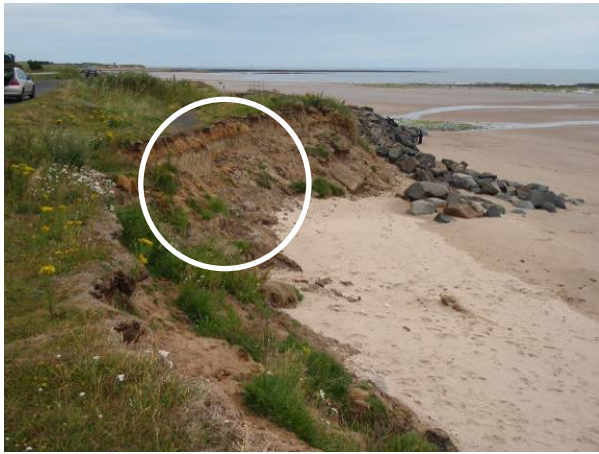
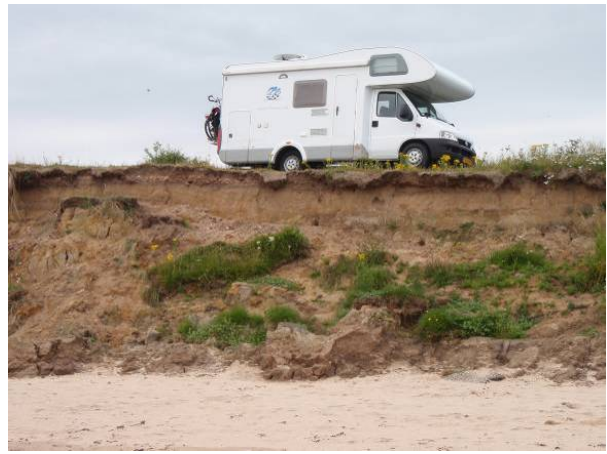
The rock revetment which protects the Hadston Scaurs Boat Club's slipway is in fair condition, but the outflanking to the south remains ongoing. There is evidence of an apparently recent large slump immediately in the outflanked section (below left), and smaller slumps further south adjacent to the road (below right).

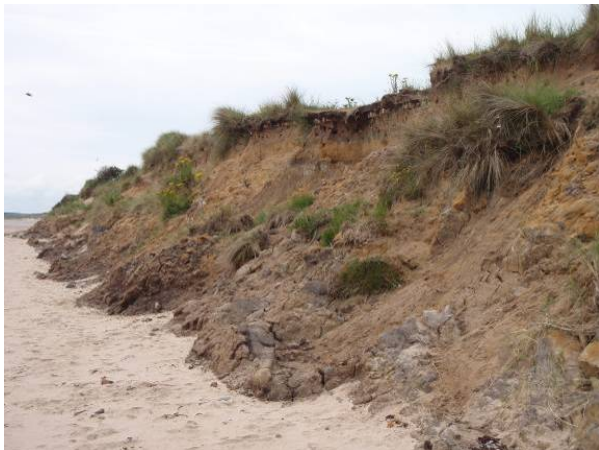
The low soft cliffs and dunes in the northern part of Druridge Bay appear to have been more actively eroding than was observed in 2008. This even has occurred in well vegetated and apparently previously stable areas, in places revealing bricks exposed in the crest (below left). It is only with southerly progression towards the Visitor Centre that the dunes become more stable, where they are backed by a substantial cobble berm at their toe (below right).

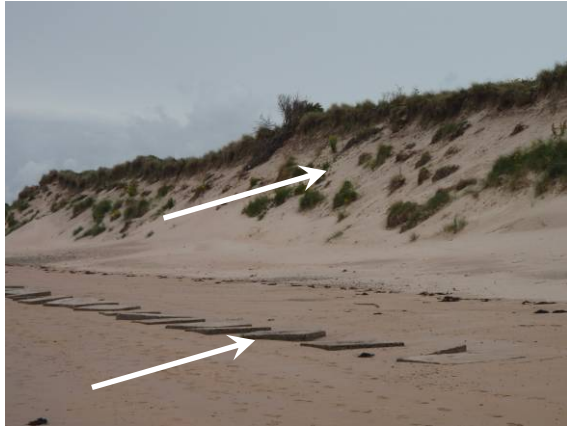
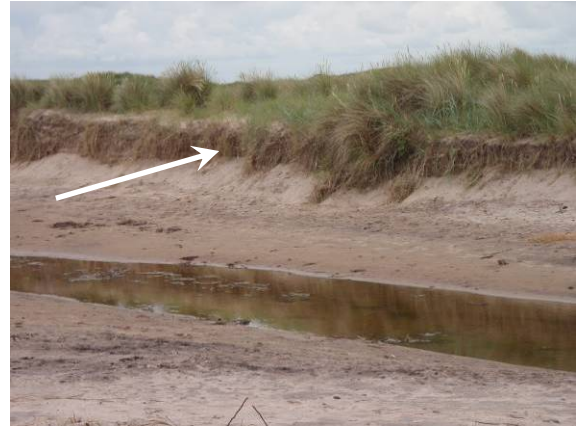
In central and southern Druridge Bay, there is clear evidence that the dunes have relatively recently experience some storm-related damage, especially at gaps between frontages protected by anti-tank blocks, but there are lots of areas where the dunes either have remained stable or have recovered back to a stable state. High beach levels have, in places, almost fully buried the anti-tank blocks (below left). This healthy beach state is likely to have helped the dunes recover and they now appear to be behaving in typically observed manners, with quite frequent areas of slumping along the dune face (below left) and most toe 'cliffing' erosion focused around the mouths of the outfalls of the backing lakes and ponds (below right).

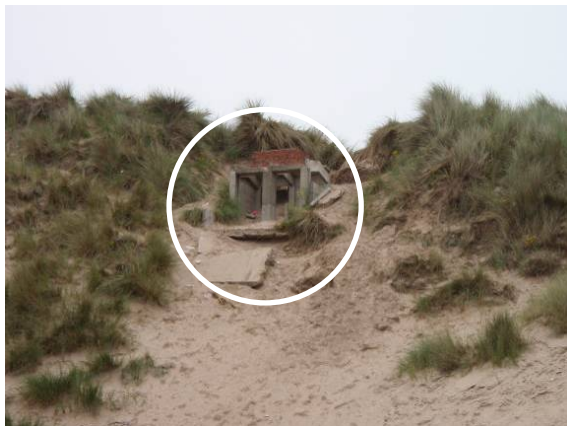
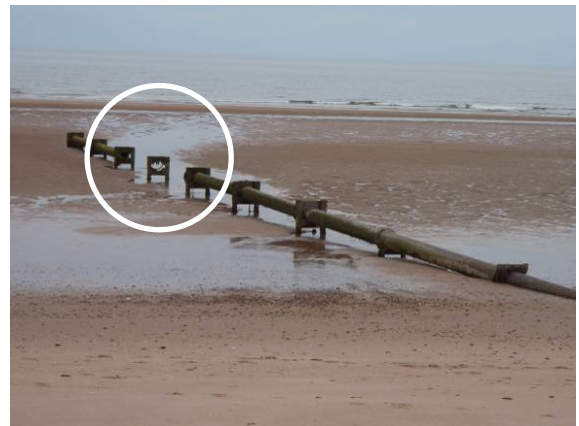
One structure is breaking up in the dune crest just south of the Visitor Centre (below left), and one partially buried narrow piped outlet at the southern end (just north of The Scars at Creswell) has a missing section (below right).

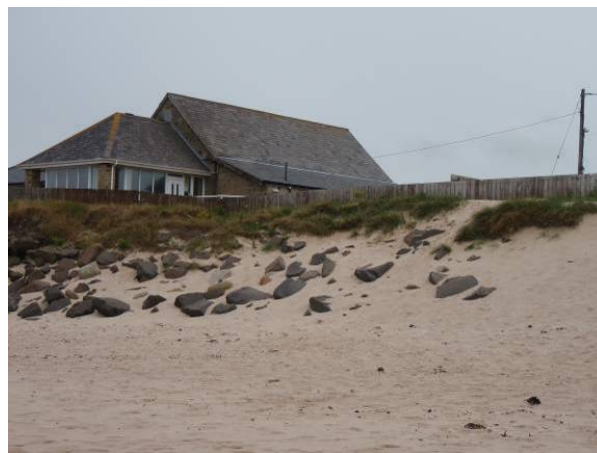
In the southern end of Druridge Bay, at Creswell, the foreshore builds seawards in the form of a tombolo in the lee of the rocky foreshore outcrop of The Scars (below left). The rock revetment which protects the backing shoreline is very loosely constructed and to the north of the access steps was totally buried by high beach levels. Sand also covered a large part of the access steps themselves. To the south of the steps, there appeared to have been some loss of material from the cliffs behind the sparse revetment but this was not compromising the backing houses (below right).

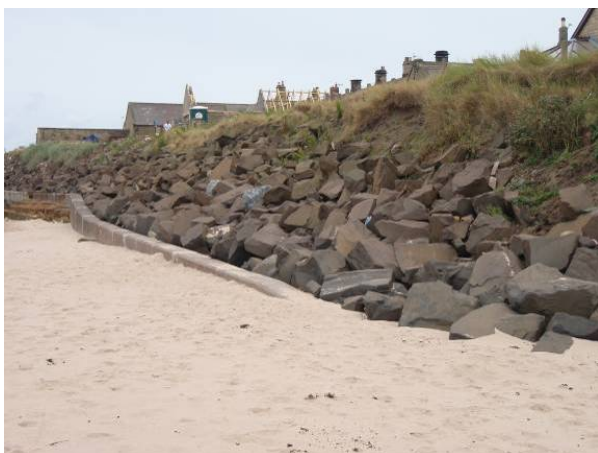
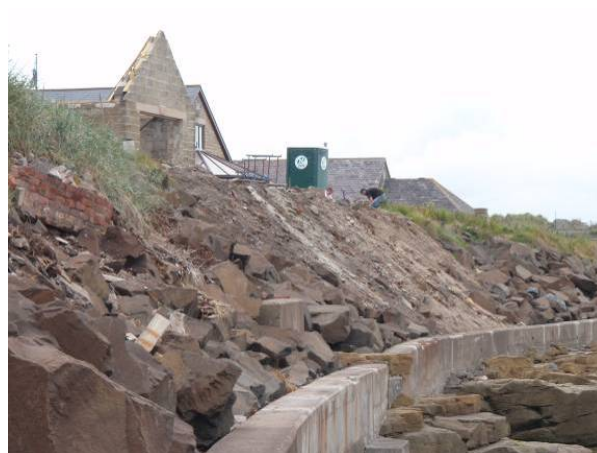
The revetment blends into a low concrete wall built at the back of the rocky foreshore, with rock armour revetment placed behind the wall to protect the vegetated cliff (below left). The visible section of the wall appeared in fair condition, save for minor abrasion at areas of previous concrete repairs, although beach levels were high at the time of the inspections so parts of the structure were buried by sand. Of more concern, however, was the apparent tipping of construction waste (rubble) down the seaward face of the revetment in an area where building work was being undertaken by Langan Developments behind the property known as The Skears, creating an unsightly appearance (below right).

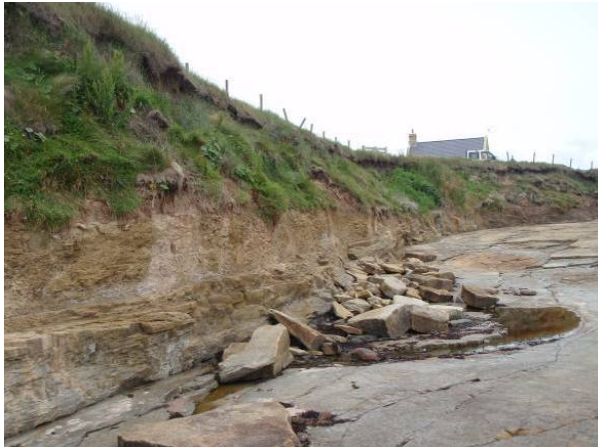
The cliffs backing Stark Letch Rocks have experienced extensive lengths of rockfall (below left), with some remaining rock being heavily fractured. The overlying softer material has subsequently experienced slumping (below left). This is not threatening any assets, although the boundary fence of the backing field is suspended in mid-air in one place. Between Stark Letch Rocks and Brig Head, there were high levels of cobble and seaward accumulation on the foreshore, substantially covering the poor condition outfall and leading to ponding of its discharge, rather than the creation of a channel across the foreshore. The large sand berm on the upper foreshore, about 10m from the cliff toe, and the cobble berm, directly at the toe, meant that the backing cliffs were mostly stable (below right).

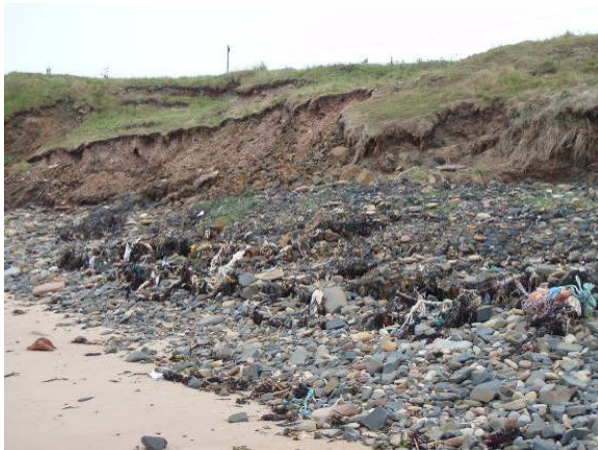
Further south, towards Snab Point, the cliffs become more active once again, where the cobble berm becomes sparser and the gabions are becoming damaged and outflanked (below left). Where the gabions have split, the cobbles have spilled out, resulting in slumping in the backing cliffs, including one area where the cliff top has now cut back to within a very short distance (a few centimetres) of the road edge (below right).

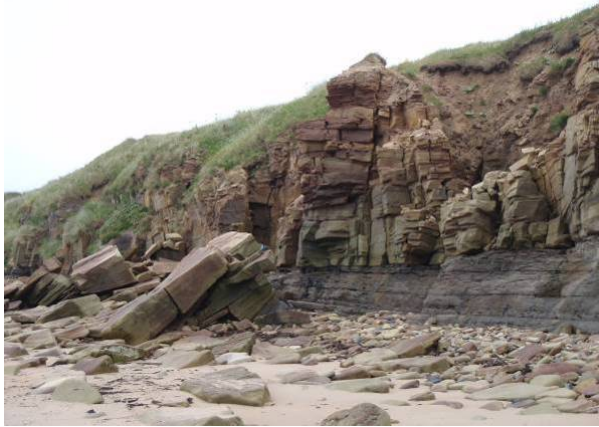
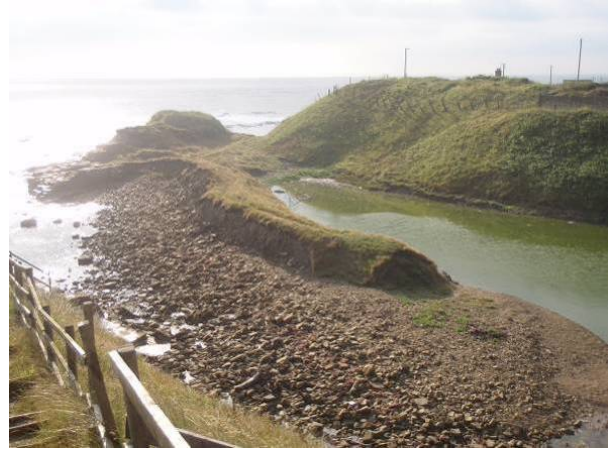
Approaching the Snab Point headland, two large rock falls have occurred to the north of the car park (below left) and erosion has occurred in the mound of land running along the southern edge of the small 'inlet' leading to the tidal pond created in the area of the disused quarry (below right).

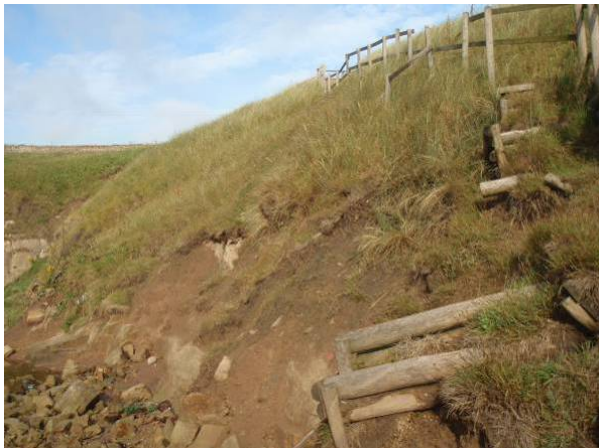
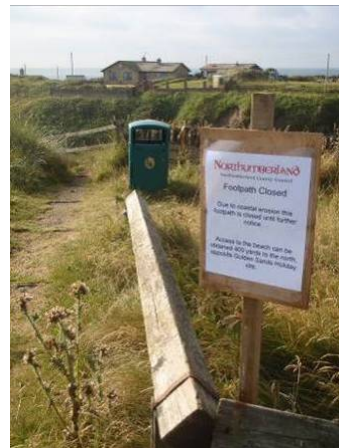
Erosion has also occurred steps along the cliff on the northern edge of this inlet, adjacent to the foreshore access from the car park (below left), resulting in their closure to the public (below right).

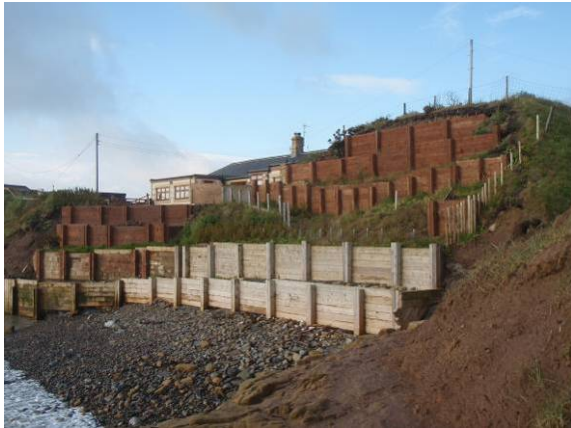
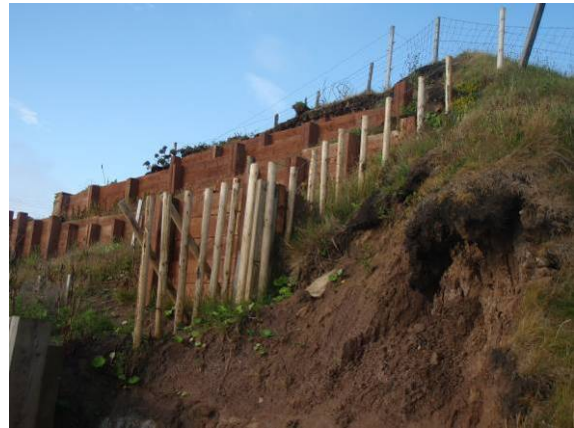
The private defences comprising timber breastwork retaining walls, built shortly before the 2008 inspections, have been further improved with two new rows of timber breastwork in the area where slumping was continuing in the upper cliff (below left). There remains some upper cliff slippage immediately adjacent to this area, however, which over time could cause problems of undermining or outflanking (below right).

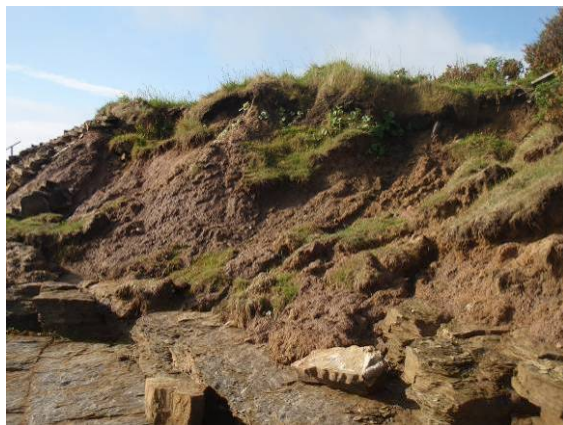
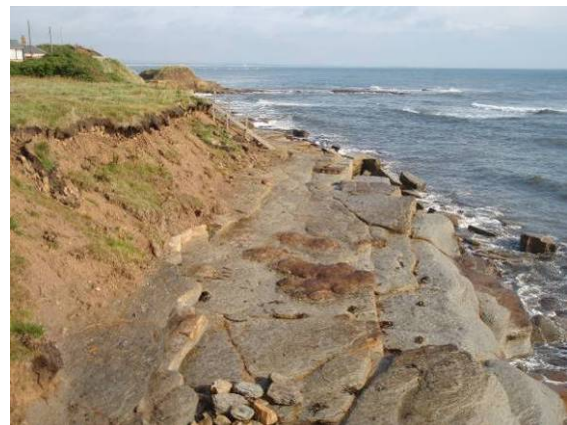
Generally, further south around Snab Point, there have been occasional local slumps in the upper softer material with local rock falls in the underlying rock ledge (below).

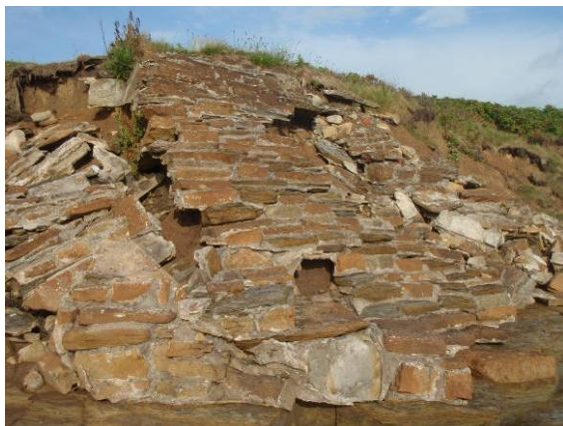
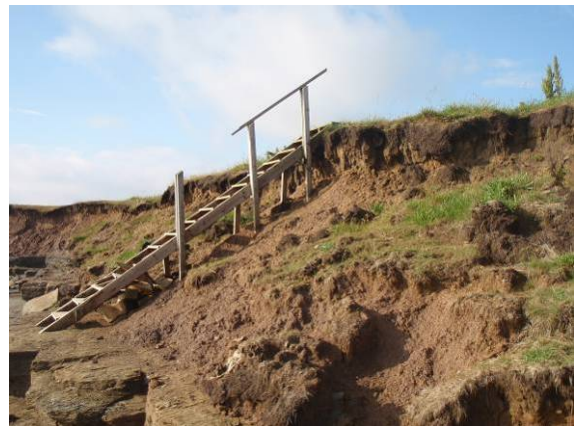
In one location, an obsolete blockwork structure built into the softer upper cliff material and sitting on the rock ledge is actively breaking up (below left), with debris falling on to the rock ledge, and slightly further south a set of timber access steps has damage to both its handrailing and step boards and is actively being outflanked by erosion (below right).

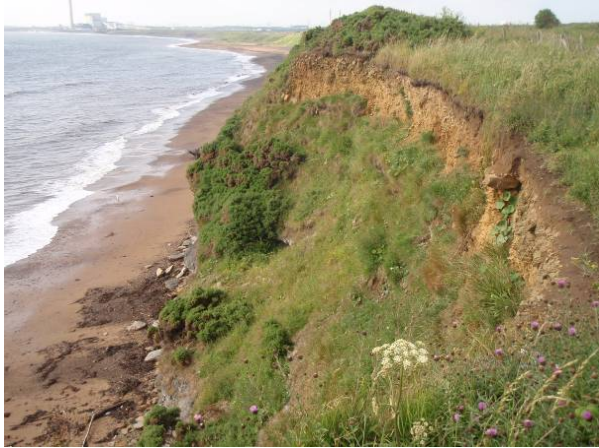
The northern section of Lynemouth Bay comprises a low rock cliff overlain with softer material. There is evidence of local rock falls in the basal layer and slumping in the softer material, despite the presence of much vegetation on the cliff face (below left). Further south, the protection afforded by the wide spoil beach means that the low cliffs are much more stable, adopting a shallow profile with considerable vegetation cover (below right).

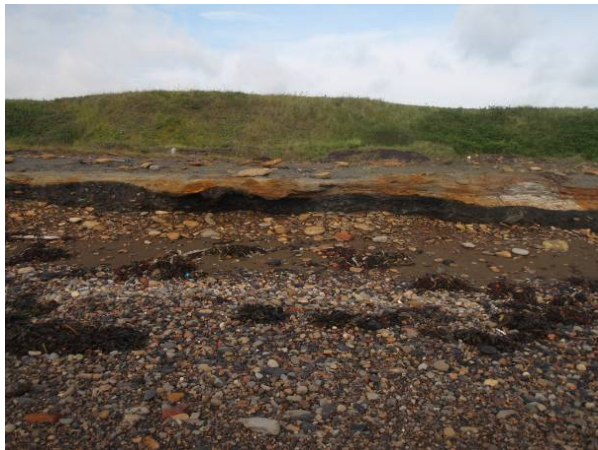
The shoreline fronting Lynn Hill is less well protected by a spoil beach. Where a narrow width of is present, it is actively eroding, resulting in cliffing on the seaward face (below left). Where there is no spoil beach present, the backing spoil cliffs are eroding, releasing debris to the foreshore. Where these cliffs contain softer soil there is evidence of soil cracking, slumping and a steep profile. Along one short length, the cliff face is entirely composed of colliery spoil in a near-vertical profile (below right).

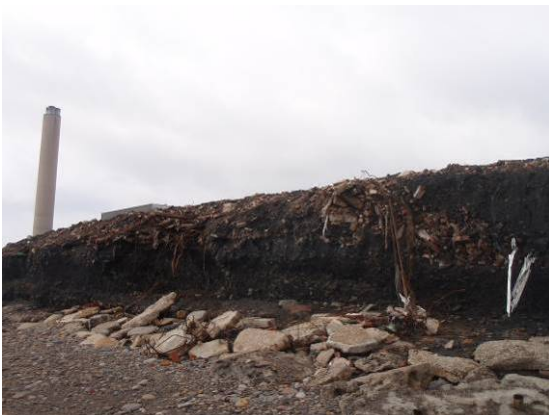
South of the River Lyne, there is a short length of undefended colliery spoil 'cliff', formed by historic waste tipping over the coastal slope, which is very actively eroding, releasing waste of various descriptions onto the foreshore (below left). The land behind this actively eroding frontage is effectively a spoil yard with no built assets (below right). Consideration should be given, however, to the environmental impact of the continued release of waste from this eroding frontage.

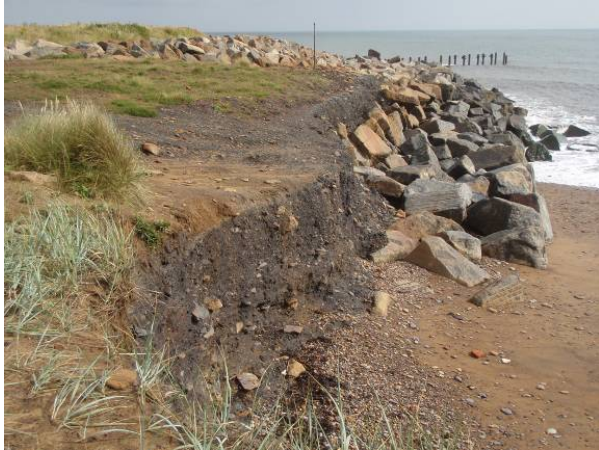
There is, however, some erosion at the southern end where the revetment ‘tapers out’ and the cliff line is undefended (below left). This is not presently outflanking the defence, but the situation should be monitored. Between this section and Beacon Point, the shoreline again comprises colliery spoil, with erosion of the spoil cliff in the north ongoing at modest rates (below right) before the central and southern sections become more stable, with wide backing dunes and a fronting cobble berm.

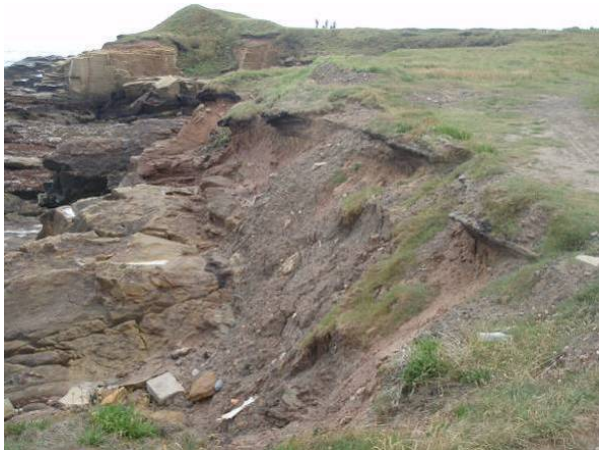
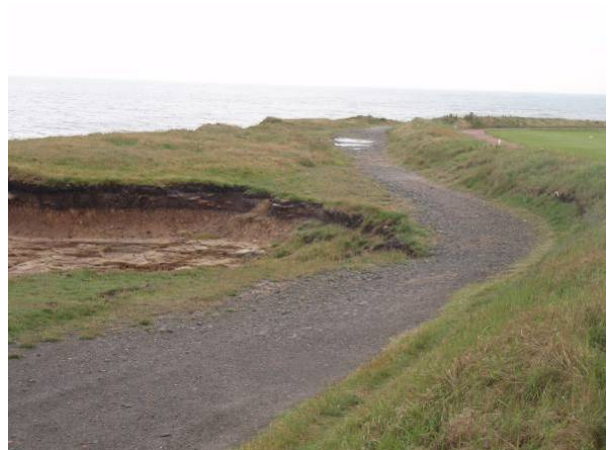
The cliffs leading around the headland to Beacon Point are comprised of a hard rock base and a thin overlying layer of softer material. Here there are small-scale rock falls with occasional local slumps in the soft material (below left). Further around Beacon Point, the slumps in the upper cliff have cut the cliff top back to the footpath in a number of areas (below right), but there is sufficient space to realign the path landwards when necessary. The cliffs here are fronted by an extensive rock ledge and therefore the recession rates are low and the events are very localised.

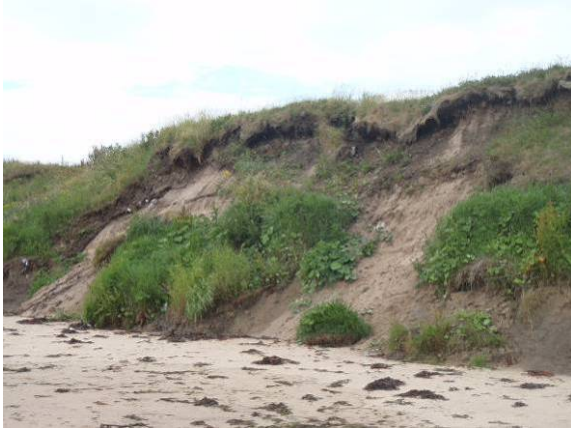
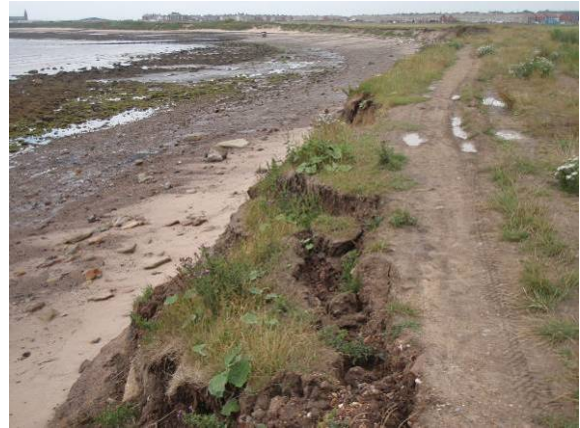
Along the main section of cliffs within the shallow bay fronting the golf course at Newbiggin Moor, however, the cliffs are unprotected by rock platform and have no rock base and as a consequence are more actively slumping along their length (below left). Cracking in the cliff top and steep profiles (below right) indicate that slumping will remain ongoing and parts of the golf course will need to be reconfigured over time. In one location, the cliffs dip to a lower level and here rubble has been tipped to prevent erosion and sea flooding.

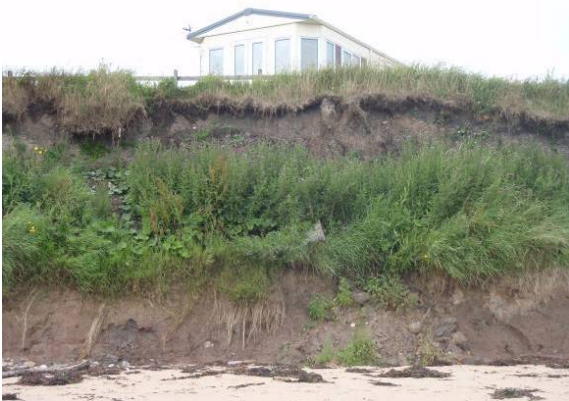
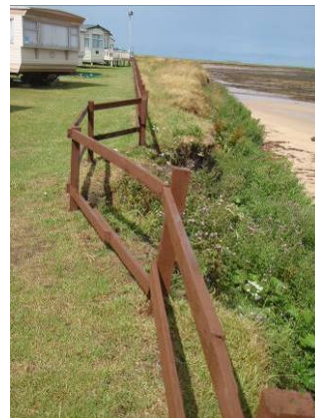
The cliffs fronting Newbiggin Caravan Park comprise three distinct sections. The northern section is unprotected by coastal defences or rock platforms and is actively eroding through a series of regular local slumps (below left). This has prompted the Caravan Park to erect warning signs along the cliff top footpath and realign short lengths of its boundary fencing (below right).

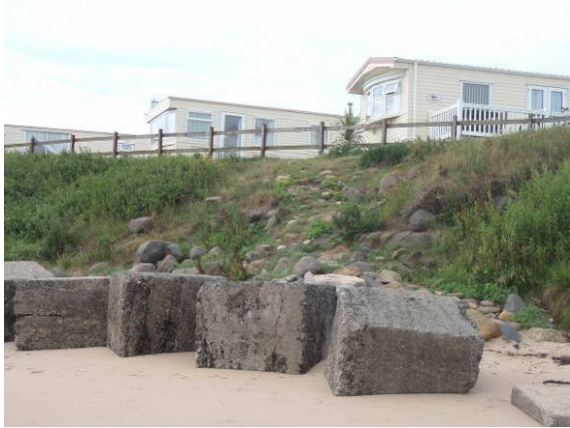
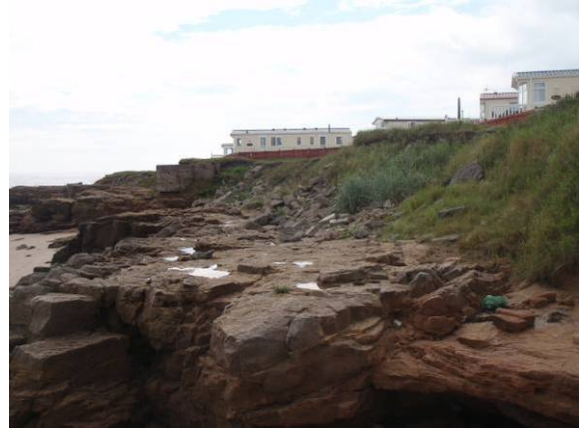
The central section is protected by concrete anti-tank blocks and these have assisted to an extent in generally stabilising the cliffs (below left); although some slumps have continued locally in places the cliffs are considerably less active than the undefended section to the north. The southern section is protected by a rock ledge (below right) but, despite this, occasional local slumps remain evident. In both sections, efforts to arrest the slumping have been made by local tipping of rubble down the cliff face.

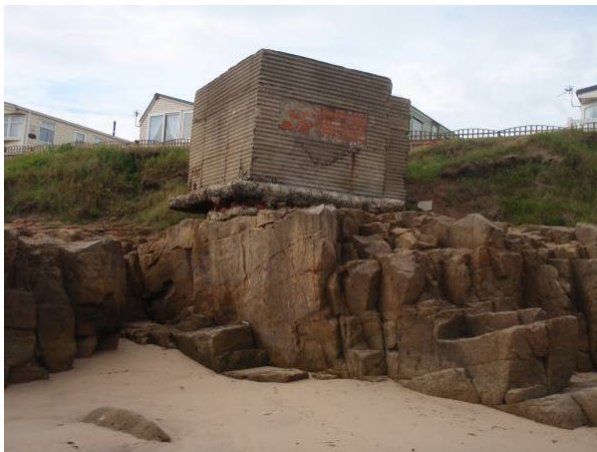
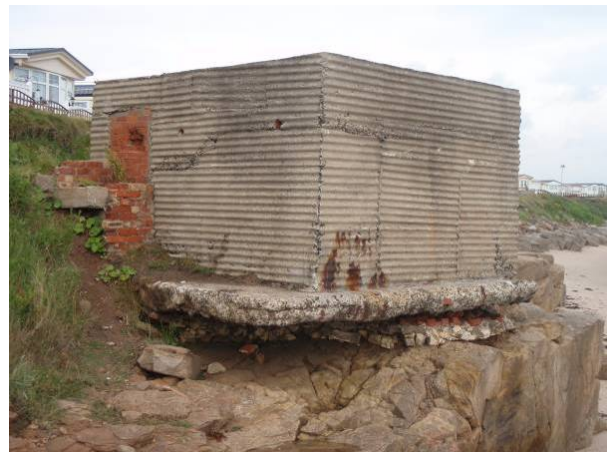
Along the southern section of the Newbiggin Caravan Park, two pill boxes (below) are located on the rock ledge, with erosion of the surrounding soft cliff material now leaving them perched precariously.

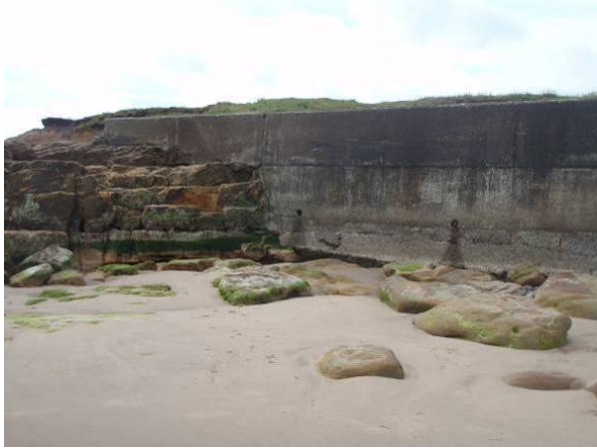
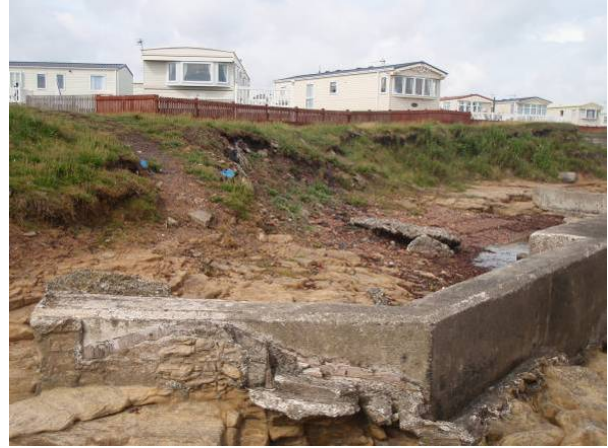
At Beacon End a short length of concrete seawall is present, which appears to have a fair condition seaward face (below left), despite a vertical crack which has not worsened since the 2008 inspection, but which is continuing to suffer badly from toe abrasion, undermining and most notably outflanking, particularly at the return-section 'tie-ins' at either end of the structure. These tie-ins are being undermined and outflanked (below right). The soft cliff material behind each return section is actively being eroded and slumping, thereby further contributing to the problem. The overall situation at this seawall seems to have worsened since the 2008 inspections.

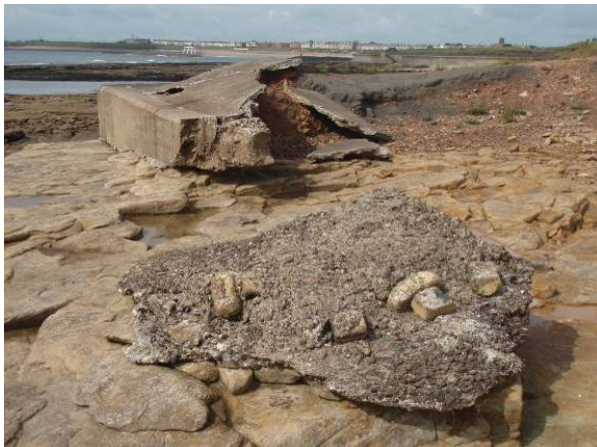
The second length of seawall is slightly further south around Newbiggin Point and remains in very poor condition. The tie-in sections remain actively breaking up, with concrete debris remaining on the rock ledge. Although the damage at the northern tie-in looks recent, this situation was also recorded in the 2008 inspections (below left). Further deterioration undoubtedly is occurring, however, at the southern tie-in where outflanking due to erosion of the soft cliff continues (below right).
