**Cell 1 Regional Coastal Monitoring Programme
Coastal Walkover Inspections 2010**

**Northumberland County Council
Final Report**

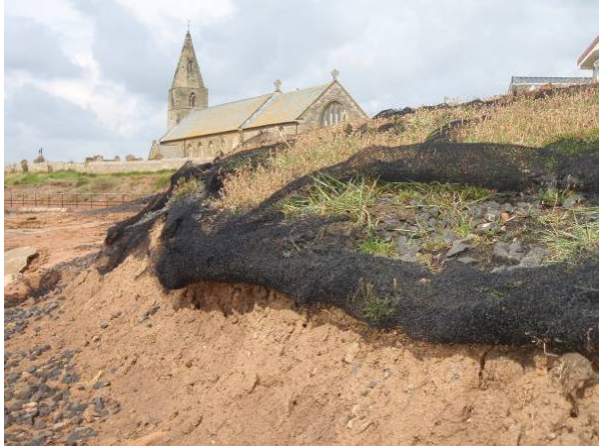
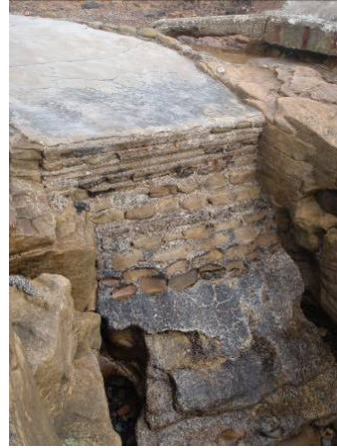
Between here and the larger Church Point seawall, the cliffs are composed of a continuation of the low, irregular rock ledge, with overlaying soft material which remains actively slumping locally, causing the soil netting used in attempt to stabilise the land to become unravelled (below left). Where the rock ledge has become locally eroded, localised concrete and masonry walls have been built to infill crevices in ten areas. All of these structures are experiencing undermining and toe abrasion, although this is particularly problematic in the five most northerly wall sections (below right).

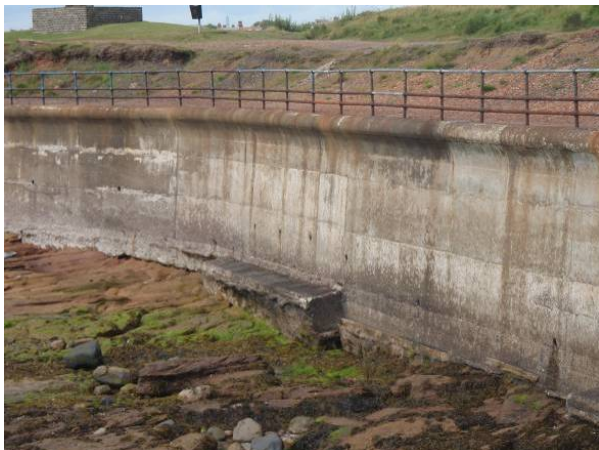
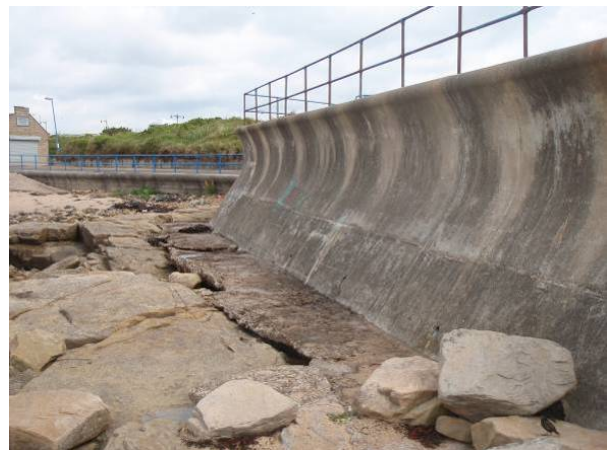
The vertical, northern, end of the Church Point seawall is in an overall fair condition, although there is a reasonable amount of abrasion at the toe and crest and there signs of local toe undermining (below left). The hand railing is badly rusted and needs replacement. The recurved section of the seawall, extending towards the original breakwater, is generally also in fair condition, although missing sealant at the base of the joints should be replaced and there is some undermining of the poured concrete apron nearer its western end (below right).

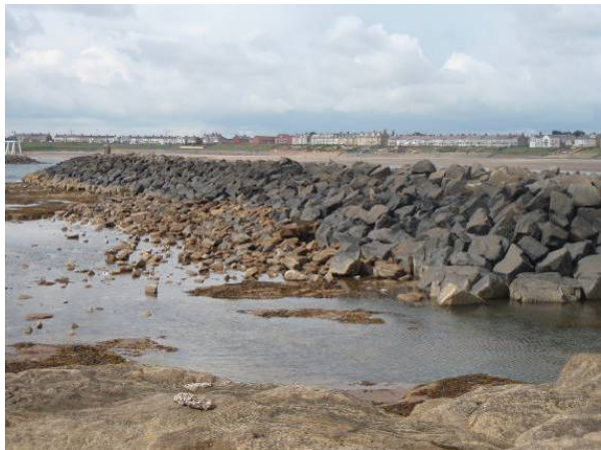
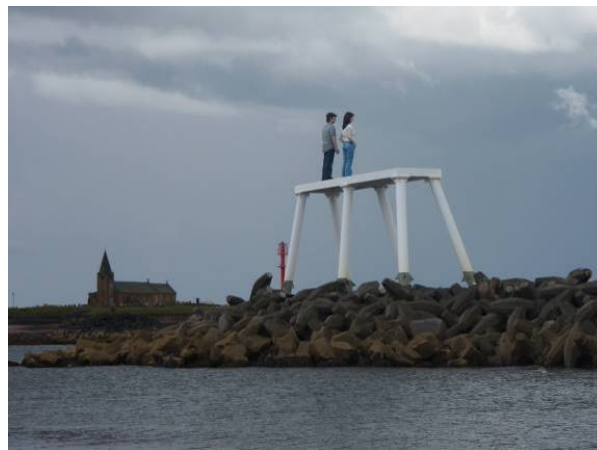
The start of Newbiggin Bay is marked by the original rock breakwater (below left), built along the edge of Hully Rocks extending from near the shore at Church Point (although the structure is not actually shore-connected). This is in good condition, although there are a few displaced rocks now sitting on the foreshore. The newer offshore breakwater (below right), constructed in the centre of the bay as part of the 2007 scheme, is composed of inter-locking concrete units and appears in 'as built' condition.

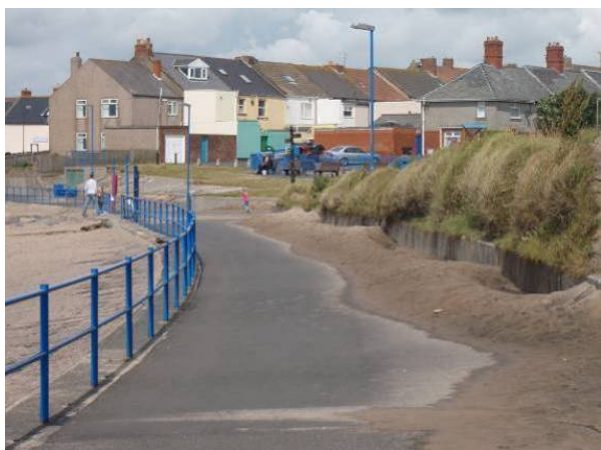
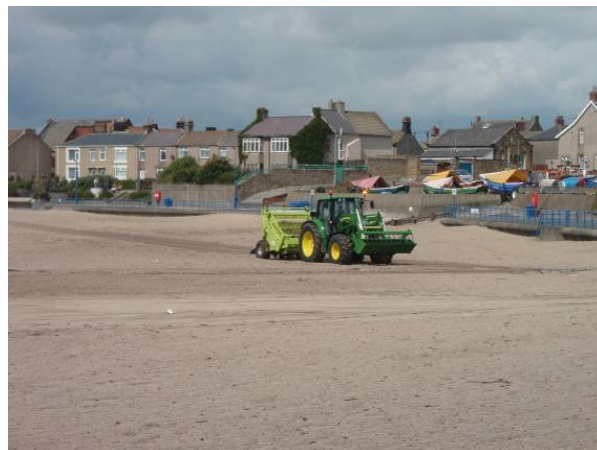
The sea walls throughout Newbiggin Bay are protected by high beach levels following the beach replenishment operations in 2007, although some wind-blown sand was observed at the rear of the promenade (below left) and a tractor was observed on the beach (below right), apparently recycling some sand from the northern part of the bay. In the replenished beach a 'salient' feature (build up of sand towards the breakwater) is forming in the centre of the bay, in the quiescent zone in the immediate lee of the offshore breakwater.

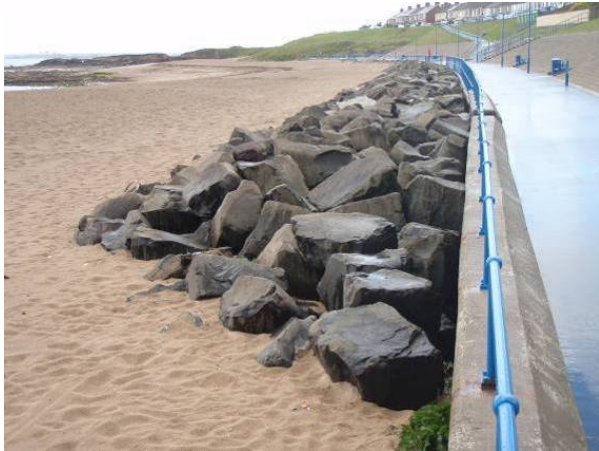
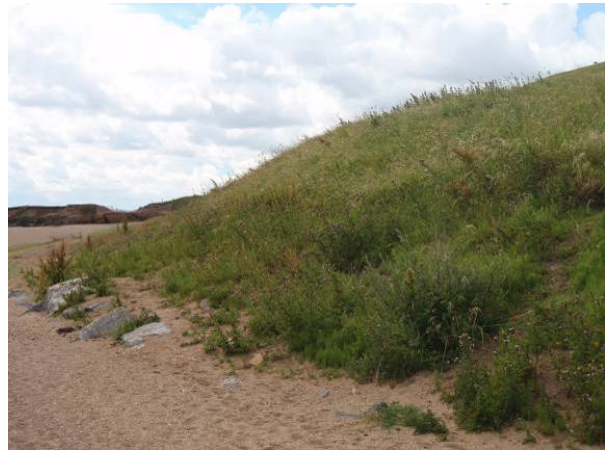
At the southern end of the bay, the seawall is further protected by a short length of rock revetment (below left), which then grades into undefended coastal slope which generally remains stable (below right).

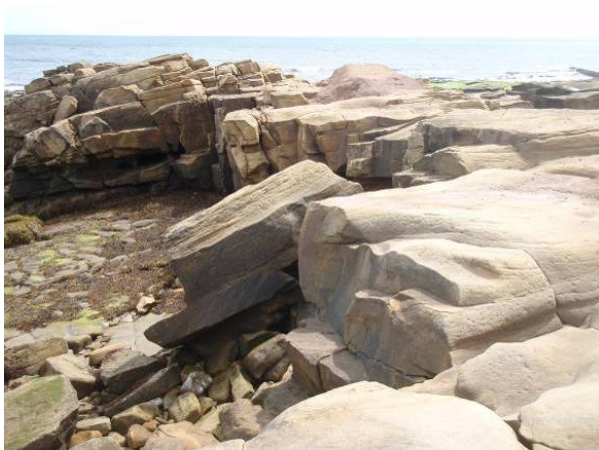
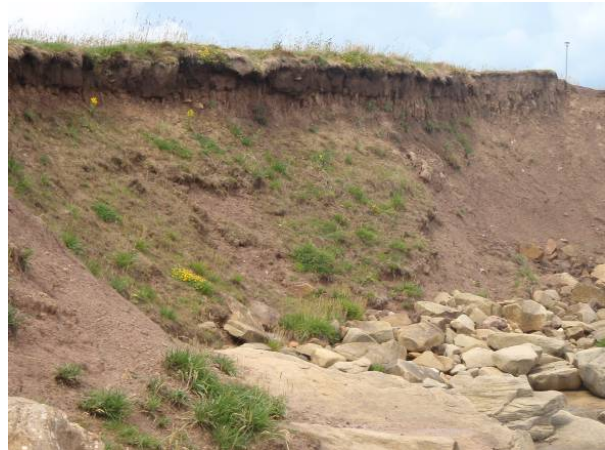
At Spital Point, the cliffs are mostly stable, but there is evidence of occasional rockfalls (below left) which have left the overlying softer material overhanging in places (below right).

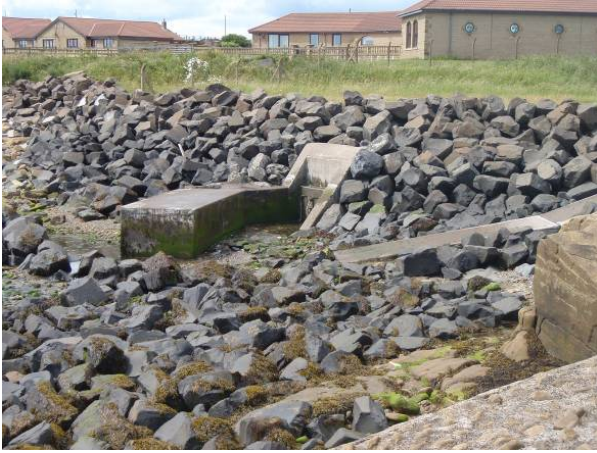
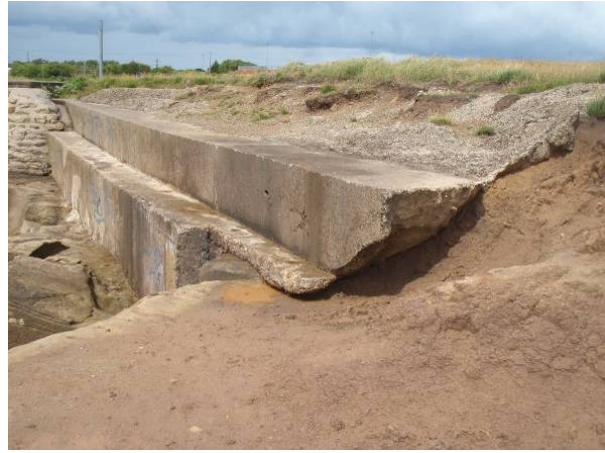
South of the headland, Northumbrian Water Limited's storm outfall is very well protected by rock armour and the concrete headwalls are sound (below left). To the immediate north, there is an older concrete outfall structure, which is being slightly outflanked where it sits into the soft cliff material overlaying the hard rock base at Spital Point (below right).

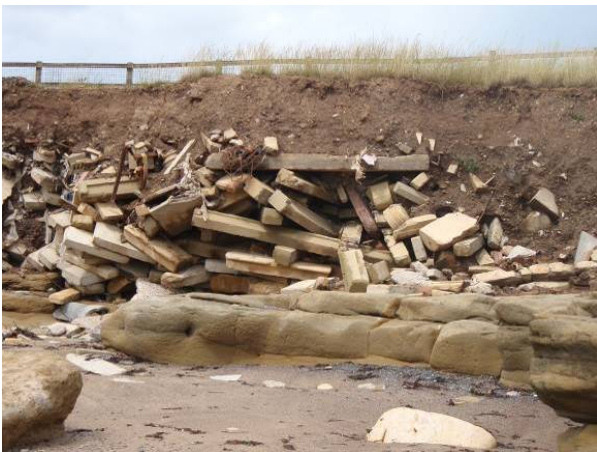
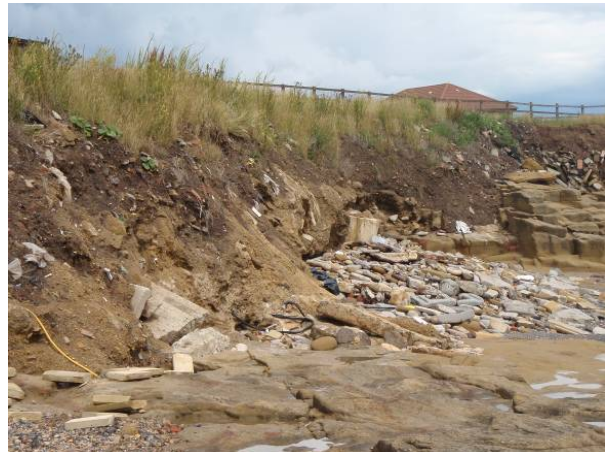
South of the outfall, there is a short section of cliff fronting Links Quarry which has significant quantities of rubble and quarry waste tipped down its seaward face and actually comprising its core (below left). This continues to experience slumping in the softer material, releasing waste and debris onto the foreshore (below right).

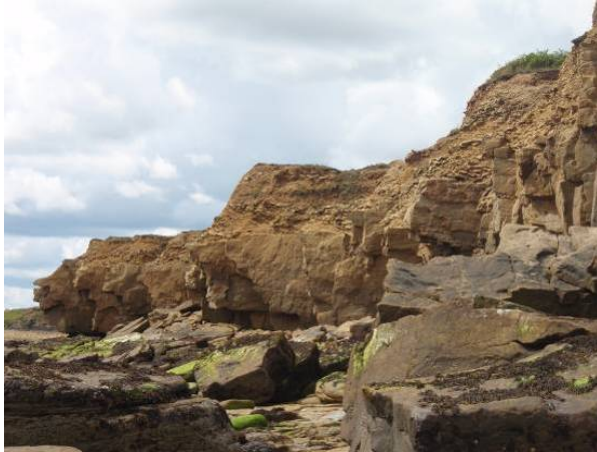
Hawks Cliff (below left) generally experiences gradual, local erosion caused by slumping in the upper soft material and occasional rock falls in the base. However, over the severe winter of 2009/2010 the whole section has been active. Tragically, there was a fatality in January 2010 when a section of cliff collapsed during severe weather (freezing temperatures, heavy rainfall and snow loading) and harsh marine conditions (high tide storm) and a sea angler standing on the cliff top fell to the foreshore. This section not only appears to have experienced a rock fall, but a slump in some of the overburdening till was also triggered by this event (below right).

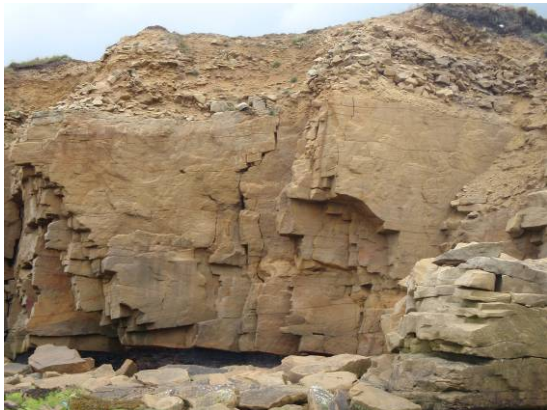
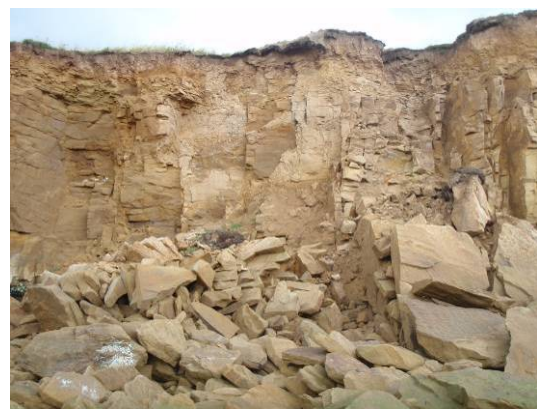
It is clear to see that there has now been significant fracturing in the rock structure along the whole length of cliffs (below left). Much of this fractured section has recently been active, with numerous rock falls (below right).

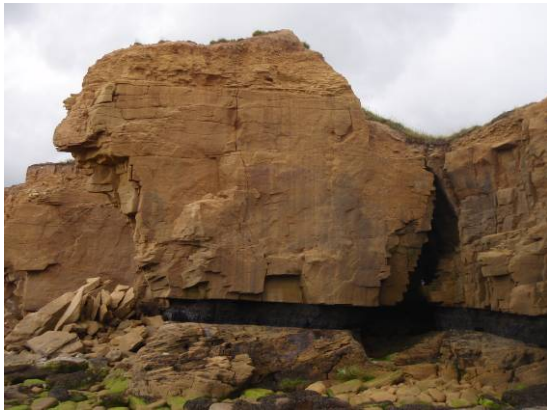
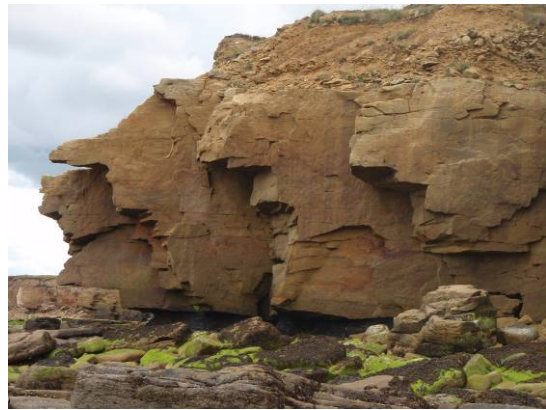
These have left many notable rock overhangs (below) which, together with the fracturing to the remaining rock structure, leave the cliff line in a precarious situation. The owners of Sandy Bay Caravan Park have placed warning signs and fenced off a section of the cliff-top footpath, diverting it slightly inland.

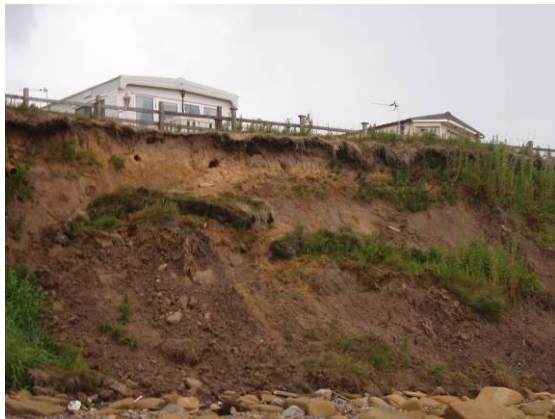
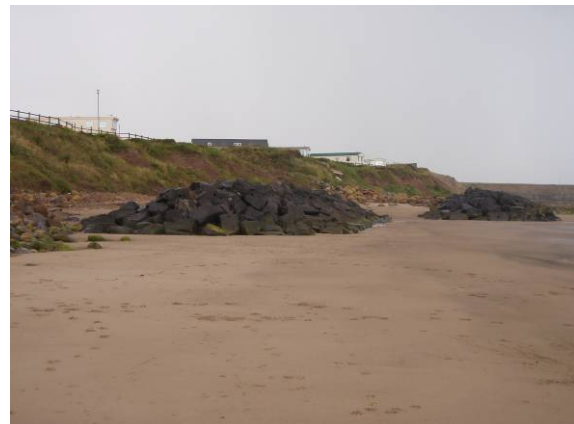
The cliffs directly fronting Sandy Bay Caravan park have experienced occasional slumps at the northern end and then more frequent slumping further south where there is no protective shore platform (below left). Despite the presence of three nearshore rock berms on the foreshore (below right), erosion of the cliffs behind continues and rubble has been tipped down the cliff in attempt to arrest this.

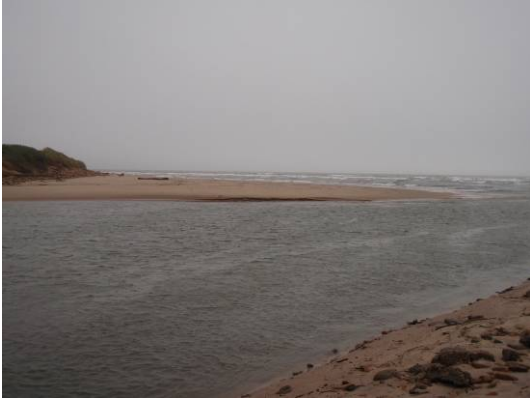
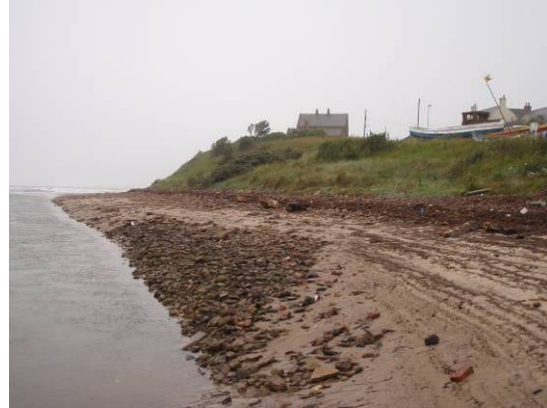
This section comprises a sheltered estuarine frontage. On the north bank there is an accreting sand spit (below left) which is pushing the estuary channel more towards the south bank. This is backed by stable dunes. On the south bank there is a steeper sandy foreshore topped with occasional cobbles (below right). The main channel of the estuary encroaches close to this south shore.

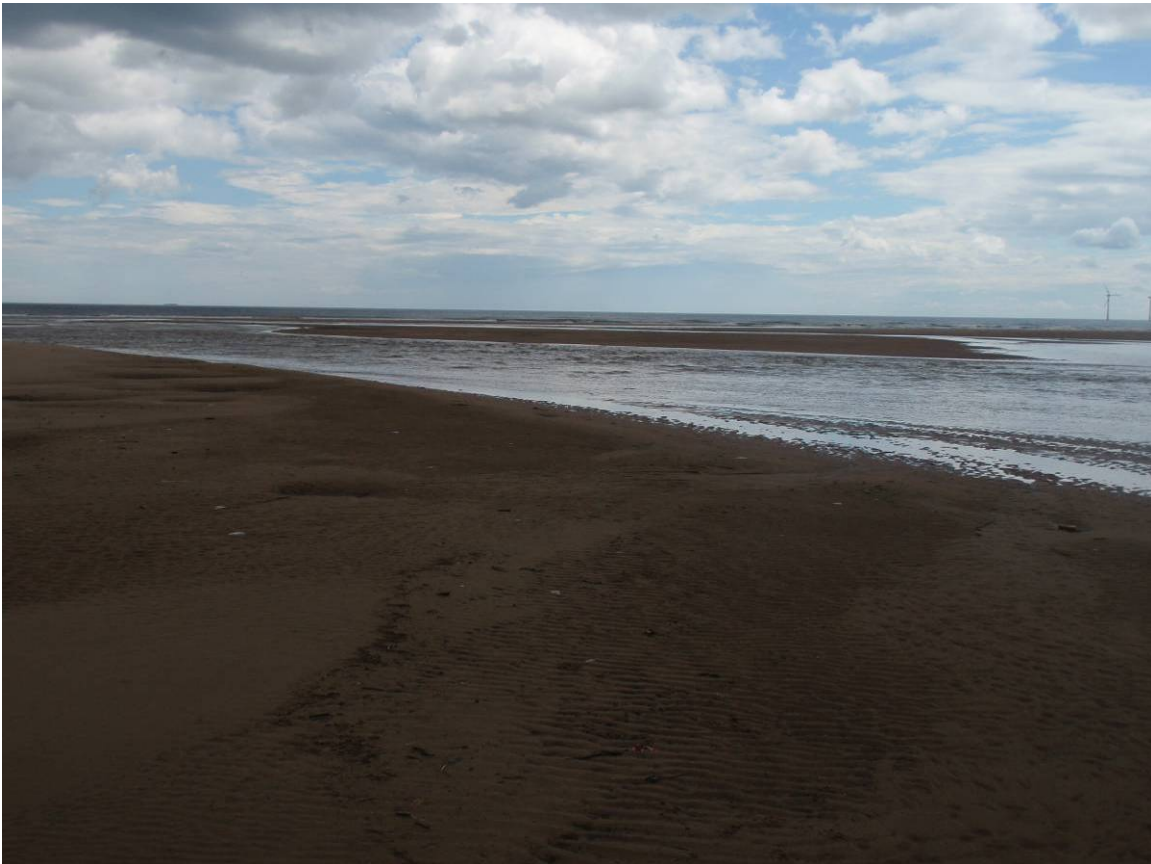
One local resident spoken to whilst dog-walking on the beach mentioned that at low water it is now possible to wade across the estuary mouth between Cambois and Sandy Bay due to the presence of a sand island in the channel and relatively shallow channel depths where its discharge fans out across the foreshore (below).

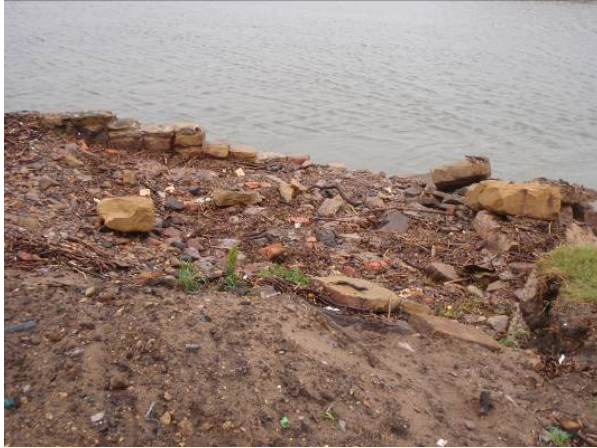
Associated with the Wansbeck Boat Club are various lengths of masonry walls and slipways. In the indented 'bay' these have often been patched-up, but around the protruding earthen and rubble 'promontory' the masonry wall has failed and the backing land and rubble is being washed-out (below left). Eastwards of this feature, the walls are somewhat patched-up (below right). Further patch repairs should be made to the failing promontory to avoid further rubble and soil being washed into the estuary.

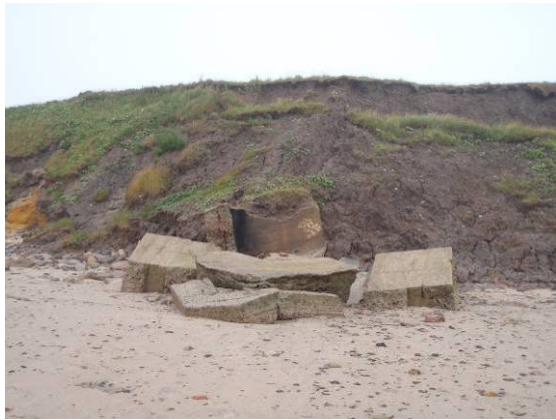
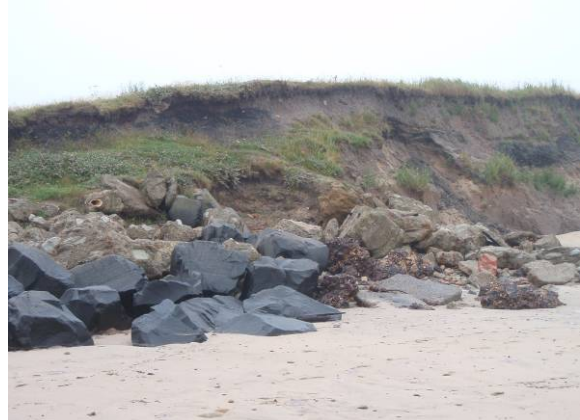
The pill box which was previously eroded out from the cliff face has started to break up on the foreshore, and although it does still act as a local hard point control, cliff slumping is continuing in its lee (below left). At the intersection of the cliffs with the access ramp from the car park, the tipped rock armourstone and large rubble is partially stabilising the outflanking problem of the ramp, although again slumps are continuing in the cliffs behind (below right).

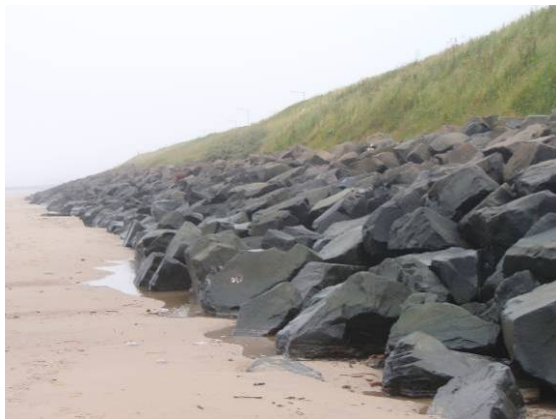
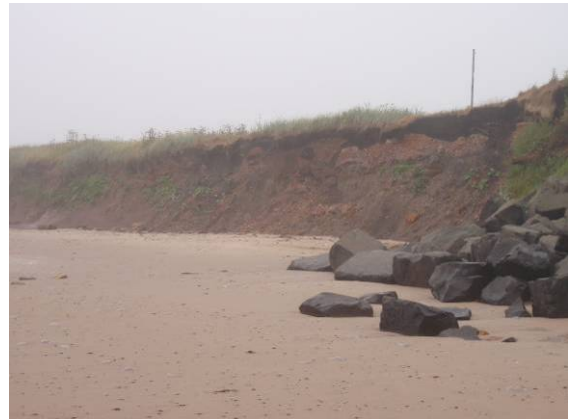
The rock revetment that was constructed by private industry to protect the former foundry remains in a good condition, with a stable and well vegetated slope behind (below left). At the southern end, near the long sea outfall, the problem of 'downdrift' erosion remains ongoing along a length of approximately 50m (below right) and future surveys should continue to check for outflanking of the revetment.

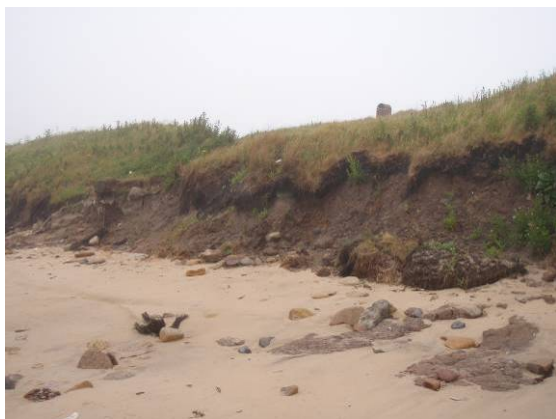
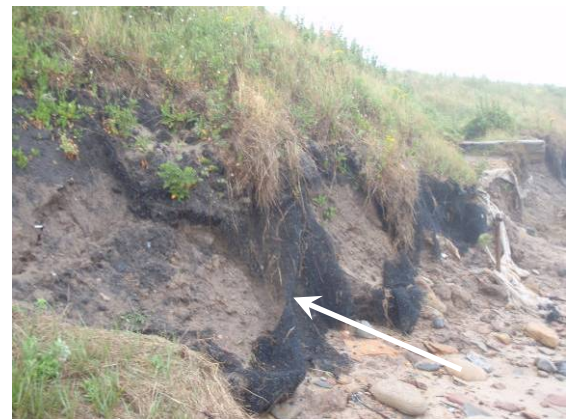
Further south, the cliffs exhibit more typical behaviour of occasional local slumps (below left), especially between the two outfalls. The southerly outfall is broken and obsolete. Around this point, soil netting has been exposed in one cliff slump (below right).

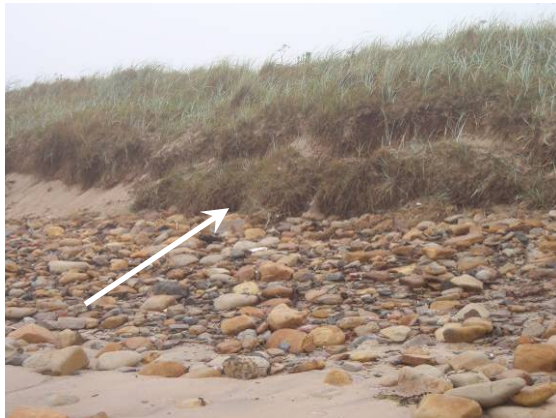
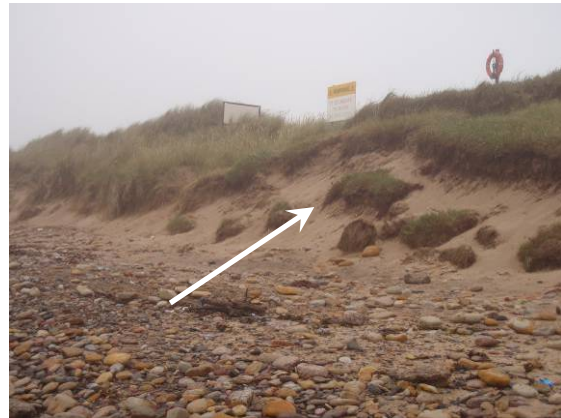
Southwards of the southern outfall, the frontage is characterised by dunes. Along their northern section, the toe is eroding in clumps along a considerable length (below left), but further south the behaviour typically reverts to occasional slumps within otherwise generally stable areas (below right).

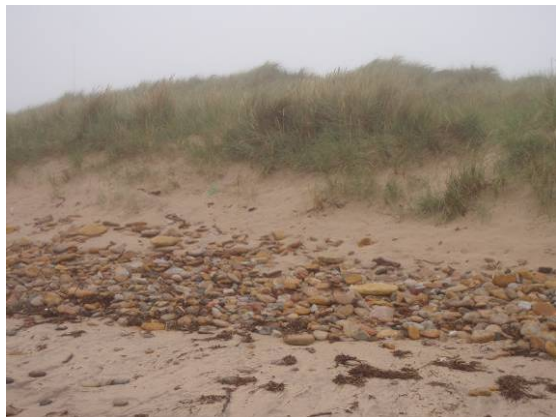
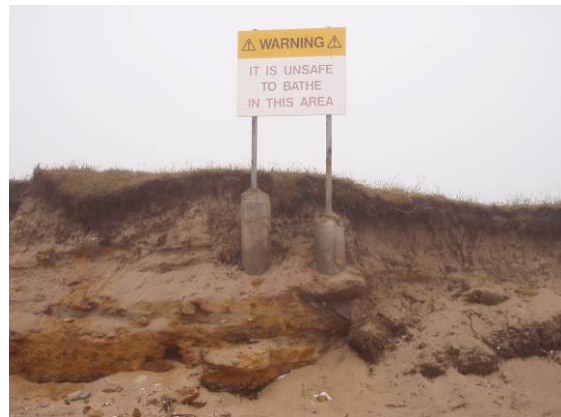
Towards the south of the dunes, a cobble berm is formed on the beach, affording protection to the backing dunes which have become very stable and well vegetated here (below left). There remain occasional lengths where slumping has occurred, but this dune erosion does not presently cause a concern for management, other than threatening the loss of a public warning sign (below right).

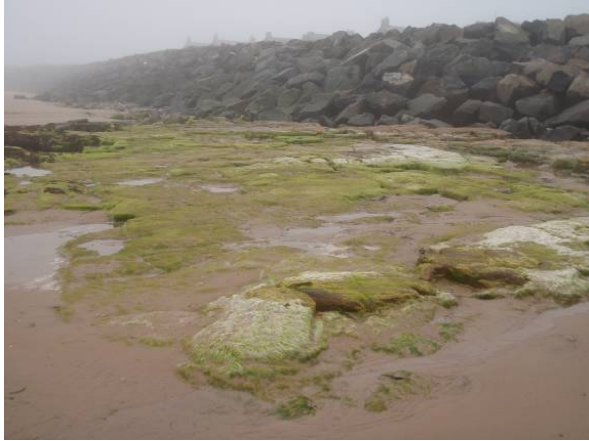
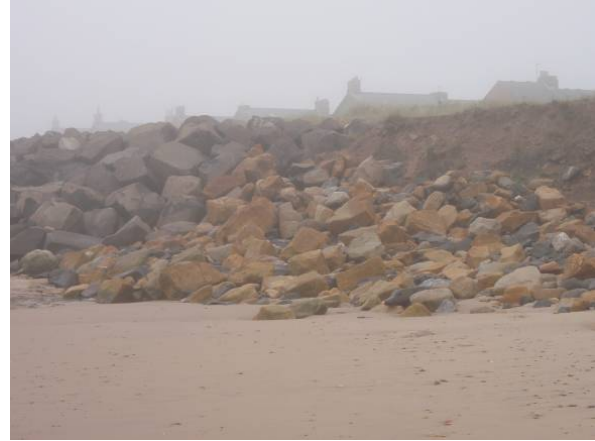
The whole North Blyth frontage is protected by man-made defences. At the northern end, these comprise a rock revetment capped with rock-filled gabions, which is a substantial structure that remains in fair condition (below left). At the northern end of this revetment there has been cut-back erosion, however, and efforts have been made to reduce this by tipping rock (below right). This has simply deflected the problem area further north.

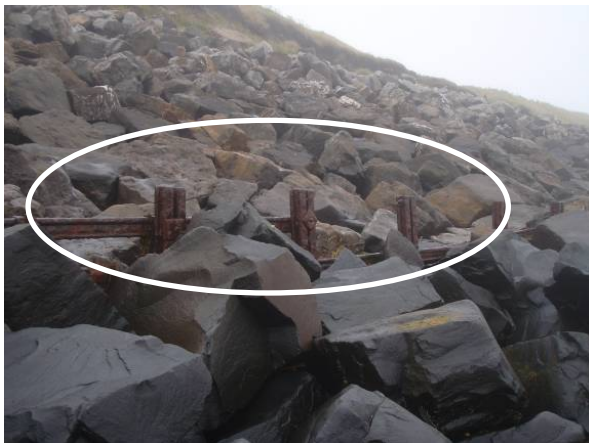
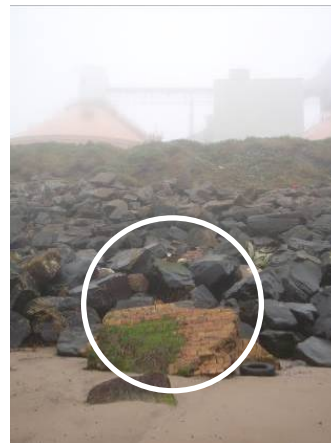
The revetment changes further south to a composite structure with large rock armourstones at the base, separated from the smaller upper armourstones by steel breastwork which now seems largely in a poor condition, with extensive corrosion and numerous failed members (below left). There are a few slumps in the cliffs behind the revetment and towards the southern end, some rubble has been tipped down the cliff to fill such sections. Some of this rubble has fallen into the revetment and some onto the upper foreshore (below right).

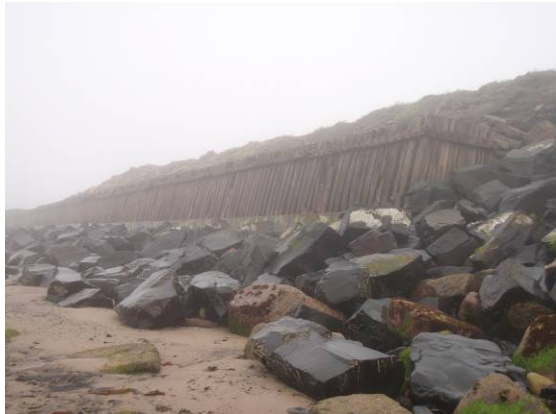
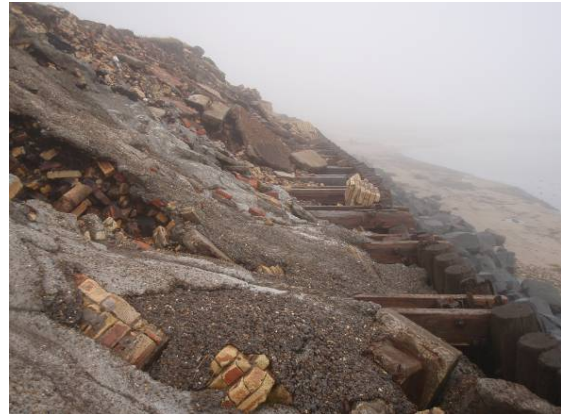
Fronting Alcan's facilities is a composite structure comprising timber breastwork (below left) with a backing tipped rubble slope (below right), sitting on a concrete apron with rock armour at the toe.

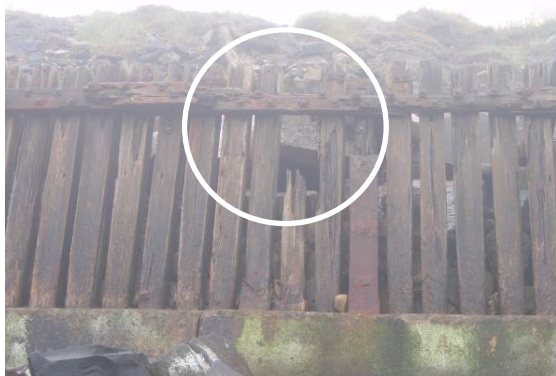
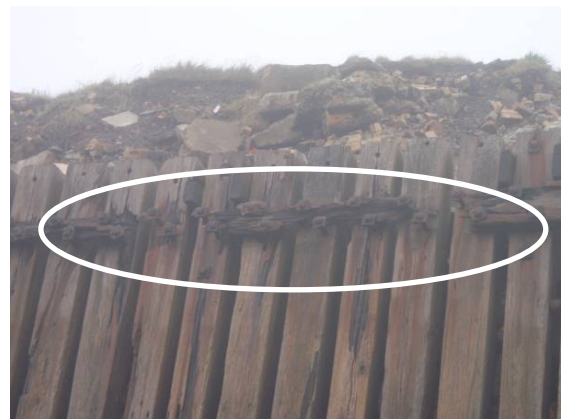
The timber breastwork is considerably damaged in places, with broken vertical timber boards (below left), and rotten horizontal fixing beams (below right). There is a risk that without further maintenance the breastwork may fail, spilling rubble onto the foreshore. There is an obsolete outfall structure on the foreshore.

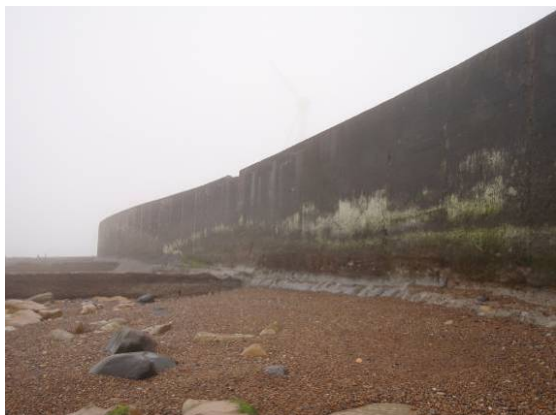
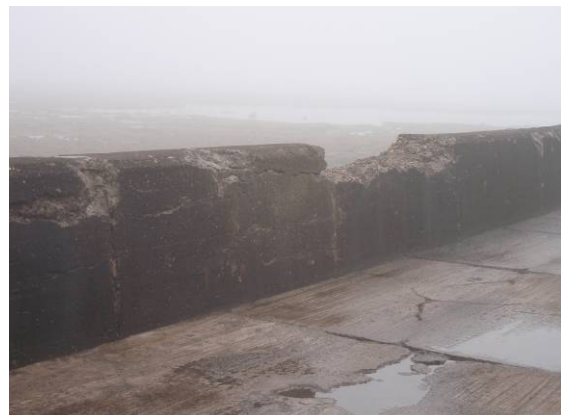
A seawall then extends south to the Blyth East Pier (below left). The seaward face has abrasion at the toe apron, vertical cracks, gaps in vertical joints between some adjacent section units, and occasional horizontal cracks. The crest wall has one damaged section (below right), but immediately adjacent are four section units with a continuous horizontal crack connecting to the failed section. There are also numerous defects in the deck and evidence that overtopping occurred at the preceding high water. This section of wall is in urgent need of repair. Blyth East Pier was not inspected due to access restrictions.

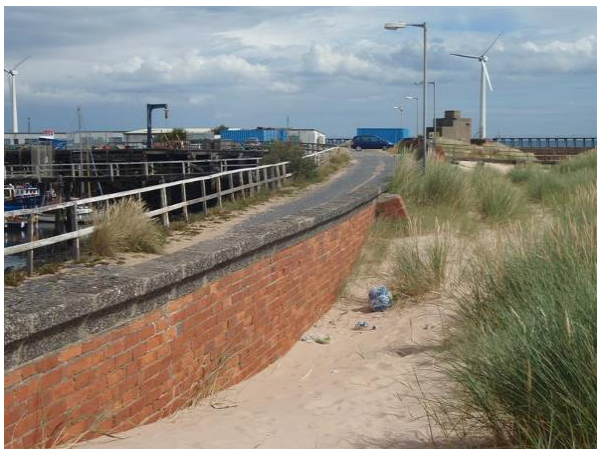
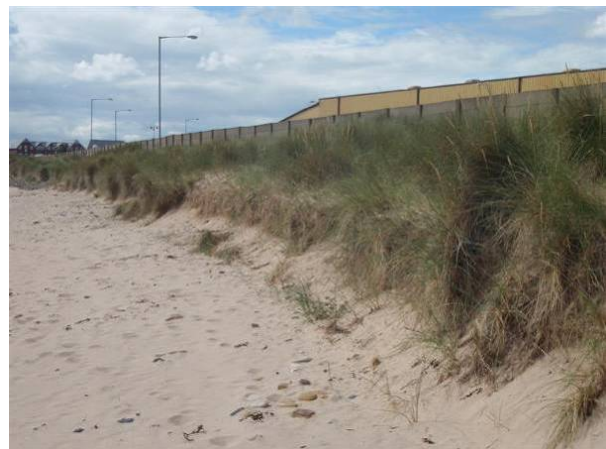
At the rear of the dunes is a boundary wall of the Port of Blyth facilities (docks, berths and haulage road to the port). The beach levels in the spending beach, between the West Pier and the South Pier, remain healthy and the dunes are vegetated and stable. Initially the backing boundary wall is comprised of a brick wall on a concrete toe, with concrete coping and regular brick strongbacks (below left). This section of the boundary wall has some very minor cracking and occasional loss of mortar at joints in the concrete coping but overall is in fair condition. The width of dunes decreases with progression south and the boundary wall changes in form to a concrete plank wall supported by concrete posts. The wall has occasional missing concrete planks but remains well protected by dunes in its northern section. Further south, however, towards the outfalls that cross the foreshore, the dune width narrows considerably and the seaward face of the dunes is cliffing through erosion (below right). This section of dunes needs careful consideration by the Port of Blyth so as to prevent breaching through to haulage road to the port.

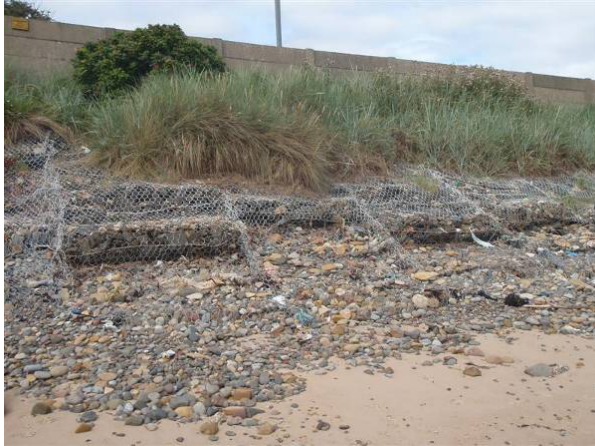
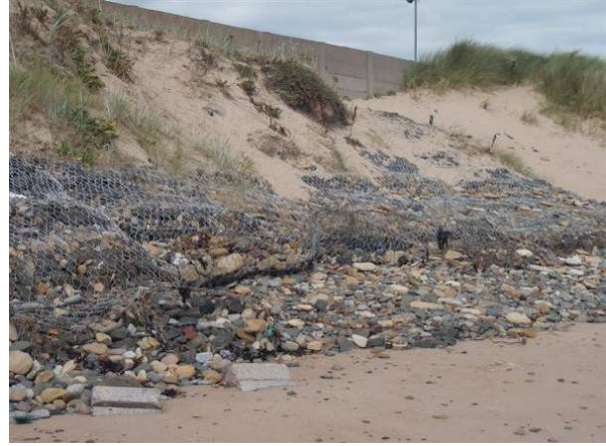
Along the southern-most section of the port boundary wall, the dunes are protected along the seaward face and toe by cobble-filled gabions. These appear to have deteriorated further since the 2008 inspections and now at both ends of this length, the gabions have broken and spilled cobbles onto the foreshore (below). Replacement of broken gabions should be undertaken, potentially in conjunction with consideration of management options for the undefended dunes further north, as described above.

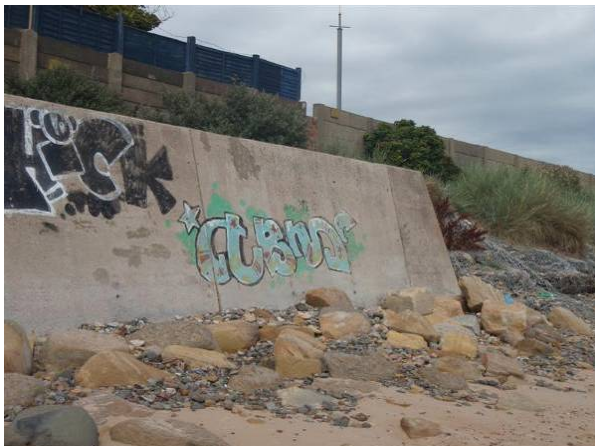
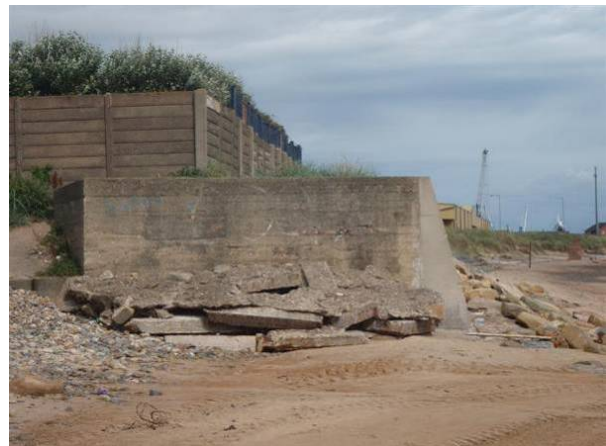
South of the gabions is a short section of sea wall that protects backing properties. Beach levels at this frontage can vary and during the inspections rocks were noted at the toe of the wall (below left), as was the case in 2006. During the 2008 inspections these had been covered by beach sand at the toe of the wall. The wall itself is on good condition, but with some gaps at construction joints which should be re-sealed. At the southern end, concrete slurry has now been further protected by tipped concrete rubble, presumably to prevent undermining. (below right)

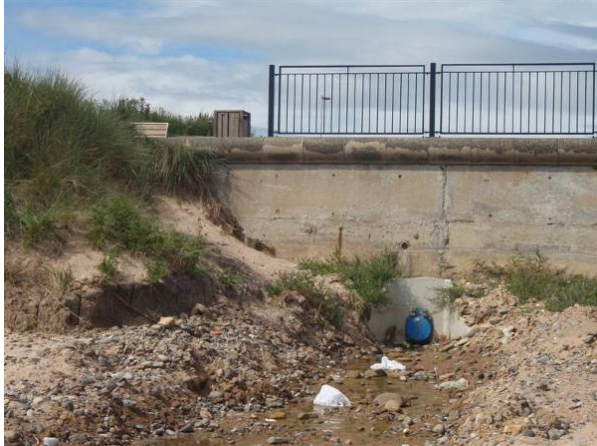
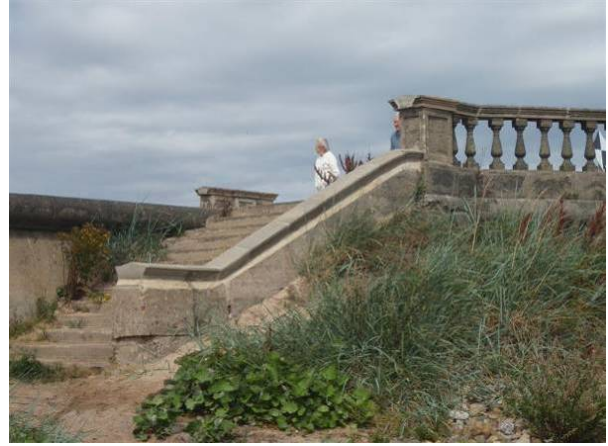
South of the boat ramp, the short section of sea wall is mostly buried by vegetated sand dunes. These dunes appear stable, whereas in 2008 they were notably eroding. The wall itself remains generally sound in the visible areas, although the cracks should be filled through routine maintenance. A new outfall through the wall appears to have been constructed since the previous inspections (below left). The cosmetic damage to the ornamental wall, noted in 2008, has been addressed through new coping on the access ramps (below right).

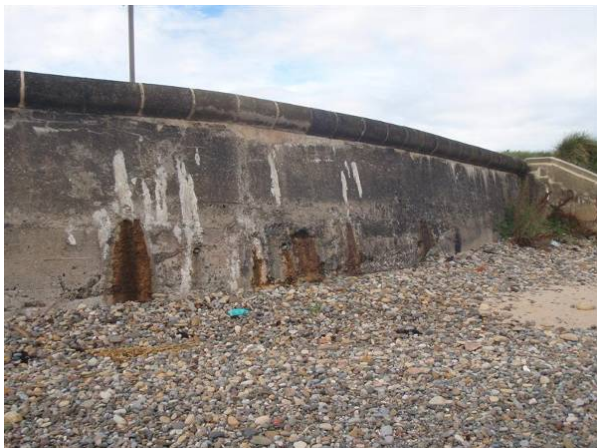
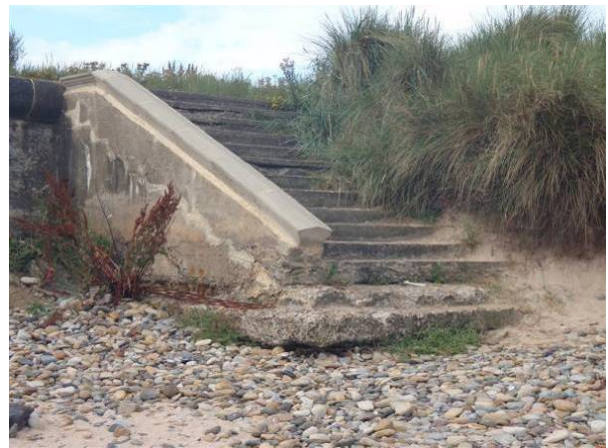
South of the dunes, runs a fairly aged sea wall, which has numerous cracks and notable abrasion and staining at its northern end (below left) which could usefully be addressed through maintenance. Some cracks have previously been filled, but these remain in need of further attention. At the northern end, the access steps remain horizontally cracked and a little undermined at their toe, despite replacement of the previously damage coping since the 2008 inspections (below right). In this northern section, the upper part of the sandy foreshore is covered by a thin veneer of cobbles which were not noted in 2008.

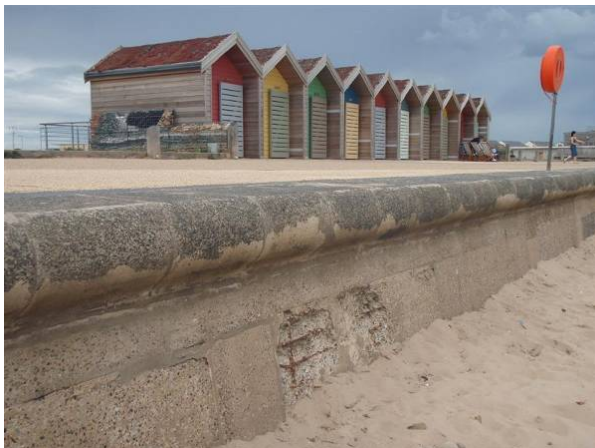
The sea wall fronting the promenade was largely buried by high beach levels at the time of the inspections, but some minor cracks and gaps at construction joints were noted in the visible sections of wall, as well as a few patchy areas of abrasion, leading to exposed and corroded reinforcement bars (below).

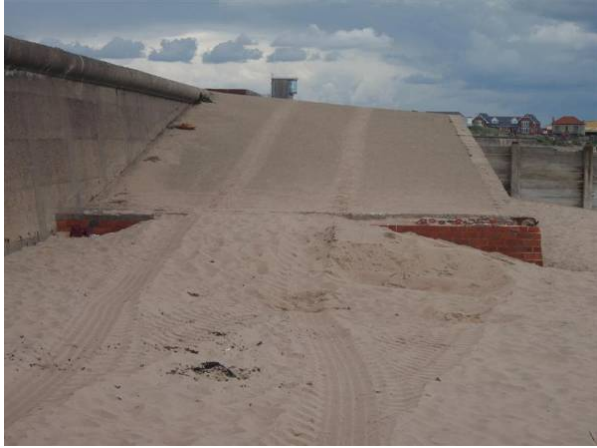
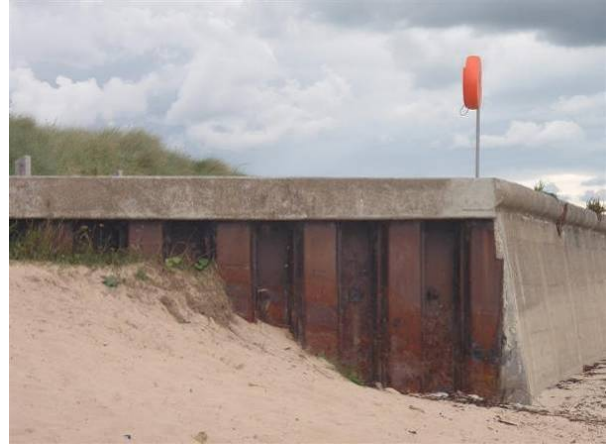
A temporary ramp of sand had been constructed to enable construction plant to access the foreshore via the concrete access ramp towards the southern end of the promenade (below left). Tracks were observed extending as far north as the spending beach and southwards around the toe of the timber groynes, suggesting some sand recycling had occurred along the frontage from the spending beach to the vulnerable section of dunes. At the southern end of the sea wall, the sheet piles protecting the 'tie-back' section remain corroded (below right), but do not appear to have worsened since the 2008 inspections.

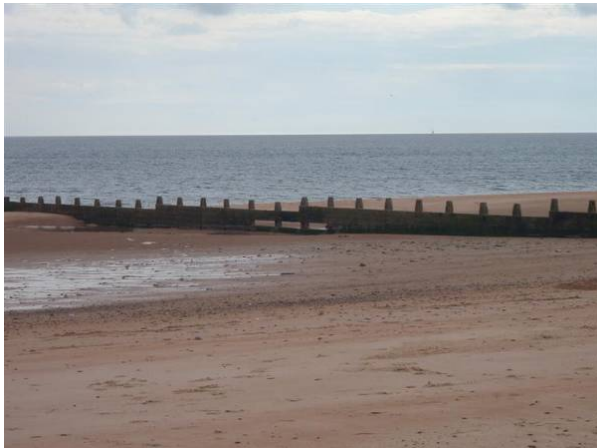
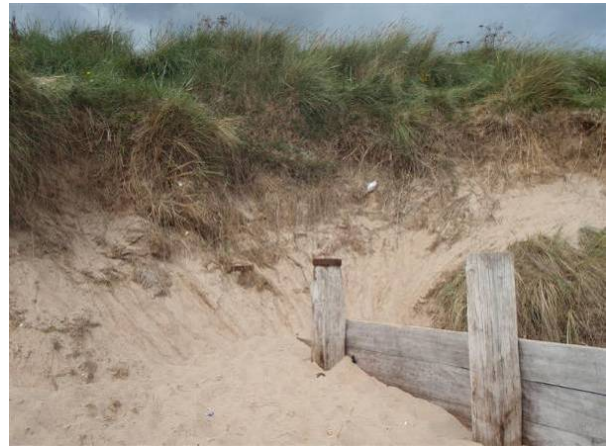
Meggie's Burn had very little water discharge due to the relatively dry summer experienced to date, and remained blocked with sand at the discharge pipe to a notable level. In 2008 the channel that cuts across the foreshore tended in a northerly direction upon leaving the concrete outlet pipe. At that time, this resulted in erosion of dunes to the north. During the 2010 inspections, a far more southerly-orientated channel was observed (below left). As a consequence, the upper foreshore to the north of the burn accumulated sediment and protected the dunes, making them more stable, but those to the south were actively cliffing and eroding. This dune erosion extended a short distance south of the outfall, where some concrete debris was being eroded from the dune face behind an area where concrete anti-tank blocks were being used for protection at the toe (below right).

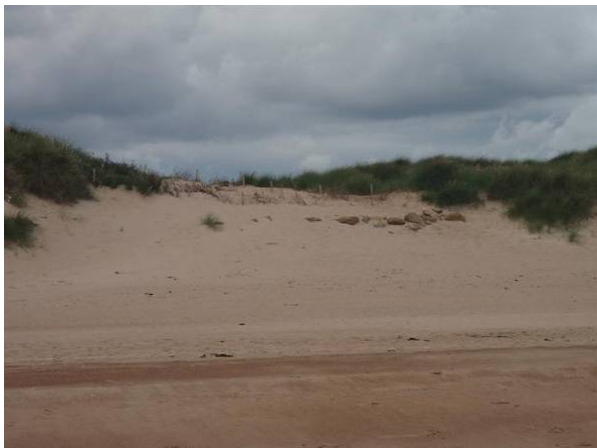
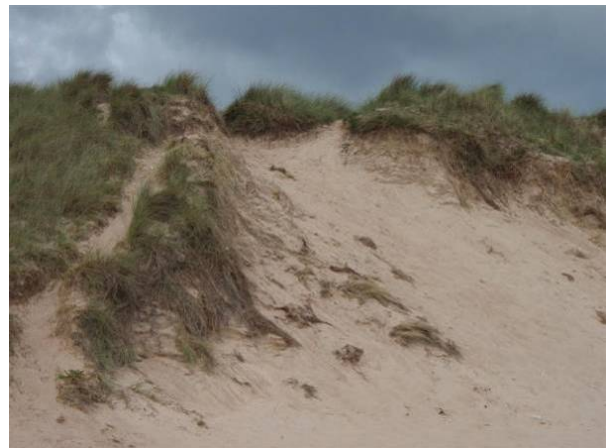
The sand-filled geotextile bags used to stabilise the dune toe on the two most vulnerable sections of the central frontage were not observable due to high foreshore levels at the toe. Christmas trees placed in barren areas to encourage sand trapping and dune build up have been reasonably effective, although there has been no dune vegetation establishment (below left). The southern section of South Beach remains highly stable and there has been notable pioneer vegetation growth on the lower dunes (below right). The low masonry wall towards the southern end of South Beach remains in good condition.

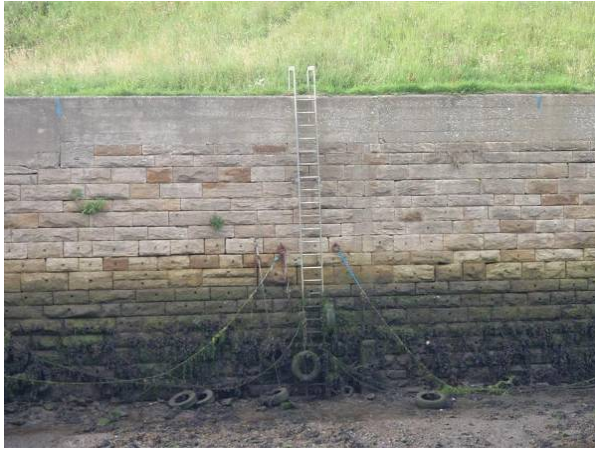
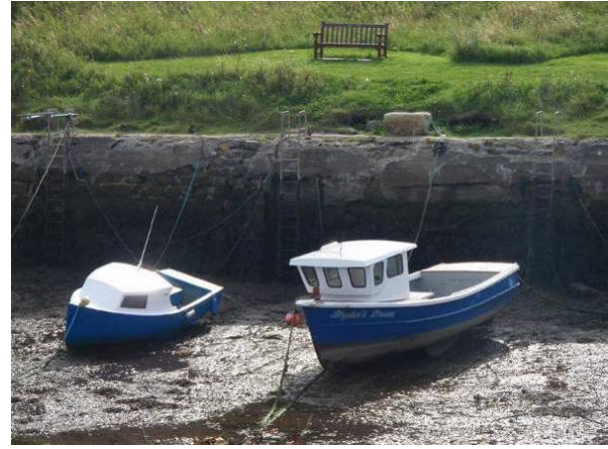
The eastern bank section from the channel, extending along the western side of Rocky Island, is generally in good condition (below left), although with some local areas of settlement, missing mortar and gaps between adjacent blocks which should be repaired through routine maintenance (below right).

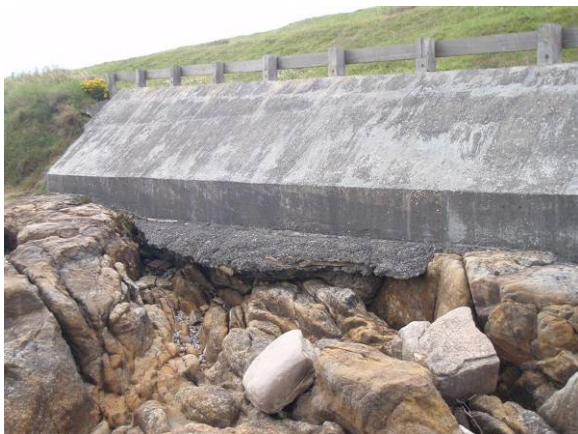
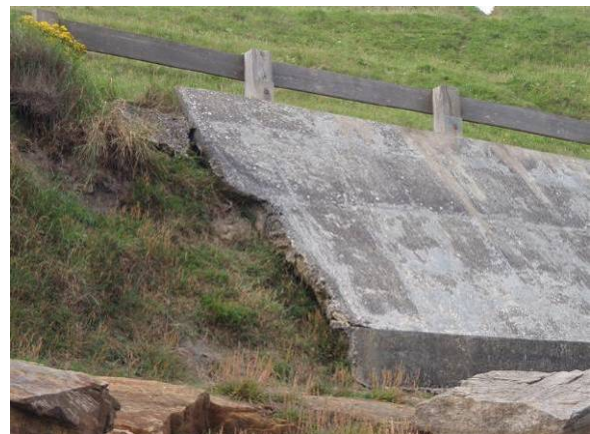
The coastal slope adjacent to the ramp has experienced occasional small-scale slumps but this does not present any concerns at present. The harder rock cliffs extending from Crag Point to the southern boundary of Northumberland County Council part-way along Hartley Cove have some fracturing to the rock structure. As a result of this fracturing, several rock falls have occurred (below left) leaving numerous overhangs. In places caves have formed at the base of the cliffs (below right).
