**Cell 1 Regional Coastal Monitoring Programme:  
Walk-over Visual Inspections of Assets**

**North Tyneside Council  
Final Report**

**December 2012**

## Walkover Inspection Survey

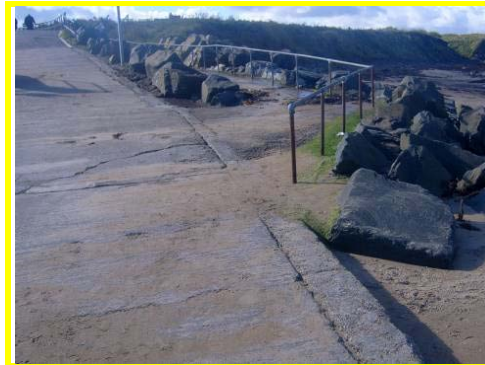
The causeway to St Mary's Island has a number of patch repairs and is generally in a poor condition. There are numerous cracks, voiding, displaced edge-coping and abrasion. The undermining noted in 2010 was still evident in places along the causeway and at the landward ramp although this doesn't seem to have worsened.

*Cracks in the causeway to St Marys Island.*

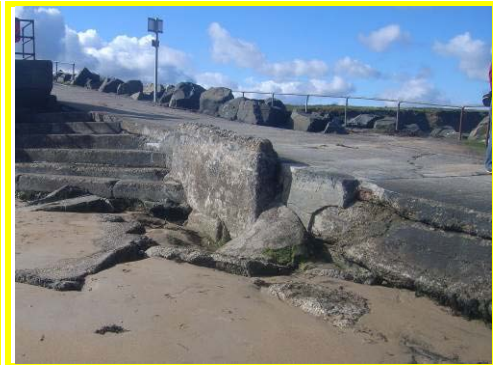
*Some undermining of causeway but not currently cause for concern.*

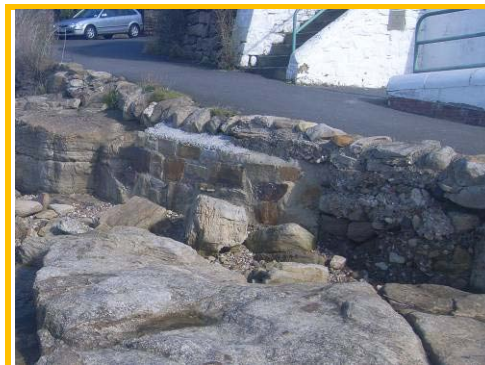
The buildings on St Mary's Island are generally well protected by a variety of defences, although the low masonry wall on the western side fronting the access ramp is still suffers from voiding caused by loss of masonry. The masonry wall on the north facing corner of the island is in good condition with the undermining identified during the 2010 inspection having been filled. There are several abraded concrete outfall structures across the foreshore.

*Missing masonry blocks and voids in low masonry wall at access ramp.*

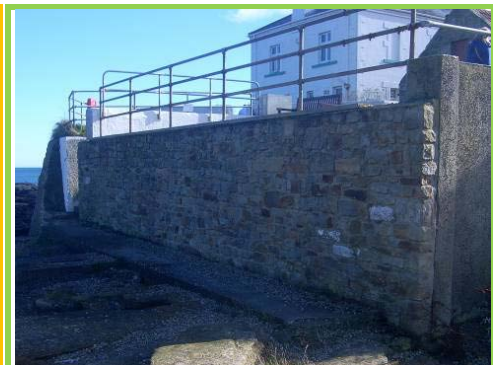
*Void beneath masonry wall on north side of island has been filled.*

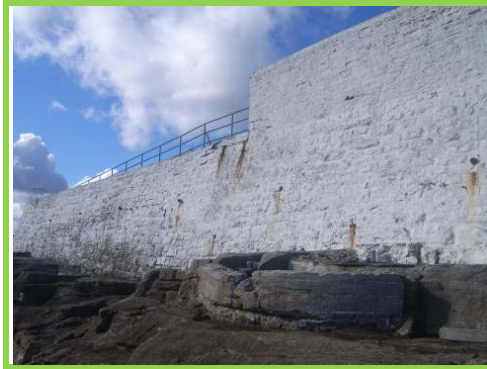
The high masonry walls around the east side of the island are well founded on the rock foreshore and remain in fair/ good condition. Some minor loss of mortar at mid height was observed, possibly coinciding with wave action at high tide.

*Masonry wall on east side of island well founded on rock foreshore.*

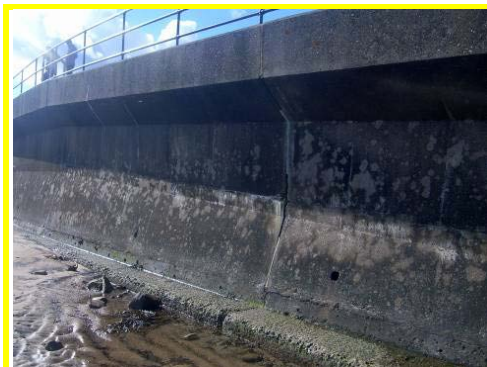
The Trinity Road seawall is generally well founded on the rock foreshore and in good condition with no signs of movement. Beach levels are generally very low with only a thin veneer of sand on the rock foreshore at the north end. Sealant has been replaced at a number of expansion joints. Minor spalling is evident at a number of joints although this does not appear to have worsened since the previous inspection in 2010. The access ladders, promenade surfacing and shallow grassed earth embankment behind the wall are also in good condition. At the south end of the wall erosion of the high earth cliff and outflanking continues with displacement of the rock armour across the foreshore. Although this outflanking does not seem to have worsened since the previous inspection in 2010, stability of the seawall at this location could become an issue and immediate action is still recommended.

*Low beach levels and exposed toe along the Trinity Road seawall.*

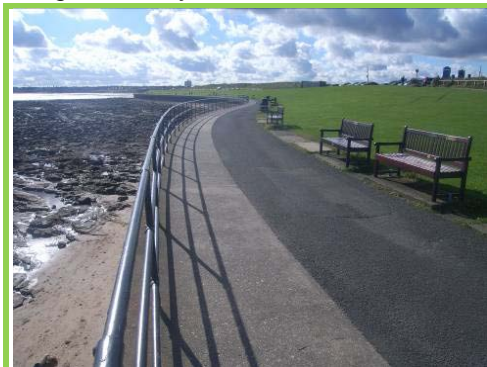
*Promenade and shallow grass embankment in good condition.*

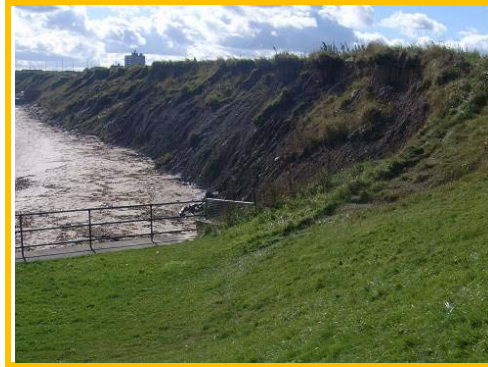
As reported during the previous inspection, the undefended sea cliffs at the northern end of Whitley Sands are actively slumping despite the presence of a relatively high boulder beach and sandy foreshore along their toe. As this erosion continues, the cliffs release material, including boulders, to the foreshore. This process also cuts the cliff top back, through successive slumping failures, closer to the footpath. In

time, this process will start to affect the seaward edge of the Briardene Car Park and the municipal golf course. Some sections of the undefended cliff are prone to imminent slumping since the soft material is extensively cracked.

*Active slumping of soft cliffs at the north end of Whitley Sands.*

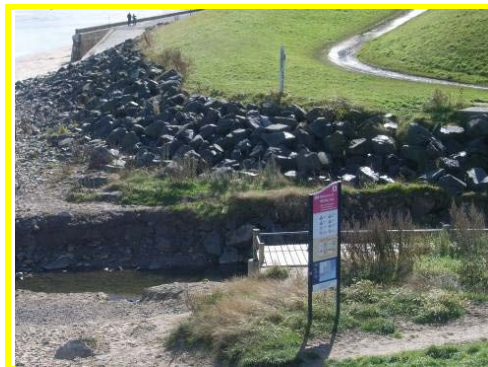
The rock revetment immediately to the south of Briardene Burn remains in fair condition despite evidence of a slight flattening of the profile and minor displacement of rocks at the toe. No noticeable changes were observed since the previous inspection in 2010.

*Revetment immediately south of Briardene Burn in fair condition.*

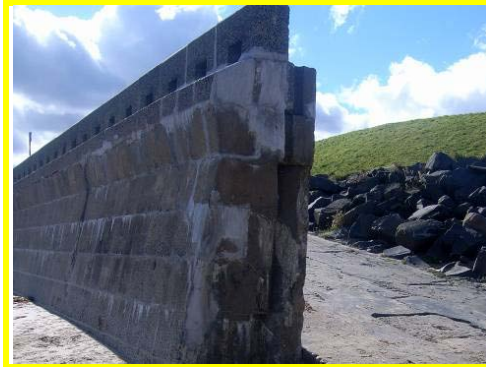
in fill cracks, reseal gaps and repair abrasion damage. Some repairs to defects identified in 2008 and 2010 such as cracks/ abrasion along the coping at the north end and missing blocks along the cope and access steps have now been repaired and are in good condition.

*Repairs to some cracks along in Whitley Links Sea Wall good condition.*

The Whitley Links Sea Wall extends in front of the Northern Promenade and whilst still being in an overall fair condition would benefit from some further maintenance to

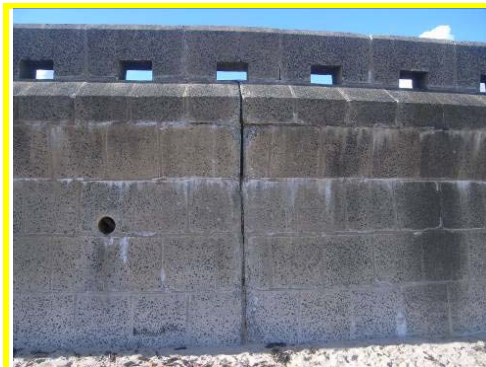
Along other areas of the sea wall areas of cracking, spalling and abrasion still remain. In particular, vertical gaps and abrasion at construction joints and missing mortar beneath the cope. Just south of the Rendezvous Cafe the diagonal crack through the blocks identified in the previous inspection has not worsened although this should continued to be closely monitored. Beach levels along the whole wall generally appear to be slightly higher (by 1 block) than during the previous survey.

*Full height gaps and abrasion in the wall at construction joints.*

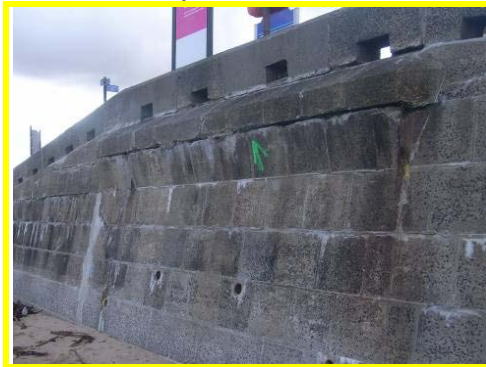
*Gaps beneath the cope along the ramp at the Rendezvous Cafe.*

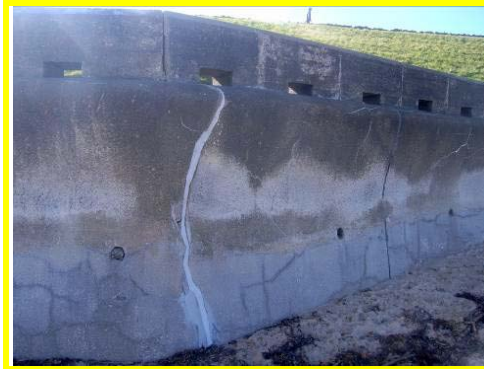
The rendered sections of sea wall along the Panama Gardens frontage is in fair condition with repairs identified during the previous inspection in 2010 still good. In some locations the concrete render is cracked with spalled sections at the south end revealing the reinforcement mesh beneath. The spalling damage along the base of

*Previous repairs to crack in rendered section of seawall remain good.*

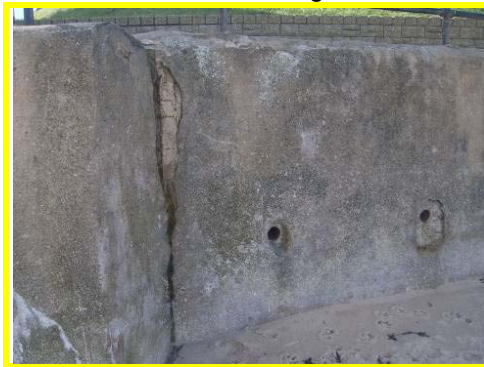
*Spalling of concrete render and exposed rebar at south end of seawall.*

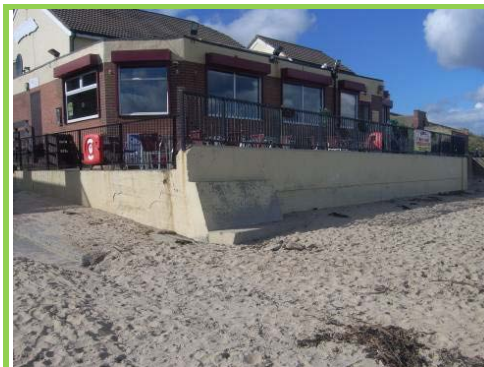
The yellow-painted concrete wall fronting the Boardwalk Cafe at the south end of Whitley Sands is in good condition. The exposed timber piles and undermining identified during the previous survey were not observed due to high beach levels.

*Concrete wall fronting Boardwalk Cafe in good condition.*

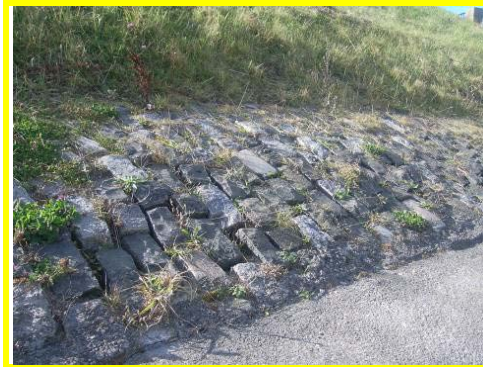
Along the Spanish City frontage is a steep vegetated slope protected by a blockwork revetment and low concrete wall. The repaired area of blockwork 2009/10 remains in good condition although growth of vegetation and gaps were observed at other locations. Some cracks and spalling of concrete was also evident at the steps.

*Vegetation growth and some gaps between blocks along revetment.*

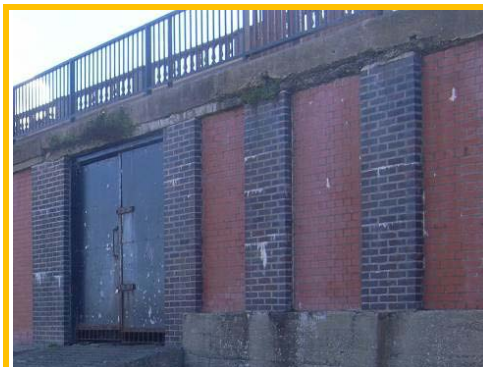
The Central Lower Promenade is protected by various sections of sea wall. Beach levels at the toe of the wall continued to remain relatively high at the time of the inspection, mainly with sands and some cobbles. Although the brickwork appears relatively new and in good condition the visible sections of concrete have extensive abrasion damage, especially along the toe and the coping and at the access steps. The two short lower access ramps remain extensively abraded and cracked on both sides and at risk of becoming voided and collapsing. The concrete surfacing to the main full high access ramp is also cracked in places.

*Abrasion along the concrete cope of the Central Lower Promenade seawall.*

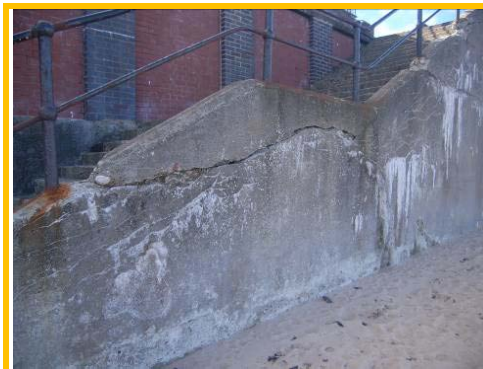
*Cracks and abrasion at the access steps of the seawall.*

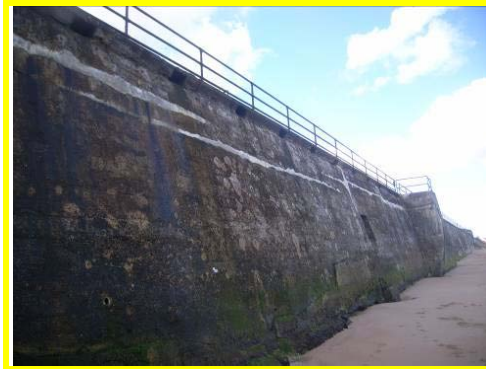
The final section of straight concrete seawall at the south end of Whitley Sands is generally in fair condition with no signs of movement or undermining. The large horizontal cracks below the crest identified during the previous survey have been filled. However, there is continued loss of the concrete render along much of the face of the wall, exposing the reinforcement mesh which has corroded and been lost in many places. The hand railing at the access steps is in very poor condition and continues to deteriorate with the lowest post and hand railing now missing.

*Recent repairs to horizontal cracks along upper section of sea wall at south end of Whitley Sands.*

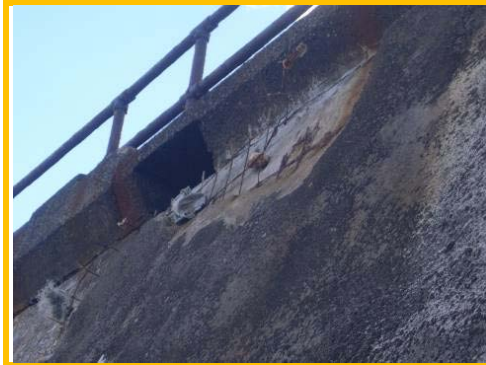
*Continued loss of concrete encasement and corrosion of reinforcement mesh.*

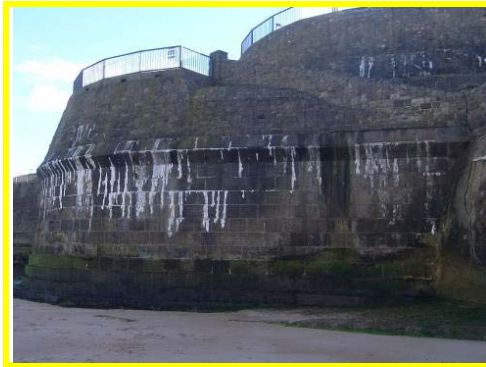
The high curved masonry blockwork sea wall adjacent to South Parade road is in fair/ good condition although there is evidence of heavy staining to the face. No gaps or cracks were observed in the upper masonry brickwork section. The hand railing along the top of the wall appears in good condition.

*Masonry blockwork and upper masonry brickwork in fair condition.*

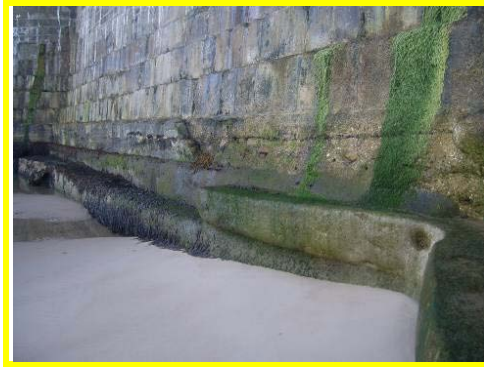
The straight section of high masonry seawall to the south is also in fair condition with no signs of movement or undermining. However, there is noticeable abrasion at the toe and a noticeable horizontal gap in the upper brickwork below the crest. The hand railing along the top of the wall appears in good condition.

*Abrasion at the toe of the straight section of seawall*

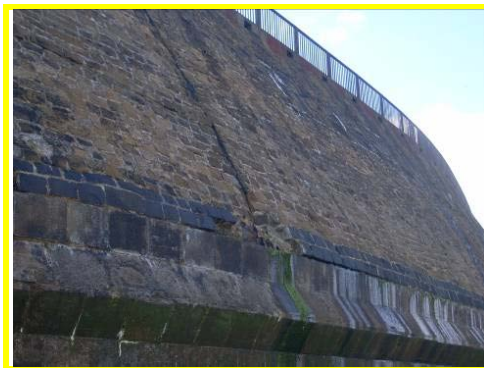
To the south, the curved masonry blockwork wall and upper sloping brickwork is generally in fair condition with no gaps observed in the lower concrete blocks. There are two sections of missing brickwork at the south end of the upper wall although this does not appear to have significantly worsened since the previous inspection in 2010.

*Section of missing brickwork at centre of upper sloping masonry wall.*

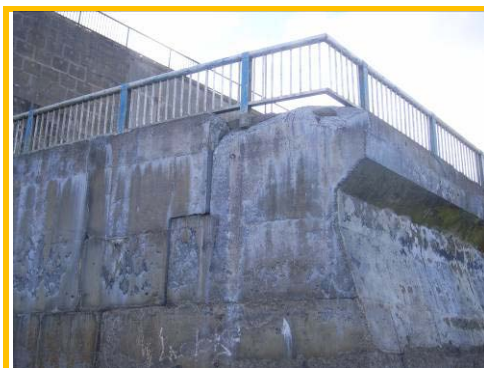
The short section of concrete seawall with intermediate terrace is in overall fair condition. However, there are three sections where concrete is missing from the crest at construction joints, as identified in 2010. The most southerly of these has exposed the base of the hand railing which could affect its stability causing a public safety hazard. Sealant is also missing from most construction joints. The lower access steps to the beach remains highly abraded with no hand railing along the lower section. These steps cause a public safety hazard and should be closed. At the south end there is also voiding and undermining of the toe apron slab which should be monitored.

*Missing section concrete along the crest has undermined one hand railing post.*

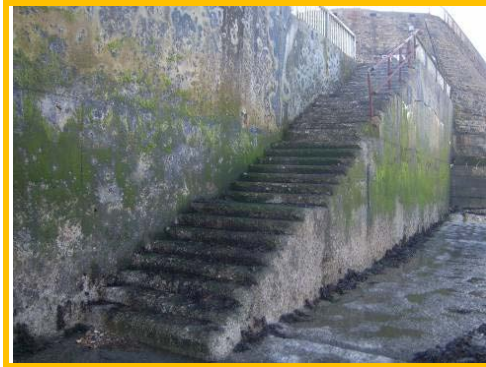
*Highly abraded access steps and missing hand railing.*

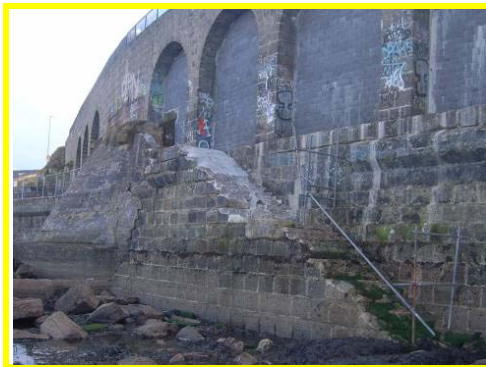
The high masonry blockwork wall with masonry arched upper section supporting the Promenade Road is in fair condition although there is noticeable abrasion along the toe at the north end. Since the previous inspection in 2010 the archways have been enclosed with concrete blocks and at the time of the survey the void behind was being filled with concrete (by Lumsden & Carroll Civil Engineering). The access steps remain in a delapidated condition and are closed. The undermining of the rock 'bull nose' identified during the previous inspection continues although this does not appear to have an effect on the stability of the wall. Some loss of mortar between the upper blocks was noted. The hand railing along the top of the wall is in good condition.

*Dilapidated access steps are close and now redundant due to blocking up of arches.*

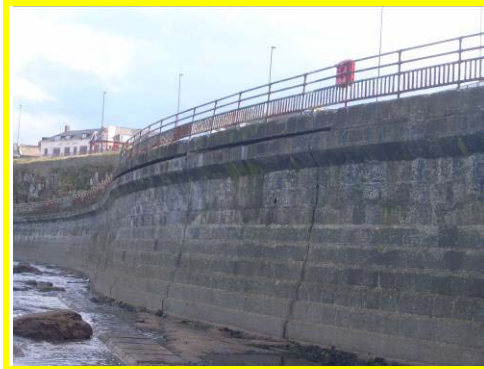
To the south, the lower masonry blockwork wall fronts the Southern Lower Promenade. This wall is generally in fair condition although there is missing mortar and gaps beneath long sections of the coping. There is also a wide gap between the coping block and the surfacing along much of the wall, in particular at the south end. Large sections of surfacing have been repaired with concrete which appear in good condition although other sections of asphalt surfacing and kerbing along the centre section remain damaged. The hand railing along the whole wall is very corroded with one rail section missing along the centre section. The beach access steps are heavily abraded but now redundant since they have been closed off. The inspection was undertaken at low water however the toe along the southern section remained below water and was therefore not observed.

*Missing mortar and gaps beneath coping at Southern Lower Promenade.*

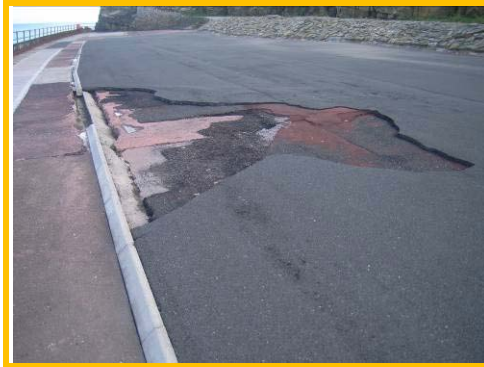
*Damage to asphalt surfacing and missing kerbing at south end.*

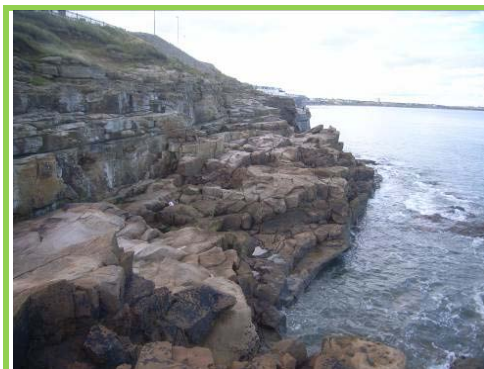
The north end of Brown's Bay is marked by rock cliffs. The condition of these cliffs does not appear to have changed since the inspection in 2008 due to the protection afforded by the extensive rock platform of Table Rocks.

*No change to rock cliffs at north headland of Browns Bay.*

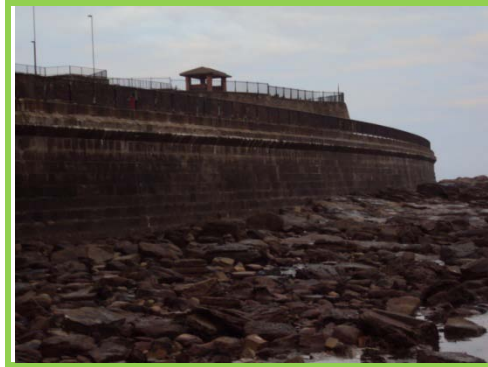
Brown's Bay has two separate sections of seawall. In the northern part of the bay, the wall is generally in good condition, although the cracks, joint gaps and abrasion around joint gaps increase in frequency to the south. The ramp to the beach area is locally in poor condition and repairs are required. The southern wall is generally in fair condition with localised undermining still evident to toe.

*Northern wall at Browns Bay generally in good condition.*

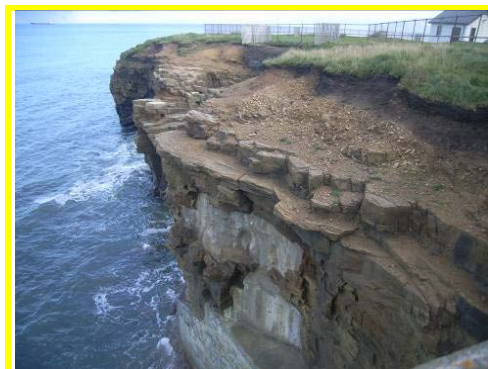
The Cliffs at Brown's Point initially are comprised of hard rock with small capping of softer till. As reported during the previous inspection the hard rock continues to show signs of fracture with evidence of several local rock falls on the foreshore and some cave formations at the base of the cliffs. South of Brown's Point the hard rock dips, leaving a greater thickness of capping softer material. No significant change since the previous survey was observed with three historic rock falls having led to slippages in the overlying till, including one area where the cliff top has cut back to within a few metres of the boundary fence.

*Rock falls and slippages in the overlying till at Brown's Point.*

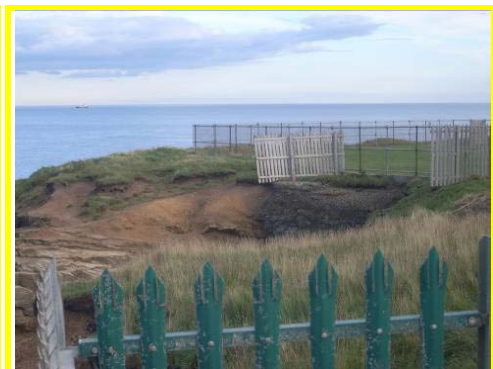
*Cliff top recession to within a few meters of the boundary fence.*

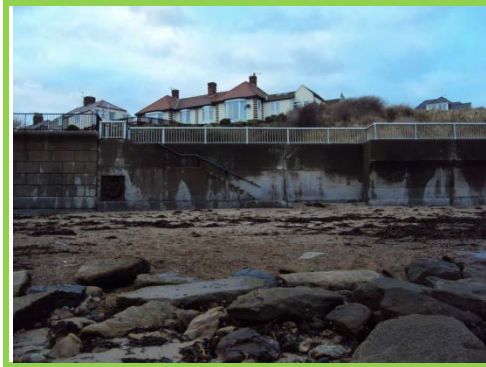
*Concrete recurve wall and steps, steps have signs of abrasion.*

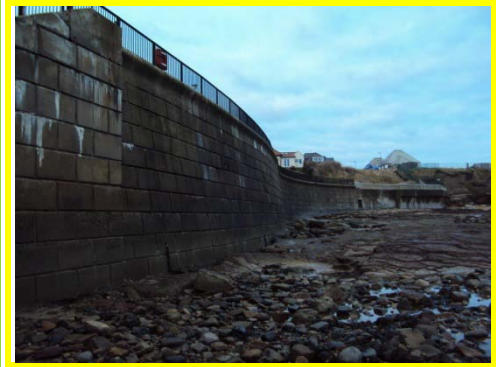
*Concrete blockwork wall with local undermining to the toe.*

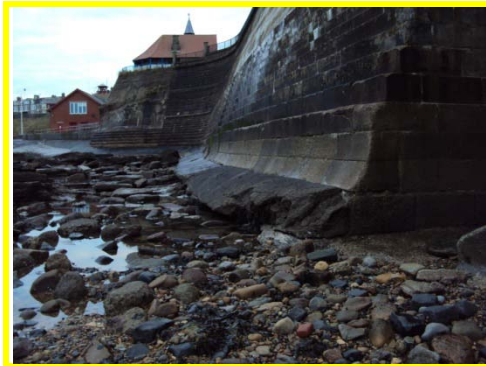
As previously reported in 2010 the final section, extending to the North Pier, is also experiencing undermining of the concrete apron, requiring remedial works (below left and right).

*Undermined concrete apron requiring repair.*

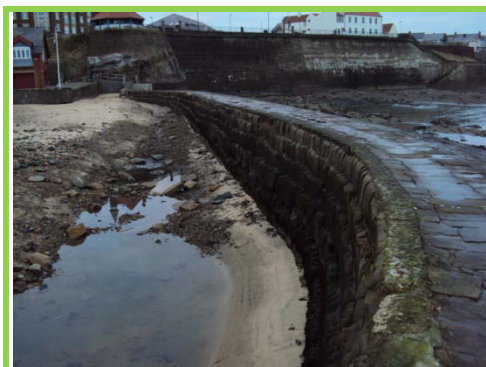
*Leeward face of north pier, masonry in fair condition.*

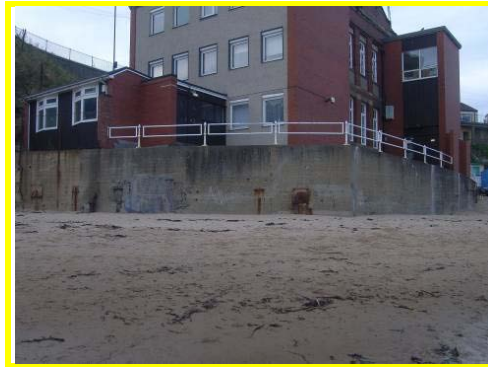
The concrete wall fronting the Dove Maritime Laboratory is in fair condition with no signs of movement or undermining. The minor vertical cracks identified during the previous inspection have now been filled and are in good condition.

*The concrete wall fronting the Dove Maritime Laboratory is in fair condition.*

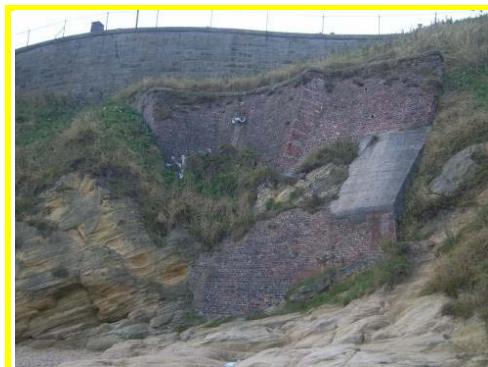
The brickwork retaining wall to the south of the Dove Maritime Laboratory is in fair condition although there is missing mortar between some blocks at each end of the wall.

*Masonry retaining wall at north side of Cullercoats Bay in fair condition.*

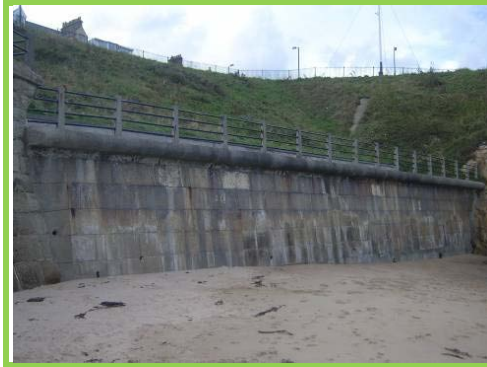
*High beach levels along the seawall on the south side of Cullercoats Bay.*

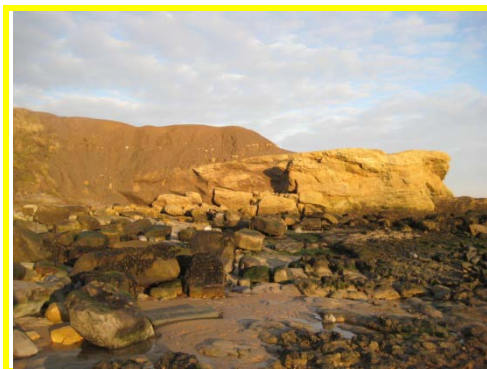
The cliffs around Tynemouth North Point have arches and caves at their base in the lower rock sections, the upper softer section of cliff shows evidence of movement (below left). At the southern end of the cliff there is evidence of recent slippage and movement (below right).

*Headland cliffs at Tynemouth North Point with slumping to upper cliffs.*

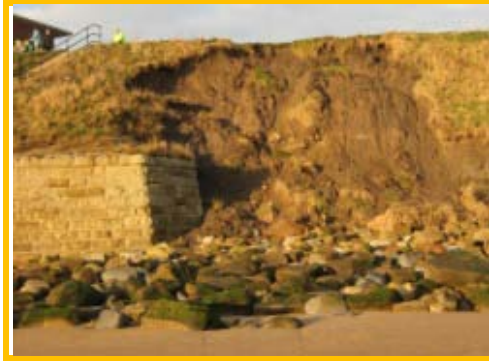
*Slumping of cliffs adjacent to the masonry wall at Tynemouth Longsands.*

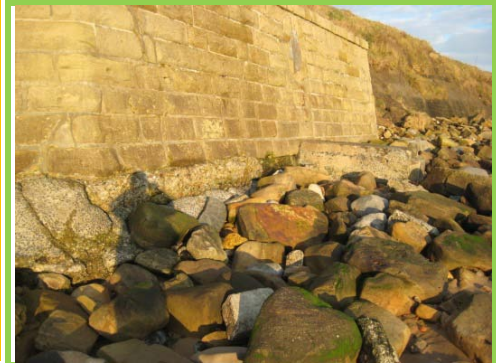
*Concrete toe apron in need of repair.*

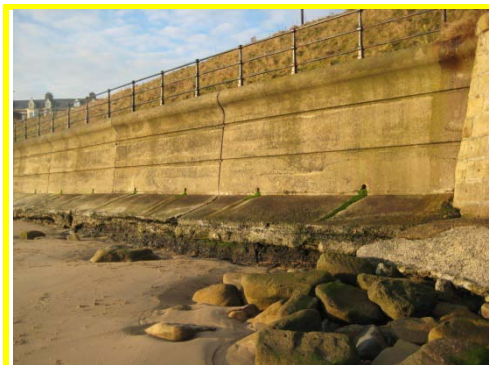
The sea wall protecting the promenade and vegetated coastal slope remains in fair condition despite some abrasion of the concrete apron toe along the northern half of the wall, at times of low beach levels this is exposing underlying Coal Measures (below left). Along the neighbouring sloping blockwork revetment, there is some damage to the crest of the splash wall, although the structure overall remains in fair condition (below right).

*Erosion undermining the concrete toe apron.*

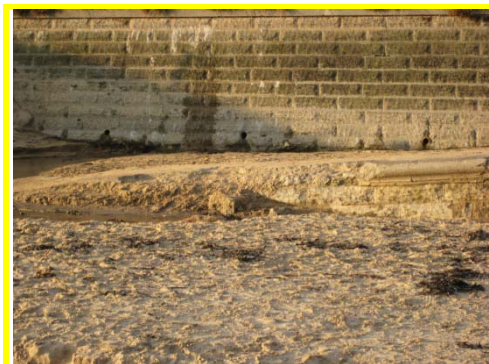
There is extensive spalling to the crest of the concrete access ramp to the beach that needs repair (below left). To the rear of the access ramp the concrete block work wall to the vegetated slope is in good condition (below right).

*Spalling to concrete access ramp.*

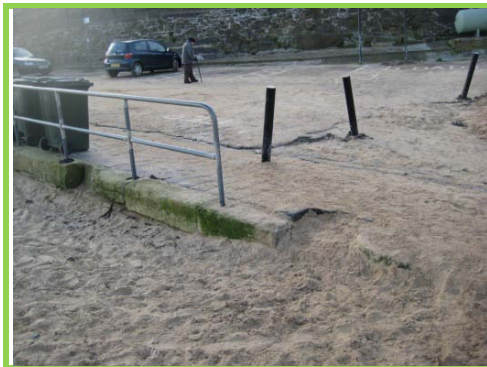
As reported in the previous surveys the access ramp at the foot of the Spa Car Park has coping stones still missing and some blocks from the ramp deck are washed out (below left). The concrete access steps south of the newer concrete platform remains cracked, with some concrete breaking away (below right).

*Missing coping and blocks to access ramp.*

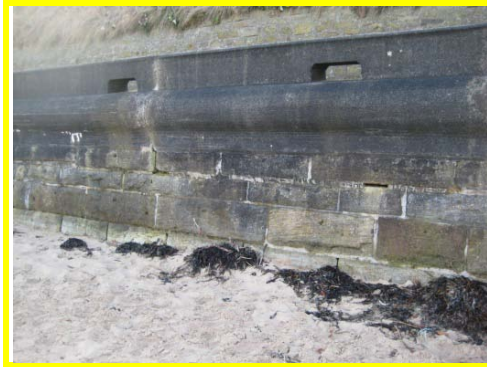
The wall extending to the Tynemouth Pool is generally in fair condition, although there are many gaps between the blocks and localised cracks which should be repaired (below left). On this section the access steps to the beach are missing sections of handrailing (below right).

*Missing mortar between joints.*

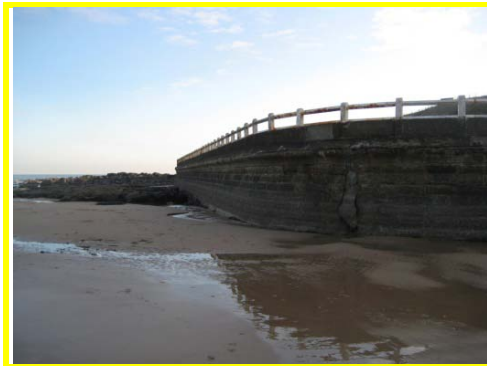
Around Tynemouth Pool, the wall on the northern-facing side has cracks and some previous patched repairs are now coming away (below left). The eastern and southern facing walls are in fair condition with abrasion and cracks at the join between the masonry wall and the concrete wave return wall (below right).

*Damaged repair with concrete infill coming away.*

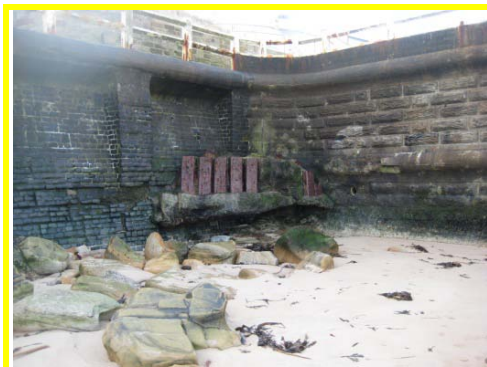
As previously reported in 2010 the short section of wall at the southern landward tie-in has its concrete apron cantilevered off the foreshore (below), although the wall behind appears sound.

*Wall at southern landward tie-in of Tyne Pool with apron undermined.*

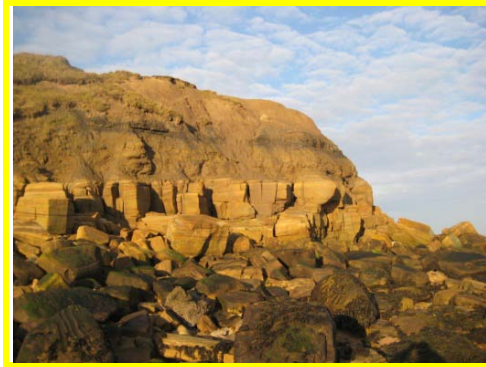
The cliffs around Sharpness Point remain highly fractured and have experienced several rockfalls and there is evidence of recent movement and slippage in upper soft cliffs too (below left). The access steps are heavily abraded (below right)

*Evidence of rockfall to foreshore at Sharpness Point.*

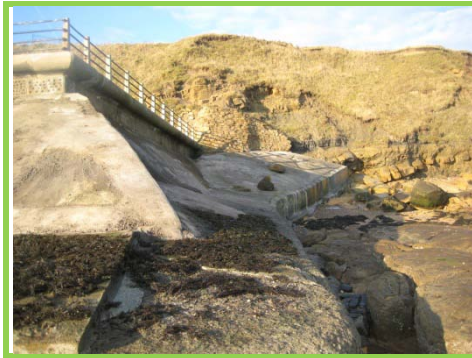
*Recently repaired concrete apron at Lower Promenade seawall.*

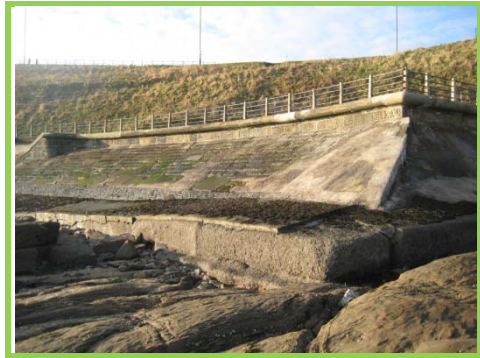
*General view of northern end of wall.*

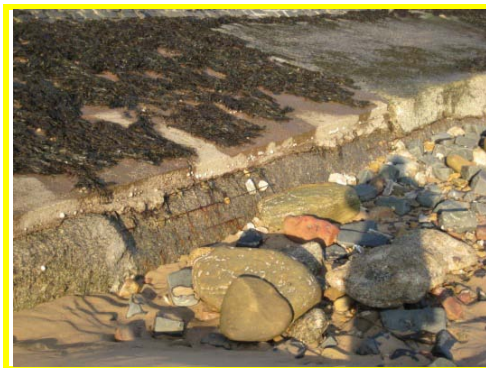
Along the sea wall to King Edwards Bay there are still considerable areas of abrasion at the toe in places exposing the reinforcement bars (below left) and on the sloping revetment face (below right).

*Abrasion at toe with exposed reinforcement*

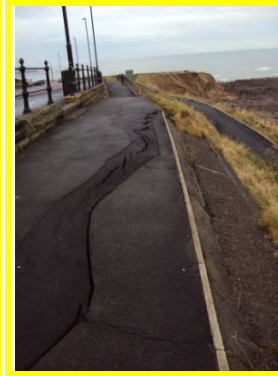
As previously reported, although the backing slope appears stable there is evidence in the pathways of cracking of the asphalt which may be indicative of some slope movement (below). There is evidence of recent superficial patch repairs which have proved unsuccessful.

*Movement at repaired cracks.*

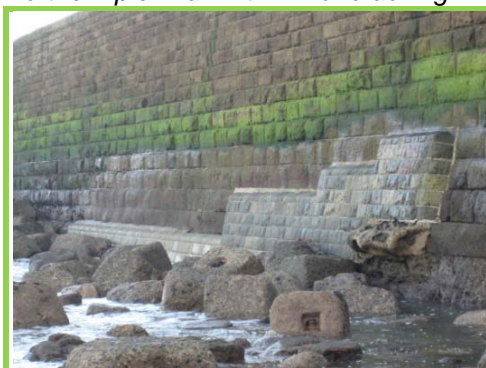
*Northern pier patch repairs*

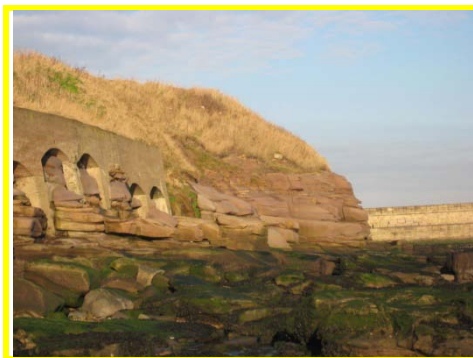
The rock headland Freestone Point is highly fractured but in fair condition (below left) as is the arched retaining wall (below right).

*Rock headland at Freestone Point*

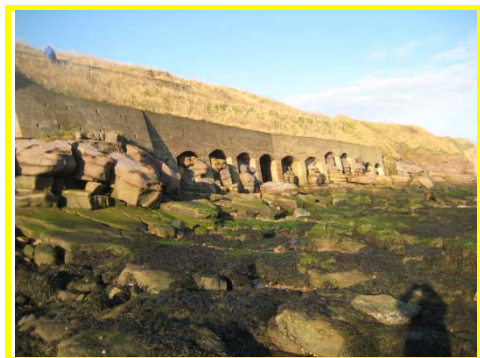
*Arched retaining wall at Freestone Point*

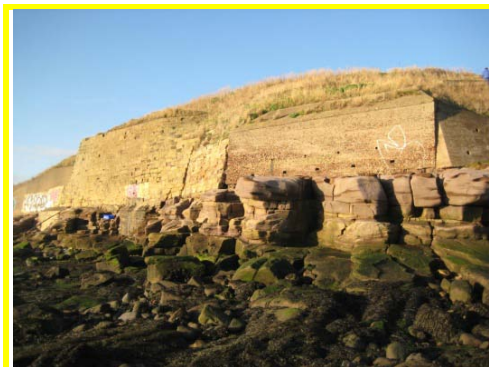
The adjacent masonry wall (below left) has blocks missing and there are signs of cracking and missing mortar in joints (below right).

*Masonry wall in fair condition*

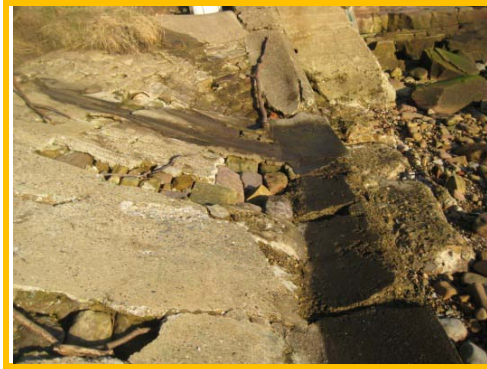
The masonry wall with a sloping concrete revetment at Sandy Goit remains in poor condition. Both the wall and revetment are failing, with extensive cracking in concrete revetment resulting in voids (below left). The low earth slope is also eroding in places (below right).

*Failing revetment at Sandy Goit*

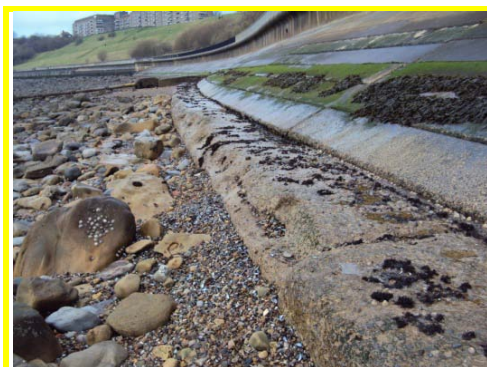
The concrete recurved wall with promenade and slope to the Knotts Flats behind runs for approximately 500m with a concrete panel sloping revetment with a concrete toe wall with evidence of abrasion (below left) . This wall is generally in a good condition although the revetment is assessed as fair, there are gaps between revetment panels and occasional cracking throughout (below right).

*Abrasion to concrete toe of seawall at Knotts Flats.*

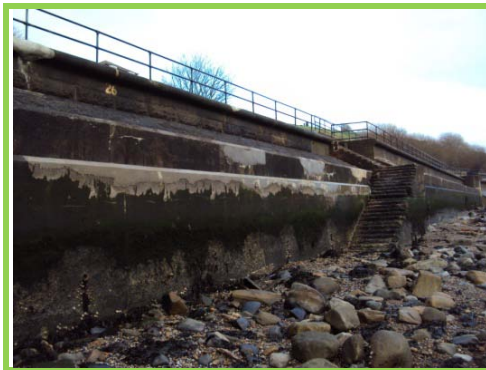
*Heavily abraded access steps with patch repairs evident in foreground*

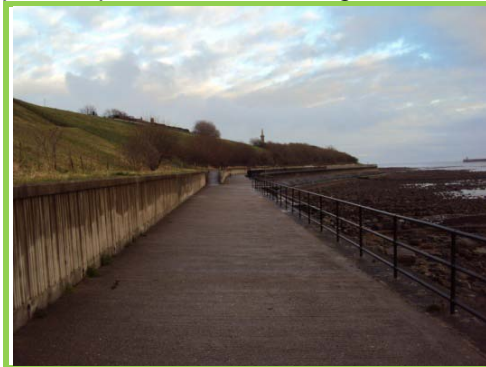
*Concrete decking with occasional minor cosmetic cracks*

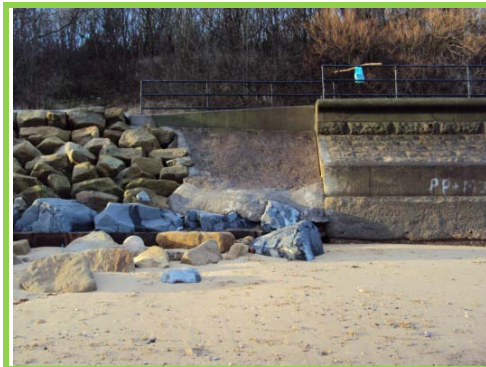
The rock revetment to the Fish Quay was in good condition with evidence of remedial works since the 2010 survey including patching works and replacement rock armour (below left) . The short section of pitched stone revetment extending to the jetty downstream of the Fish Quay was also in generally sound condition (below right).

*Remedial works at eastern end of revetment at Fish Quay in good condition.*
