**Cell 1 Regional Coastal Monitoring Programme:  
Walk-over Visual Inspections of Assets**

**North Tyneside Council  
Final Report**

**August 2014**

## Walkover Inspection Survey

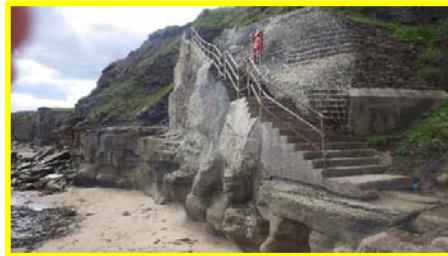
The northern boundary of North Tyneside's Coastline is part way along Hartley Cove. The local slump in soft material immediately adjacent to foreshore access steps previously reported in 2009 and 2012 does not appear to have worsened. The access steps are in fair condition with no significant signs of damage. Repairs to grouting between blocks and upper masonry remain good and the hand railings are in good condition.

Old Hartley Steps retaining wall and hand rail in fair condition (/4401c23).

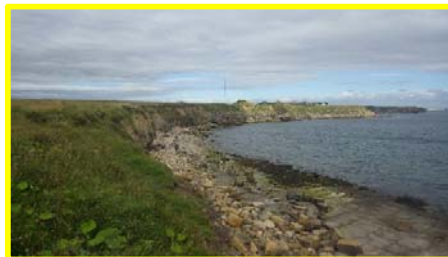
The undefended cliffs between Hartley Cove and Curry's Point have been subject to historic rock falls and slippages in the overlying softer material. There is evidence of recent rock falls and slippage between the steps and causeway to St. Mary's Island.

This cliff top recession continues to narrow the footpath in sections necessitating the need to move the footpath inland. At Curry's Point erosion of the soft earth slopes continues initiating outflanking of the north end of the rock revetment, which is in good condition, and cutting back to the access road to St. Mary's Island.

Evidence of minor rock falls and slips between Hartley Cove and Curry's Point (/4401c24).

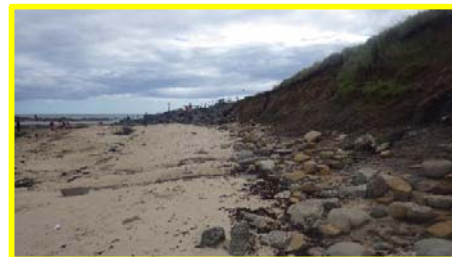
Evidence of slip adjacent to rock armour defences north of St. Mary's Lighthouse (/4401c24)

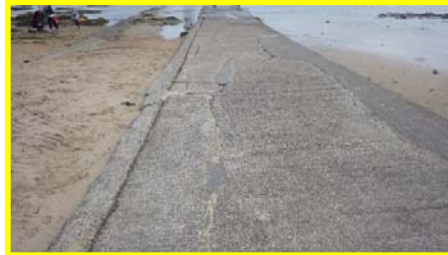
The causeway to St. Mary's Island has a number of patch repairs and is generally in a fair condition. There are numerous cracks and voiding, displaced edge coping and abrasion. The undermining noted in 2012 was still evident in places along the causeway and the landward ramp, although this does not seem to have worsened. Sand levels were good and a new concrete turning head has been constructed at the end of the causeway.

Cracks in causeway to St. Mary's Island (/4401c25).

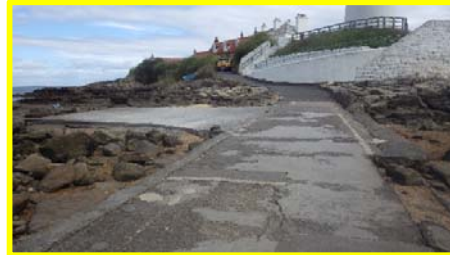
Cracks and patch repairs in causeway to St. Mary's Island and new concrete turning head (4401c25)

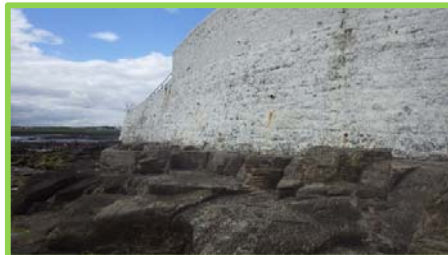
The high masonry walls around east side of the island are well founded on the rock foreshore and remain in good overall condition. There is some minor loss of mortar at mid-high point. Both flights of steps experience abrasion and concrete damage. There is evidence of under mining. Ongoing remedial works to low stone walls are being carried out.

Walls on west of St Marys Island well founded and in good condition (/4501c03).

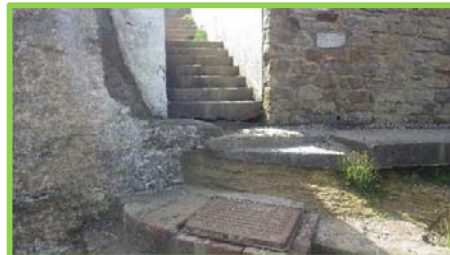
Minor erosion of concrete and undermining of steps on island (/4501c03).

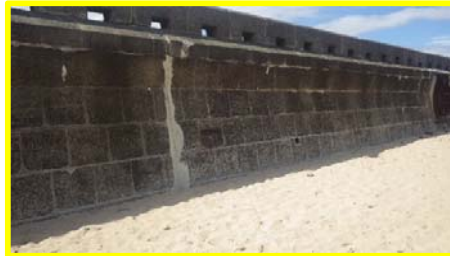
The Whitley Links sea wall extends in front of the Northern Promenade and whilst still being in an overall fair condition would benefit from some further maintenance to fill cracks, reseal gaps and repair abrasion damage. Some repairs to defects identified in previous inspections, such as cracks/abrasion along coping at the north end and missing blocks along the cope and access steps have been repaired and are in good condition. Along other areas of the sea wall evidence of cracking, spalling and abrasion still remain. In particular vertical gaps and abrasion at construction joints and missing mortar beneath the cope. Just south of the Rendezvous Cafe the diagonal crack through the blocks identified in previous inspections has not worsened, although this should continue to be monitored. Beach levels were similar to previous survey.

Some construction joints filled, others require attention, coping stones have missing mortar (/4501c07).

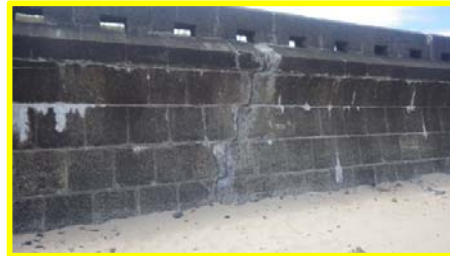
Diagonal cracking through blocks south side of Rendezvous café (/4501c07).

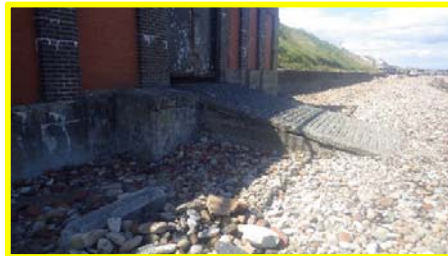
The Central lower promenade is protected by various sections of sea wall. The beach levels at the toe end of the wall continued to remain relatively high at the time of inspection, mainly sand, shingle and cobbles. Although the brickwork appears relatively new and in good condition the visible sections of concrete have extensive abrasion damage, especially along the toe and the coping. The two short lower access ramps remain extensively abraded and cracked on both sides and at risk of becoming voided and collapsing. The concrete surfacing to the main full height access ramp is also cracking in places.

Cracks and gaps beneath lower ramps (/4601c02).

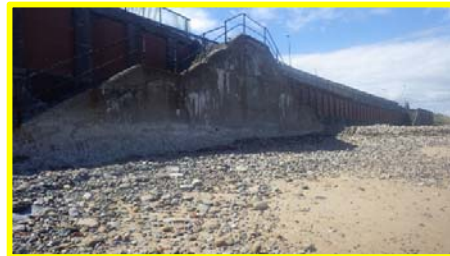
Abrasion and cracking to access steps (/4601c02).

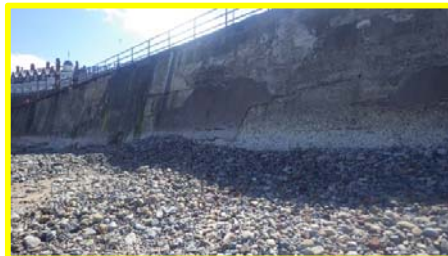
The final section of straight concrete sea wall at the south end of Whitley Sands is generally in fair condition with no signs of movement or undermining. There is continued loss of the concrete render along much of the face of the wall exposing the reinforcement mesh which has corroded and been lost in many places. The hand railing at the access steps are in very poor condition and continue to deteriorate.

Severe spalling and cracking along straight section of wall (/4601c03).

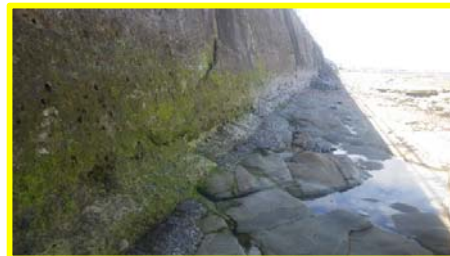
Severe spalling and cracking of rendering (/4601c03).

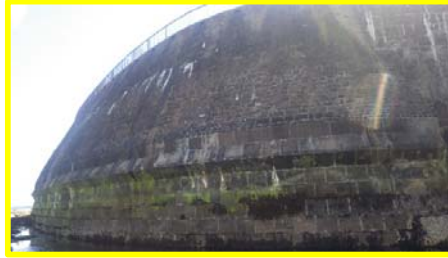
The high curved masonry blockwork sea wall adjacent to South Parade Road is in fair/good condition, although there is evidence of heavy staining to the face. No gaps or cracks were observed in the upper masonry brickwork section. The railing along the top of the wall appears in good condition.

Heavy staining in places, evidence of erosion at the base and horizontal gap in upper brickwork (/4601c04).

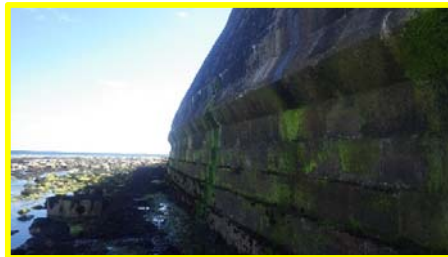
To the south, the curved masonry blockwork wall and upper sloping brickwork is generally in fair condition with no gaps observed in the lower concrete blocks. There are two sections of missing brickwork at the south of the upper wall, although these do not appear to have significantly worsened since inspection in 2012.

Wall in fair condition, minor repairs to joints required (/4601c06).

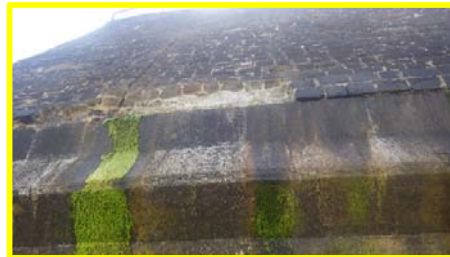
Sections of brickwork missing at south end of upper sloping masonry wall (/4601c06).

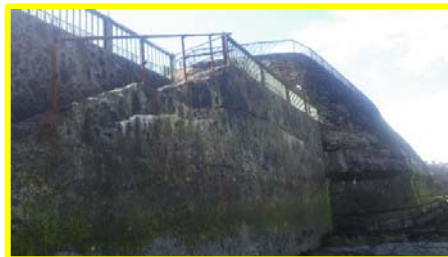
The short section of concrete sea wall with intermediate terrace is in overall fair condition. However, there are three sections where concrete is missing from the crest at construction joints as identified in 2010 and 2012. The most southerly of these has exposed the base of the hand railing which could affect its stability causing a public safety hazard. Sealant is also missing from most construction joints. The lower access steps to the beach remains highly abraded with no hand railing along lower section. These steps are in a dangerous condition and have been closed at the south end. There is also voiding and undermining of the toe apron slab which should be monitored.

Steps in very poor condition, horizontal and vertical cracks (/4601c07)

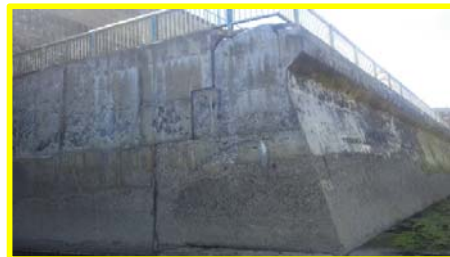
Missing section of concrete, undermining railing post, vertical and horizontal cracking (/4601c07).

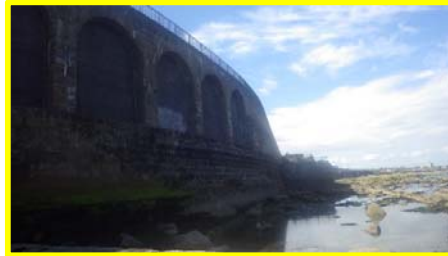
The high masonry blockwork wall with masonry arched upper section supporting Promenade Road is in fair condition although there is noticeable abrasion along the toe at the north end. The archways are enclosed with concrete blocks. The access steps remain in a dilapidated condition and are closed. The undermining of the rock 'bull nose' identified during the previous inspections continues although this does not appear to affect the stability of the wall. Some loss of mortar between the upper blocks was noted at the inspection in 2012 and it is still in the same condition. The hand railing along the top of the wall is in good condition.

Missing mortar and gaps beneath long sections of copings (/4601c08).

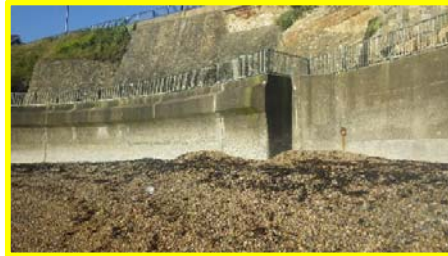
The southern wall is generally in fair condition with localised undermining still evident to the toe. The hand railing along the top of the wall is in good condition. There is evidence of cracking and abrasion of the concrete steps leading from the promenade to road level. The rear wall between the Promenade and road is generally in a fair/good condition it has been well maintained with rock bolts and wire meshing. There is cracking to the access ramp and damage to hand railing.

Railings poor and abrasion to lower section of concrete wall (/4701c01).

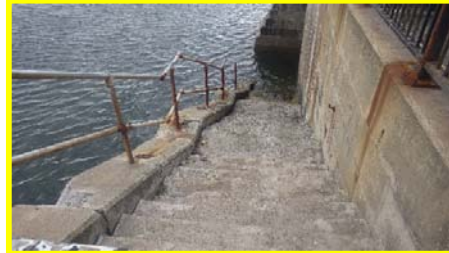
Damage to base of steps and handrailing (/4701c06).

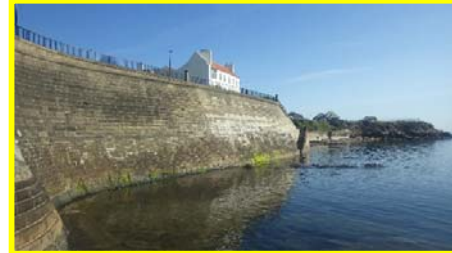
Minor joint repairs required. Some undermining of the concrete apron, (/4701c06).

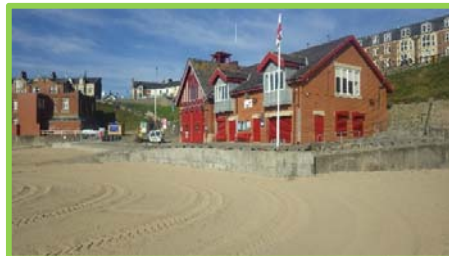
At the north end of Cullercoats Bay the low concrete wall fronting the lifeguard station and concrete works north of the station are in a very good condition with the provision of new steps and hand railing. The masonry wall at the back of the wide stepped concrete apron is in fair condition with no obvious cracks or gaps. The beach access road is in good condition. Beach levels were relatively high, similar to previous inspection in 2012.

Concrete protection to Lifeboat Station in good condition (/4701c08).

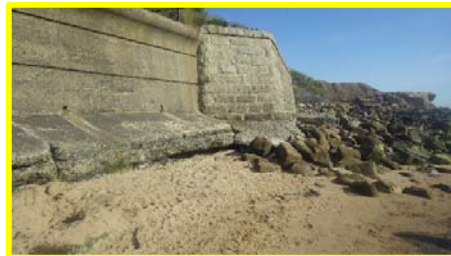
The masonry wall at the north of Tynemouth Longsands is in good condition. As identified in previous inspections there have been cracks in the masonry wall, although the concrete toe apron is broken away at certain locations. Of more concern is the slumping of the soft cliffs to the north of the masonry. However it shows no major change since last inspection.

Erosion undermining the concrete toe apron, no change since 2012 (/4701c17).

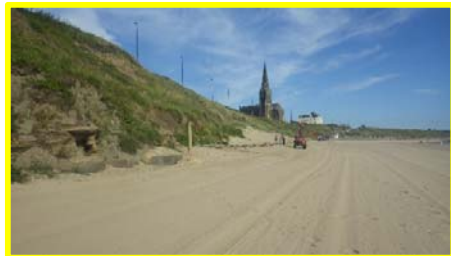
The undefended dunes along the Long Sands have experienced notable erosion during recent years. Although generally well vegetated and in good condition the winter storms appear to have moved the base of the dunes back by around 3 metres in places. A programme of fencing and planting continues to be carried out to restore the dunes. It is clear that a management strategy is in place with the construction of a new boardwalk and improved signage to manage the dunes and pedestrian movements.

Erosion of Longsands dunes, remedial fencing and replanting underway (/4701c21).

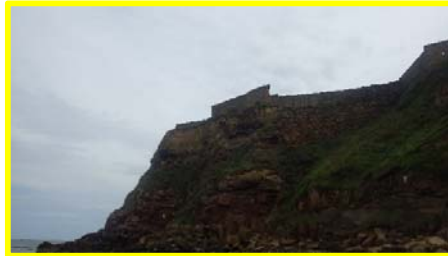
The cliffs at Tynemouth Headland have a highly fractured rock structure and there are several areas with rock falls on the foreshore in places. This has left overhangs in the

cliff face with boundary walls of Tynemouth Priory close to the cliff edge. There are recent signs of further slippage on the vegetated cliff slopes to the bay.

Evidence of slippage down from Tynemouth Castle (/4701c30).

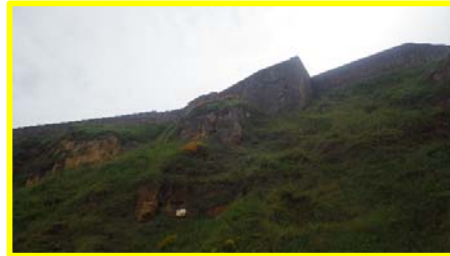
Evidence of slippage down from Tynemouth Castle (/4701c30).

The high arched retaining walls extending along a short length close to the northern side of the landward end of the North Pier remain in a fair condition. Some signs of slippage of upper vegetated cliff was evident. The short section of cliff north of the pier remains in fair condition.

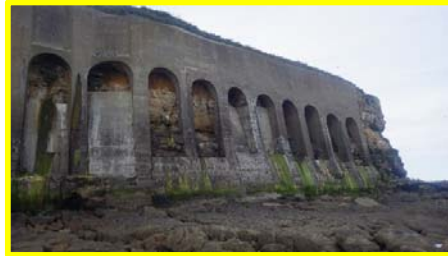
Rock cliffs and concrete arches, north of Pier (/4701c31).

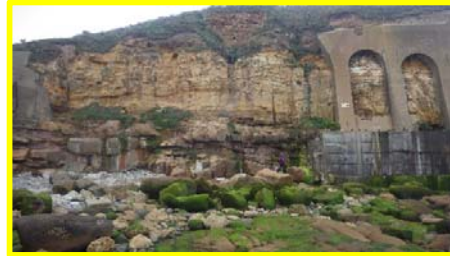
Rock cliffs and concrete arches, north of Pier (/4701c31).

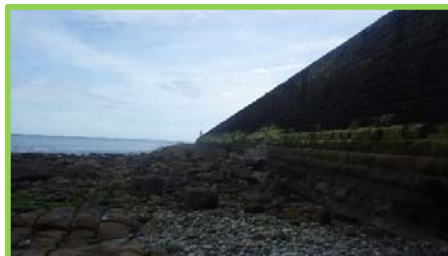
The North Pier appears well maintained, despite the apparent cosmetic defects on its deck. As previously reported there are clearly areas on the outer face where maintenance has been undertaken. No access was possible along the structure. It is assumed that the Port of Tyne undertakes its own vessel-based inspections of the structure and plans maintenance work accordingly.

Tynemouth Pier, north side (/4801c01).

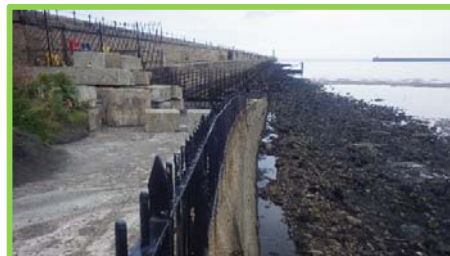
Tynemouth Pier, south side (/4801c01).

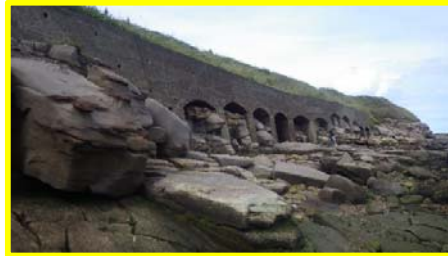
The adjacent masonry and concrete arched seawall has bricks missing and there are signs of cracking and missing mortar in joints.

Arched retaining wall at Freestone Point (/4801c04).

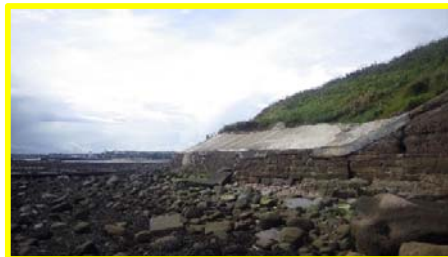
The masonry wall with a sloping concrete revetment at Sandy Goit has been subject to repair works since the last inspection but there still voids in the joints in places which require attention.

Concrete repairs to revetment (/4801c05).
