**Cell 1 Regional Coastal Monitoring Programme
Walk-over Visual Inspections of Assets**

**Durham County Council
Final Report**

July 2014

Walk-over Visual Inspections of Assets

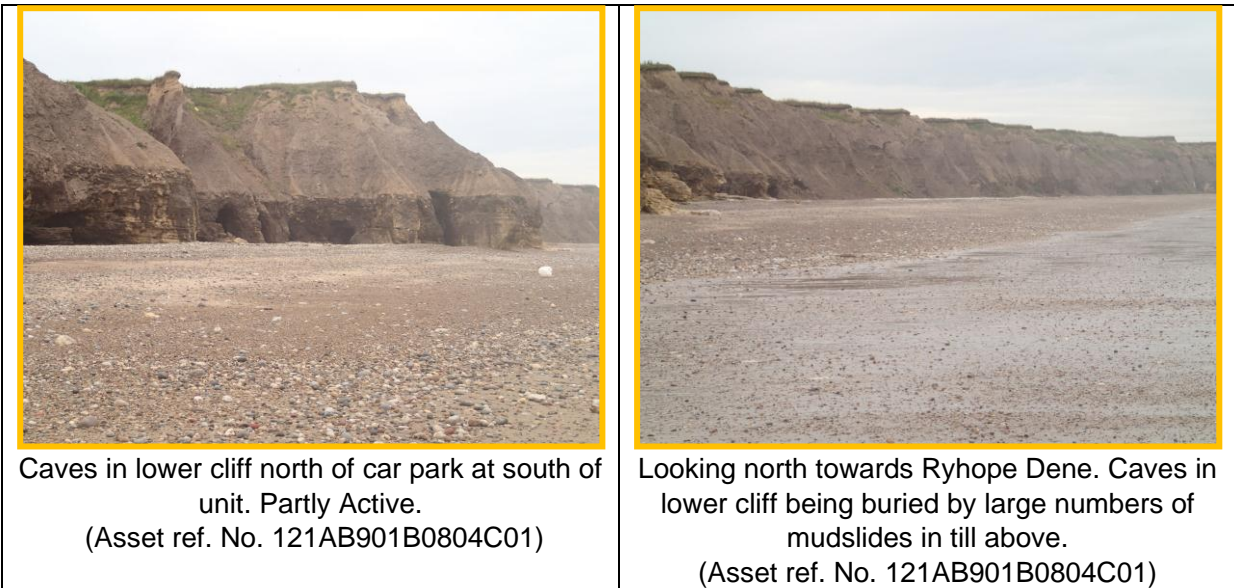
The most northern NFCDD asset length (121AB901B0804C01) within Durham County Council's jurisdiction extends along undefended sea cliffs from Ryhope Dene to the picnic site located at the north of Seaham, near Seaham Hall. The cliffs comprise a Magnesian Limestone base with overlying glacial till (below left). There is evidence of recent slumping in the till upper cliff along virtually the whole undefended length. There are frequent caves and arches formed in the limestone rock at the base of the cliffs caused by differential erosion by waves (below right).

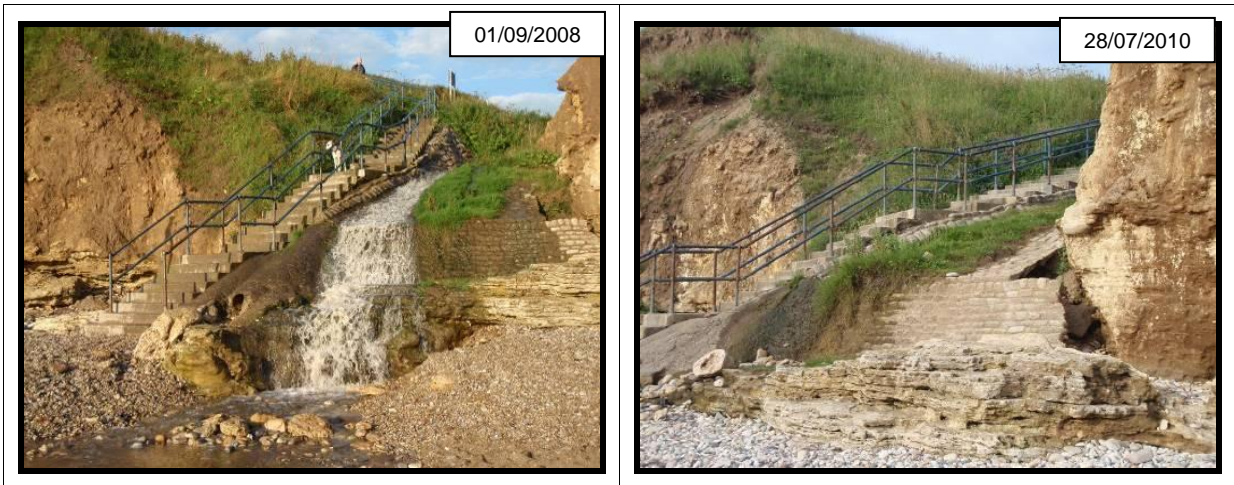
Immediately adjacent to the access steps from the picnic site car park near Seaham Hall is a small stream that discharges to the foreshore. The 2008 report notes that this stream was in spate due to the heavy rainfall that preceded the inspection (below left). During the 2010 inspections, there was very little flow (below right). Despite heavy rain at the end of September 2012 there was little flow in the beck at the time of the inspection on 4th October 2012, below lower left. The beck was very low again in 2014 and the outflanking noted previously at the short length of blockwork wall immediately to the north of the stream still, appears unchanged since 2010, see photos below and overleaf.

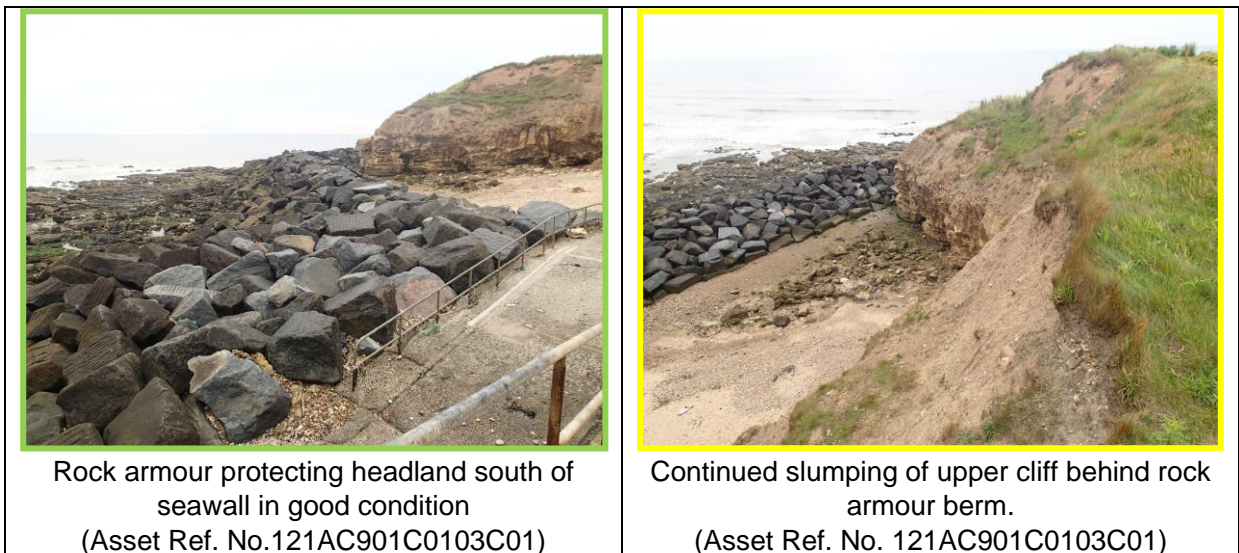
To the south of the seawall there is a rock armour berm providing toe protection to the cliffs around the headland adjacent to Featherbed rocks. As previously, the rock armour appeared in good condition although the cliffs to the rear show continue slow erosion and slumping of the upper till layers, see below right.

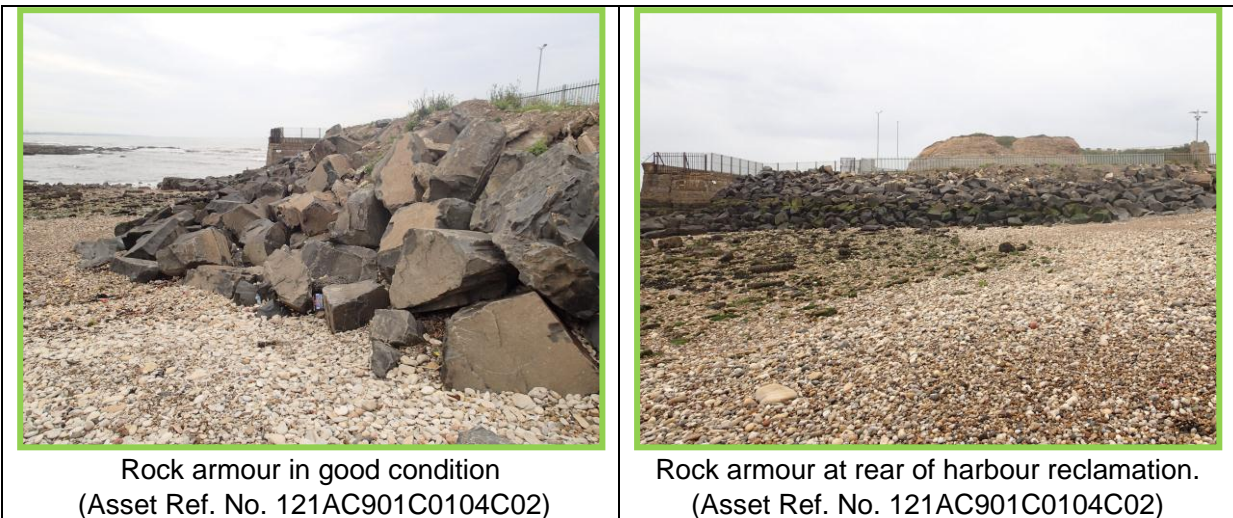
At the south end of the bay there is a rock armour revetment, asset 121AC901C0104C02, which is in good condition, see photos below. This defence forms the link to the root of the North Pier of Seaham Harbour and in a protected location where there had previously been outflanking of the North Pier.

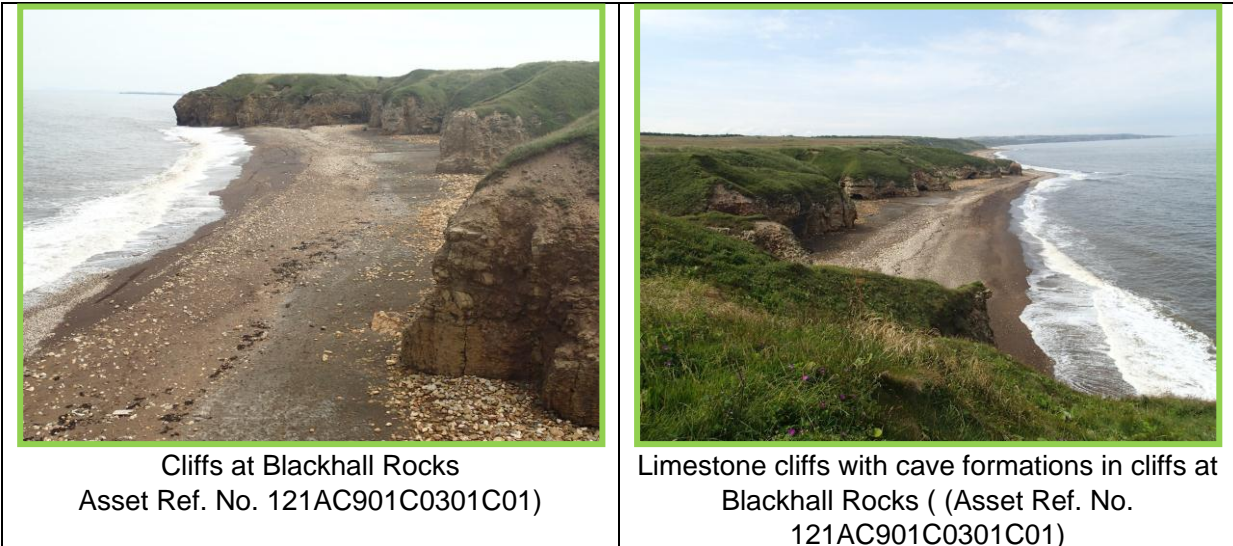
At Blackhall Rocks there is an extensive rocky outcrop on the foreshore (below left), and the backing cliffs have extensive cave formations at their base.

The frontage south of Blackhall Rocks is protected by the rock scar outcrops on the foreshore, below left and right. The cliffs are formed from softer material overlying a near vertical hard rock base. As in the previous inspections there were signs of the softer material slumping throughout although the extensive vegetation coverage indicates a relatively slow rate of erosion. Rock falls from over-steepened/overhanging sections are evident locally. Fractures are visible in the rock indicating potential failure locations in the future.
