**Cell 1 Regional Coastal Monitoring Programme  
Walkover Inspection Surveys 2016**

**Durham County Council**

**September 2016**

## Walkover Inspection Surveys 2016

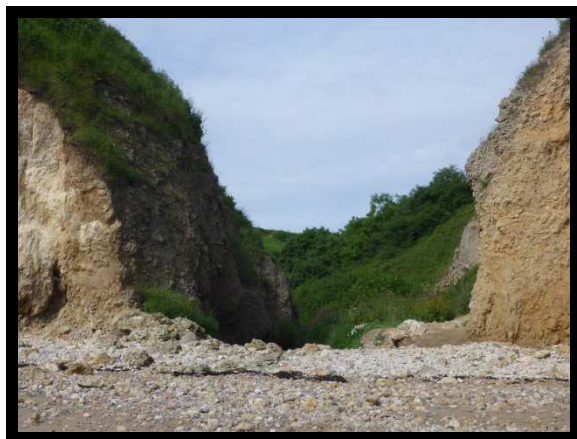
The most northern asset length (/B0804C01) within Durham County Council's jurisdiction extends along undefended sea cliffs from Ryhope Dene to the picnic site located at the north of Seaham, near Seaham Hall. The cliffs comprise a glacial till and are slumping along almost the entire length. At one location there is a relatively large 'bench' type failure involving a substantial volume of material.

*Ryhope Dene  
(northern boundary of /0804C01)*

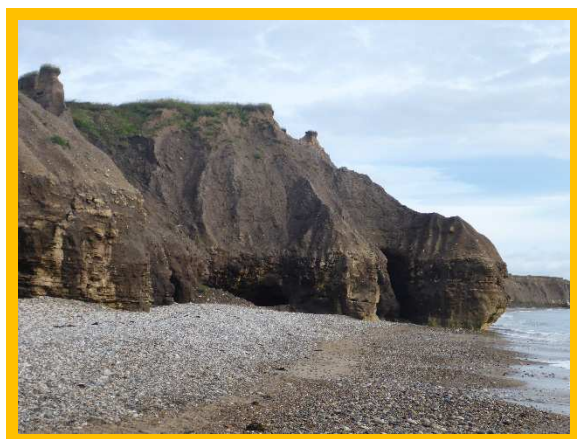
Further towards the southern end of the frontage length, the till sits on top of a harder Magnesian Limestone base. At these locations, there is evidence of recent local slumping in the upper till cliff. There are also frequent caves and arches formed in the limestone rock at the base of the cliffs caused by differential erosion by waves.

*Undefended sea cliffs with till sitting on  
limestone (/0804C01)*

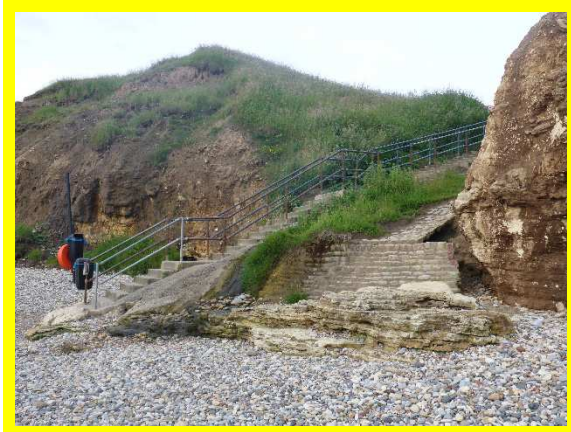
Within this asset length is a set of access steps from the picnic site car park near Seaham Hall with a small stream discharging to the foreshore over an adjacent stone revetment. There was little flow in the stream at the time of the inspection, but the previously identified outflanking of the revetment appears unchanged since 2010. There is also a small diameter pipe encased on concrete running alongside the steps. This was not discharging at the time of the inspection and the outlet was partially blocked by large cobbles.

*Access steps and stone revetment (/0804C01)*

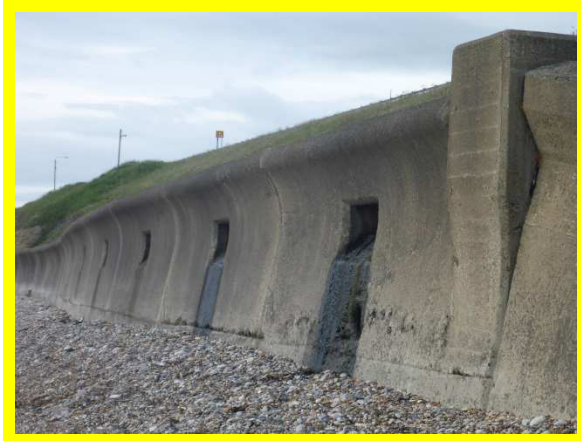
The main Seaham sea wall is fronted by a high shingle beach. The wall and promenade are both in fair condition, although at every junction with a set of access steps a crack exists between the main sea wall and the wing-wall of the steps. Joints in the main sea wall are mostly intact but a few areas would benefit from re-sealing. There is some vegetation growth in construction joints and cracks in the promenade, which should be removed and the joints sealed.

*Seaham sea wall (/0102C01)*

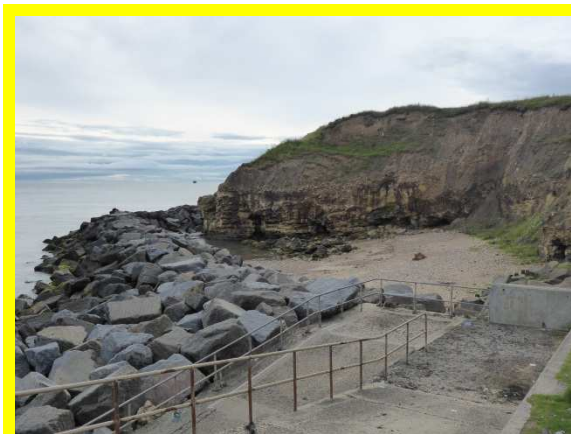
To the south of the seawall there is a rock armour berm providing toe protection to the cliffs around the headland adjacent to Featherbed Rocks. The rock armour continues south of the headland, initially protecting a short length of concrete wall with a large outfall from the culverted Dawdon Dene, and then protecting the cliffs in front of Allotment Gardens and the northern end of the Seaham War Memorial Gardens. The rock armour appears in good condition although the cliffs to the rear show continued slow erosion and slumping of the upper till layers. In particular, there is one rock fall at the cliffs of Featherbed Rocks, just to the north of the outfall and measurable slumping in the cliffs to the south of the culvert.

*Rock berm around Featherbed Rocks headland (/0103C01)*

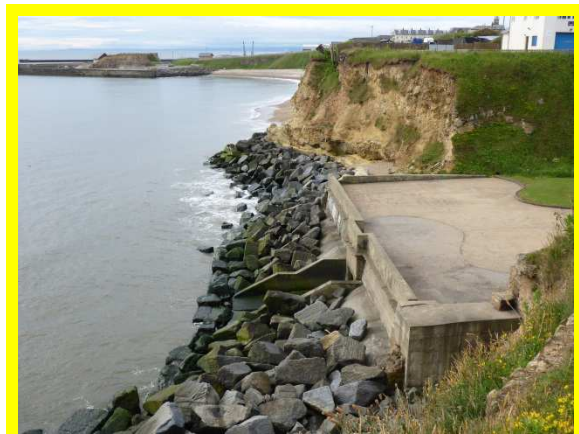
*Rock berm around Dawdon Dene culvert and further south (/0103C01)*

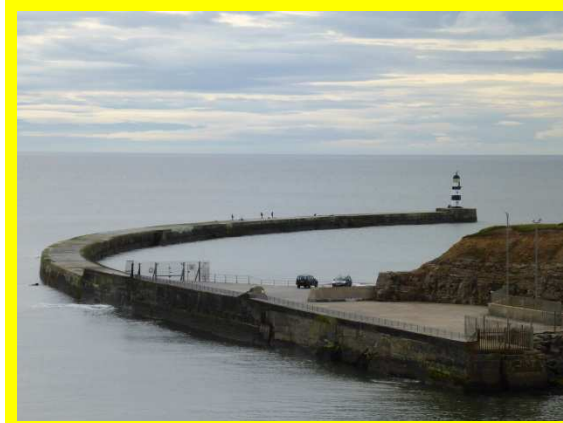
Access to the North Pier is restricted by a locked access gate at the landward end. The concrete deck shows cracking on the accessible sections, although the massive structure still clearly provides an effective coast protection function and is therefore assumed to be in fair overall condition. Recent repairs to previously-reported defects to the deck and both coping and upper

*Seaham Harbour North Pier (/0104C03)*

sections of the inner face were noted beyond the access gate, but these could not be inspected in detail. The inner face was inspected from the beach at low tide and appears in fair condition. It is recommended that, if not already in place, more detailed vessel-based and underwater inspections are undertaken by the Dock Company and if not already in progress a maintenance programme should be put in place.

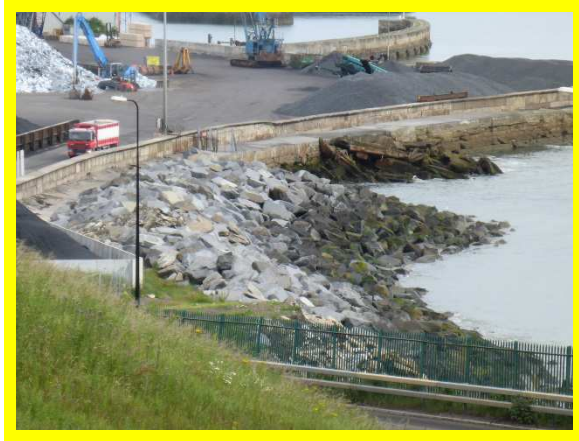
*Tipped rubble (/0104C16) and rock revetment (/0104C01)*

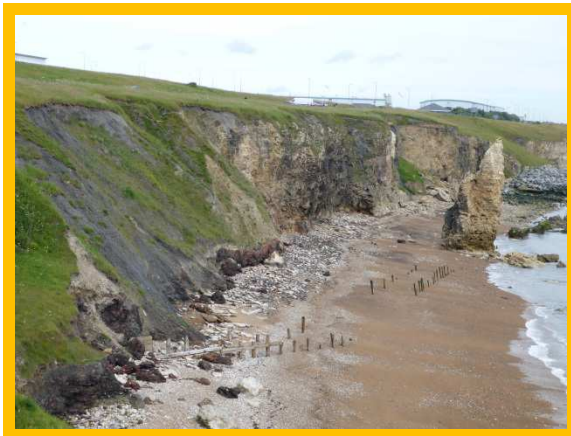
South of the revetment between Seaham Fleet Rock and Nose's Point, the unprotected cliffs were previously fronted by a colliery spoil beach (known as Chemical Beach) but this has now been virtually completely eroded and there are an increasing number of local slumps in the backing cliffs, some of which consists of colliery waste. Debris exposed by the eroding beach should be removed routinely. The erosion appears greatest towards the south of Chemical Beach, just to the north of Nose's Point.

*Little remaining spoil beach (/0103C06)*

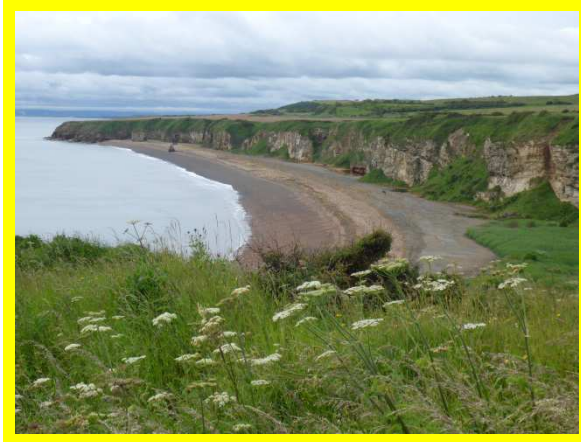
The colliery waste is continuing to erode and has been almost totally lost at the south where it meets Chourdon Point. In future the limestone cliffs will become active again when the spoil beach has been washed-away.

*Residual spoil beach at Blast Beach – view looking south (/0103C07)*

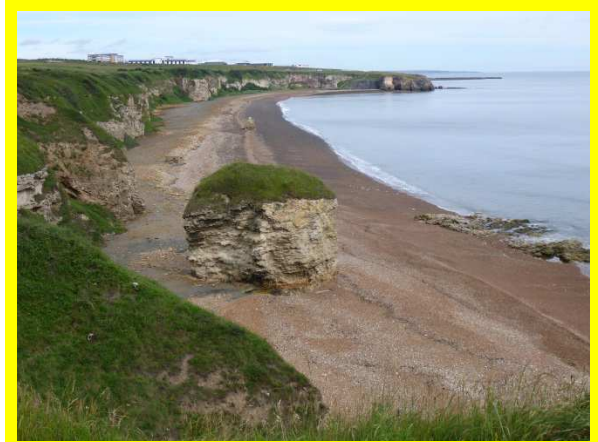
*Residual spoil beach at Blast Beach – view looking north (/0103C07)*

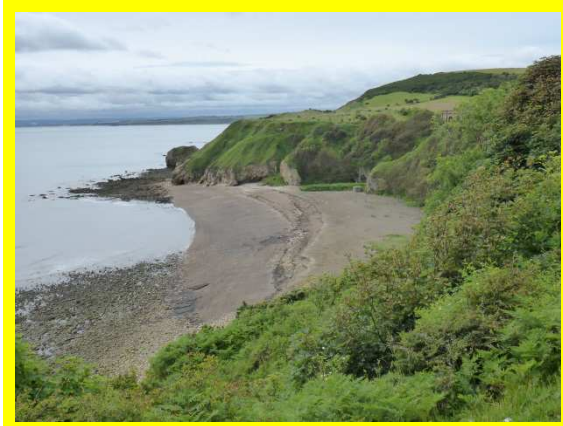
*Residual spoil beach at Hawthorne Hive (/0201C01)*

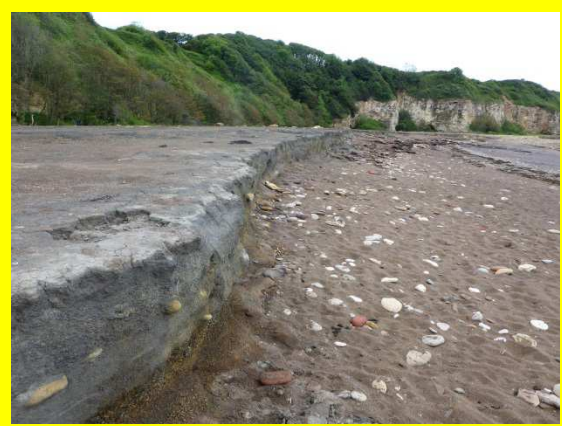
*Residual spoil beach at Hawthorne Hive (/0201C01)*

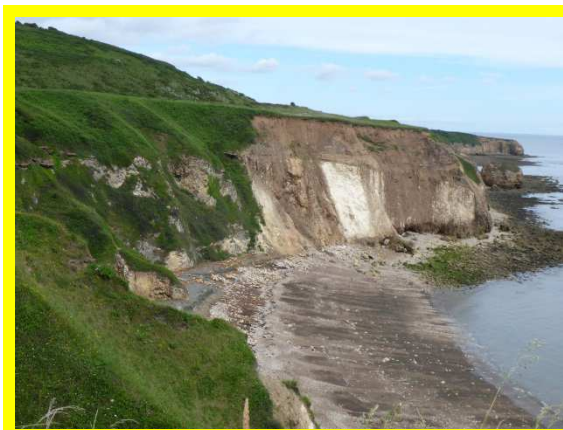
In Shippersea Bay in particular very little colliery spoil now remains and the cliffs have started to slip in one area. Spoil tipping did directly occur on the beaches fronting Easington Colliery and notable quantities still remain. Here the cliffs are generally relatively stable although there is one location near Shot Rock where a slippage has occurred and tension cracks are noted in the path at the clifftop, suggesting that further slippage may occur.

*Little residual spoil beach at Shippersea Bay (/0201C01)*

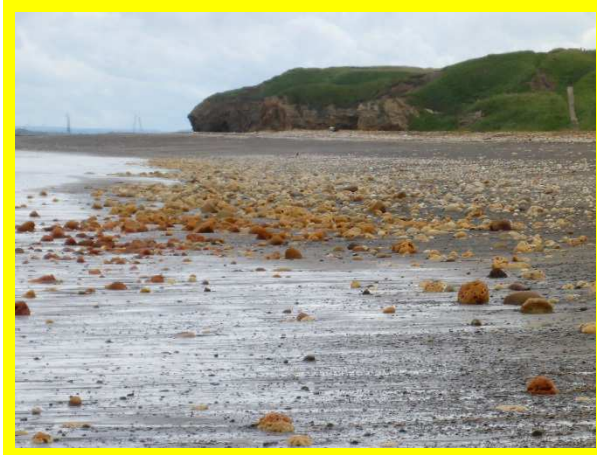
*Horden beach (/0201C01)*

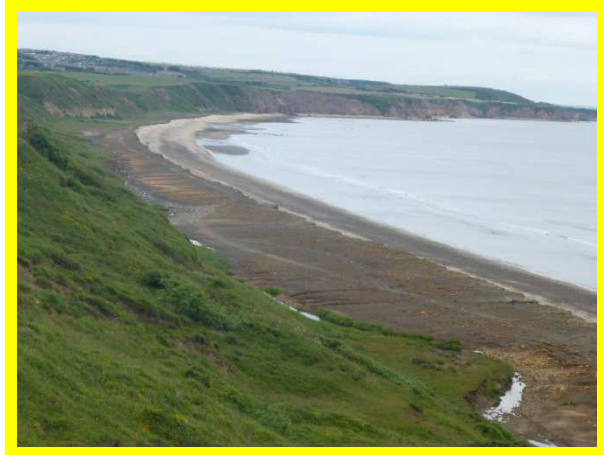
Between Horden Point and Blackhall Rocks there is a long uninterrupted length of colliery spoil beach (0201C02). This protects the backing cliffs from marine action, enabling them to become relatively stable and vegetated. However, despite the protection afforded by the foreshore and spoil beach, there remains occasional local shallow slumping in the backing slopes, especially in the centre of the frontage. In many locations there is debris on the beach such as old pipes and metalwork that is being exposed as the spoil erodes. This should be removed routinely to reduce health and safety hazards. There is an outfall structure encased in concrete at one location. The encasement is heavily abraded and in poor condition.

*Residual spoil beach at Horden beach – view looking north (/0201C01)*

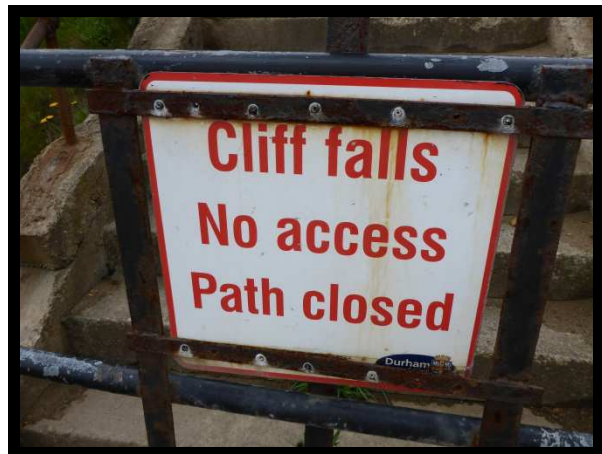
*Closed access steps (/0301C01)*

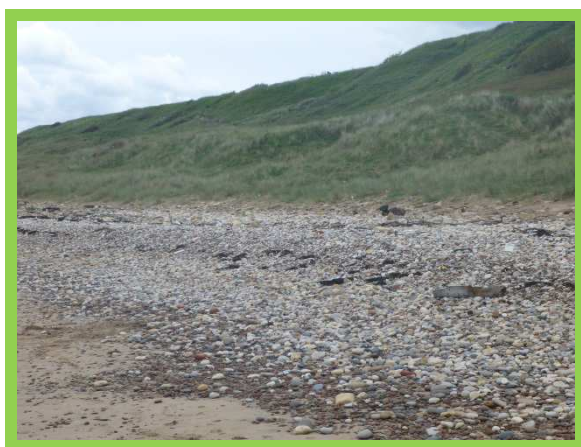
From Crimdon Park Caravan Site to the southern limit of Durham County Council's jurisdiction, at the boundary with Hartlepool Borough Council at Crimdon Beck, the frontage comprises of extensive dunes. These are generally in a very healthy condition. In one short length, the relict cliffing from a previous erosion episode was evident but this has now been almost fully restored by natural sand accumulation and the onset of embryo vegetation growth.

*Stable dunes at Crimden (/0301C02)*

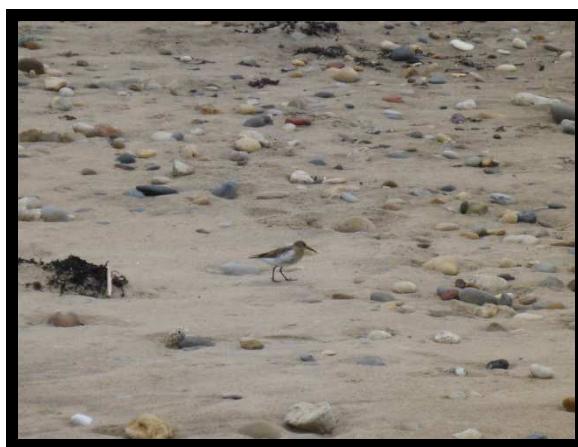
In an area of stable upper beach immediately to the north of Crimdon Beck, fencing is erected to safeguard the nesting Little Terns. Ringed Plover, Greenshank and Common Sandpiper were also observed at this location during the inspection.

*Nesting birds adjacent to Crimden Beck (/0301C02)*
