## **Cell 1 Regional Coastal Monitoring Programme Walkover Inspection Surveys 2022**

# Hartlepool Borough Council

## Walkover Inspection Surveys 2022

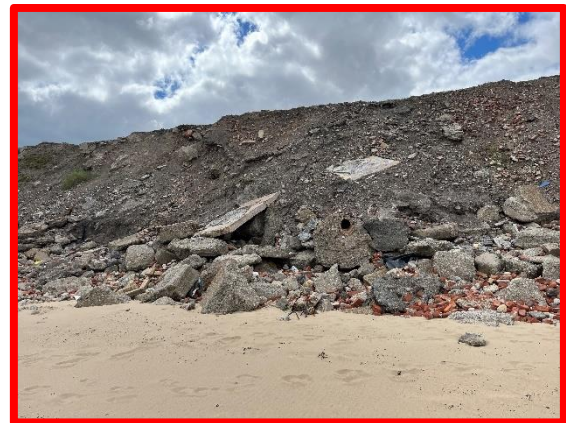
Burst brick gabions spread along foreshore to the north (/0302C02)

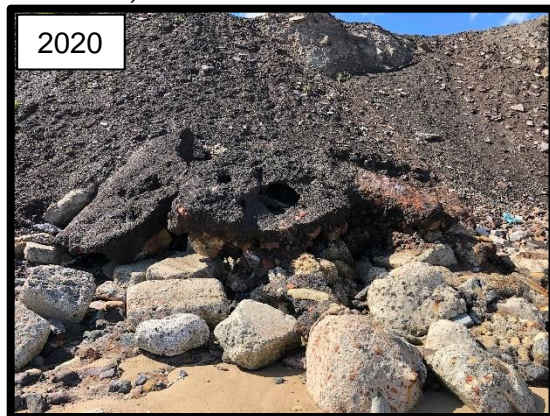
Erosion of made ground slope in 2020 (/C0302C02)

In light of the property development in the vicinity, it is recommended a formal coastal defence is considered in this area.

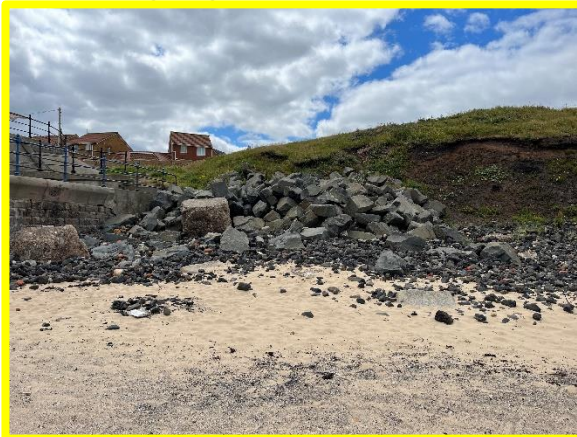
Large pieces of slag material previously poured to form a protective apron had continued to break up although the material is likely to remain *in situ*. Rock armour revetment (also incorporating several concrete tank blocks) at the interface with Marine Drive sea wall appeared in fair condition.

*Rock armour revetment at Marine Drive seawall (/C0302C03)*

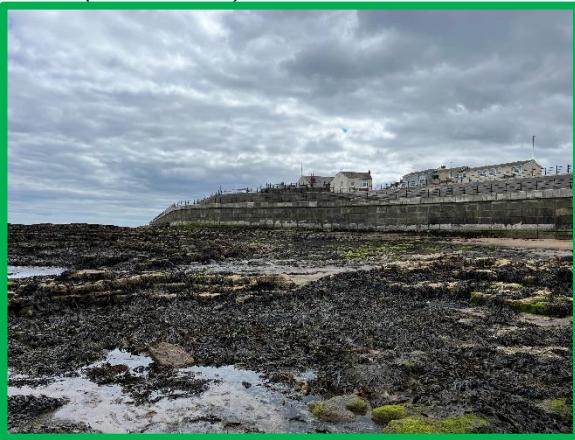
The north east tip of the headland was limited to inspection from the promenade only as the foreshore was inaccessible due to densely vegetated marine growth and wet rocks but again appeared in 'as built' condition.

*As built condition sea wall – inaccessible foreshore to the south. (/C0303C02)*

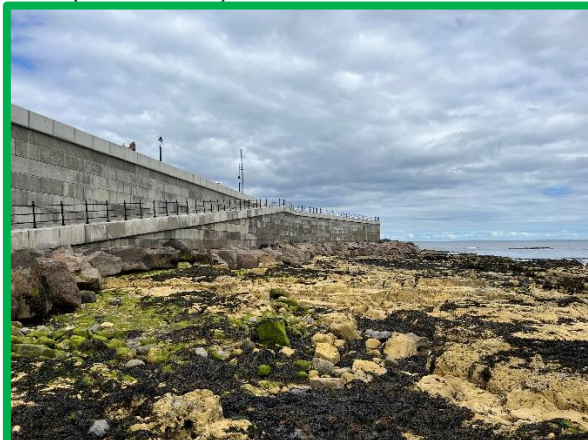
*As built condition seawall (/C0303C04)*

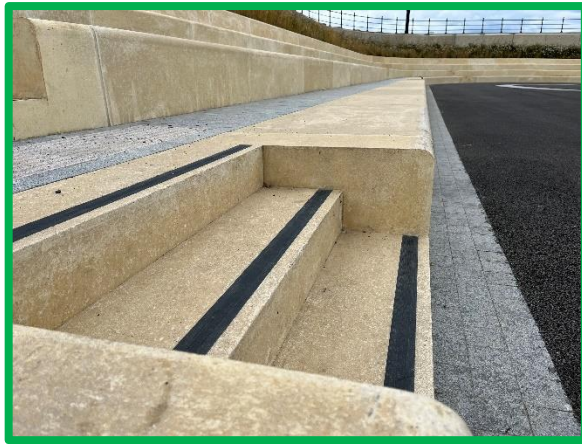
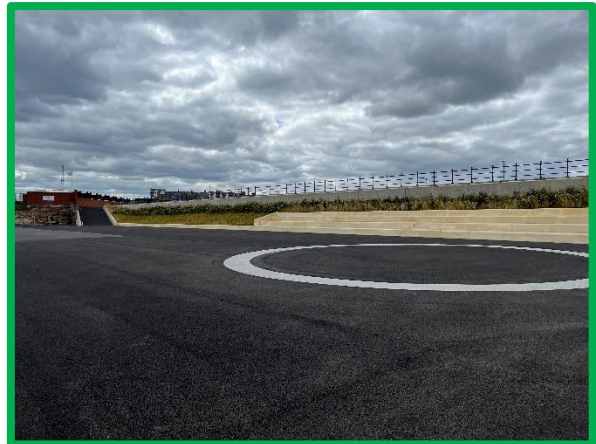
In 2021 a project to rejuvenate the Elephant Rock amphitheater, located on the lower promenade and forming a secondary defence, was complete. It remains in as built condition.

*Elephant Rock – Outdoor Event Area  
(/C0303C02)*

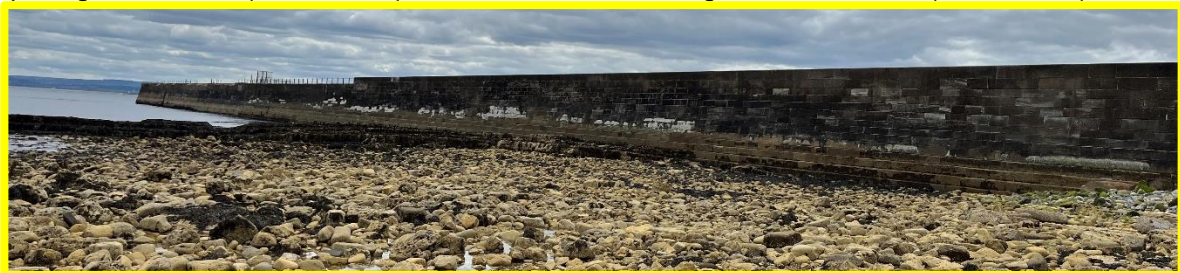
The privately owned Heugh Breakwater is not accessible to the public beyond halfway along its length, enforced with fencing and signage present. It is understood the seaward end of this structure, past the fencing, has been in failing condition for many years, thought to be as a result of differential settlement from varying founding material. The landward section of the structure generally appeared to be in fair condition when inspected from the foreshore. Some cracking/abrasion was observed in the deck slab and parapet wall. The handrails were also experiencing minor corrosion. Numerous previous repairs were visible on the deck of the structure.

Northern aspect of the Heugh Breakwater (/C0401C01)

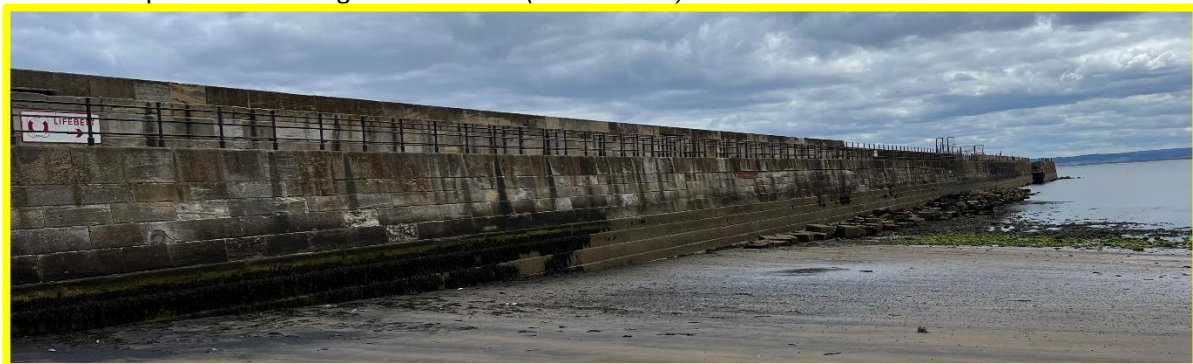
Southern aspect of the Heugh Breakwater (/C0401C01)

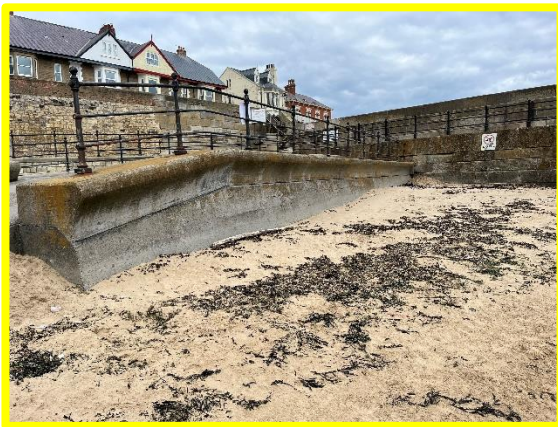
*Healthy beach levels at Block Sands adjacent to Heugh Breakwater (/C0401C03)*

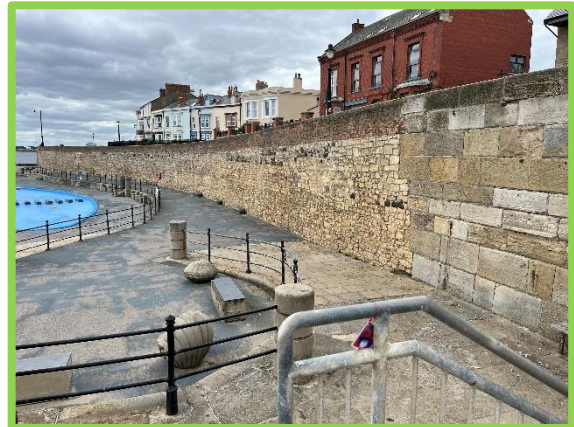
The concrete recurve wall is generally in fair to poor condition. Local cracking and spalling was observed to the face and recurve cope along extensive sections of the wall. Minor undercutting and voiding was also observed locally. The rear masonry wall was generally in fair condition throughout, with voids/loss of mortar observed locally, and several areas where historic repairs have taken place.

*Rear masonry wall in fair to good condition (/C0401C03)*

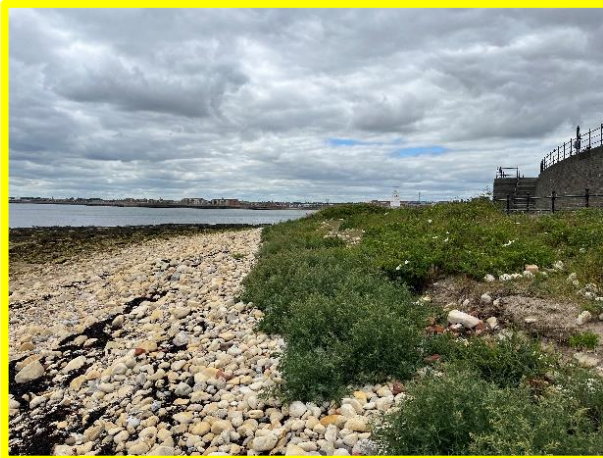
*Steep pebble beach fronting vegetated area (/C0401C05)*

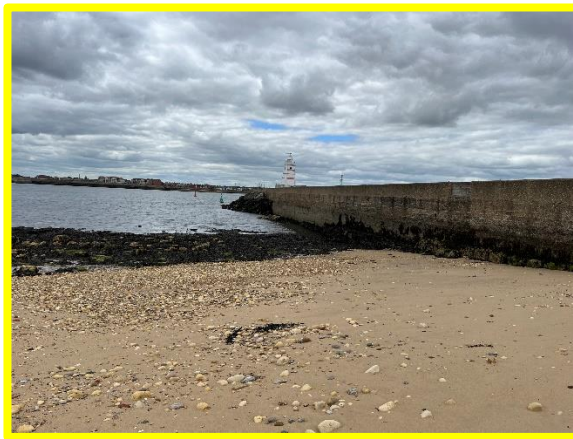
*Southern aspect of the Old Pier (Pilot Pier)  
(/C0401C34)*

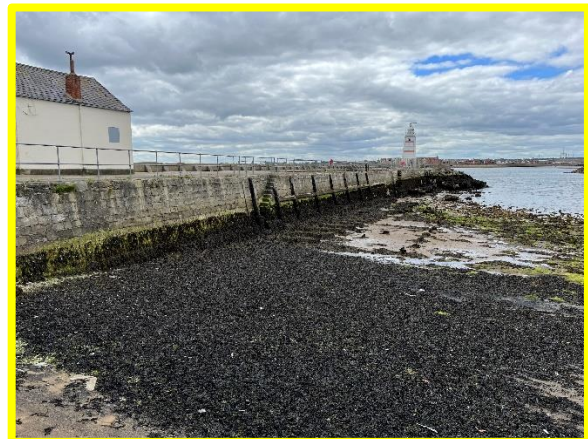
The inner face of the structure (Pilot Pier) generally appears in fair condition with some abrasion noted to the masonry blocks. Significant vegetation growth may be concealing more defects. Local bulging of the wall has been reported previously but does appear to have worsened since the previous inspection.

*Inner face of North Pier – uneven profile  
suggesting potential settlement of masonry  
blocks (/C0401C06)*

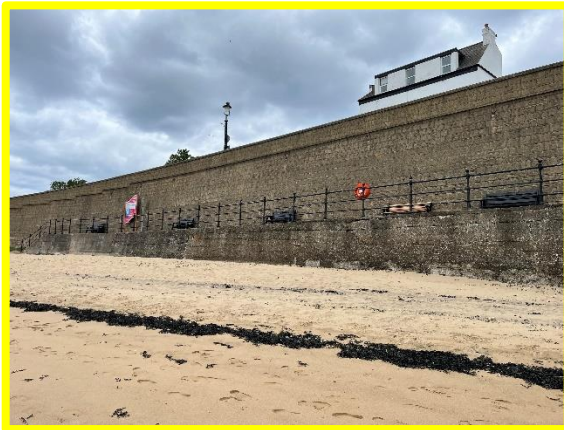
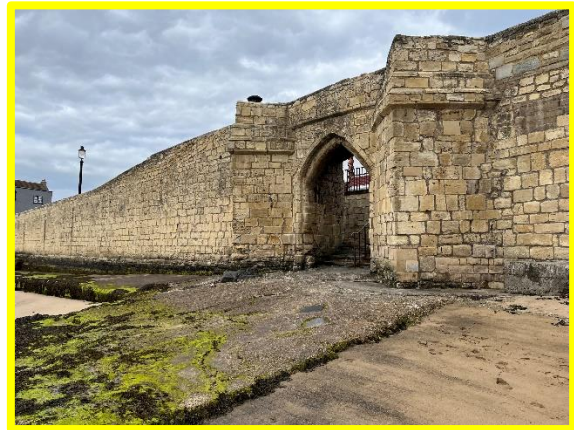
*Town Wall benefiting from recent repointing works (/C0401C35)*

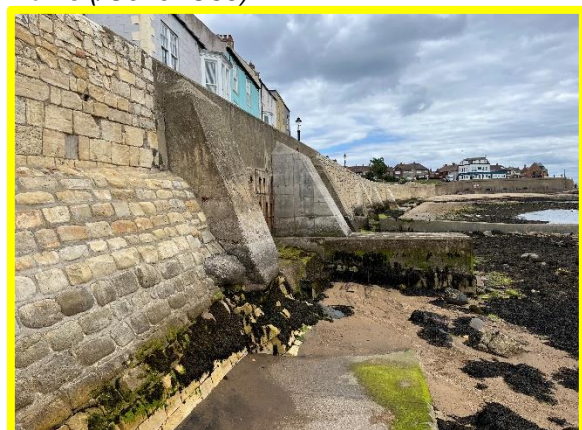
The more recent repairs works to the concrete outfall, concrete abutment and footway promenade to the rear of the seawall, reported in 2018, remain in good condition.

*Recently constructed outfall and abutment. (/C0401C35)*

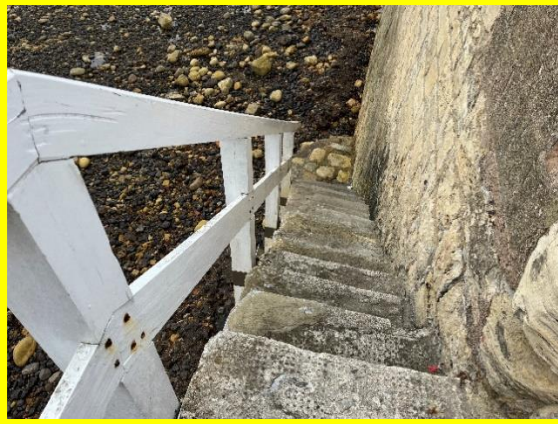
The narrow pedestrian access steps, providing access onto the foreshore from Town Wall Road, have recently been repaired (pre 2020) with new concrete treads and a reinstated timber handrailing. The steps have not deteriorated since the previous survey although it was noted the handrail is slightly loose and should be monitored.

*Repaired handrailing and beach access steps (/C0401C35)*

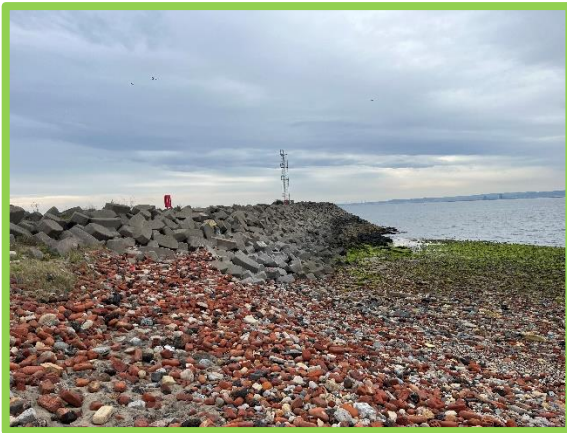
The concrete Accropode armour units, forming Middleton Jetty, displayed good interlock with a consistent slope/profile throughout and there was no evidence on the crest to suggest significant global movement or distress. Construction rubble, predominantly bricks, had accumulated against southern face of structure, as a result of the burst brick gabions to the south (/C0401C17).

*Middleton Jetty south aspect. Buildup of construction rubble in the foreground (/C0401C16)*

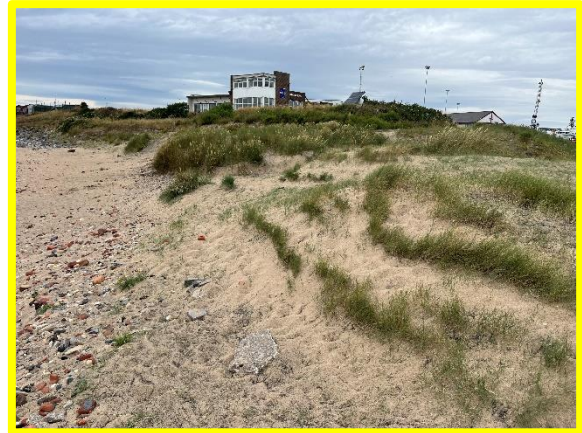
A small stretch of embryonic dunes are observed forming at the transition between Middleton Jetty and the gabion wall. The dunes are heavily trodden and the vegetation coverage is sparse. The dunes in front of the gabion wall have been eroded.

*Embryonic dunes between Jetty and stacked gabion wall (/C0401C17)*

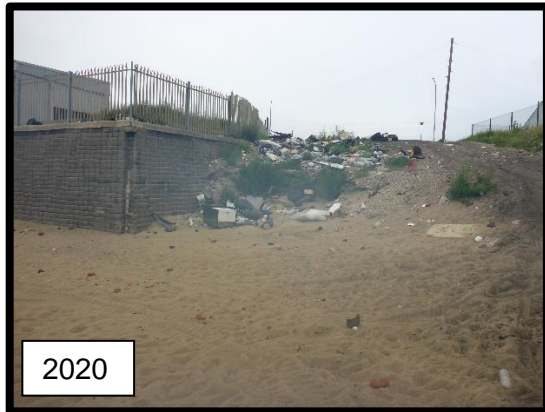
The short length of undefended frontage comprises an informal beach access ramp. Erosion has started to outflank the adjacent seawall causing the retreat of the southern section of the ramp. It is likely that the ramp will become unusable if erosion continues. As a result the need for the ramp should be reviewed. Evidence of fly-tipping was again observed in this location, but not to the same extent as in 2020.

*Informal access ramp 2020 (/C0401C18)*

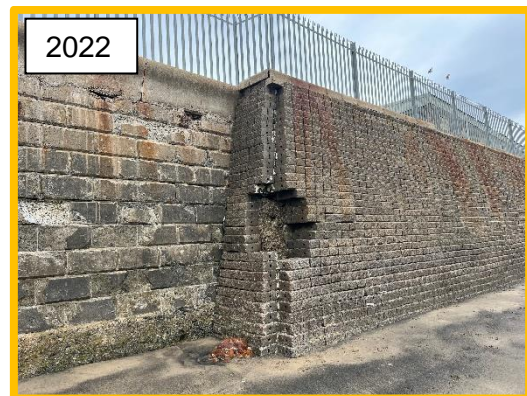
*Progressive loss of blocks at interface between two walls. (/C0401C19)*

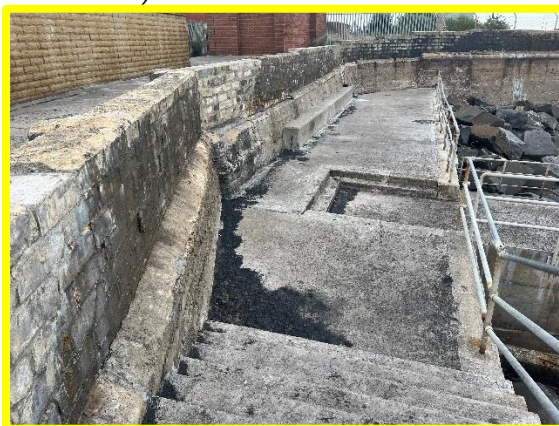
*Access structure to Middleton beach in fair  
condition (/C0401C20)*

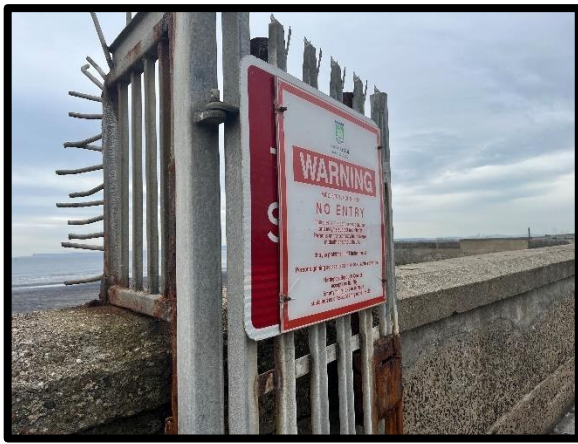
Public access to the North Pier and its inner arm is prevented by security fencing and signage limiting the inspection to the foreshore and adjacent structures only. The signage states the pier is in a “dangerous condition”. Despite the signage on the day of survey all of the security gates were open and anglers were observed fishing of the pier head. In addition, access could be gained from the foreshore to the north at low tide. This may be considered a health and safety issue.

North Pier signage (/C0401C22)

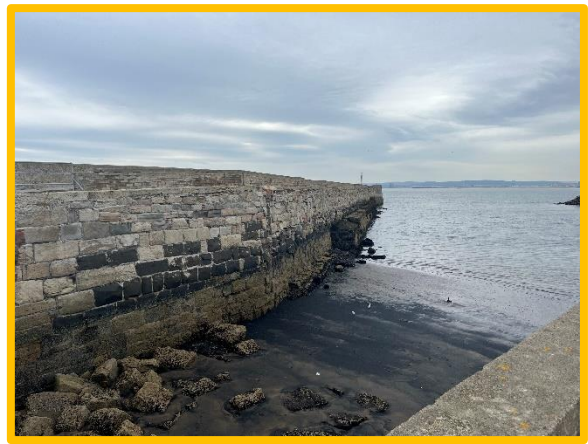
The landward end of the structure was viewed from the foreshore. As identified in previous surveys, the masonry structure appeared in fair to poor condition. Locally lower beach levels exposed timber piles and a masonry apron with open jointing and local voiding. As reported previously, the voiding should be addressed urgently to prevent further deterioration.

South face of North Pier (/C0401C22)

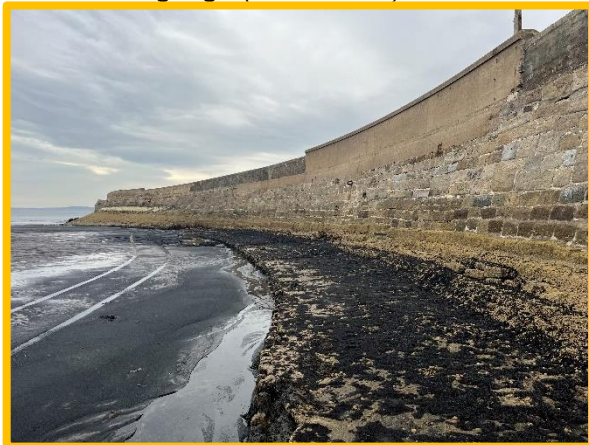
North face of North Pier (/C0401C22)

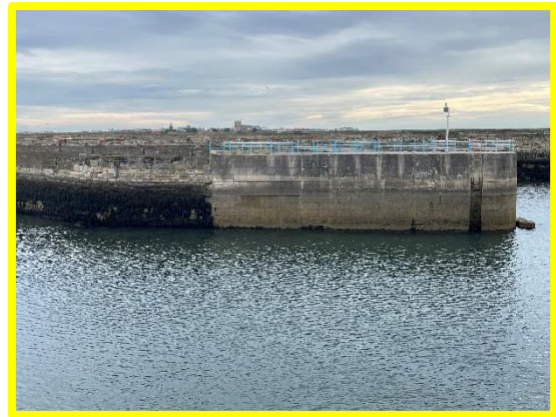
*Inner arm south face (/C0401C21)*

Consideration should be given to undertaking a more detailed survey of the structure, including a boat/dive survey to inspect the permanently submerged seaward ends. It is recommended that repair works are carried out urgently to prevent further deterioration of the structure.

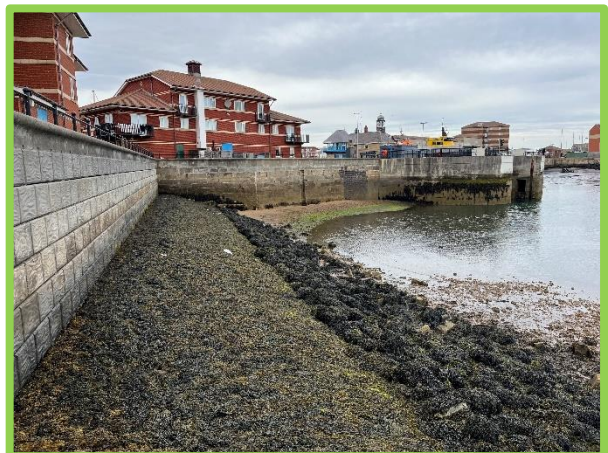
*Concrete blockwork revetment obscured by vegetation (/C0401C25)*

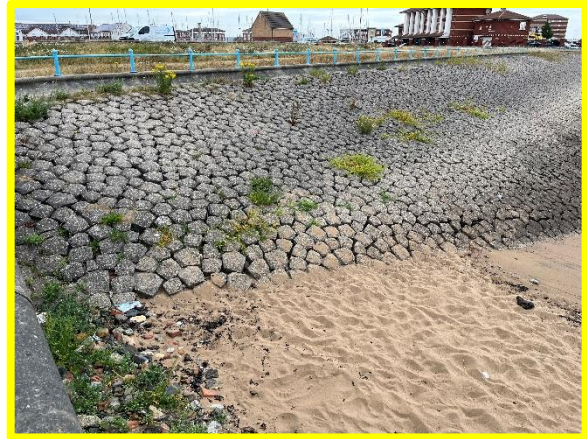
*Steeper profile to the south (/C0401C26)*

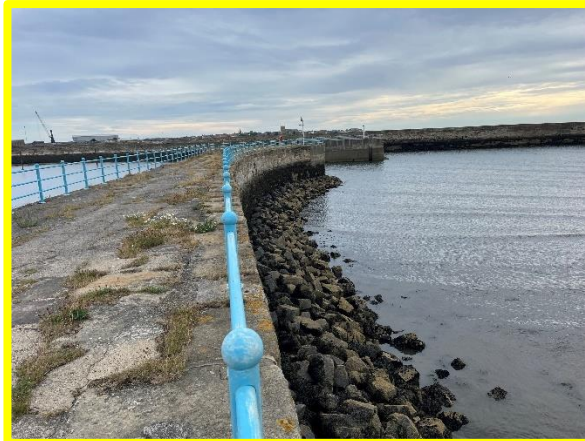
Generally, the Middle Pier appeared in fair condition. The inner face, inspected from the foreshore, is heavily overgrown with marine vegetation. Minor mortar loss was noted to the lower courses, however it is thought that the vegetation might be concealing the true extent of the defects. The rock armour placed against the outer face remains in good condition, however at the seaward end of the structure the coverage became increasingly sparse. It is recommended that rock armour is re-profiled, to ensure efficient and effective coverage around the structure. As noted in previous reports, significant vegetation growth was evident in the construction joints on the deck which should be removed and joints repointed. Cracking to the cope stones around the handrailing fixings is also noted.

*Rock armour against outer face of Middle Pier (/C0401C28)*

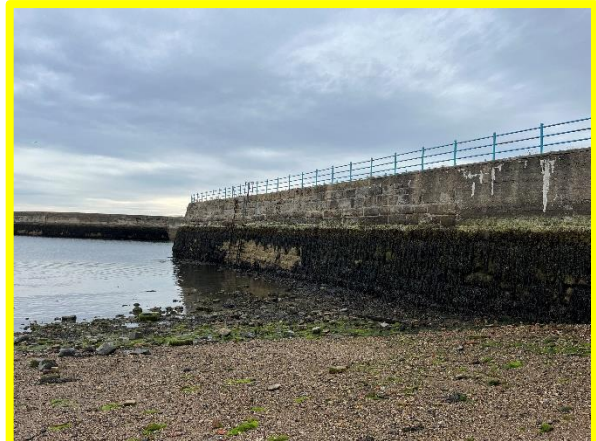
*Inner face of Middle Pier heavily vegetated (/C0401C28)*

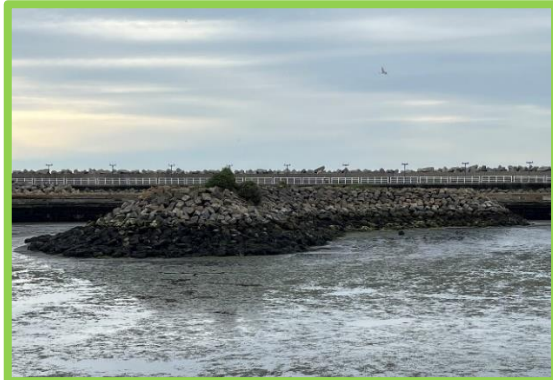
South Pier remains in good condition. The rock armour placed to the inner face maintained a consistent profile and good interlock. As noted in previous surveys the vegetation growth observed at the crest of the rock armour, should be removed to prevent the root network damaging the concrete structure or rock revetment. Some of the vegetation is now mature and presents a significant risk to the integrity of both the wall and the revetment.

*Rock revetment breakwater in good condition bar mature vegetation growth (/C0401C30)*

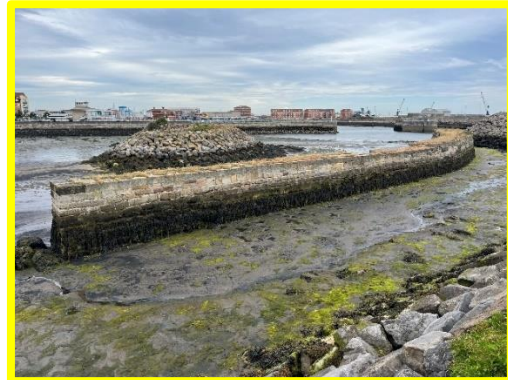
*Old quay wall structure in fair condition (/C0401C31)*

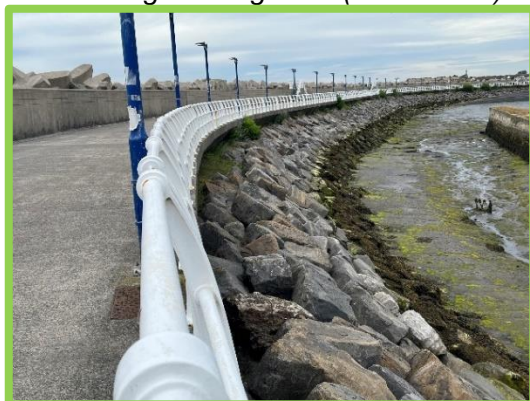
*Inner face of South Pier. Vegetation can be seen on crest. (/C0401C32)*

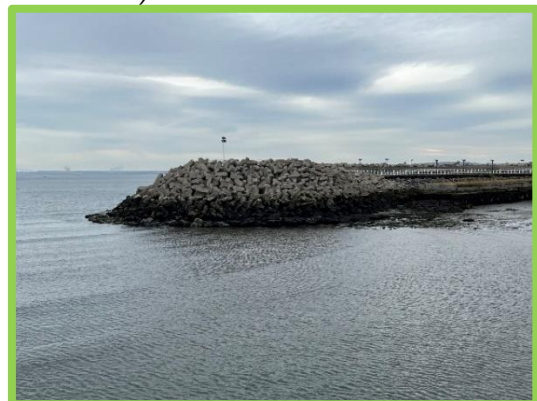
The concrete Accropode units placed on the seaward face of the South Pier maintained a consistent crest height and profile with good interlock between units. The roundhead was viewed from Middle Pier, however due to the nature of the structure, inspection of the lowest parts of the outer face was not possible and a boat survey at low tide should be considered. As in 2020 there were no signs of global movement, so a boat survey is not imperative.

*South Pier roundhead (/C0401C32)*

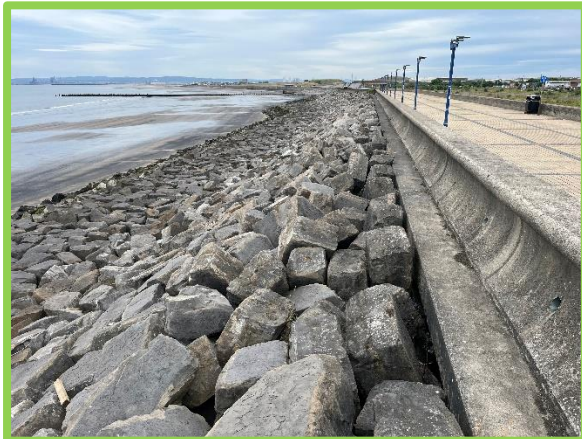
To the south of South Pier, the Accropode revetment ties into a rock armour revetment with a concrete crest wall which runs for approximately 2.3km to Little Scar at the north of Seaton Carew. As in previous inspections the defences along this section remained in good overall condition.

*Rock armour revetment and concrete seawall (/C0401C33)*

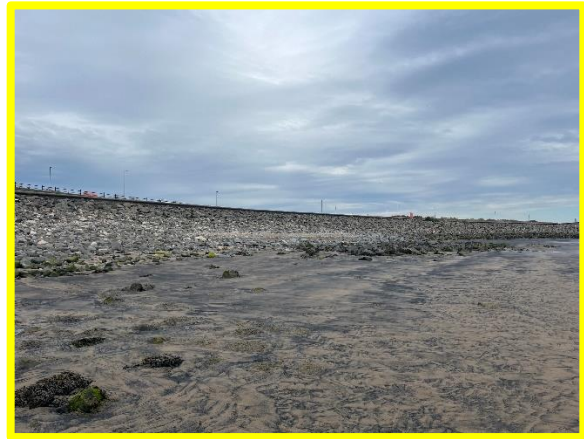
At Newburn Bridge towards the northernmost end of Carr House Sands, as noted in previous surveys there has been some local displacement of rock armour units. This is evidenced by an obvious encroachment of the revetment toe onto the foreshore north of the Newburn Bridge outfall structure.

*Displaced rock at toe north of Newburn Bridge outfall structure. (/C0401C33)*

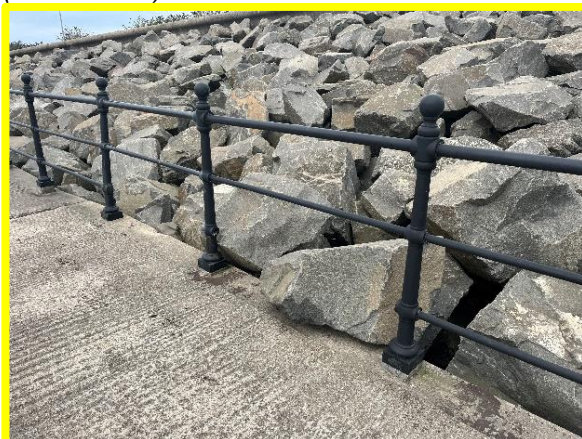
On the adjacent access ramp, several rock armour stones have been displaced, damaging the handrail in one location. Mature vegetation growth is observed towards the top of the ramp and should be removed as not to compromise the structures integrity. As reported previously, the sealant between deck slabs has been washed out. In one location the exposed joint has started to abrade creating a potential trip hazard.

*Displaced rock damaging handrail (/C0401C33)*

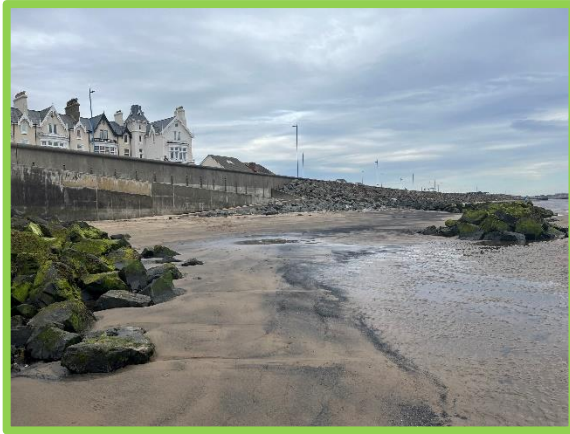
The Little Scar access ramp remained unchanged since the previous inspection. Beach levels in the area were broadly comparable to the previous inspection with the sediment reaching halfway up the lower ramp. This is higher than those observed in 2012 and 2010 (prior to reconfiguration of the

*Exposed rock armour berm at Little Scar access ramp (/C0401C33)*

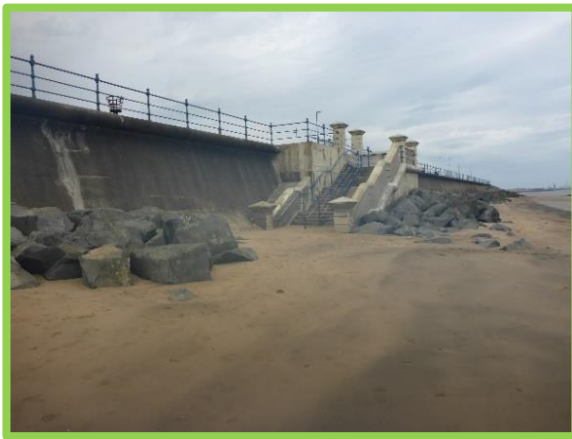
*Northern access steps (/C0501C05)*

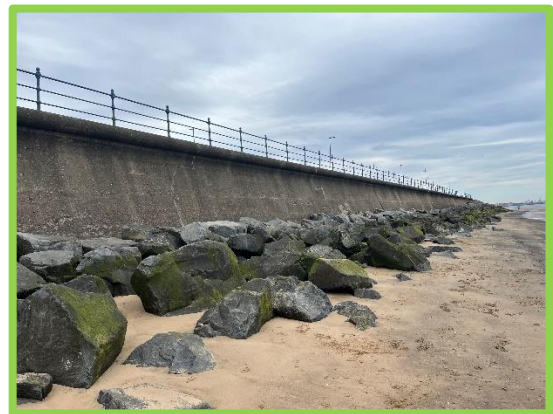
The coverage and interlock between rock armour units was good, although high beach levels again concealed much of the toe of the revetment structure. As a result, the displacement of rock armour identified in 2018 was not visible. This displacement should be monitored as it may indicate a loss of interlock between units.

*View looking north. High beach levels concealing toe of revetment structure. (/C0501C05)*

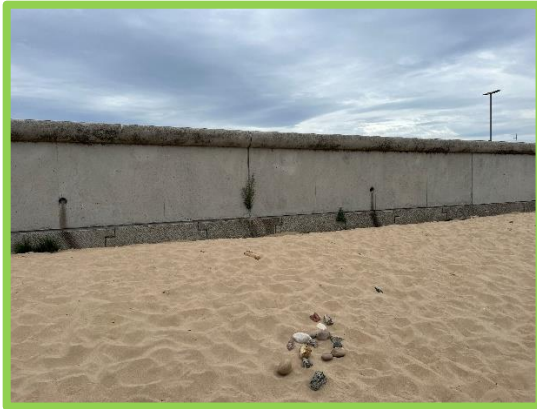
To the south of the beach access point at Church Lane, the seawall remains in very good condition over approximately 600m, to the landward return at the sewerage pumping station. The majority of defects observed were cosmetic only including outfall staining and graffiti. There does remain some localized vegetation growth from joints between the precast concrete façade units fronting the new

*Vegetation growing in joints – should be removed (/C0501C04)*

seawall. This should be removed to prevent damage to the precast units. As in previous years, an 150m section of the frontage was cordoned off for nesting Little Terns, as a result the wall could only be inspected from a distance. The beach levels along this frontage remains high, with notable vegetation observed growing in the windblown sand up against the structure.

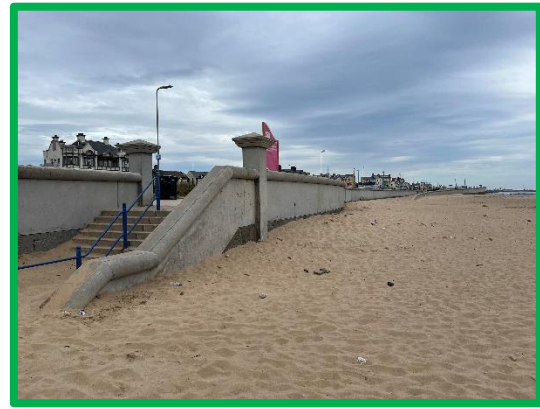
*High beach levels at access steps (/C0501C04)*

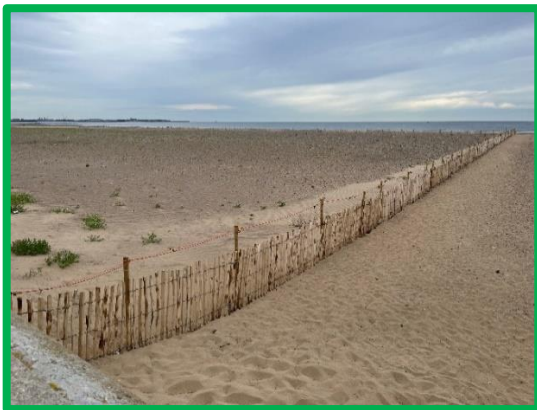
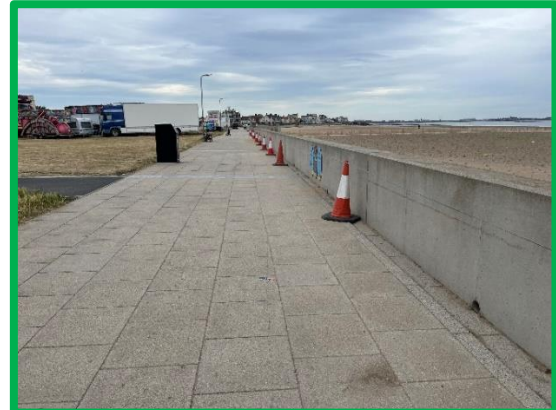
*Cordoned off section of frontage for nesting Little Terns (/C0501C02)*

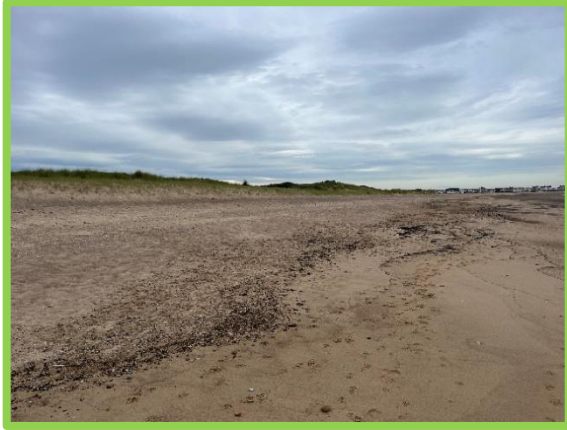
At the northern end, embryo dunes are again observed to be forming at the toe of the existing dunes. To the south, cliffing of the foredune has deteriorated since the previous inspection and is at its worse just north of the informal rock revetment. Although the dunes backing the informal revetment are also showing signs of cliffing, the revetment is offering some protection.

*Embryo dunes forming along the frontage  
(/C0502C01)*

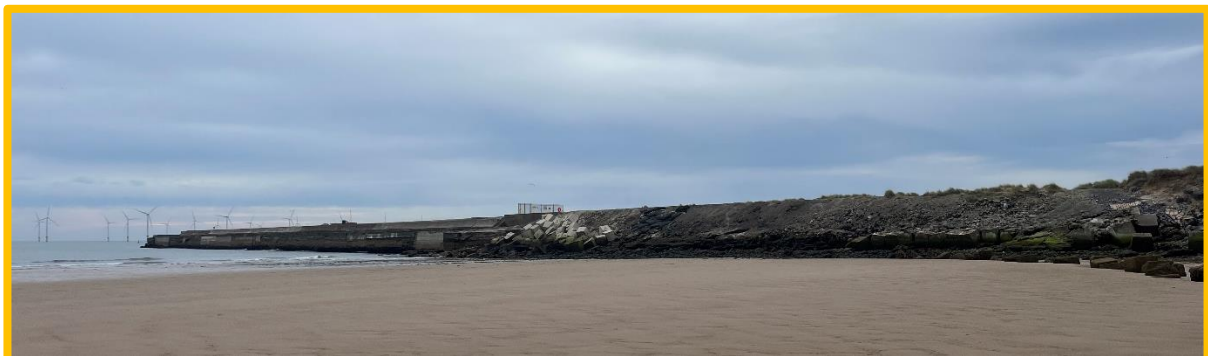
Northern aspect of North Gare Breakwater (/C0503C01)

The concrete and masonry structure incorporates a multitude of *ad hoc* repairs and, as reported since 2008, appears in poor to very poor condition. Visible defects include cracking, spalling, undercutting, void formation, loss of masonry, loss of concrete render, evidenced of settlement/displacement of previous concrete infill repairs and displaced/damaged slabs. Significant voiding to the northern face of the breakwater was reported in 2020 causing substantial washout of material.
