**Walk-over Visual Inspections of Selected Assets  
following Storm Surge of  
5<sup>th</sup> December 2013**

**Scarborough Borough Council  
Supplementary Report**

**December 2013**

### Walk-over Visual Inspections of Selected Assets following Storm Surge of 5th December 2013

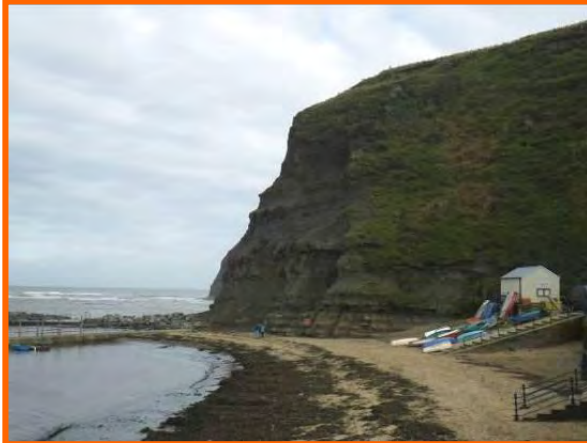
**MU4/2** –Vegetated cliff with localised erosion, behind Staithes harbour (Partly Active). Photo from Sept 2012

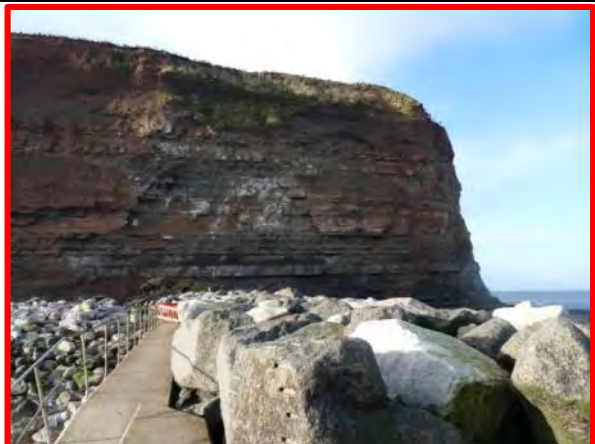
**E60/1a-** The northern part of Cowbar Nab after the December 2013 surge. Note relatively fresh scarring and talus accumulation on left of photo. (Totally Active)

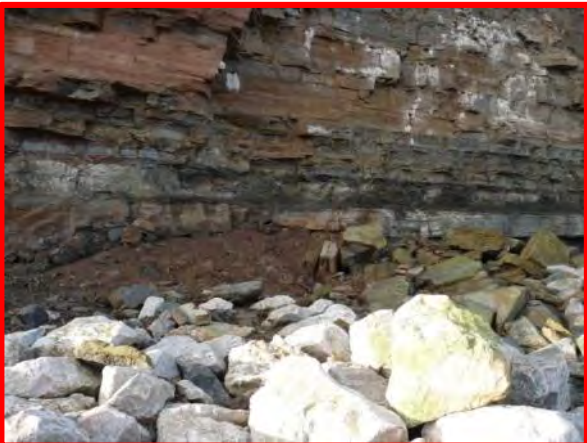
**During the post-surge inspection in December 2013, it was noted that in these units there had been relatively recent rockfalls and that there were significant talus deposits. Displaced rock armour and a rockfall block was noted on the path beneath these units,**

**MU4/1a** Close up photo of talus accumulation behind rock armour after the December 2013 surge. (Totally Active)

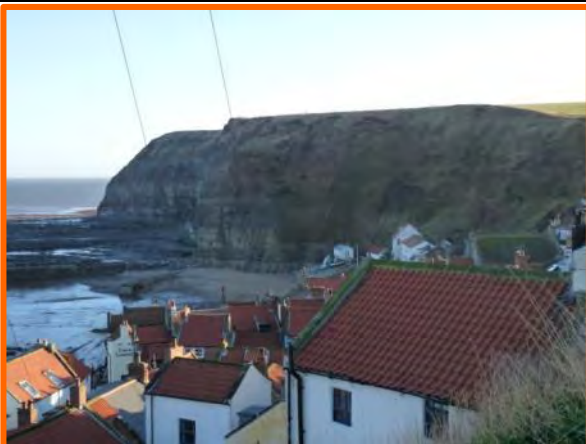
**MU4/2 – Cliff behind Staithes harbour. No notable change post December 2013 surge except lack of talus accumulation. (Partly Active)**

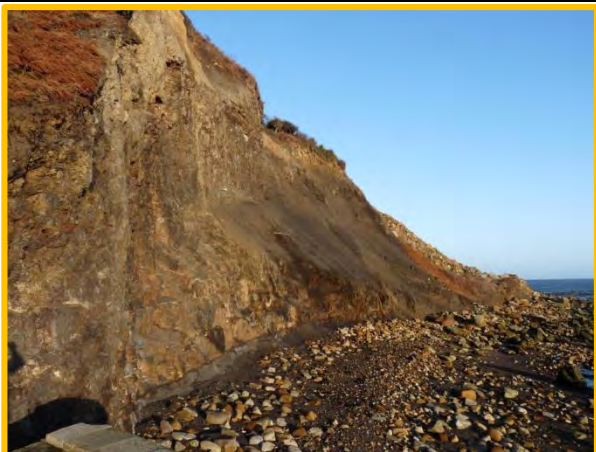
**MU6/8** – Small rockfalls witnessed from this unit during post December 2013 Storm Surge Inspection. Partly Active

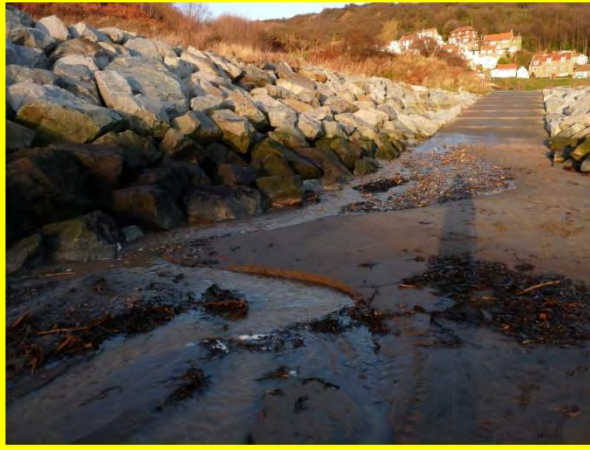
Following the December 2013 storm surge and a preceding night of heavy rain, a significant flow of water was noted issuing through the defences in this section. Also, toe erosion seems to have increased at the southern end of the unit therefore the activity status of this unit has been increased to 'Locally Active'.

MU7/2 Stream issuing through defences after heavy rainfall during post-December 2013 storm surge inspection. Locally Active.

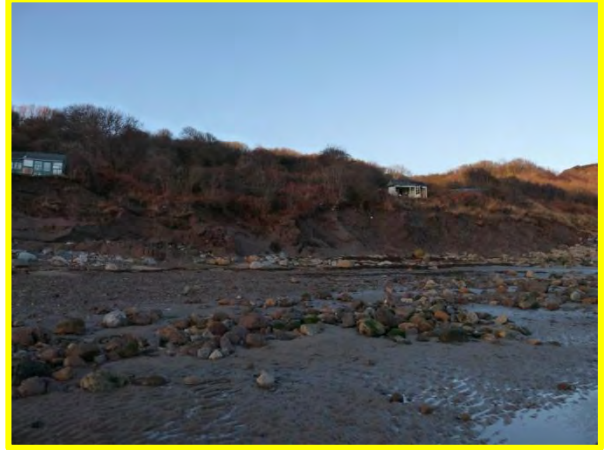
MU7/2 Increased toe erosion at southern end (where defences lower) at far right of photo. Locally Active.

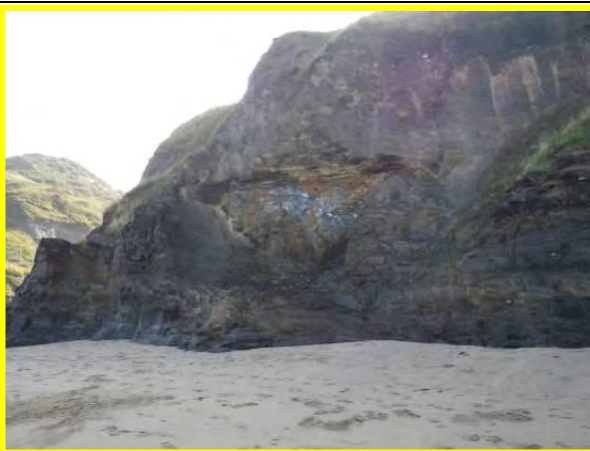
**Units MU7/3 and MU7/4** are located behind Runswick Sands. The cliffs here are vegetated and of a shallow gradient, similar to those within unit MU7/2. The units do not have any protection at the toe and therefore are subject to continual marine activity. The toe is generally steep as a result, does not support any vegetation cover, and shows evidence of recent slumping. As a result, both units were classified as Locally Active in 2012.

**MU7/4** – Toe erosion at the base of the cliff (Locally Active) (September 2012)

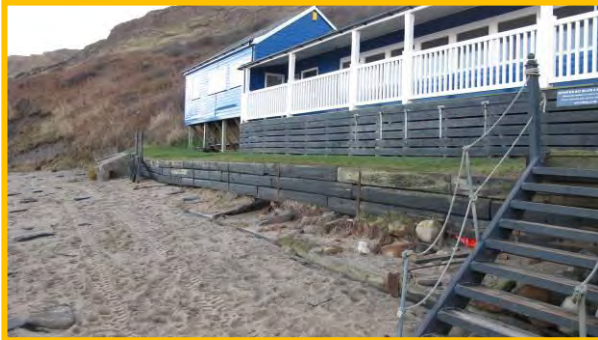
The Sailing Club, located in the bay some 600m south of the village, where the beach is wider has been constructed on timber struts and features a mix of coastal defences (Asset Ref. 1221D901D0602C05), below left and right. The informally placed relic tank trap blocks at the south end show extensive cracking. The timber defences across the front of the main building are showing signs of rot and will need replacement in future. **Since the storm surge of 5<sup>th</sup> December 2013, it is notable that beach levels in front of the Sailing Club are now higher than in 2012. However one set of access steps has been demolished by wave action.**

Runswick Bay sailing club timber defences at south end, 17<sup>th</sup> December 2013. Note missing steps to beach.  
(Asset Ref. 1221D901D0602C05)

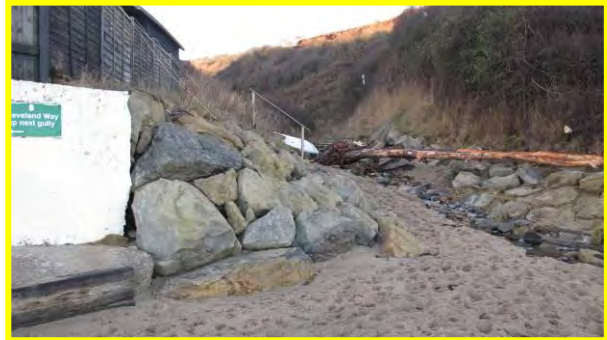
Northern end of defences at Runswick Bay sailing club, 17<sup>th</sup> December 2013. Note higher beach levels compared to 2012.  
(Asset Ref. 1221D901D0602C05)

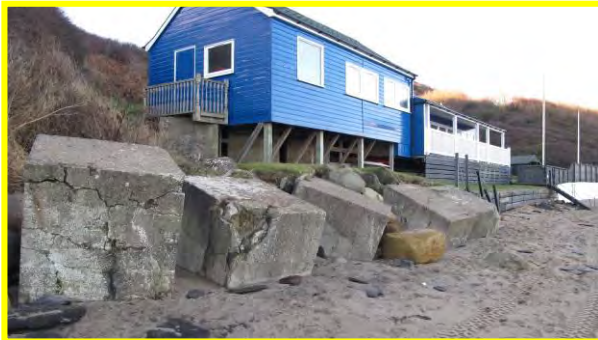
Runswick Bay sailing club concrete block defences at south end, 17<sup>th</sup> December 2013.  
(Asset Ref. 1221D901D0602C05)

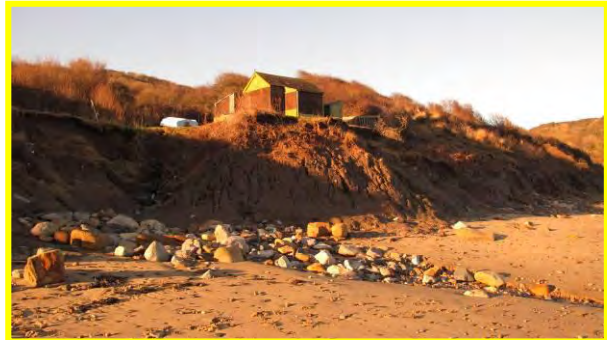
Eroding cliffs at Dunsley Dale near Runswick Bay Sailing club, 17<sup>th</sup> December 2013.

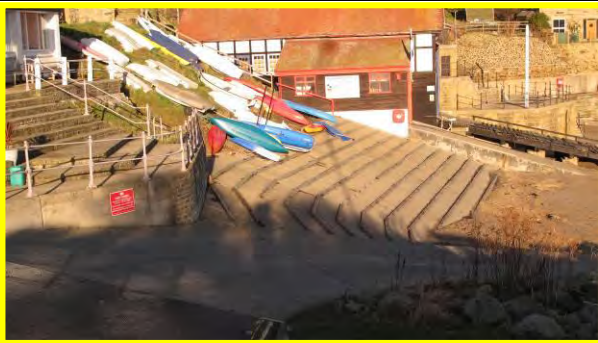
At the northern end of the rock armour, the slipway adjacent to the RNLI building was reported to be in good overall condition in October 2012, although the timber strips to support the small boats were rotting in many places and will need replacing and joints between slabs need resealing, below left. The seawall around the pumping station to the north of the RNLI building was also in very good condition, below right, although the standards for all of the handrails were showing corrosion and needed cleaning and repainting.

Northern slipway adjacent to the RNLI, 17<sup>th</sup>  
December 2013. Some timbers now missing.  
(Asset Ref. 1221D901D0601C04)

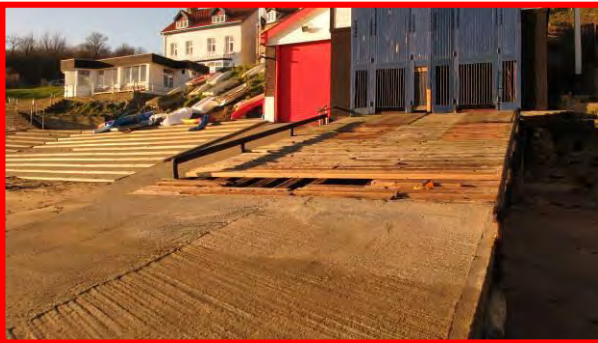
**Runswick Bay:** The rock armour defence remains in good condition. However, the series of patchwork defences to the north of the RNLI building exhibit a variety of defects. There are several large cracks in the walls and erosion and abrasion of the rocky foreshore is undercutting the foundations in several locations. However, there has been a slight recovery of beach levels with a small build-up of coarse grey sand / gravel from the eroding cliff to the north. Following the storm surge of 5<sup>th</sup> December 2013 significant elements of the patchwork defences north of the RNLI building have been damaged and removed by the sea. The RNLI timber slipway has also been damaged.

RNLI slipway damage, 17<sup>th</sup> December 2013  
(Asset Ref. 1221D901D0601C04)

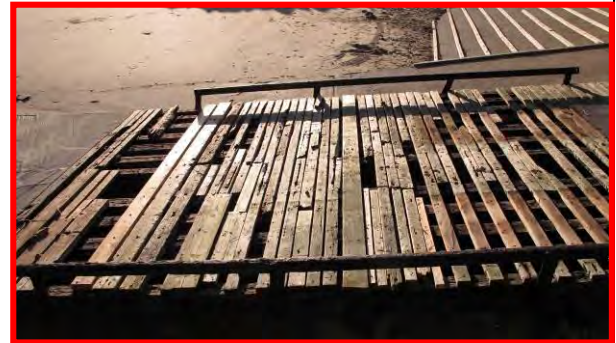
RNLI slipway damage viewed from the  
pumping station, 17<sup>th</sup> December 2013.  
(Asset Ref. 1221D901D0601C04)

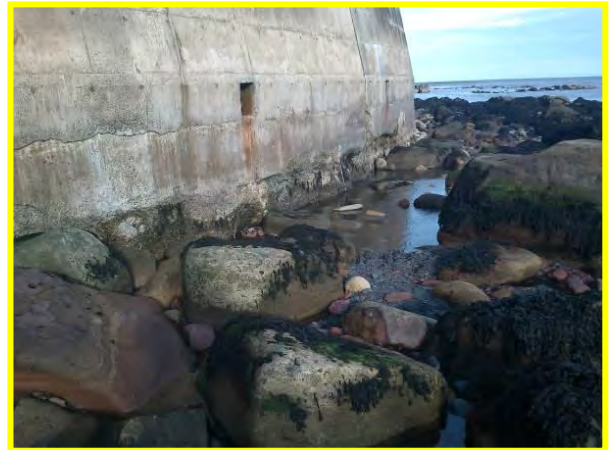
In October 2012 it was noted that the sea wall defences to the north of the new pumping station showed a variety of defects ranging from minor to more significant issues. The most northern coastal sea wall (Asset Ref. 1221D901D0601C01) is suffering from surface cracking and erosion. Erosion of the underlying rocky foreshore continues to cause undercutting of the sea wall. Further investigation is required to determine the rate of undercutting. Further defects include washed out sealant joints, flap valves on weep holes which have seized shut, wash out of the joints under the capping beam, vertical cracks through the wall, missing joints and filler in the seawall face and promenade surface with vegetation growth, and outflanking at tie in to eroding cliff at northern end, see photo lower right below. It was noted in 2012 that although changes are limited since the 2009 inspection it was recommended that the issues described were addressed.

Foreshore scour at toe of seawall, photo from 30/10/2012 (Asset Ref. 1221D901D0601C01) October 2012

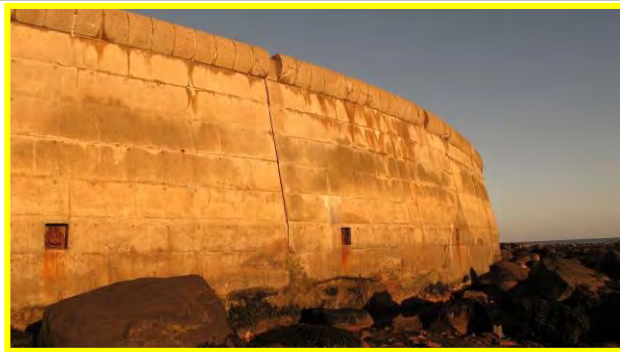
Northern coastal seawall, 17<sup>th</sup> December 2013 (Asset Ref. 1221D901D0601C01)

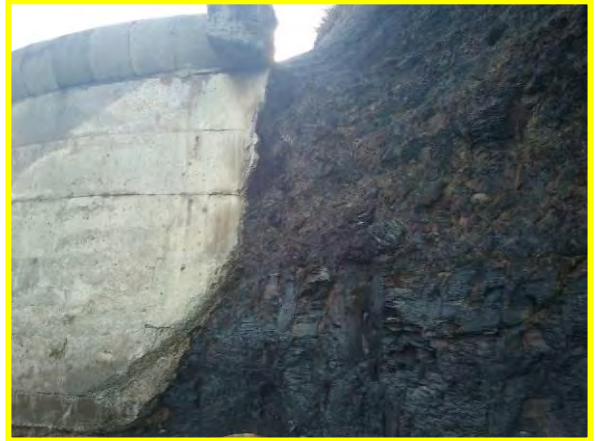
Erosion of cliff adjacent to north end of seawall,  
30/10/2012 (Asset Ref. 1221D901D0601C01)

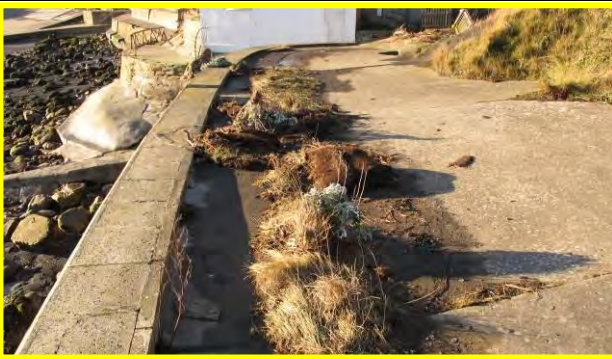
Promenade on top of northern seawall, 17<sup>th</sup>  
December 2013. Evidence of overtopping shown.  
(Asset Ref. 1221D901D0601C01)

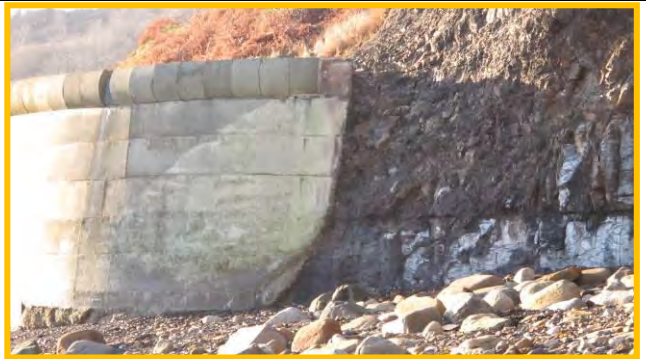
Erosion of cliff adjacent to north end of seawall, 17<sup>th</sup>  
December 2013.  
(Asset Ref. 1221D901D0601C01)

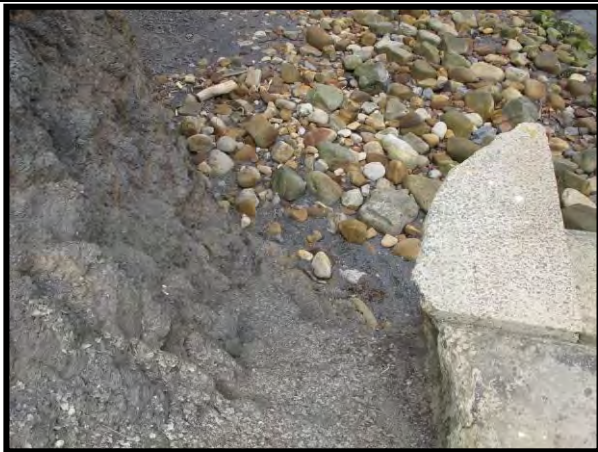
Cliff adjacent to north end of seawall from the top  
promenade, 10<sup>th</sup> July 2013.  
(Asset Ref. 1221D901D0601C01)

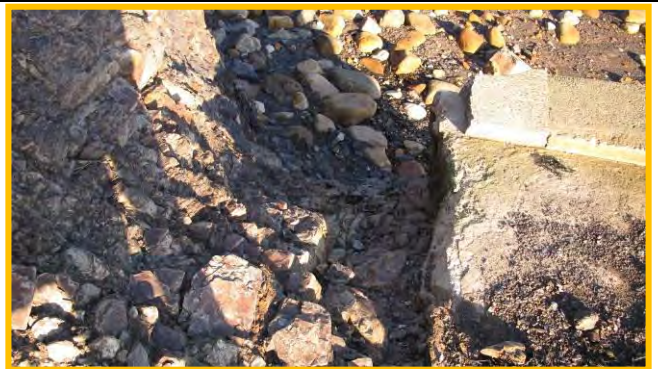
Further erosion of cliff adjacent to north end of  
seawall, and seawall damage since July 2013, from  
the top promenade, 17<sup>th</sup> December 2013. Old  
concrete wall/cliff abutment now missing.  
(Asset Ref. 1221D901D0601C01)

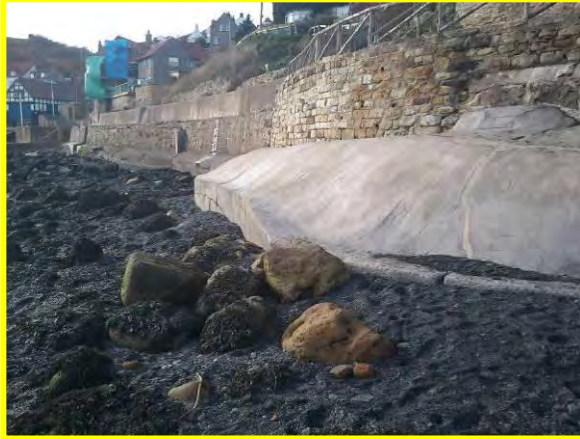
Moving south, the protruding section of wall (1221D901D0601C06) protecting the individual property is in fair condition. There are signs of repairs to the large vertical cracks in the wall and toe apron. However there are cracks in the top of the concrete bagwork part of the wall. **The fencing (private property) on top of the wall has been damaged during the storm surge event of 5<sup>th</sup> December 2013 indicating significant wave overtopping in this area.**

Repaired vertical cracks to toe of wall, and horizontal cracks holding, Oct 2012.  
(Asset Ref. 1221D901D0601C06)

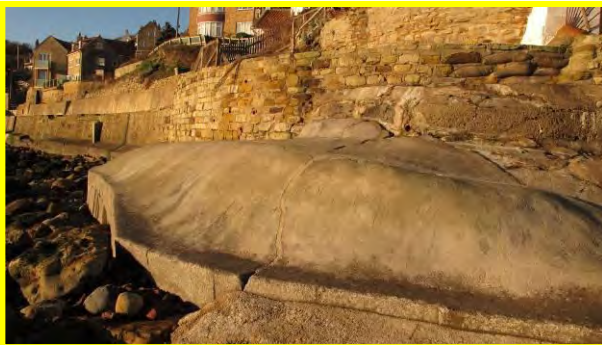
Toe of cottage wall, 17<sup>th</sup> December 2013.  
(Asset Ref. 1221D901D0601C06)

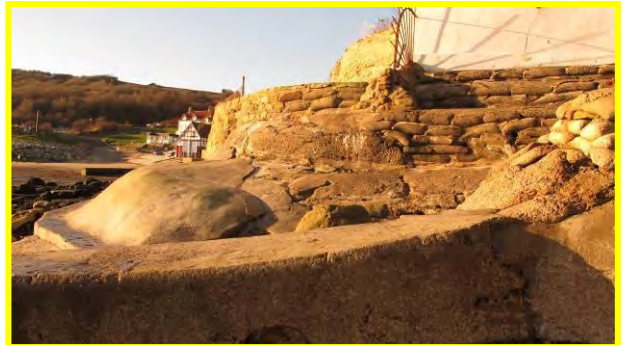
View of northern end of concrete bagwork, 17<sup>th</sup> December 2013.  
(Asset Ref. 1221D901D0601C06)

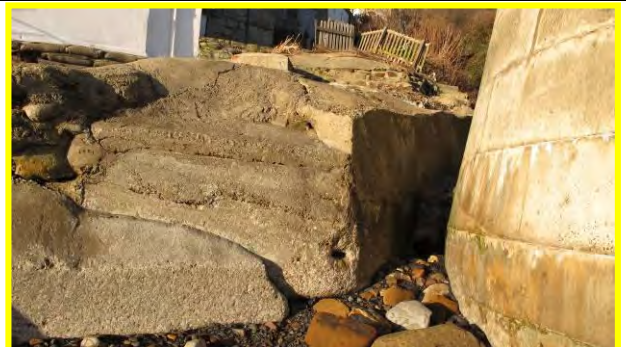
View of Runswick Beck outfall, 17<sup>th</sup> December 2013.  
(Asset Ref. 1221D901D0601C06)

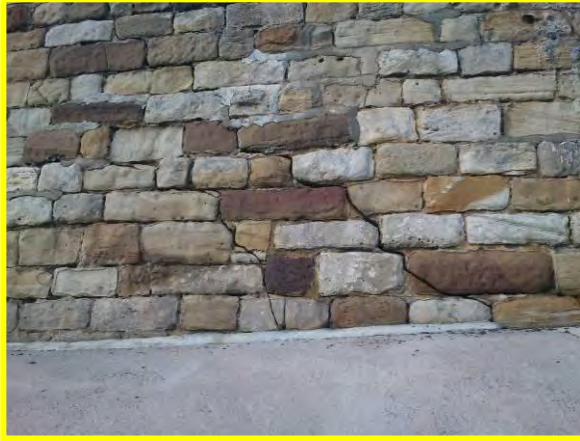
The main length of wall below the properties, Asset Ref. 1221D901D0601C03 is in variable condition. Although there are signs of repair work there are significant cracks in the wall and undercutting of the toe in several locations, see photos below. In October 2012 it was noted that the beach level has recovered here since the 2009 inspection with a small accumulation of coarse grey shale sand from the eroding landslip to the north of the village. **Various elements of blockwork on top of the wall have been damaged during the storm surge event of 5<sup>th</sup> December 2013.**

Diagonal cracks in wall. Oct 2012.  
(Asset Ref. 1221D901D0601C03)

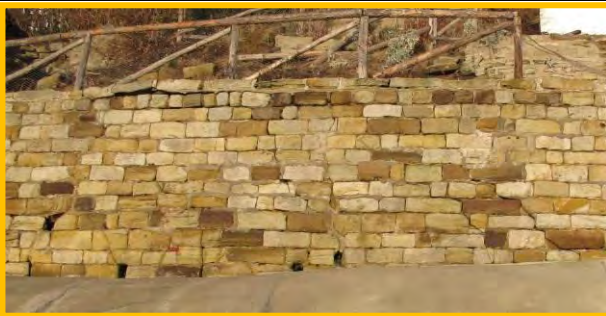
Same area as above with diagonal cracks and coping damage in wall, 17<sup>th</sup> December 2013.  
(Asset Ref. 1221D901D0601C03)

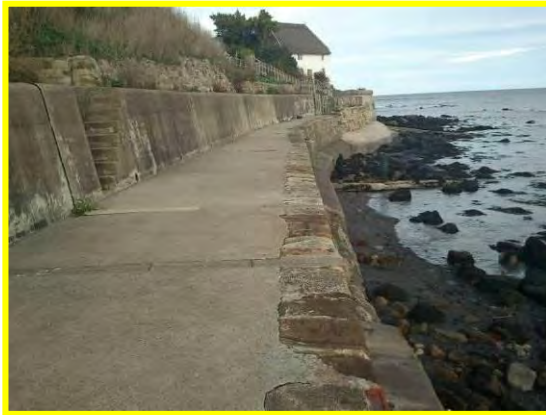
Overview of wall, Oct 2012.  
(Asset Ref. 1221D901D0601C03)

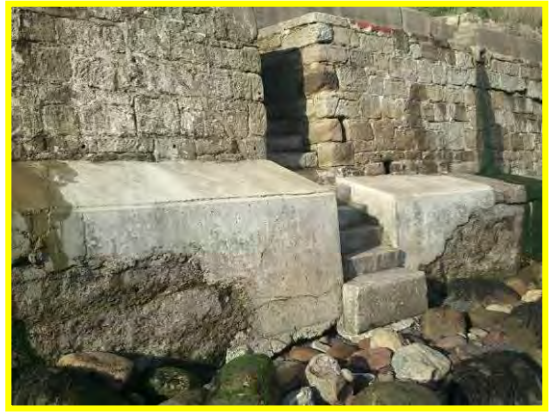
Undercutting of toe adjacent to steps, Oct 2012  
(Asset Ref. 1221D901D0601C03)

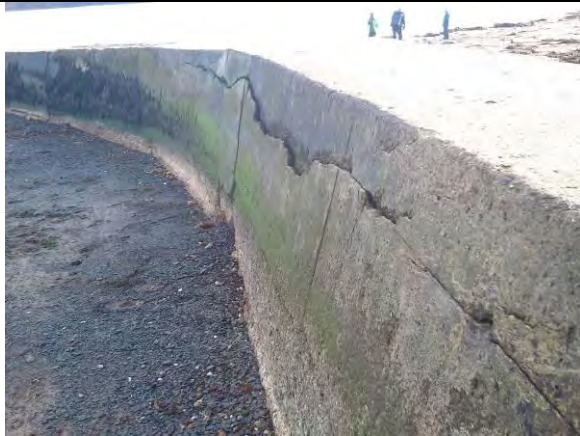
The concrete breakwater or groyne (Asset Ref. 1221D901D0601C02) to the north of the pumping station and lifeboat slip was noted to be in need of repair during the 2009 survey, with large horizontal and vertical cracks on both sides propagating through the defence. **The condition at the time of the October 2012 and December 2013 inspections was similar or slightly worse.**

Large horizontal crack to breakwater, Oct 2012.  
(Asset Ref. 1221D901D0601C02)

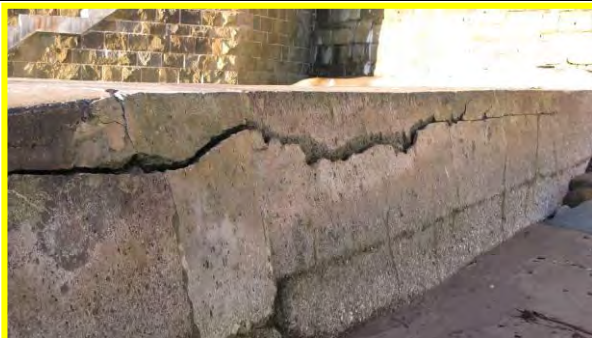
Large horizontal crack to breakwater, 17<sup>th</sup>  
December 2013.  
(Asset Ref. 1221D901D0601C02)

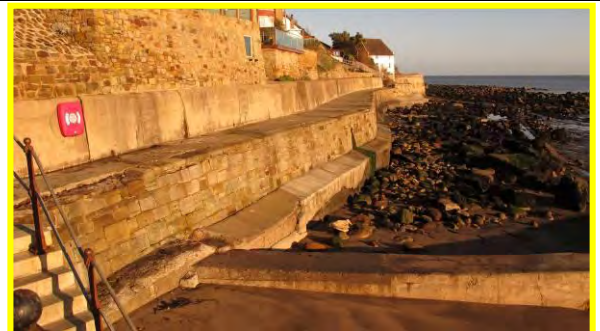
Head of breakwater, 17<sup>th</sup> December 2013.  
(Asset Ref. 1221D901D0601C02) and  
blockwork wall (Asset Ref.  
1221D901D0601C03)

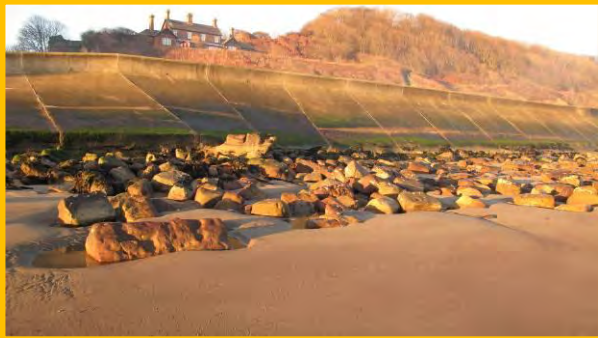
Sandsend Beck, see below right. There was also missing filler in the slipway joints and in the crest wall joints (2012). **The 17<sup>th</sup> December inspection found the condition to be similar, with defects slightly worse.**

Concrete revetment at the north of Sandsend, 17<sup>th</sup> December 2013. (Asset Ref No.1221D901D0701C02)

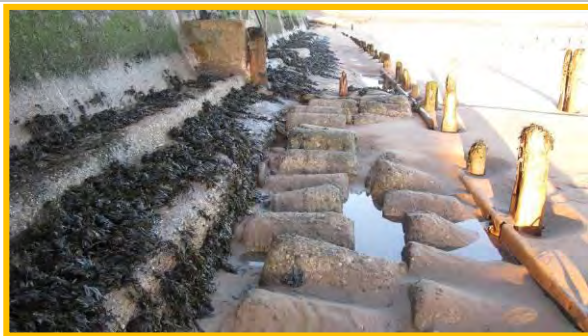
Similarly to the 2009 inspection, the beach was low in front of the main concrete seawall in front of Sandsend village (Asset Ref. 1221D901D0702C01) (October 2012 **and December 2013**). The groyne field is derelict and the remains have no significant impact on sand movement. The toe of the seawall was showing evidence of significant damage and movement in 2009 and the defence appears to have worsened over the last three years, with the timber breastwork deteriorating and allowing the ad hoc toe protection units to move. There are cracks in the wall and significant abrasion at the steps.

Failed timber groynes and timber breastwork at toe of wall in front of Sandsend, 17<sup>th</sup> December 2013. (Asset Ref. 1221D901D0702C01)

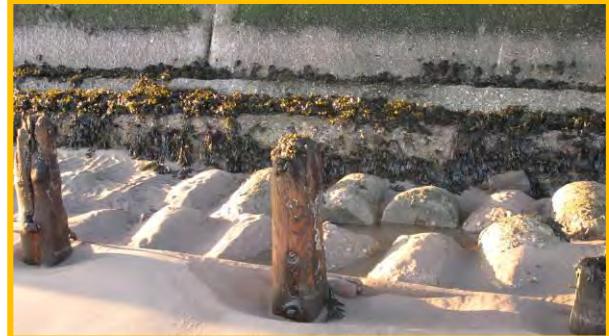
Failed timber breastwork at toe of wall in front of Sandsend, 17<sup>th</sup> December 2013. (Asset Ref. 1221D901D0702C01)

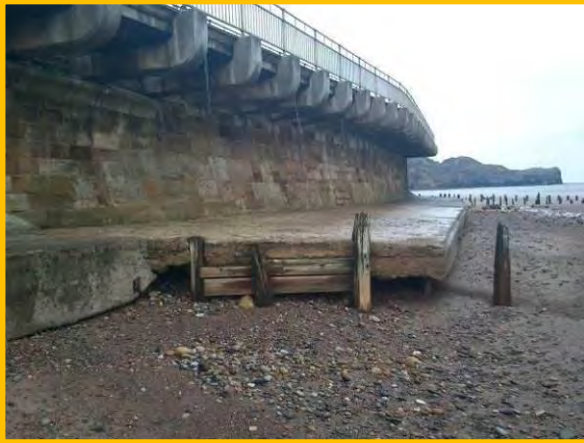
The newer short section of masonry blockwork sea wall (Asset Ref. 1221D901D0702C04) that supports a cantilevered promenade just north of East Row Beck was noted in the 2008 inspection to suffer from undercutting of the toe of the structure with steel sheet piling in need of repair. Although the main wall is in fair condition the defence has an overall rating of poor. The steel toe piling was visible in several locations during the 2012 inspection and is corroded and abraded. There are holes through the piles and voids behind under the apron. There is a particularly large void under the southern end of the apron, see below left. **The large void under the toe apron at the south end of the blockwork defence with the cantilevered walkway is now more apparent since the storm surge of 5<sup>th</sup> December 2013. The walkway itself has also suffered significant damage from wave action and has been closed to the public. Pedestrians are currently having to use the carriageway in this location.**

Masonry blockwork sea wall with cantilevered footway, showing large void under toe apron and failed groynes, Oct 2012. (Asset Ref. 1221D901D0702C04)

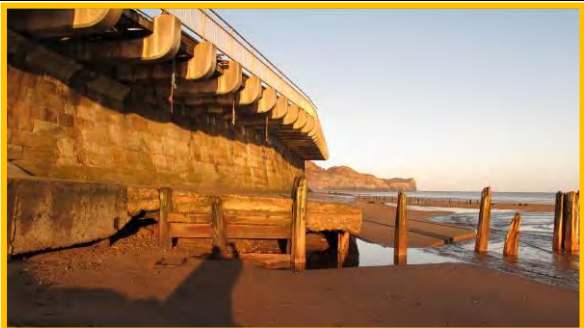
Masonry blockwork sea wall with cantilevered footway, 17<sup>th</sup> December 2013, showing larger void under toe apron and failed groynes. (Asset Ref. 1221D901D0702C04)

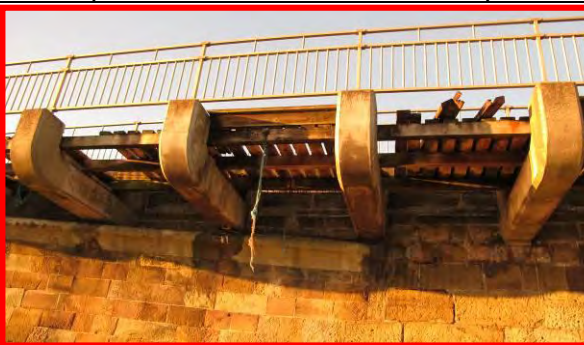
Cantilevered footway, 17<sup>th</sup> December 2013, showing storm damage on 5<sup>th</sup> December. (Asset Ref. 1221D901D0702C04)

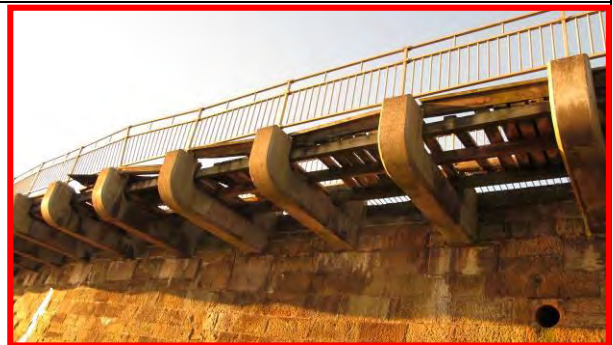
Cantilevered footway, 17<sup>th</sup> December 2013, showing storm damage on 5<sup>th</sup> December. (Asset Ref. 1221D901D0702C04)

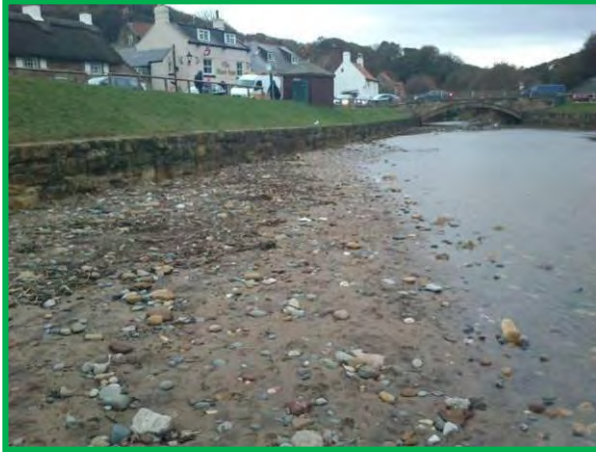
The low masonry wall (Asset Ref. 1221D901D0702C03), below left and right, that returns into both sides of East Row Beck adjacent to the road bridge is in overall good condition, although there is minor abrasion damage to some blocks and locally missing sections of mortar. **It is notable that since the storm surge of 5<sup>th</sup> December 2013, extensive beach material has accumulated in the East Row Beck inlet area between the retaining walls.**

Low masonry wall at east Row Beck, south bank, Oct 2012. (Asset Ref. 1221D901D0702C03)

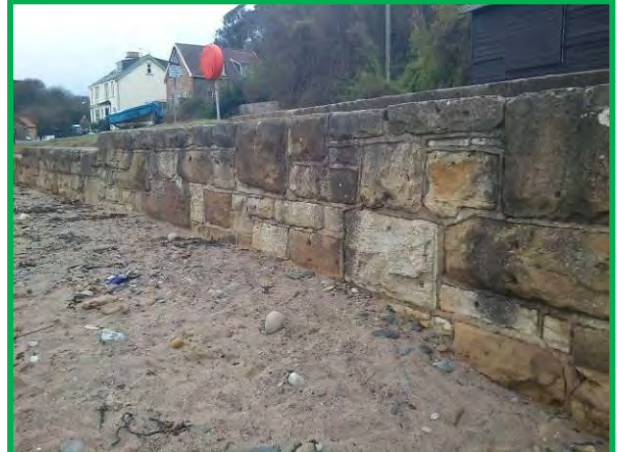
Low masonry wall at east Row Beck, north bank, Oct 2012. (Asset Ref. 1221D901D0702C03)

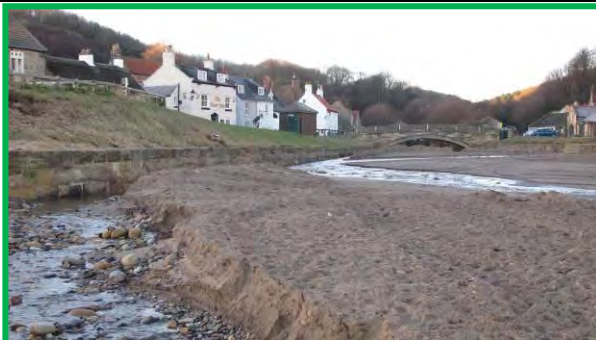
Low masonry wall at East Row Beck, south bank, 17<sup>th</sup> December 2013. Note accumulation of sand with the beck cutting through. (Asset Ref. 1221D901D0702C03)

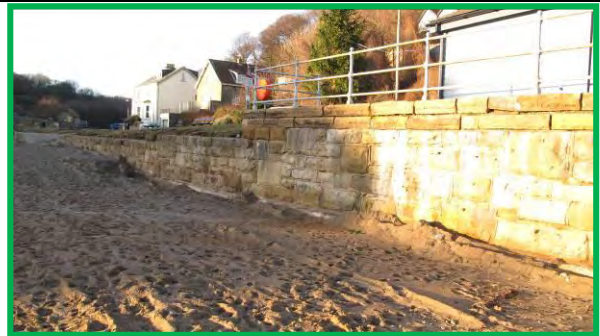
Low masonry wall at East Row Beck, north bank, 17<sup>th</sup> December 2013. (Asset Ref. 1221D901D0702C03)

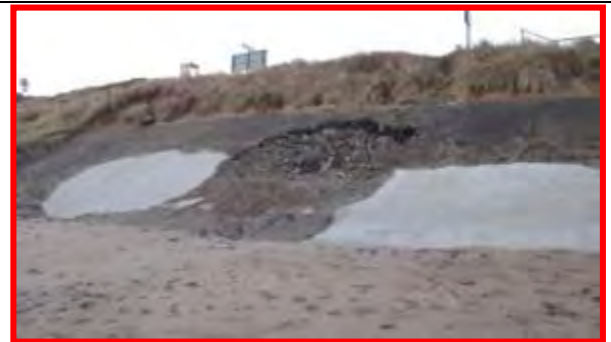
New large void in revetment adjacent to previous and more recent patch repairs, 17<sup>th</sup> December 2013. Compare to 2012 inspection (left). (Asset Ref. 1221D901D0702C02)

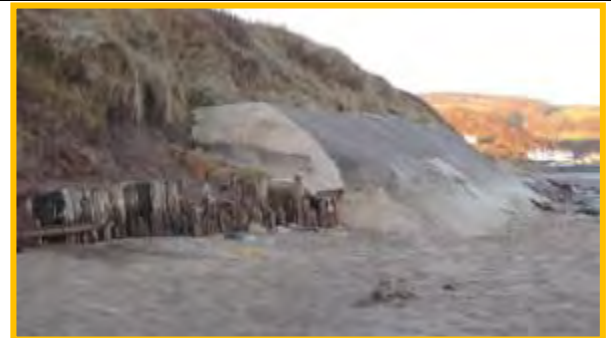
East end of the concrete revetment, 17<sup>th</sup> December 2013. Note lower beach levels compared to 2012 inspection (left). (Asset Ref. 1221D901D0702C02)

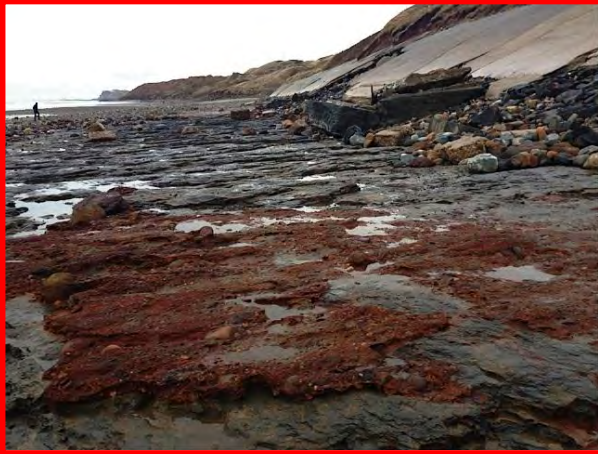
Significant further damage to the asset was evident following the storm surge of 5<sup>th</sup> December 2013. North Yorkshire County Council (NYCC) carried out a visual inspection on 8<sup>th</sup> December 2013 as the defence fronts the A174 carriageway. Notable during this inspection was the loss of beach material on the foreshore exposing clay. Some sand recovery is however evident during the inspection of 17<sup>th</sup> December. Various elements of the sloping concrete defences south of Sandsend have been broken out and scoured by the sea during the storm surge. The voids have been temporarily refilled with rock debris rescued from the beach area (ongoing operation on 17<sup>th</sup> Dec 2013) but the whole wall needs urgent attention.

Sandsend seawall revetment and eroded beach following the storm surge of 5<sup>th</sup> December 2013. Photo taken on 8<sup>th</sup> December 2013, NYCC inspection.  
(Asset Ref. 1221D901D0702C02)

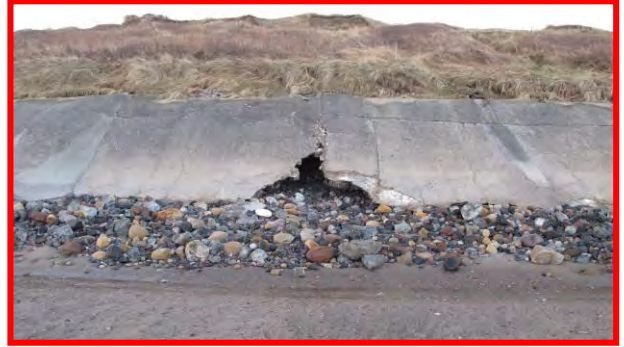
Viewing defence east to west, void in eastern revetment, 17<sup>th</sup> December 2013.  
(Asset Ref. 1221D901D0702C02)

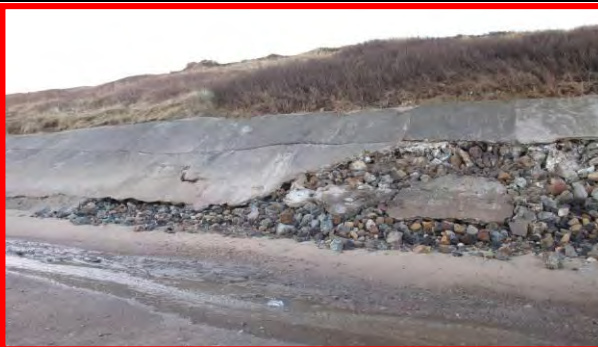
Extensive damage to revetment temporarily filled in, 17<sup>th</sup> December 2013.  
(Asset Ref. 1221D901D0702C02)

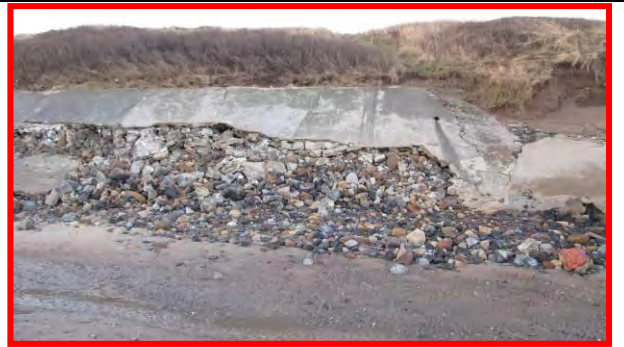
Extensive damage to revetment temporarily filled in, 17<sup>th</sup> December 2013.  
(Asset Ref. 1221D901D0702C02)

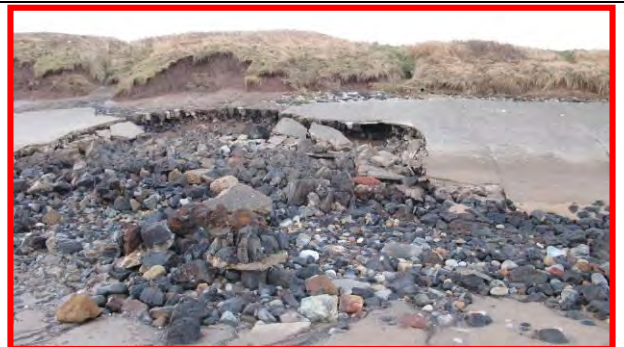
Previous repairs to revetment scoured out, 17<sup>th</sup> December 2013. Note slight recovery of beach sand compared to 8<sup>th</sup> December photograph at the same location (left).  
(Asset Ref. 1221D901D0702C02)

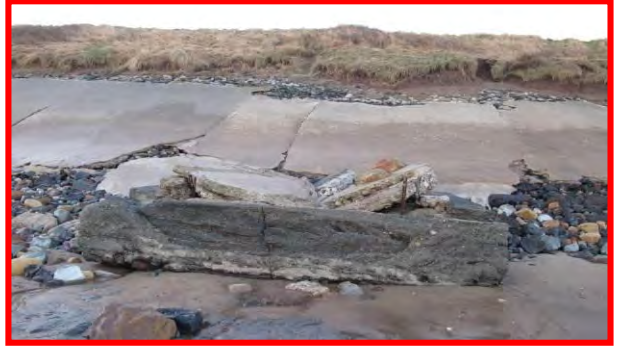
Extensive damage to revetment on 17<sup>th</sup> December 2013. Same location as previous photo (left). Again slight recovery of beach sand evident. (Asset Ref. 1221D901D0702C02)

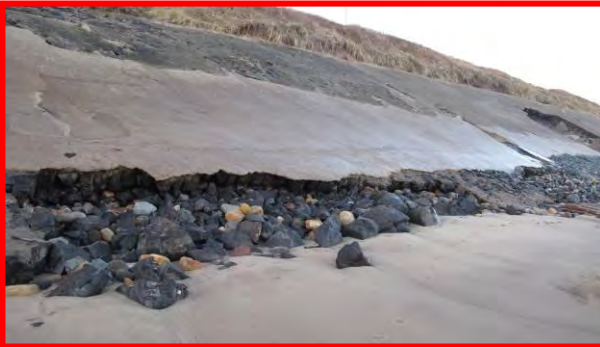
Extensive damage to toe of revetment, 17<sup>th</sup> December 2013. (Asset Ref. 1221D901D0702C02)

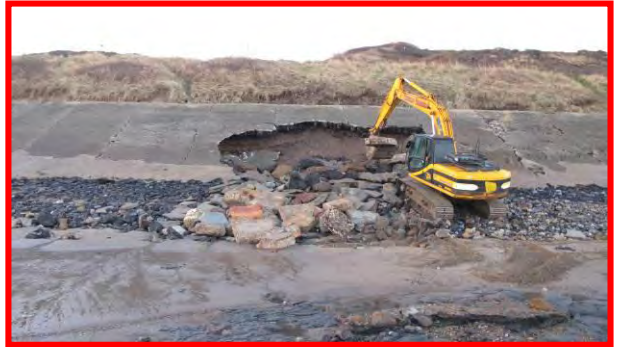
Temporary repairs to revetment being carried out on 17<sup>th</sup> December 2013. (Asset Ref. 1221D901D0702C02)

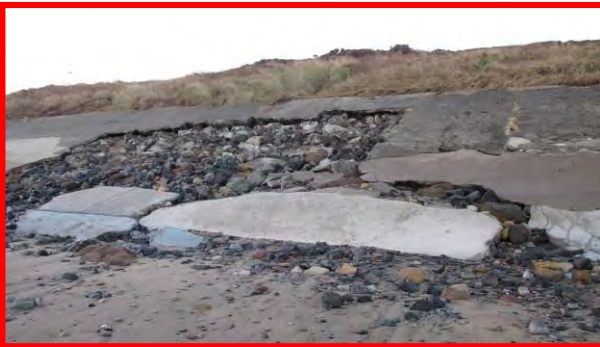
Temporary repairs to revetment voids on 17<sup>th</sup> December 2013. (Asset Ref. 1221D901D0702C02)

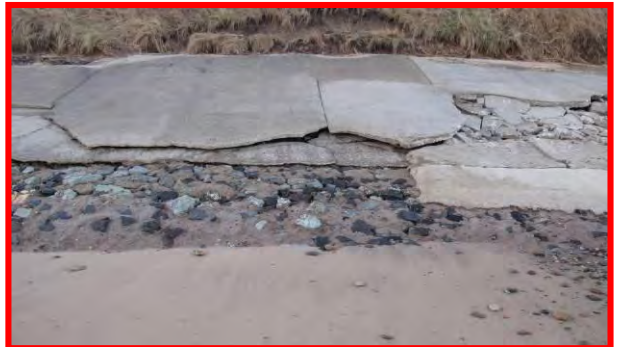
Extensive damage to revetment slabs, 17<sup>th</sup> December 2013. (Asset Ref. 1221D901D0702C02)

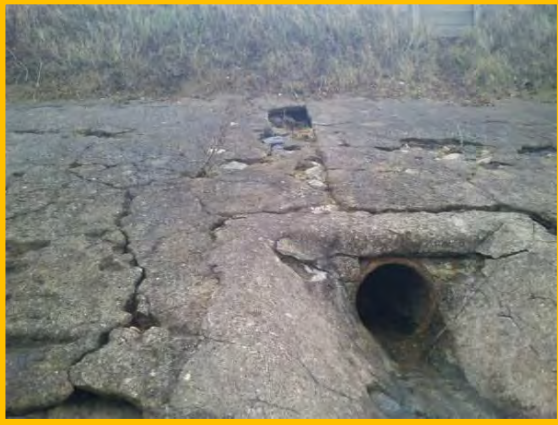
Cracks and voids in surface of concrete revetment, Oct 2012. (Asset Ref. 1221D901D0702C02)

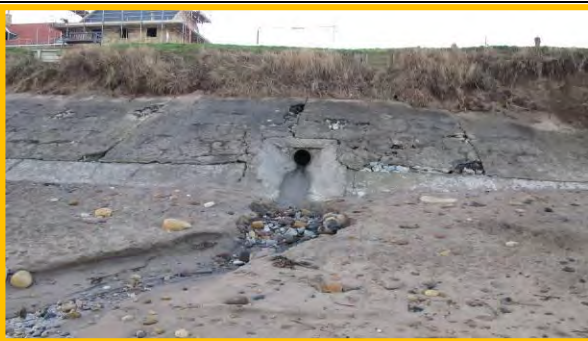
Cracks and voids in surface of concrete revetment, 17<sup>th</sup> December 2013. (Asset Ref. 1221D901D0702C02)

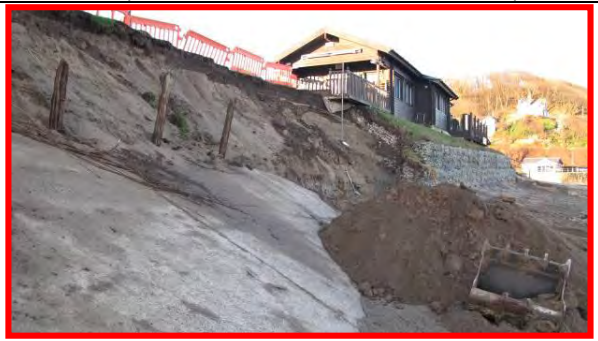
Corner of gabions protecting café at NW end of revetment being repaired, 17<sup>th</sup> December 2013. (Asset Ref. 1221D901D0702C02)

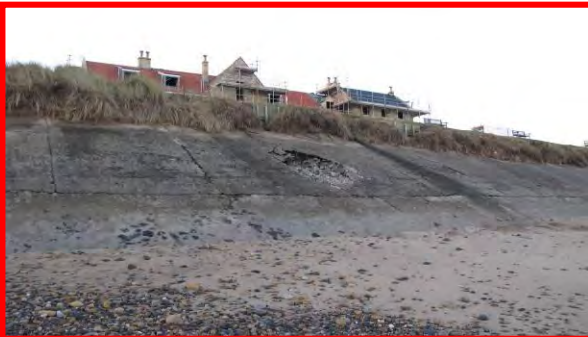
Cracks and voids in surface of concrete revetment, 17<sup>th</sup> December 2013. (Asset Ref. 1221D901D0702C02)

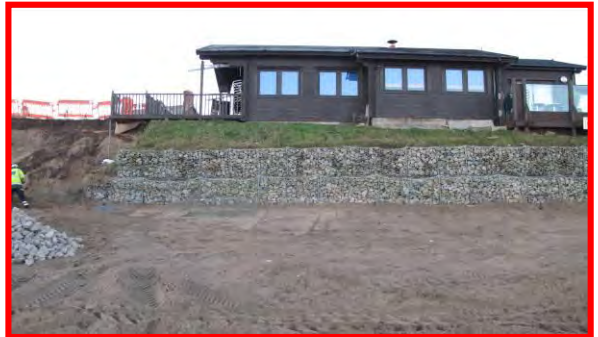
Gabions protecting café at NW end of revetment, 17<sup>th</sup> December 2013. Area to the left being repaired with extension to gabions. (Asset Ref. 1221D901D0702C02)

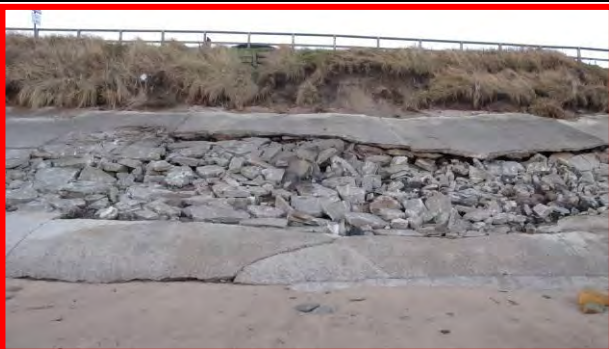
Extensive damage to revetment temporarily filled in, 17<sup>th</sup> December 2013. (Asset Ref. 1221D901D0702C02)

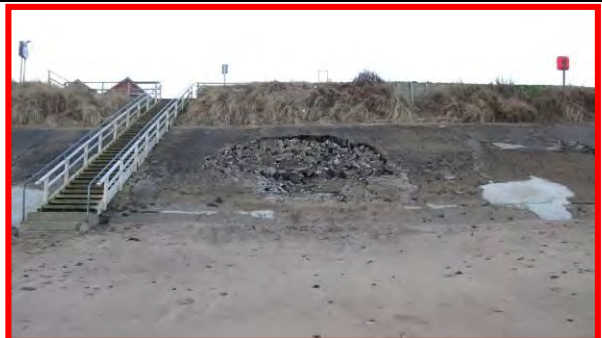
More voids forming in surface of concrete revetment, 17<sup>th</sup> December 2013. (Asset Ref. 1221D901D0702C02)

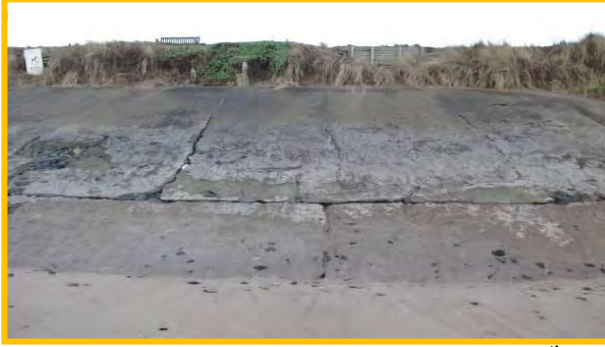
Cracks in surface of concrete revetment, 17<sup>th</sup> December 2013. (Asset Ref. 1221D901D0702C02)

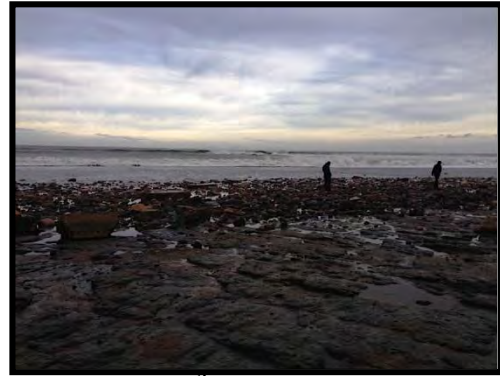
Foreshore on 8<sup>th</sup> December 2013, NYCC inspection. (Asset Ref. 1221D901D0702C02)

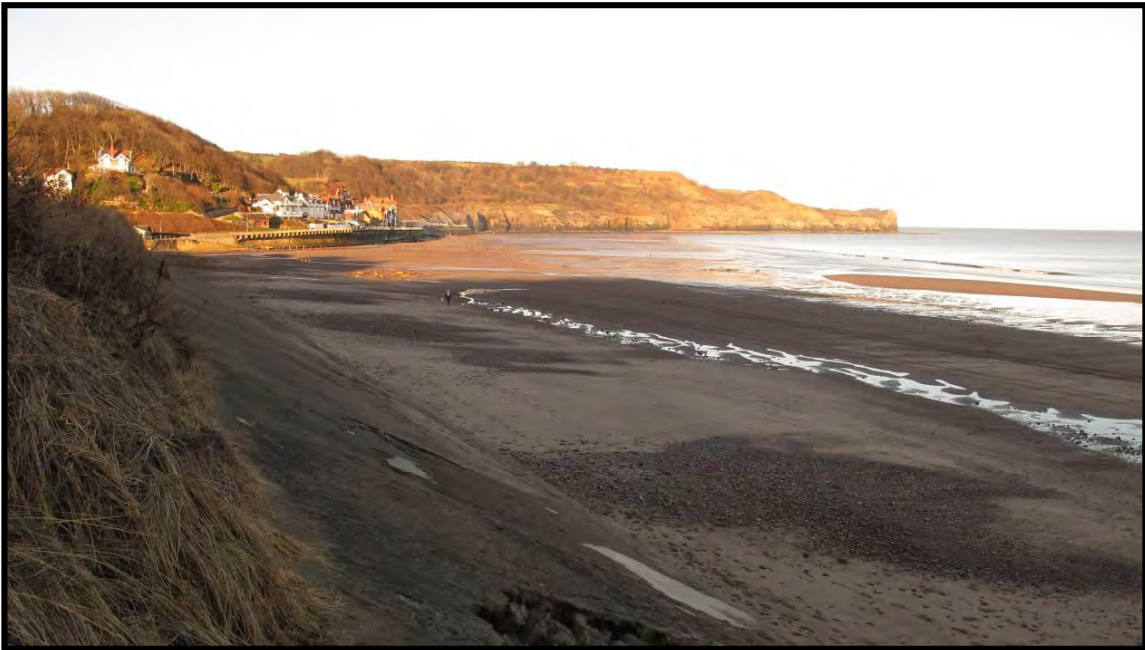
General view of Sandsend beach looking North West with beach levels on 17<sup>th</sup> December 2013. (Asset Ref. 1221D901D0702C02)

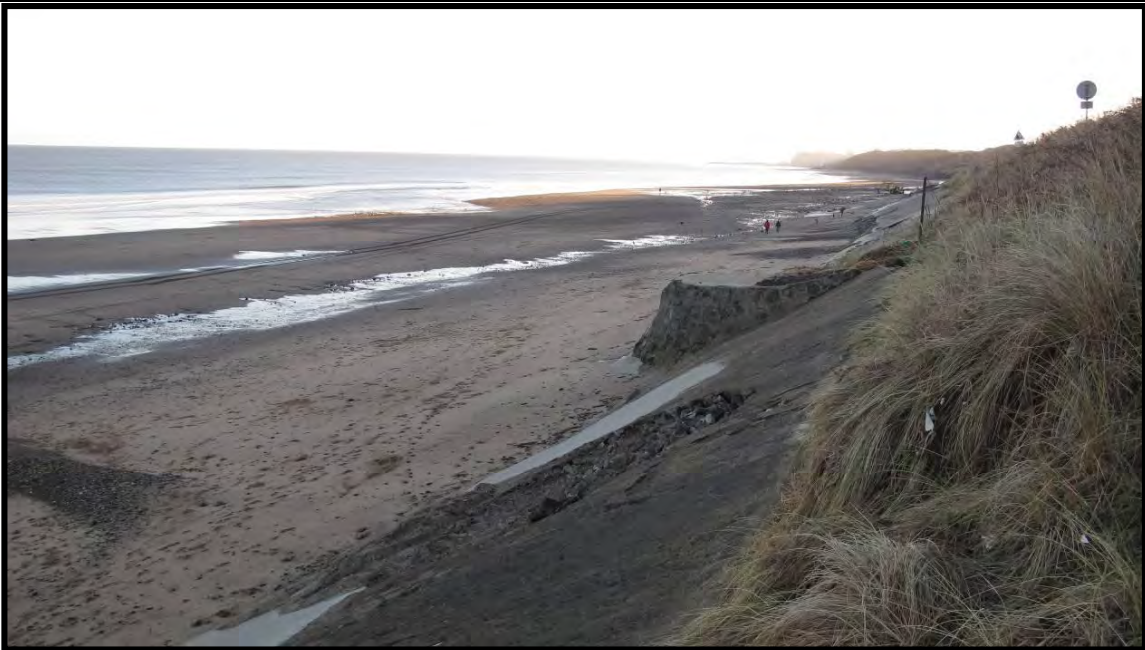
General view of Sandsend beach looking South East with beach levels on 17<sup>th</sup> December 2013. (Asset Ref. 1221D901D0702C02)

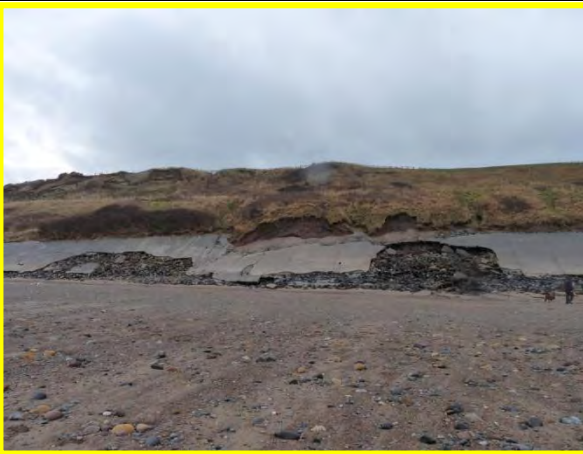
During the post-December 2013 storm surge inspection, recent toe erosion and active erosion in the upper slopes were noted in unit MU9/4 and its status of 'Locally Active' has therefore been retained. Toe erosion in unit MU10/1, whilst relatively limited in its upslope extent, was continuous through seaward facing part of the unit and therefore the activity status of this unit has been elevated to 'Locally Active'. Unit MU10/2 had experienced significant toe erosion along the entirety of its length, but with erosive activity increasingly extending into the upper slopes towards the eastern end of the unit. The difference in the extent of activity into the upper slopes towards the eastern end of the unit could arguably justify a 'Totally Active' status. However due to the lesser degree of activity in the upper slopes towards the western end of the unit an activity status of 'Partly Active' has been retained. There may be a case for splitting this unit into MU10/2a and MU10/2b, with the more westerly receiving a 'totally active status'. This should be reviewed during the 2014 walkover inspection.

**MU9/4** Recent erosion of the toe (above the defences) and erosive features in the upper slopes (December 2013). (Locally Active).

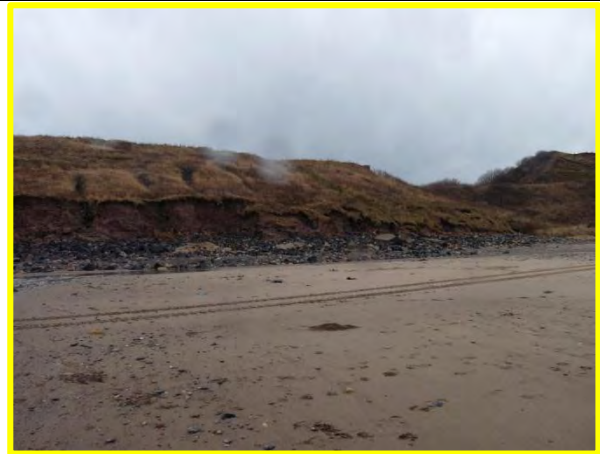
**MU10/1** (Right of centre) Note toe erosion resulting in elevation of status to 'Locally Active'

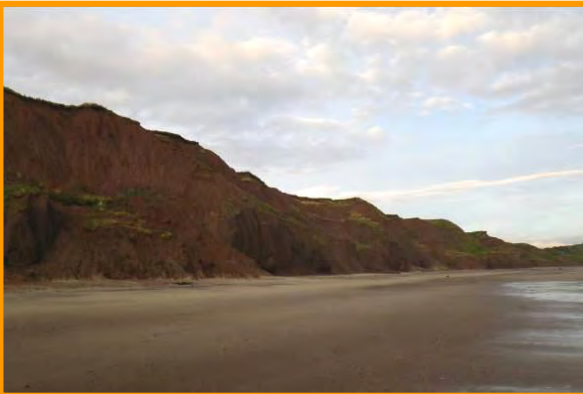
**Unit MU10/2** comprises the till cliffs behind Upgang Beach. These cliffs are prone to episodic failure in the form of mudsliding and block failure onto the beach. Vegetation cover is patchy along the cliff face and is likely to be related to the landslide cycles. This unit is classified as Partly Active.

**MU10/2** The collapsing till cliffs at Upgang Beach (Partly Active) (Sept 2013)

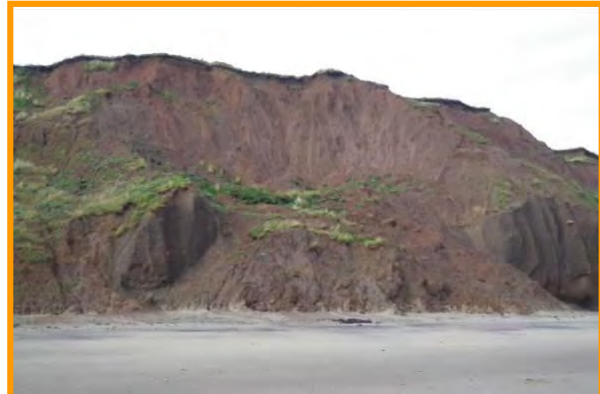
**MU10/2** An example of the failures seen along Upgang Beach (Partly Active) (Sept 2013)

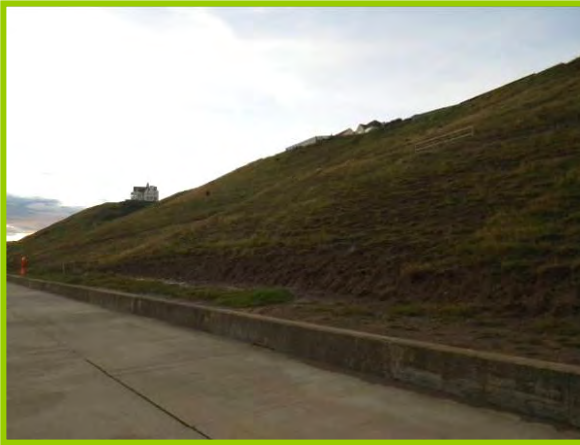
**MU11/1** Regraded, stabilised slopes (Inactive)  
Oct 2012
