**Walk-over Visual Inspections of Selected Assets  
following Storm Surge of  
5<sup>th</sup> December 2013**

**Scarborough Borough Council  
Supplementary Report**

**December 2013**

### Walk-over Visual Inspections of Selected Assets following Storm Surge of 5th December 2013

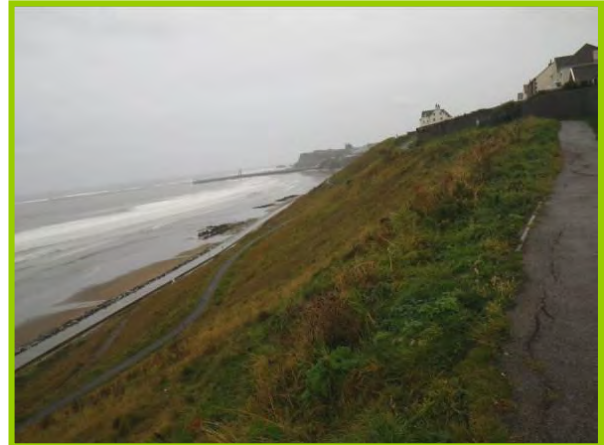
**MU11/1** The upper sections of the slopes are in good condition (Inactive) Oct 2012

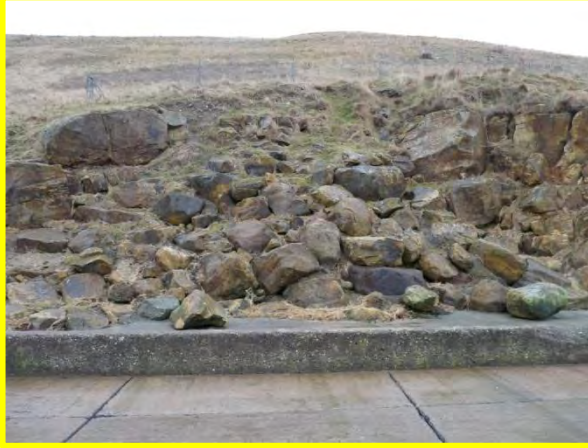
allowing more powerful waves to overtop of the sea wall at the highest tides and cause toe erosion at this point. Some recent movement and chipping of rockfall blocks was also noted and bedrock was exposed at the most eastern point in the unit.

**MU11/1 – Recently chipped and moved rockfall blocks at eastern end of unit. December 2013. (Locally Active)**

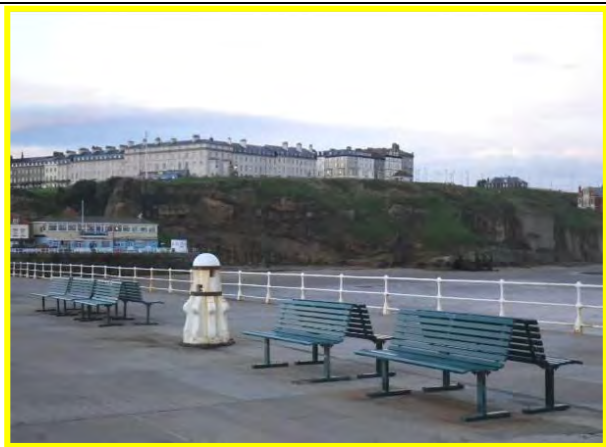
These units are generally protected by a variety of coastal structures. The coastal slope at **unit MU1/3** shows very few signs of activity and therefore is classified as Inactive. Exposed rock faces are showing minor erosion in the absence of defences in places within **unit MU11/14**. As a result, this unit is classified as Locally Active.

**MU11/4** Localised erosion above Whitby Sands (Locally Active)

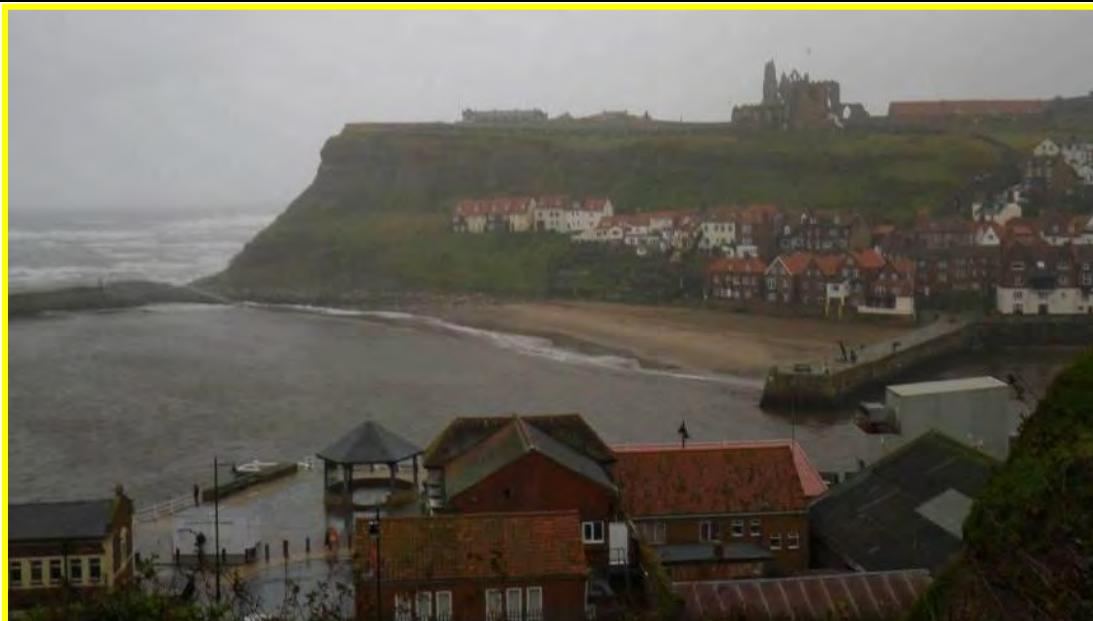
This Management Unit consists of **unit MU12/1**, which is situated beneath Whitby Abbey and St Mary's church on the town's East Cliff ([Appendix A, Map 2](#)). The slopes are well vegetated with toe protection afforded by the harbour walls meaning much of their face is covered by a debris apron. Localised activity occurs at the headscarp and in the debris apron. This unit is classified as Locally Active, which has not changed status since 2009.

**MU12/1** Below Whitby Abbey the slopes are vegetated, but with localised signs of erosion (Locally Active). Cliffs behind Henrietta St (row of white cottages extending along cliff face below St Mary's

church) are subject to periodic failure.

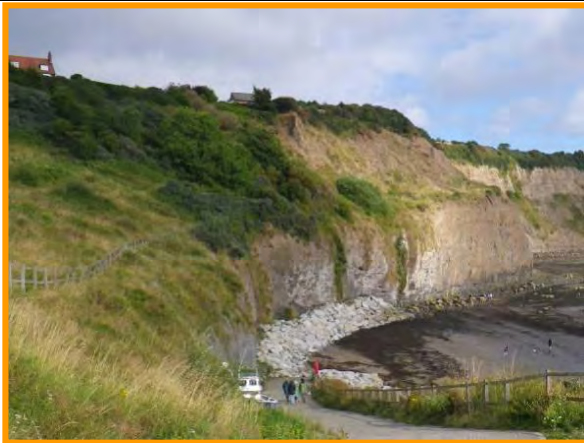
**MU16/1** Cliffs below the upper part of Robin Hood’s Bay Village (Partly Active) Sept 2012

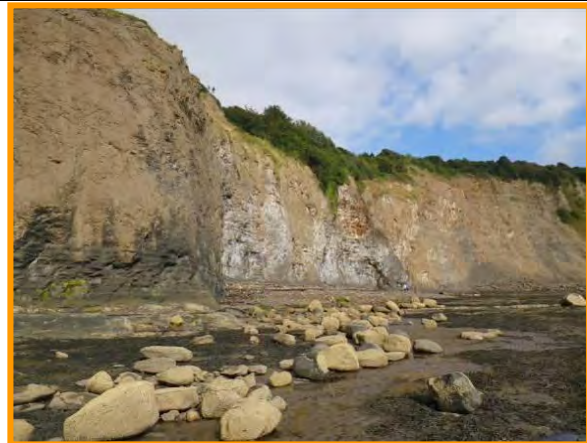
**MU16/1** the base of the cliff continues to erode. The undercutting of the cliff is evident in the left side of the photograph (Partly Active) Sept 2012

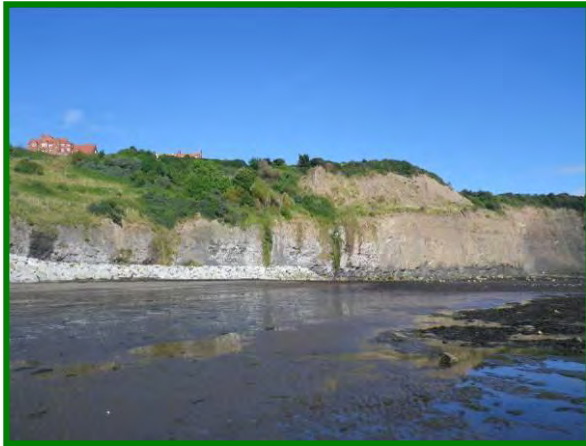
**MU16/2** The cliffs have been stabilised at the toe but show some signs of erosion on their face (Dormant). Sept 2012

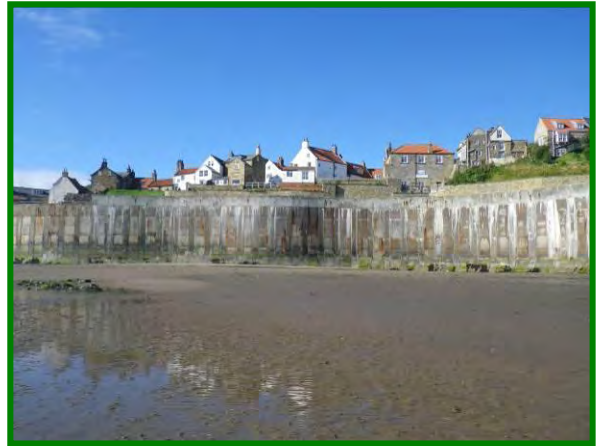
**MU16/3** The cliff at this location has been stabilised and is not visible through much of the unit (Dormant).Sept 2012

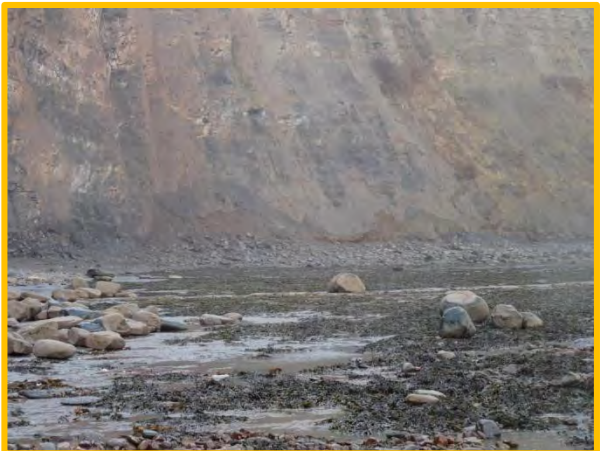
**MU16/1** Erosion and coarse, angular debris (centre photo) at the cliff toe, December 2013.

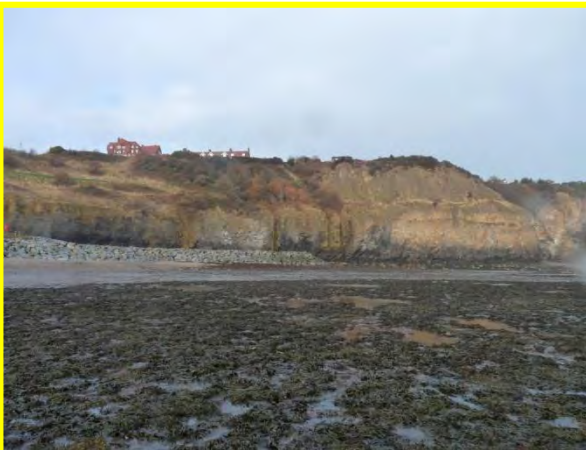
**MU16/2** Northern half of MU 16/2, December 2013. Note increase activity beyond end of defences (Locally Active)

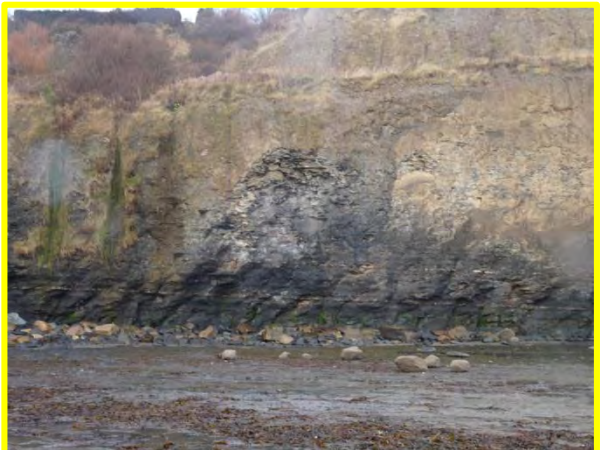
**MU16/2** Close up of scar in cliff in northern third of the unit indicating continued erosion and therefore a status of 'Locally Active'. December 2013.

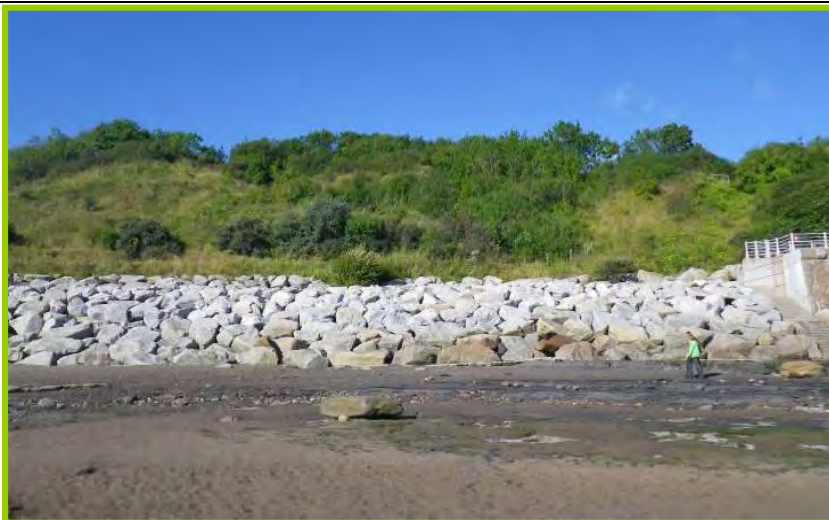
**MU17/1** The defended toe and heavily vegetated slopes show that the unit has been stable (Inactive) Sept 2012

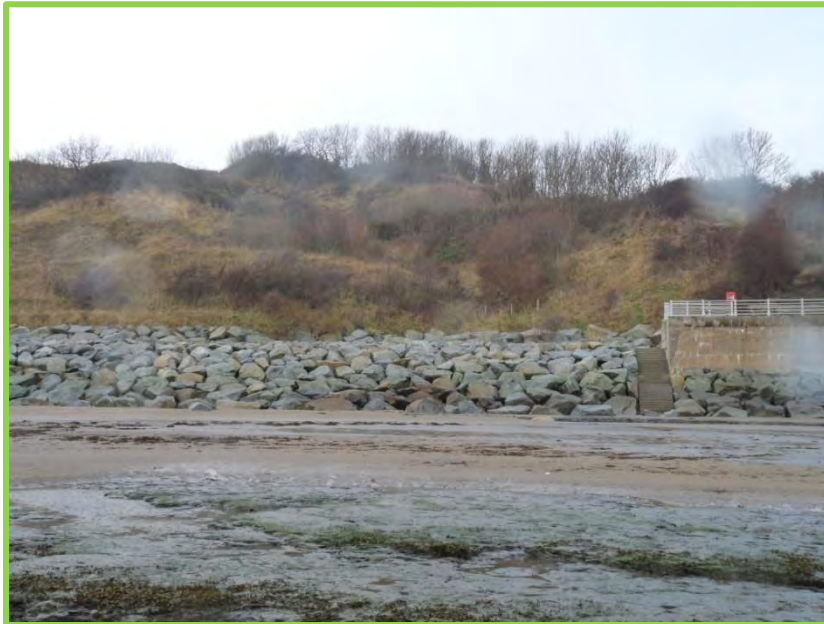
**MU17/1** No change was noted to this unit following the December 2013 storm surge.

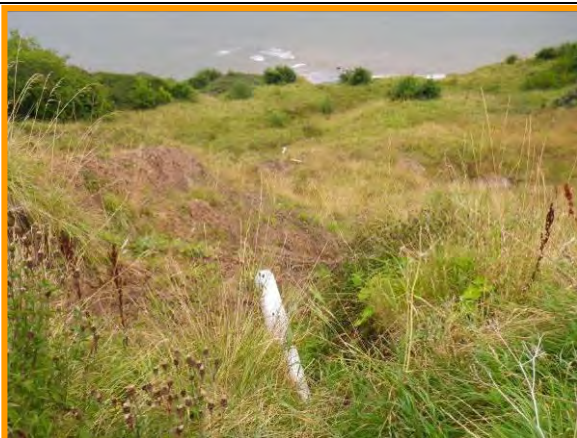
**MU17/2** The land drains from the adjacent fields are draining on to the cliff and causing instability (Partly Active). Sept 2012

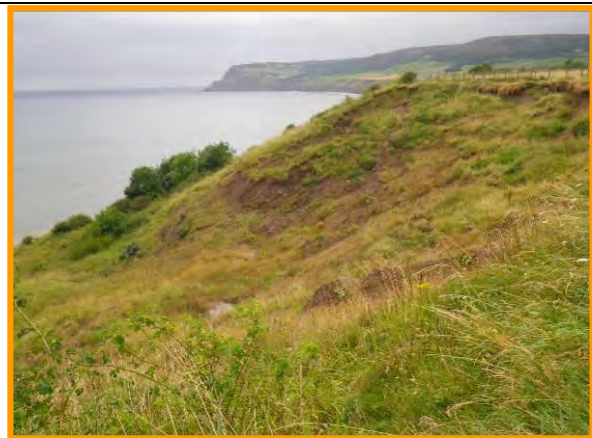
**MU17/2** The slope is showing evidence of ground movement (Partly Active). Sept 2012

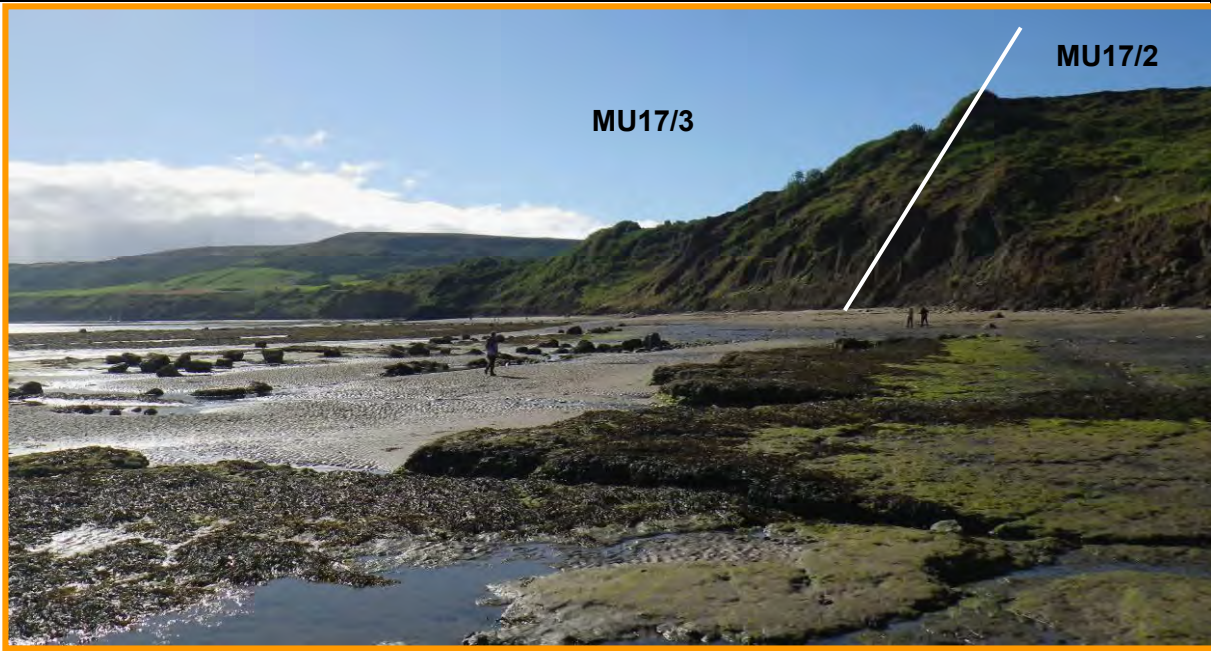
**MU17/3** Looking south across Robin Hood's Bay (Partly Active) (approx. unit extents shown)  
Sept 2012

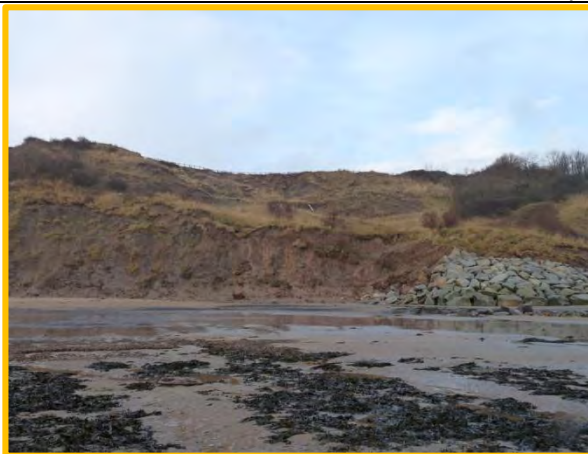
**MU17/2** Recent erosion at toe and erosive features higher in cliff, December 2013 (Partly Active).

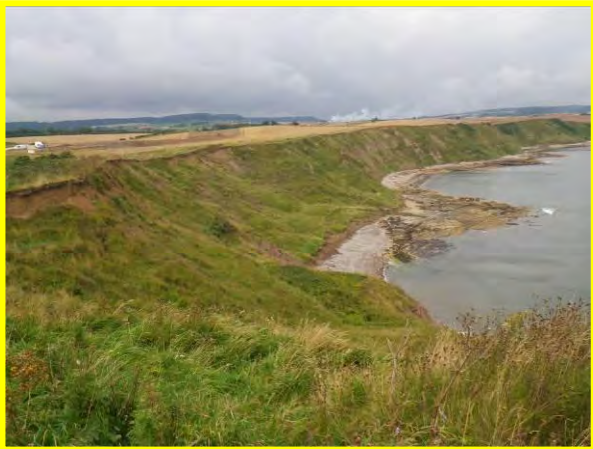
**MU19/9** There is evidence of headscarp erosion and erosion of the toe (Locally Active) Sept 2012

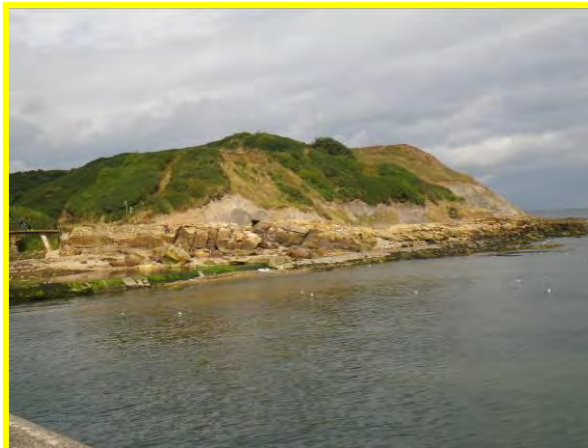
**MU19/11** Long Nab is eroding at the toe but the cliff face is well-vegetated and stable (Locally Active) Sept 2012

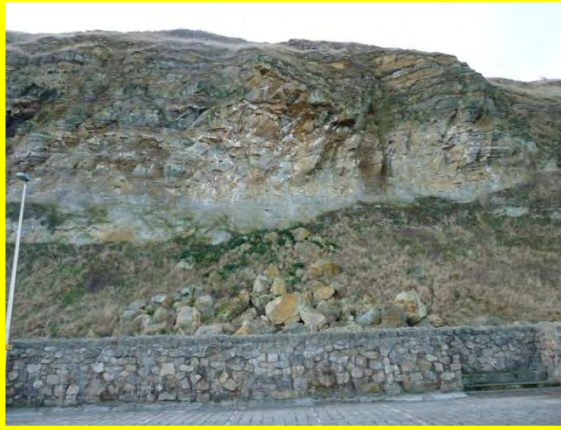
**Castle Cliff promontory was observed to still be locally active during the December 2013 walkover inspection, with significant areas of the cliff vegetated, but also with large areas of exposed bedrock. Large rockfall debris was present at the toe of the slope (behind the wall separating the cliff from the road) and a near-continuous stratum of particularly eroded sandstone was noted near the top of the cliff, the erosion of which may be undermining and causing rockfalls from the more competent strata above.**

**MU21/2 – December 2013. Large rockfall but with significant proportions of the slope still vegetated (Locally Active)**

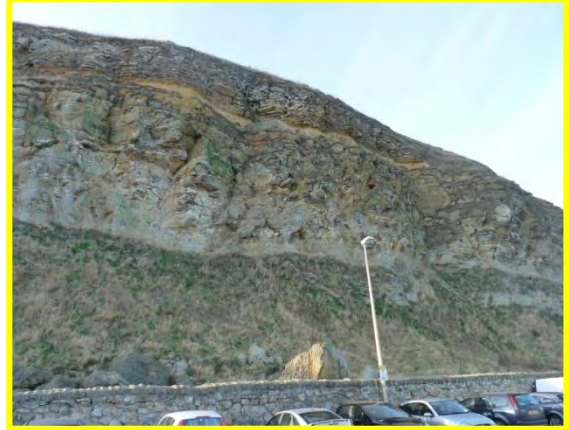
**Mu21/2 – December 2013. Note near continuous band of eroded sandstone towards top of cliff. (Locally Active).**

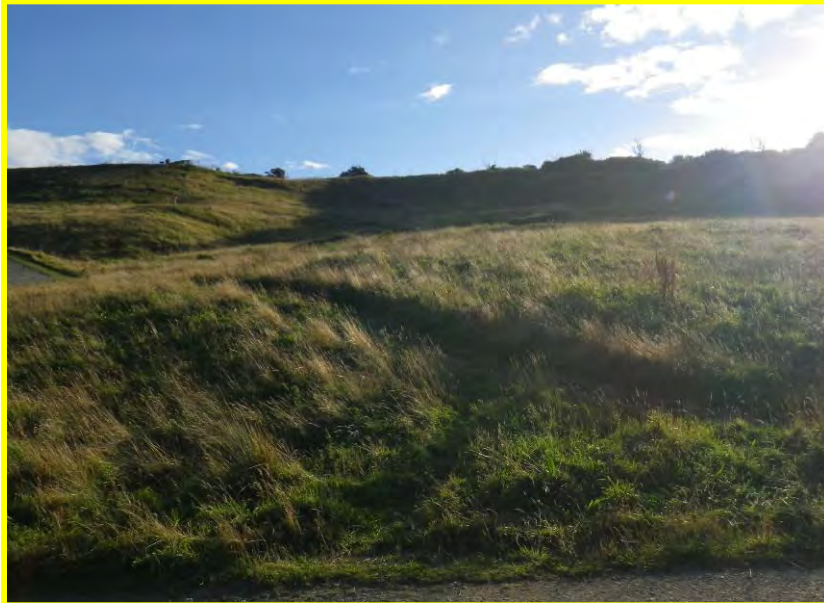
**MU22/8** Localised activity at the headscarp of the Holbeck Hall landslide run-out (Locally Active)  
Sept 2012

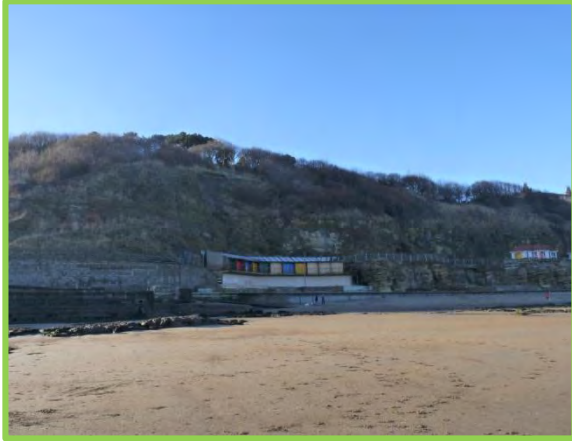
**MU22/5 – Exposed cliff face above furthest right (south) end of huts. December 2013. (Inactive)**

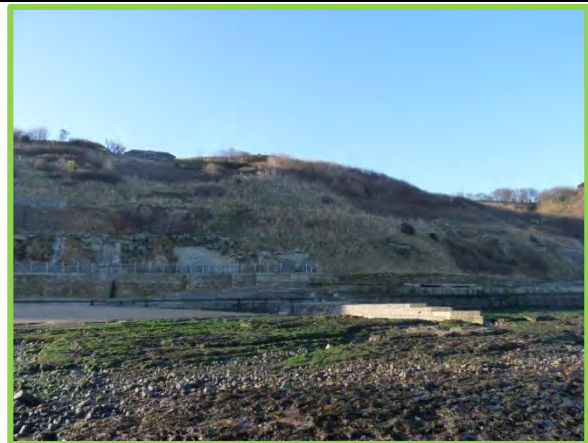
**MU22/7 – Small areas of the cliff are without vegetation and therefore indicative of limited ongoing activity. December 2013. (Inactive).**

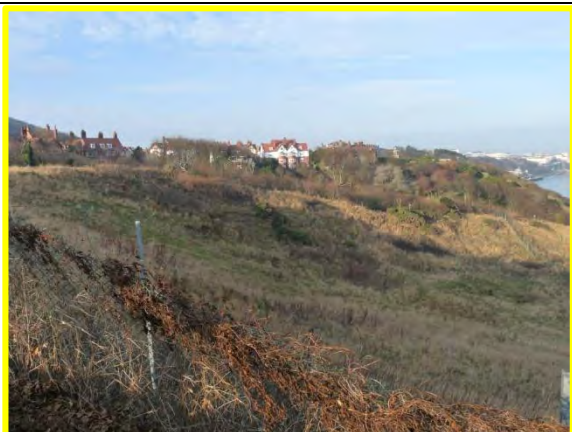
**MU22/8 – Locally active (note small slips in scarp). December 2013 (Locally Active).**

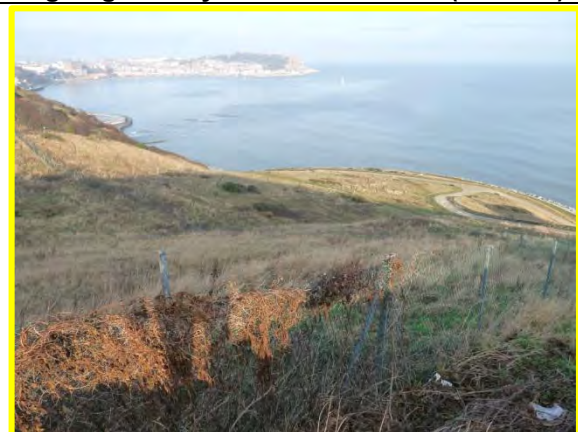
**MU22/8 – Locally Active. On the day of survey a small amount of flow was issuing through the rock armour at this toe. 2013**

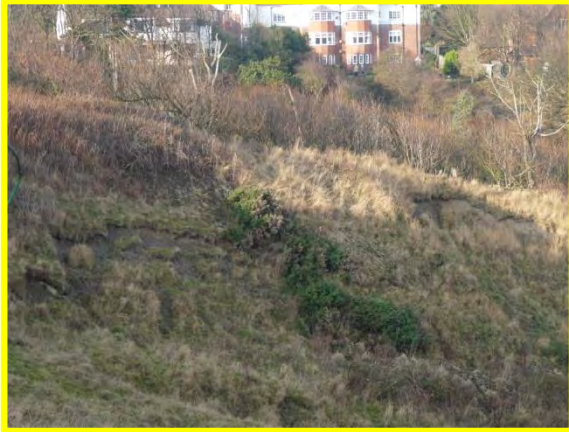
**MU22/8** – Close up of headscarp failures. December 2013. (Locally Active).

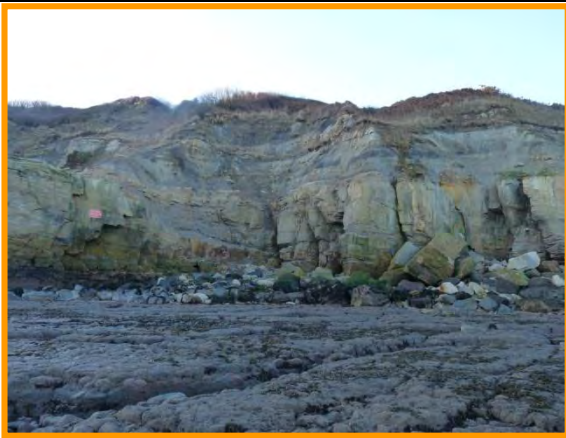
**MU23/A – Recent rockfalls (centre right). December 2013 (Partly Active)**

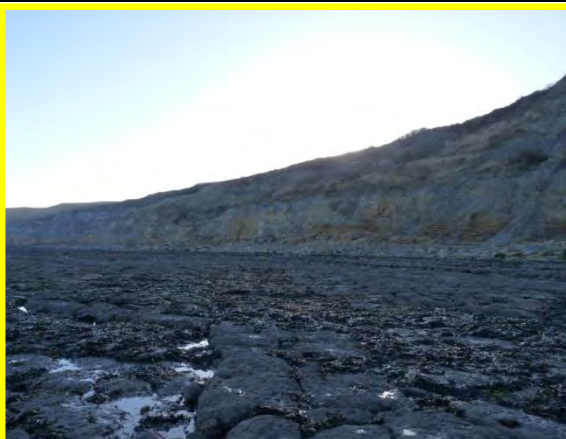
**MU23/C - December 2013. Toe erosion throughout (Locally Active).**

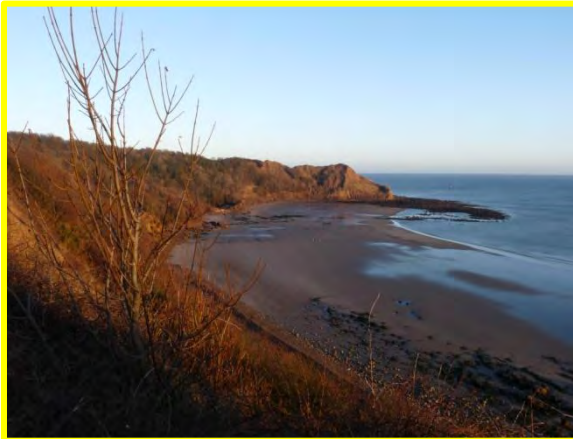
**MU24/A** - General view including beach level and Knipe Point. December 2013. (Locally Active)

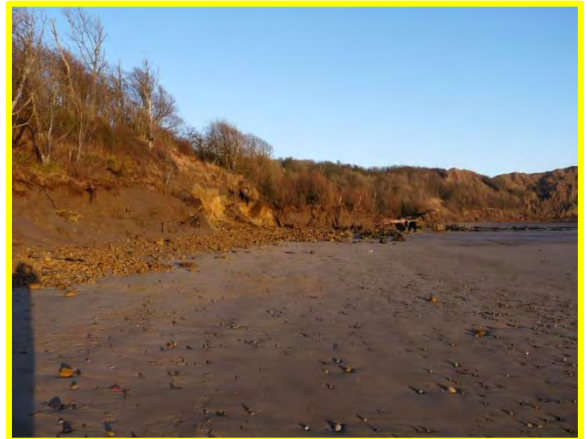
**MU23/A** – General view including beach and toe erosion in tills. December 2013 (Locally Active)

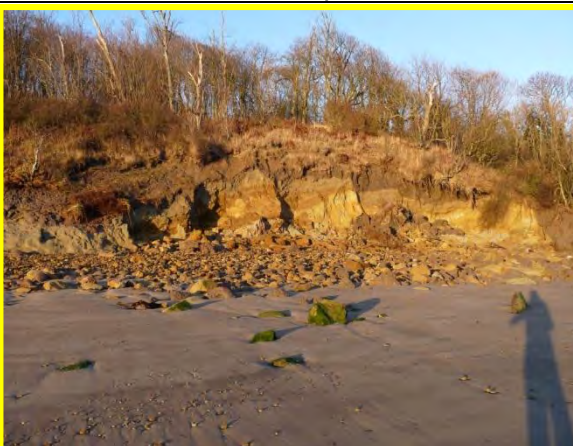
**MU24/A** - Toe erosion in bedrock (not in situ). December 2013. (Locally Active)

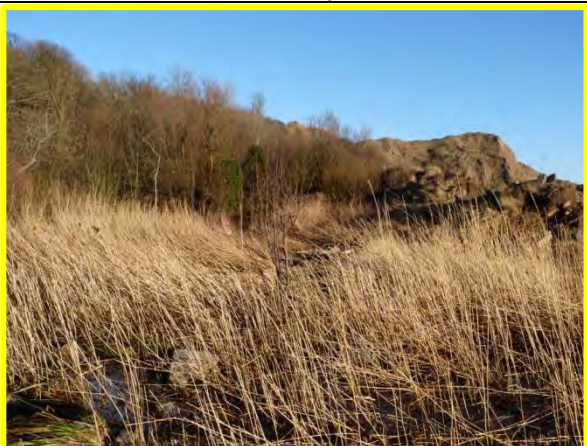
**Unit MU24/A** comprises the main body of the Cayton Cliff landslide complex that reactivated during 2008-2009. Significant recession of the headscarp was occurred in this event, resulting in the loss of land and properties at Knipe Point Drive. During 2009, headscarp recession and activity within the body of the landslide had reduced resulting in a classification of Partly Active. Activity has reduced more by 2012, with only localised activity noted at the toe and headscarp, and no evidence for movement noted in the body of the landslide. The unit is therefore considered to be Locally Active. **During the post-December 2013 storm surge inspection, no new activity was noted within the landslide complex. However toe erosion was continuous throughout the unit, exposing a range of materials in the landslide blocks including bedrock and superficial deposits. It was evident that waves during the storm surge had penetrated some way inland as in more gently sloping areas of the toe, water flattened vegetation (flattened in a landward direction) was evident well above mean high water.**

**MU24/A** - Wave-flattened vegetation and ponded water above MHW following December 2013 storm surge. (Locally Active).

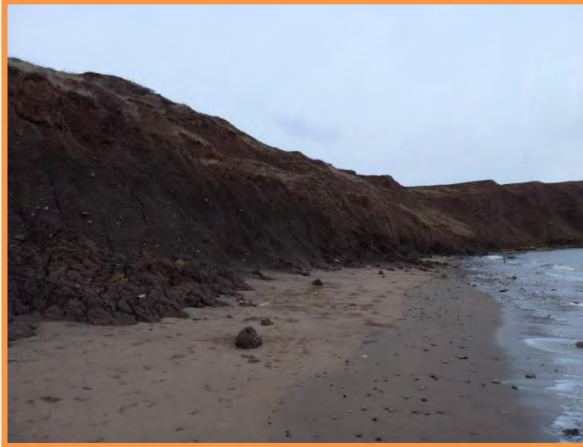
**Units MU27/T and MU27/U** are located in the vicinity of Filey sailing club and were classified as Locally Active in 2012. These units were better vegetated than those Partly Active units to the north, yet feature localised common areas of erosion. In 2012 there was minor activity at the unit head scarps and toes, with some slumping and sliding mid-slope. Both units were Locally Active in 2009 and again in 2012. **These units were increased in status to Partly Active following the December 2013 storm surge due to widespread toe erosion and recent failures in these units.**

**MU27/T – Northern end of unit. Note recent toe erosion throughout unit. December 2013 (Partly Active)**

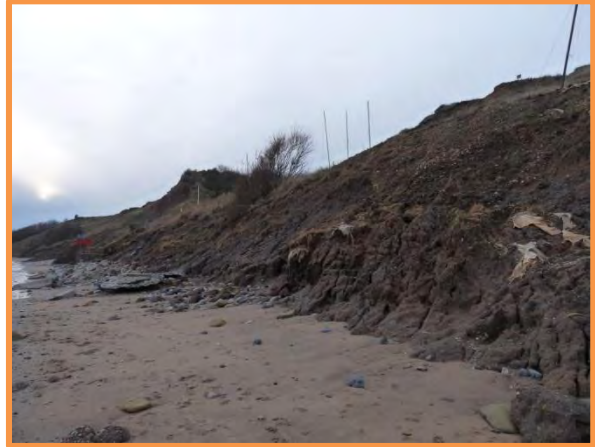
**MU27/T – Southern end of unit. Note recent toe erosion throughout unit. December 2013 (Partly Active)**

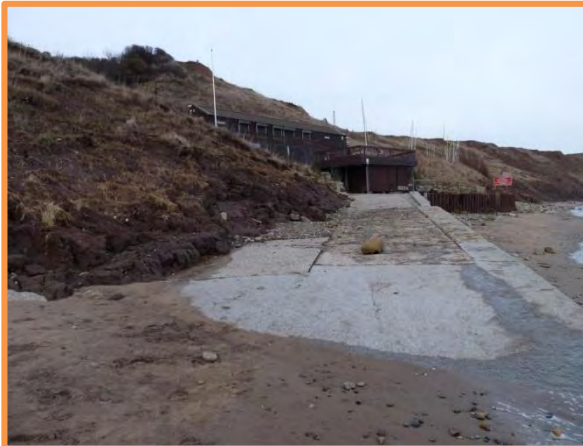
**Unit MU27/V**, is located just south of the sailing club. The unit was classified as Partly Active in 2012. This unit is lacking in vegetation cover, has an eroding headscarp and is heavily rilled and gullied. **Following the December 2013 storm surge a very recent mudslide was noted which affected almost the entire height of the cliff; the source being near the cliff top and its runout lobe on the beach. Also, encroachment of the toe of the cliff onto the sailing club slipway was noted.**

**MU27/V – Far northern end of unit. Note encroachment of the toe of the cliff onto the sailing club slipway**

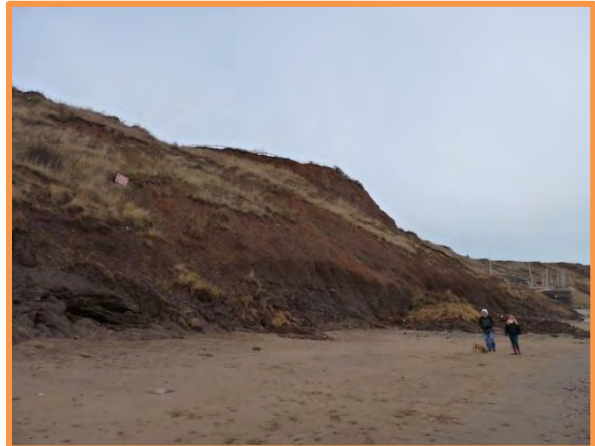
**MU27/V – South of sailing club. Note mudslide lobe on beach in left of photo (behind people). December 2013.**

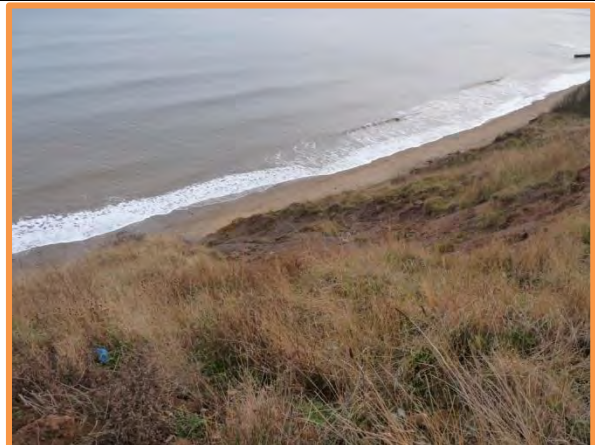
**MU27/V – Mudslide from top of cliff. Note unvegetated mudside track in centre photo and lobe just visible on the beach (left of centre). December 2013 (Partly Active).**

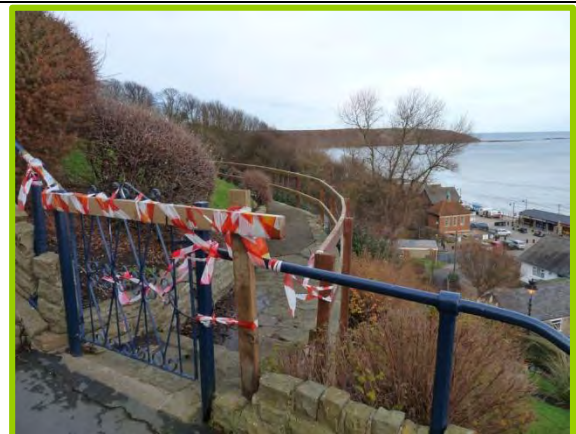
Much of the town frontage lies within **unit MU28/Y**. There were no signs of activity on the coastal slopes in 2012 and this unit was classified as Inactive. **In December 2013, it was noted that several areas of the landscaped gardens on the cliff showed some signs of minor slope movements, including cracked walls and pathways. Nonetheless a status of 'Inactive' is still deemed appropriate for this relict cliff unit.**

**MU28/Y – Cracking in pathway within landscaped gardens Dec 2013**

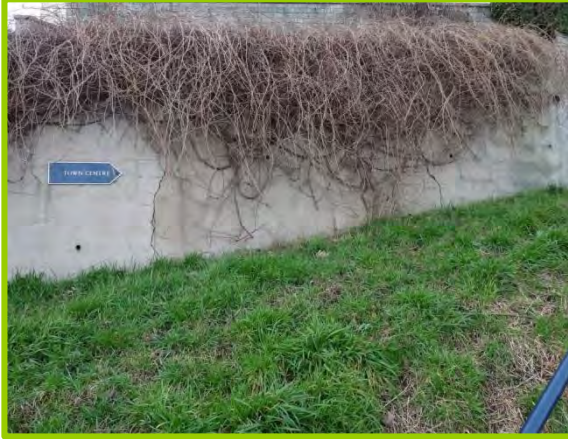
**MU27/Y - Cracking in wall in landscaped gardens. December 2013 (Inactive).**

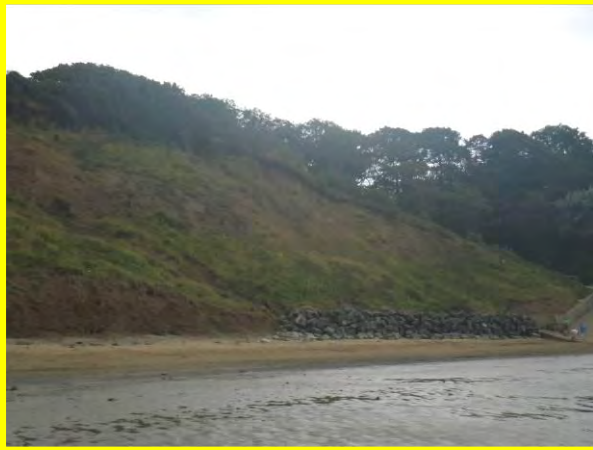
**MU29/AA** Very common intense erosion and headscarp recession (Locally Active) Sept 2012

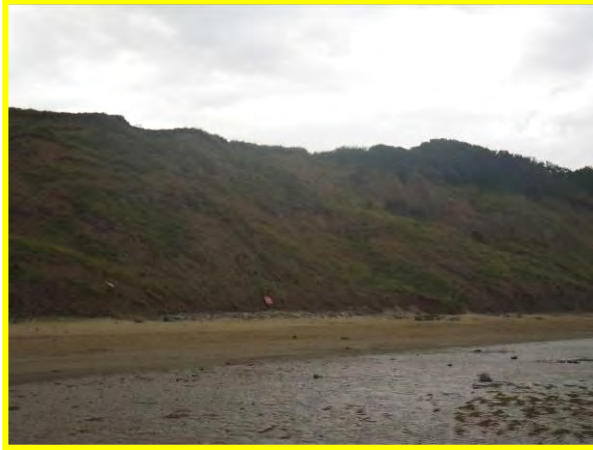
**MU29/AB** Eroding toe and sliding mid-slope (Locally Active) Sept 2012

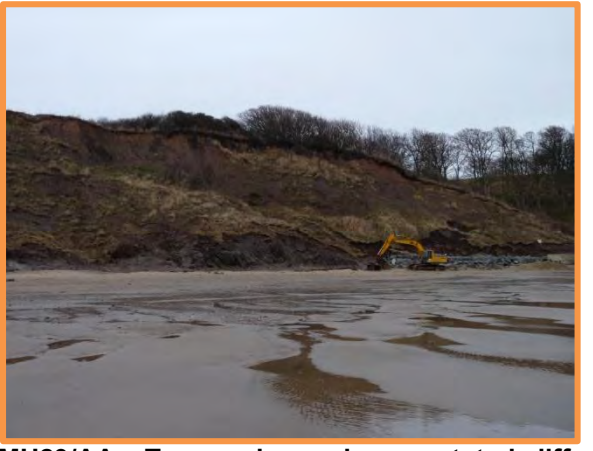
**MU29/AA** – Toe erosion and unvegetated cliff. December 2013 (Partly Active)

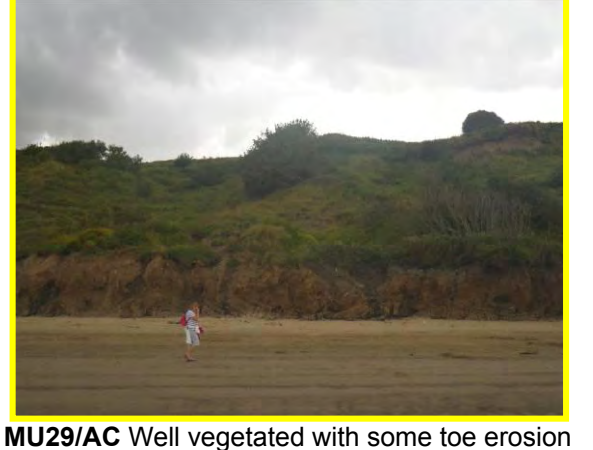
**MU29/AC** Well vegetated with some toe erosion (Locally Active) Sept 2012

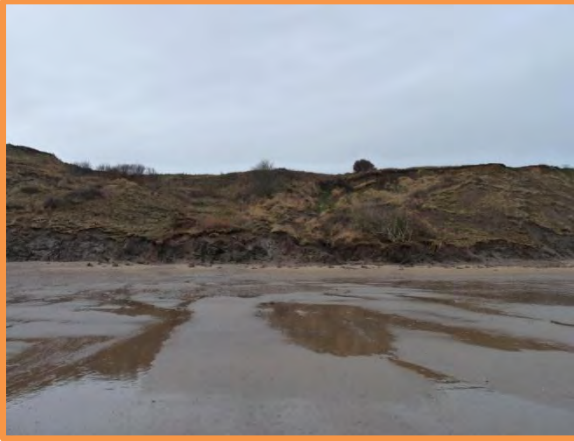
**MU29/AC** Note further failure of toe to centre left of photo relative to earlier photo (above). December 2013 (Partly Active).

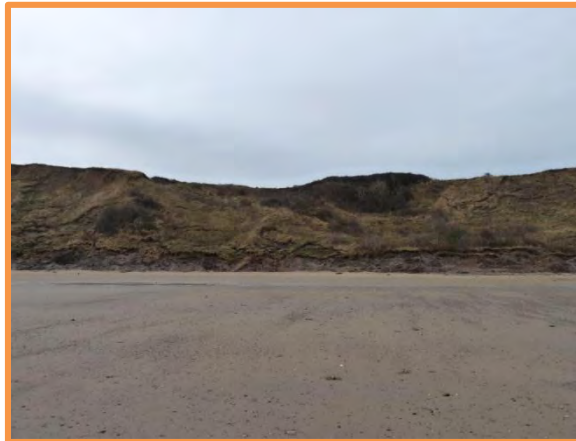
**MU29/AD** - Extensive toe erosion. December 2013 (Partly Active).

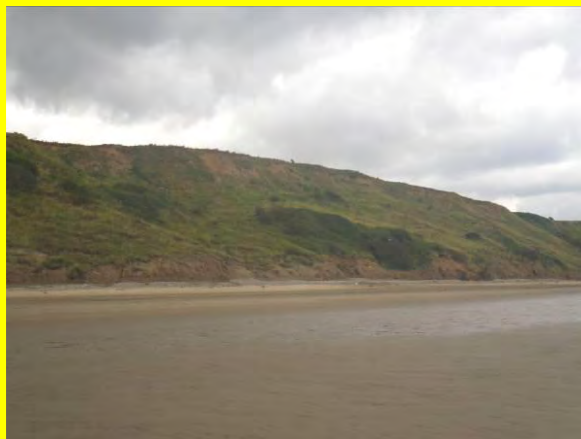
**MU29/AE** The slope is well vegetated with erosion at the toe and headscarp (Locally Active) Sept 2012

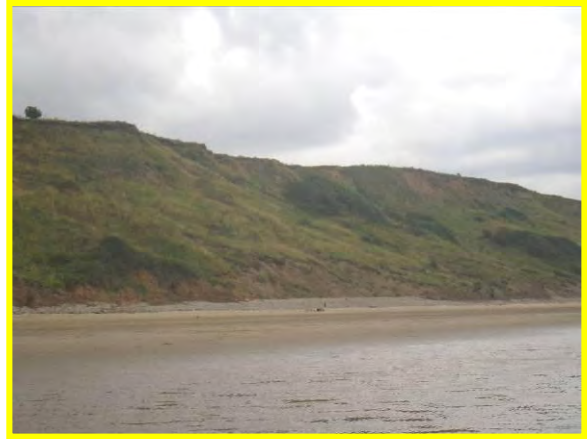
**MU29/AF** Well vegetated with some toe erosion (Locally Active) Sept 2012

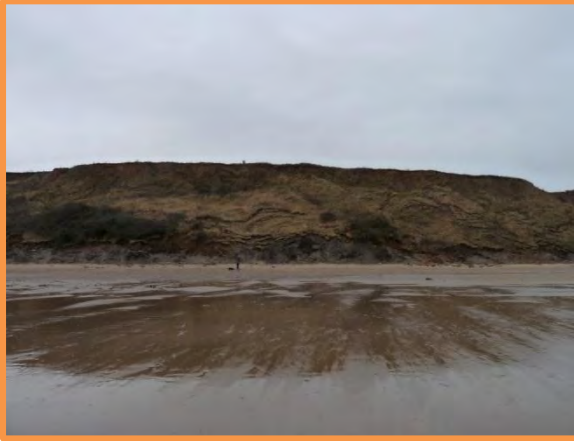
**MU29/AE** – Toe erosion throughout unit to several metres above the beach level. Note detachment of vegetation indicating failure of lower slope throughout much of the unit. December 2013 (Partly Active)

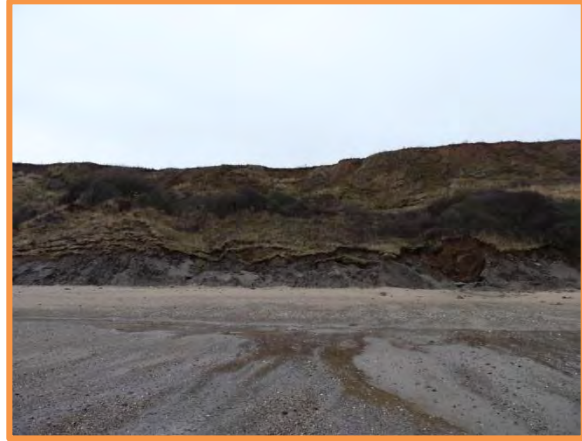
**MU29/AF** – Extensive toe erosion throughout unit. Note particularly severe toe erosion on left of photograph. December 2013 (Partly Active).

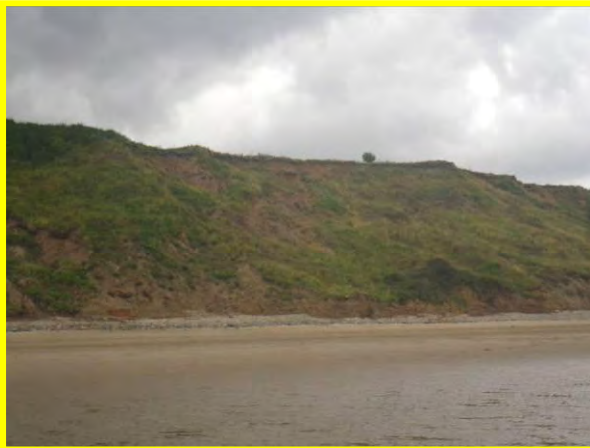
**MU29/AG** The slope is showing localised signs of erosion (Locally Active) Sept 2012

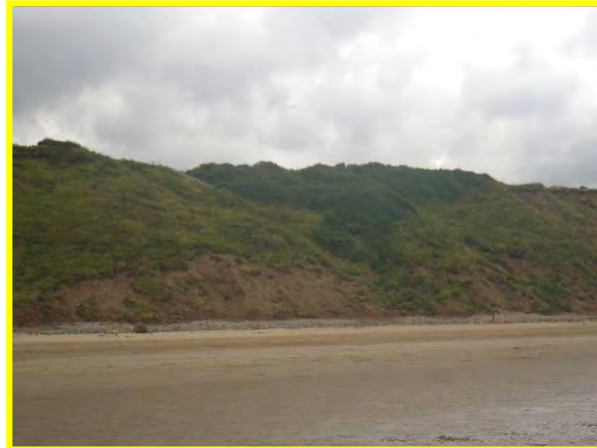
**MU29/AH** Heavily vegetated with toe erosion, which is severe in places (Locally Active) Sept 2012

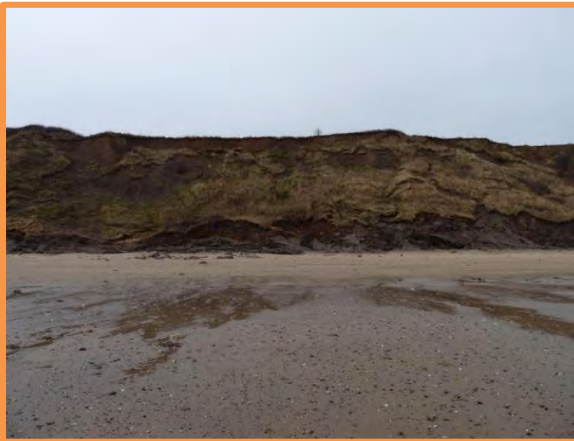
**MU29/AG** – Recent toe erosion throughout unit. December 2013 (Partly Active)

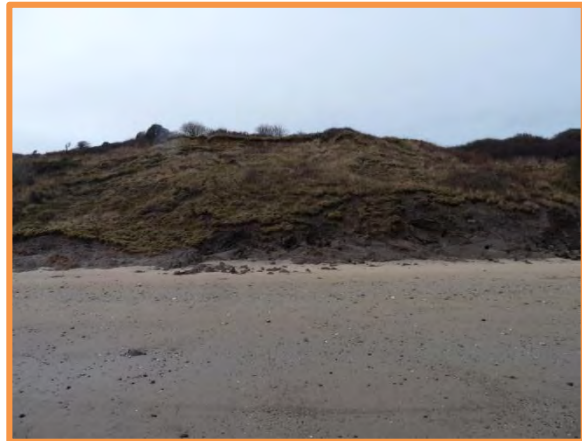
**MU29/AH** – Still substantially vegetated but with erosion to >2m above the beach at the toe of the slope. Failure affecting near whole slope in left of photo (see photo below). December 2013 (Partly Active).

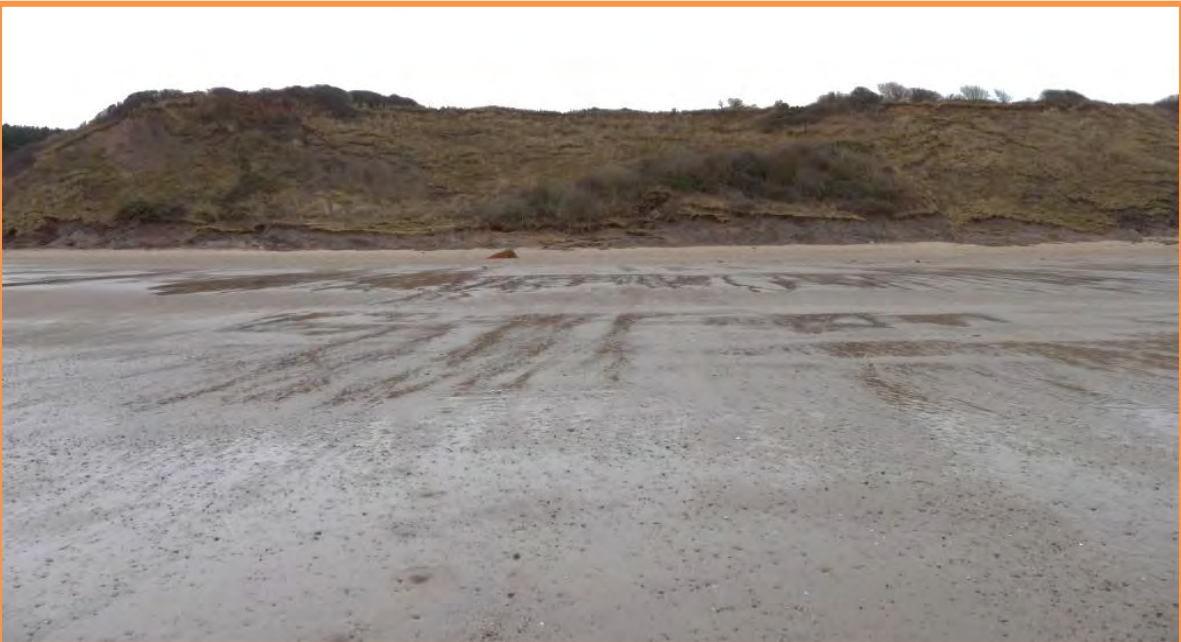
**MU29/AI - Whole unit, December 2013. Continues to have locally steep exposed toe throughout unit. Erosion here possibly less severe relative to units further north.**

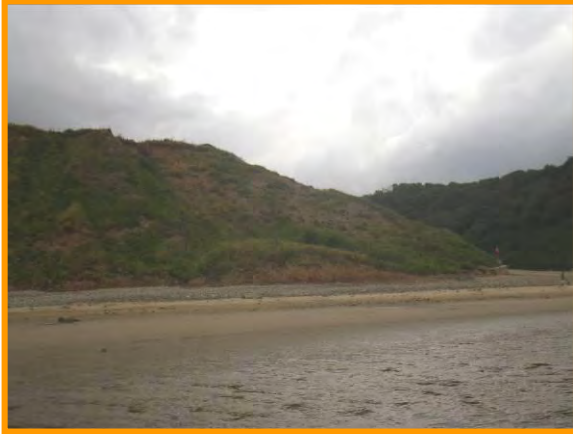
MU29/AJ Areas of intense erosion at the toe and headscarp (Partly Active). Sept 2012

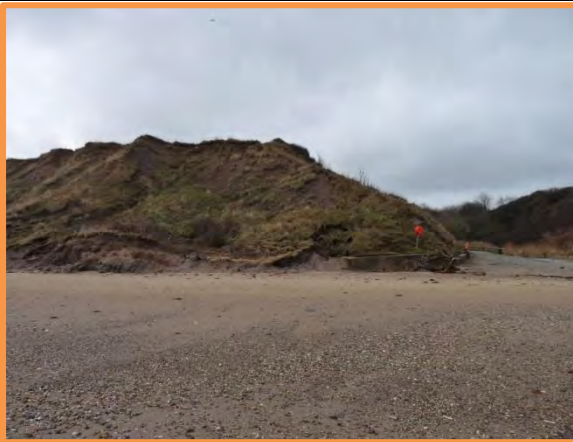
MU29/AJ – Continued intense upslope erosion and recent toe erosion/failure, particularly in the centre photo. December 2013 (Partly Active).

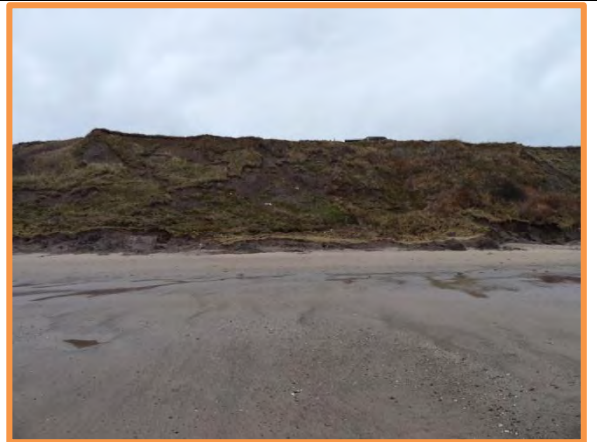
MU29/AK – Recent toe erosion and unvegetated areas in the mid and upper-slopes (Partly Active).

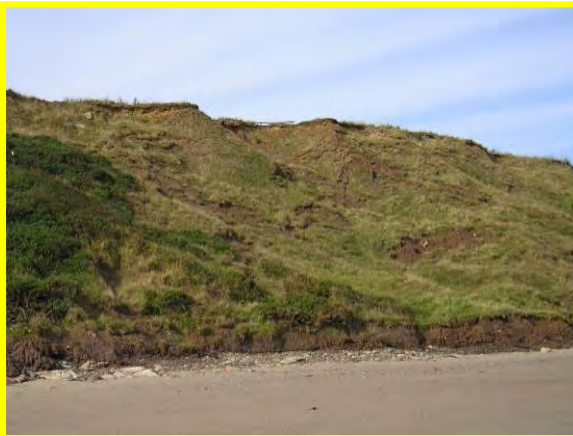
MU29/AL and M Erosion at the toe and headscarp, sliding mid-slope (Locally Active).

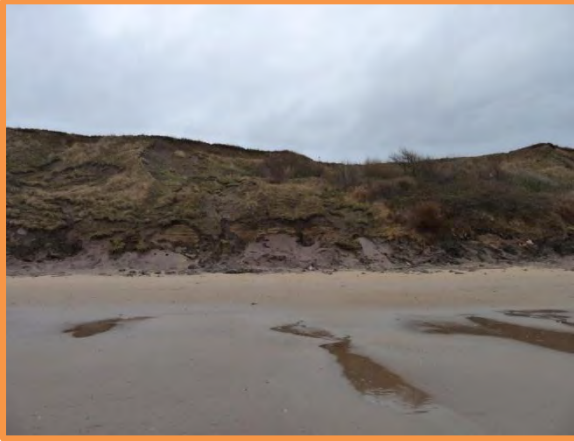
**MU29/AL and M – Severe Erosion at the toe exposing laminated sandy strata over which clay has slumped onto beach. December 2013 (Partly Active).**

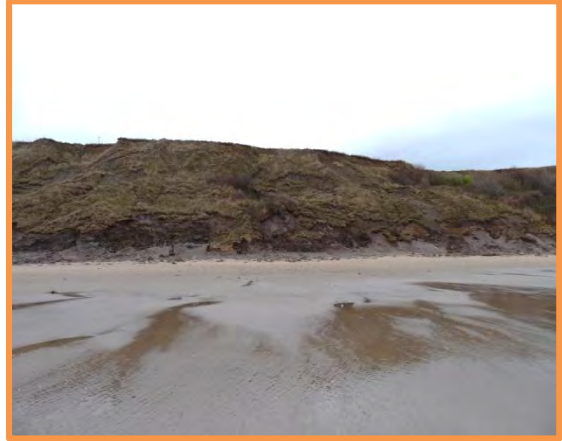
**MU29/AN - Severe toe erosion. December 2013 (Partly Active)**

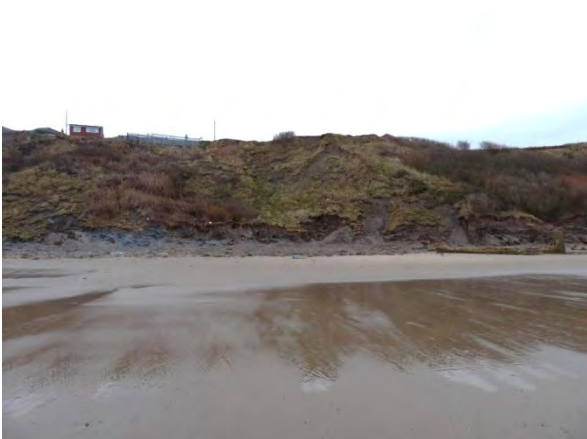
**MU29/AQ – December 2013. Substantial toe erosion. (Partly Active)**

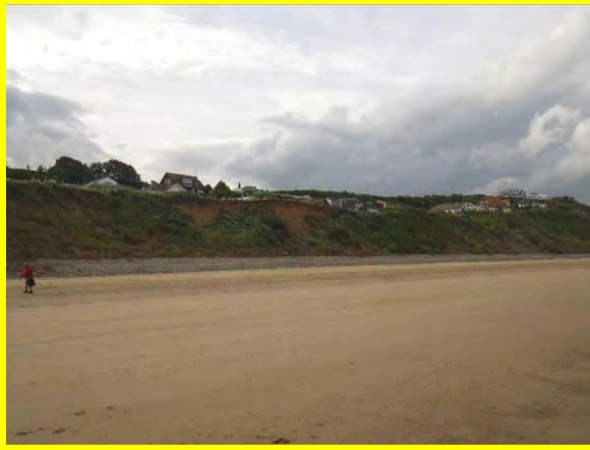
**MU29/AR** Continuing mudslide activity and toe erosion at Flat Cliffs (Locally Active). Sept 2012

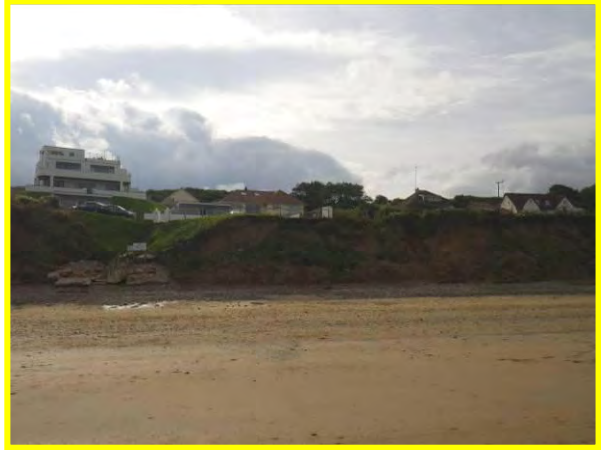
**MU29/AS** Continuing mudslide activity and toe erosion at Flat Cliffs (Locally Active). Sept 2012

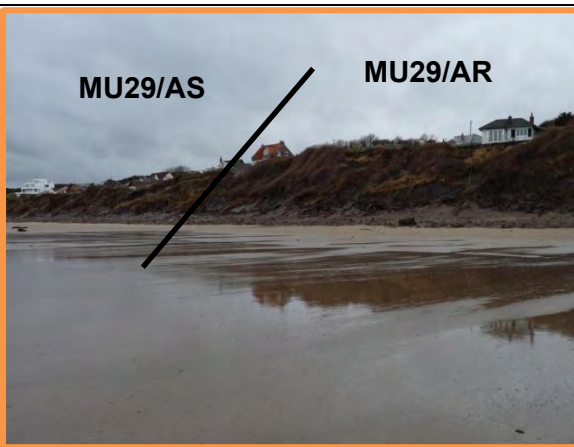
**MU29/AR and AS** – Substantial toe erosion throughout unit exposing drainage pipes. December 2013 (Partly Active).

- **MU29/AA to MU29/AT** - Elevated to 'Partly Active Status'. Whilst the upper cliff remains largely vegetated there is evidence of failure throughout the whole cliff in some units and the units immediately around Flat Cliffs (**MU29/AR and MU29/AS**) have experienced particularly severe toe erosion and failure of the lower cliff

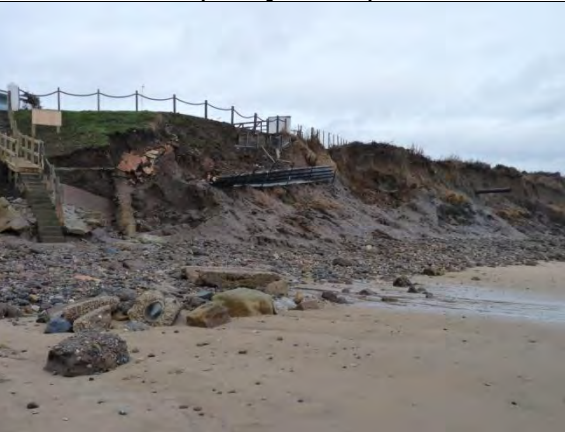
**MU29/AS** – Severe toe erosion and failure of steps and fences, southern end of unit. December 2013 (Partly Active).

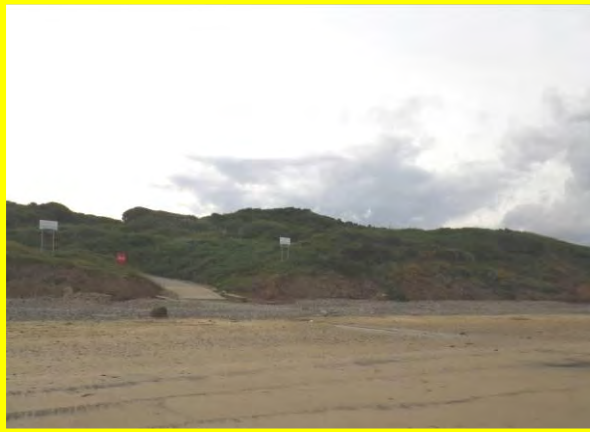
**MU29/AT** this large unit is showing eroding at the toe with thick vegetation higher up the unit (Locally Active). Sept 2012
