**Walk-over Visual Inspections of Selected Assets  
following Storm Surge of  
5<sup>th</sup> December 2013**

**Scarborough Borough Council  
Supplementary Report**

**December 2013**

### Walk-over Visual Inspections of Selected Assets following Storm Surge of 5th December 2013

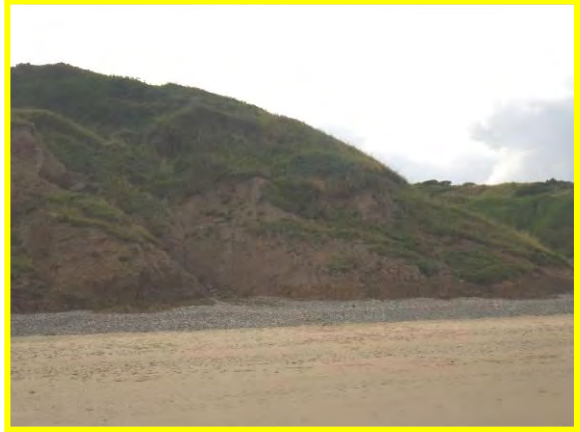
**MU29/BA** The small unit at Butcher Haven does not support vegetation on its lower slopes and is undergoing erosion. (Locally Active). Sept 2012

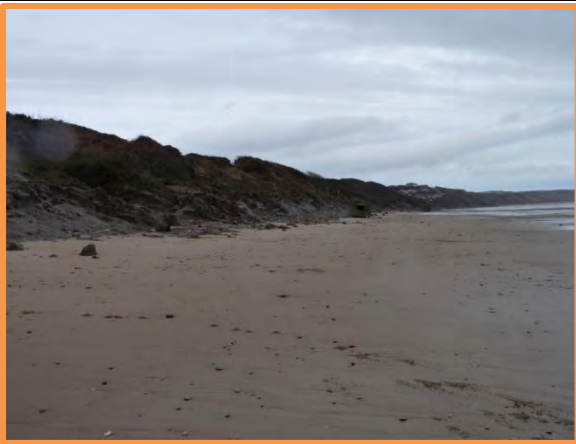
**MU29/T** – Showing toe erosion and beach condition. December 2013 (Partly Active)

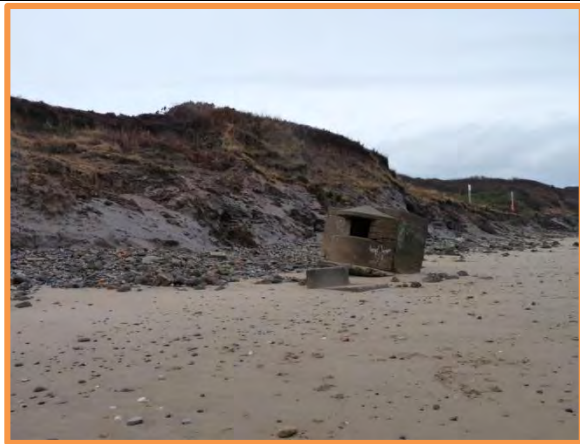
**MU29/T** – Showing erosion in lower cliff and position of pillbox for future reference. December 2013 (Partly Active).

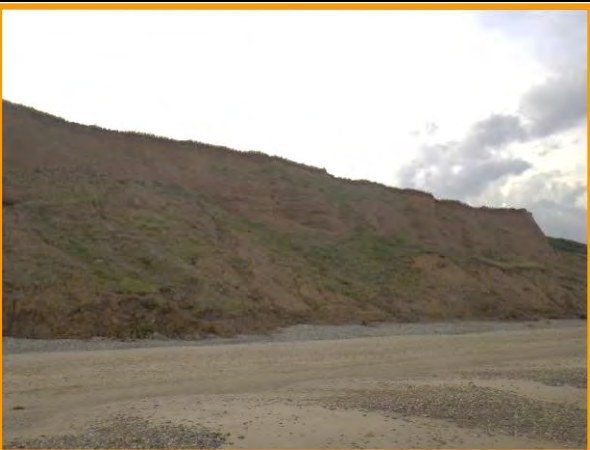
**MU29/BB and BC** Steeper cliffs with very common areas of intense erosion (Partly Active). Sept 2012

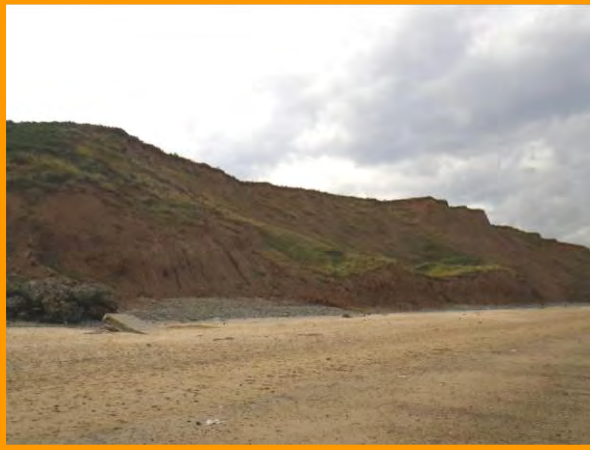
**MU29/BE** Headscarp and toe erosion (Partly Active). Sept 2012

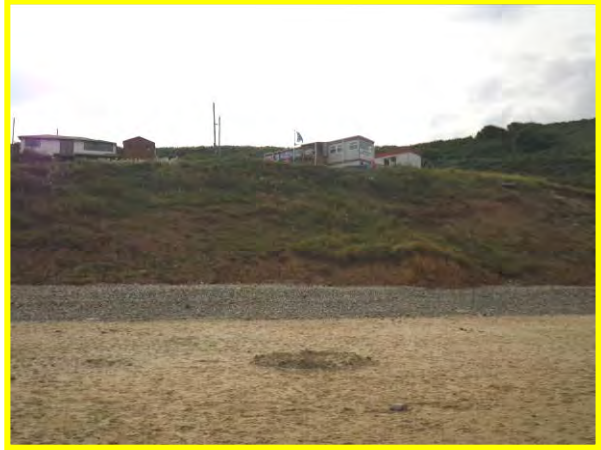
Unit MU29/BE2 is a newly (2012) defined unit at Hunmanby Gap. The cliffs here are relatively shallow and well vegetated. There is localised erosion at the unit toe and some sliding and cracking mid-slope resulting in a classification of Locally Active.

**MU29/BE2** The Hunmanby Gap unit is more stable than the units to the NW (Locally Active). Sept 2012
