Ongoing Analysis and Interpretation of Coastal Monitoring Data

Second Review of Full Suite Monitoring

Geotechnical Interpretative Report

Document Ref. No. 721229/002/GIR/007/Final

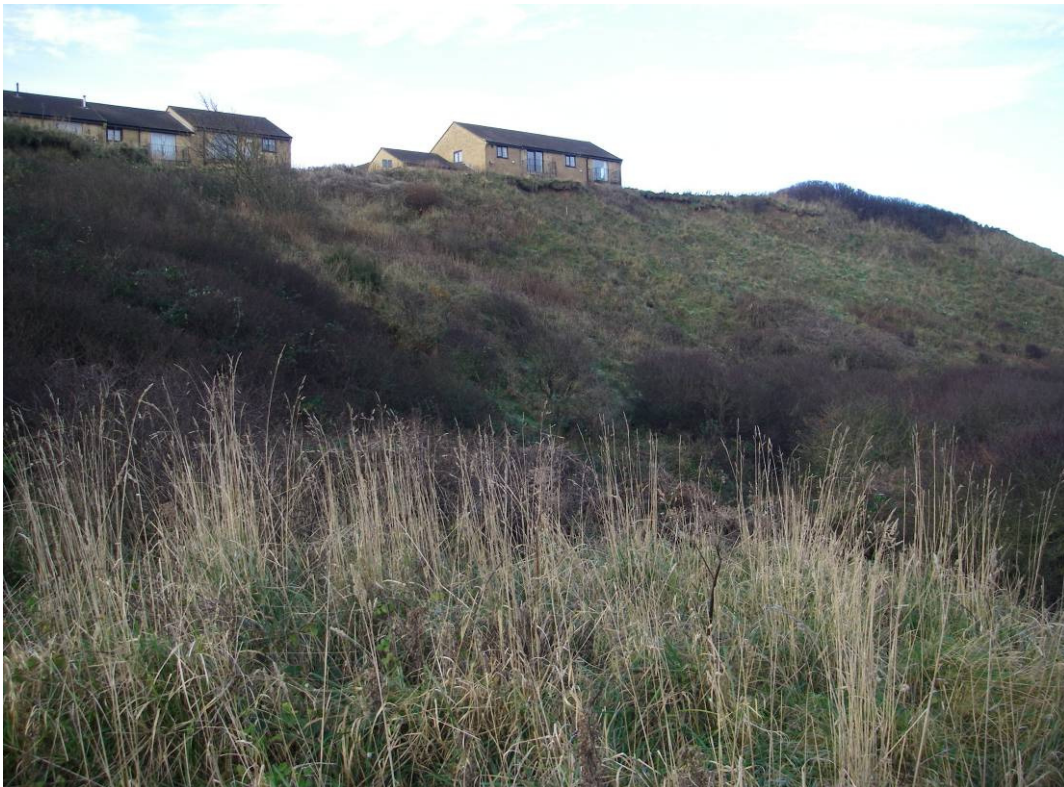
Plate 12 Site view of Behaviour Unit II showing over steepened back-scarp below Upper Plateau.

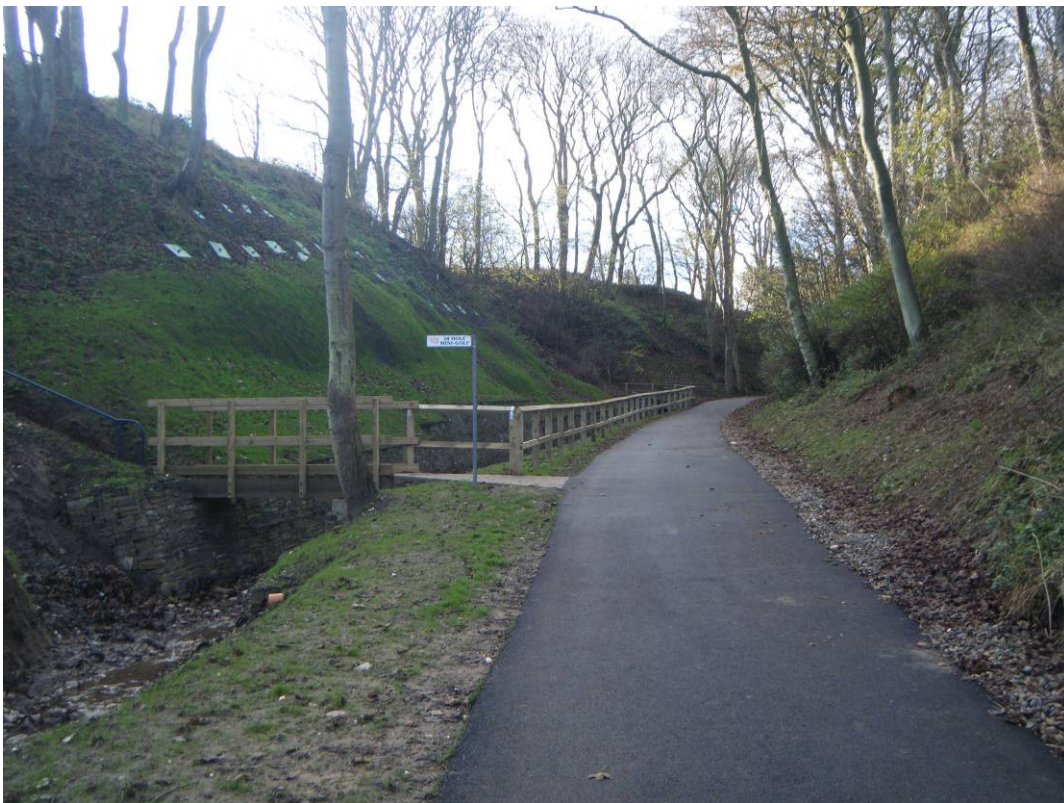
Plate 35 Site view looking up Martin's Ravine. (Remediated slopes on left).

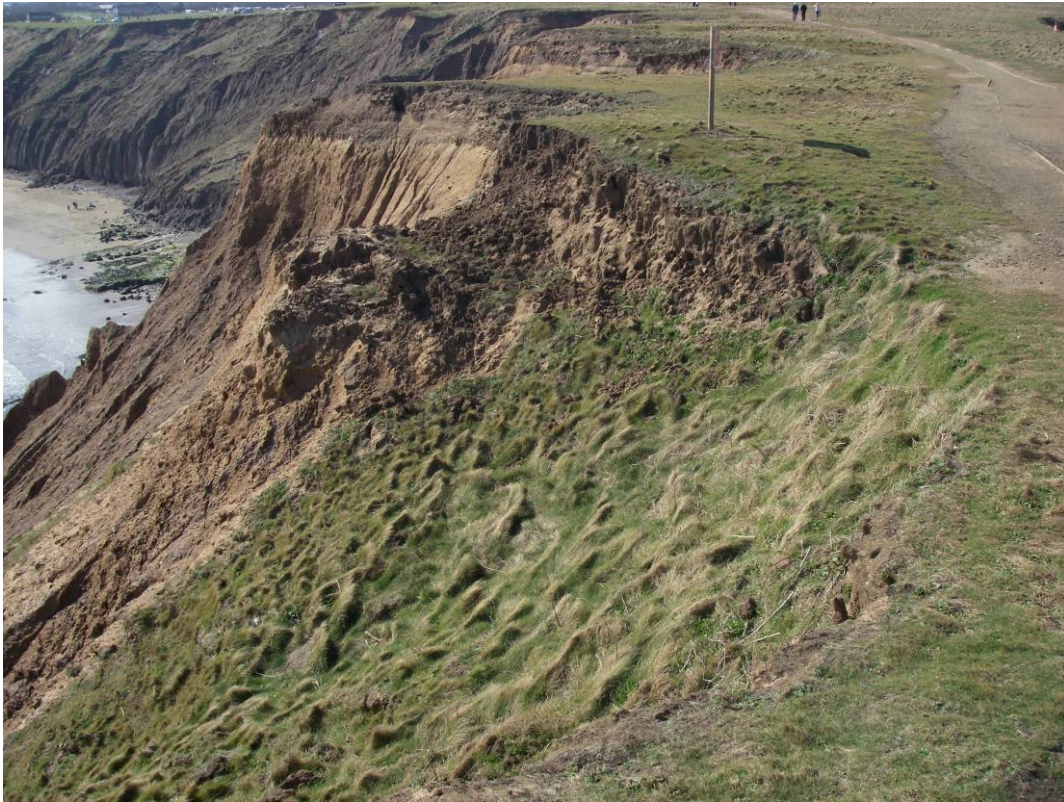
Plate 38 Site view of gullying and slumping of glacial tills at Filey Brigg.

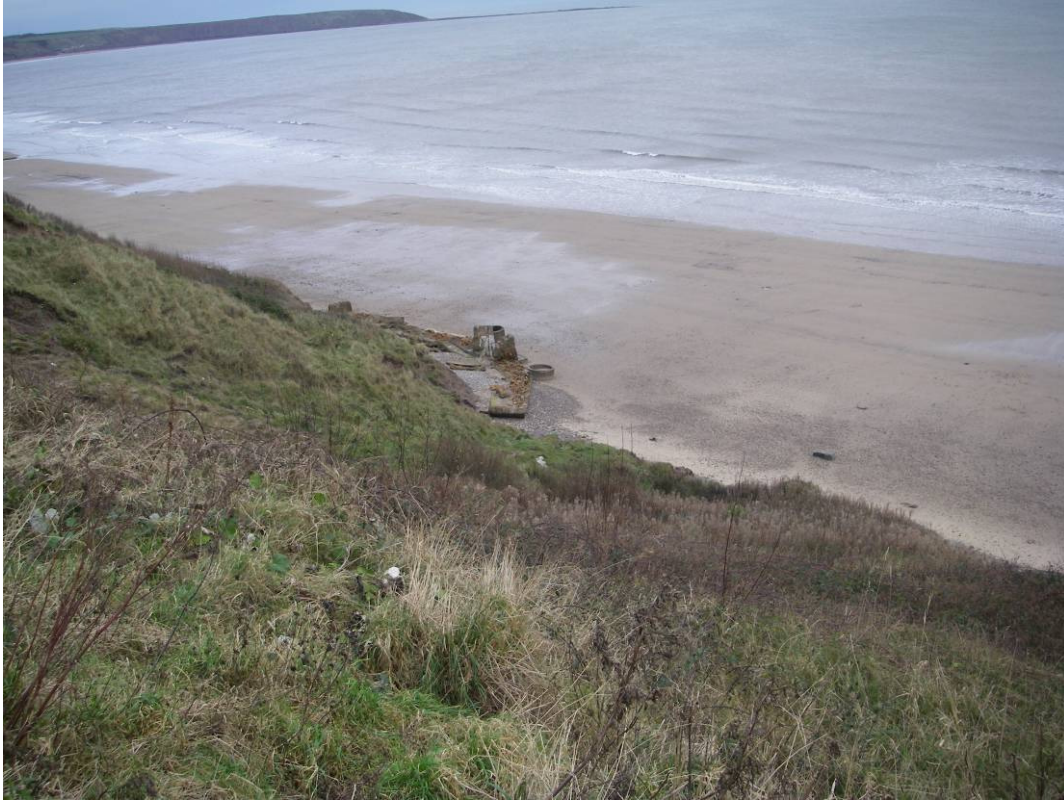
Plate 40 Site view looking north across Filey Bay towards Filey Brigg.
