# Interpretation Report 11: June 2018 to November 2018

*Prepared for*  
Scarborough  
Borough Council

February 2019

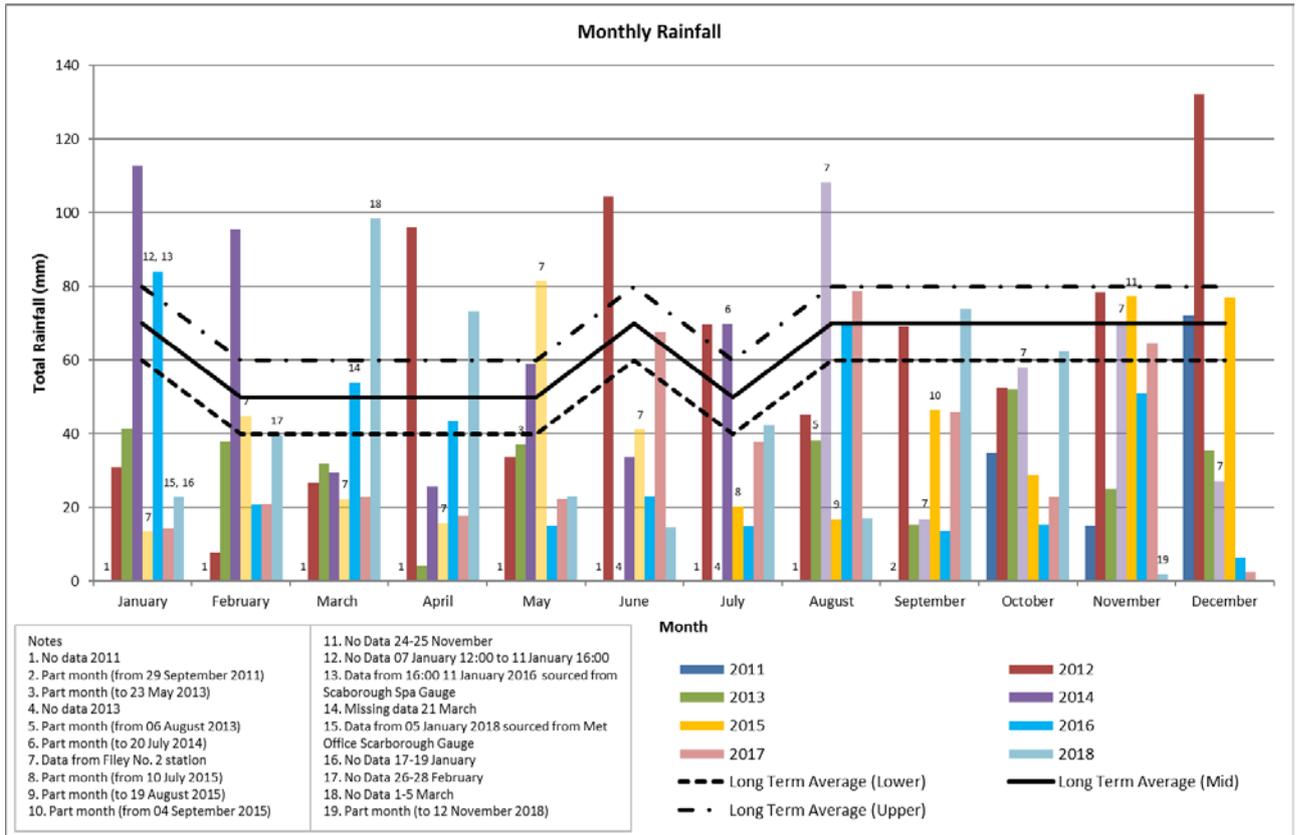
Figure 2.1 Comparison of monthly rainfall records (2011 to 2018).

Data from all sources are summarised in Table 2.1 and Figure 2.1. The records for the last six months show that summer 2018 was drier when compared to past records but that autumn 2018 was marginally wetter on average, with September close to the long-term mean (upper range).

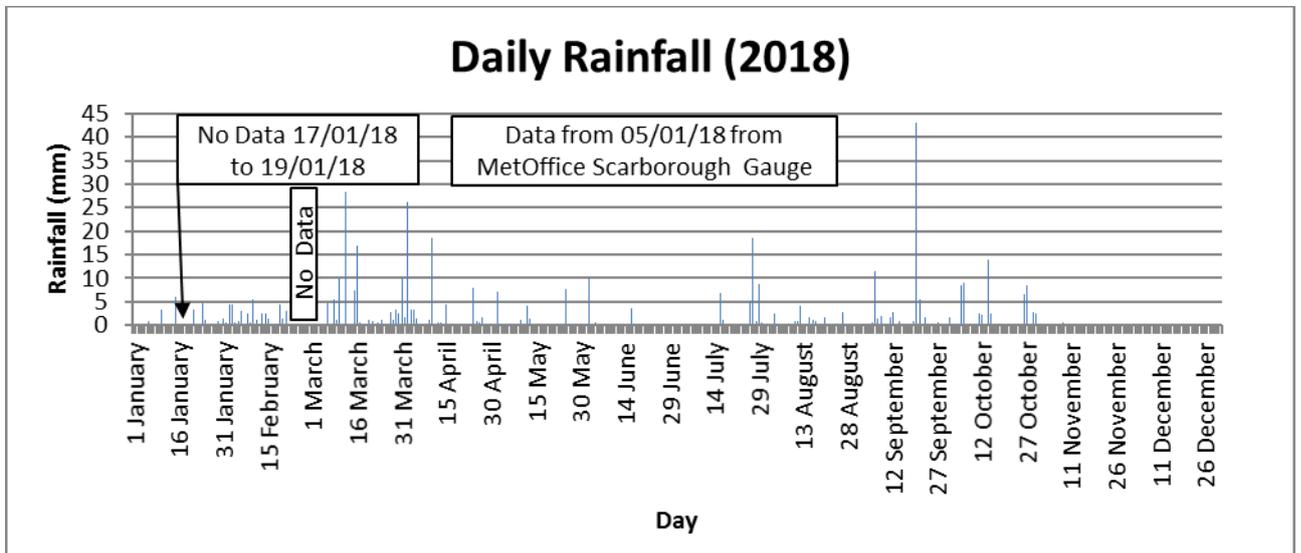
Figure 2.2 Daily rainfall recorded at Scarborough Spa during 2018.

Daily rainfall totals recorded by the Scarborough Spa weather station are presented in Figure 2.2, which shows peaks on 27 July, 2 and 20 September and 14 October. The 20 September event was exceptional and a daily peak rainfall total of 43 mm was recorded. This event was Storm Bronagh, where an intense low-pressure system resulted in heavy rainfall and strong winds over Yorkshire on that day.

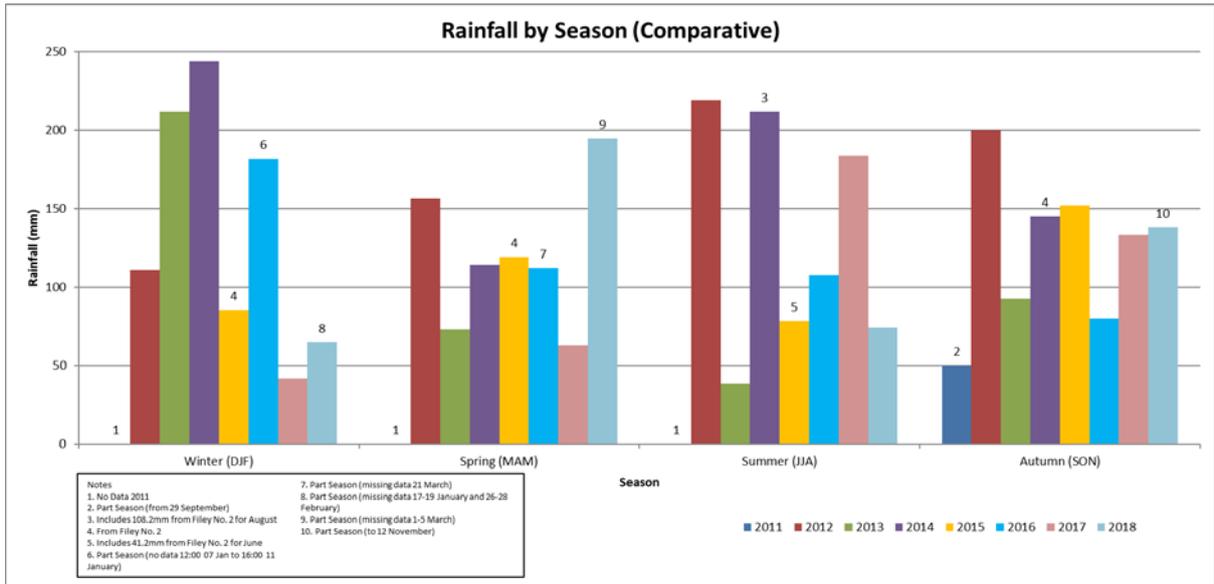
Figure 2.3 Seasonal rainfall comparison (2011-2018)

Seasonal totals are shown in Figure 2.3, which shows that the wettest seasons tend to be winter and summer and that the spring is the driest. The wettest season on record was winter of 2013/14 (i.e. December 2013, January and February 2014) that received a total of 244mm rainfall. The summers of 2012 and 2014 were also very wet, receiving 219mm and 211mm respectively. The winter of 2015/16 received around double the rainfall of 2014/5, but the spring was marginally drier. The winter of 2016/17 and spring 2017 have been the driest on record. The summer of 2017 was relatively wetter than previous years, receiving 183mm of rainfall, whereas slightly drier conditions occurred through autumn 2017 and into the winter of 2017/2018. The spring of 2018 has been the wettest during this season on record, receiving a total of 195mm rainfall. However, the summer was especially dry. Autumn 2018 was relatively wet compared to past years.

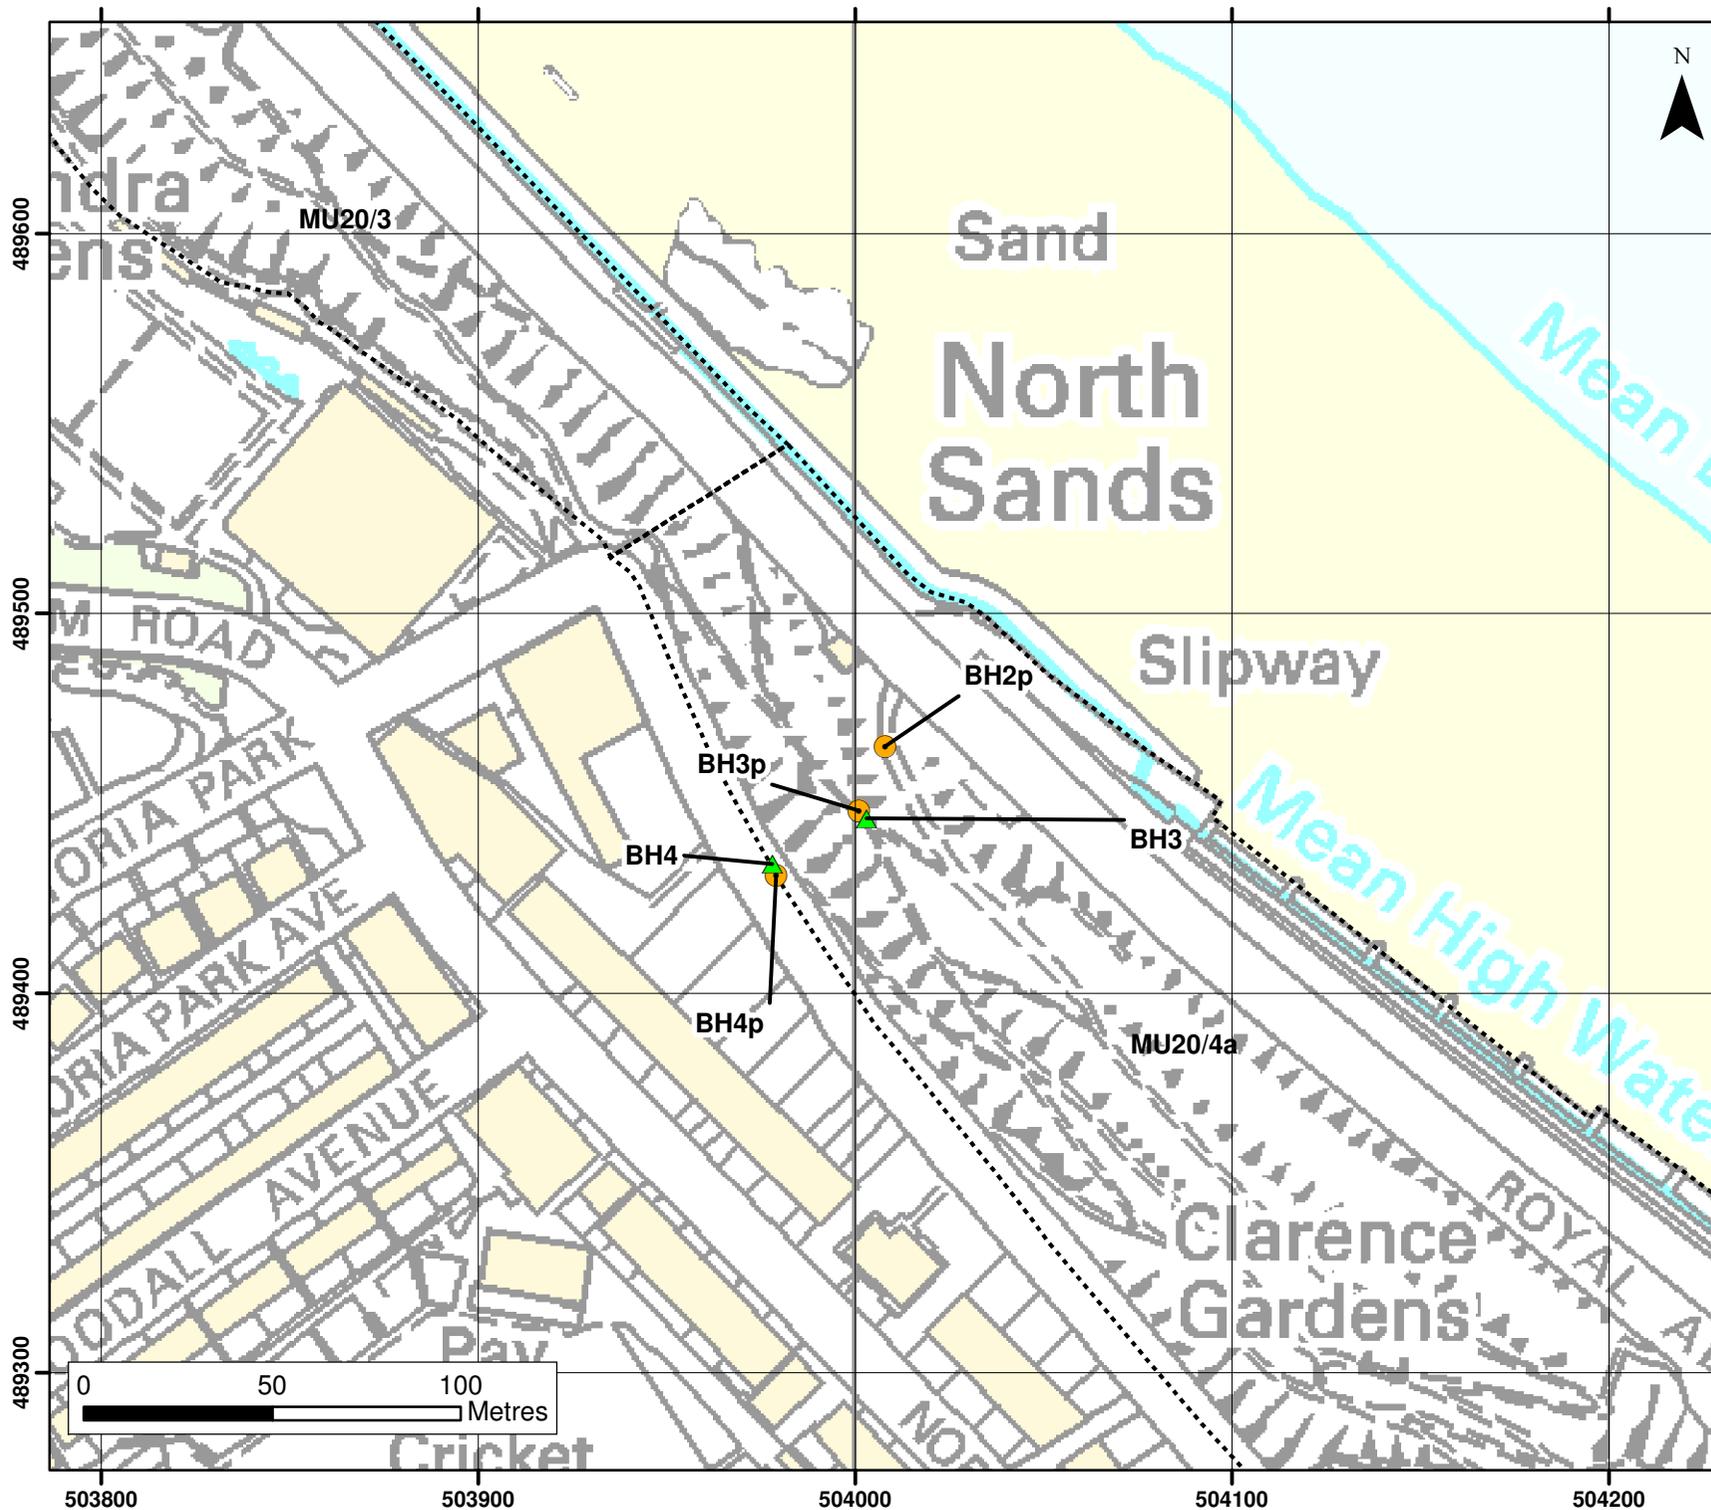
**Figure 7.1 Location of slope monitoring at Scarborough North Bay –Oasis Cafe**

Oasis Café cliffs are situated in the southern part of Scarborough’s North Bay and occupy part of Clarence Gardens, which are landscaped coastal slopes open to the public (Figure 7.1). The cliffs rise to c. 30m OD and have a typical angle of 25-30°, although the main headscarp reaches 50°. The upper c. 15m of cliff is cut in glacial sediments and Jurassic sandstones and mudstones form the basal part of the cliff. The Holbeck to Scalby Mills strategy study (High-Point Rendel, 1999) classified the cliffs as multiple rotational landslides formed predominantly in the Jurassic bedrock. The landslides are fronted by the Marine Parade road and coast protection scheme and have not experienced toe erosion for over 100 years. Despite the toe protection, cliff instability risk in response to extreme rainfall remains a concern.

This frontage is covered by a single cliff behaviour unit, MU20/4a. Geomorphological mapping undertaken as part of the strategy study recognises a series of discrete landslides within this CBU, but all are classified as multiple rotational landslides formed predominantly in bedrock. It is assumed the basal shear surface is near Ordnance Datum and has formed in weak layers within the interbedded sandstones and mudstones. The monitoring regime comprises inclinometers and co-located automated piezometers at the cliff top, mid-slope and cliff toe positions aligned along a southwest to northeast bearing (Figure 7.1).
