LOCAL COASTAL SLOPE MONITORING ANALYSIS

# Interpretation Report 15: August 2020 to December 2020

*Prepared for*  
Scarborough  
Borough Council

February 2021

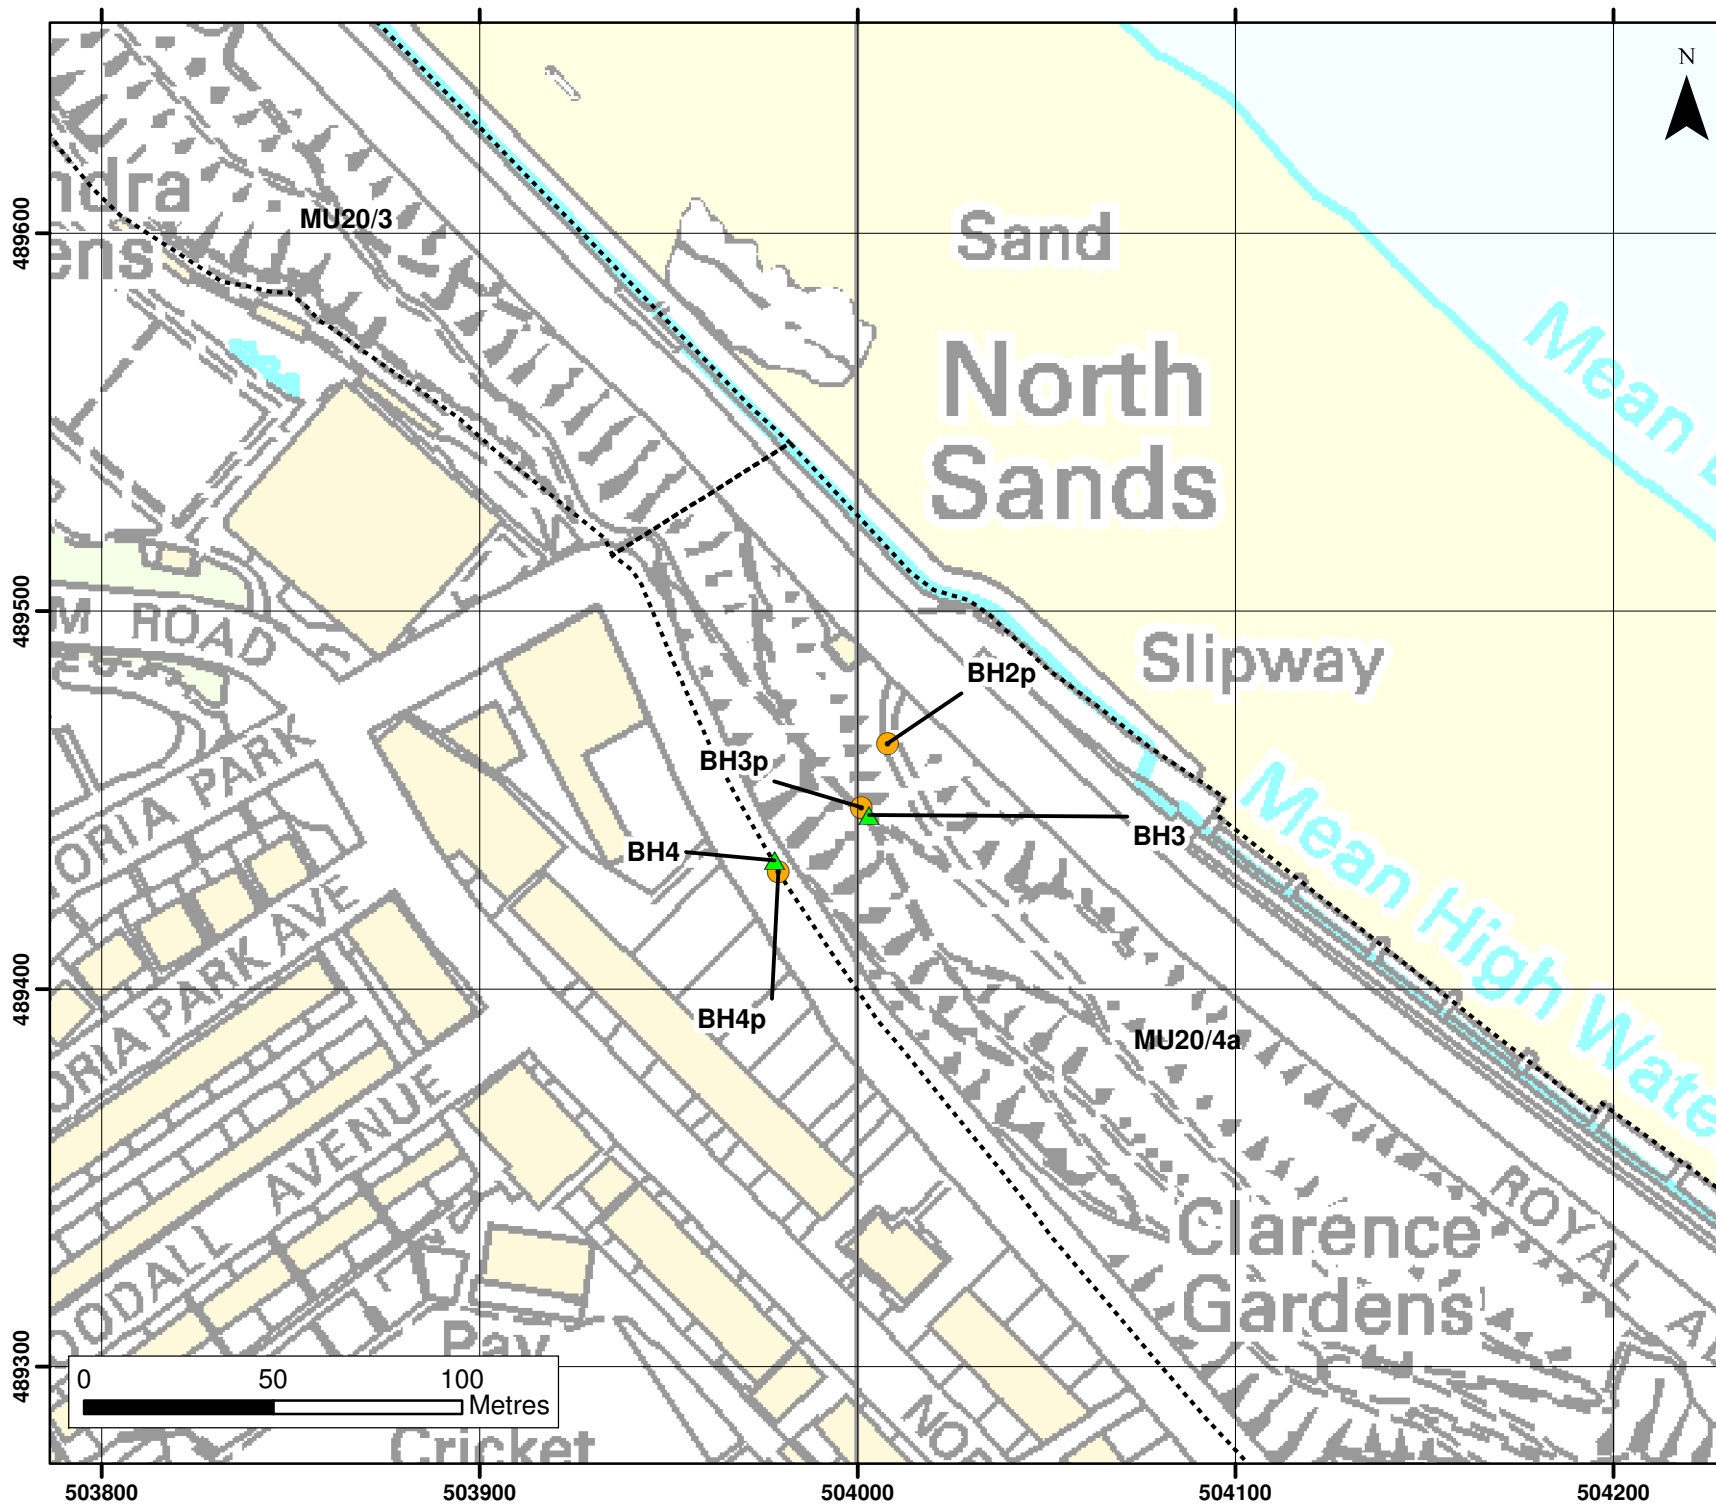
**Figure 7.1 Location of slope monitoring at Scarborough North Bay –Oasis Cafe**

Oasis Café cliffs are situated in the southern part of Scarborough’s North Bay and occupy part of Clarence Gardens, which are landscaped coastal slopes open to the public (Figure 7.1). The cliffs rise to c. 30m OD and have a typical angle of 25-30°, although the main headscarp reaches 50°. The upper c. 15m of cliff is cut in glacial sediments and Jurassic sandstones and mudstones form the basal part of the cliff. The Holbeck to Scalby Mills strategy study (High-Point Rendel, 1999) classified the cliffs as multiple rotational landslides formed predominantly in the Jurassic bedrock. The landslides are fronted by the Marine Parade road and coast protection scheme and have not experienced toe erosion for over 100 years. Despite the toe protection, cliff instability risk in response to extreme rainfall remains a concern.

This frontage is covered by a single cliff behaviour unit, MU20/4a. Geomorphological mapping undertaken as part of the strategy study recognises a series of discrete landslides within this CBU, but all are classified as multiple rotational landslides formed predominantly in bedrock. It is assumed the basal shear surface is near Ordnance Datum and has formed in weak layers within the interbedded sandstones and mudstones. The monitoring regime comprises inclinometers and co-located automated piezometers at the cliff top, mid-slope and cliff toe positions aligned along a southwest to northeast bearing (Figure 7.1).

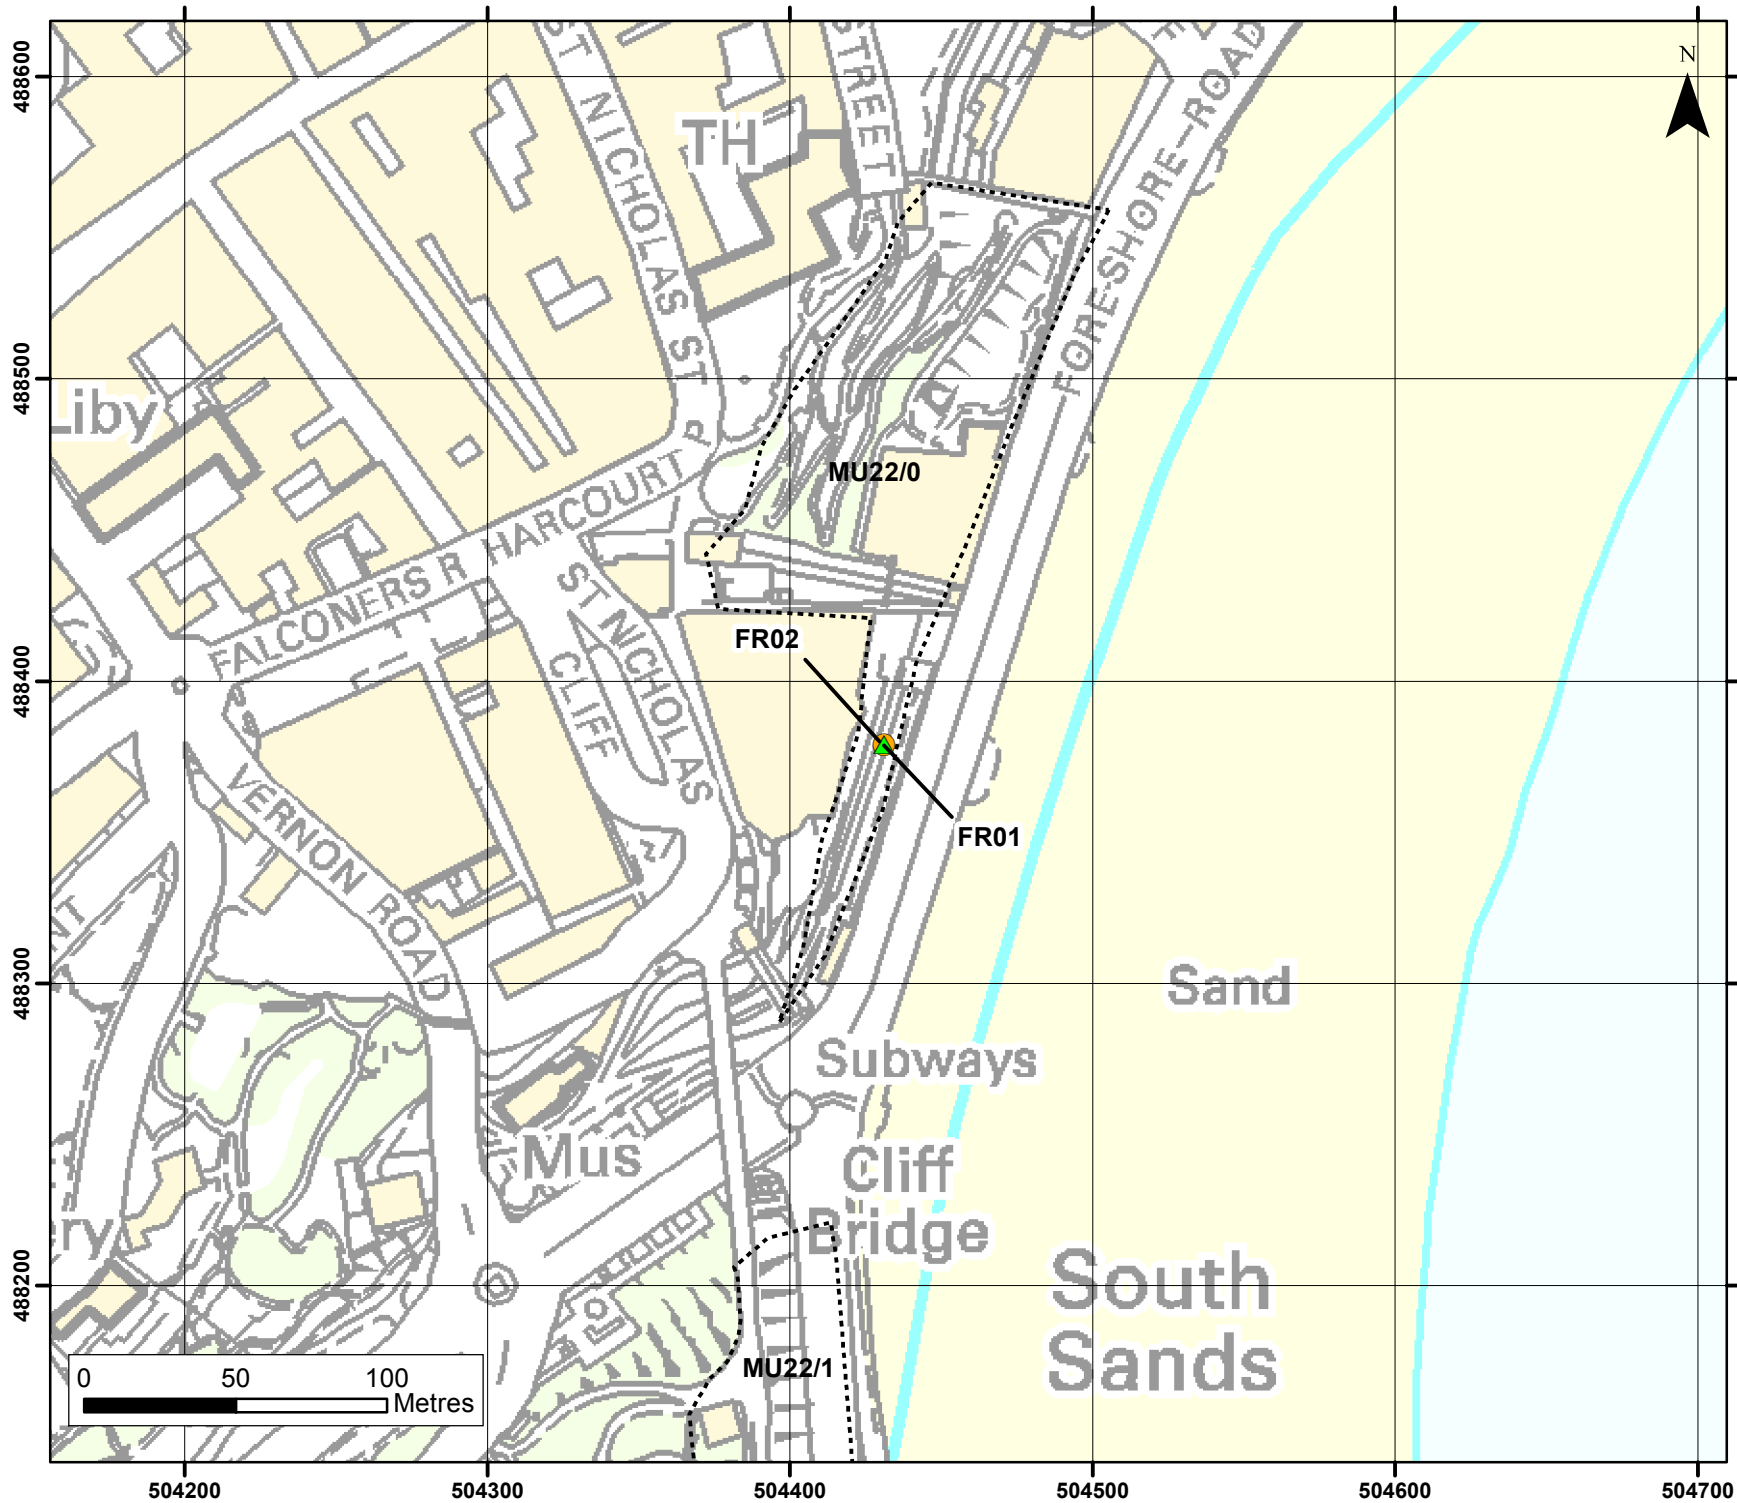
**Figure 9.1A Location of monitoring at Scarborough South Bay**

The cliff here is around 30m high and heavily landscaped with terraces and footpaths and formed in fine-grained glacial sediments (Figure 9.1A). Average slope angle is 20 to 30° but is locally steeper with sections supported by retaining walls. The cliff is crossed by a cliff lift and the cliff top is occupied by the Grand Hotel. There is no history of instability in recent years and this CBU was not reported on by Mouchel.
