Coastal Slope Monitoring Analysis Interpretation Report 17: July 2021 to November 2021

Document no: 11/2021
Revision no: 1

Scarborough Borough Council

Local Coastal Slope Monitoring Analysis
7 December 2021

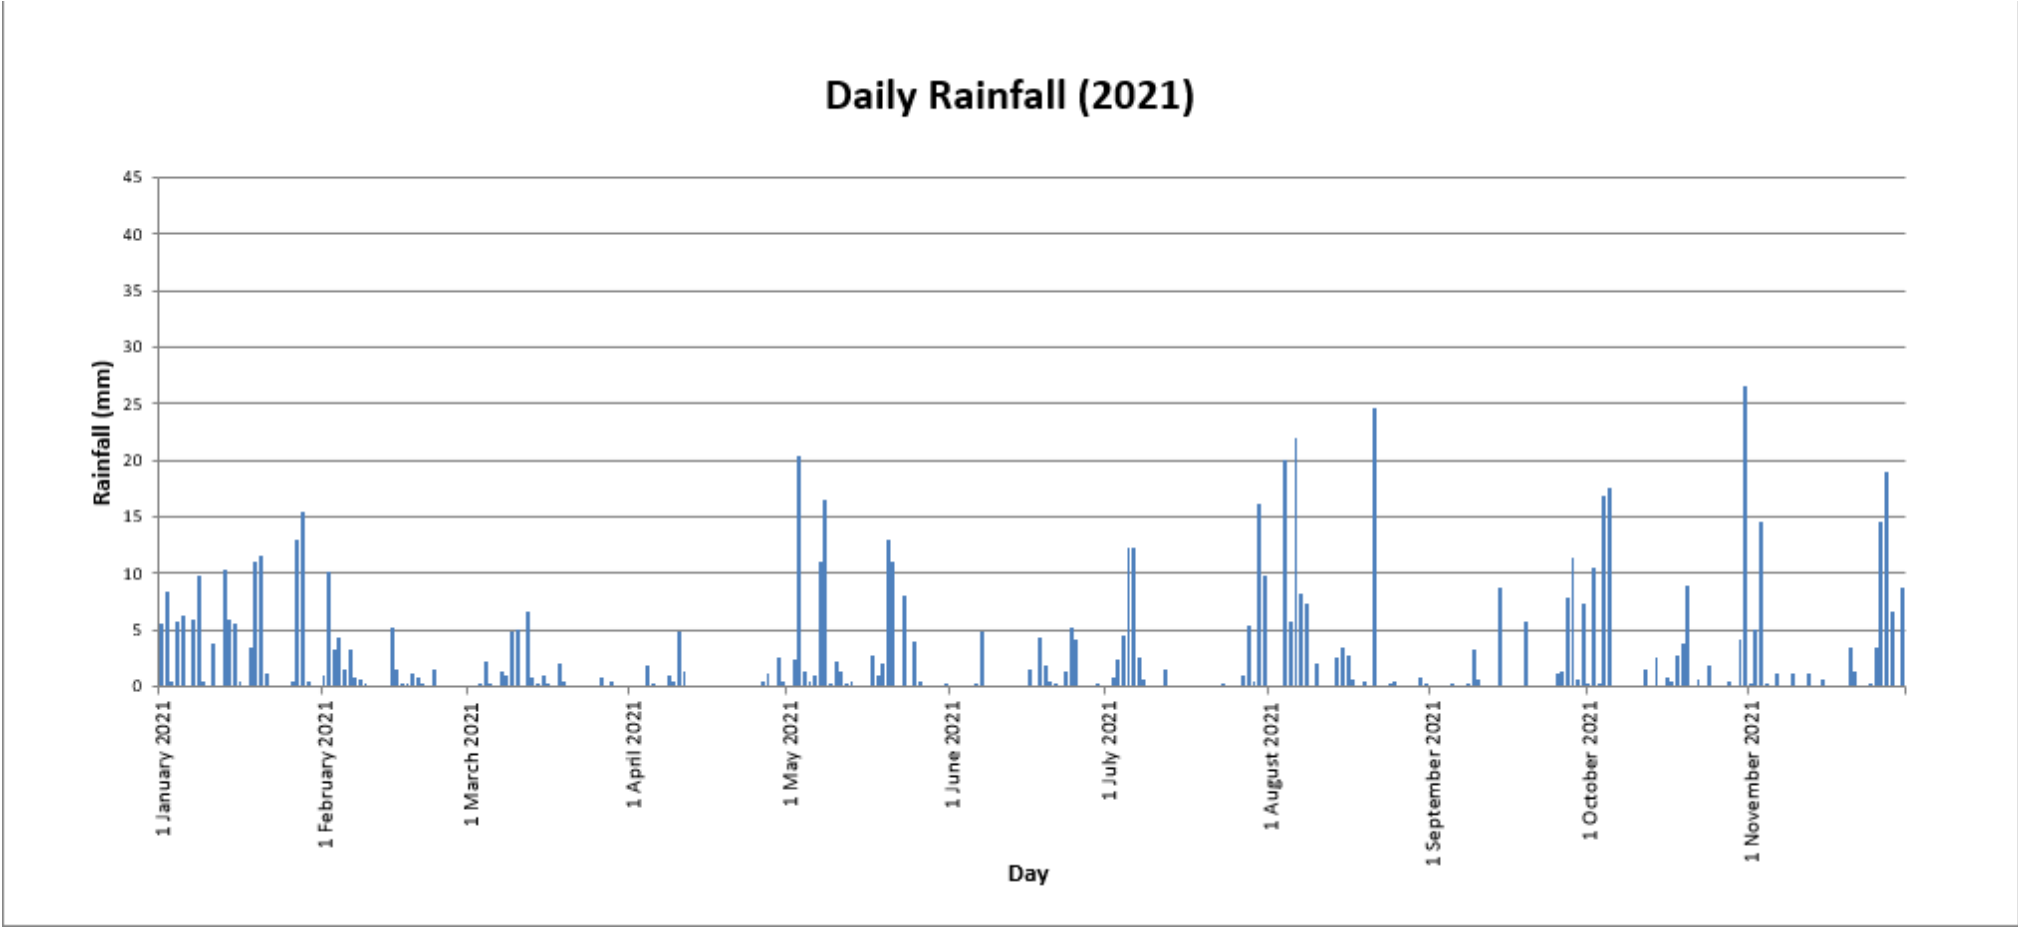
Figure 2-2 Daily rainfall recorded at Scarborough Spa from January to November 2021

Daily rainfall totals recorded by the Scarborough Spa weather station are presented in Figure 2-2, which highlights peaks in daily rainfall over 10 mm occurring in all the months during this monitoring period (July to November). The highest daily rainfall total over this monitoring period equalled 26.6 mm on 31st October, which is the greatest level of daily rainfall that has occurred in 2021.

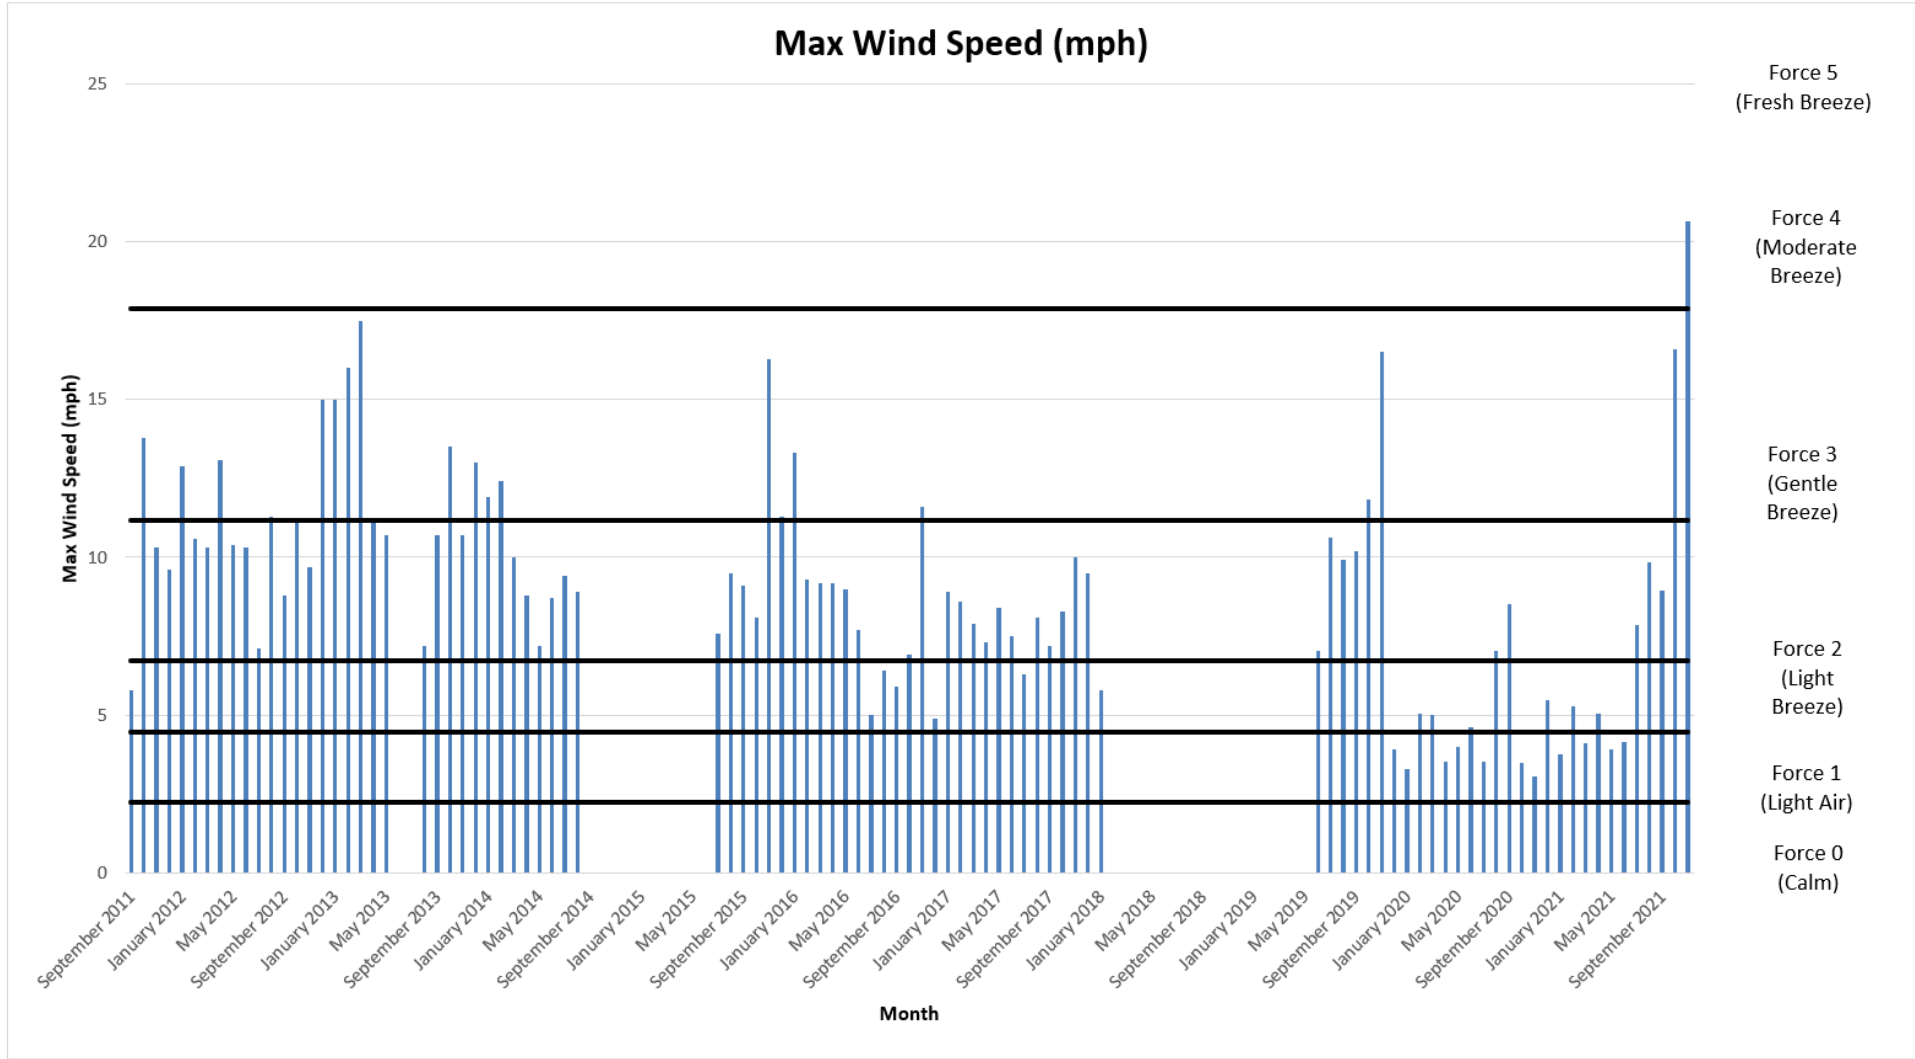
Figure 2-4 Maximum daily wind speed (2011 to 2021).

Wind speed and air temperature records are presented in Figure 2-4 and Figure 2-5. November 2021 had the highest wind speed on record since 2011 at 20.6 mph, equalling a Force 5 on the Beaufort Wind Scale. This event relates to Storm Arwen.

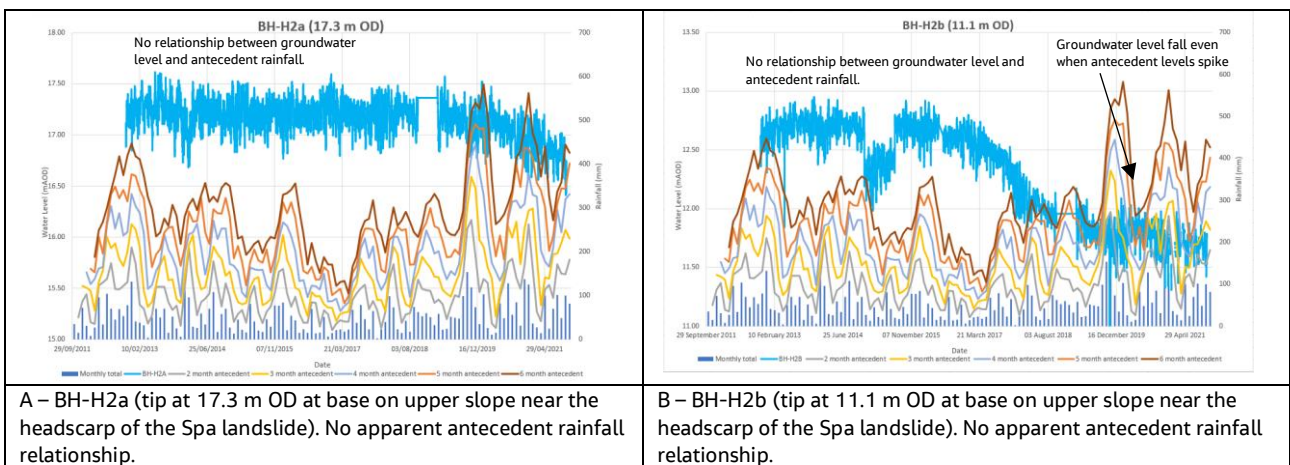
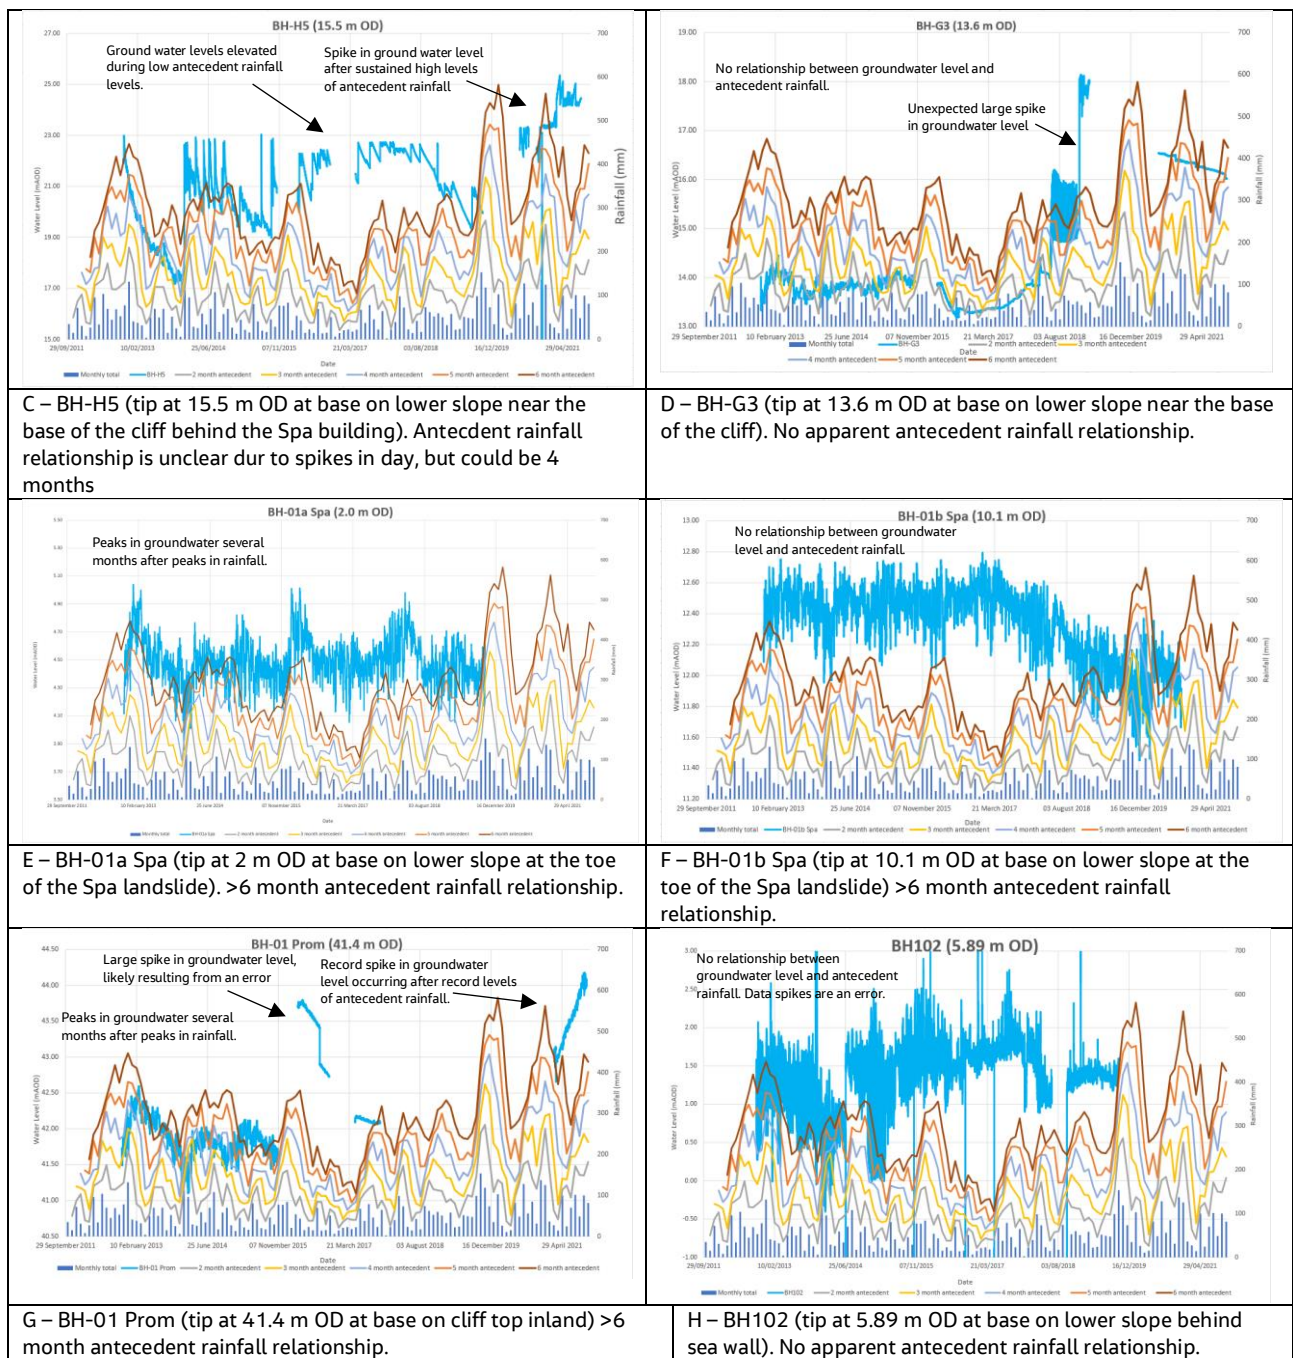
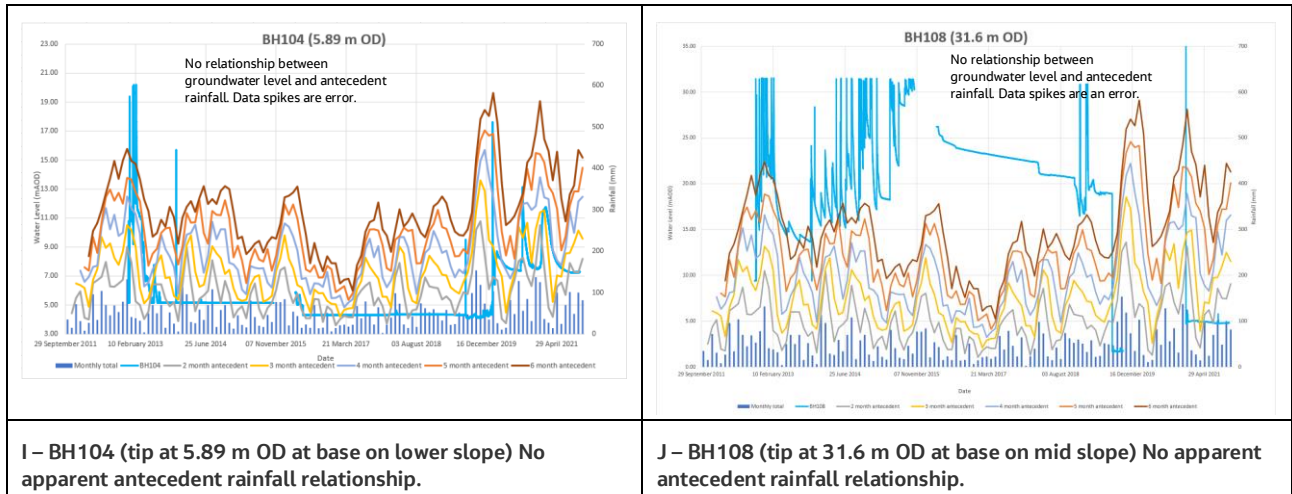
Figure 9-4 Relationship between groundwater levels and antecedent rainfall at Spa.

At St Nicholas cliff (Figure 9-2) BH-FR02 shows an antecedent rainfall relationship that appears greater than 6 months. At Spa Chalet (Figure 9-3), antecedent rainfall relationships are unclear, with responses often appearing following 6 months antecedent rainfall and greater. The picture is similar at the Spa (Figure 9-4), where BH-01a Spa and BH-01 Prom also show responses of greater than 6 months. In contrast BH-H5, which is at the base of the slope behind the Spa building, suggests an antecedent rainfall relationship of 4 months. All other automated piezometers at the Spa do not have an apparent antecedent rainfall relationship. At South Cliff Gardens (Figure 9-5), the antecedent rainfall relationship is greater than 6 months at BH-D2a, BH-E2a and BH-E2b. Relationships at other automated piezometers at the South Cliff Gardens remain complex.
