Interpretation Report 7: June 2016 to November 2016

Prepared for
Scarborough
Borough Council

January 2017

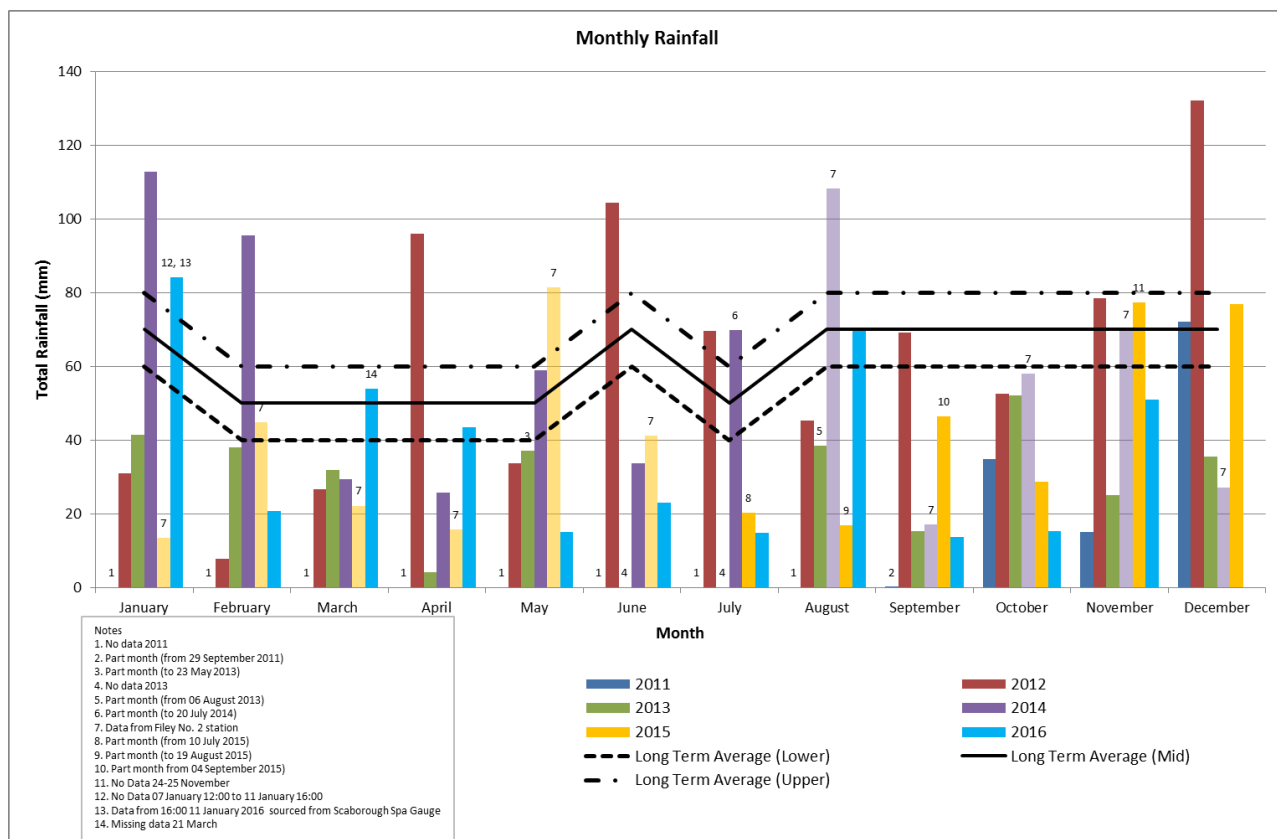
Figure 2.1 Comparison of monthly rainfall records (2011 to 2016).

Data from all three weather stations are summarised in Table 2.1 and Figure 2.1. The records for the last six months show that August 2016 was close to the long-term mean (upper range) when compared to past records, whereas other months were relatively dry.

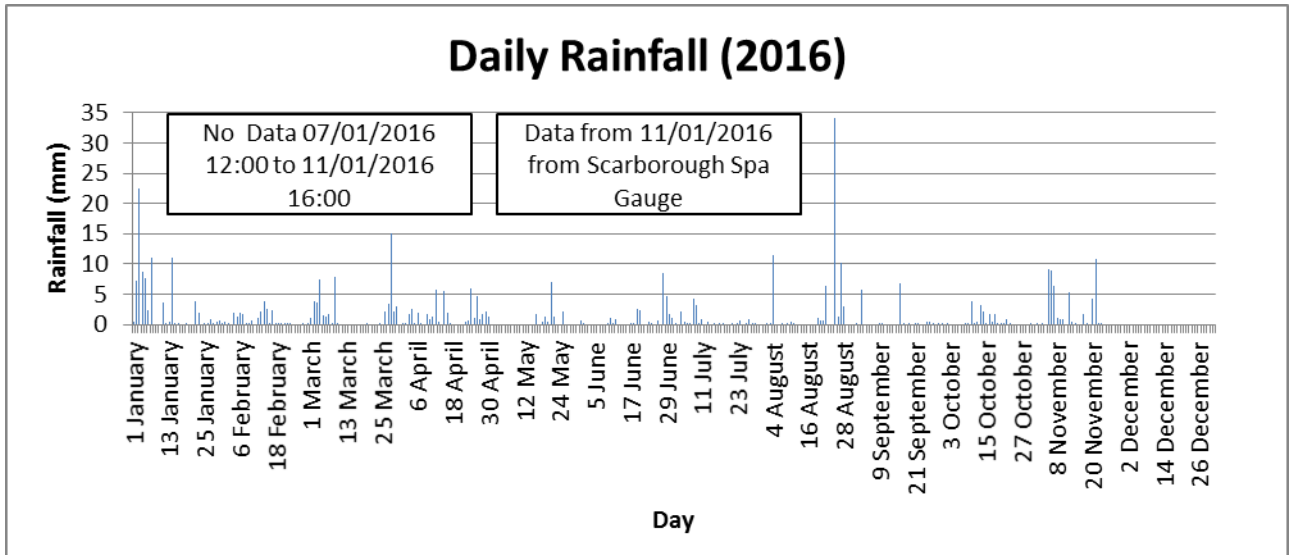
Figure 2.2 Daily rainfall recorded at Flat Cliffs during 2016

Daily rainfall totals recorded by the Scarborough Spa weather station are presented in Figure 2.2, which shows peaks on 4 and 25 August. The combined dataset has been used for comparison with all coastal slope monitoring data in order to identify relationships. The data are taken to be representative of the whole Scarborough Borough Council frontage, but it is accepted that micro-climate effects may lead to local variations.

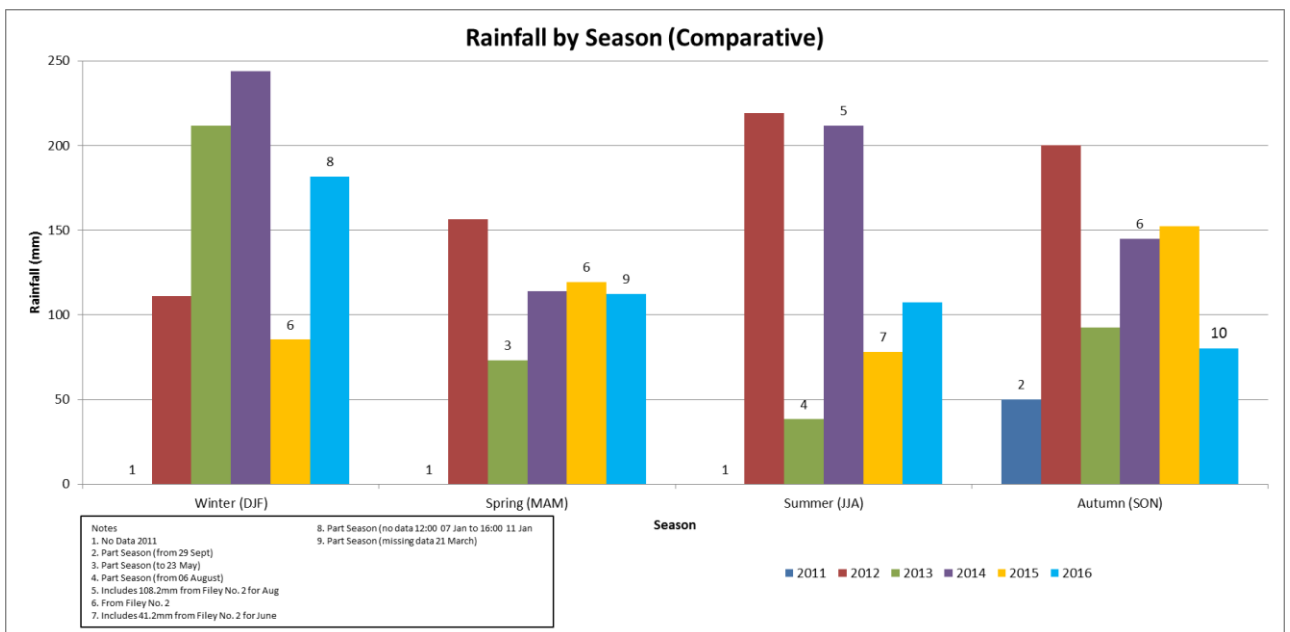
Figure 2.3 Seasonal rainfall comparison (2011-2016)

Seasonal totals are shown in Figure 2.3, which shows that the wettest seasons tend to be winter and summer and that the spring is the driest. The wettest season on record was winter of 2013/14 (i.e. December 2013, January and February 2014) that received a total of 244mm rainfall. The summers of 2012 and 2014 were also very wet, receiving 219mm and 211mm respectively. The winter of 2015/16 received around double the rainfall of 2014/5, but the spring was marginally drier.

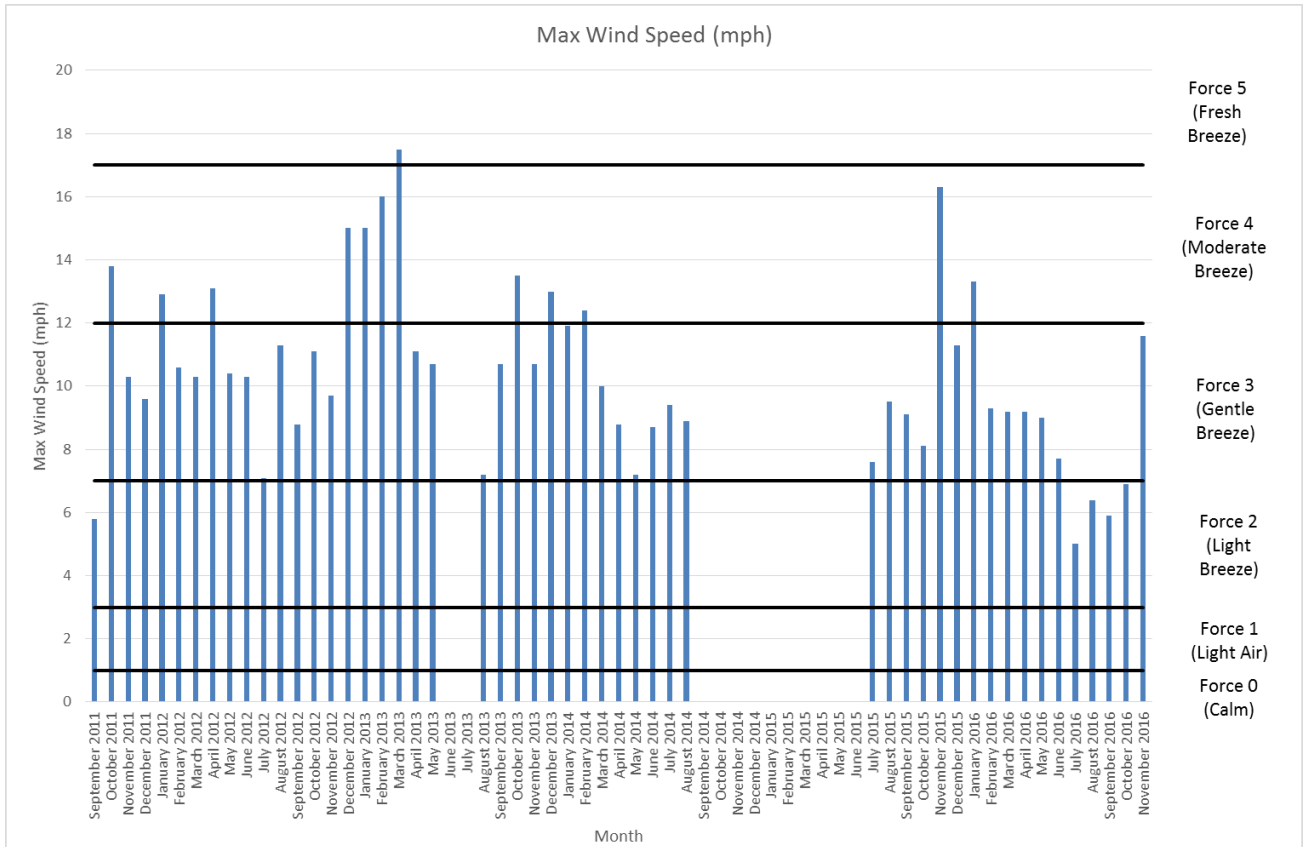
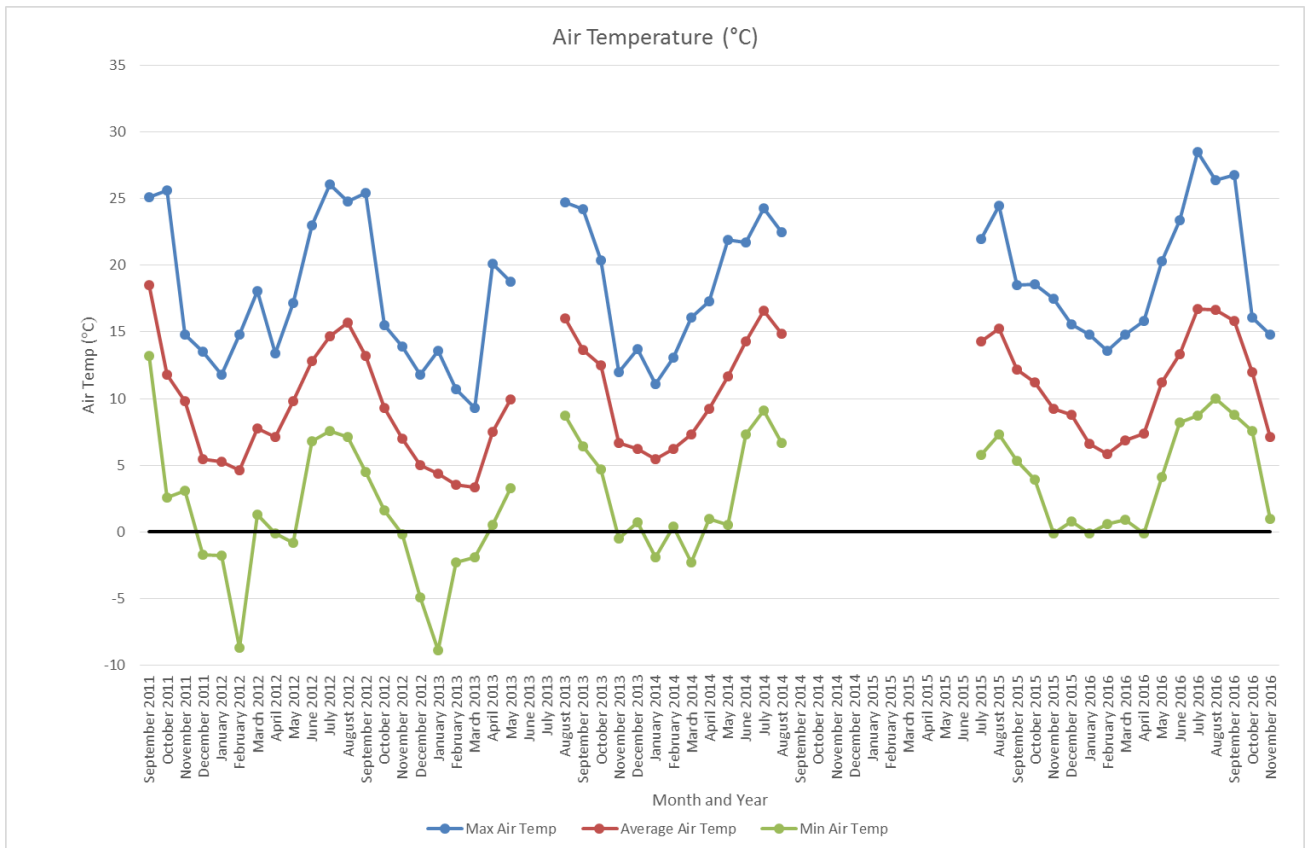
Wind speed and air temperature records from Flat Cliffs are presented in Figures 2.4 and 2.5. The data shows November 2016 as the windiest month in the monitoring period and relatively gentle conditions persisted during late summer-early autumn 2016. Recorded temperatures during 2016 are average, except for the relatively warmer summer of 2016.

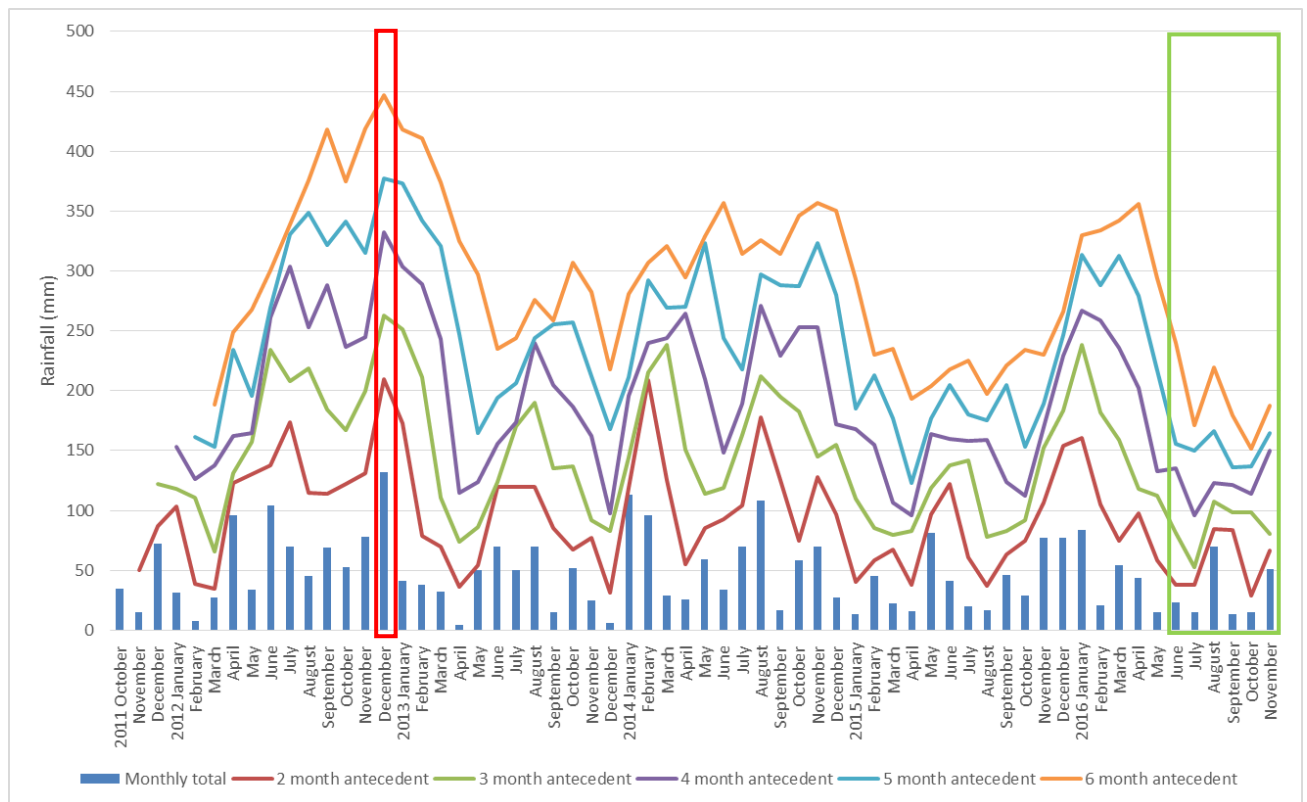
The weather records for the SBC frontage spans a relatively short time period, but does include the particularly wet year of 2012. The only 'significant' ground movements at this time were recorded in BH7 at Scalby Ness, which occurred during December 2012. Monthly rainfall totals are provided in Table 2.1 and antecedent totals are presented in Figure 2.6. Assuming that rainfall was the sole trigger of this ground movement, it suggests a three month antecedent rainfall threshold of 263mm is required to trigger movement. The absence of movements elsewhere on the coast at this time suggests that the antecedent rainfall threshold levels are above this at other locations.

Antecedent rainfall over the current June-November monitoring period show peaks that are lower than December 2012 and with a similar pattern to the previous June to November period.

Figure 2.6. Monthly rainfall and two to six month antecedent totals (2011 to 2016). Ground movements were recorded at Scalby Mills during December 2012 (red box). Current monitoring period shown by green box.
