# Interpretation Report 9: June 2017 to November 2017

*Prepared for*  
Scarborough  
Borough Council

February 2018

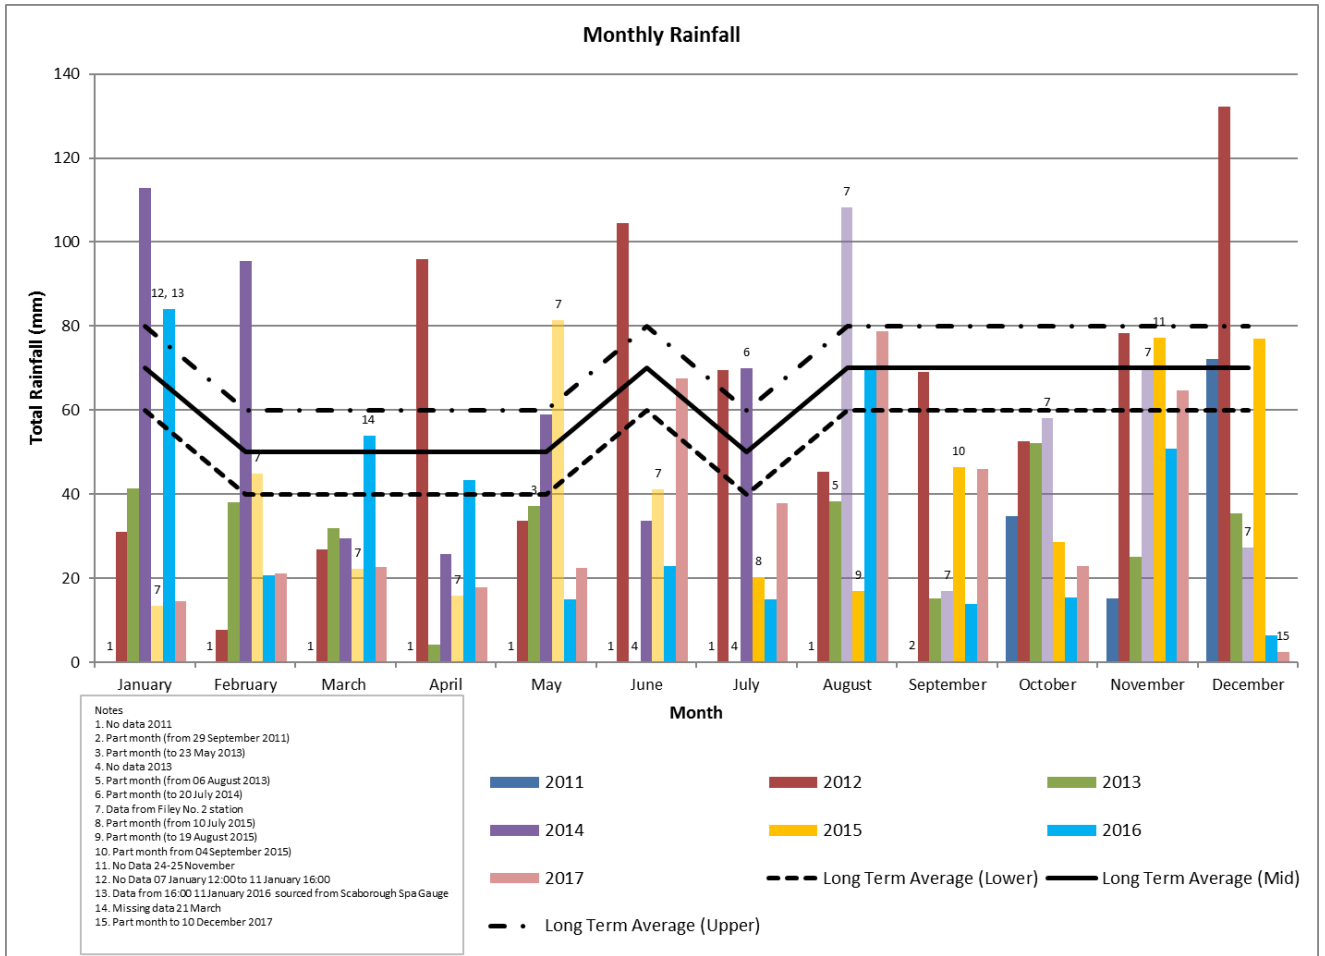
Figure 2.1 Comparison of monthly rainfall records (2011 to 2017).

Data from all three weather stations are summarised in Table 2.1 and Figure 2.1. The records for the last six months show that overall summer 2017 was relatively wetter when compared to past records, with June and August close to the long-term mean (upper range). Comparatively, autumn 2017 was drier on average, with the exception of November which was close to the long-term mean (lower range).

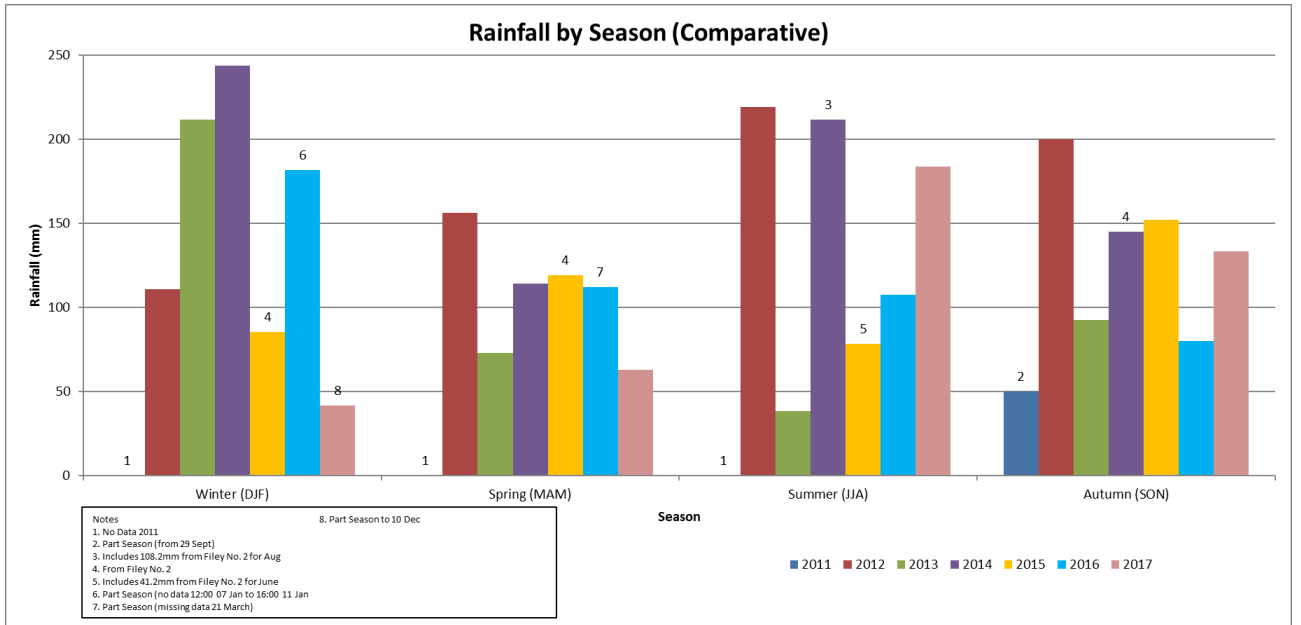
Figure 2.3 Seasonal rainfall comparison (2011-2017)

Seasonal totals are shown in Figure 2.3, which shows that the wettest seasons tend to be winter and summer and that the spring is the driest. The wettest season on record was winter of 2013/14 (i.e. December 2013, January and February 2014) that received a total of 244mm rainfall. The summers of 2012 and 2014 were also very wet, receiving 219mm and 211mm respectively. The winter of 2015/16 received around double the rainfall of 2014/5, but the spring was marginally drier. The winter of 2016/17 and spring 2017 have been the driest on record. The summer of 2017 has been relatively wetter than previous years, receiving 183mm of rainfall, whereas slightly drier conditions occurred through autumn 2017.

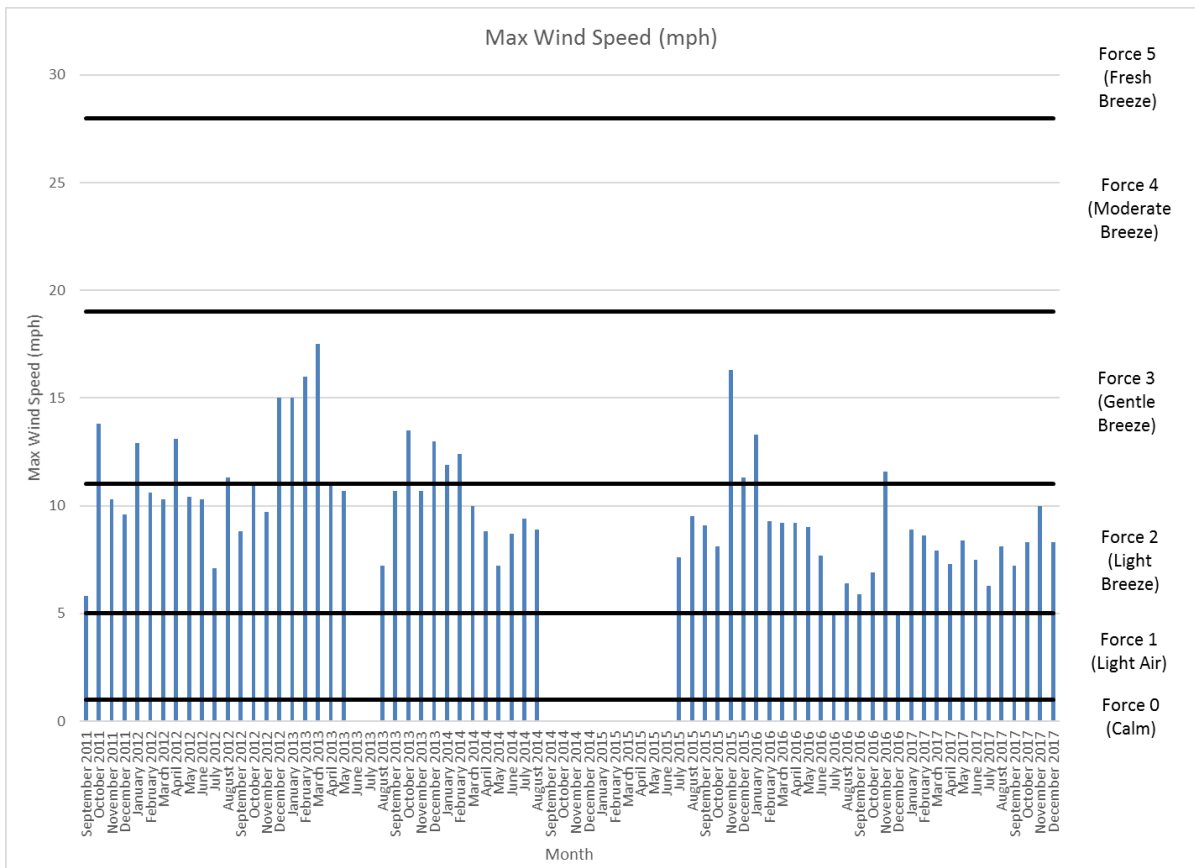
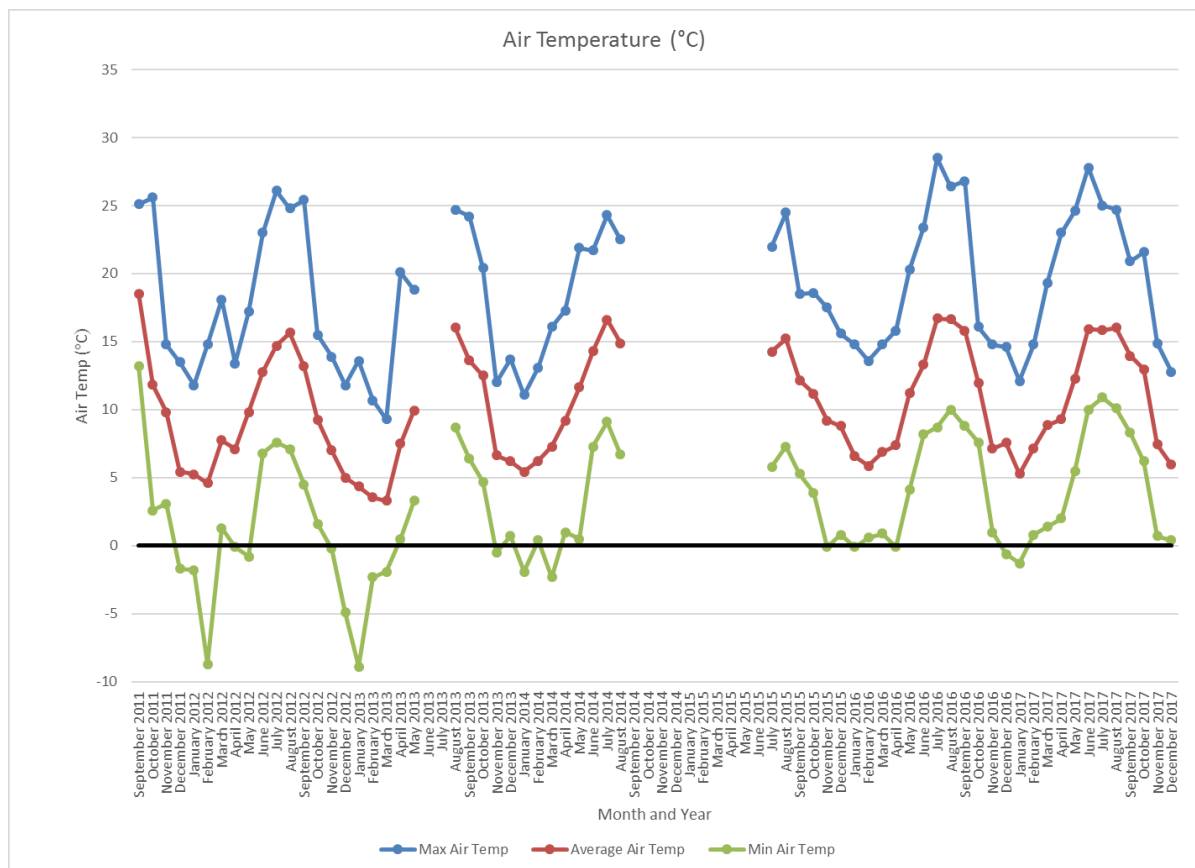
Wind speed and air temperature records from Flat Cliffs are presented in Figures 2.4 and 2.5. The data shows November 2017 as the windiest month in the monitoring period. Relatively gentle conditions persisted during over summer and early autumn 2017. Recorded temperatures during 2017 are average.
