Flat Cliffs stability assessment and management plan

Ground investigation and monitoring report

Scarborough Borough Council

31 May 2012

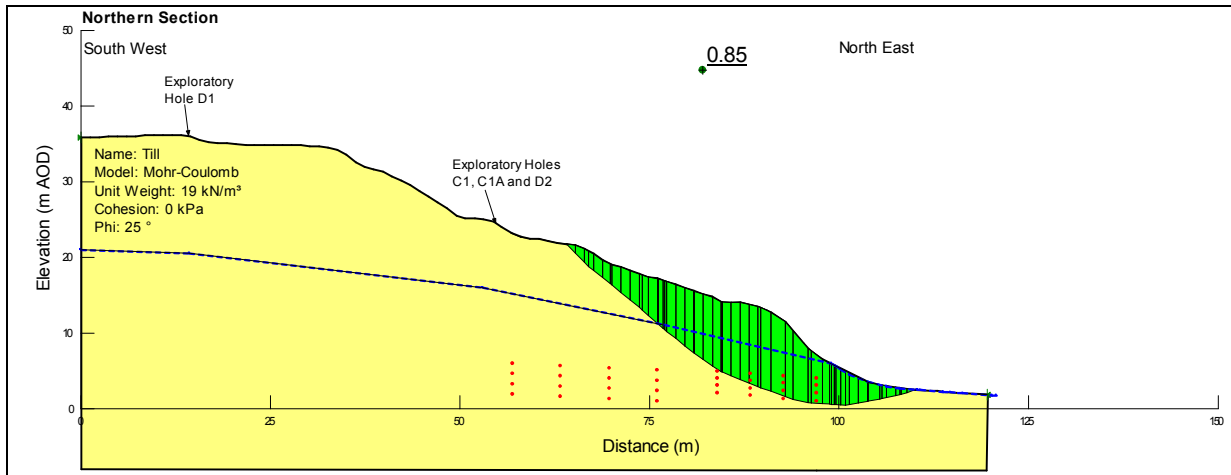
Figure 9. Northern Section; Long term stability of the existing slope toe

The long term global factor of stability was computed as 0.94 and is presented in Figure 8. Despite this model showing a value less than unity and therefore a failed state, in reality it shows that the slope has marginal instability. The stability of the toe is shown on Figure 9 and this shows that with a FoS of 0.86 the toe is in the process of failing or has a low margin of stability.

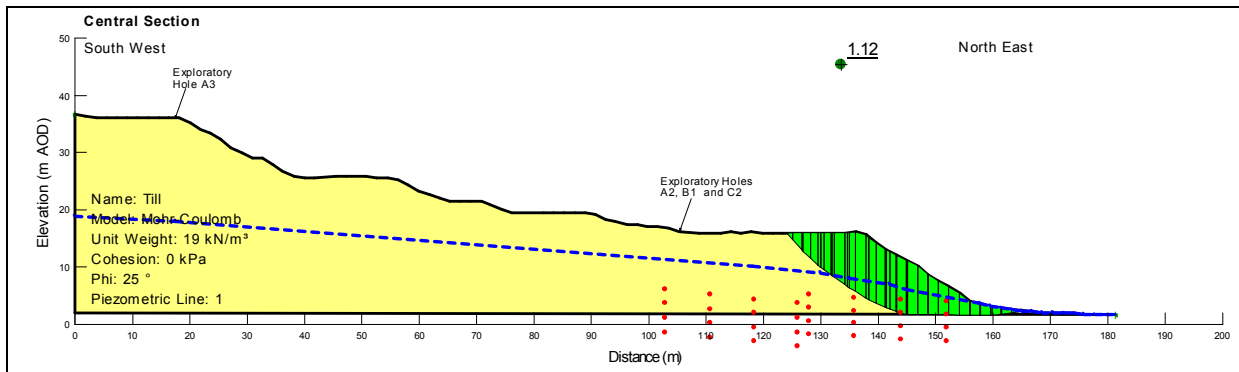
Figure 14. Central Section; Long term stability of the existing slope toe

The exploratory holes relevant to the central section are: C2 (AEG 2011 investigation) and A2, A3 and B1 (Figure 1). The long term global stability of this section shows a FoS of 1.96 (Figure 13) and the stability of the toe shown on Figure 14 has a FoS of 1.12. Both of these conditions are shown to be stable in the long term with their current ground surface and 'average' groundwater profile modelled.
