**Robin Hood's Bay Seawall,
North Yorkshire**

CONCRETE CONDITION SURVEY

20H/01363

for Restek UK Ltd

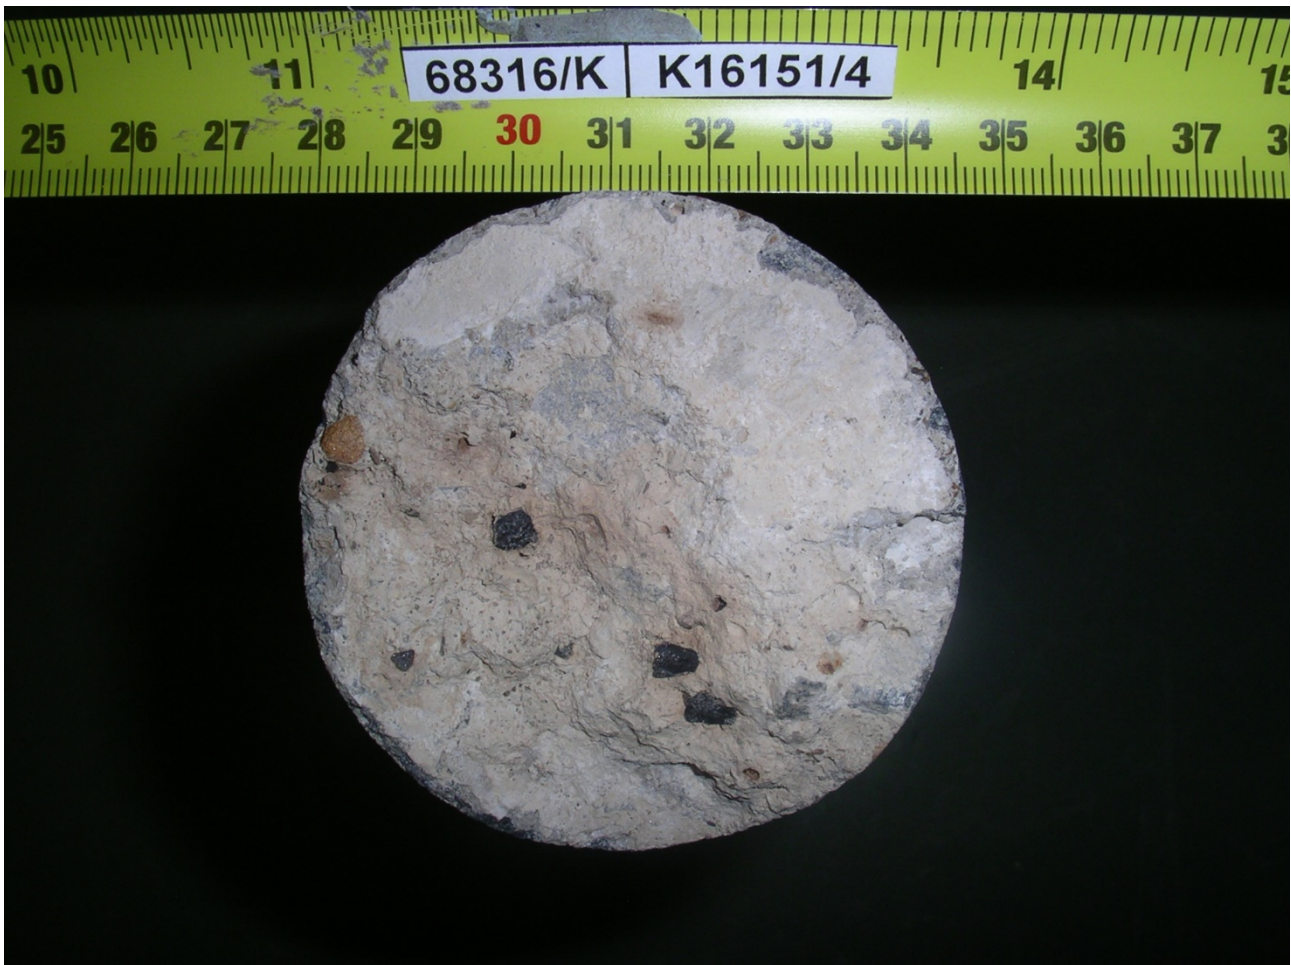
Figure B13

Sample K16151/4

The sample as received, inner surface:

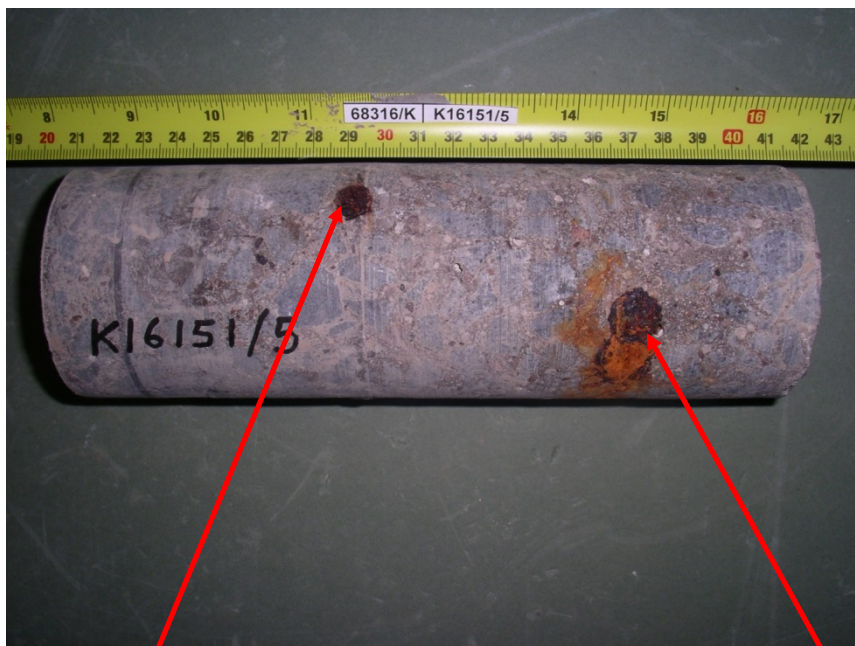
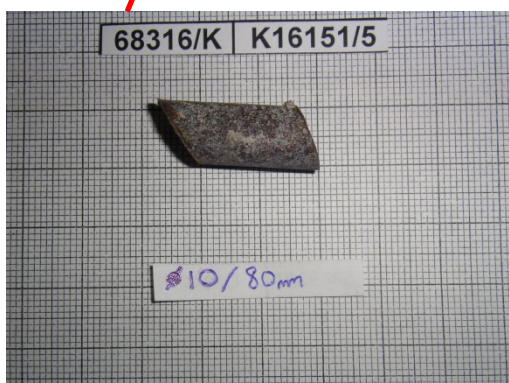
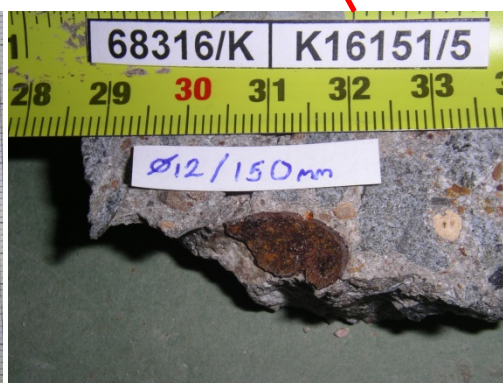
Figure B14

Sample K16151/5

The sample as received, side view of core:

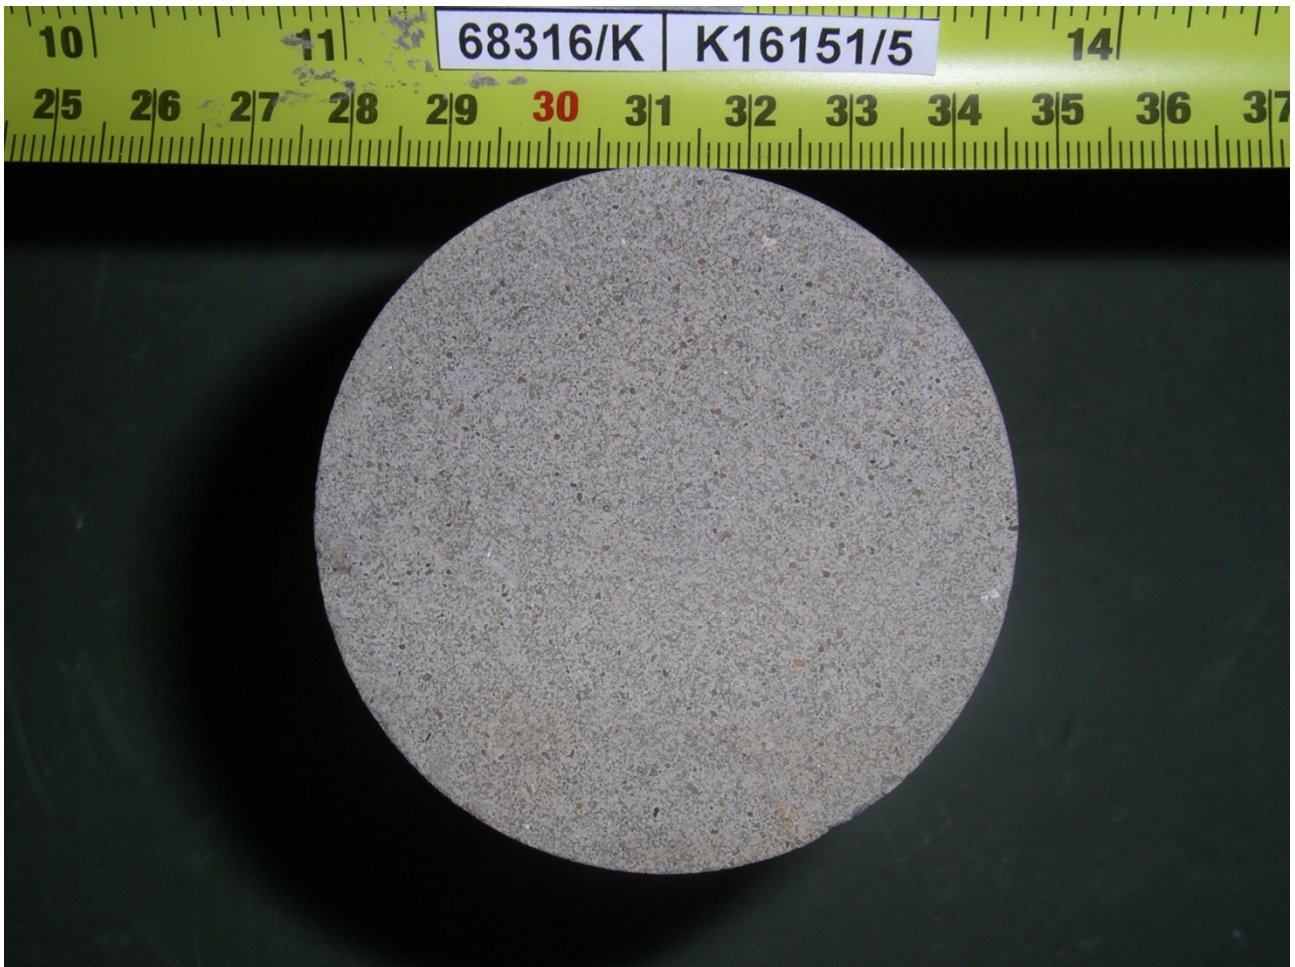
Figure B15

Sample K16151/5

The sample as received, outer surface:

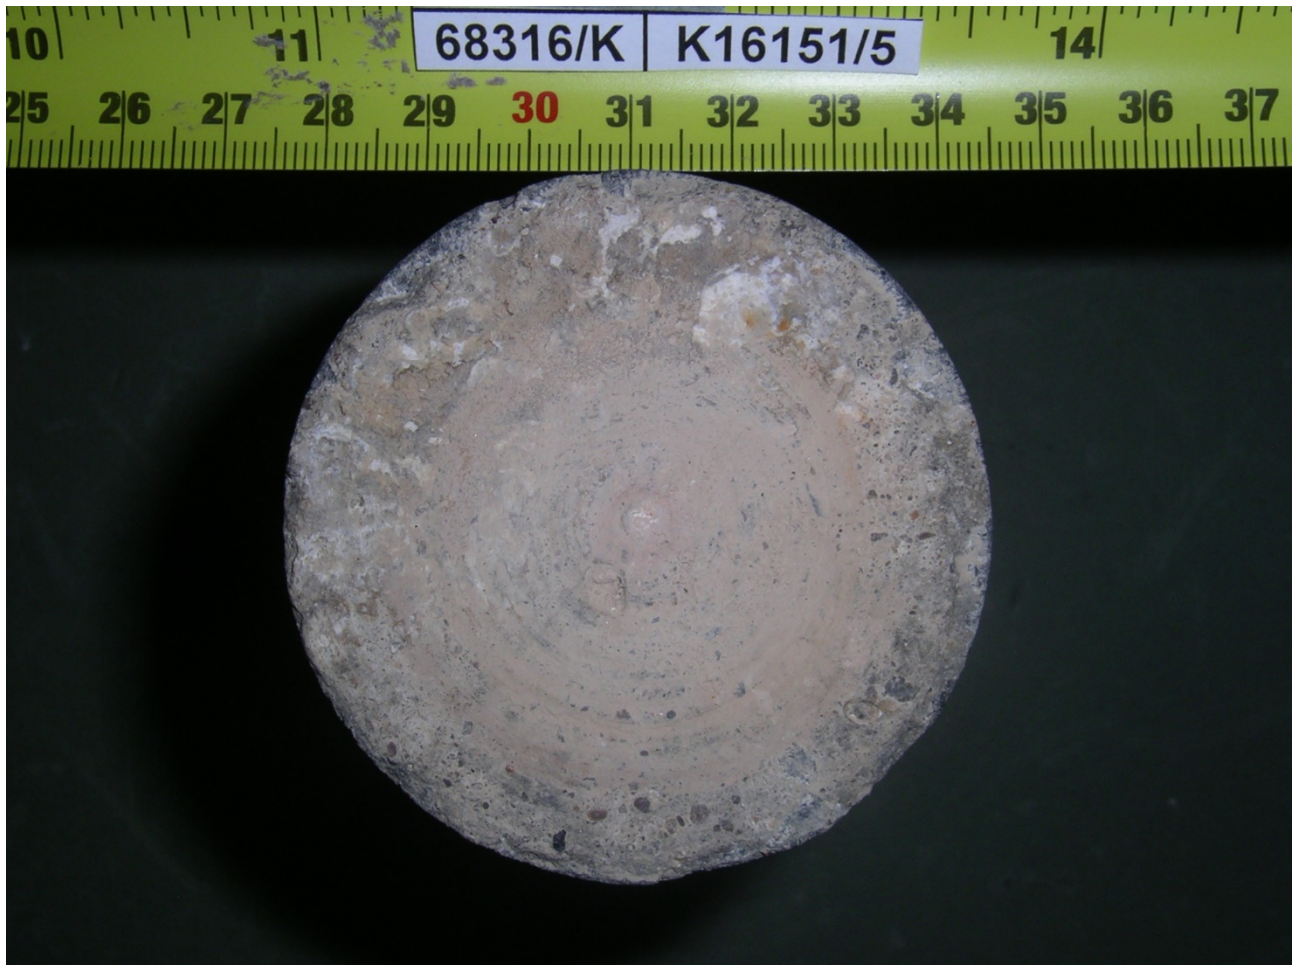
Sample K16151/5

The sample as received, inner surface:

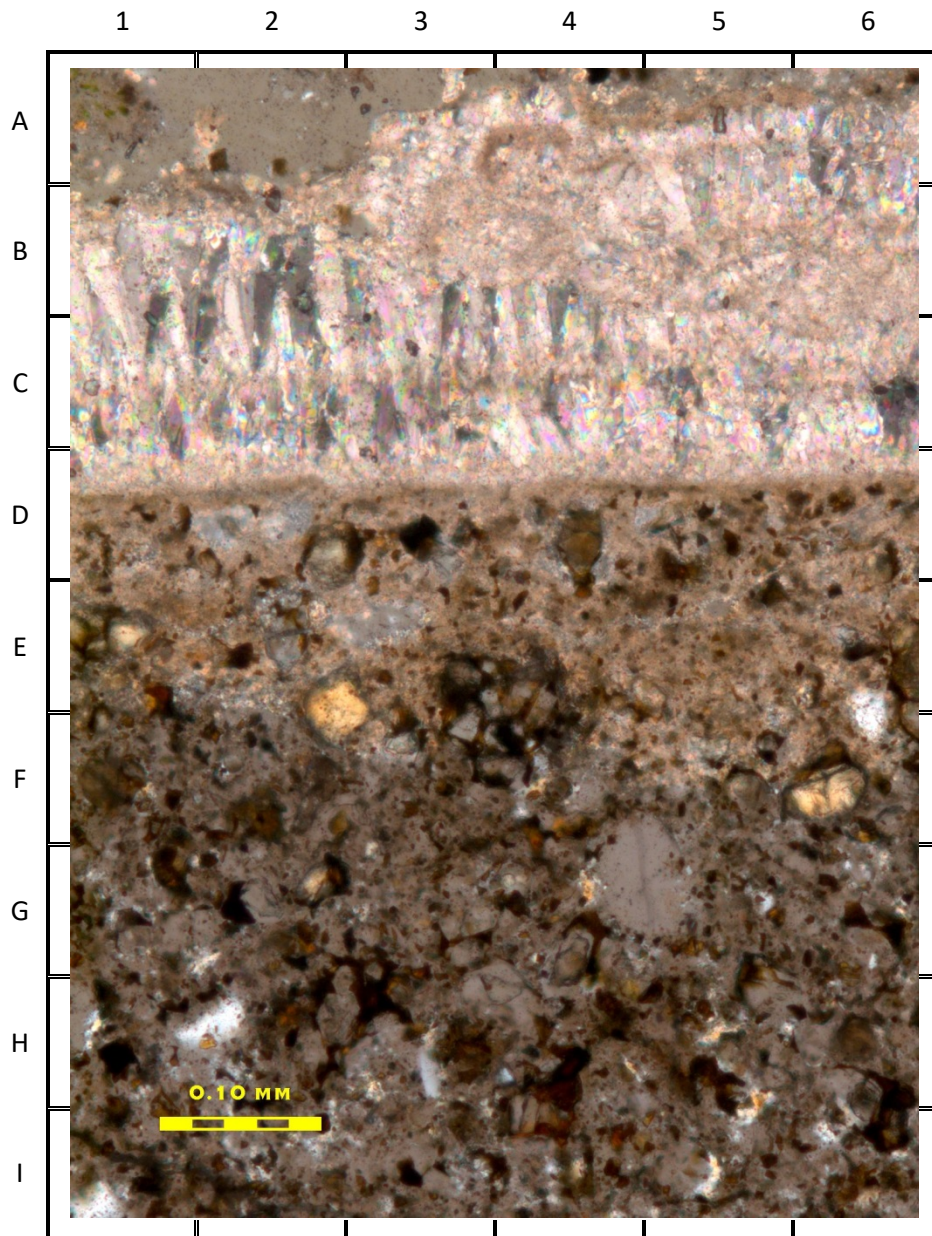
Figure C1

Sample K16151/1

Thin section, oblique polars: View showing a cross section through the outer surface. Layered calcite deposits are visible from B/C1 to B/C6. A shallow zone of carbonated paste occurs in the concrete surface from D/E1 to D/E6. Much of the lower half of the field of view is occupied by uncarbonated Portland cement paste containing fine portlandite crystals that are visible for example in H/15.

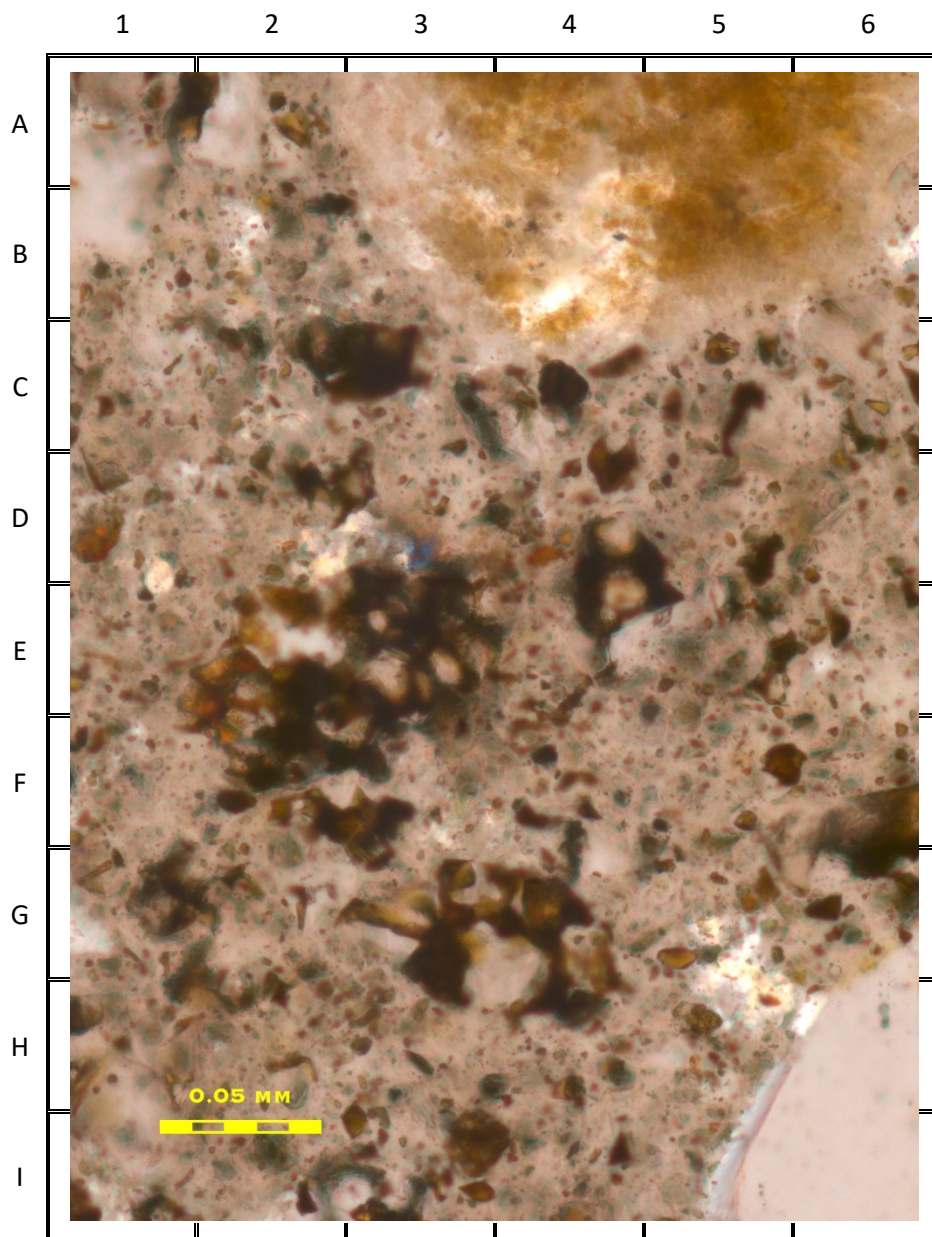
Figure C2

Sample K16151/1

Thin section, oblique polars: View showing the typical appearance of the paste in thin section. Particles of pseudomorphically hydrated Portland cement are visible for example in E2/3 and G4. Fine portlandite crystals appearing mottled yellow to white occur for example in G/H5. A flint particle occurs in A4/5 and a particle of quartz occurs in I6.

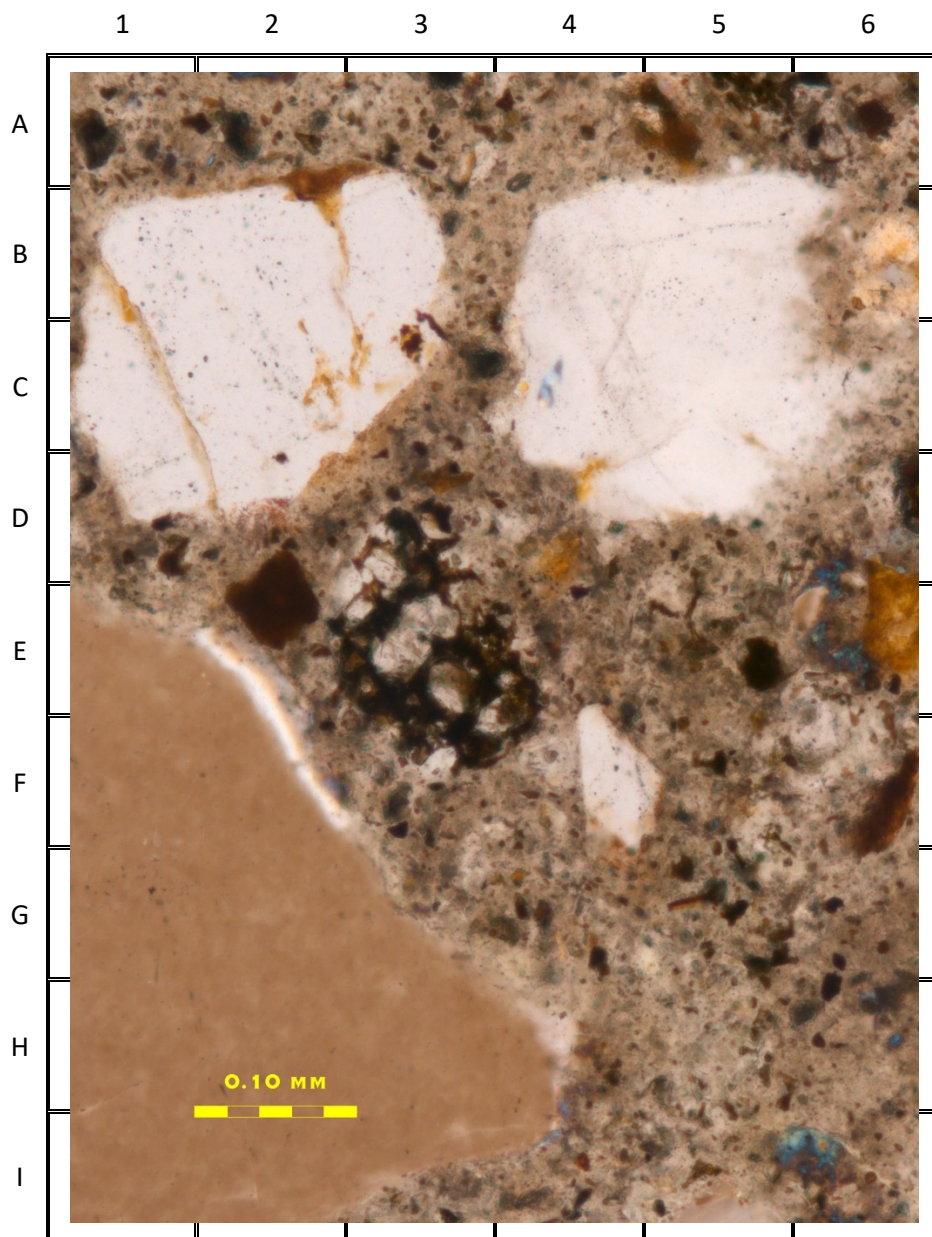
Sample K16151/3

Thin section, oblique polars: Particles of quartz are visible in B/C2, B/C5 and G1. An unhydrated Portland cement grain resembling a particle of sulfate-resisting Portland cement occurs in E3. Fine portlandite crystals can be seen for example in B6 and I5/6.

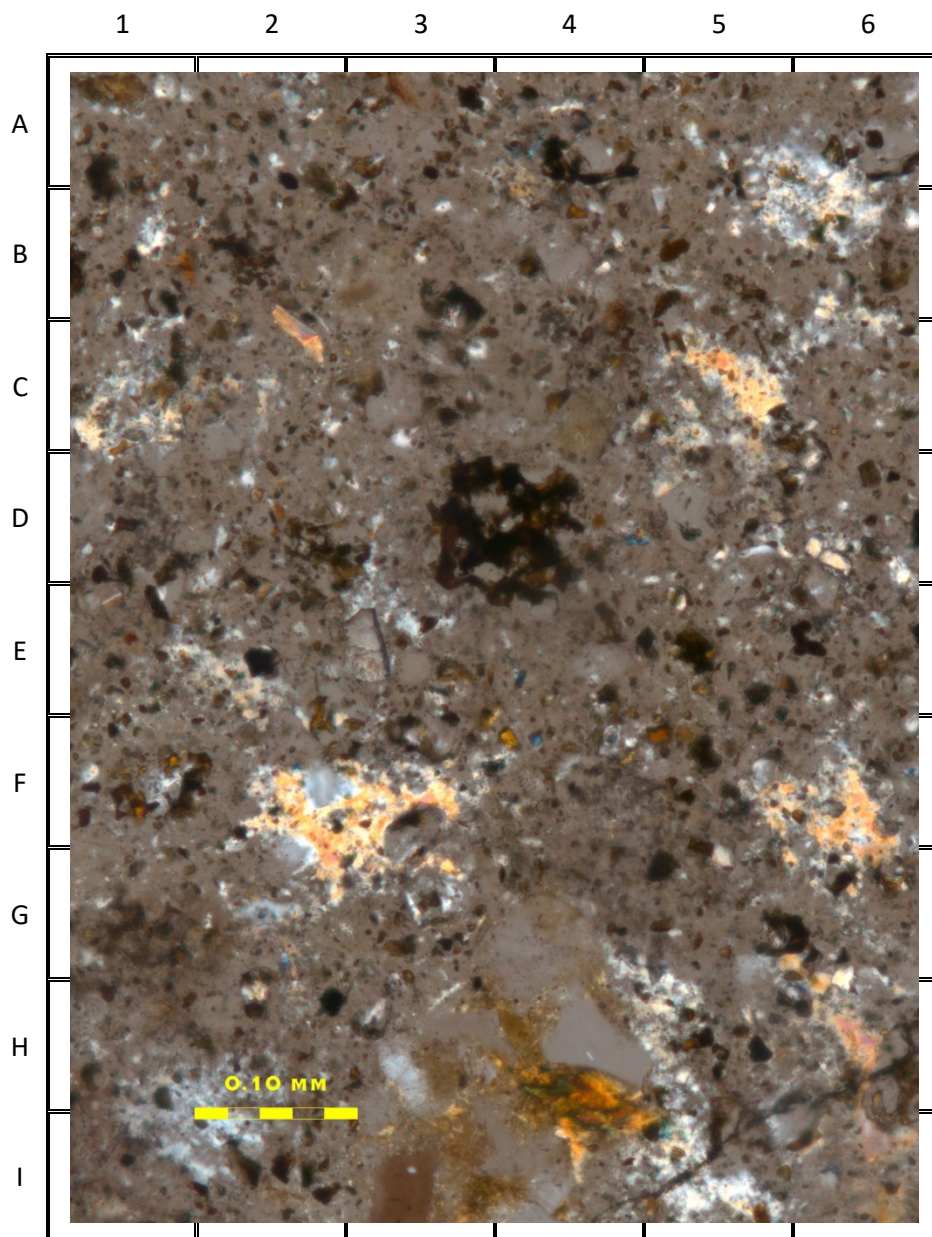
Figure C6

Sample K16151/3

Thin section, crossed polars: The field of view is dominated by uncarbonated paste containing moderately coarse portlandite crystals appearing mottled yellow to orange and visible for example in F/G2 and F/G6. A particle of unhydrated Portland cement resembling sulfate-resisting Portland cement occurs in D3/4.

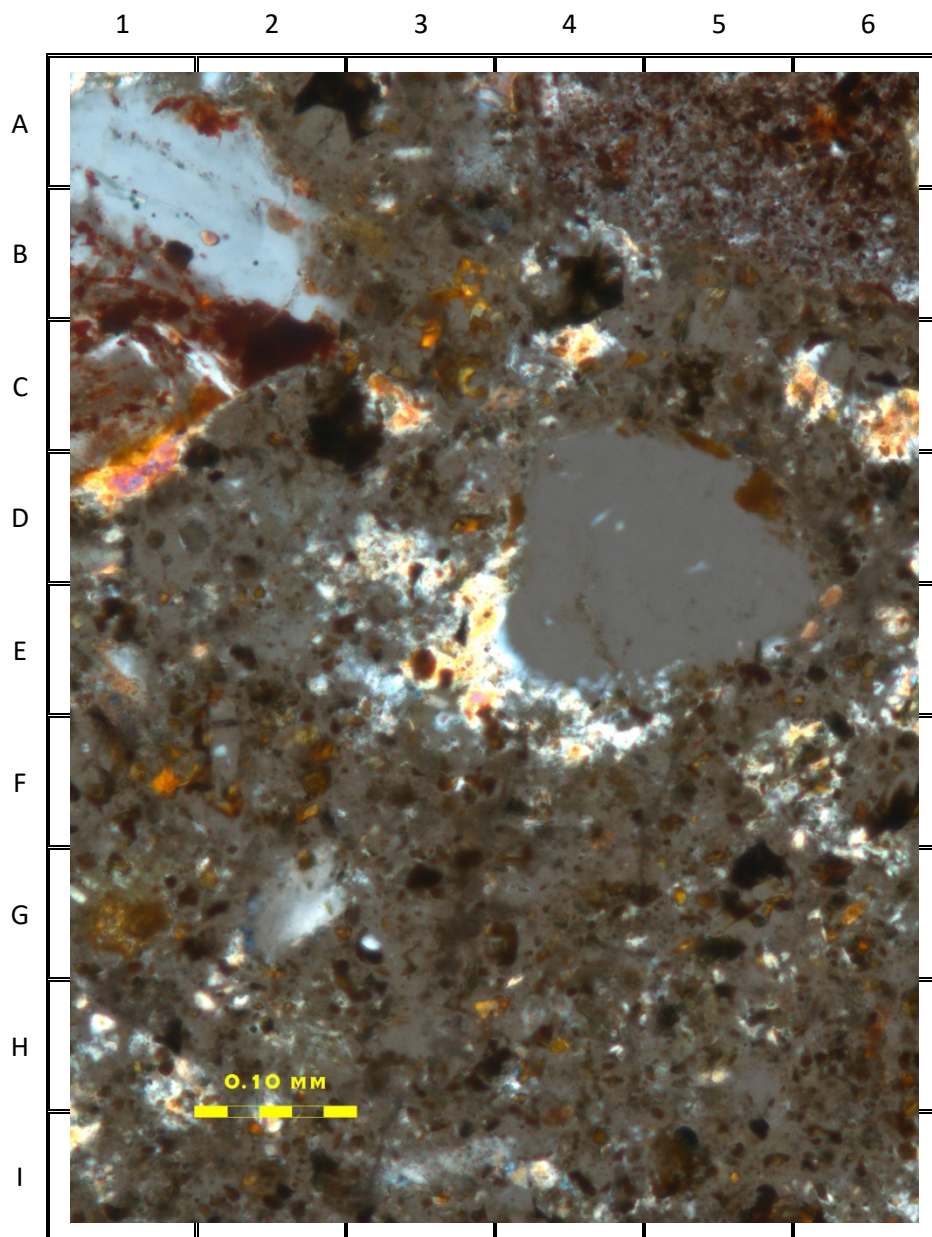
Sample K16151/4

Thin section, crossed polars: The field of view is dominated by uncarbonated paste that is typically of low porosity and contains fine portlandite crystals appearing mottled yellow to orange and visible for example in C6 and E3. A basalt particle occurs in A/B1. A quartz sand particle occurs in D/E5.

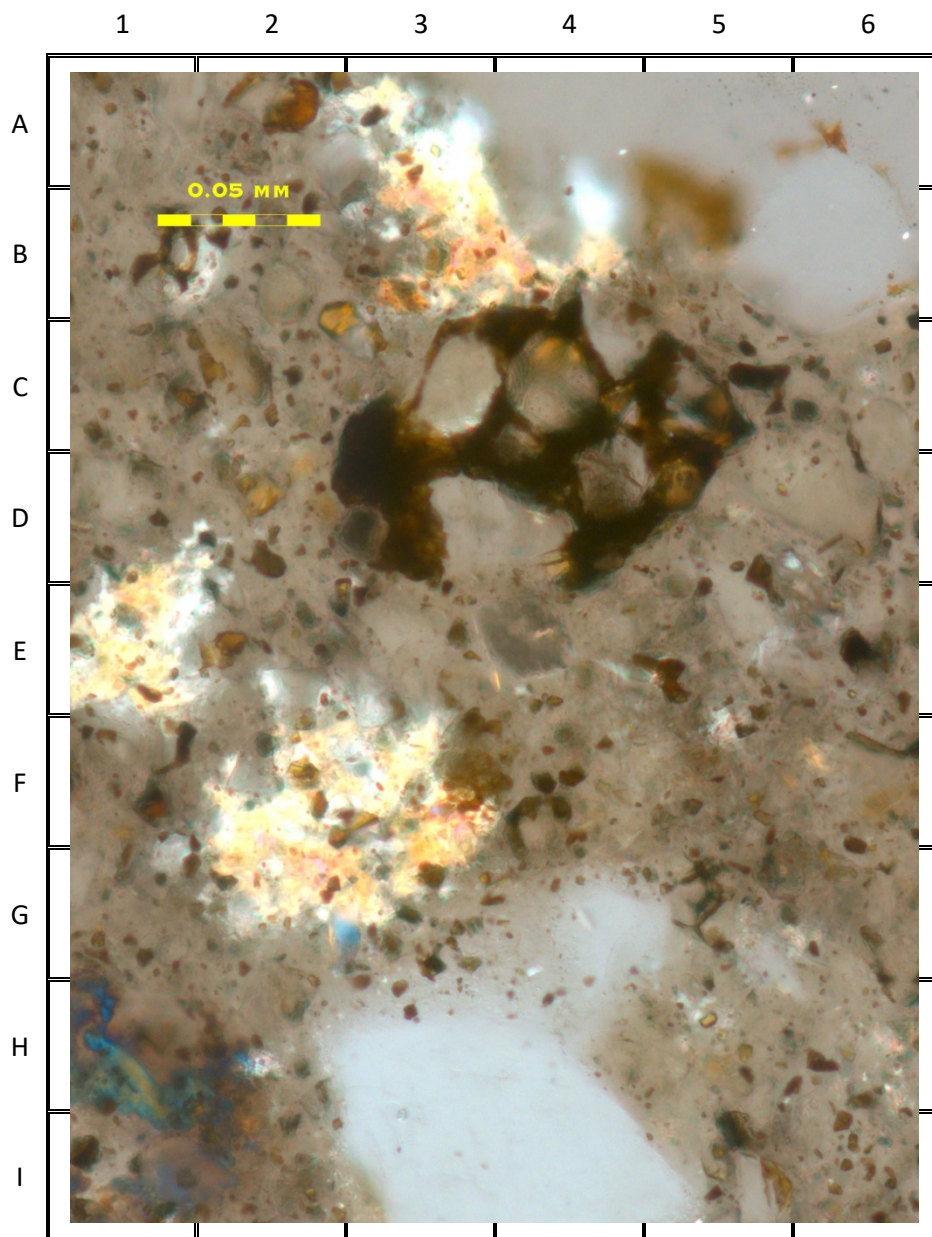
Sample K16151/5

Thin section, oblique polars: A particle of unhydrated Portland cement resembling a particle of sulfate-resisting Portland cement occurs in C/D4. Irregular portlandite crystals appearing mottled yellow to orange occur on the surface of a quartz particle in B3 and in the paste in E1 and F/G3. Particles of quartz occur in A5 and I3/4.

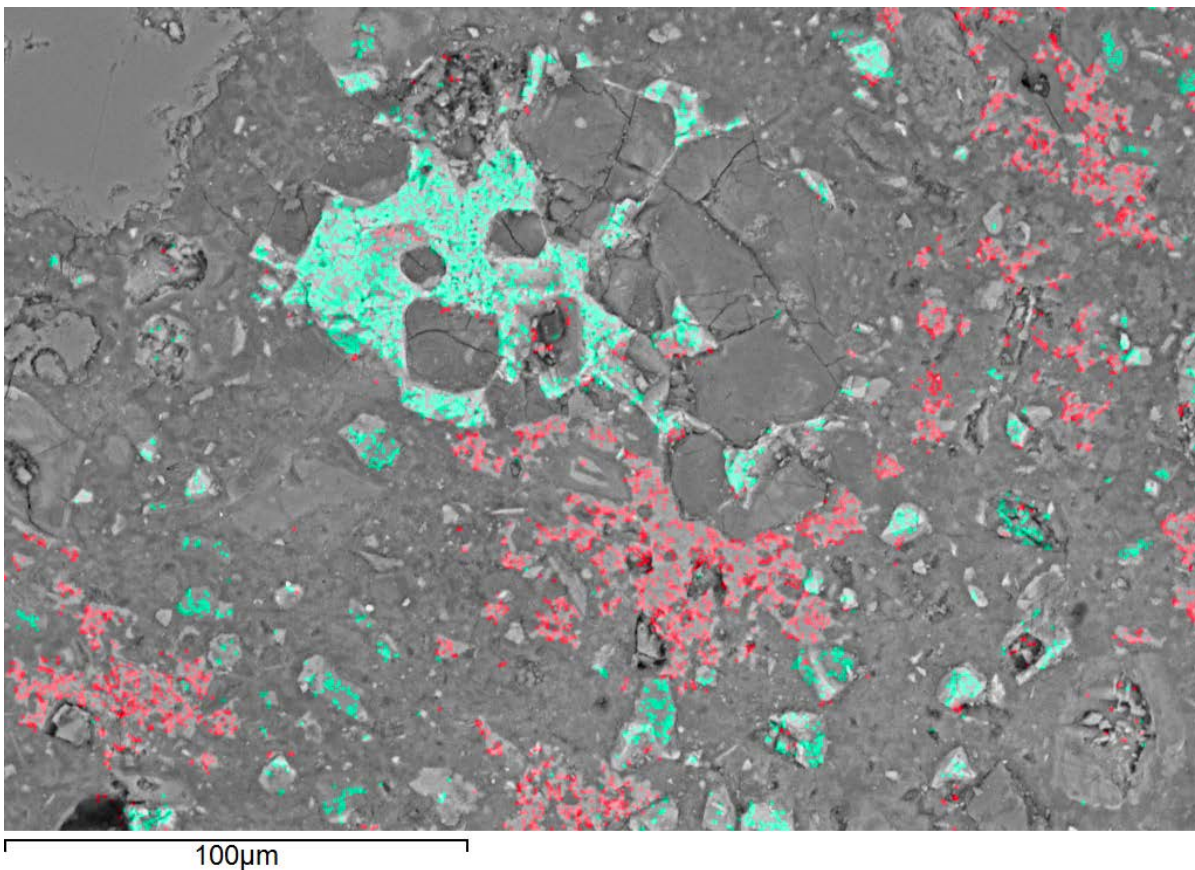
Figure D1

Sample K16151/3

Polished surface, backscattered electron image with superimposed X-ray phase map: View showing an area of hydrated Portland cement paste at 74mm depth. A pseudomorphically hydrated Portland cement grain dominates the field of view and this includes unhydrated calcium-alumino-ferrite (highlighted in blue). The cement grain is surrounded by cement hydrates with abundant portlandite (highlighted in red).

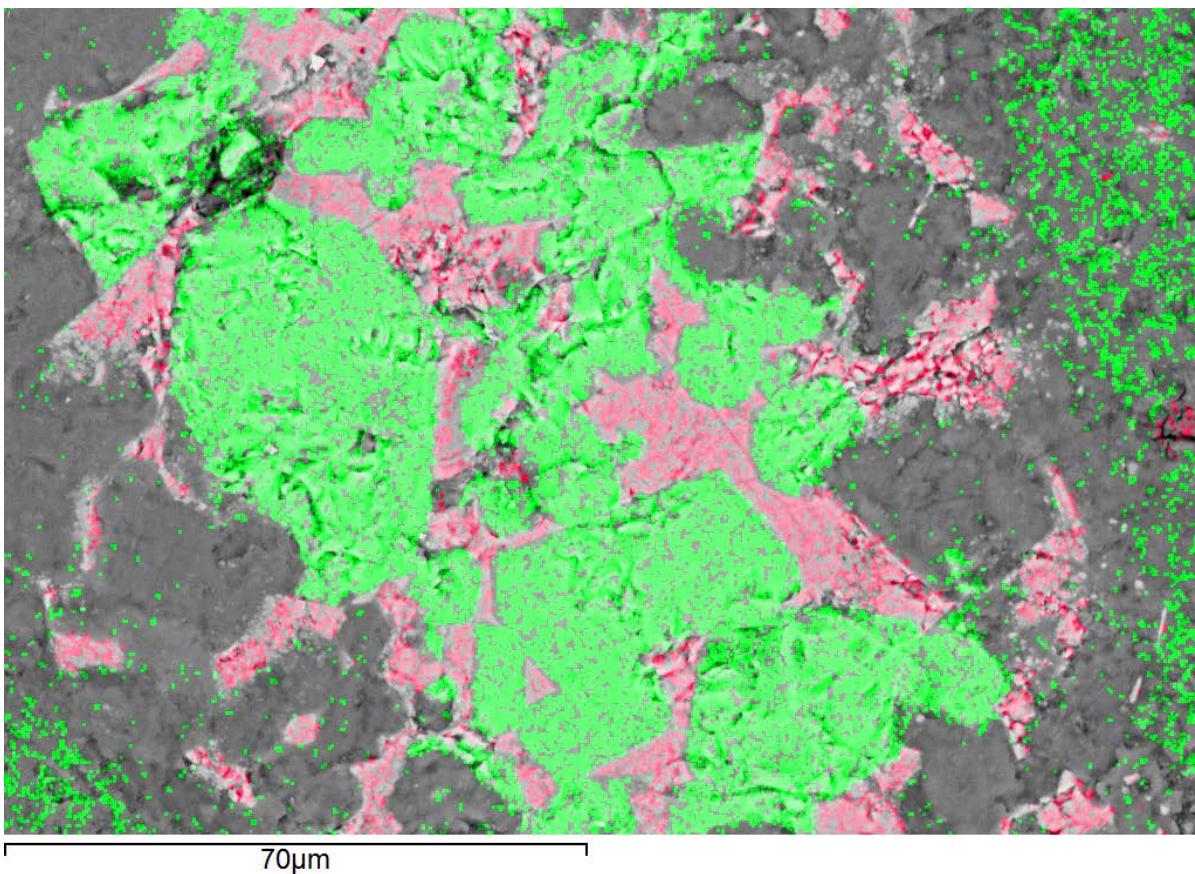
Figure D2

Sample K16151/3

Polished surface, backscattered electron image with superimposed X-ray phase map: View showing a rare almost unhydrated cement grain at 0.6mm depth. Unhydrated calcium silicate is highlighted in green and unhydrated calcium-alumino-ferrite is highlighted in pink.

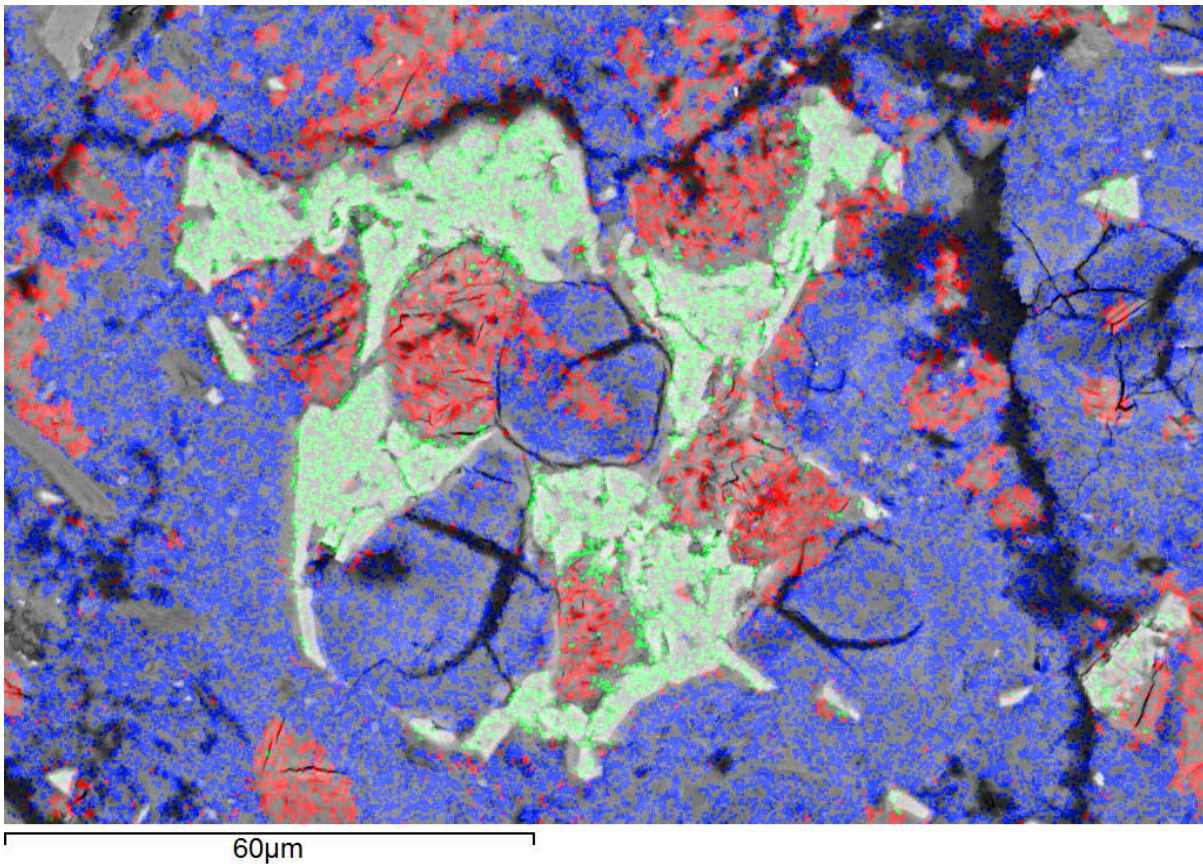
Figure D3

Sample K16151/4

Polished surface, backscattered electron image with superimposed X-ray phase map: View showing an area of hydrated Portland cement paste at 30mm depth. A pseudomorphically hydrated Portland cement grain dominates the field of view and this includes unhydrated calcium-alumino-ferrite (highlighted in green), patches of secondary ettringite highlighted in red. The field of view is dominated by hydrated calcium silicates highlighted in blue.

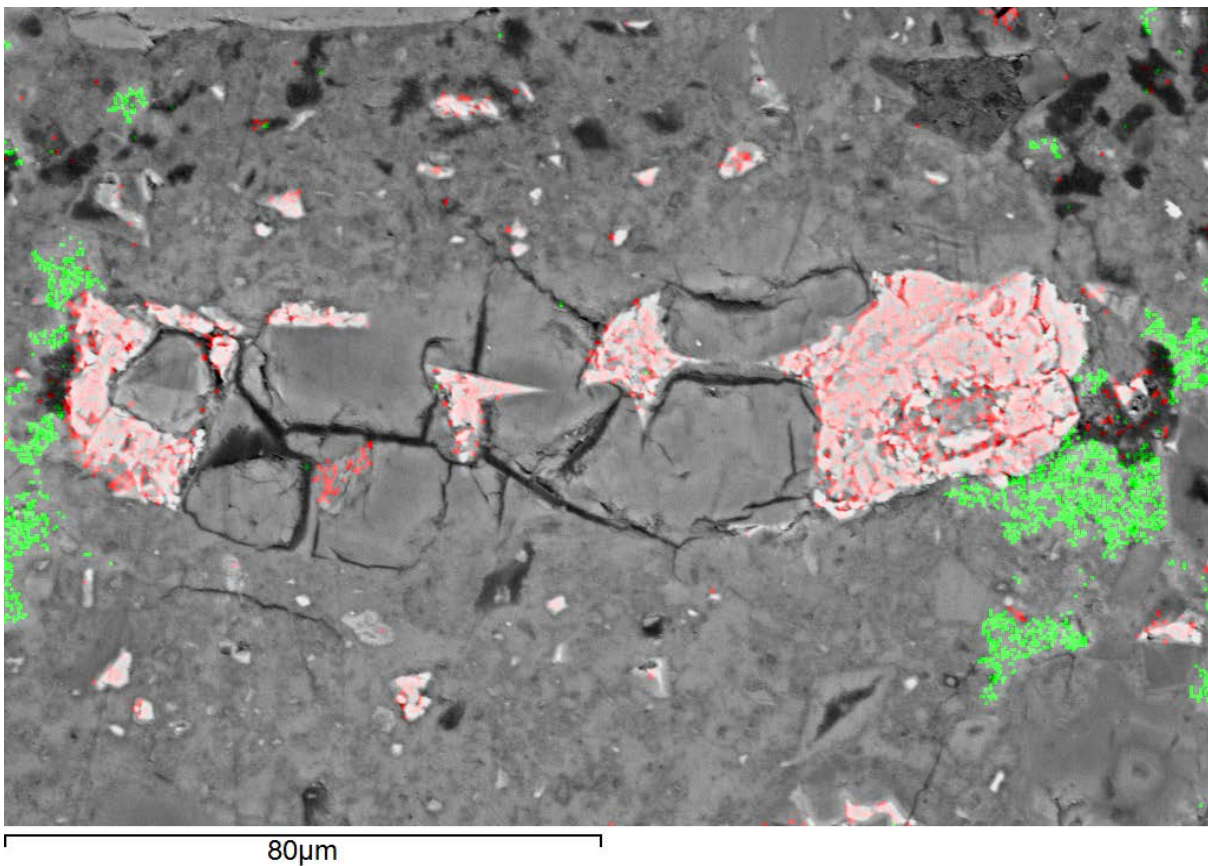
Figure D4

Sample K16151/4

Polished surface, backscattered electron image with superimposed X-ray phase map: View showing an area of hydrated Portland cement paste at 78mm depth. A pseudomorphically hydrated Portland cement grain dominates the field of view and this includes unhydrated calcium-alumino-ferrite (highlighted in red). The cement grain is surrounded by cement hydrates with moderate amounts of portlandite (highlighted in green).

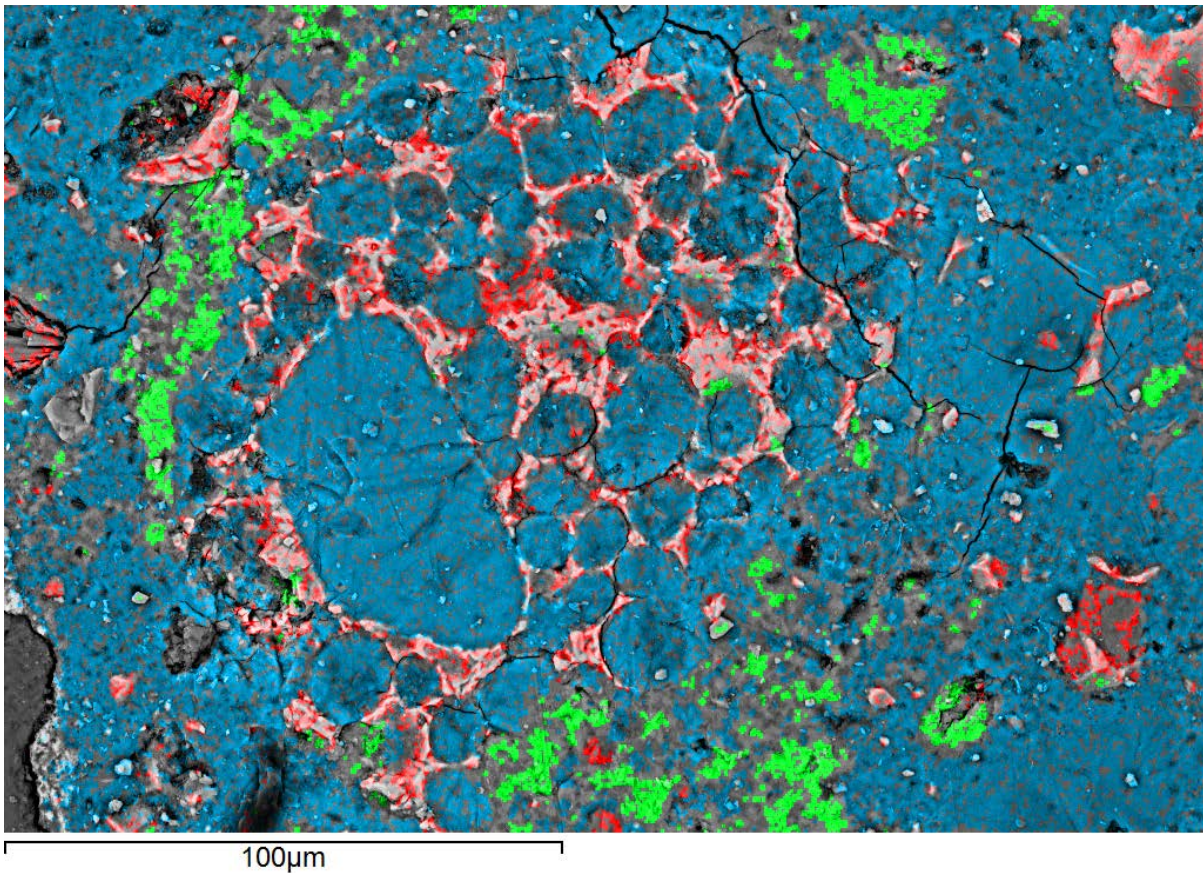
Figure D5

Sample K16151/5

Polished surface, backscattered electron image with superimposed X-ray phase map: View showing an area of hydrated Portland cement paste at 64mm depth. A pseudomorphically hydrated Portland cement grain dominates the field of view and this includes unhydrated calcium-alumino-ferrite (highlighted in red). The cement grain is surrounded by cement hydrates with moderate amounts of portlandite (highlighted in green). Calcium silicate hydrate dominates the field of view and is highlighted in blue in this view.

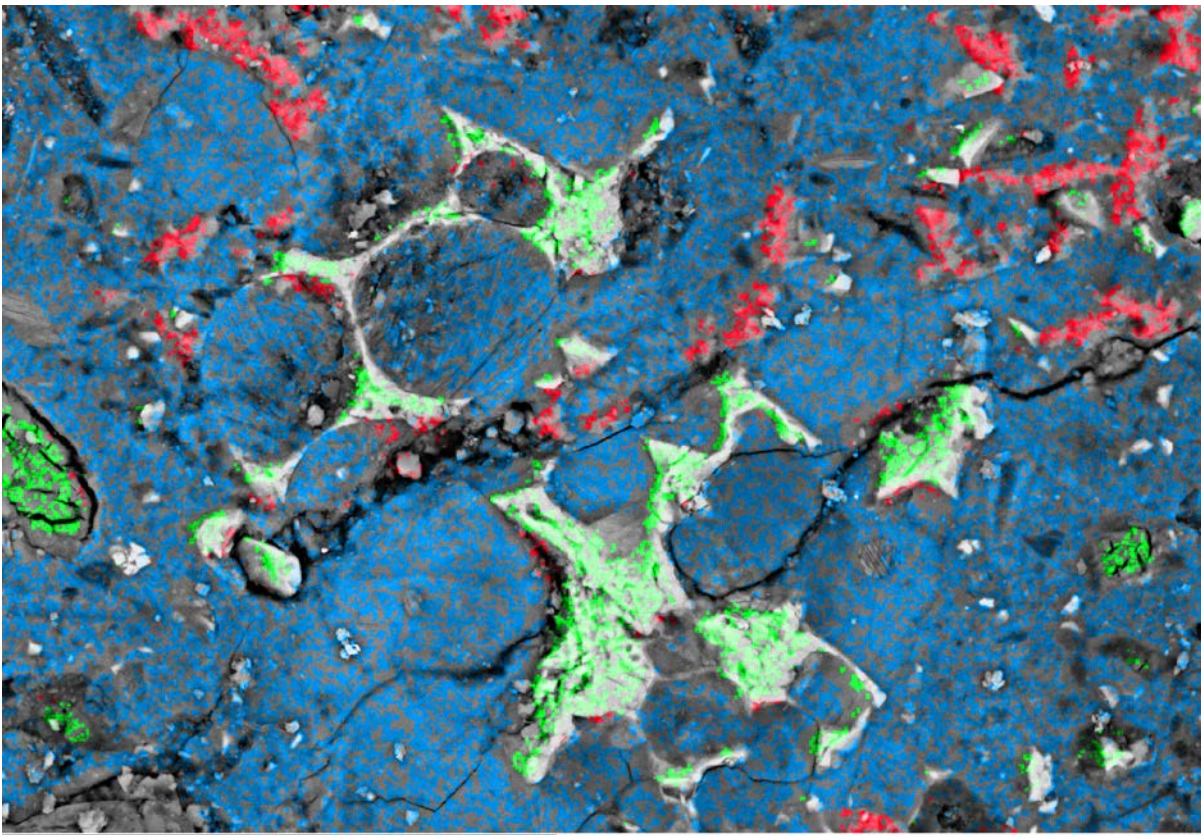
Figure D6

Sample K16151/5

Polished surface, backscattered electron image with superimposed X-ray phase map: View showing an area of hydrated Portland cement paste at 120mm depth. Several pseudomorphically hydrated Portland cement grains are present and these include unhydrated calcium-alumino-ferrite (highlighted in green). The cement grains are surrounded by cement hydrates with moderate amounts of portlandite (highlighted in green). Calcium silicate hydrates dominate the field of view and are highlighted in blue in this view.
