**Note / Memo**

**HaskoningDHV UK Ltd.  
Water**

**Subject: Cell 1 Coastal Asset Condition Summary\_v2**

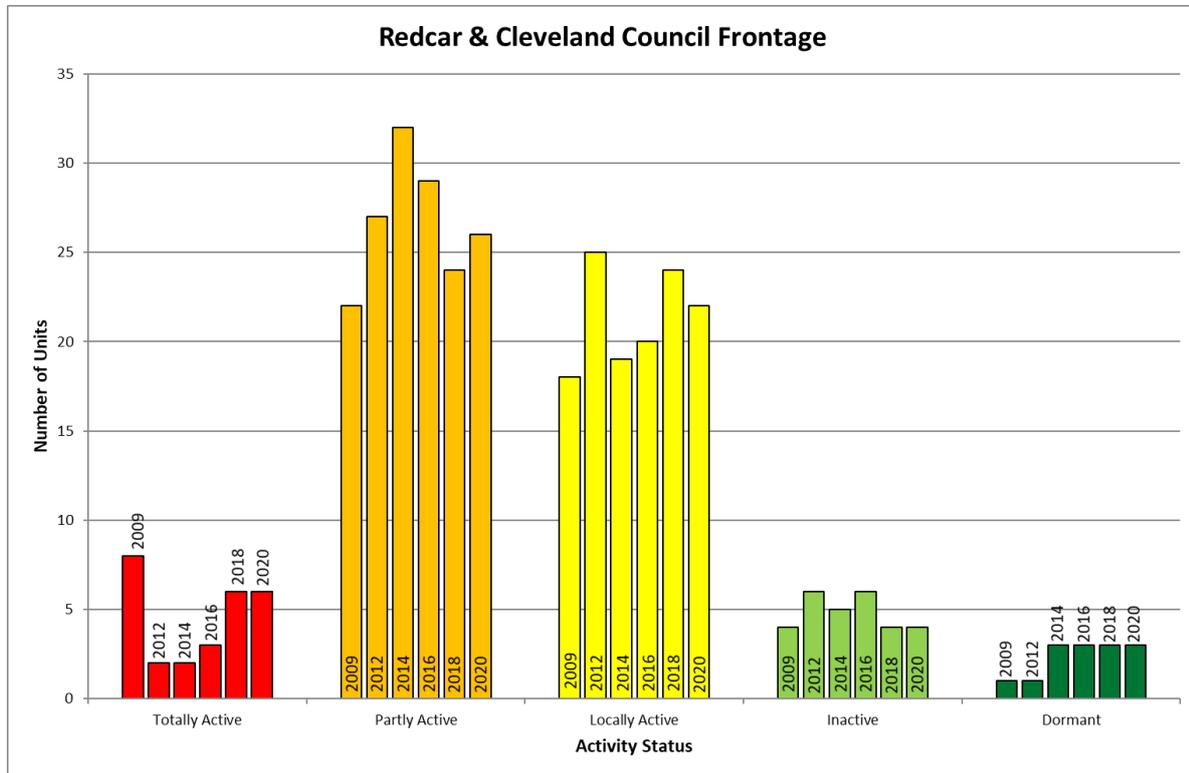
**Figure 1 - Frequency of cliff activity along the Redcar & Cleveland frontage 2010 to 2020**

Figure 1 shows the clear majority (96%) of cliff units have retained their condition since 2018, highlighting the lack of significant change along the natural Redcar & Cleveland frontage during this time. The units that have changed have been upgraded from Locally Active to Partly Active, suggesting that local slips have occurred. However, it acknowledged that some of this change may be attributable to different interpretations of classifications gradings by different inspectors (or the by the same inspections on successive surveys).

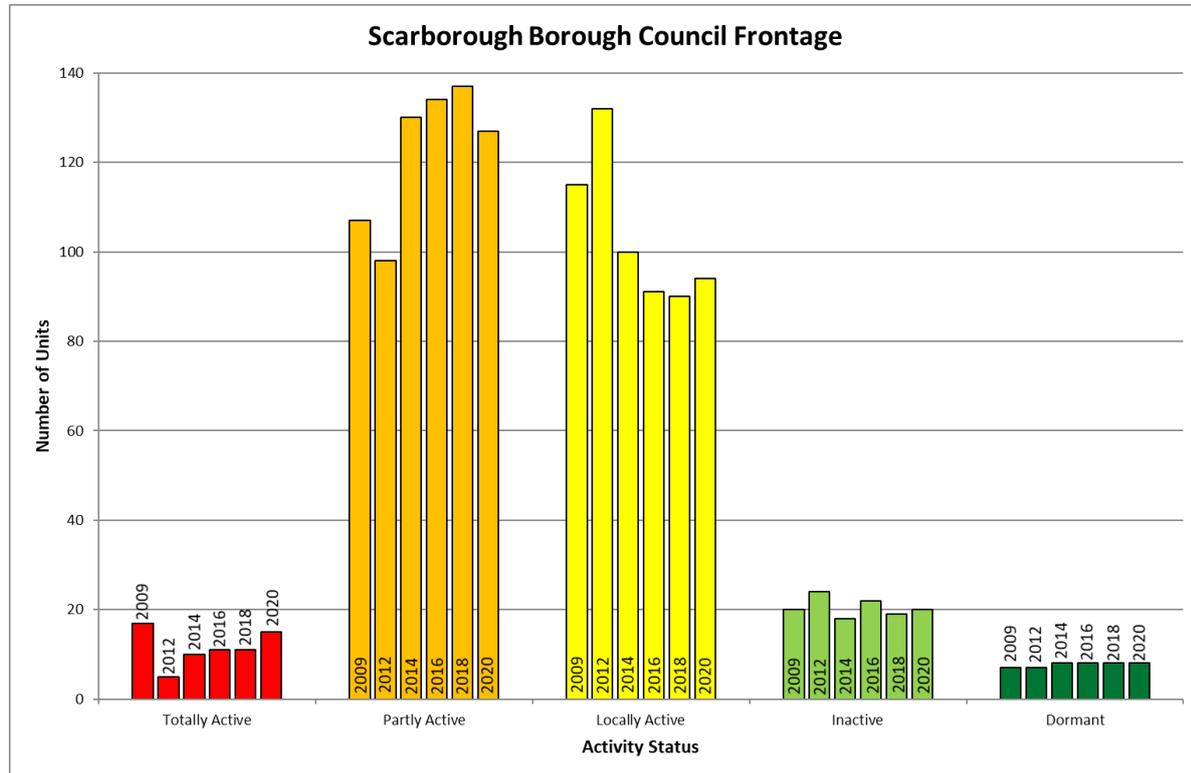
**Figure 2 - Frequency of cliff activity along the Scarborough BC frontage 2009 – 2020**

Figure 2 shows that the clear majority (approximately 90%) of the 265 cliff behaviour units surveyed during the 2020 walkover retained the same activity status as they had in 2018. This indicates little significant change along the frontage. Of those units that have changed, the majority have changed from Partly to Locally Active (or *vice versa*). A small increase in 'Totally Active' units can be observed since 2018, however all of these units are located within the immediate vicinity of previously reported sustained levels of high erosion (Tenants Cliff, Filey Brigg and Hunmanby Gap).
