Cell 1 Coastal Landfills Study

February 2019

Scarborough Borough Council

Cell 1 Regional Coastal Monitoring Programme Coastal Landfills Study

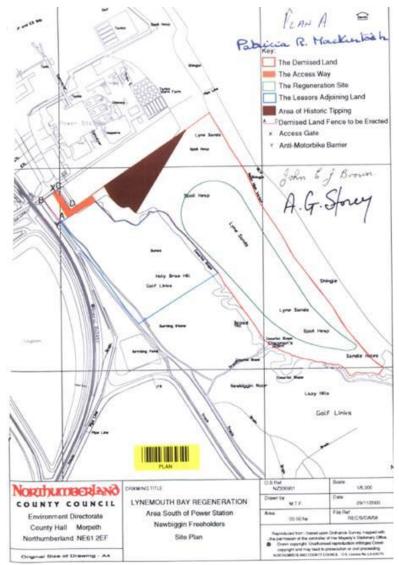
Figure 16 Plan of the Lynemouth Bay Regeneration Scheme, extracted from the Land Lease between Freeholders of Newbiggin-by-the-Sea and Northumberland County Council

- The removal from the Demised Land, see Figure 16, of all Polluted Materials;
- The construction upon the Regeneration Site of a salt water lagoon or marshland with associated underground piping and equipment and with earthworks and landscaping on the remainder of the Demised Land including the planting of marram grass, trees and shrubs and thereafter to maintain the same during the Term. [Note: This was constructed but subsequently subsumed by the sea.];
- The landscaping works and the planting of marram grass, trees and shrubs on the Lessors' adjoining land;

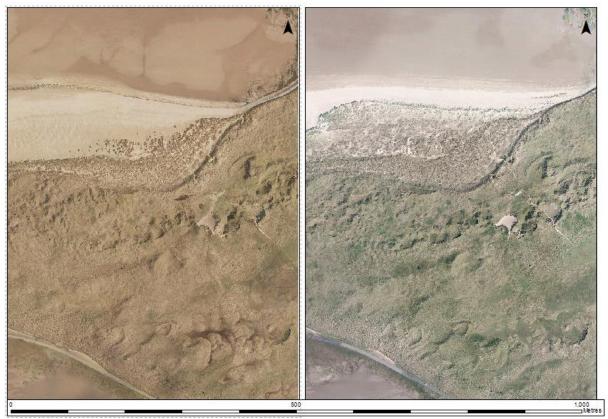
Between 2017 and 2018, the shoreline along the north of the Snook prograded 6 m to its most recent configuration (163 m in width). Over the 15-year period (2003 – 2018) of aerial imagery, the narrowest distance between shorelines along the Snook close to Reference 1 prograded by a total of 37 m. The small blowout north east of Reference 1 has complete vegetation cover and another blowout to the east has also begun to show recovery. The shoreline adjacent to the blowouts has prograded approximately 150 m north since 2003 (**Figure 27**).

Figure 27 Progradation of embryo dunes along the north of the Snook between 2010 (left) and 2017 (right)

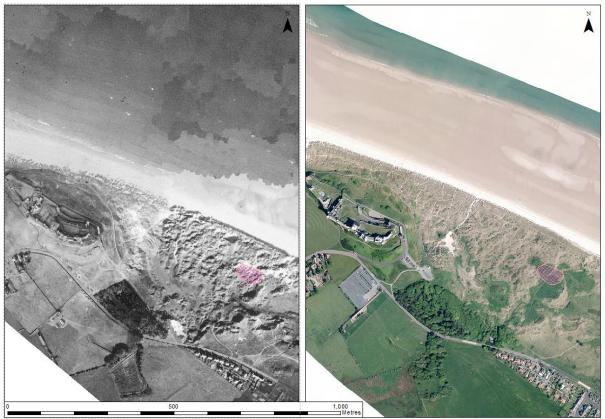
There has been significant progradation of the dunes at Bamburgh between 1940 and present day (**Figure 28**). This is most noticeable close to the castle, where the dunes have prograded by approximately 60 m, and at Shoreston Links, where the dunes have prograded by approximately 83 m. Dunes appear potholed with blowouts in 1940, becoming infilled with vegetation by present day. The Dune Tip (site Reference 3) is approximately 81 m from the shoreline in 1940, whereas it is 97 m from the shoreline in most recent aerial imagery in 2018. The historic landfill at Bowl Hole (site Reference 6) is located among the dunes on the north-eastern perimeter of a wooded area along Links Road. The site is indistinguishable from aerial imagery. A large circular blowout is present within the dunes close to Bamburgh Castle, measuring 47 m in diameter.

Figure 28 Dune frontage at Bamburgh in 1940 (left) and 2017 (right) with site Reference 3 in pink

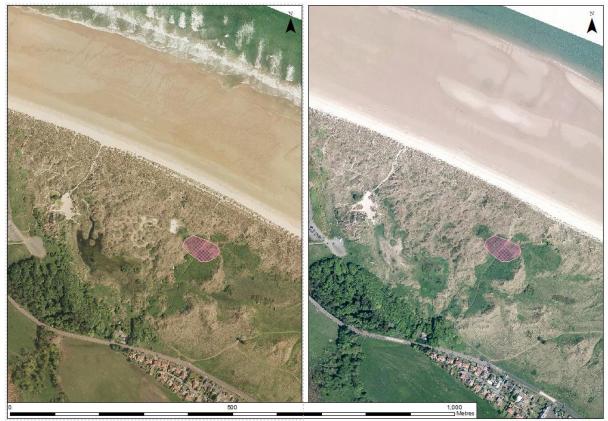
By 2018, the large blowout close to Bamburgh castle has become vegetated at either side and now measures 27 m in width. There is no change at other blowouts within the dunes and shoreline configuration has not changed from 2017.

Figure 29 Dune frontage at Bamburgh in 2010 (left) and 2017 (right) with site Reference 3 in pink

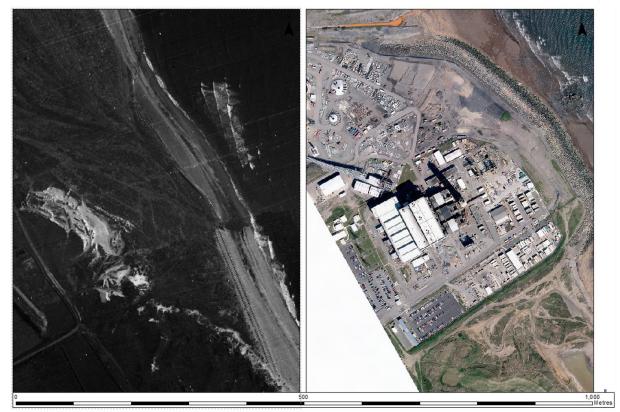
In aerial imagery from 1940, Snab Point is in a similar position and form as present day. Further south, the aluminium smelter is visible, however the Power Station has not yet been constructed. At the location of the current Power Station, dunes are degraded with several blowouts and there is are double parallel lines of what are believed to be anti-tank obstacles present along the shoreline (**Figure 30**).

Figure 30 Site of Lynemouth Power Station in 1940 (left) and 2017 (right)

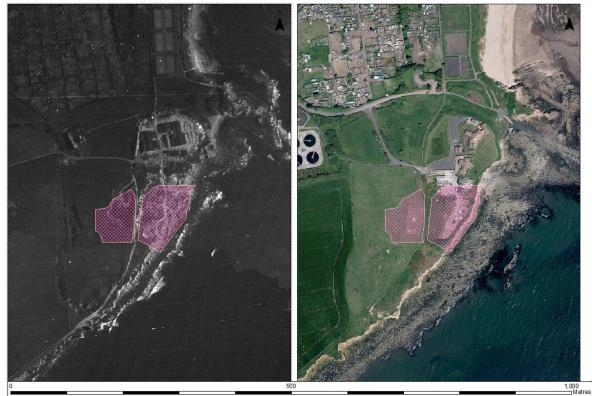
In the first available aerial imagery of this area in 1940, the promenade is clearly visible along the entire length of Newbiggin Bay, however the offshore and northern breakwater are not present. Spital Point remains in a similar position and form as present day. South of this, Links Quarry is visible and has not been infilled yet (**Figure 33**). Sandy Bay Holiday Park is

Figure 33 Spital Point / Links Quarry in 1940 (left) and 2017 (right) with site References 4 and 8 in pink

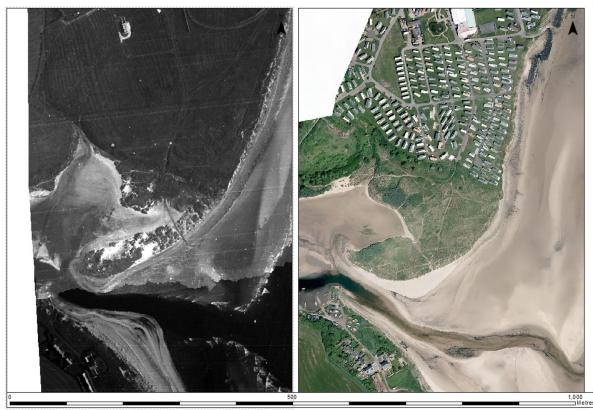
not present and the shoreline along this section is straighter and less undulating than present day. There has been significant change to the north of the Wansbeck River mouth, with progradation of vegetation between 25 - 45 m (**Figure 34**).

Figure 34 Wansbeck Estuary in 1940 (left) and 2017 (right)

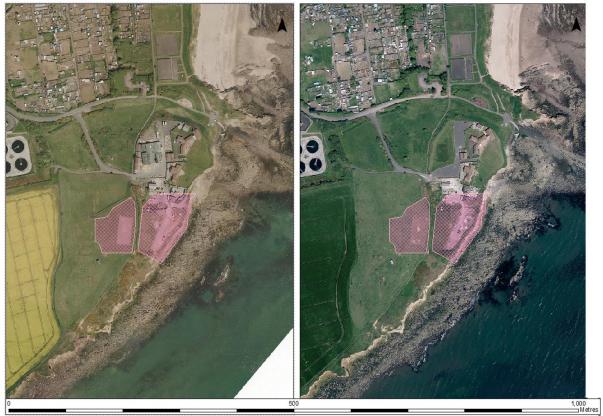
There are no discernible changes within the bay by 2017. Small sections of cliff erosion are apparent south of Links Quarry towards Sandy Bay Holiday Park, with small sections of progradation of vegetation on the northern bank of the river mouth.

Figure 35 Spital Point / Links Quarry in 2010 (left) and 2017 (right) with site References 4 and 8 in pink

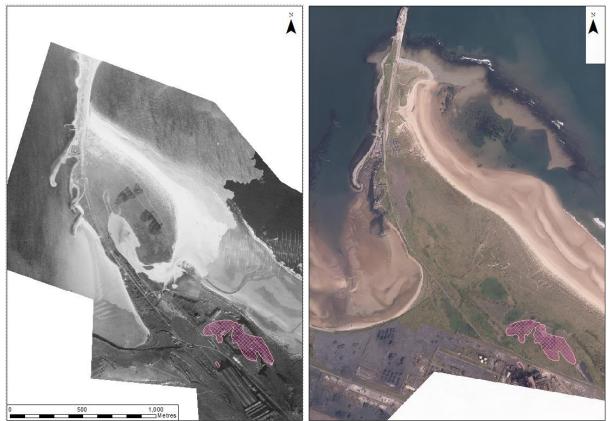
In the 1940 aerial imagery, the dunes adjacent to South Gare had not built out along the seaward edge of the spit in the manner that is observed in the present day, but instead occupied a bulbous shape, with a distinct ingress of sea water into a saline lagoon, with only a thin azimuth of land between the lagoon and the Bran Sands area of the River Tees estuary (**Figure 36**).

Imagery from 2017 show that in the immediate lee of the South Gare breakwater, the trend continued to be one of accretion in the shelter of the structure, with a notable increase in the extent of dune vegetation. Some areas of 'scalloped' dune evident in the 2017 aerial photography was also present in the photography that was collected in 2015 and appears not to have worsened. Arguably in some areas it may have marginally recovered, although remaining heavily scalloped.

Figure 36 South Gare in 1940 (left) and 2017 (right) with site Reference 9 in pink

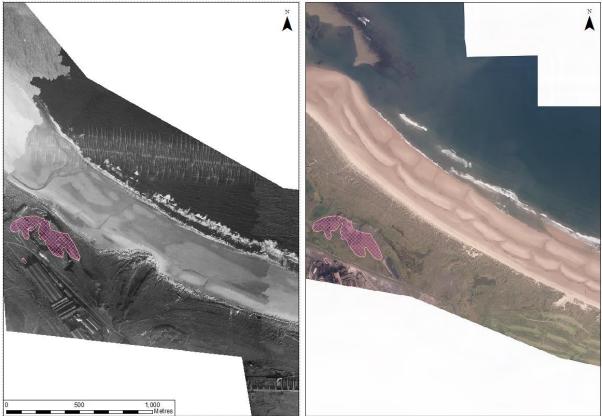
The Warrenby Slag Works are present in the 1940 imagery and slag deposits appear to push the shoreline seaward in locations immediately adjacent to the works, although the coastline here was still somewhat landward of its present-day position in 1940 (**Figure 37**).

Figure 37 Warrenby Slag Works in 1940 (left) and 2017 (right) with site Reference 9 in pink
