# Cell 1 Regional Coastal Monitoring Programme Update Report 3: 'Partial Measures' Survey 2011

Northumberland County Council

July 2011

<sup>(\*)</sup> The present report is **Update Report 3** and provides an analysis of the 2011 Partial Measures survey for Northumberland County Council's frontage. It is intended as a brief update of the key findings from this survey to maintain an understanding of ongoing changes.

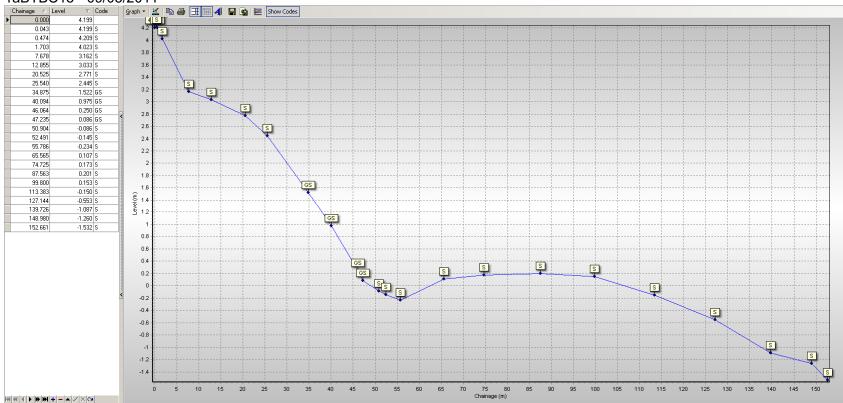
# 1aBTBC11 - 09/03/2011

Survey Date	Description of Changes Since Last Survey	Interpretation
03-2011	<b>Beach Profiles:</b> Spittal is covered by two beach profile lines during the Partial Measures survey (Appendix A). Along BTBC11 the beach levels at the upper section of beach were locally very high at around 5.2mODN along a width of around 7.5m but then lowered since September 2010 along the remainder of the transect, especially so seaward of around 100m chainage. A small berm was formed on the foreshore at around 90m chainage. Similar upper beach accretion was observed along BTBC13, but in contrast to the behaviour along profile BTBC11 there was notable accretion since September 2009 along the remainder of the transect down to low water.	It is possible that some of the material removed from BTBC11 between September 2010 and March 2011 has been moved alongshore in a southerly direction to feed profile BTBC13. All changes are within previous bounds of behaviour and therefore present no management concerns.
