Cell 1 Regional Coastal Monitoring Programme Update Report 2: 'Partial Measures' Survey 2010

South Tyneside Council

South Tyneside Council Final Report

May 2010

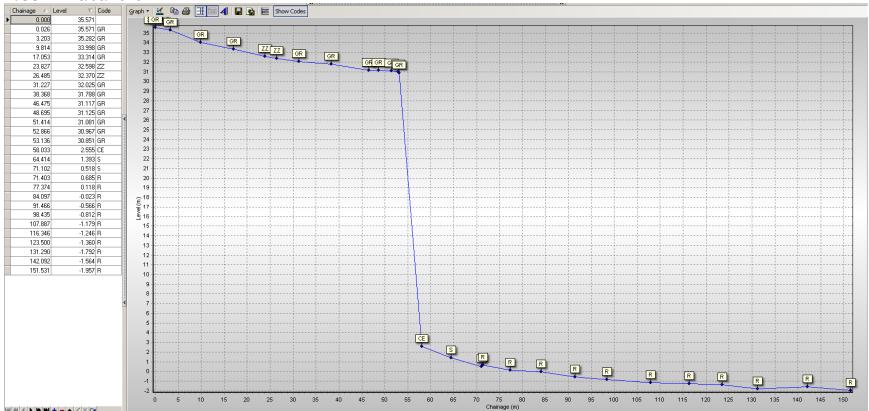
1bSS14 - 16/03/2010

Beach Profile SS14 is located at the northern end of Marsden Bay, close to the Redwell Steps. Surveys of the beach and the concrete platform and steps at the base of the cliffs are accurately undertaken on each survey. Due to this, it has become clear that the changes in the cliff form above the structure are 'apparent' changes caused by survey difficulties on this steeply bevelled cliff face. In particular, the rock that outcrops at the seaward face of the cliff is showing apparent signs of change (see Appendix A - Beach Profile 1bSS14).
