**Cell 1 Regional Coastal Monitoring Programme:
Walk-over Visual Inspections of Assets**

Northumberland County Council

Walkover Visual Inspection of Assets

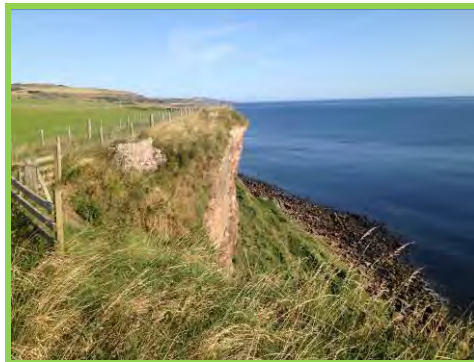
As with previous surveys, inspection the frontage between the Scottish Border and Marshall Meadows point was limited since the face of the cliff could not easily be viewed. Sections of an abandoned masonry wall (now replaced with a post/wire fence) remain very close to the cliff edge suggesting some historic recession has taken place. However, no recent change was apparent suggesting the cliffs along this length are relatively stable.

Sections of abandoned masonry wall and new fencing at north end of Marshall Meadows Bay (/601c01).

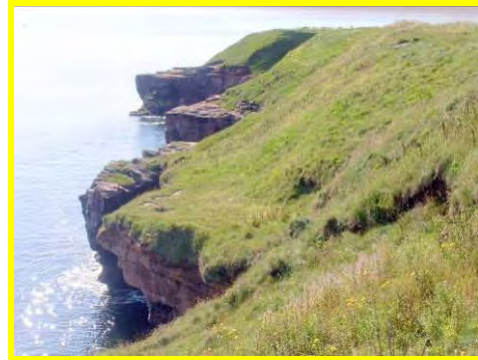
The cliffs at Magdalene Fields continue to be susceptible to local and occasional slumping in the upper soft material which was again observed at a number of locations. Slumps have cut the cliff top back to the footpath in places at the Golf Course. In the harder rock base there are numerous caves, fissures and rock overhangs although no significant rock falls were observed.

Caves and fissures in cliffs and slumps in upper soft material (/601c05).

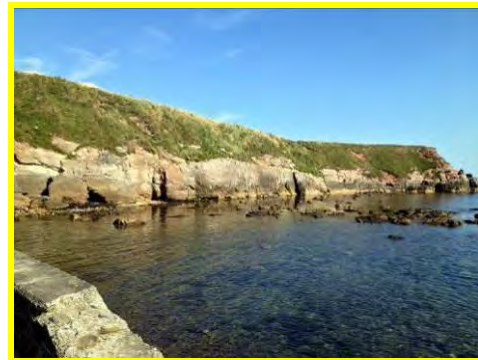
Vertical fissures and caves in cliffs north of Sharpers' Head (/701c03).

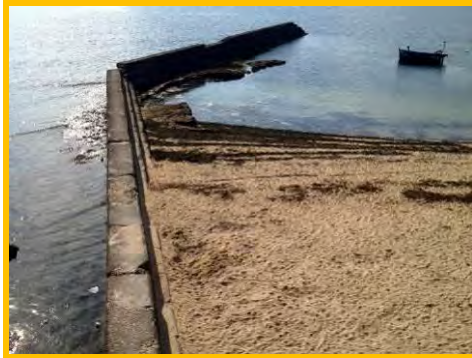
The crest of Green Haven breakwater remains in a poor condition and is likely to experience further failure at the seaward end due to cracking and voids.

Although Green's Haven Breakwater remains in poor condition no significant change was evident since the previous inspection. The structure continues to show signs of heavy abrasion along most of its length with loss of the upper section of crest at two location. Ongoing horizontal cracking and spalling along much of the rest of its length is likely to lead to further damage of the crest. The 2010 inspection reported that the breakwater was somewhat undermined, however inspection at low tide shows the structure to be well founded on the rock platform, which is being undercut. There is however some initial undercutting of this rock platform on the landward side of the breakwater however this is not currently affecting the structure. Although the structure is in poor condition it is still performing the function of retaining the sand within the bay.

Damage to crest and head of Green's Haven Breakwater (/701c04).

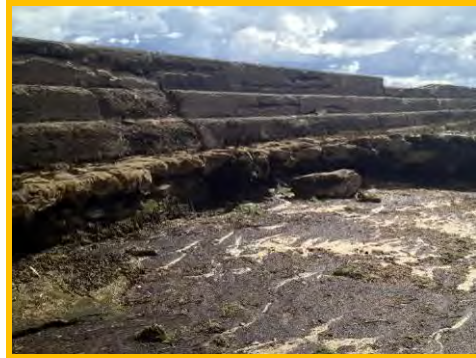
Cracking, spalling and undercutting of the rock foundation (/701c04).

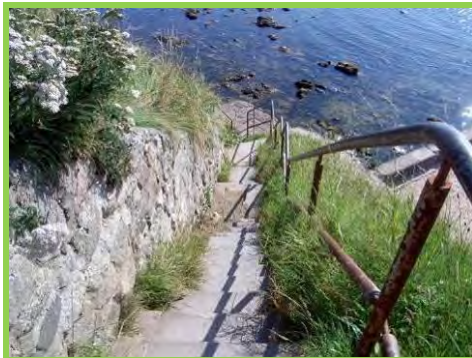
The steel, timber and concrete access steps at the root of the breakwater are generally in good condition. Despite there being two deep caves in the cliffs at the base of the steps, these appear to be stable with no change observed since the last inspection.

Steps and hand railing at Green's Haven in good condition (/701c05).

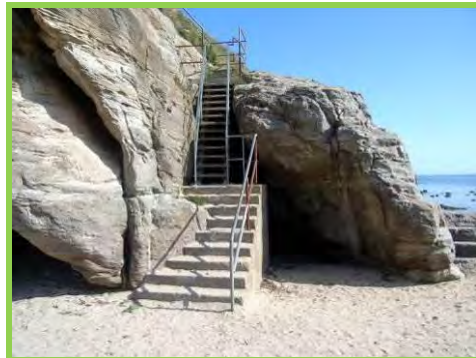
Deep caves adjacent to base of access steps (/701c05).

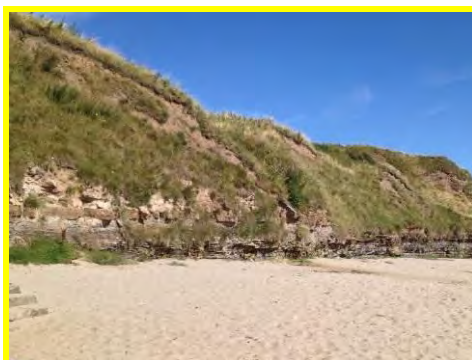
The hard rock cliffs around Green's Haven show occasional slumps in the upper soft material and evidence of one large rock fall, although no particular change since the previous inspection was evident. The most noticeable slip being at the south end where the cliff edge has cut back to the footpath above. Various lengths of concrete apron and walls extending around the centre of the bay remain in poor condition and provide limited protection to the soft cliffs behind. Concrete access steps at the centre of the bay and concrete steps/ ramp at the south end of the bay remain in fair condition.

Slumps in upper soft cliffs at Green's Haven (/701c09).

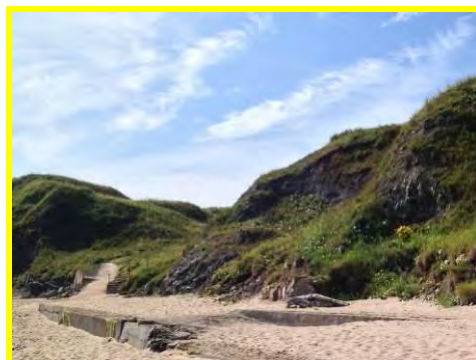
Concrete apron in poor condition, slumps in upper soft cliffs cutting back to footpath above (/701c07).

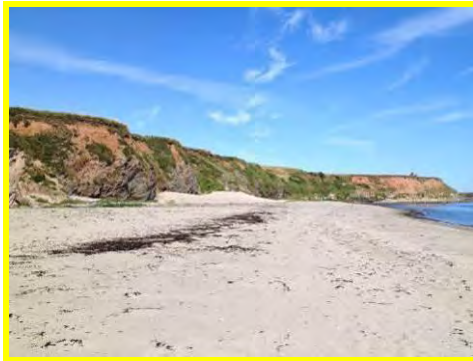
The cliffs at Bucket Rocks show evidence of continued localised rock falls and slumping in the upper soft cliff material. At Meadow Haven just north of the Berwick Pier there is a wide foreshore backed by wide and well vegetated dunes. The 2010 inspection reported the dune edge starting to exhibit signs of erosion but this was not observed, suggesting that the dunes may be stabilising.

Slump in soft upper cliffs at Bucket Rocks (/701c12).

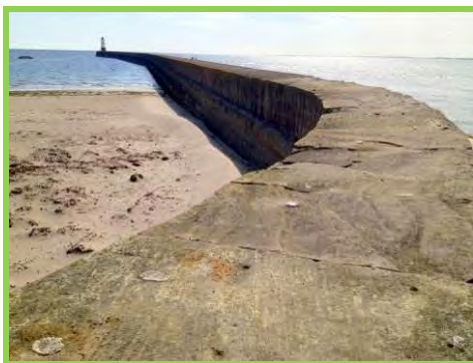
The Berwick Pier underwent substantial refurbishment during 2012/13, including repair of a significant hole midway along the leeward face and replacement of the concrete deck. The new repairs appeared to be in very good condition with some minor cracking evident in the old section deck and minor spalling of some of the concrete render. Inspection of below water elements was not possible.

Refurbishment of the Berwick Pier completed in 2012 (/701c14).

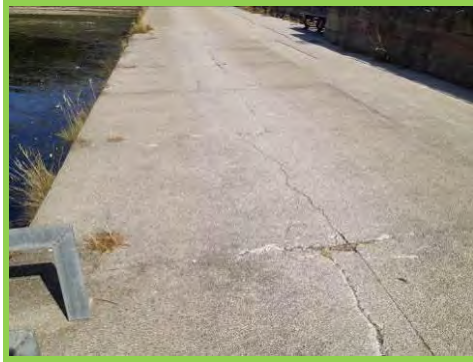
Minor cracking in old concrete deck slab (/701c14).

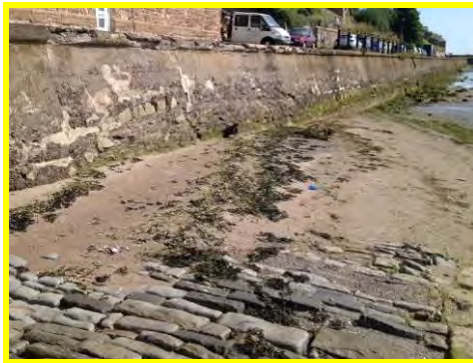
The west end of seawall along Pier Road remains in poor condition with outflanking, undermining and collapse of the upper revetment. Displacement of cobbles at the slipway continues.

The masonry seawall along Pier Road at Berwick-on-Tweed remains in fair condition with occasional minor cracking and spalling of the concrete coping. At the south end of the wall abrasion and loss of the concrete encasement is evident along with outflanking and collapse, although this does not appear to have worsened since the previous inspection and appears to have changed little since 2004. The old cobble slipway midway along the wall continues to deteriorate with blocks continuing to be displaced across the foreshore.

Damage to sections of coping along the Pier Road masonry seawall and displacement of cobble stones on the slipway (/801c07).

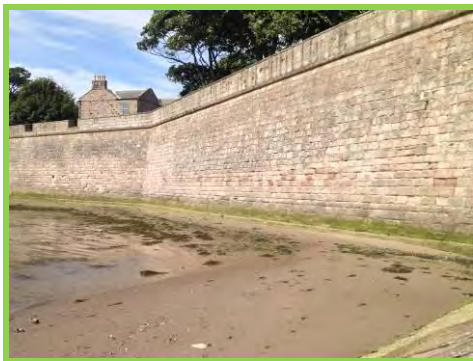
The historic masonry wall of Fisher's Fort remains in relatively good condition with some abrasion to the footing and minor mortar repairs and replaced blocks undertaken c2009.

High masonry seawall wall around Fisher's Fort (/801c06).

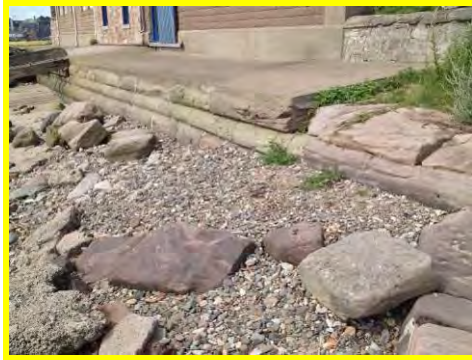
The short sections of masonry seawall and rock revetment fronting the properties at Gardo's Battery remain in good condition with armour well packed and high beach levels burying both structures.

Masonry seawall buried by high beach levels (/801c05).

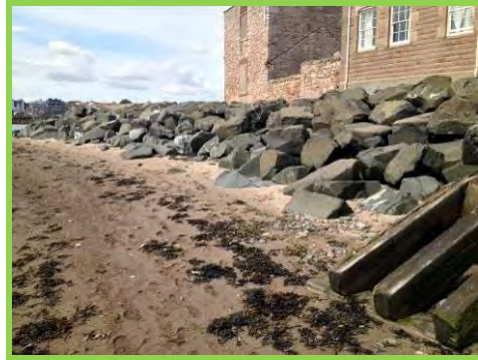
Rock revetment well packed and buried by high beach levels (/801c04).

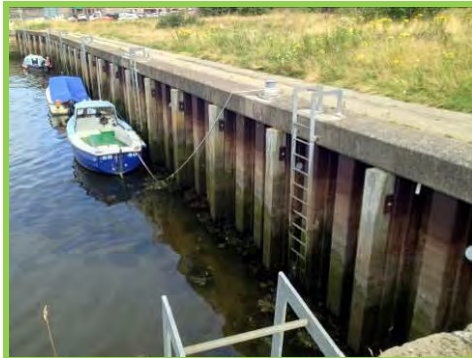
The Berwick quay walls consist mostly of a sheet piled wall with a short masonry walls extending around the dock area. The steel piles, concrete capping beam, ladders and timber fenders are all in good condition. However, at the junction with a short masonry wall gaps between the blocks and a crack in the capping beam/surfacing could be an indicator of washout of fill and settlement. The masonry quay wall in the small dock is in fair condition with some blocks broken and abraded and a number of open gaps evident. One vertical crack in the wall on the north side could indicate potential movement.

Berwick sheet piled quay wall generally in good condition (/801c03).

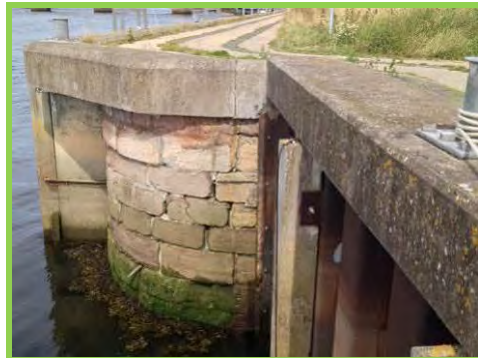
There are a number of gaps between masonry blocks at Berwick quay with some blocks broken and a crack in the masonry walls at the small dock area. The hand railing is also in poor condition.

Loss of mortar between blocks in short section of masonry wall (/801c03).

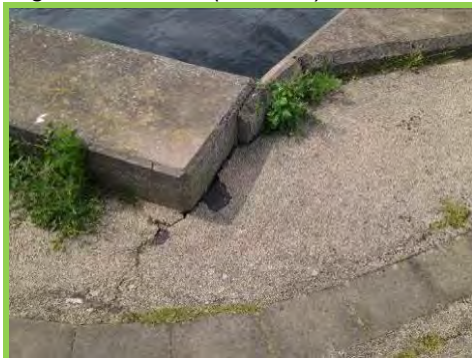
Crack in surfacing behind short section of masonry blockwork (/801c03).

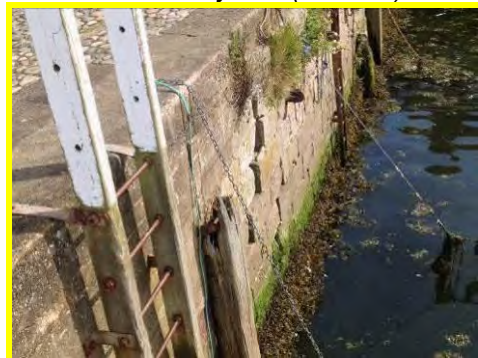
Vertical crack and potential movement of blocks in the north wall of the dock (/801c03).

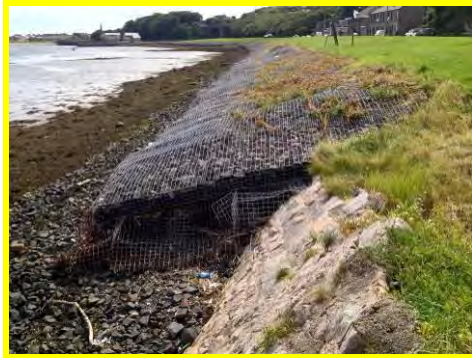
The stone filled gabion baskets along Dock Road are generally in fair/ poor condition but have not worsened since the previous inspection. The crest of the structure has settled in places and a large number of baskets along the toe have burst with loss of

stone across the foreshore. This damage was initially identified in 2008. Repairs to the lower gabions at the south end were undertaken c2012.

Gabion structure providing erosion protection along Dock Road (/901c04).

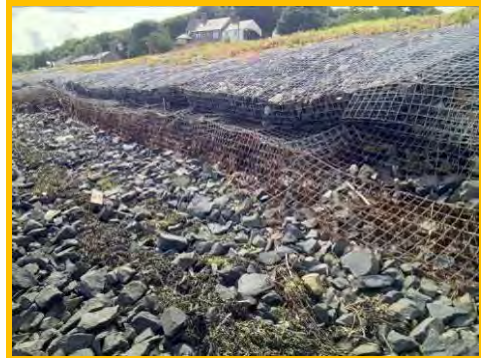
Along the south bank of the Tweed gabions have burst in a number of places along the toe displacing stone onto the foreshore. Some repairs at the south end were apparent.

Loss of stone from the lower gabion baskets (/901c04).

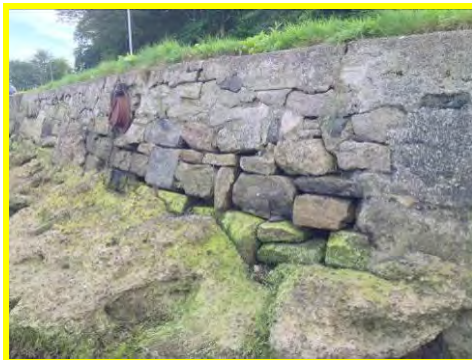
The low masonry wall to the south of Spittal Pier is in fair condition with loss of concrete facing to part of the wall and gaps between the block. The masonry quay wall at Spittal Pier is in poor condition with localised but significant abrasion and cracking to some masonry blocks and exposure of reinforcement in the coping. No settlement was apparent in the surfacing behind the wall suggesting that no significant loss of fill is occurring. However, this should be monitored.

Gaps in the low masonry wall south along Dock Road (/901C05).

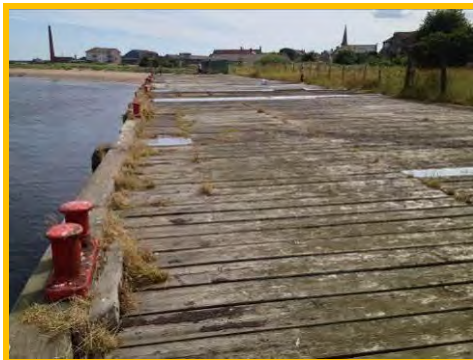
The opened piled timber jetty at Spittal Quay remains in a dilapidated condition. This structure has been closed to public access however, at the time of the inspection the gate at the west end of the quay was unlocked and public (including children) were fishing from the structure. The loss of beach material to the east side of the structure identified in 2012 has recovered and now covers the masonry toe. This toe was previously reported to be in a poor condition with missing and displaced blocks. Although dilapidated this pier structure was previously identified as an important erosion control feature for the whole area.

Low beach levels fronting Spittal Quay exposing masonry toe (/901C07).

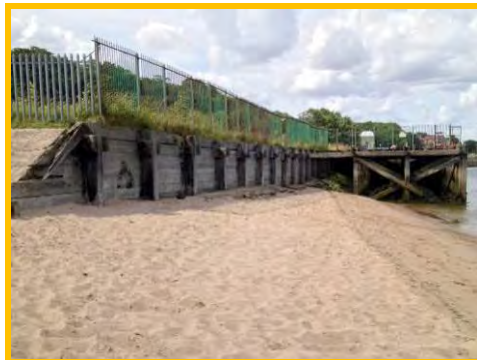
Displacement of stones and unravelling of masonry toe at Spittal Quay (/901C07).

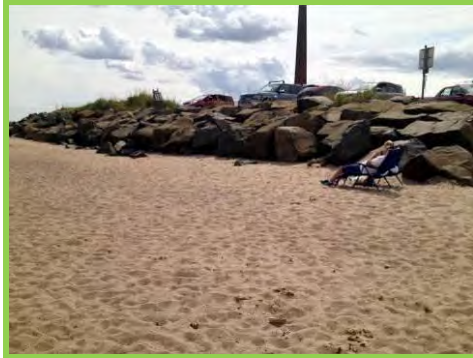
The revetment at Sandstell Point remains in good condition and relatively stable with a fairly consistent profile and no signs of undermining or movement at the toe. Minor localised deformation of crest gabions and localised erosion of the embankment has not worsened with high beach levels at the south end continuing to bury the structure. Beach levels appeared to be relatively high compared to the previous inspection, partly burying the revetment toe and many of the dilapidated groynes. Significant erosion of dunes/ beach reported during the 2010 inspection is no longer evident.

High beach levels at Sandstell Point burying the toe of the revetment (/901C10).

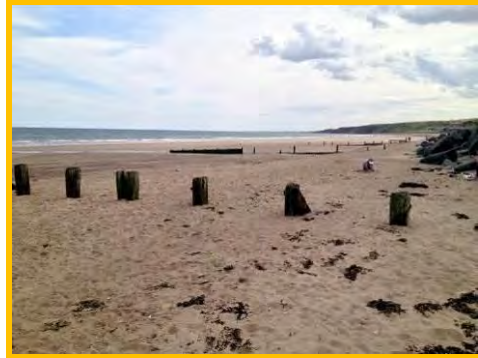
Groyne at Sandstell Point almost completely buried (/901C10).

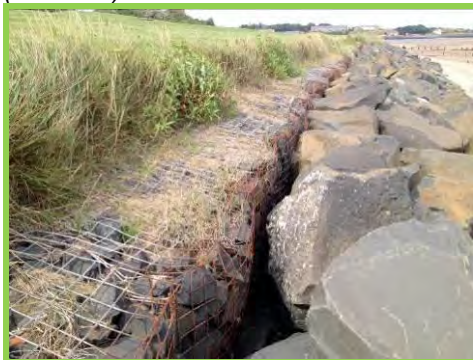
Localised erosion of embankment behind revetment crest (/1001c01).

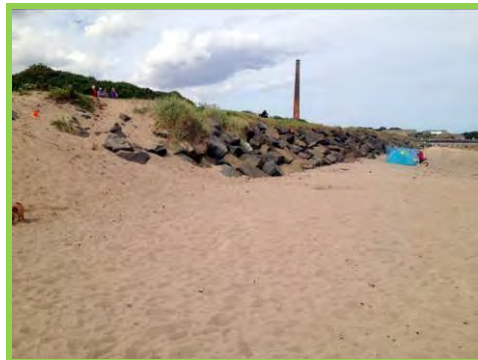
High beach levels burying south end of revetment (/1001c01).

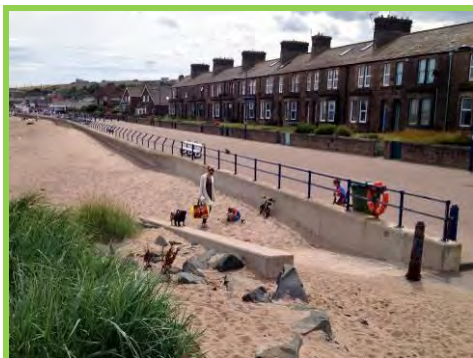
The Spittal seawall and hand railing remains in good condition with only minor cracks and loss of joint sealant apparent. Some blocks were missing on the promenade steps. Localised repairs at joints generally appear good but some crack repairs appear to be incomplete or have failed. Beach levels at the time of the inspection continued to be healthy, appearing higher than during the previous inspection.

Spittal seawall, hand railing and surfacing in good condition (/1001c02).

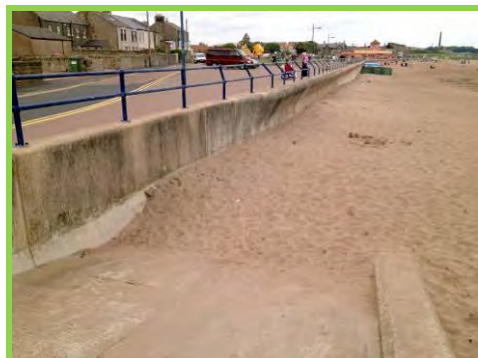
High beach levels up to underside of recurve in many places (/1001c02).

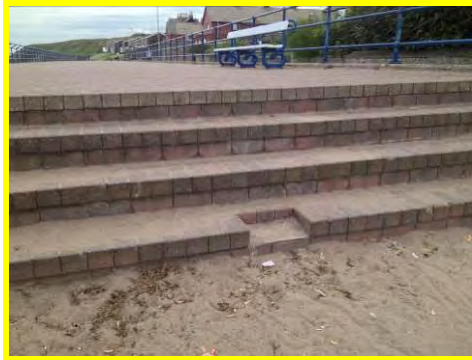
Missing blockwork surfacing on promenade steps (/1001c03).

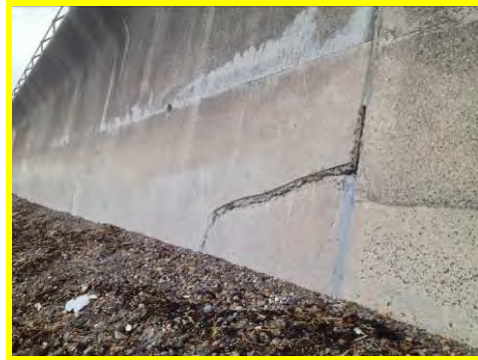
Incomplete or failed crack repairs on face of seawall (/1001c03).

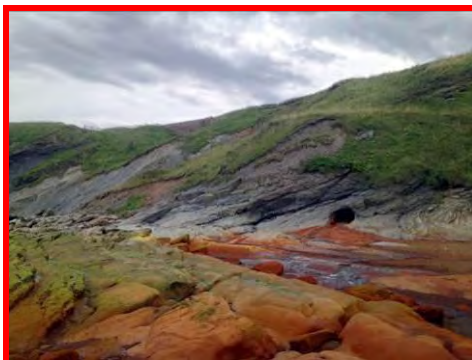
At the south end of Spittal Beach a significant landslip was reported in the previous inspection, exposing underlying rock. This landslip doesn't appear to have worsened since 2010 however it was noted that the masonry wall remains very close to the cliff edge. The cliffs between Spittal beach and Cocklawburn beach are in fair condition although erosion and significant but localised collapse of rock headlands continues.

Landslip in soft cliffs at the south end of Spittal seawall (/1001c05).

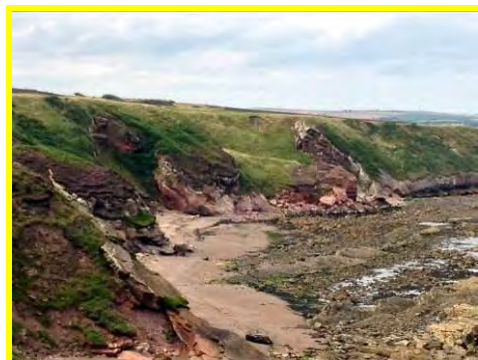
Localised collapse of rock headlands between Spittal beach and Cocklawburn beach (/1101c01).

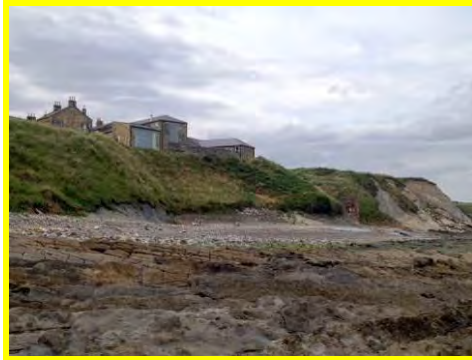
Immediately north of Cocklawburn Beach there is significant erosion of the soft earth cliffs with continued loss of the disused paved roadway.

Erosion at toe of soft earth cliffs fronting Sea House (/1101c04).

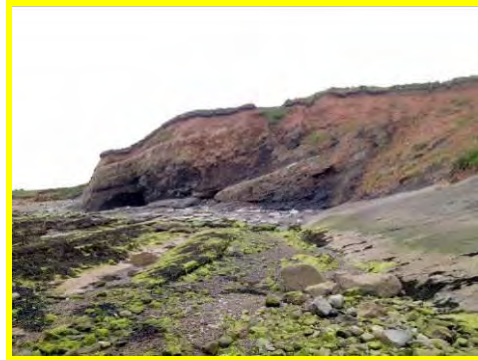
Significant but localised erosion of earth cliffs at Saltpan Rocks (1101c05).

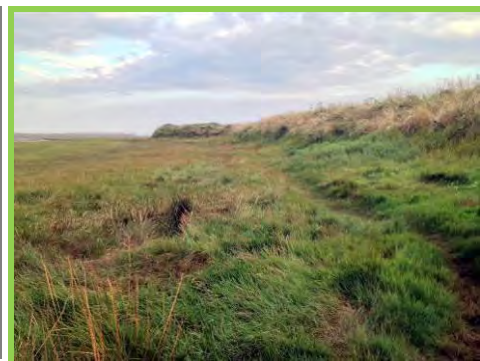
Localised erosion at the toe of the vegetated slope appears to have recovered (/1401c02).

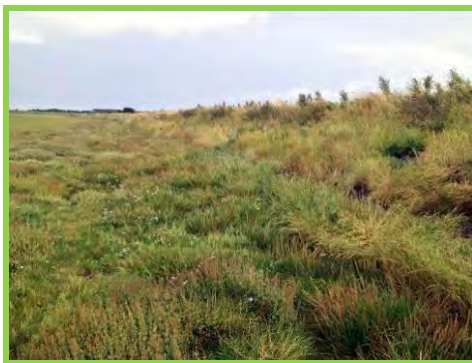
Flood embankment east of bird hide at Elwick (1401c98).

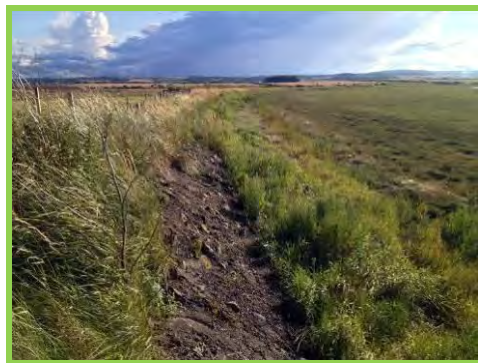
East of the bird hide at Elwick there is a flood embankment fronted by salt marsh. The embankment is protected by an asphalt and stone revetment which is generally in good condition despite being largely overgrown. This structure appears to continue to be effective in preventing sea flooding to a local low-lying bank of farmland across Ross. However a few areas could benefit from routine maintenance to infill gaps in the stones. Further along the frontage is a bracken-covered coastal slope leading to the Ross Links dunes. This remains mostly stable with some signs of erosion at the toe and historic blow-outs.

Asphalt and stone revetment largely overgrown (1401c98).

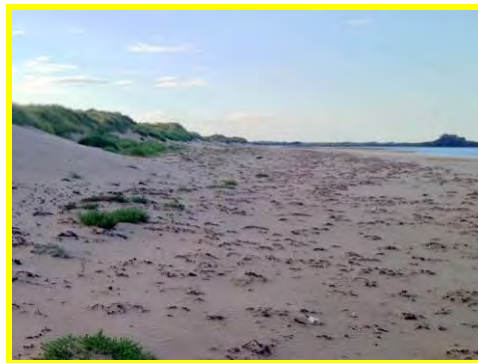
The dunes at Old Law are in fair condition. The landward side of the dunes are well vegetated and stable and fronted by a cobble berm. The seaward side of these dunes continues to show signs of partial erosion along much of their length to the navigation markers at Guile Point. Two navigation beacons are present at Guile Point, one directly on the foreshore and the other on the dunes.

Erosion of seaward face of Old Law dunes (/1401c99).

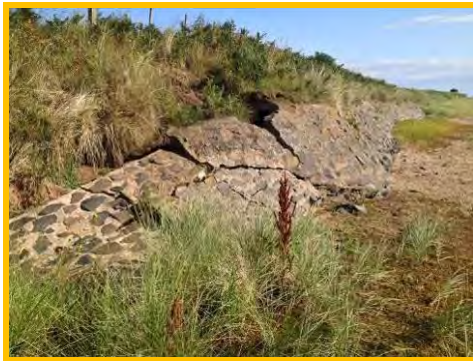
Various walls and grouted stone revetments, rip-rap and concrete retaining walls extending around Links End towards the sluice at Ross Low channel. These assets are generally in fair condition although undermining and collapse of one structure appears to have worsened resulting in breach of the adjacent embankment. Recent but localised lowering of foreshore levels along another section of revetment has started the onset of undermining of the toe.

Undermining and collapse of south end of grouted stone revetment at Links End (/1401c27).

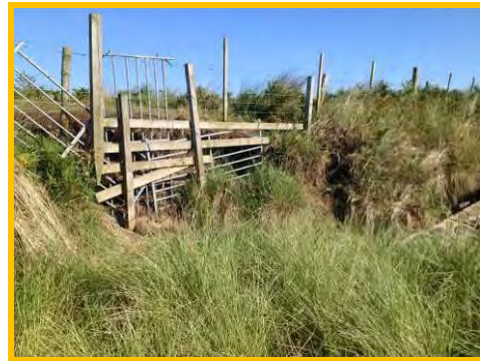
Breach in the embankment at south end of revetment (/1401c27).

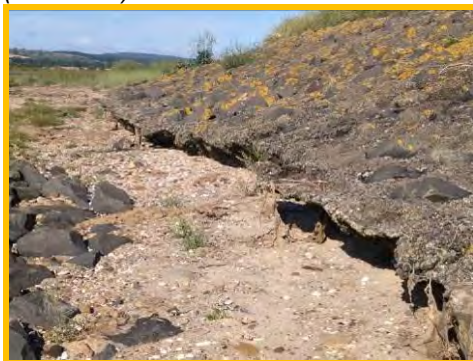
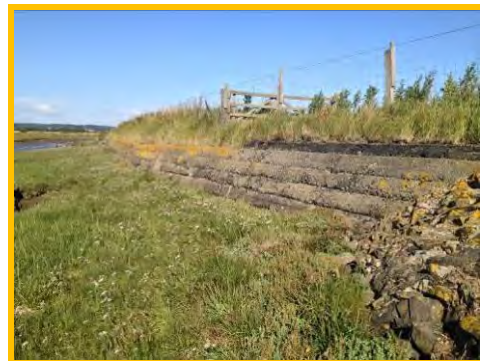
Concrete walls at Links End in fair condition (/1401c27)..

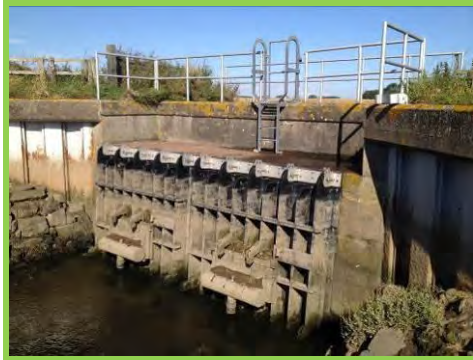
The sluice at Ross Low channel continues to be in good a good state of repair with sheet piles, capping beams, hand-railings and ladders generally in good condition.

The sluice structure south of Ross Low channel appears in good condition (/1401c18).

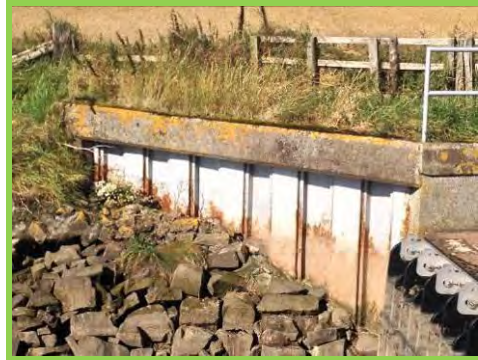
Sheet piles at the sluice repainted in 2008 (/1401c19).

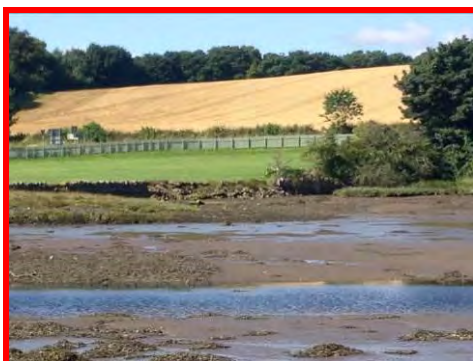
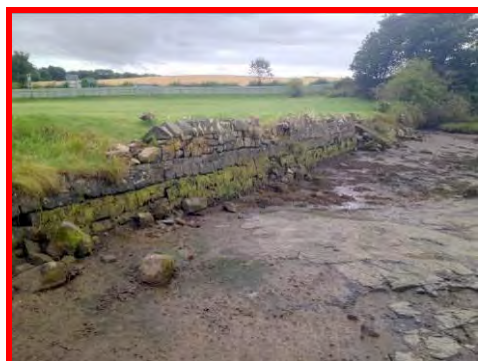
At Warren Mill, the wall fronting the private land at the head of the bay remains in very poor condition with significant collapse along the central section of masonry. Through discussion with the owners it is understood that they are arranging to have the wall repaired.

Significant collapse of central section of blockwork wall at Warren Mill (/1501c02).

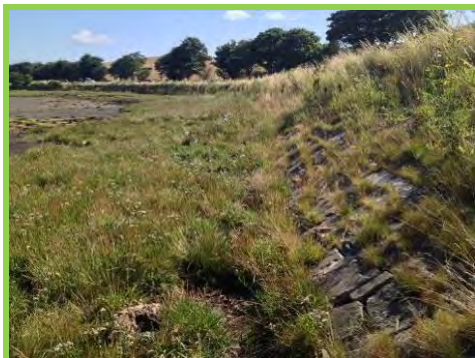
The revetment fronting the B1342 appears in good condition although somewhat overgrown and in need of repointing. The masonry wall at the south end of the revetment appears in good condition. These structures are fronted by a wide salt marsh with some evidence of edge erosion.

Gaps between blocks and overgrowth on stone revetment along B1342 (/1501c04).

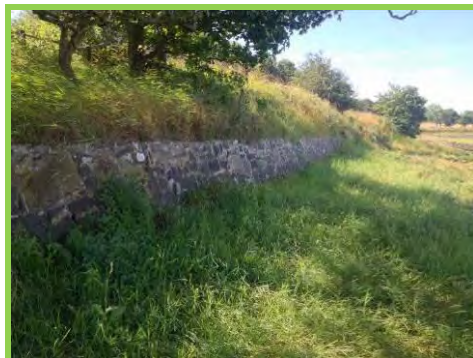
Masonry wall at south end of revetment in good condition (/1501c04).

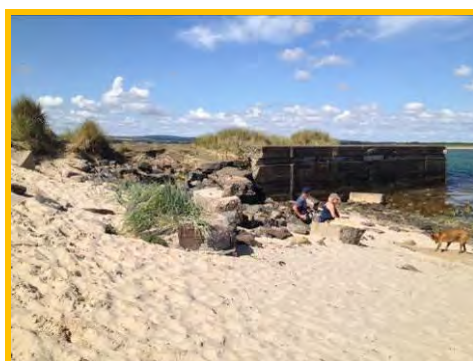
Partial collapse of northern wall of pier and loss of fill.

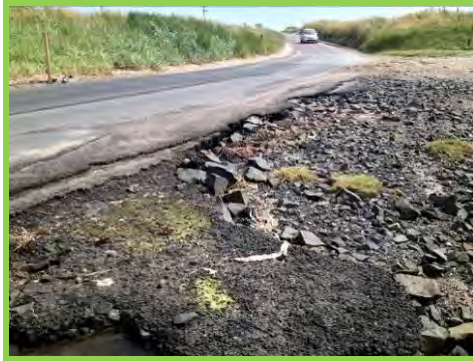
The damage to the causeway road at Chare Ends reported during the 2012 inspection has not been repaired but does not appear to have worsened. The dunes extending south from the causeway road towards The Basin are well vegetated and remain stable.

Localised erosion damage to road at Chare Ends (4901c01).

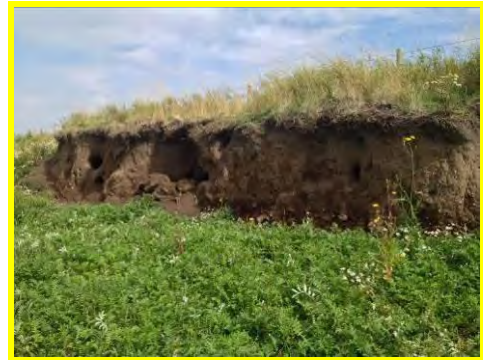
Holes from Sand Martins in exposed section of cliff at The Basin (/4901c03).

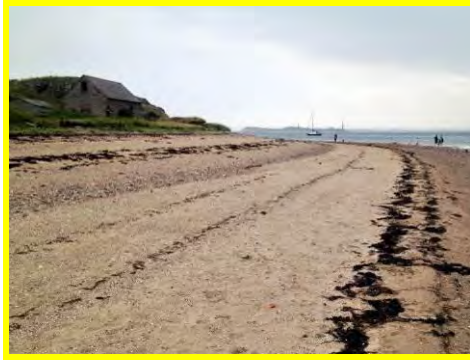
Narrow sandy beach and cobble berm in the lee of St Cuthbert's Isle (/4901c04).

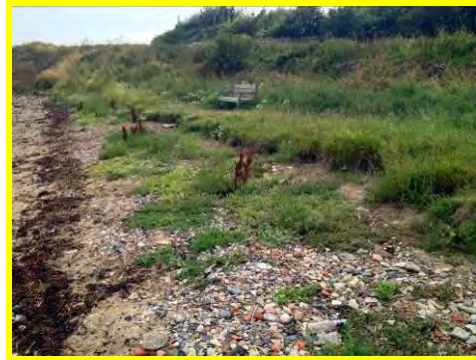
At the small bay sheltered by St Cuthbert's Isle, the narrow sandy beach is backed by a cobble berm. No noticeable change is apparent to the beach which appears stable since the 2008 inspection, however erosion of the low grass bank was evident, most notable at the north end behind the low wall.

Erosion along low grass bank at the back of the beach (/4901c04).

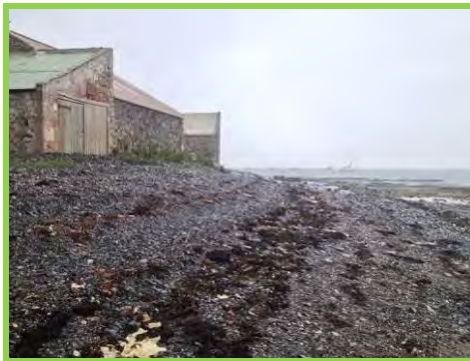
Increase in crest level of the shingle beach in front of boat houses (/4901c05).

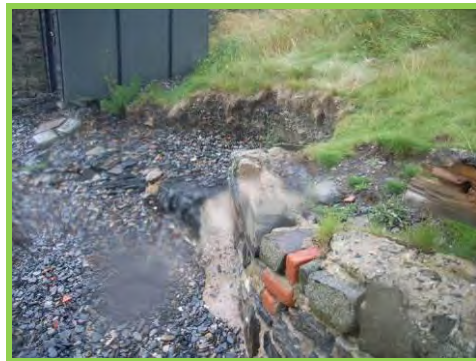
Beach levels of the shingle beach at the boat houses west of the pedestrian footpath to Heugh headland appears to have raised slightly. However, beach levels in front of the low masonry wall have reduced exposing the rock ledges and previous erosion and outflanking at the west end.

Lowering of beach levels at west end of masonry wall exposing previous outflanking (/4901c05).

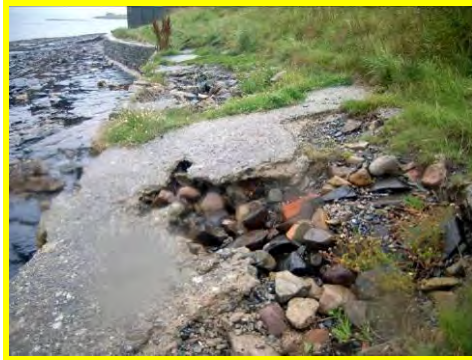
Damage to concrete apron along crest of wall (/4601c06).

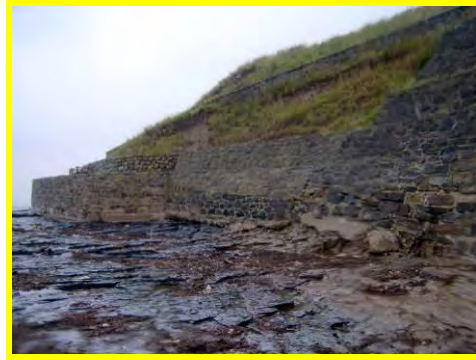
Cliff slumps at beach access ramp in 2012

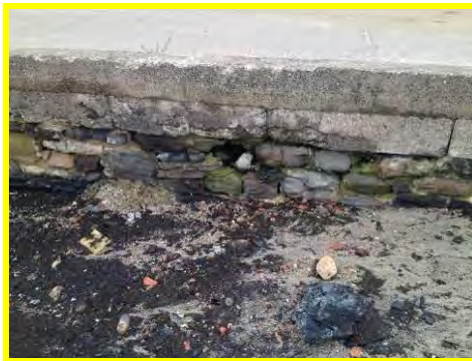
As first noted in the 2008 inspection, there is missing mortar and voids in the masonry section at the landward end of the harbour pier. There are also gaps between the deck slab and coping and also below the coping along the pier. Of more concern is the undermining of the toe of the northern face and voids (~0.3-0.5m deep) beneath the wall. Whereas this does not appear to have worsened since identified during the 2012 inspections, repairs are recommended before the damage progresses to destabilise the pier.

Missing mortar and voids in masonry section of harbour pier (/4901c09).

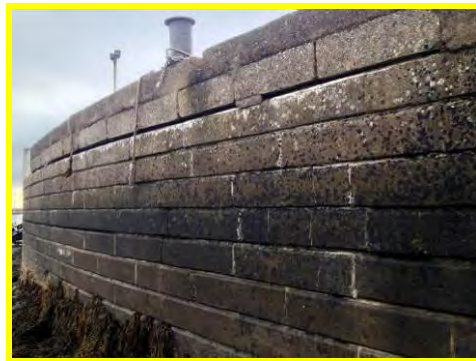
Missing mortar below coping (/4901c09).

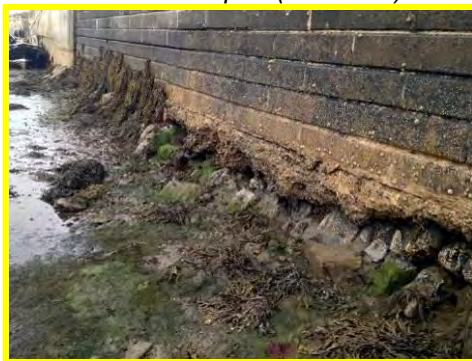
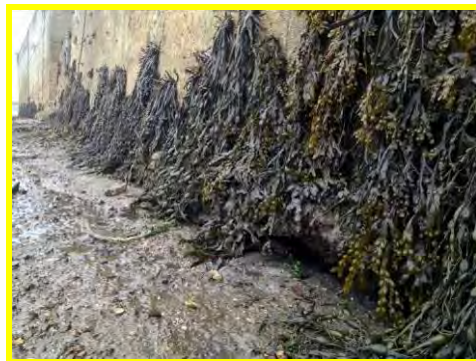
Undermining and voids at toe of northern face of pier (/4901c09).

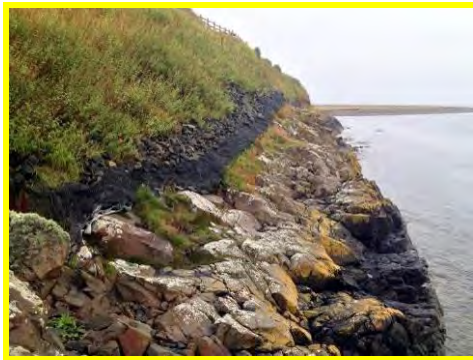
At Lindisfarne Castle, damage to the hexagonal netting and stone fill placed to stabilise the soft material covering the harder rock base below the castle does not appear to have worsened. However, this still requires repair and refilling to help delay further slumps. Erosion of the upper soft earth cliffs at the east end of the erosion control matting appears to be continuing. The 2010 inspection also recommended extending the erosion control matting further east but this still needs to be undertaken.

Hexagonal erosion control matting below castle in fair condition (/4901c12).

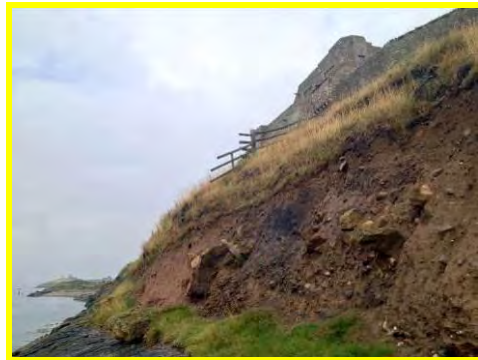
Slumps in cliff below castle east of erosion matting (/4901c12).

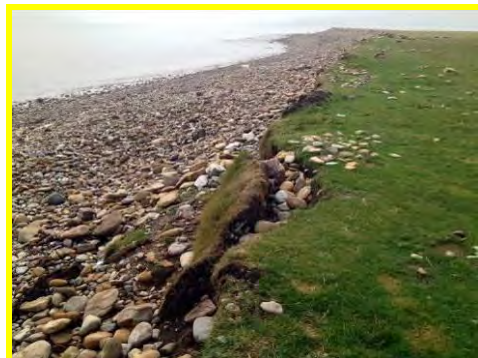
The shingle ness at Castle Point remains in a healthy condition, but there is erosion and cliffing of the grassed over coarse cobbles towards the north where it nears the path. This has started to undermine the boundary wall.

Erosion and undermining of grassed shingle on north side of ness (4901c14).

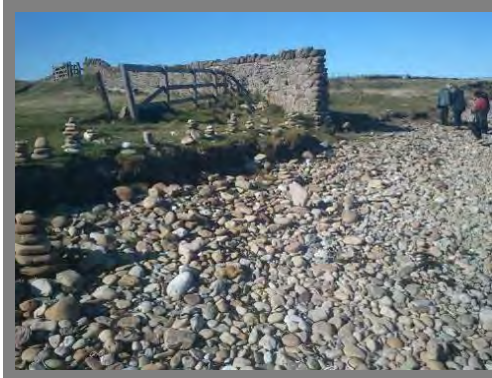
Erosion adjacent to boundary wall in 2012.

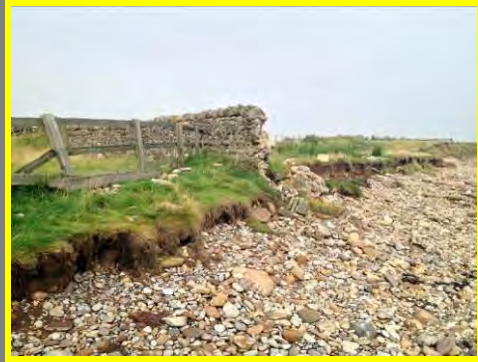
Erosion and partial collapse of boundary wall in 2014 (/4901c14).

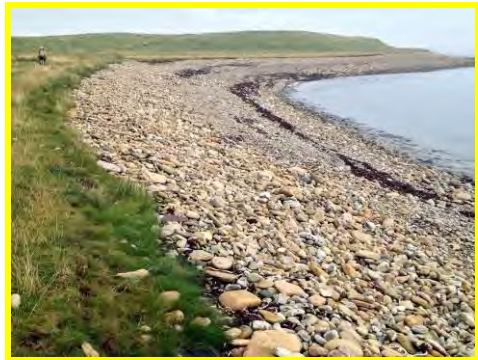
Erosion at grassed area of cobbles and shingle at Sheldrake Pool (/5001c03).

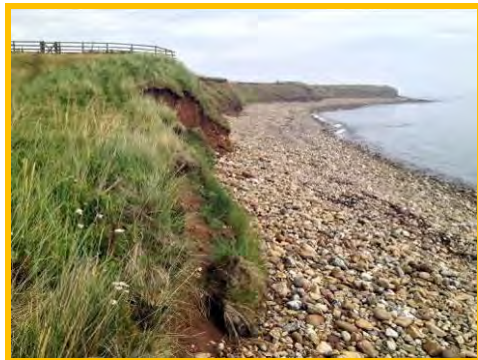
The 2012 and 2014 photographs below looking from Red Brae north to Emmanuel Head shows that through the ongoing cliff slumps the overall change is slow but there has been some cut-back and loss of a small section of the field boundary fence.

Recent erosion of earth cliffs at Red Brae in 2014 (/5001c05).

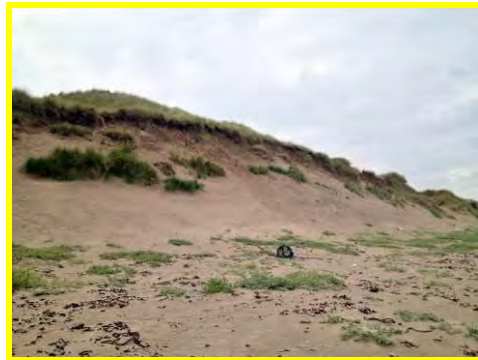
In Sandham bay, west of Emmanuel Head the dunes to the west and east are stable where they are protected by the cobble spit and rocky reefs of Castle Head Rocks. However, active erosion to the seaward face of higher dunes in the centre of the bay continues.

Eroding dunes in centre of Sandham Bay (/5001c06).

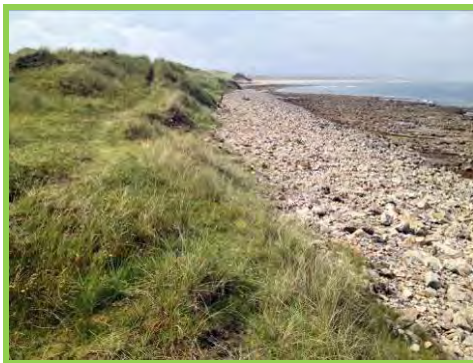
Cobble beach and stable dunes at west end of Back Skerrs rocks (/5001c09).

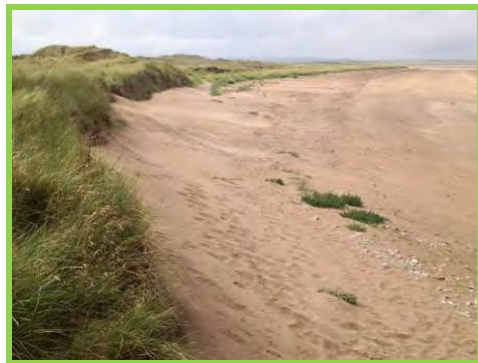
Well vegetated dunes and stable beach between Back Skerrs and causeway (/5001c10).

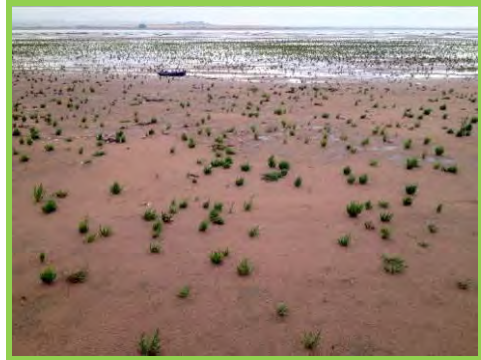
Growth of new vegetation across foreshore north of causeway (/5001c10).

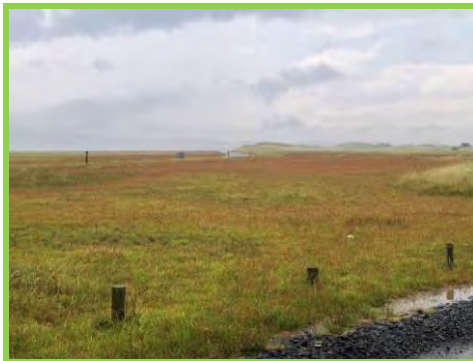
Causeway road looking west (/5001c11).

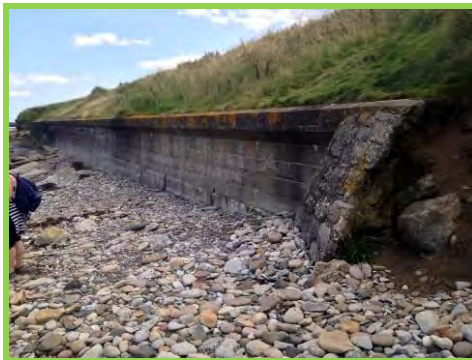
The seawall along St Aidan's road appears in good condition although some loss of mortar beneath the coping is apparent. Erosion of the earth cliffs continues causing some outflanking at the west end. Repairs to overtopping damage of the coping at the east end appear sound although some localised erosion in the upper earth bank above is apparent.

Onset of outflanking at the west end of seawall at St. Aidan's Road (/1701c54).

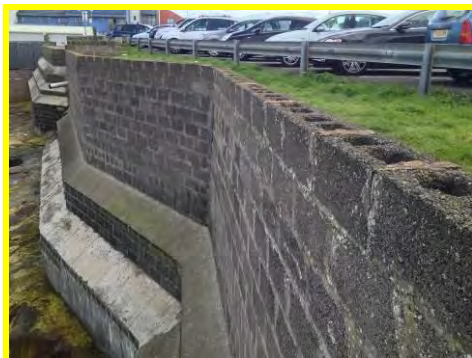
Concrete blockwork wall fronting car park in fair condition (/1701c02).

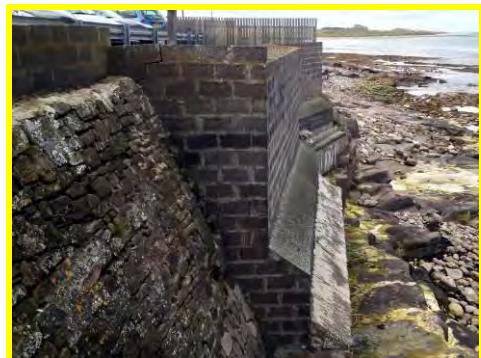
The retaining wall adjacent to the pay and display car park north of North Sunderland Harbour consists of two blockwork walls either side of a central masonry section. The masonry wall is quite abraded and has gaps and missing mortar between stones. Some settlement behind the crest wall is apparent with localised holes and some landward rotation of the crest wall at the north end. Along the concrete blockwork sections some of the concrete blocks at the toe are showing signs of abrasion and there are a number of missing sections to the concrete toe.

Missing mortar and gaps between upper masonry wall (/1701c03).

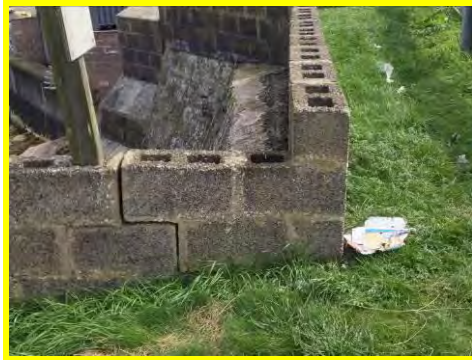
Settlement of fill and rotation of crest wall (/1701c03).

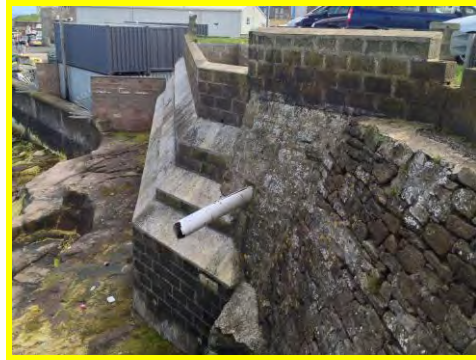
Missing concrete coping blocks along part of toe (/1701c02).

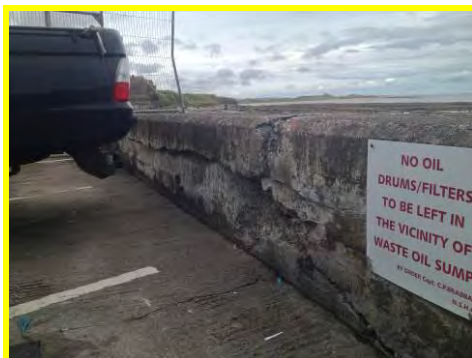
A significant horizontal crack in the crest of the seawall opposite the RNLI building remains, however this does not appear to have worsened. The seaward face of the Main Pier remains heavily abraded with scour holes reported. These holes were identified during the last inspection in 2010, repairs to the largest of these holes were recently undertaken by the Harbour Master. The localised rock armour attenuation at the landward end is in fair condition but the profile continues to flatten with some stones displaced across the rock foreshore.

Significant horizontal crack in crest of seawall opposite RNLI building (/1701c06).

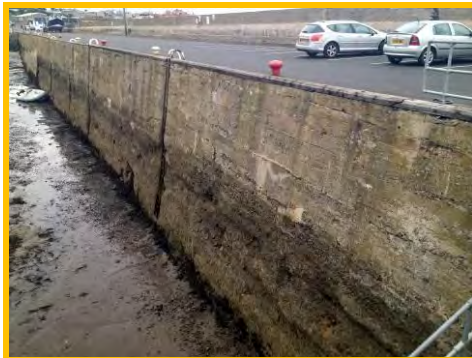
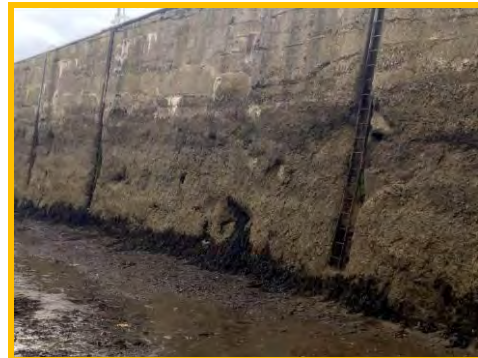
The inner face of the Main Pier is also highly abraded with various small holes and voids apparent. Although not observed during the inspection it was reported by the Harbour Master that a significant scour hole approx. 1-2m deep has developed beneath the south east corner of the stub end at the end of the Main Pier. This scour hole is cause for increasing concern and remains in urgent need of repair. Resurfacing on the Main Pier undertaken in 2011 to improve safety for pedestrian's remains in good condition. A flexible asphalt (rather than concrete) is understood to

Significant abrasion, holes and small voids in inner face of Pier (/1701c09).

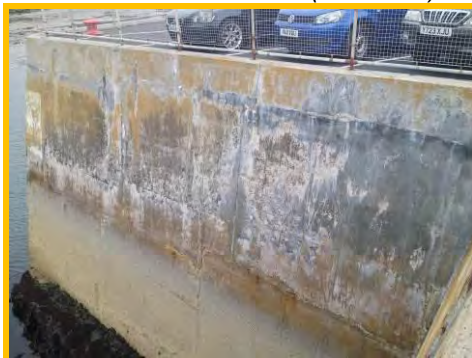
Large scour hole reported beneath Main Pier stub (/1701c08).

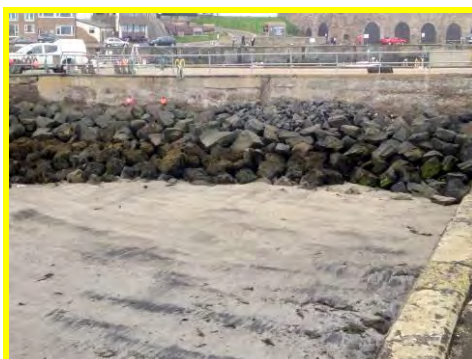
Rock armour attenuation with smaller rocks along crest (/1701c10).

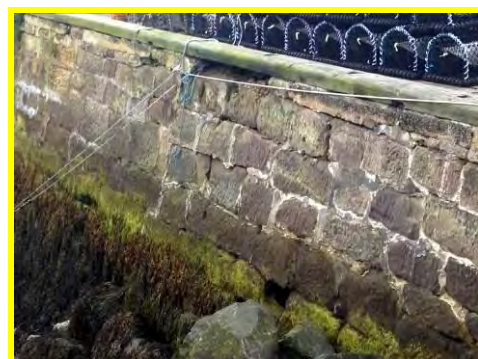
Some gaps beneath crest of Central Pier (/1701c10).

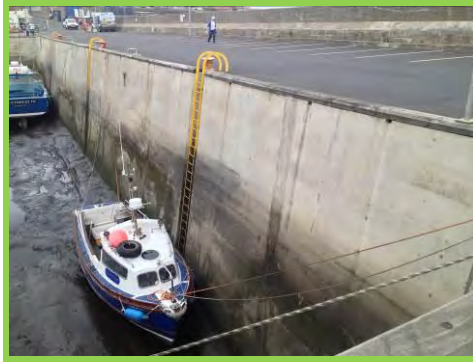
Inner face of Main Pier in good condition with only minor vertical cracks apparent (/1701c11).

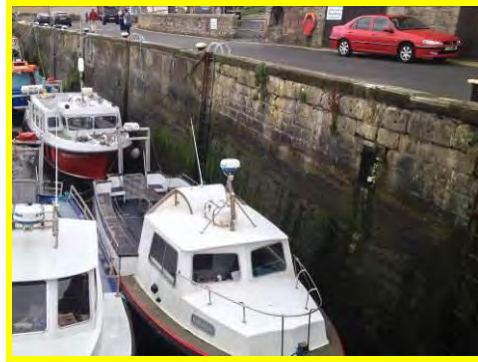
Some weathering of masonry blocks and loss of mortar (/1701c13).

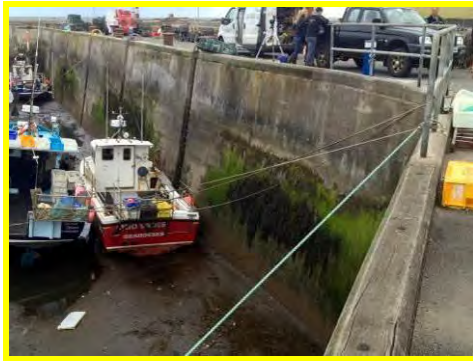
Inner concrete face of South Pier in good condition (/1701c14).

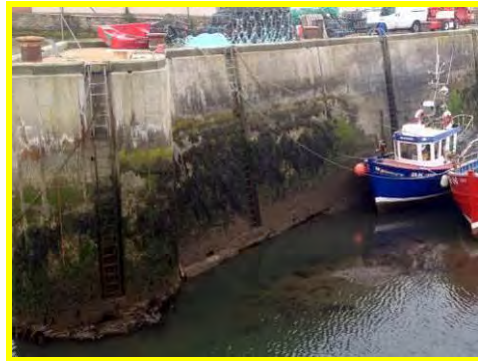
Along the South Pier the inner concrete face appears in good condition. There was possibly signs of undermining at the seaward end, however it was not possible to inspect this closely so will need further investigation. The outer masonry face of the pier is showing signs of general weathering and loss of mortar. Of more interest is the apparent movement across a large area of blocks at the centre of the wall. This should continue to be monitored.

Some evidence of undermining seaward end of South Pier (/1701c14).

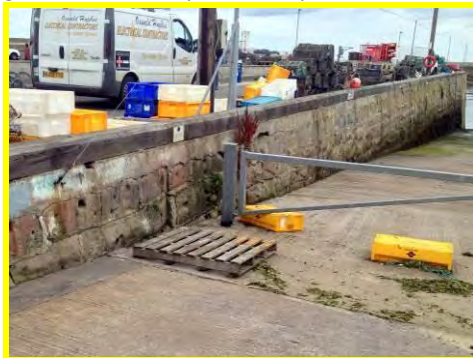
General weathering and missing mortar of blocks along outer face of South Pier (/1701c14).

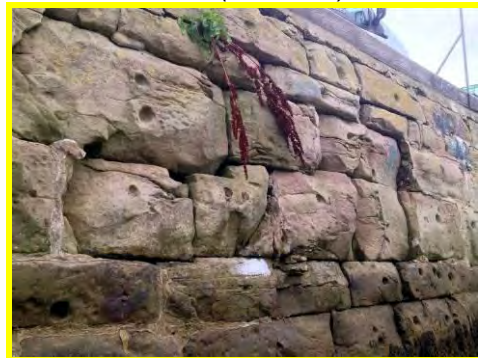
Apparent movement in an area of masonry blocks on outer face of Pier (/1701c14).

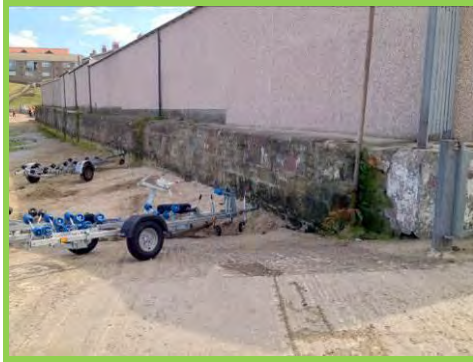
Masonry wall along back of sheds in good condition (/1701c15).

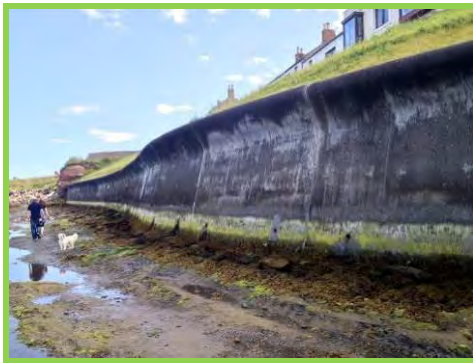
Concrete Seawall south of North Sunderland Harbour in good condition (/1701c18).
