**Cell 1 Regional Coastal Monitoring Programme:
Walk-over Visual Inspections of Assets**

Northumberland County Council

Walkover Visual Inspection of Assets

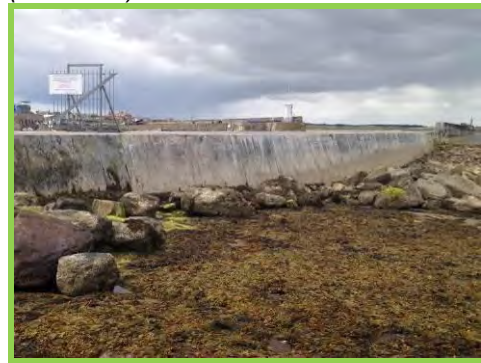
Repairs to crest of North Sunderland Harbour breakwater in good condition (/1701c21).

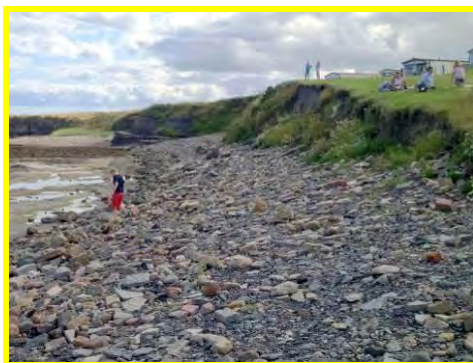
Erosion and cliffing of low earth cliffs fronting caravan park at Seahouse Pt (/1701c19).

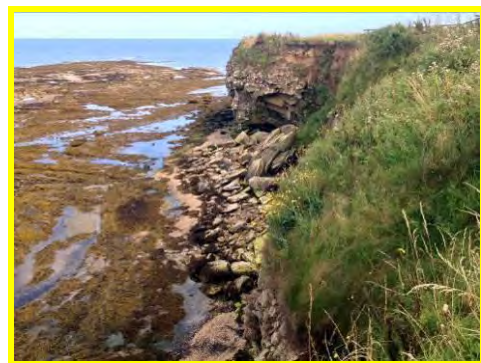
Localised rock falls near the sewage works at North Sunderland Point (/1701c22).

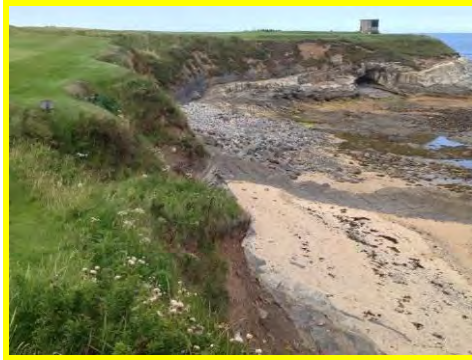
Erosion and cliffing of low earth cliffs fronting golf course (/1701c22).

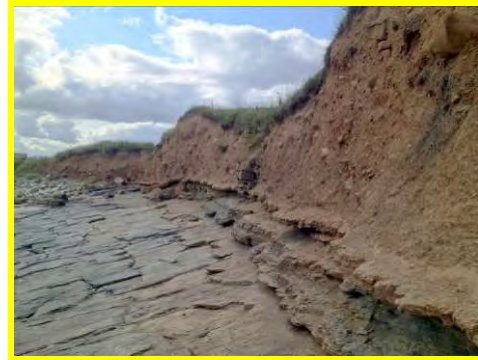
Erosion of the thin earth ridge (2m wide) at North Sunderland Point (/1701c23).

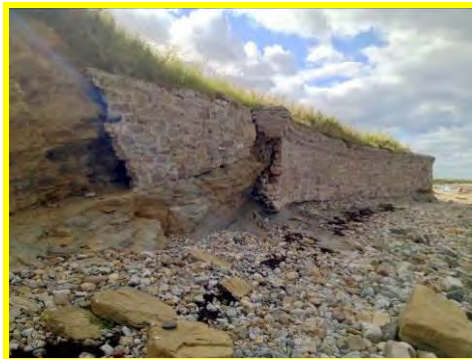
Masonry seawall north of Dell Point (/1701c25).

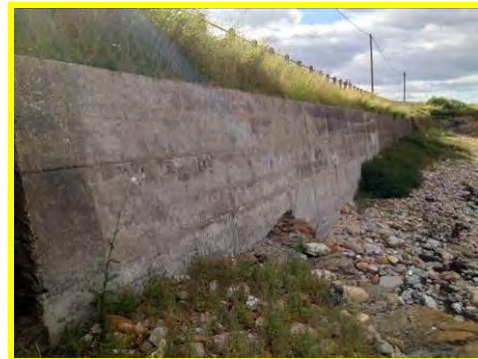
Masonry and concrete seawalls north of Dell Point in fair condition (/1701c25).

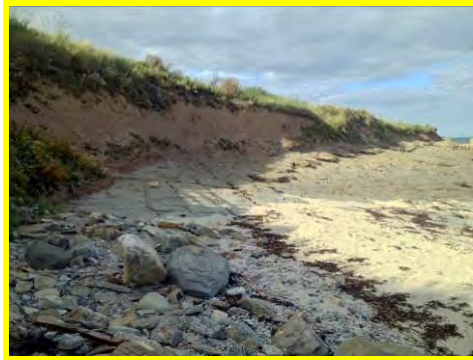
Ongoing erosion of soft cliffs south of Dell Point (/1701c30)

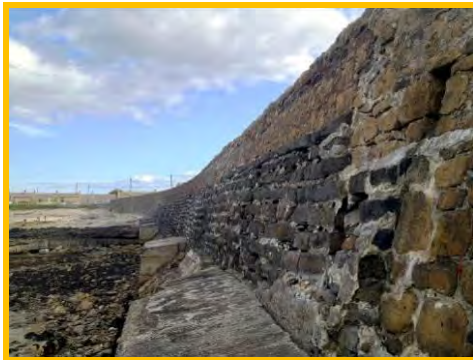
Masonry seawalls around Nackers Bay in poor condition (/1701c36).

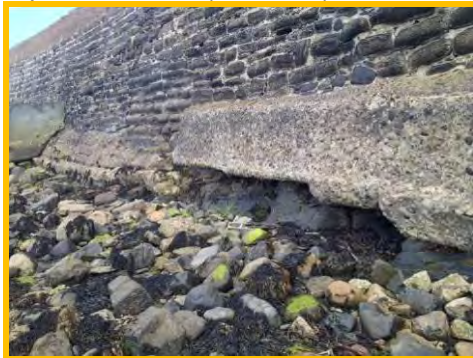
General undermining at mid-point of wall with potential loss of concrete toe works (/1701c36).

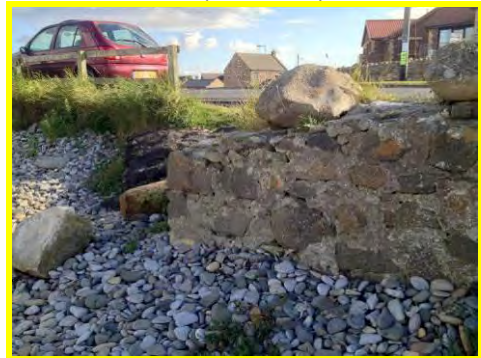
Loose coping stones at south end of seawall at Beadnell (/1701c37).

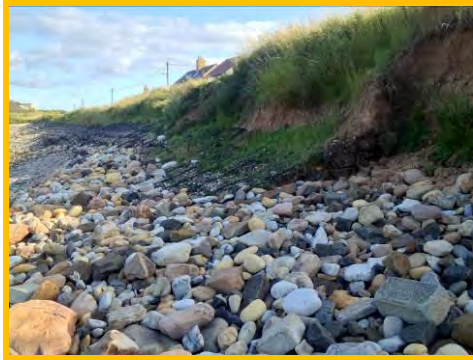
Burst baskets along the toe of the gabion revetment at Ladies Hole (/1701c39).

Further south at Lady's Hole, the gabion revetment remains in poor condition and in need of repair with burst baskets along the toe. Since this frontage and that at Nackers Hole Beach are linked in terms of access to the village and harbour the previous inspection recommended a review of the defence strategy in this area. Given the ongoing poor condition of these structures this view is still supported.

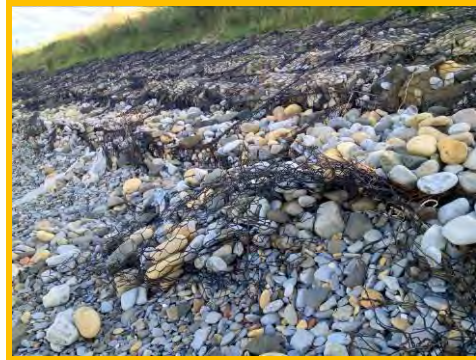
Burst baskets at the toe and loss of stone across the foreshore (/3701c39).

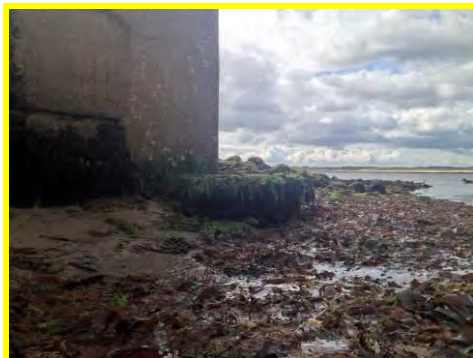
Undercutting of the toe apron at the head of Beadnell Harbour breakwater (/1701c50).

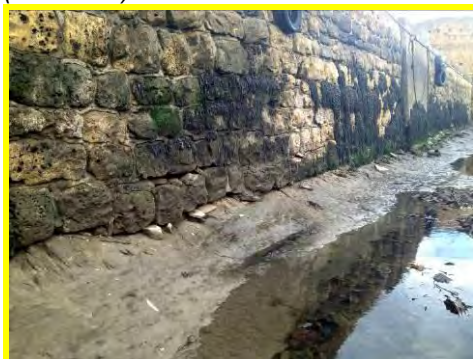
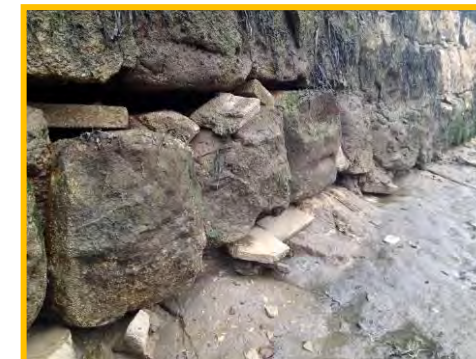
Localised undermining at the north quay resulting in movement of some blocks (/1701c52).

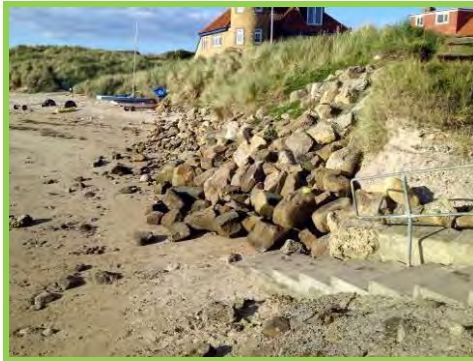
Localised dumping of rock at north end of Beadnell Bay to protect harbour road (/1701c52).

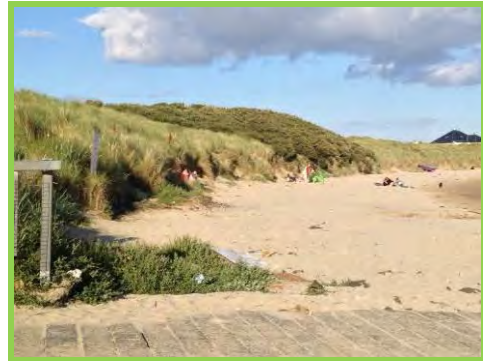
Localised erosion of dunes at the access to the car park (/1701c53).

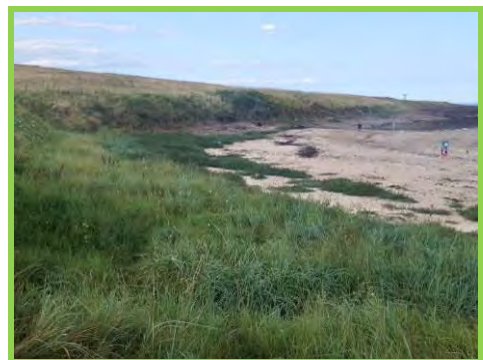
Vegetated dunes and sandy foreshore at Newton Haven (/2001c01).

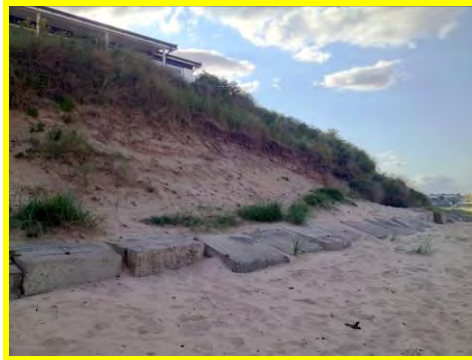
Erosion and cliffing of dune fronting holiday homes at golf course (/2001c03)

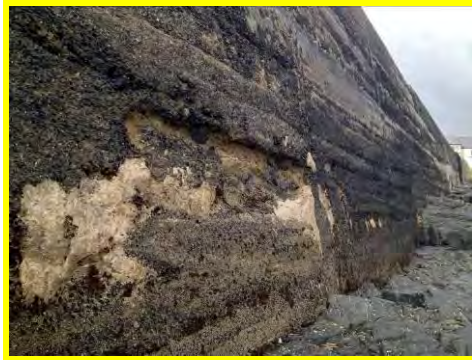
At Craster Harbour no significant change was evident since the last inspection with all structures remaining in a fair condition. The landward and seaward face of both north and south harbour arms show noticeable signs of abrasion and localised spalling along the crest wall. Initial undermining of the toe apron at the seaward end of the pier was observed however this did not appear to progress beneath the main wall. As noted during the previous inspection, a historical full height crack approximately 10m from the end of the north arm is evident through both faces but not across the decking. This crack does not appear to have worsened since the previous inspection but should be monitored regularly for signs of movement. Undermining and a deep void beneath the boat ramp continues to worsen.

Abrasion to the seaward face of the north harbour arm at Craster (/2201c04).

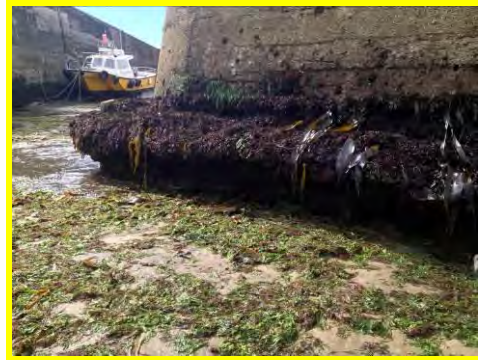
Initial undermining of toe apron at seaward end of north pier (/2201c04).

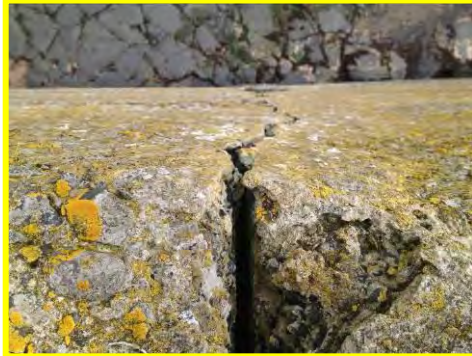
Full height crack on outside and inside face at seaward end of north pier (/2201c04).

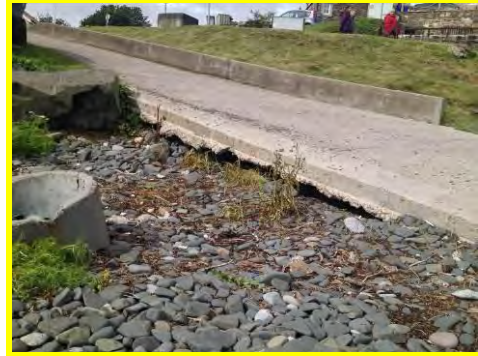
Undermining and a deep void beneath the boat ramp at back of harbour (/2201c06).

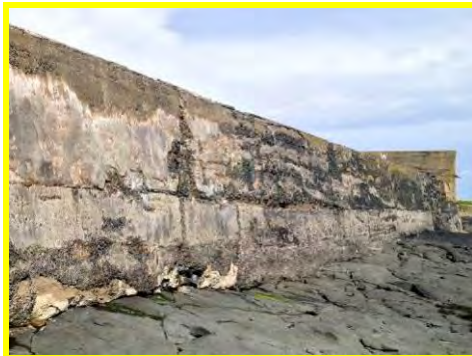
The full height crack and gaps at the toe on the outer face on the south pier has not worsened since the previous inspection. Previously identified cracks in the concrete decking have recently been repaired.

Abrasion and vertical cracks to outer face of south pier (/2201c11).

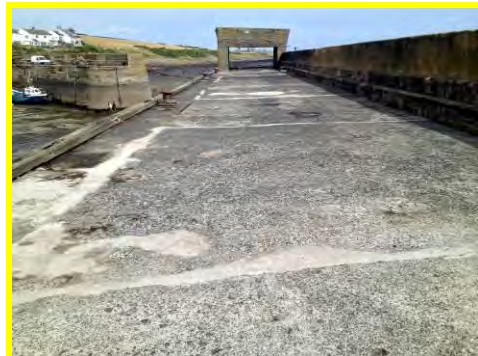
Recent repairs to the concrete decking on the south pier (/2201c11).

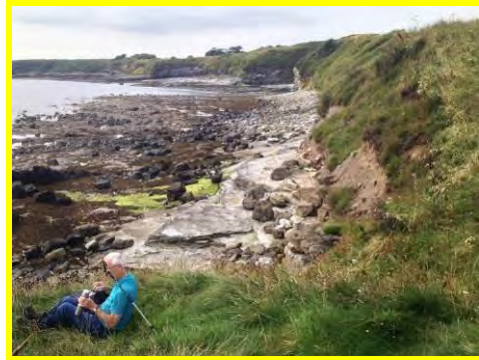
The coastline between Craster and Howick consists largely of hard rock slabs with vegetated upper slopes which are generally stable and in fair/ good condition. South of Howick the low vegetated slopes at the back of the sand/ shingle foreshore are in fair/poor condition with partial erosion and cliffing along much of the frontage.

Some erosion of upper earth slopes south of Cullernose Point (2401c01).

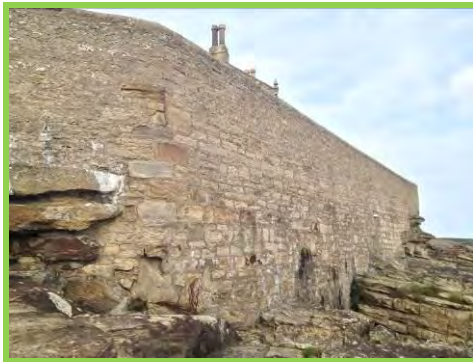
The high masonry wall around The Bathing House is in good condition with no signs of undermining or loss of mortar. Further south at Howick Haven there are two masonry retaining walls at the back of the beach. These walls are in a poor condition with weathering of blocks and loss of mortar in both walls and seaward rotation of the lower wall evident.

High masonry wall around The Bathing House in good condition (/2401c02).

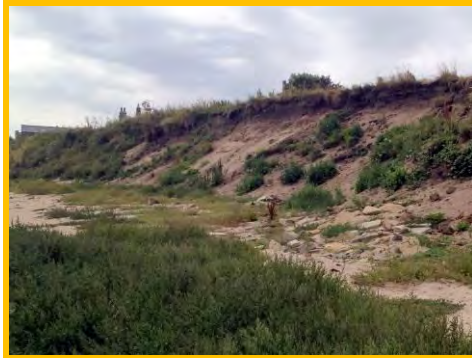
At Boulmer, erosion of the steep undefended earth slopes at the north end of the village continues resulting in cliffing along the crest. Holes from Sand Martins are also visible in this exposed section of cliff. As identified during the previous inspection one property is within a few meters of the edge but erosion of this section of cliff does not appear to have worsened.

Erosion of earth cliff and overhanging crest north of Boulmer (I2601c01).

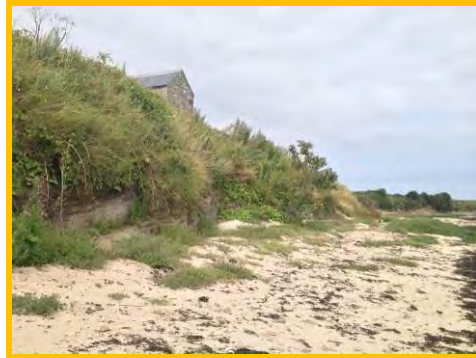
Property within a few metres of cliff edge at Boulmer (I2601c01).

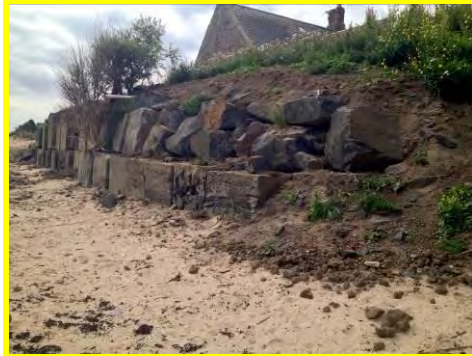
Rock armour added to north end of concrete block revetment (I2602c02).

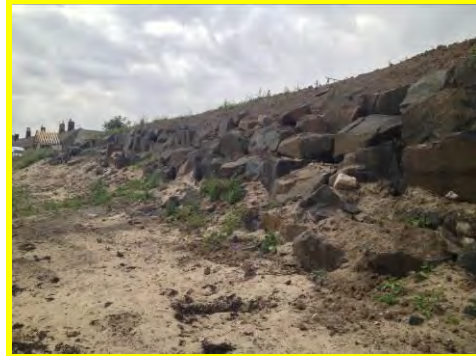
Rock armour added to south end of concrete block revetment (I2602c02).

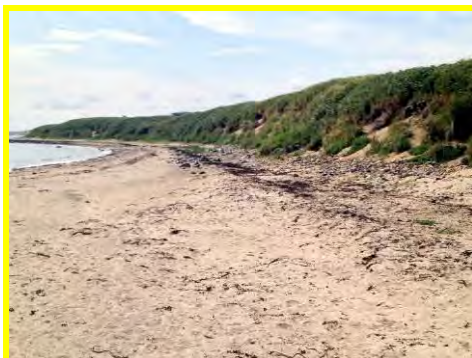
The dunes and low vegetated coastal slopes from Boulmer to Seaton Point are generally in fair condition with some localised erosion and cliffing.

Localised erosion of low vegetated coastal slopes at Seaton Point (I2601c07).

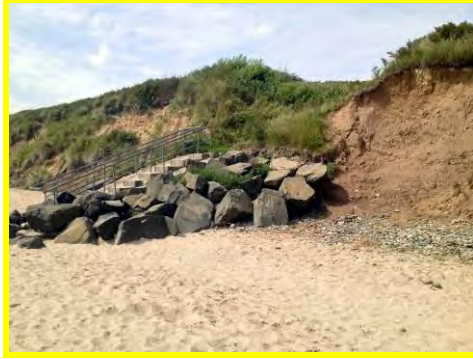
Rock armour at access steps in fair condition but outflanking continues (/2601c09).

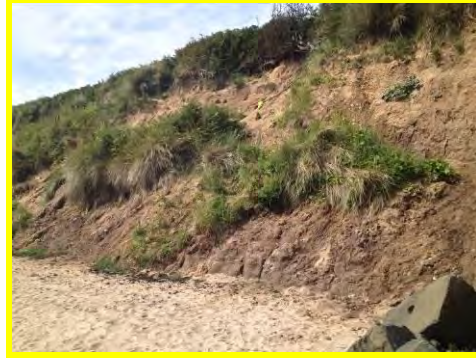
South of Seaton Point the cliff line continues to show signs of slippage and cliffing although there does not appear to have been any recent toe erosion since the 2010 inspection. The footpath along the cliff edge remains closed. The beach is relatively narrow with the strand line close to the toe of the slope. The 2010 inspection noted that the level of the beach in this area can fluctuate. The concrete steps and rock armour at the centre of the bay appear to be fair condition although outflanking due to erosion of the adjacent soft earth cliffs continues.

Signs of significant historic slippage along the cliffs south of Seaton Point (/2601c09).

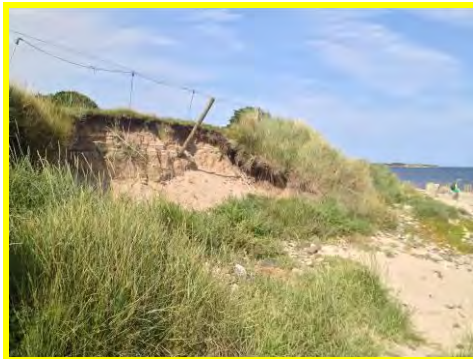
Localised erosion of low vegetated dunes behind groyne field at Marden Rocks (/2701c05).

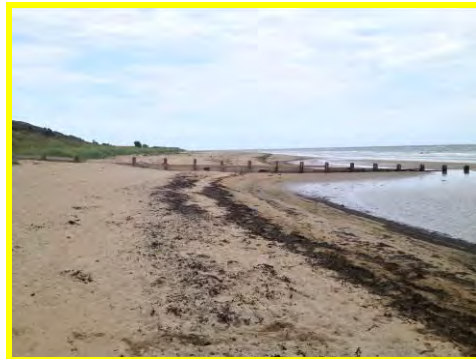
The coastal slopes and embankments from Foxton Hall are generally in good condition and fronted by a relatively wide sand and shingle beach. The deteriorating rock breakwater structure continues to disintegrate at the seaward end with rock scattered across the foreshore. At Marden Rocks erosion at the toe of the earth cliffs was observed with some slippages in the lower slopes. South of Marden Rocks the timber groynes are in poor condition with gaps and missing boards, however beach levels remain relatively high. Some localised erosion is apparent along the low vegetated dunes along the back of the beach.

Groynes in poor condition and high beach levels south of Marsden Rocks (/2701c05).

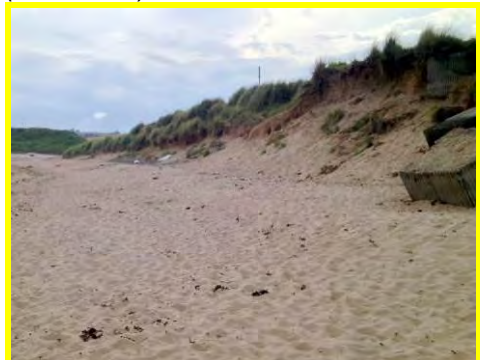
Erosion and cliffing of dunes at south end of relic anti-tank blocks (/2701c08).

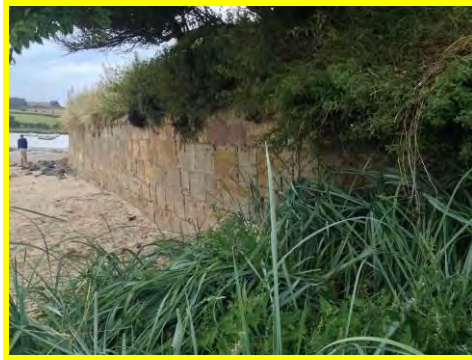
Beach levels in front of the masonry wall along Riverside Road appear relatively stable and unchanged since the previous inspection. Continued vegetation growth was evident at the bottom of the timber steps. The central section of masonry wall shows some historic signs of rotation as indicated by two vertical cracks. However, this does not appear to have worsened since the previous inspection but should continue to be monitored.

Stable beach levels and vegetation growth fronting the wall at Riverside Road (/2801c02).

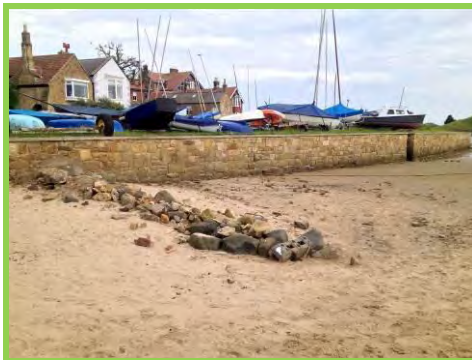
Low masonry wall at River Aln Boat Club (/2801c03).

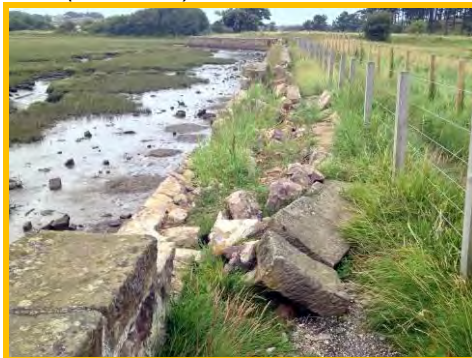
The low masonry wall fronting the River Aln Boat Club and Peases Park was constructed in 1993 and remains in good condition. The masonry wall along the footpath from Peases Park is in fair condition. The previous inspection raised concerns over cracking, gaps and missing blocks along much of the masonry wall to the north. This wall has now partially collapsed (possibly due to large waves during the recent winter storms) resulting in a 50m section of crest blocks moving landward. The footpath behind this wall has been diverted and the damaged area fenced off.

Collapse section of wall crest north of Peases Park and diversion of footpath (/2801c06).

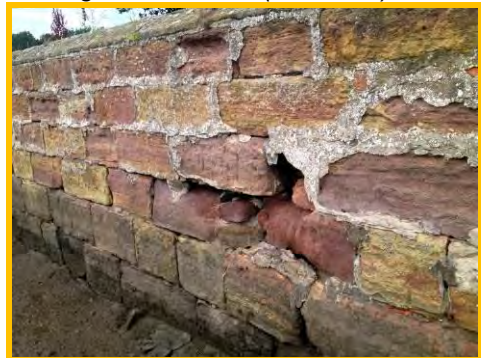
General abrasion, missing mortar and gaps along much of wall at Peases Pk (/2801c06).

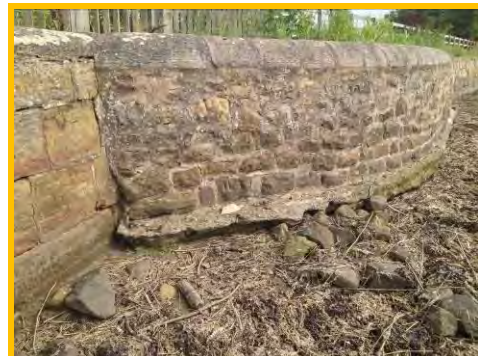
Initial undermining along one section of wall (/2801c10).

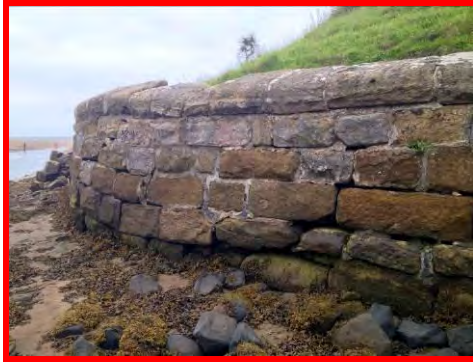
The low masonry wall around the bottom of Church Hill remains in very poor condition with some missing coping blocks, loss of mortar joins and two significant full height cracks in the joints and blocks at the centre of the wall. There continues to be some displaced blocks along the wall, most notably at the location where a 2m hole was identified during the previous inspection which has now collapsed. Some outflanking of the wall is also occurring at the inland end. Progressive collapse is expected to continue if remedial works are not undertaken urgently. The wall is largely buried by high beach levels at the seaward end.

Cracks, loss of mortar and displaced blocks causing loss of material behind wall at Church Hill (/2801c13).

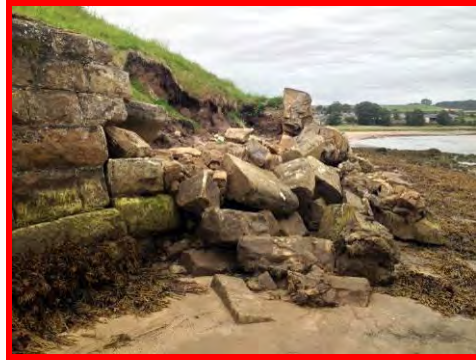
Collapse of section of wall due to loss of mortar, displaced blocks and loss of retained fill (/2801c13).

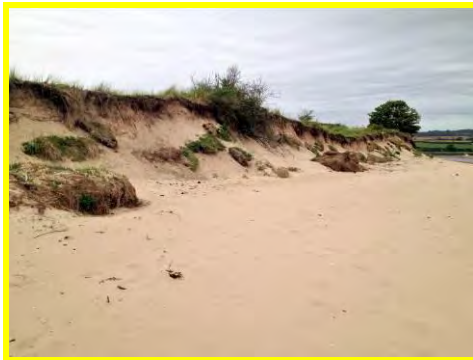
The high dunes along the south bank of the River Aln and further south towards Birling Carrs are in fair/poor condition. Ongoing erosion and cliffing along much of the length continues despite the presence of concrete blocks. This erosion appears to have continued to worsen since the previous inspection.

Erosion and cliffing of dunes south of Rive Aln (/2901c01).

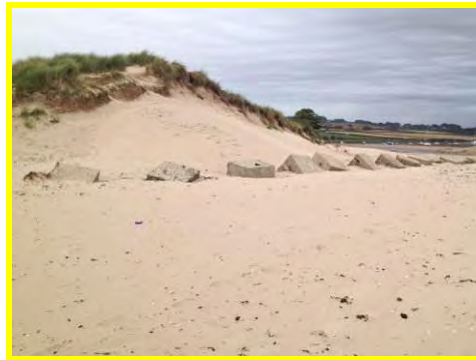
Cutting back of dunes south of River Aln despite the presence of concrete blocks (/2901c01).

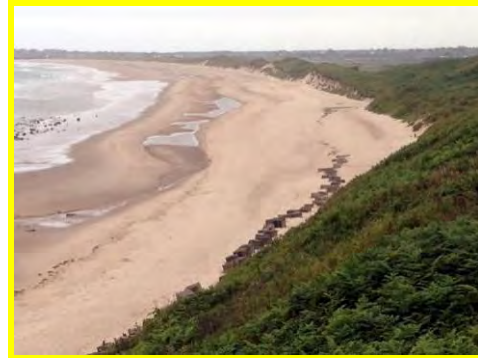
The dunes north of the rocky outcrop of Birling Carrs are stable although the hard rock base has suffered from local undermining and rock falls. However, the Warkworth Dunes to the south are in worse condition with partial erosion and slips continuing along much of the frontage.

Partial erosion and slips continuing along the Warkworth Dunes (/2901c02).

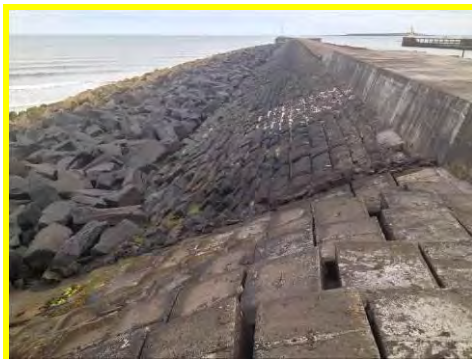
The large armourstone along the exposed north face of the North Pier continues to appear in good condition. There is no obvious signs of undermining/ settlement of the toe or flattening of the profile. The masonry blockwork at the seaward end is also in good condition with no obvious gaps or cracks. The revetment on the south face of the Pier is in slightly worse condition with some movement of small stones and some small gaps opening in the pitched stonework. The concrete crest along this section also appears in fair condition with no significant cracking or erosion.

Rock armour on north side of pier in good condition, some gaps visible in blockwork (/3001c01).

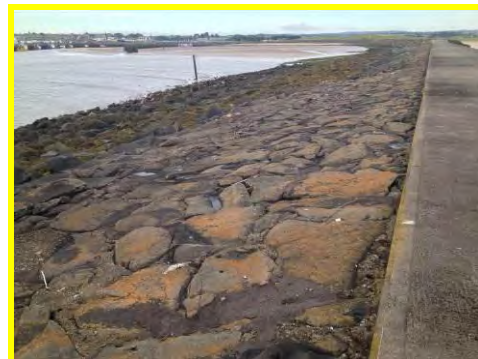
Rock armour and masonry on south face of North Pier in good condition (/3001c03).

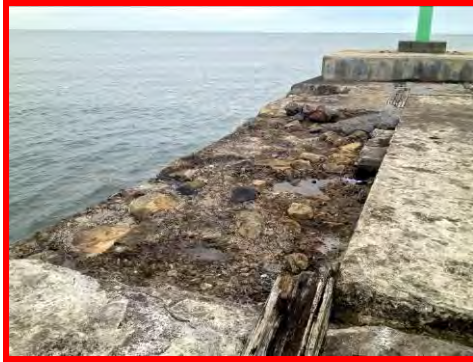
The seaward end of the North Pier remains in very poor condition with extensive abrasion of the concrete and a missing section of deck. The large crack (~1m wide) and rotation of the tip of the pier identified during the previous inspections is still cause of concern. However, no further movement appears to have occurred. Through discussions with the Harbour Master it is understood that this displacement is historic and dates back many decades however, it should still be monitored.

Loss of concrete deck slab at seaward end of North Pier.

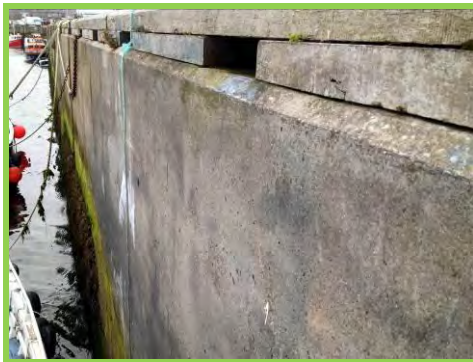
The concrete quay wall at the western end of Warkworth Harbour is generally in good condition with only minor localised cracks visible in the concrete deck. The slight bulge in the quay wall and small hole in the deck identified during the 2010 inspections was not observed. However, recommendations for the area to be inspected from the river using a vessel-based inspection at an appropriate stage of the tide is still advised. The masonry walls in the small harbour basin are generally in fair condition with some gaps between blocks, missing mortar, abrasion to the concrete cope and some small voids in the upper wall. A brickwork repair to the coping and timber edging at the back of the harbour has recently been undertaken.

Slight bulge in quay wall adjacent to lifeboat station not observed (/3001c05).

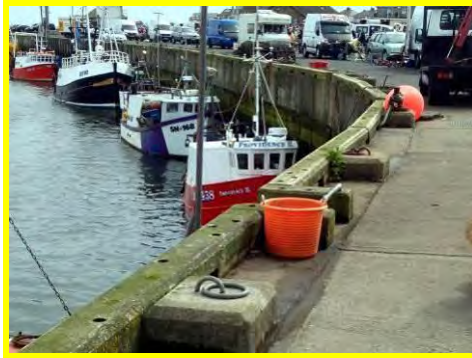
At the east end of the Warkworth Harbour, repairs to the collapsed Broom Hill quay were completed in 2013. This section of quay reopened to vessels after being closed for 5 years. The rest of the wall appears in good condition with no cracking or settlement of the deck or obvious defects in the face of the wall. However, at the time of the inspection boats moored against the wall made inspection difficult and no below water inspections were undertaken. The Warkworth Harbour structures are owned and maintained by Warkworth Harbour Commission.

Existing quay wall at Warkworth Harbour in good condition (/3001c05).

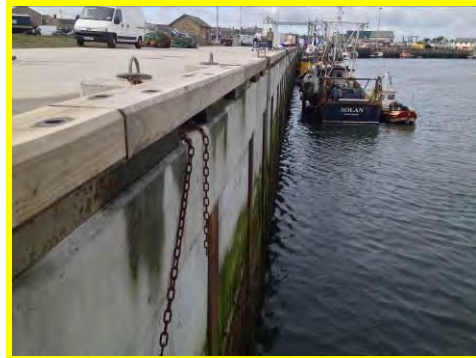
Repairs to failed section of Broom Hill quay completed in April 2013 (/3001c05).

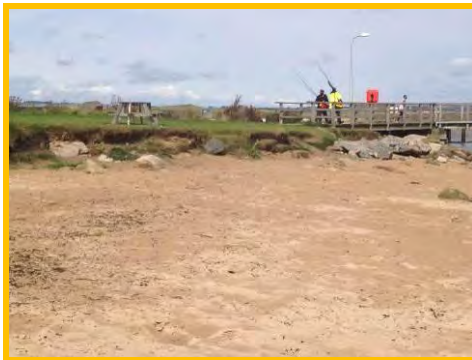
At the east end of Broomhill quay the timber linkspan bridge erected c2008/9 is still in very good condition. Some rock armour and construction waste has been tipped along the low vegetated bank to prevent erosion but this continues to be only partially successful and erosion continues to the south. The low masonry wall along the back of the enclosed bay is generally in good condition although one or two missing stones were noted. This wall is protected by a well vegetated area of dunes/links.

Continued erosion of low earth bank despite dumping of construction waste (/3001c07).

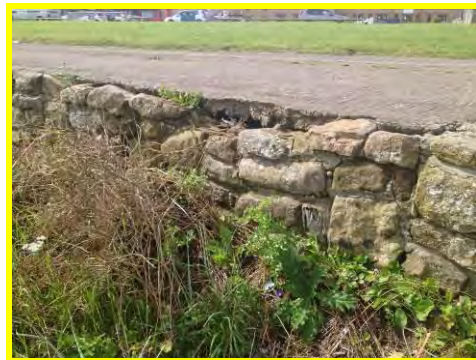
Some localised cracking and missing stones in masonry wall (/3001c09).

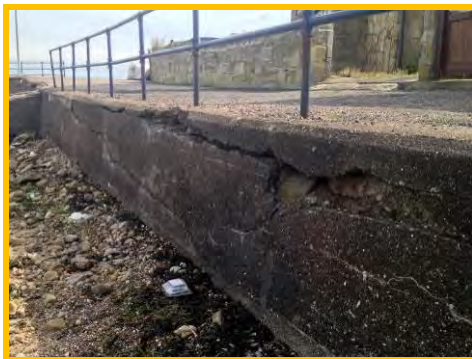
The condition of the concrete seawall along Bay View road continues to worsen with horizontal cracking and missing sections of coping, corroded and missing hand railing and voids in the access ramp. Safety issues should be addressed.

Horizontal cracks along the cope of the seawall at Bay View Road (/300c10).

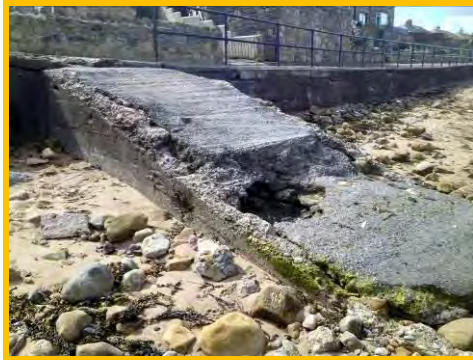
Abrasion, spalling and voids in seawall access ramp (/300c10).

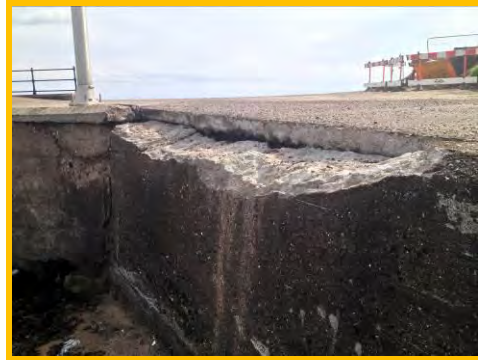
Localised spalling of the coping at the seaward end (/300c10).

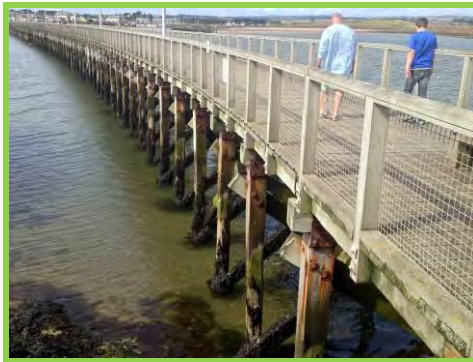
The South Jetty is in good condition with no gaps in the timber decks and all hand railing intact. The top section of all timber piles has previously been replaced and are in good condition. The lower section of piles remains in a reasonable condition. The half tide barrier remains effective with noticeable accretion within the basin. New lighting posts were installed in 2012.

Timber piles and superstructure of South Jetty in good condition (/3001c11).

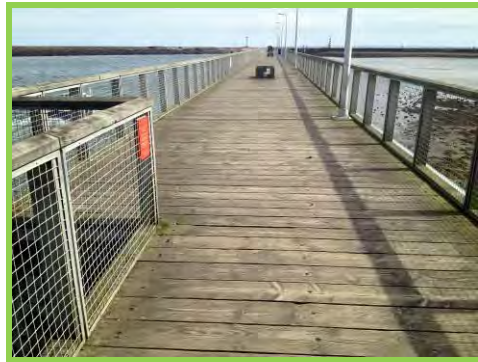
Timber decking in good condition (/3001c11).

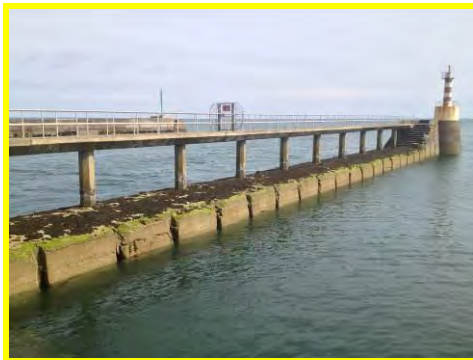
The South Pier Head is closed to public access so it was not possible to inspect the seaward end of this structure. The section that was inspected appears highly abraded, most notable along the base, at the access steps to the lighthouse and at the junction with the South Pier. Minor rotation and loss of sealant in one concrete deck section was noted, apparent by an enlarged gap between two of the sections. This was also noted during the previous inspection but does not appear to have worsened.

Significant abrasion to the base of the South Pier Head (/3101c01).

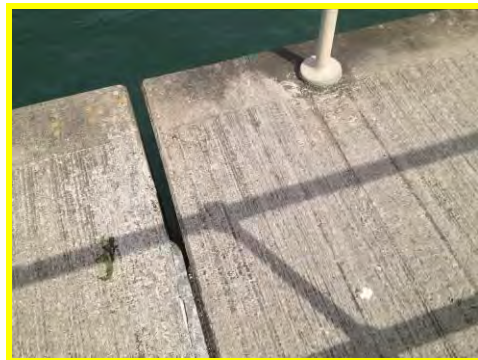
Minor movement in one deck section and loss of sealant (/3101c01).

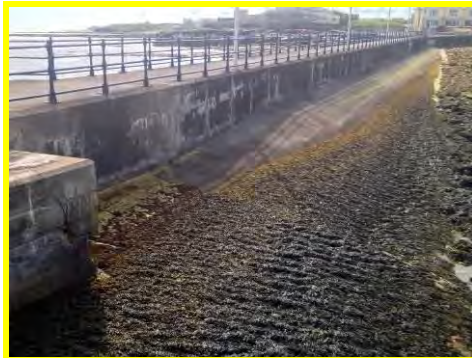
The condition of the inner face of the South Pier does not appear to have changed significantly since the last inspection and remains in fair condition along most of its length. Abrasion and cracking at the junction with the Bay View Road and the South Jetty identified during the previous inspection remains unaddressed.

South Pier generally in fair condition with some abrasion and cracking evident (/3101c02).

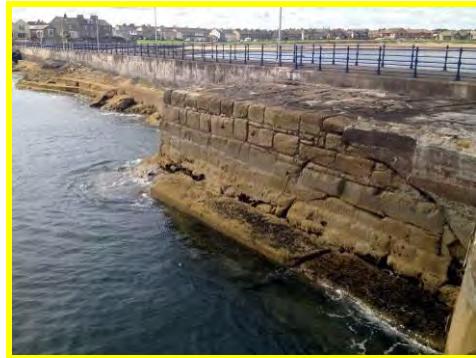
Abrasion and cracking of the South Pier at the junction with Bay View Road (/3101c02).

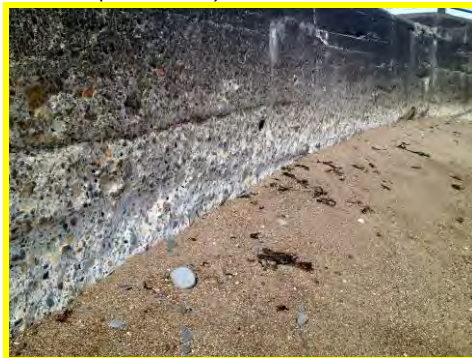
The seaward face of the south Pier has also not changed significantly since the last inspection. The structure is generally in fair condition with frequent horizontal cracking at the south end. The access steps at the south end of the Pier are highly abraded and, as these provided the only access to the beach, present a public safety hazard. Although the concrete stub groyne is also highly abraded it still serves its current function to retain the rock armour on the north side.

Horizontal cracks along South Pier and highly abraded toe (/3101c03).

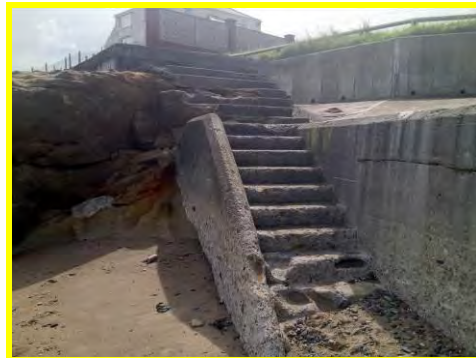
Highly abraded access steps presenting a public safety hazard (/3101c03).

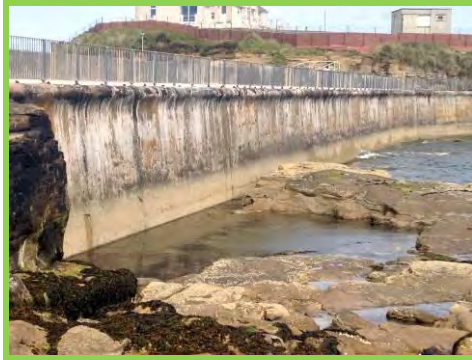
The seawall fronting the children's play area south of Pan Point is generally in fair/good condition with no signs of undermining or movement. Some localised cracks, rust staining and spalling along the wave return wall and setback wall were noted. The damaged bitumen surfacing has recently been replaced with a concrete decking which is in very good condition.

Localised cracks, rust staining and spalling along the wave wall (/3101c05).

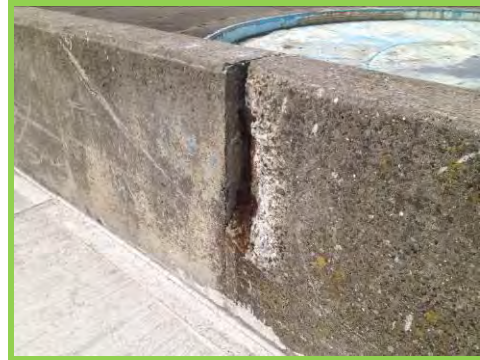
Spalling and rust staining to the setback wall, new concrete decking (/3101c05).

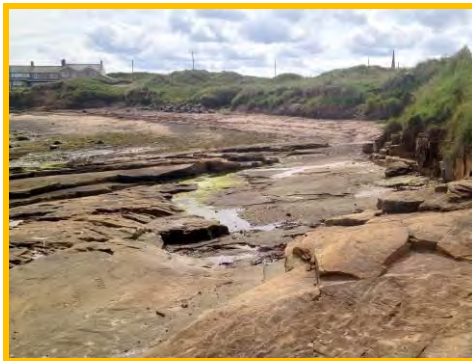
The earth slopes and dunes along the Amble Links are showing signs of erosion with cliffing along much of the frontage although this does not appear to have worsened. Dumped rock armour is controlling erosion at the centre of the embayment and adjacent to the seawall at the south end. Fly tipping as identified in 2010 was not apparent. The concrete seawall at Island View headland (constructed in 2003) at the south end of the dunes remains in good condition with no evidence of movement at construction joints, as noted in 2010.

Erosion and cliffing in face of dunes along much of the Amble Links frontage (/3101c06).

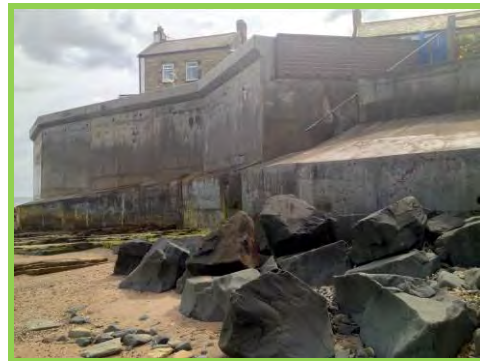
Seawall at Wellhaugh Point in good condition (/3101c07).

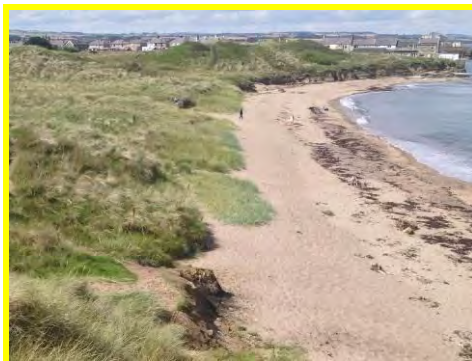
The low vegetated dunes north of Wellhaugh Point were reported to be subject to erosion in 2009/10. Some erosion and cliffing is still apparent at the north side of the bay but this does not seem to have worsened. Some new vegetation growth is apparent at the centre of the bay. The outfall structure remains in a dilapidated condition and previous recommendations for either removal or repair remain.

Erosion and cliffing of dunes north of Wellhaugh Point has not worsened (/3101c09).

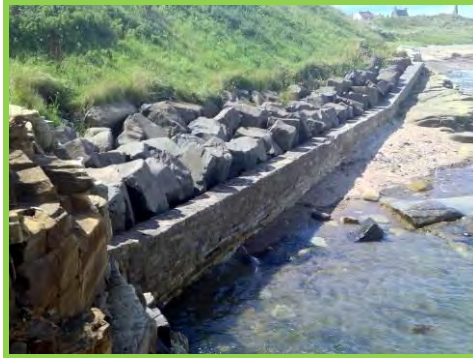
A short low masonry wall backed by a rock revetment at Wellhaugh Point remains in good condition with no signs of deterioration apparent. The notable erosion, slumping and recession of the dunes south of Wellhaugh Point continues. Towards Beacon Hill the dunes become more stable with protection provided by a cobble toe berm. The highly rusted outfall structure remains in need of repair or removal. The gabions by the access steps remain generally in good condition but are becoming slightly deformed with a notable dune blown out to the south.

Low masonry wall at Wellhaugh Point in good condition (/3101c10).

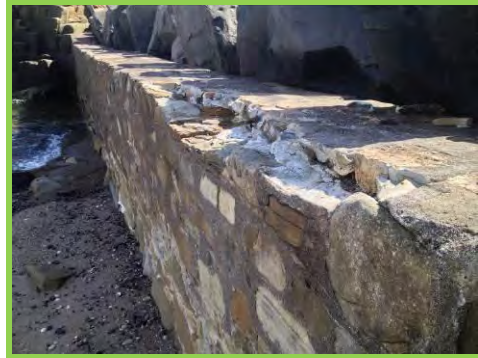
Damage to masonry along crest of low masonry wall at Wellhaugh Point (/3101c10).

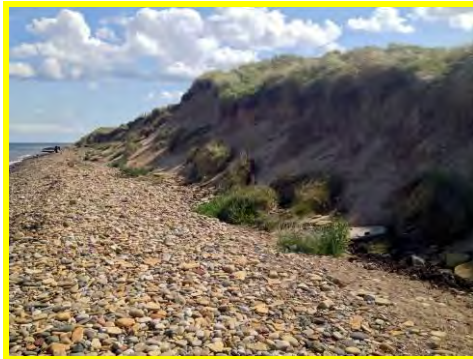
Erosion and collapse of dune face south of Wellhaugh Point (/3101c12).

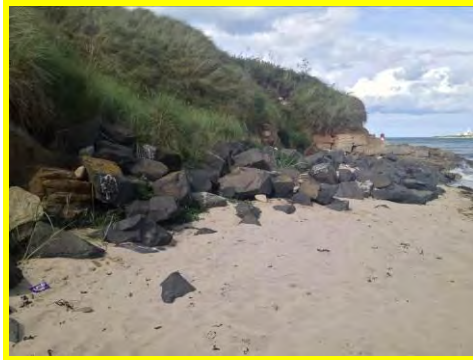
South of Beacon Hill there is a section of informally dumped rock armour. This armour is loosely packed and but appears in fair condition, continuing to stabilise the backing vegetated cliff. The one small area of minor movement observed during the 2010 inspection was not apparent. The rock revetment fronting the property north of the access ramp at Low Hauxley also remains in fair condition although beach levels appear to have dropped by around 0.5m since the previous inspection.

Stable vegetated cliff fronted by rock armour south of Beacon Hill (/3201c02).

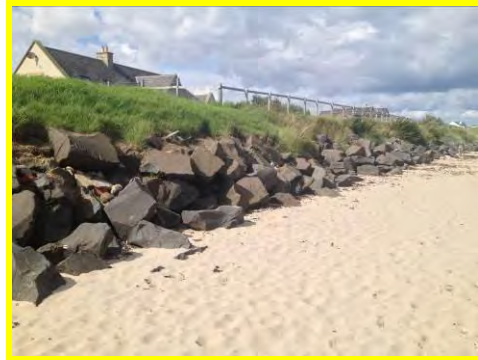
Lower beach levels fronting the rock revetment at Low Hauxley (/3201c02).

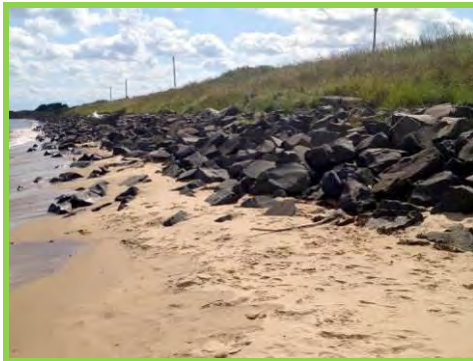
The dumped stone revetment south of the access ramp at Low Hauxley is in good condition although erosion to the vegetated bank behind the crest and tipped building rubble was evident. The line of concrete blocks forming the toe of the rubble revetment to the north of Hauxley Nature Reserve has a number of large gaps between the blocks with some movement apparent. Erosion and cliffing of the low earth bank continues with ongoing dumping of construction waste largely ineffective.

Dumped stone revetment south of Low Hauxley in good condition (/3201c03).

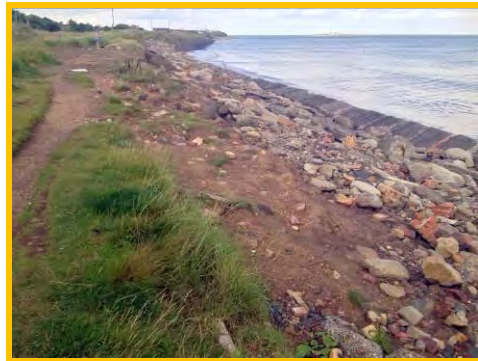
Erosion of low earth bank and dumped construction waste at Hauxley Nature Reserve (/3201c04).

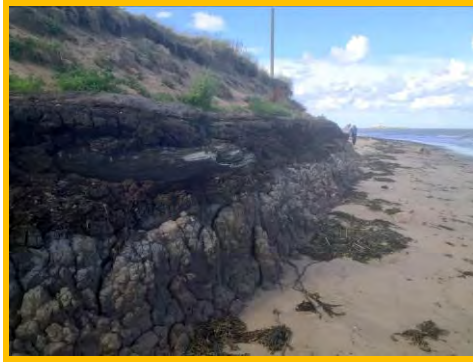
South of the outfall at Bondi Carrs active erosion of the dunes continues with cliffing and collapse evident along much of the length. However, this does not appear to have significantly worsened since the previous inspection. Erosion of the lower peat layer was also evident although no clumps were apparent on the foreshore as noted during the 2010 inspection.

Erosion of lower peat layer and cliffing in the upper slopes south of Bondi Carrs (/3201c07).

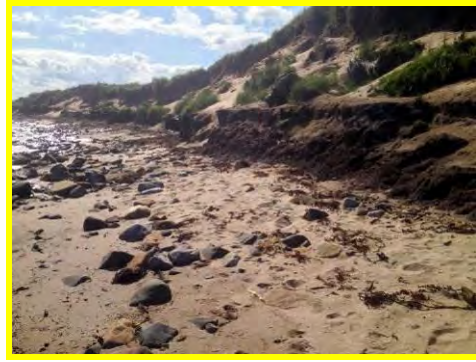
Erosion, cliffing and collapse of dunes south of Bondi Carrs (/3201c08).

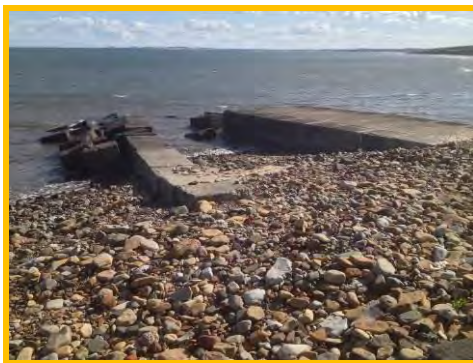
The outfall at the northern end of Druridge Bay is in poor condition with abrasion of blocks and broken concrete at the seaward end. The flap valve cover remains missing posing a safety risk to the public. Concrete blocks placed to shelter the structure are showing signs of movement. The dunes along Togston Links continue to erode with partial cliffing and slumping evident along most of the frontage. South of the car park at the piped outlet across the beach, erosion continues to cause cut back of the dunes. The attempts to prevent this outflanking using rock armour and rubble do not appear to have been successful. These dunes become more stable towards Hadston Carrs, where a coble toe berm is present at the toe and the rock outcrop affords some protection to the shoreline.

Abrasion of blocks, broken concrete and missing flap valve cover to outfall (/3201c09).

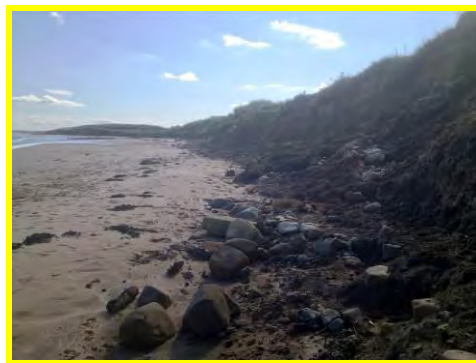
Erosion and slumps in the soft earth cliffs south of Hauxton Nature Reserve (/3201c10).

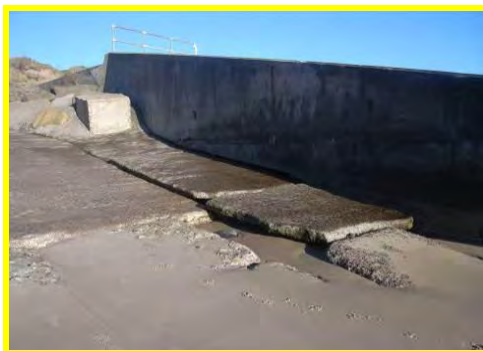
The large outfall structure adjacent to the Hadston Scaurs Boat Club remains largely in good condition with minor cracking to the wing walls. Undermining, settlement and cracking of the concrete apron reported in 2012 is now buried by high beach levels.

Undermining, settlement and cracking of to Hadston Scaurs outfall apron in 2012.

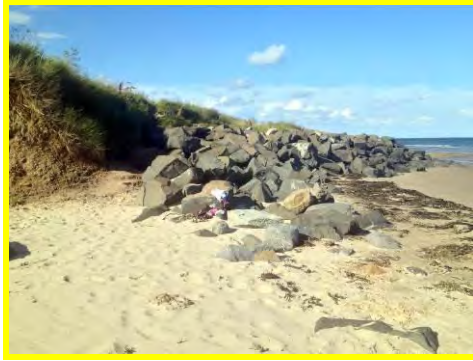
The rock revetment protecting the Hadston Scaurs Boat Club slipway is in fair condition with no movement at the toe or erosion behind the crest. However, the structure continues to be actively outflanked at the northern end resulting in unravelling of the structure with some rocks displaced across the foreshore. The low vegetated earth cliffs to the south are in poor condition with recent slumps and cliffing evident causing cut back to within a metre of the road. This does not appear to have worsened since the previous inspection.

Outflanking of the revetment south of the Hadston Scaurs slipway (/3201c13).

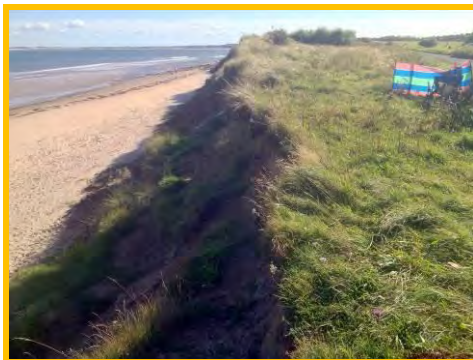
Active erosion of low earth cliffs and dunes in northern extent of Druridge Bay (/3201c14).

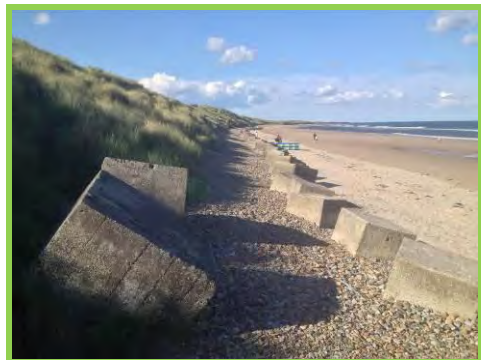
Dunes at north end of Druridge Bay protected by cobble berm and concrete blocks (/3201c15).

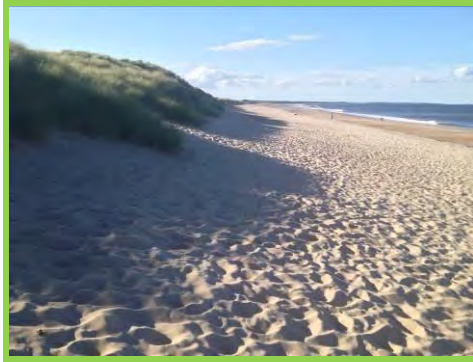
Healthy beach levels and stable dunes at the centre of Druridge Bay (/3201c15).

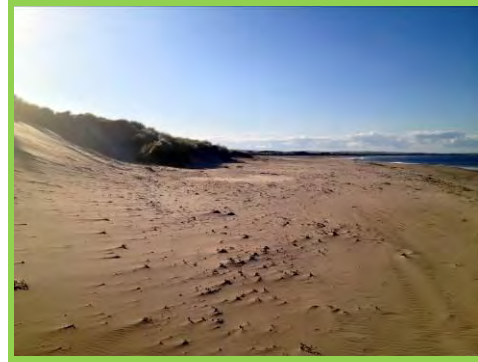
Healthy beach levels and stable dunes at the south end of Druridge Bay (/3201c16).

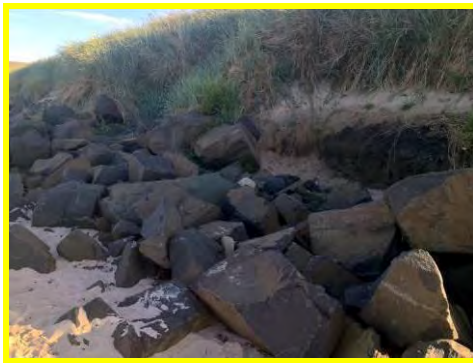
North of Cresswell the foreshore builds seaward in the form of a tombolo in the lee of The Scars outcrop. Beach levels at the steps appear to have lowered by around 1m since the previous inspection, exposing more of the rock revetment as well as previously buried concrete blocks along the beach. The revetment to the north of the steps is of loose construction but in good condition, with evidence of additional smaller rocks tipped on top. As noted during the previous inspection, localised erosion at the crest was observed, but this has not worsened. The revetment to the south of the steps remains in fair condition with loss of interlock and some new smaller rocks added. No new erosion at the crest was evident.

Loosely placed rock and localised crest erosion south of Cresswell access steps (/3201c17).

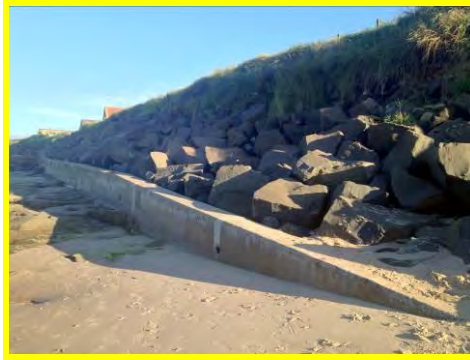
This revetment blends into a low concrete wall built at the back of the rocky foreshore with rock armour placed behind the wall to protect the vegetated earth cliffs. Beach levels appear to have remained low along the northern section of the wall compared to the 2010 inspection with much of the rock foreshore and north end of the wall exposed. The wall is generally well founded on the rock foreshore and in fair condition with minor cracking and staining. Previous patch repairs are in good condition although some locations repairs appear not to have been completed and reinforcement continues to corrode. Some rocks in the revetment appear to have moved over the toe wall. The earth face along the upper slope is showing signs of overtopping damage with significant dumping of construction rubble noticeable.

Lower beach levels fronting low concrete wall at Cresswell (/3201c18).

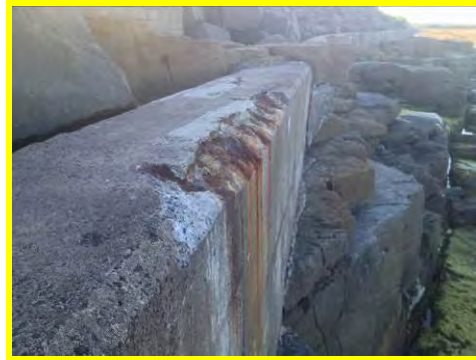
Incomplete crack repair resulting in corrosion and rust staining (/3201c18).
