**Cell 1 Regional Coastal Monitoring Programme:
Walk-over Visual Inspections of Assets**

Northumberland County Council

Walkover Visual Inspection of Assets

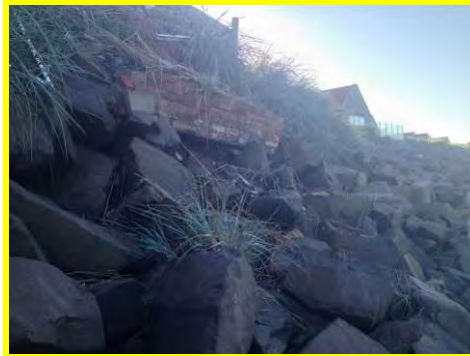
Erosion of earth slopes behind crest and tipping of building rubble (/3201c18).

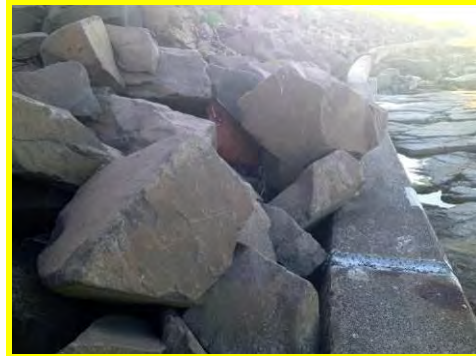
Erosion of earth slopes behind crest and tipping of building rubble (/3201c18).

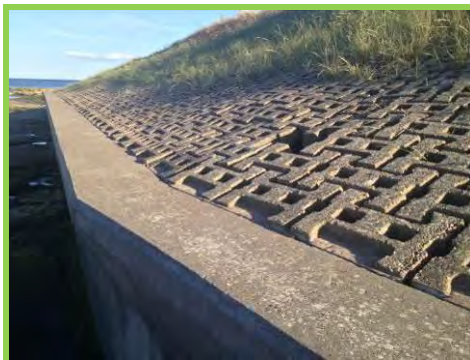
To the south of Cresswell the low concrete wall and concrete block revetment is largely in good condition. One missing block apparent along with an area of spalling and minor signs of abrasion.

Missing block along concrete revetment at south end of Cresswell (/3201c19).

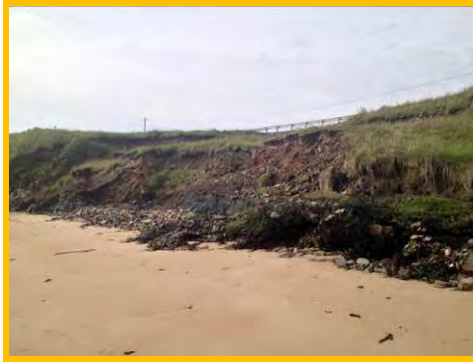
Further south fronting the Golden Sands Holiday Park north of Snab Point, the cliffs become more active once again, where the cobble berm is sparser. The condition of the gabions continues to degrade along with ongoing erosion and large scale slippage of the earth slopes to within a few meters of the road. Construction of a vehicle barrier has now been completed along the top of the slump identified in 2010. However, movement of the road base below the concrete foundations already appears to have occurred suggesting this area is still active.

Damage to gabions and loss of material along toe of slopes north of Snab Point (3201c22).

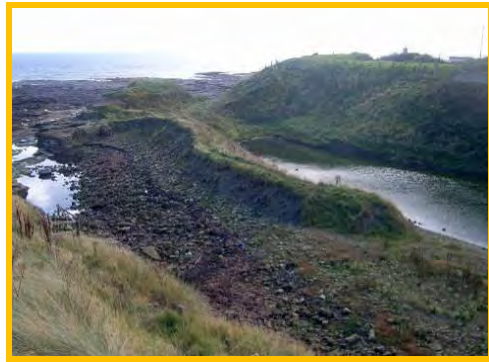
Erosion along the mound of land at the disused quarry has not worsened (/3301c01).

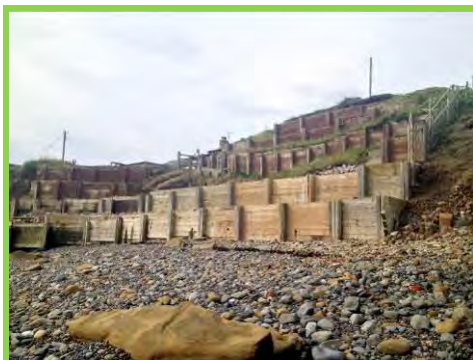
Erosion and slips at the northern edge of retaining wall could lead to outflanking (/3301c01).

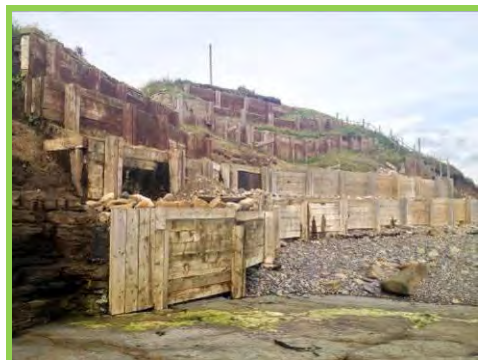
Timber breastwork extended in 2010 to prevent slips in upper slopes (/3301c01).

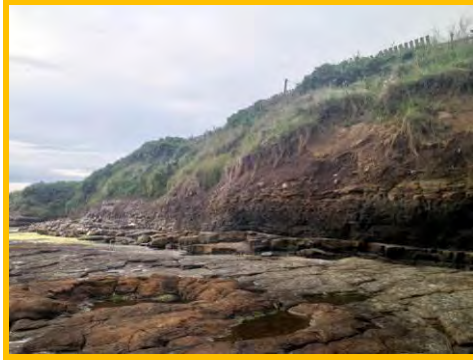
Erosion of toe of soft cliffs at Snab Point (/3301c01).

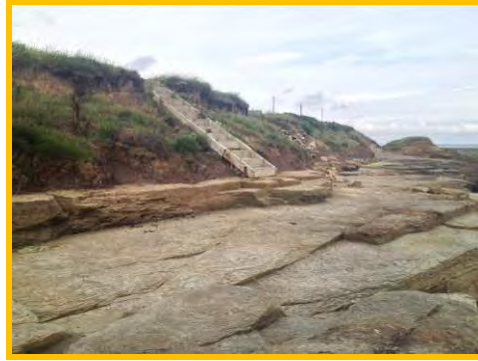
No recession evident in earth cliffs behind access steps at Snab Point (/3301c01).

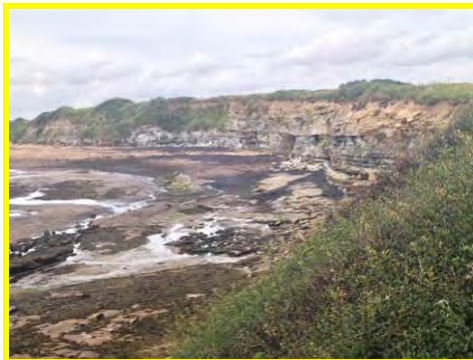
Rock falls and erosion of the soft upper cliffs at the north end of Lynemouth Bay (/3301c02).

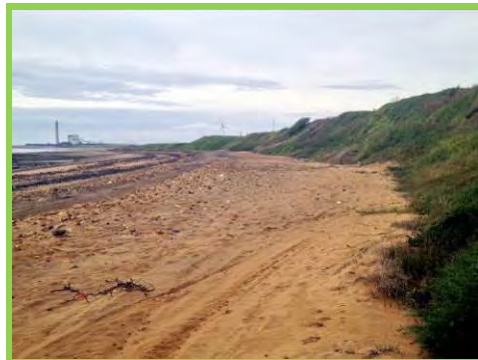
Wide spoil beach providing protection to the coastal slopes (/3401c01).

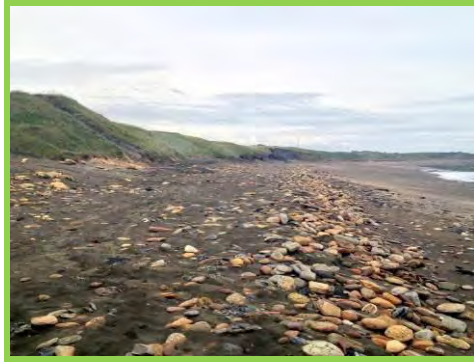
Spoil beach narrows at the centre of Lynemouth Bay (/3401c01).

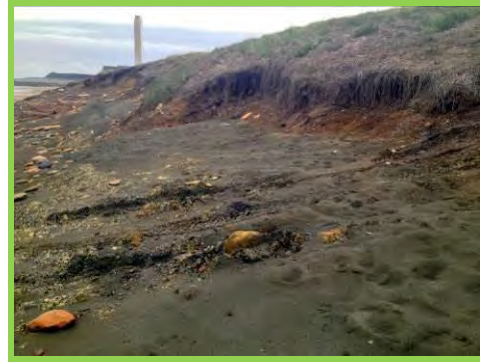
Erosion and cliffing along the toe of the coastal slope (/3401c05).

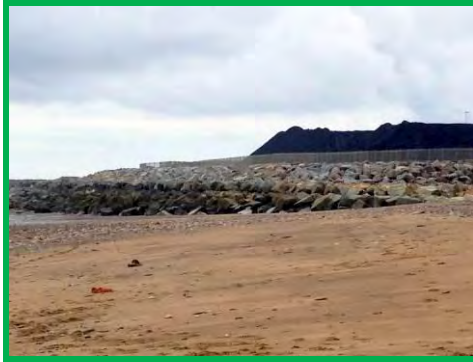
Rock armour revetment fronting coal stocking yard (/3401c07).

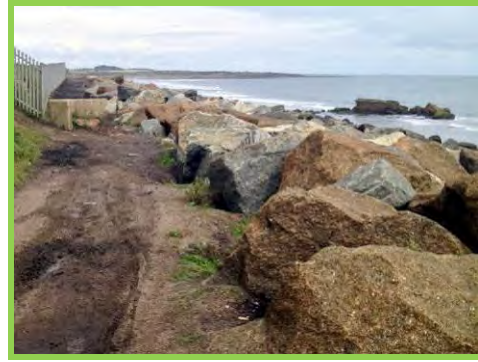
Minor erosion behind crest of revetment fronting power station (/3401c08).

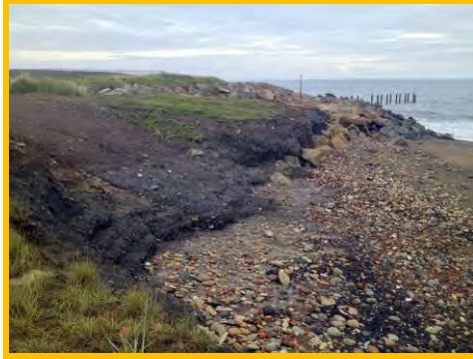
Erosion and onset of outflanking at south end of revetment (/3401c08).

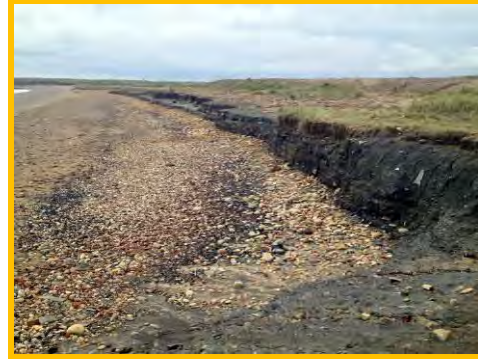
Active erosion of colliery spoil cliff at the north end of the bay (/3501C01).

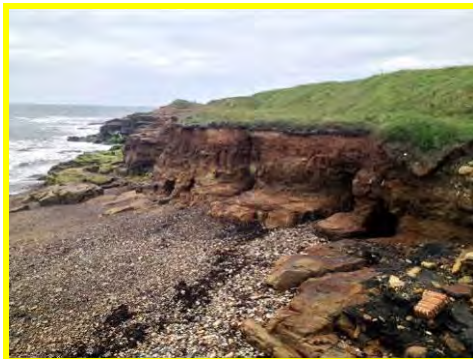
Ongoing erosion in thin layer of overlying soft material at Beacon Point (/3501C03).

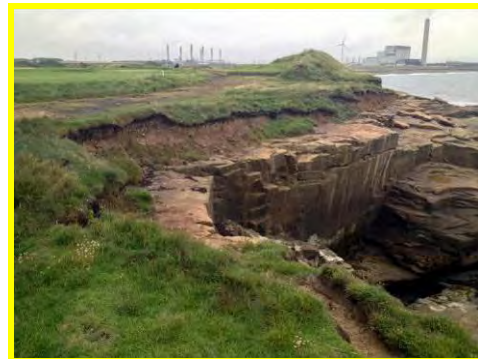
Upper cliffs fronted by extensive rock ledge slowing rates of erosion (/3501C03).

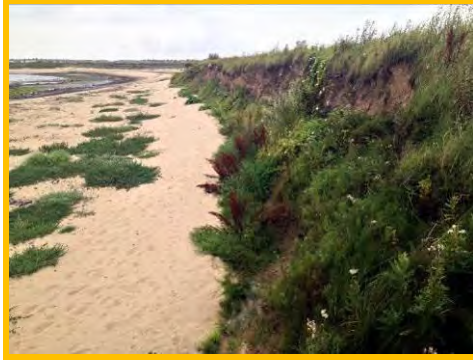
Erosion and slumping of soft upper cliffs at north end of Newbiggin Moor (/3501C04).

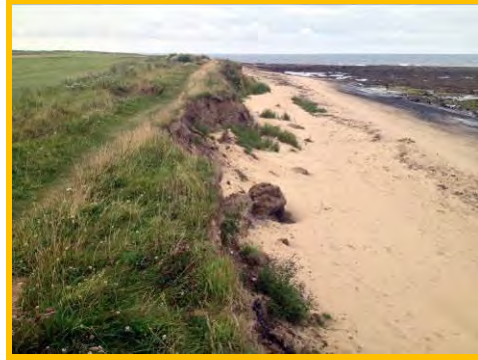
Accretion of beach material providing protection to soft cliffs in centre of bay (/3501C04).

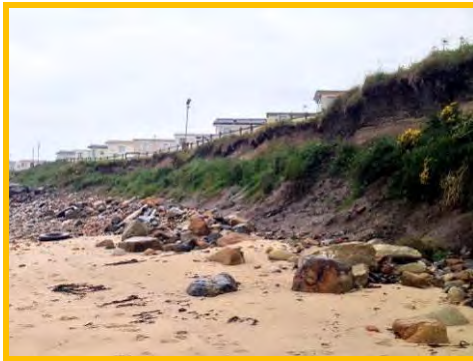
Active erosion in cliffs fronting north end of Newbiggin Caravan Park (/3501C05).

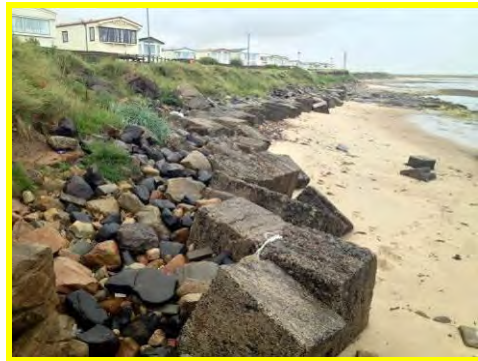
Cliffs fronting central section of caravan park stabilised by anti-tank blocks (/3501C06).

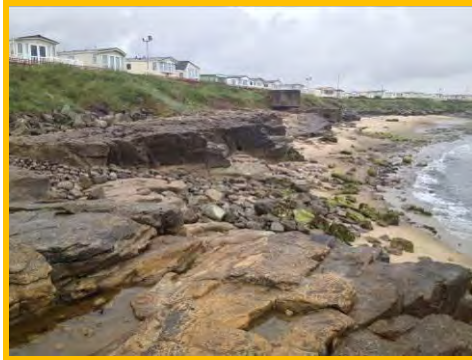
South end of cliffs fronting Newbiggin Caravan Park protected by rock ledge (/3501C07).

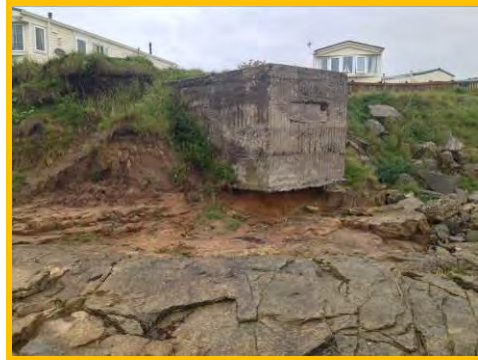
Pill box perched precariously on cliff edge (/3501C07).

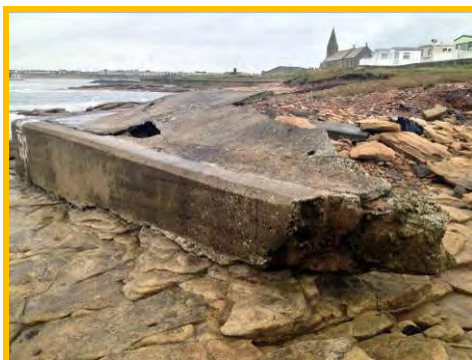
The second length of concrete wall is further south around Newbiggin Point and remains in very poor condition. The tie-in sections are actively breaking however no new damaged was observed. Although the damage at the northern tie-in looks recent, this situation was first noted in 2008. Erosion of the soft earth cliffs behind the structure continues.

Damage to crest slab and undermining of the low wall at Newbiggin Point (3501c09).

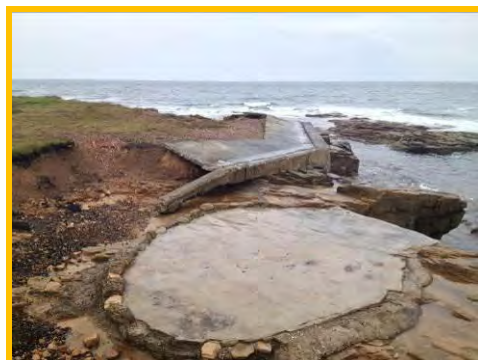
Undermining, outflanking and collapse of south end of low wall (3501c09).

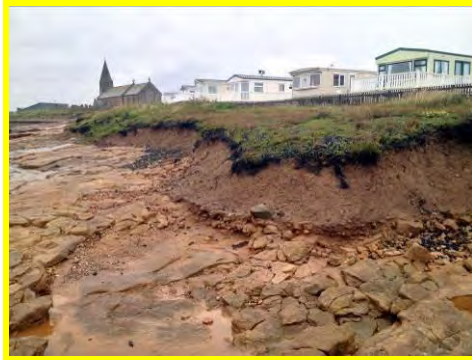
Between Newbiggin Point and the church the cliffs are composed of a continuation of the low irregular rock ledges with overlaying soft material which remains actively slumping locally. The soil netting and gravel used in an attempt to stabilise the low earth cliffs continues to unravel. Where the rock ledge has become locally eroded, short sections concrete and masonry walls have been built to infill crevices in a number of areas. All of these structures are experiencing undermining and toe abrasion, although this is particularly problematic in the five most northerly wall sections.

Slumps in cliffs and unravelling of soil netting west of Newbiggin Point (3601c01).

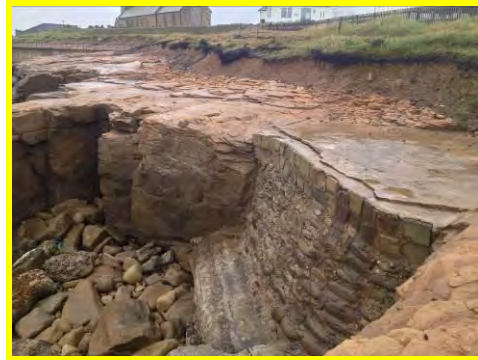
Abrasion and undermining of toe of localised masonry/ concrete walls (3601c01).

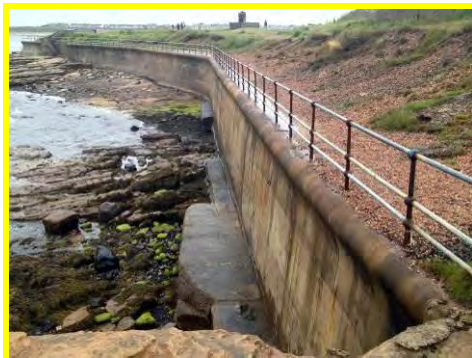
The vertical concrete seawall at Church Point remains in overall fair condition. However, there is a reasonable amount of abrasion at the toe and crest as well as signs of local undermining between the toe and rock slab. There is also erosion of the slope behind the crest and the hand railing is showing signs of corrosion.

Erosion of the vegetated slope behind the crest of the seawall at Church Point (/3601c12).

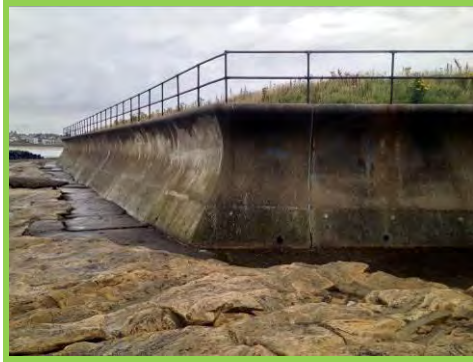
The recurved section of seawall to the west is well founded on the rock foreshore and generally in good condition. Slight undermining of the concrete apron nearer its western end remains although this is unlikely to affect the stability of the structure.

Some minor undermining of the toe apron of the recurved seawall (/3601c13).

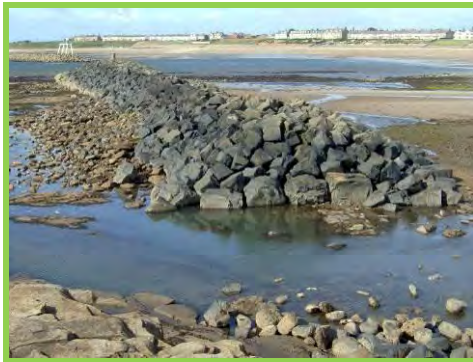
The start of Newbiggin Bay is marked by a rock armour breakwater, built along the edge of Hully Rocks and extending from just off shore of Church Point. This structure is in good condition though there are some smaller rocks displaced across the foreshore on the seaward side. The profile and crest level along the structure appears stable with no signs of displaced rock, toe erosion or settlement. The new offshore breakwater in the centre of the bay was constructed in 2007 and comprises inter-locking concrete armour units. Although this structure could only be inspected from the beach it appears in very good condition with a uniform crest and no signs of displaced units or settlement.

Displaced rocks along seaward side of north breakwater in Newbiggin Bay (/3601c14).

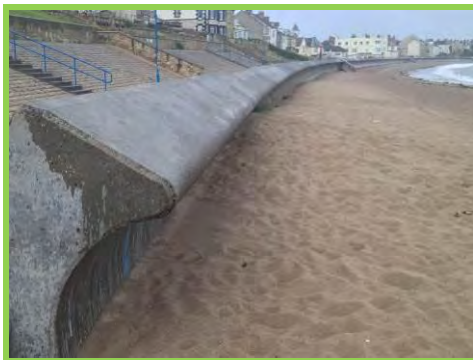
The high recurved seawall and promenade at the centre of the bay are in good condition. High beach levels mean the lower stepped seawall and piled toe which was previously identified as being vulnerable to erosion and undermining was almost completely buried. At the south end of the bay the vertical section of seawall is protected by a rock revetment. This revetment is part of the defences that were in poor condition prior to the 2007 scheme, but is now largely buried by high beach levels. Where visible this rock revetment continues to appear in good condition. High beach levels have also resulted in windblown sand on the promenade.

Increased beach levels largely burying toe apron of Newbiggin seawall (/3601c07).

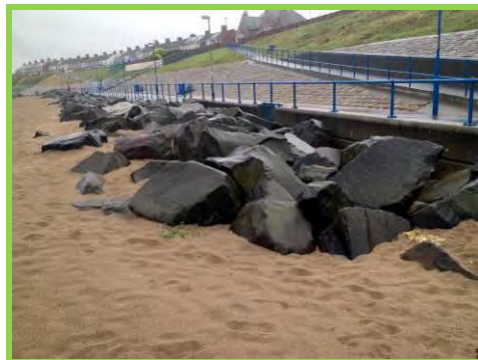
Rock armour largely buried by high beach levels at the south end of the bay (/3601c08).

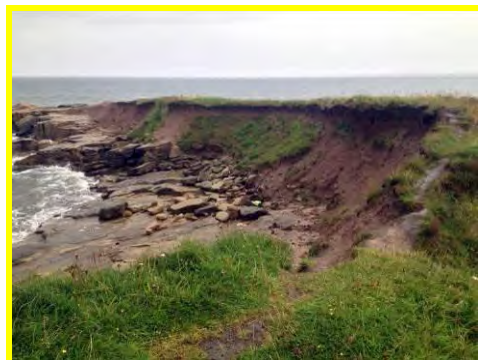
At the south end of Newbiggin Bay the soft earth slopes are largely stable and protected by a wide beach with new vegetation growth evident on the foreshore. However, at Spital Point there is evidence of continued rock falls and slips in the overlying softer material which is noticeably worse since the previous inspection.

Occasional rock falls and slips in the soft upper slopes at Spital Carrs (/3601c10).

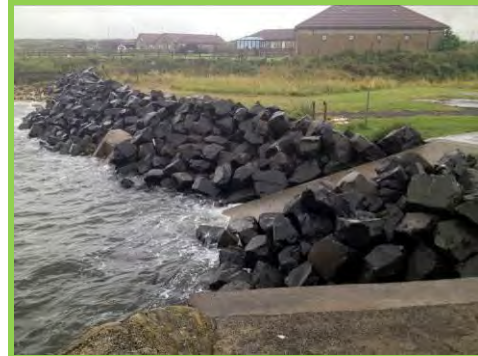
Slipway Slight undermining and outflanking of old concrete outfall at Spital Point (/3601c11).

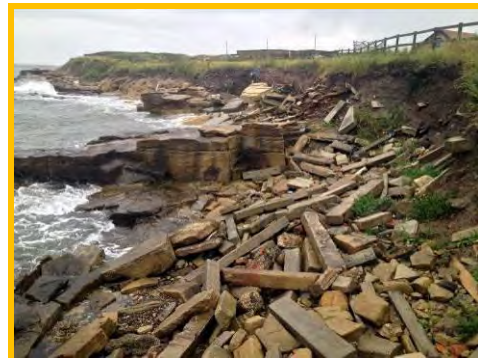
Erosion of soft cliffs continues despite tipping of building/quarry waste (/3701c01).

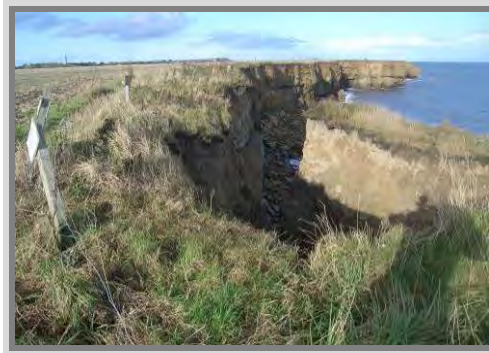
Hawks Cliff is known to typically experience gradual, local erosion caused by slumping in the upper soft material and occasional rock falls in the base. Previous inspections reported that over the severe winter of 2009/10 the whole length had been active. A number of local rock falls, fractures, overhangs, slump in some of the overburdening till and a noticeable section of partially collapse cliff was evident. The footpath along this section of cliffs has been closed in the interest of public safety due to severe erosion.

Partially collapsed cliff and closed footpath at Hawk Cliffs. In 2012.

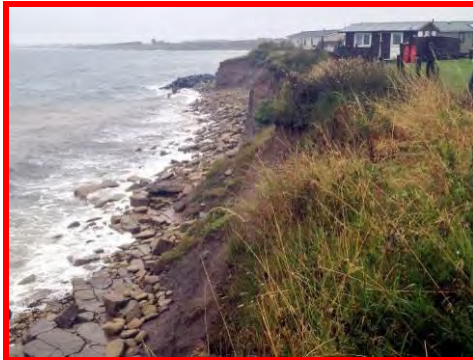
The cliffs directly fronting Sandy Bay Caravan Park are in very poor condition. Active erosion continues along the entire length resulting in recession of the cliff top to within a few meters of the caravans. Sand has accumulated in the lee of the three near-shore rock breakwaters providing some limited protection to the cliffs behind but erosion continues despite tipping of building rubble.

Active erosion and slumping of cliffs along the Sandy Bay Caravan park (/3701c03).

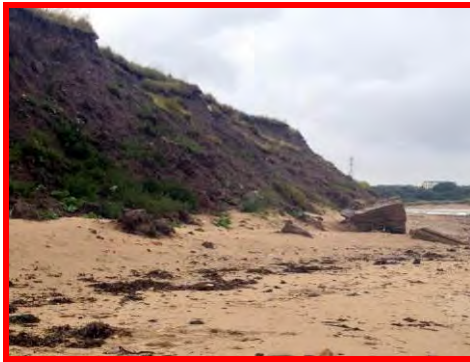
Progressing from the sheltered estuarine frontage with its stable cliffs to the more active open coastline of Cambois Bay there is a transitional section of cliff fronting Cambois House. These cliffs are in poor condition with slips along the entire frontage and more significant erosion and cliffing of the upper slope further south. Erosion appears to have worsened since the previous inspection with up to 5m of recession reported by the Coastal Warden. Breakup of the pill box on the foreshore continues. North of the access ramp the rock armour and some dumped concrete rubble continues to partially stabilising the outflanking problem of the ramp.

Continued slumps along the cliffs and breakup of pill box at Cambois House (/3901c01).

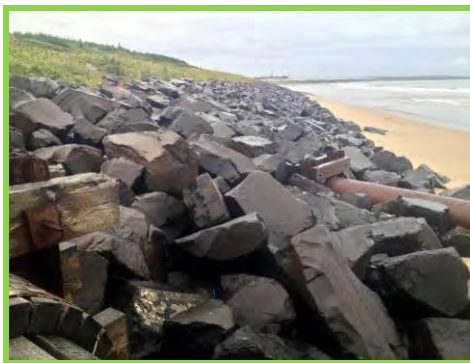
The rock revetment to the south is understood to have been constructed by private industry to protect the former foundry. This structure remains largely in good condition although displacement of some rocks along the toe were noted. The well vegetated slope behind is general stable with no signs of erosion, except one minor area at the north end. At the south end erosion of the cliffs is leading to the onset of outflanking. The disused and damage outfall pipe across the beach at this locations is reported by the Coastal Warden as causing access issues for beach users.

Some displaced rocks along toe of revetment fronting site of old foundry (/3901c05).

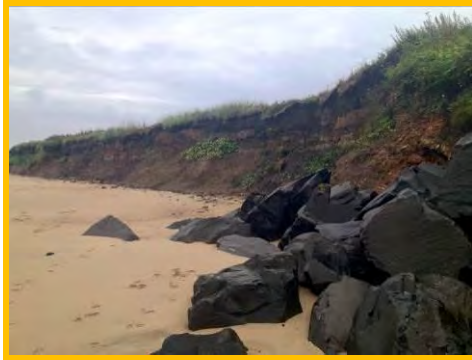
The low earth cliffs to the south of the revetment are experiencing erosion and slumping along most of their length. Up to 4m of erosion was reported by the Coastal Warden. In particular, immediately south of the revetment erosion and cliffing is leading to the onset of outflanking of the structure. However this does not appear to have significantly worsened since the previous inspection. A new timber stairs structure was constructed in 2012 adjacent to the southern car park providing access to the beach.

Erosion of earth cliffs and outflanking of revetment at south end (/3901c03).

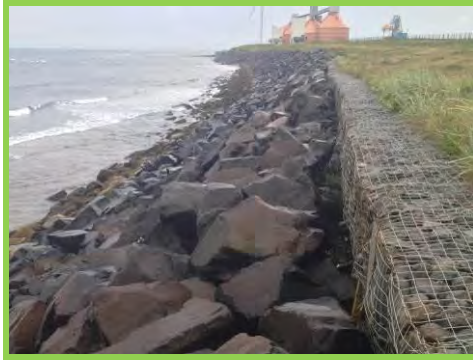
The North Blyth frontage is protected entirely by man-made defences. At the northern end, this comprise a substantial rock revetment with rock-filled gabions along the crest. Despite some displaced stones along the toe and areas of slight settlement of the profile, this structure remains in good condition. At the north end of this revetment there has been cut-back erosion in the soft cliffs. Efforts appear to have been made to address this by tipping smaller rock armour which has provided some protection to the structure but moved the erosion to the north.

Some displacement of rocks at the toe of the revetment at North Blyth (/4001c01).

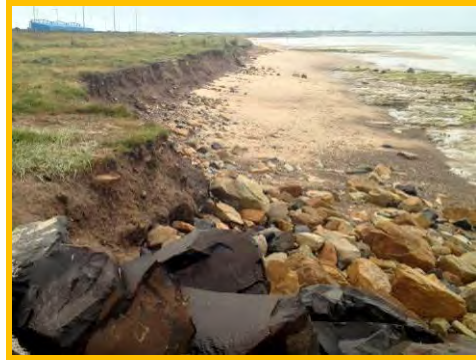
Erosion and outflanking at the north end and placement of smaller armour rocks (/4001c01).

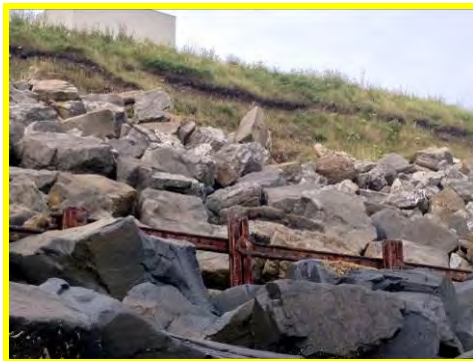
To the south, the revetment changes to a composite structure with large rock armourstone at the base separated from the smaller upper armourstone by steel breastwork. This breastwork is largely in a poor condition with extensive corrosion and numerous failed members. Some erosion and slumps are apparent in the cliffs behind the revetment crest with dumped construction waste and smaller tipped rocks at the crest in an attempt to protect these sections.

Corrosion and failed steelwork and slumps in upper earth slopes (/4001c02).

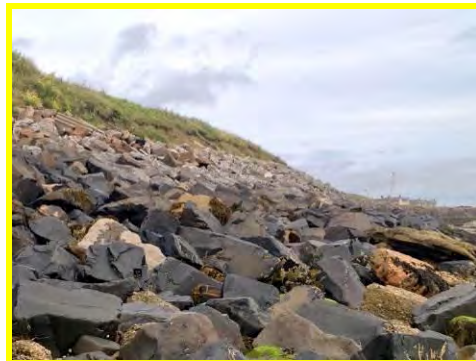
Dumped construction waste and smaller tipped rocks along crest (/4001c02).

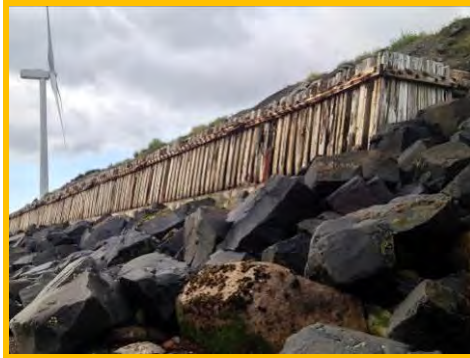
Fronting the Alcan aluminium processing plant is another composite structure comprising timber breastwork with an upper slope of tipped rubble. This sits on a concrete apron with rock armour at the toe. The structure remains in a poor condition with considerable damage to the timber breastwork, including broken vertical timber boards and rotten horizontal wailings. There is significant erosion to the upper slopes exposing the timber tie-backs with ongoing construction waste being dumped in an attempt to control this. Whereas no movement or undermining was observed there is a risk that without further maintenance the breastwork may fail resulting in partial collapse of the access roadway above. An obsolete outfall structure was noted on the foreshore.

Broken and missing timber boards and rotten wailing beam to breastwork (/4001c03)

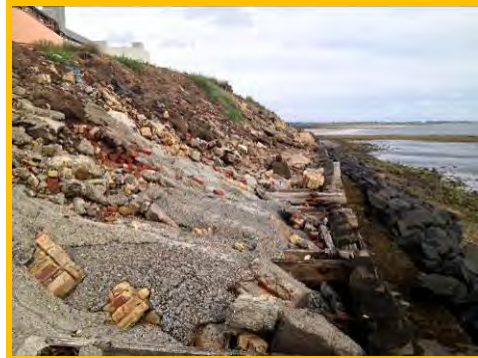
Erosion of slopes behind timber breastwork and dumped construction waste (/4001c03).

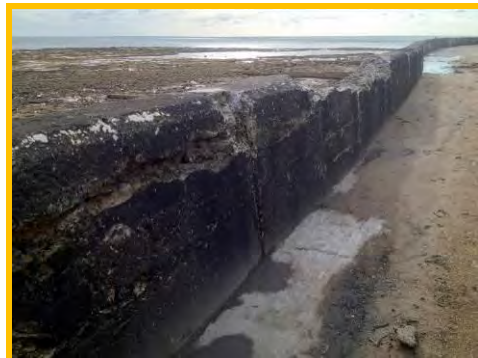
Significant horizontal cracking and spalling of crest wall (/4001c04).

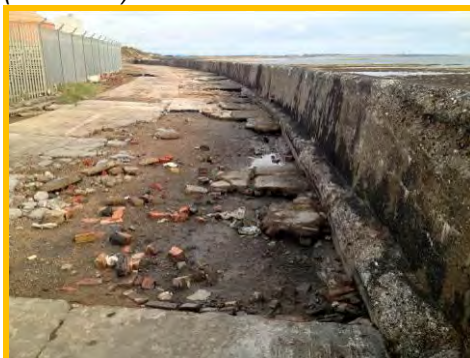
Breakup of concrete deck behind crest wall (/4001c04).

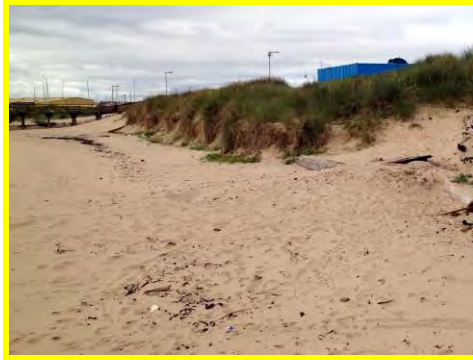
the Royal Northumberland Yacht Club and Port of Blyth. Beach levels at the spending beach area between the West Pier and the South Pier remain healthy with the strand line 10m from the toe of the dunes. The dunes are well vegetated and stable with some historic erosion and cliffing but no recent activity evident. The masonry boundary wall is generally in fair condition with some vertical cracking in the brickwork and occasional loss of mortar at joints in the concrete coping. A slightly seaward rotation in the wall was noted at the south end. Although no recent signs of movement were apparent, this should continue to be monitored for further change.

Historic erosion and cliffing to face of dune at spending beach but no recent activity (/4201c10).

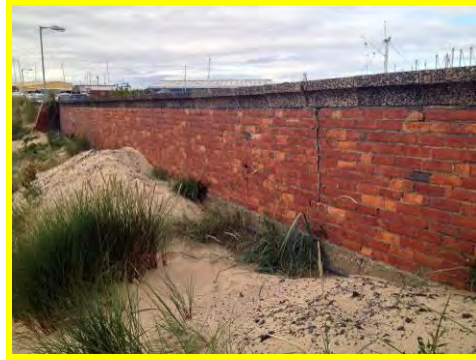
Some vertical cracking in the brickwork and loss of mortar at the coping (/4201c10).

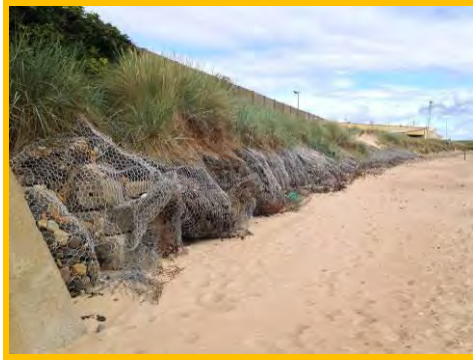
Along the southern-most section of the port boundary wall, the dunes are protected along the seaward face and toe by cobble-filled gabions. These continue to deteriorate at both ends of this length with broken gabions spilling cobbles onto the foreshore. At the north end, the gabions have been outflanked and erosion of the dune has started to expose the foundations of the concrete wall. Replacement of broken gabions in conjunction with consideration of management options for the undefended dunes further north therefore remains urgent to prevent loss of the dune and collapse of this wall.

Deformed and burst gabions along the toe of the dunes at north end of South Beach (/4201c03).

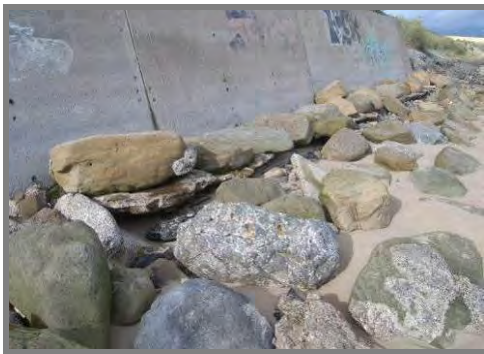
Low beach levels and undermining of toe of seawall in 2012.

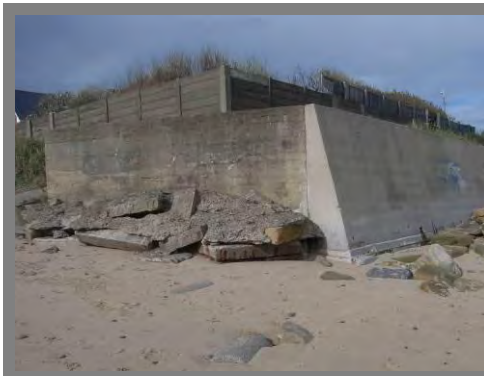
Post and plank crest wall observed in 2012.

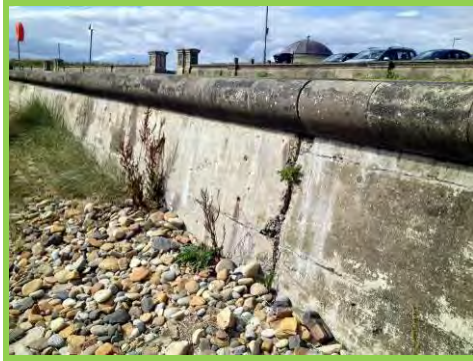
Minor cracks and spalling in the seawall to the south of the access ramp (/4201c05).

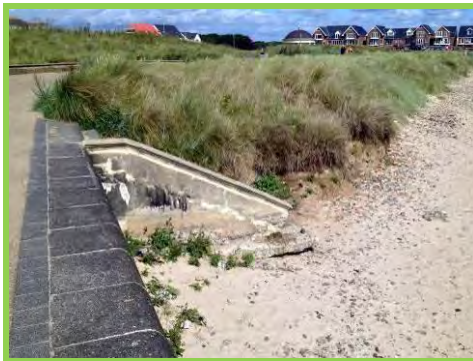
High beach levels burying the bottom of the steps south of the dunes (/4201c06).

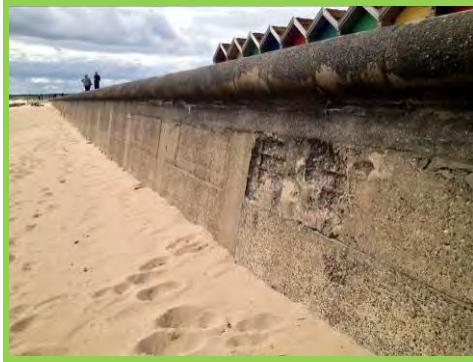
Areas of abrasion and exposed rebar on seawall adjacent to Links Road carpark (/4201c07).

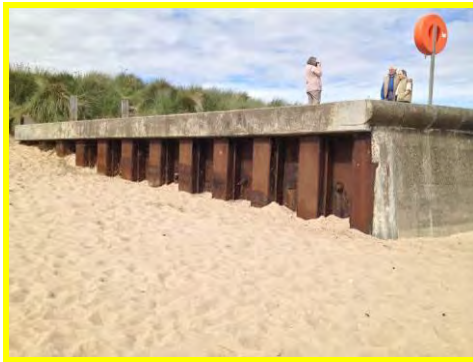
High beach levels in front of sheet pile return wall (/4201c08).

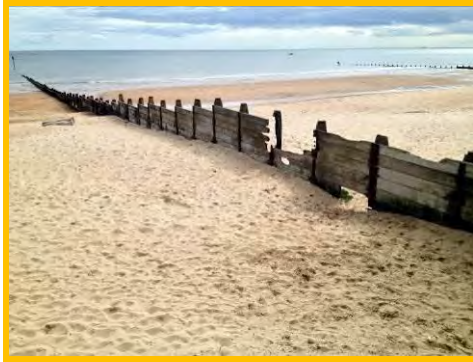
Gaps between groyne planks, arson damage and low beach levels (/4301c01).

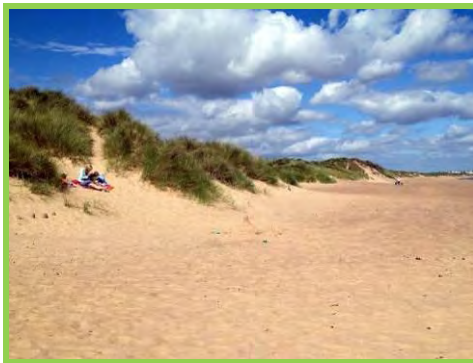
New vegetation growth at toe of dunes at the south end of the bay (/4301c02).

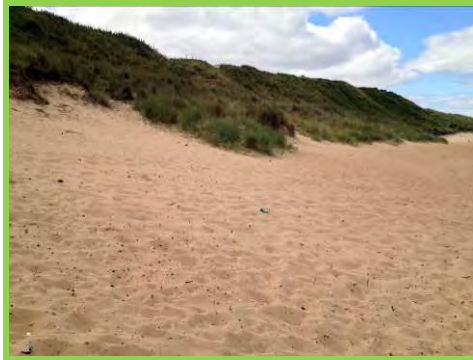
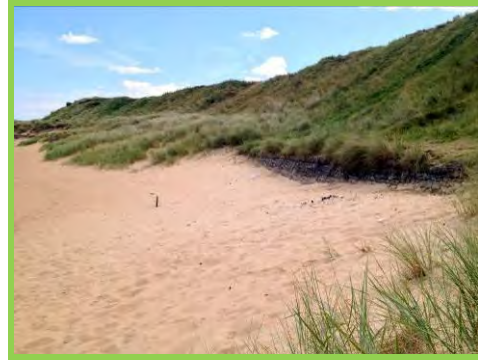
High beach levels and vegetation burying masonry wall north of harbour (/4401c01).

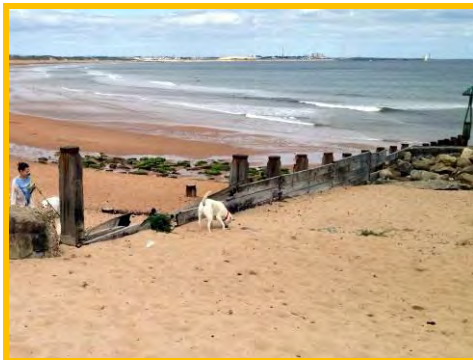
Missing planks and damage to timber groyne at mouth of Seaton Burn (/4402c02).

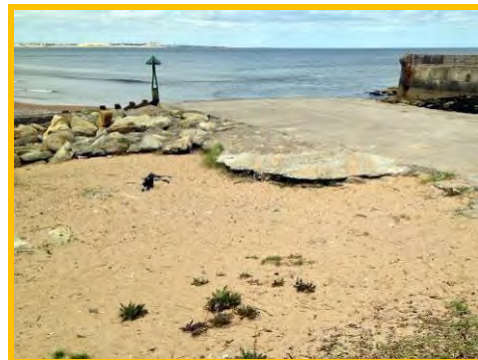
Undermining of concrete deck adjacent to groyne (/4402c02).

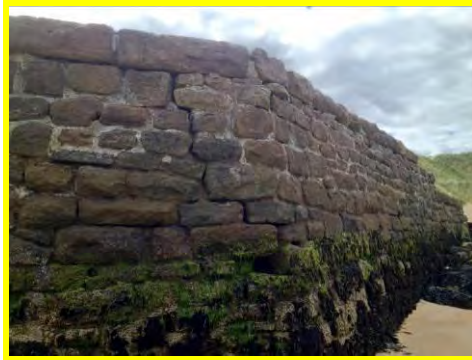
Vertical crack and missing block at seaward end of east harbour wall (/4401c03).

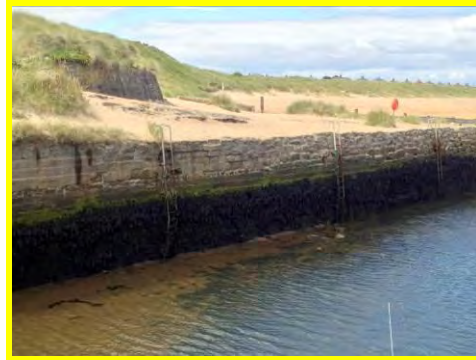
Accumulation of sand along crest of masonry wall on west side of entrance (/4401c04).

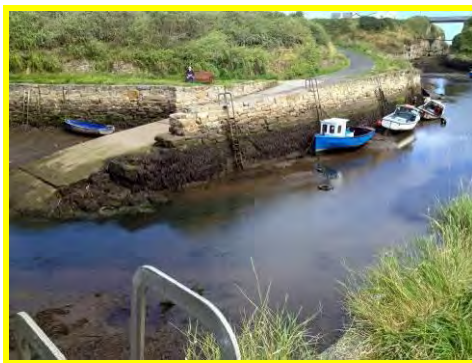
Some missing blocks and rotation of outer wall of slipway (/4401c05).

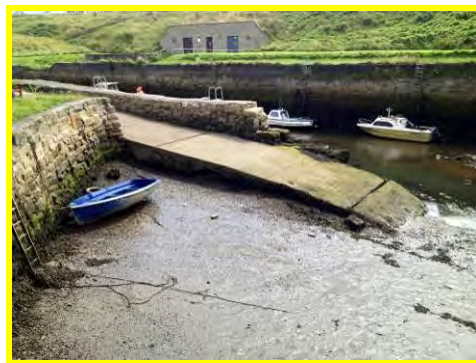
Full width cracks at top and bottom of slipway ramp (/4401c05).

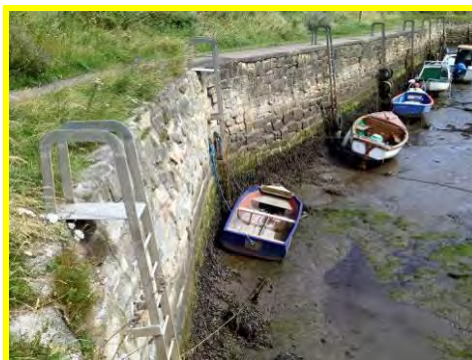
Some small gaps between blocks in wall along the inner north bank (/4401c05).

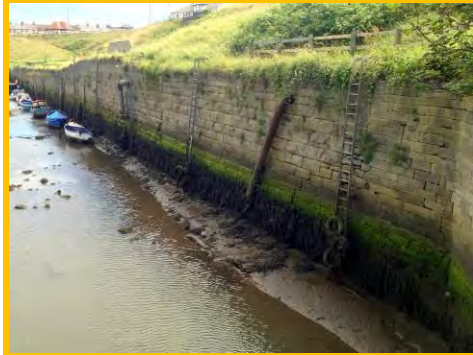
Gaps between blocks at west end of south bank quay wall (/4401c06).

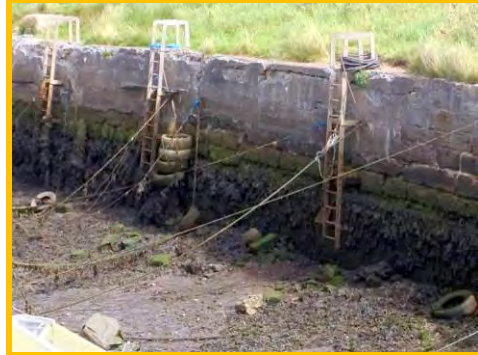
Coping at east end of wall cracked and highly abraded with large gaps and some missing blocks at the toe (/4401c06).

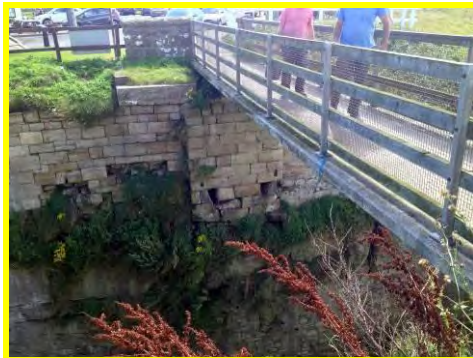
Gaps and missing blocks in the masonry wall along the man-made channel (/4401c07).

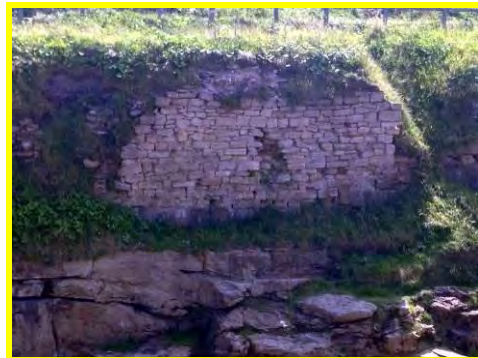
Gaps and missing blocks at the east end of the wall (/401c07).

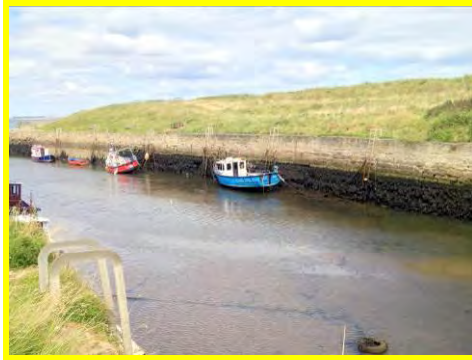
Missing mortar and gaps between blocks along eastern harbour quay wall (/4401c08).

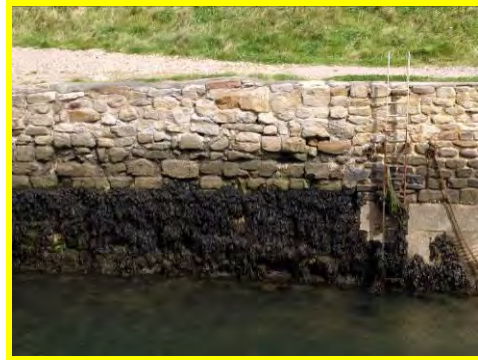
Settlement, abrasion and missing mortar in masonry quay wall (/4401c08).

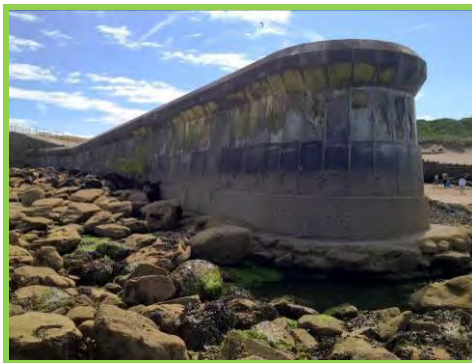
Undermining of toe at seaward end of pier (/4401c10).

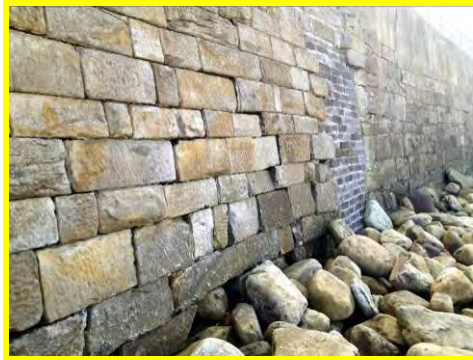
Cracks in upper section of masonry seawall on Rocky Island (/4401c11).

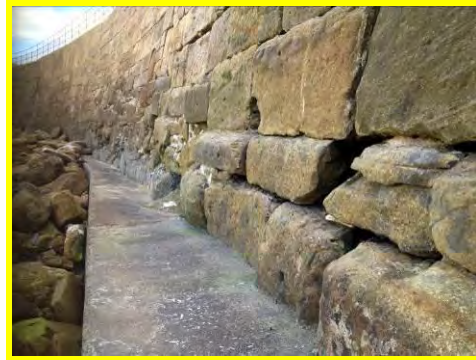
Gaps and some larger holes between blocks in masonry seawall (/4401c11).

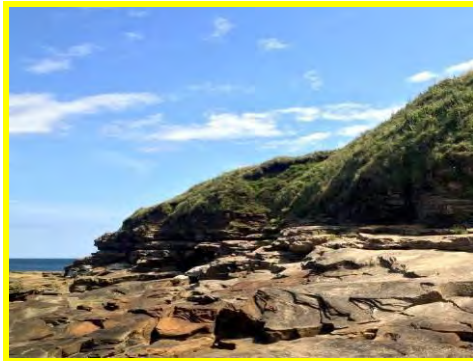
Occasional overhangs and local rock falls on the north edge of Rocky Island (/4401c12).

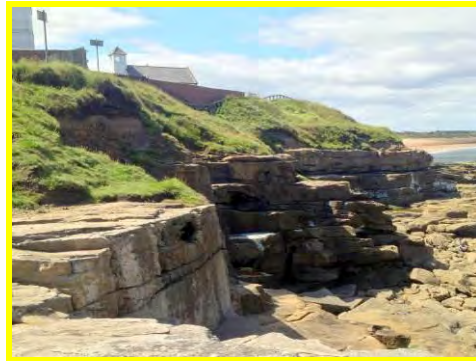
Slumps in the upper soft material cutting back to the footpath (/4401c12).

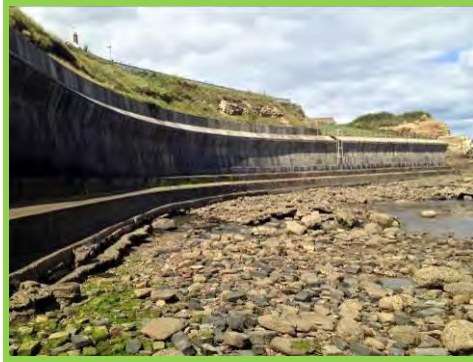
Slips in soft cliffs above seawall and material falling onto foreshore (/4401c14).

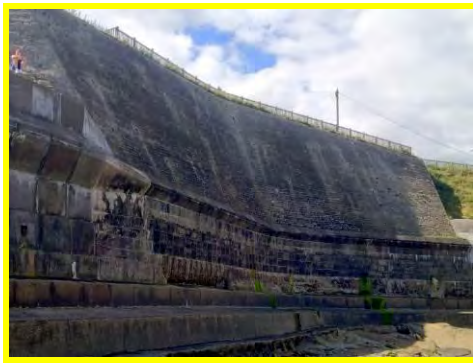
Loss of mortar on the recurve along most of the wall (/4401c15).

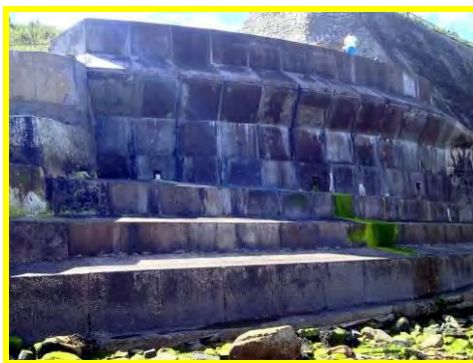
The wall further south remains in good overall structural condition. The toe should continue to be monitored for any signs of undermining that could lead to failure. As with the seawall to the north, all weep holes are missing their flaps along with staining and calcium deposits blocking the most southerly weep hole.

Missing flap valves and calcium deposits blocking southerly weep hole (/4401c16).

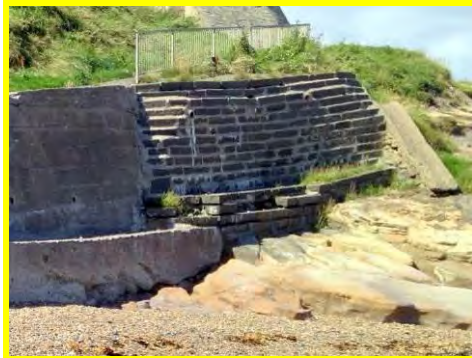
Immediately south of this wall, there a short brickwork/ concrete wall end supporting the access ramp. The brick section of wall is generally in a fair condition although

there are several missing bricks along the base. The concrete section has a large horizontal crack along the base and appears to have rotated seaward slightly. The toe of the ramp is abraded.

Missing bricks along toe of wall supporting access ramp (/4401c17).

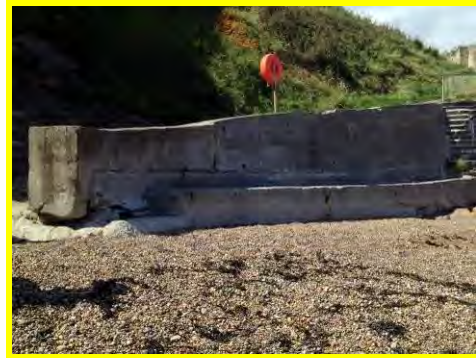
Large horizontal crack at base of wall and undercutting at south end (/4401c17).

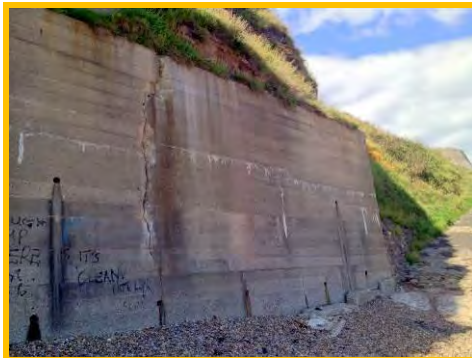
The high vertical concrete sea wall at the centre of Collywell Bay is generally in fair condition. Maintenance work to fill three notable vertical cracks is still required however, no movement was apparent at these locations and they don't appear to have worsened since the previous inspection. The toe apron and access steps remain highly abraded and cracked in places. Above the structure, fencing along the access path appears to have moved suggesting that there may be slippage in the steep vegetated slopes above. However no significant change was apparent since the previous inspection.

Notable vertical crack in high seawall at centre of the bay (/4401c17).

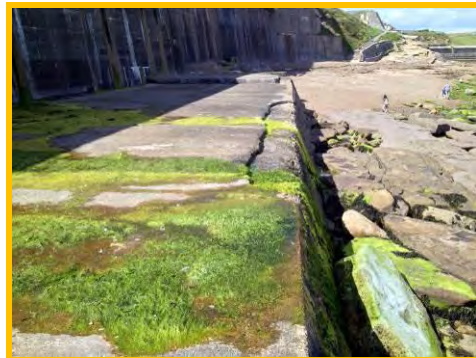
Significant abrasion at the toe and horizontal cracks (/4401c17).

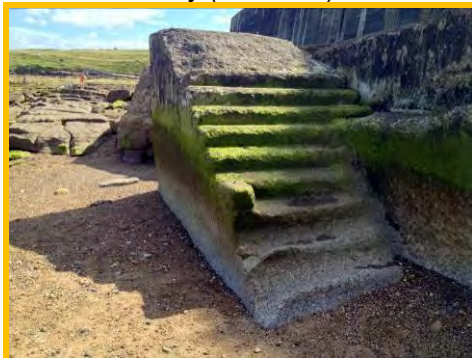
Significant abrasion of access steps from foreshore.

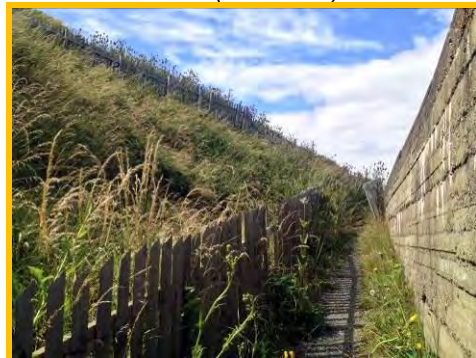
Movement in fencing along the access path above the high seawall.

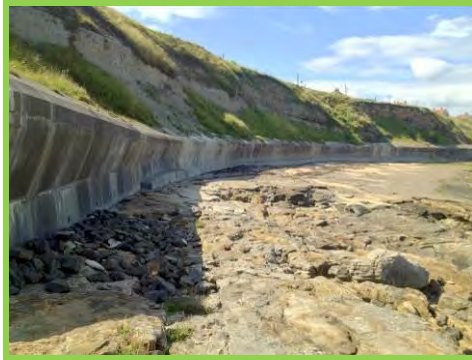
apparent but have not worsened. Above the wall slips in the vegetated earth slopes remain apparent but only appear partially active with no material visible on the foreshore. The escape ladder at the centre of the wall is completely missing.

Slips in upper earth slopes and material on the foreshore at the south end of the bay (/4401c18).

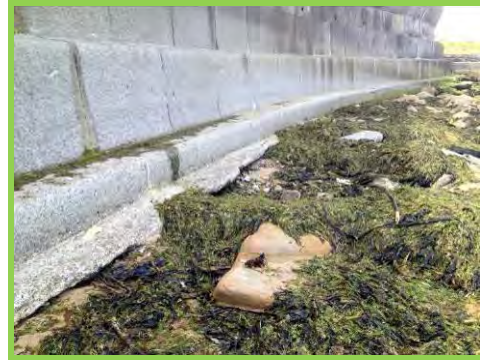
The concrete seawall at the south end of Collywell Bay is generally in good condition. Beach levels rise towards the south end. At the north end a cobble toe berm is visible along with abrasion and onset of undermining of the toe. Minor cracks and gaps at construction joints identified during the 2010 inspection were still

Initial undermining of toe at north end of wall (/4401c08).

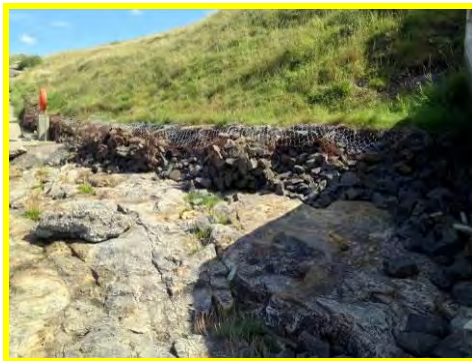
At the south end of Collywell Bay gabions protect the toe of the coastal slope above the beach access ramp. These gabions are in poor condition and continue to degrade, spilling rocks across the foreshore. The access ramp itself has some undermining where it joins the rocky shore platform, although this has not worsened since the previous inspection. There is also some undermining and onset of outflanking where the ramp joins the undefended cliffs at its other end.

Gabion baskets at the bottom of the access ramp continue to degrade (/4401c19).

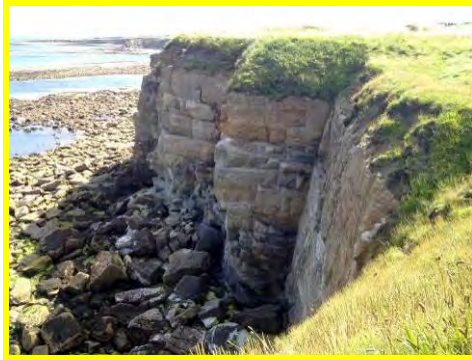
The harder rock cliffs extending from Crag Point to the southern boundary of Northumberland County Council part-way along Hartley Cove have some fracturing to the rock structure. As a result of this fracturing, several rock falls have occurred leaving numerous overhangs and in places caves have formed at the base of the cliffs. However, no change was evident since the previous inspection. A wide crack was also noticed a few meters from the cliff edge close to the fence line although this does not appear to be recent. The footpath runs very close to the cliff edge in this area and so may need realignment if slips/ rock falls continue.

Several historic rock falls evident in high rock cliffs at Crag Point (/4401c21).

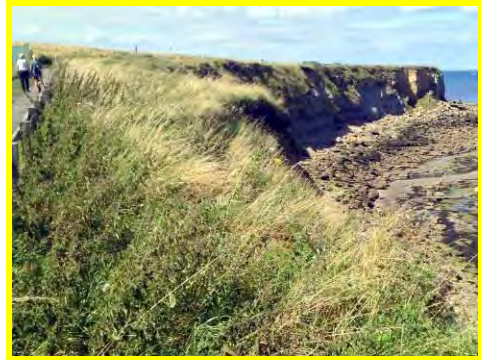
Several historic rock falls evident in high rock cliffs at Crag Point (/4401c21).
