Cell 1 Regional Coastal Monitoring Programme Walkover Inspection Surveys 2016

Northumberland County Council

Walkover Inspection Surveys 2016

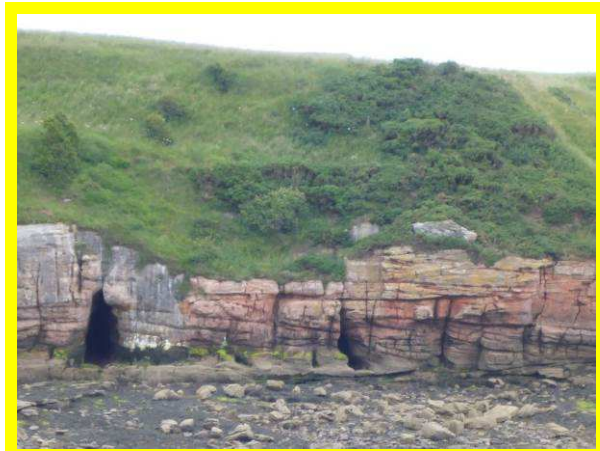
Between Burgess' Cove and Shapers' Head the hard rock base is highly fissured and areas of partial slumping have occurred in the overlying softer cliff material, cutting the cliff top back to the fence line in some locations. There is a concrete pavilion and access steps located at the centre of the bay which are in generally in fair/poor condition with signs of abrasion around the waterline.

Fissures and caves along base of cliffs at Dodd's Well (/0701C02)

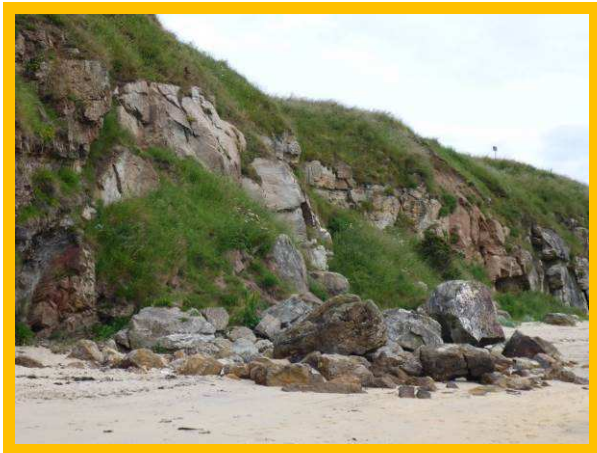
The cliffs around Green's Haven show fairly frequent activity in terms of slippages and there have also been occasional rock falls. Signs are erected warning holiday makers at the caravan park of unstable cliffs. One slippage, just to the north of the southern access steps, has left a length of fencing suspended in mid-air, whilst the backing land has been fenced off to ensure that visitors stay well away from the cliff edge.

Rock fall in cliffs at Green's Haven (/0701C05)

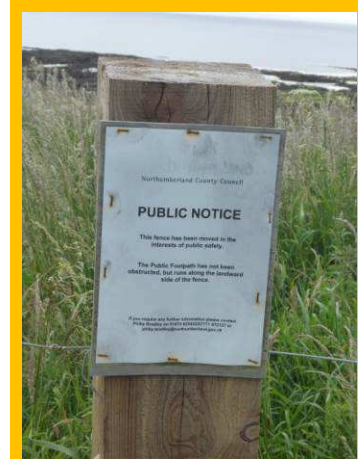
Relocation of fencing and footpath due to slumping cliffs along Magdalene Fields (/0701C12)

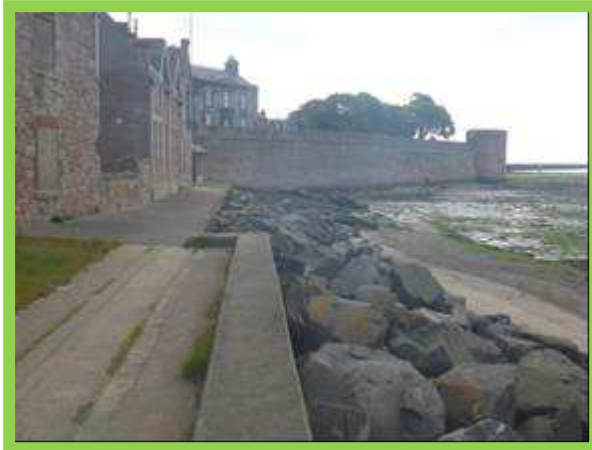
The short sections of masonry seawall (with concrete deck) fronting the properties at Gardo's Battery are in fair condition and where fronted by a rock revetment this remains in good condition with armour well packed. The timber slipway at this location is obsolete.

Rock revetment in good overall condition (/0801C04)

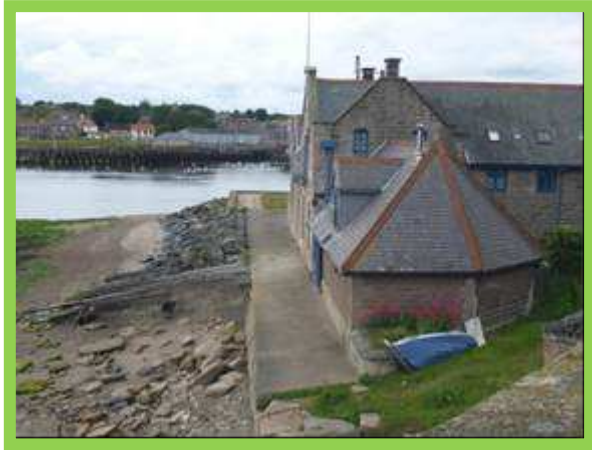
Rock revetment in good overall condition with wall in fair overall condition (/0801C05 & C04)

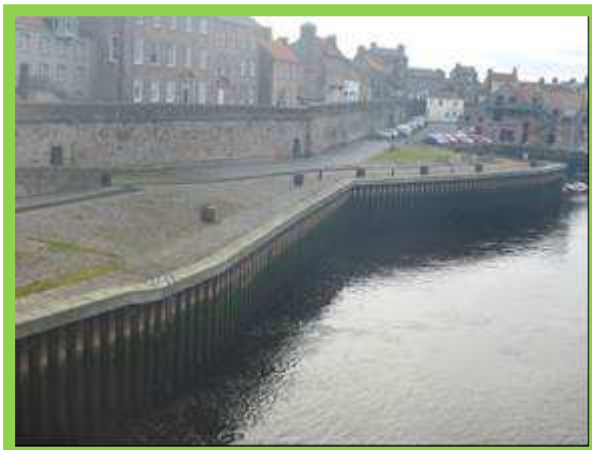
The Berwick quayside consist mostly of sheet piled walls, with a short masonry wall extending around the dock area. The steel piles, concrete capping beam, ladders and timber fenders are all in good condition. The masonry wall in the small dock is in fair condition with some blocks broken and abraded and a number of open joints evident that would benefit from re-pointing. There is one crack to the coping near The Chandlery.

Steel sheet piled quay walls in good overall condition (/0801C03)

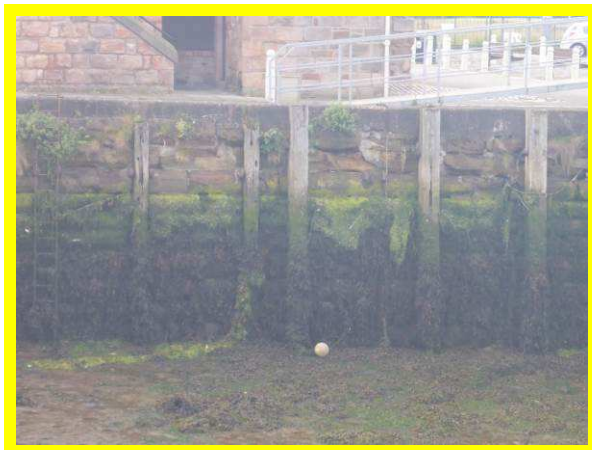
Masonry quay walls in dock area in fair overall condition with some open joints, cracks and abrasion (/0801C03)

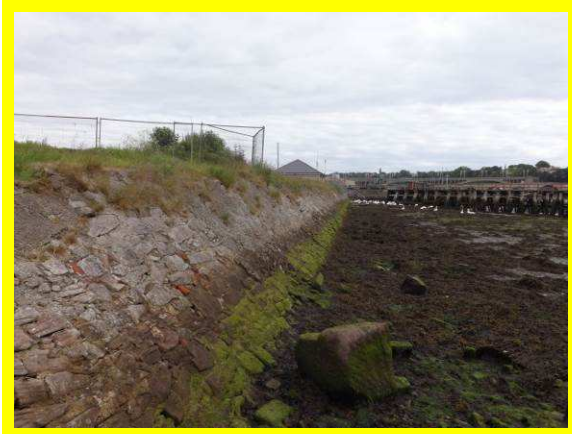
Defence length 121AA901A0901/ C04 runs from the southern jetty at the entrance of the Berwick Dock through to the area of the Pier and IRB Station at Carr Rock. The defence comprises two sections, the first being a masonry revetment protecting land formerly occupied by sheds (removed between 2006 and 2008). This section has undergone previous repairs and is generally in fair condition. The main section of defence, protecting the open grass area in front of Dock Road, comprises gabion (Reno-mattress) defence. This defence appears to have undergone stages of major repairs. Much of the exposed original square mess baskets have failed along the toe. It appears that a new upper layer of mattress was constructed by 2006. This was reported as in poor condition in 2014 (and previously in 2012, 2008 and 2006) and continues to deteriorate. In particular there is undermining at the upstream end and continuing loss of integrity around the small outfall.

Masonry revetment 901c04 at northern end.

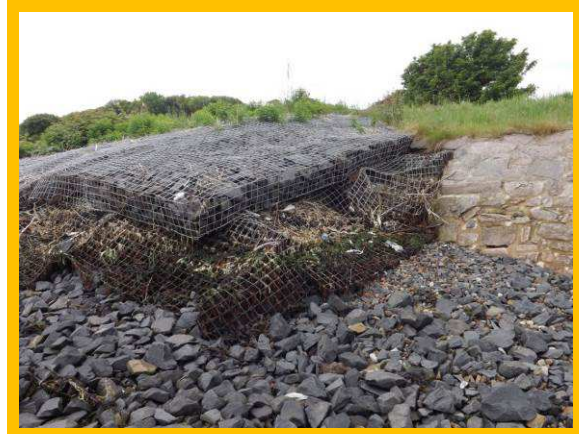
Undermining due to failure of lower baskets at northern end.

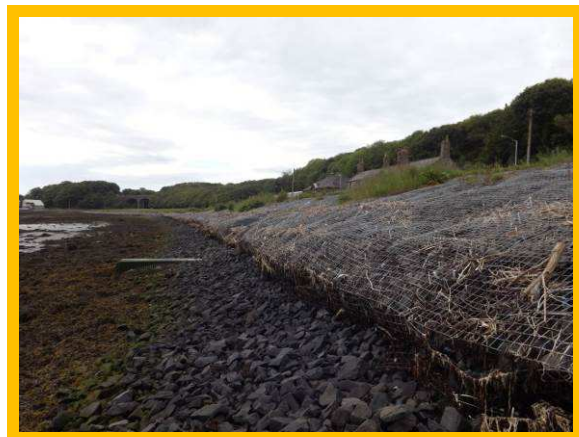
Loss of toe and local damage at outfall 2016, 901c04.

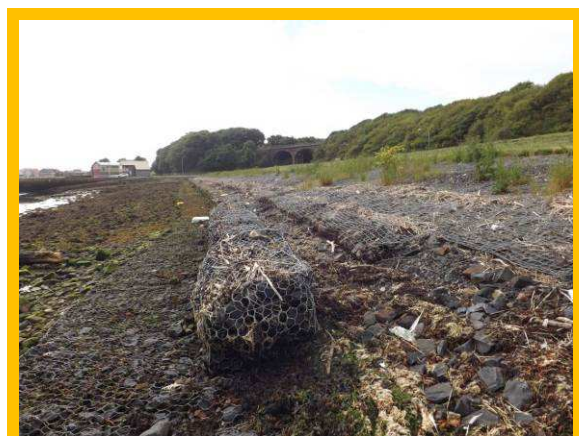
Deterioration due to corrosion of wrapped basket 2016, 901c04.

This defence seems unlikely to suffer catastrophic failure. However, as identified in the SMP2, there is a need to review ongoing management of the area.

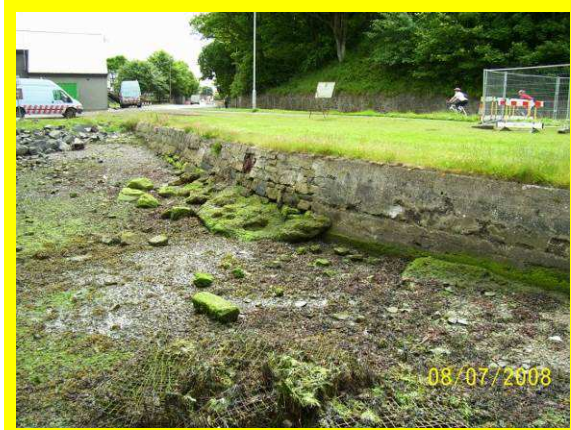
Defence lengths 121AA901A0901/ C05, and C06 comprise a section of masonry / concrete wall linking through to the Spital Pier. Previous reports highlight the main risk being the condition of the masonry and gaps between masonry. These are old structures and can only really be assessed in term of change rather than in terms of immediate condition.

In both cases there has been little change and while both structures show significant gaps and cracking, neither structure appears to have deteriorated further. Part of the upper surface of the pier has been resurfaced with tarmac improving previous concerns over surface deterioration.

901c06 in 2008 showing toe level and condition of masonry.

901c06 in 2016 showing little change compared to 2008.

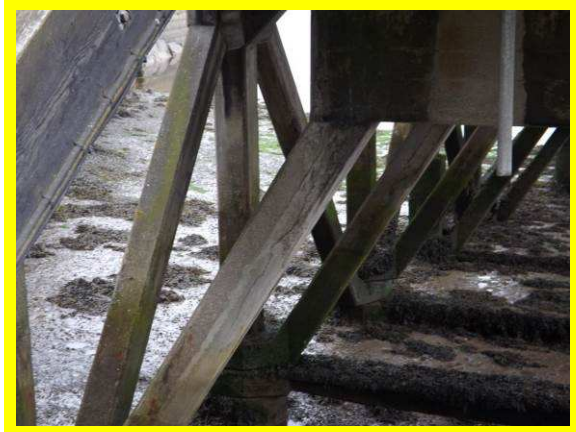
901c07 – evidence of concrete spalling to support structure of RNLI building.

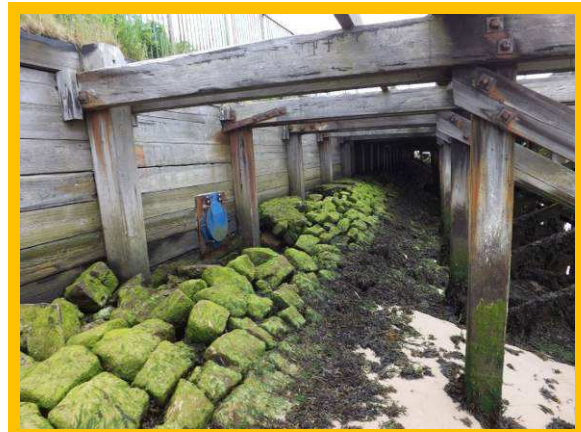
901c07 – further displacement of revetment, associated with maintenance of flap valve.

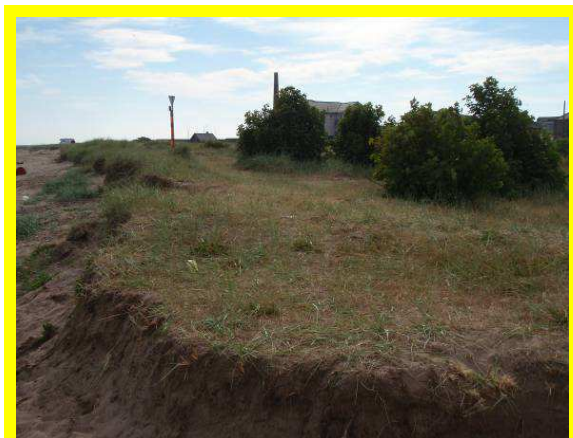
Generally the increase in beach levels continue along the dunes to Sandstell Point, however this clearly changes over the length with erosion towards the centre of the dunes and significant accretion over the northern end. The following images show the variation both by position and over time. These changes are linked to the change in the Sandstell Point bank across the mouth of the estuary and the associated movement of the channel. The SMP recommends that a buffer zone is recognised to allow for change.

901c08 - erosion in 2012.

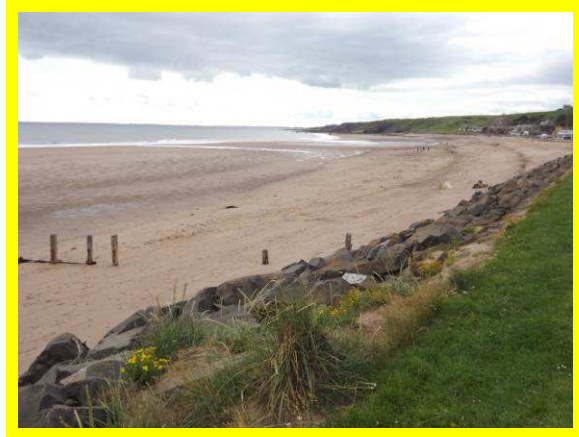
1001 c01 – showing no worsening of erosion at crest but also showing alignment in advance of natural beach shape.

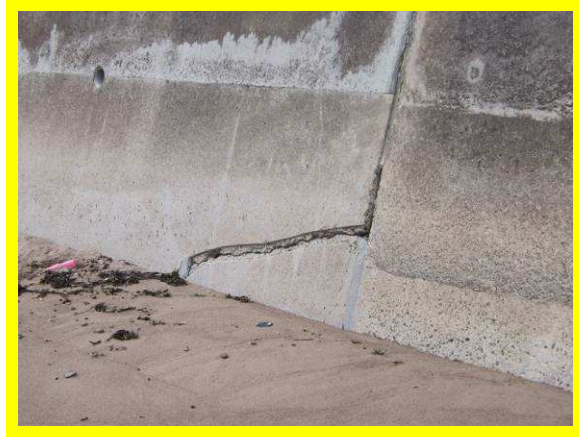
Beach levels to 121AA901A1001/ C03 remain high. The missing paving block in 2014 has not been repaired. The crack or failed repair identified in 2014 remains in the same condition. Further investigation of this shows that this crack was present in 2010 and does not appear to have deteriorated. There is significant loss of joint sealant as previously indicated but overall the defence appears in good condition.

1001 c03 – Crack noted previously 2008 through to 2014.

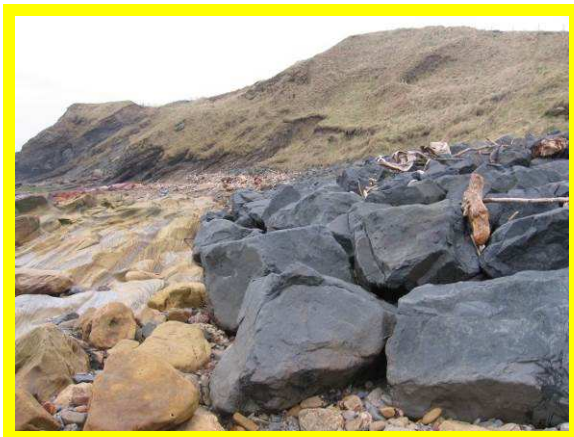
1001 c04/ 05 – low foreshore levels and erosion and slippage of coastal slope in 2006.

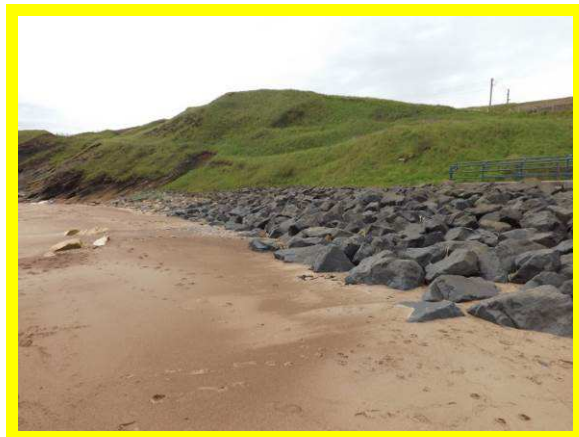
There has been some minor erosion of the lower grassed slope to the south of the frontage but, in comparison with 2006, very little change in the upper slope. The rock revetment at the south of the sea wall remains in good condition.

1001 c04/ 05 – higher beach levels, vegetation to previous coastal slope slippage..

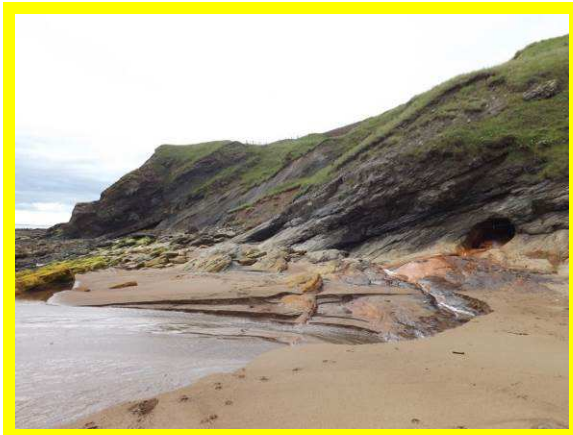
As noted in the previous unit (MU2) there has been some slight erosion of the lower coastal slope just to the south of the Spittal frontage but little change since 2008 effecting the upper crest and upper slope.

General slippage and erosion of lower coastal slope to 1001/ C05

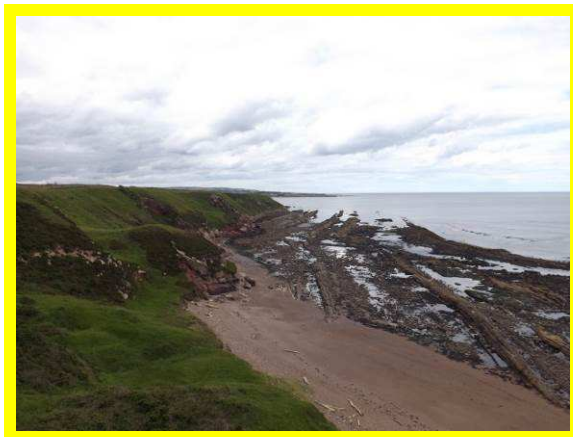
Between Spittal and Sea House farm (Scremerston) the high cliffs continue to exhibit slow erosion but with no assets at risk.

1101/c01 general view of cliffs and beach to north of Sea House.

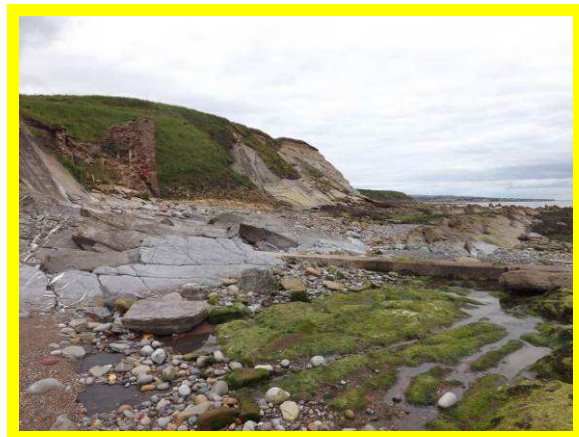
1101/c03 Cliff immediately north of Sea House, showing ruins of masonry structure.

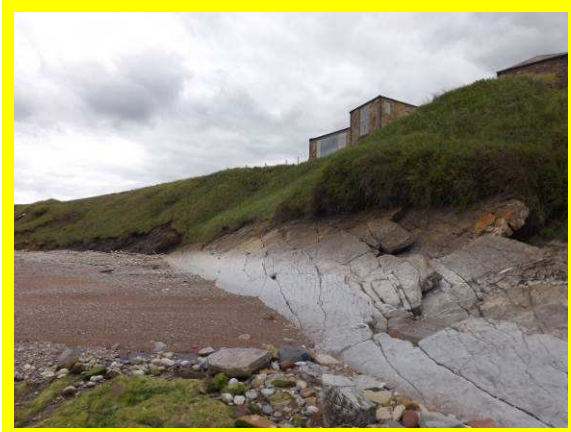
1101/c04 Sea House possibly constructed to rock with erosion of surface cover.

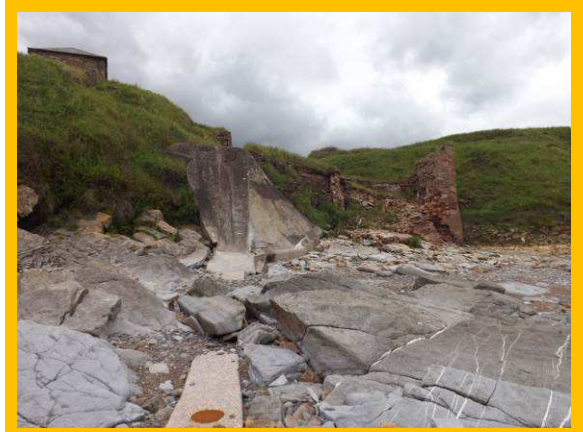
Sea House Farm is possibly founded to the underlying rock rather than being reliant on the eroding vegetated surface cover. However, the adjacent section to the north of the house is protected by a concrete wall, which is cracked at its base and shows evidence of water weeping through the crack. The land owner should be made aware of the risks.

1101/c04 Outfall and concrete slope protection, cracked and weeping water.

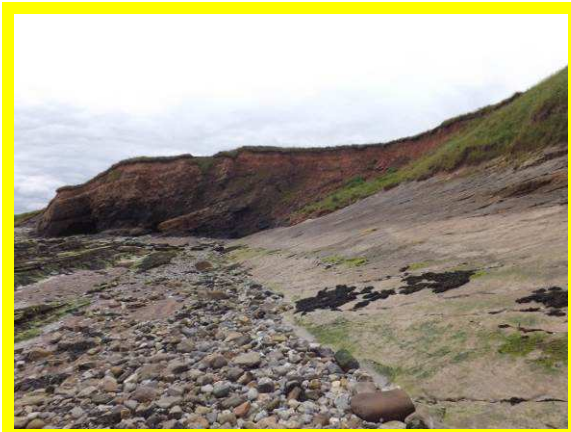
Further south of Sea House Farm, the shoreline reverts to a generally hard rock basal cliff with varying thickness of surface deposits. Some sections continue erode but where the road comes down to the Cocklawburn beach the cliff remain relatively stable.

1101/c05 general view of frontage showing continued erosion in area of old road.

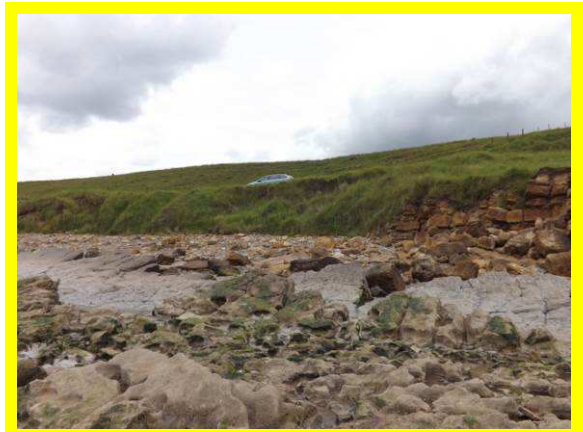
1101/c05 Critical section of frontage closest to road.

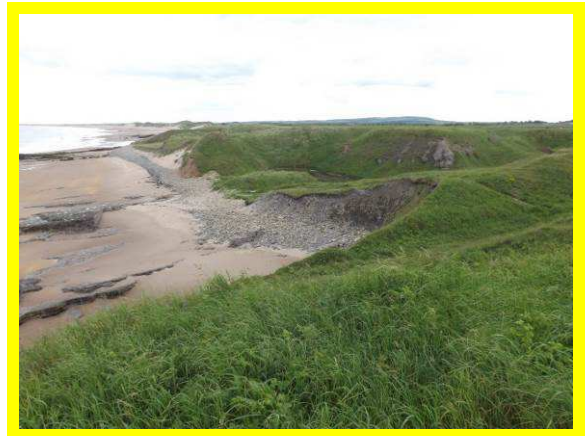
1202/c05 south of Far Sker 2016. Continued erosion but with vegetation to crest.

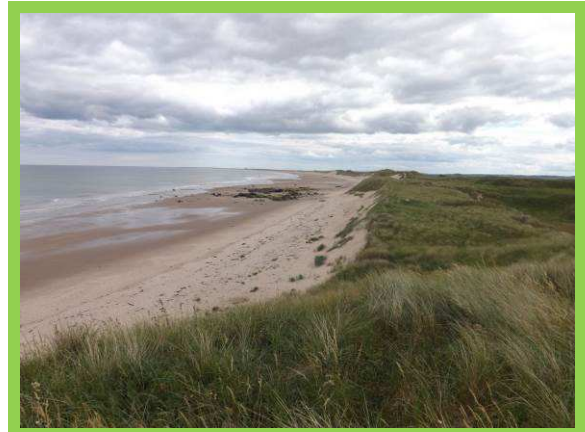
To the northern end of this area the dunes continue erode slowly, cutting back to crest of dune ridge but maintain slope and vegetation.

1201/ C02 – 2016 showing set back of frontage but higher beach levels and accumulation of sand to front face.

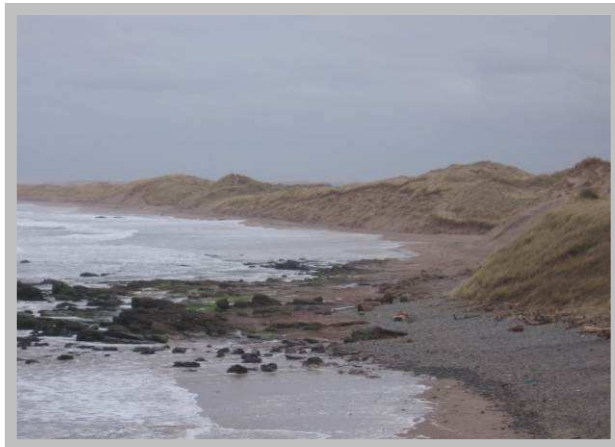
1201/ C02, C03 – 2006 showing recent erosion but dune system further forward than present day

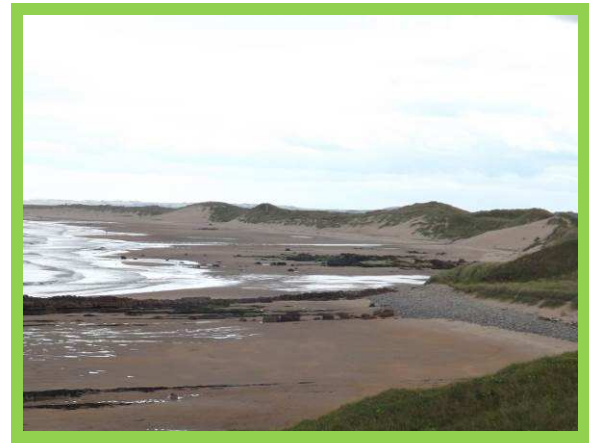
1201/ C02, C03 – 2016 showing set back of frontage but some re-vegetation.

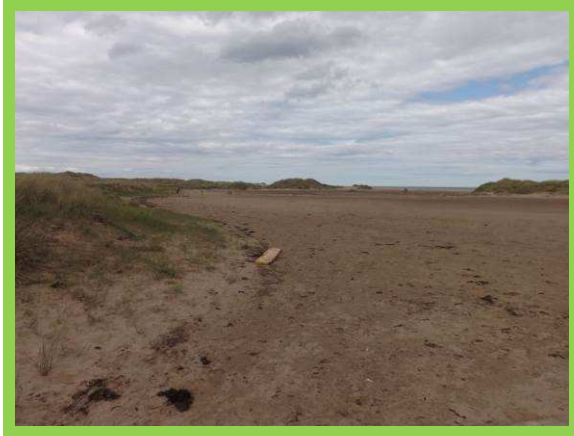
1201/ C03, 1301/C01 – at main golf course access looking north, showing recent continued development of embryo dunes.

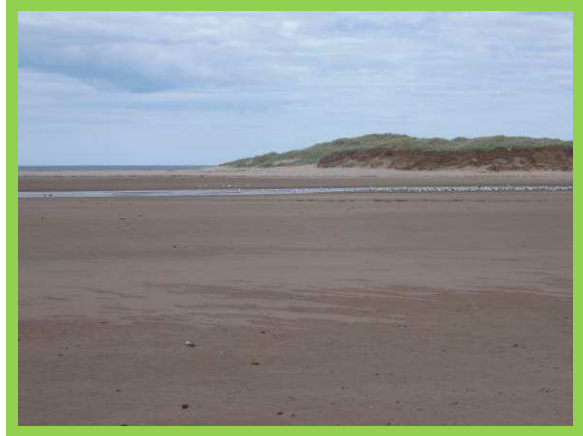
1301/ C01, erosion of “isolated dune island” interaction North Low channel but dune growth beyond.

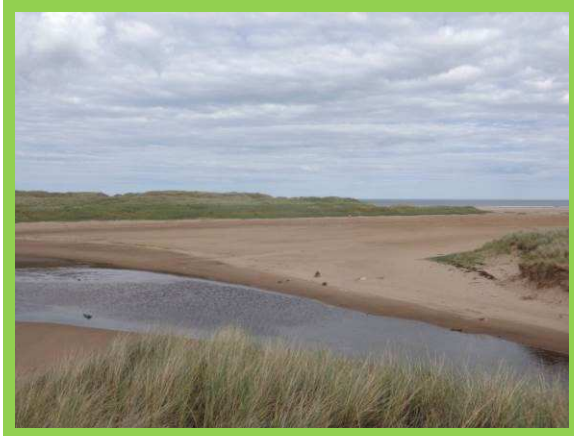
1301/C01 – North Low channel cutting through higher beach and embryo dune “tail” from island.

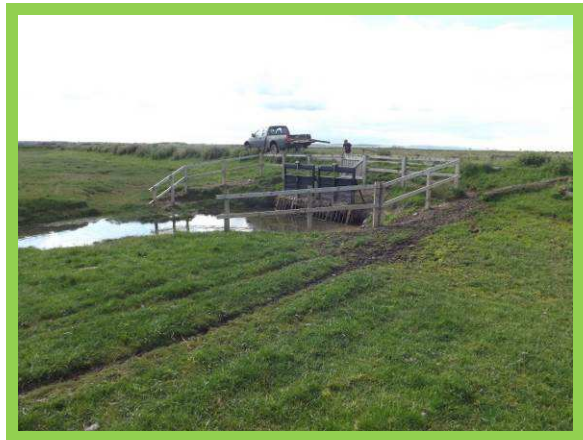
1401/ C31, Sluice to South Low. New fencing installed.

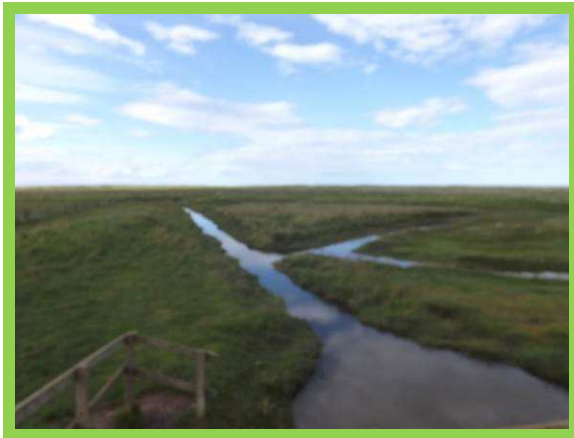
1401/C31 – channel development to South Low.

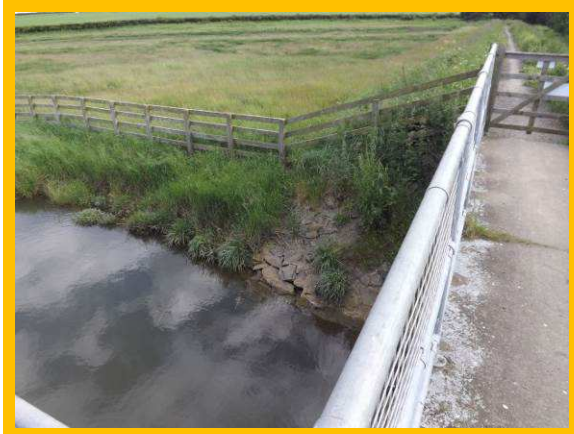
There is minor damage / undercutting to edge bank protection either side of main Beal Sluice.

1401/C01 – undermining of edge protection.

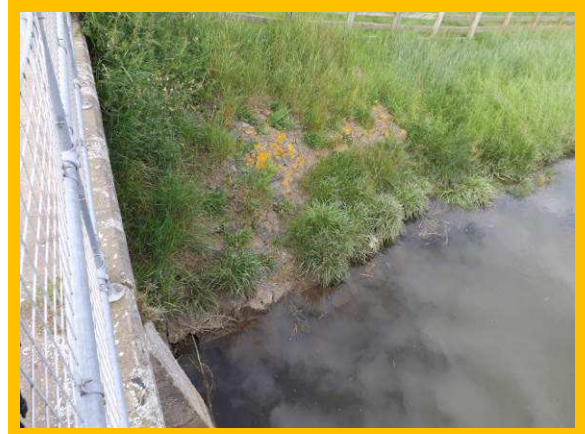
1401/ C01, undermining of edge protection. .

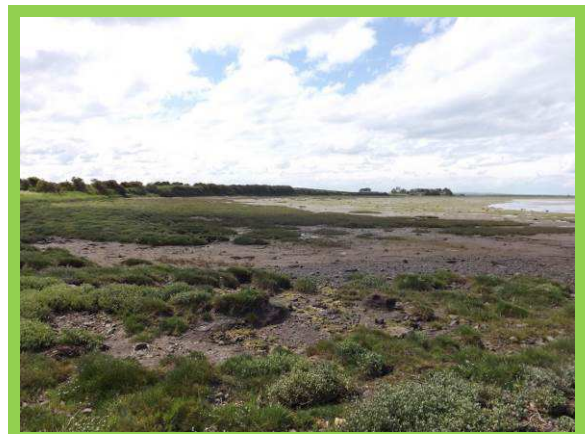
1401/ C23, reduced vegetated width looking back towards Fenham Mill.

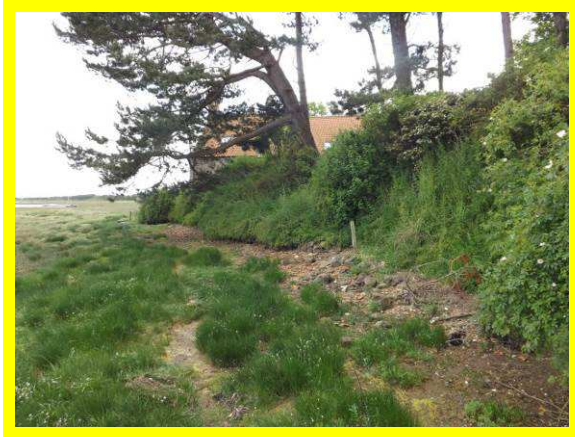
Generally the marsh fronts a low earth bank to rising land behind and overall is in fair condition. There are various local defences at Fenham Mill, including to the slipway. Towards Tealhole Point there has been some minor erosion and local piling up of rock has been undertaken to mitigate this.

1401/C23 – local timber defence.

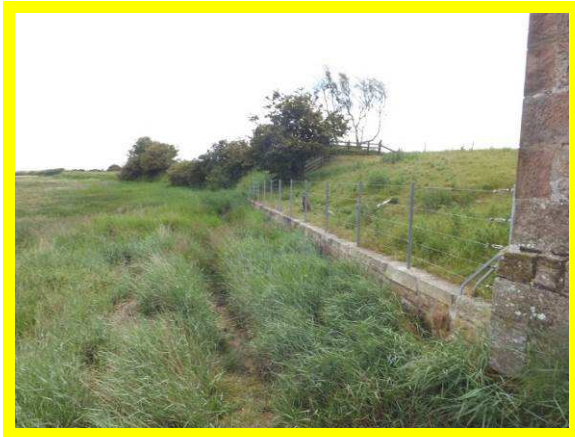
1401/C23 – local defence north of slipway.

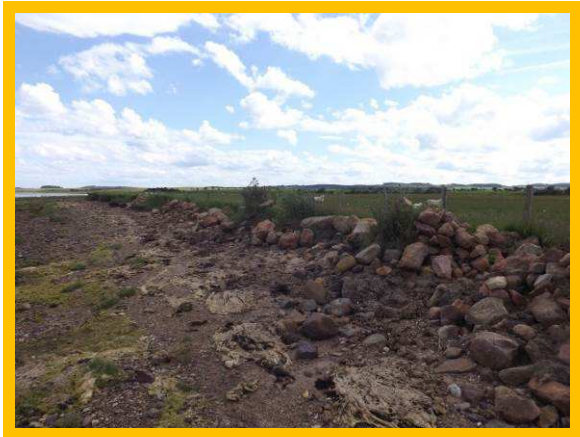
1401/ C23, Local piling of rock to prevent erosion.

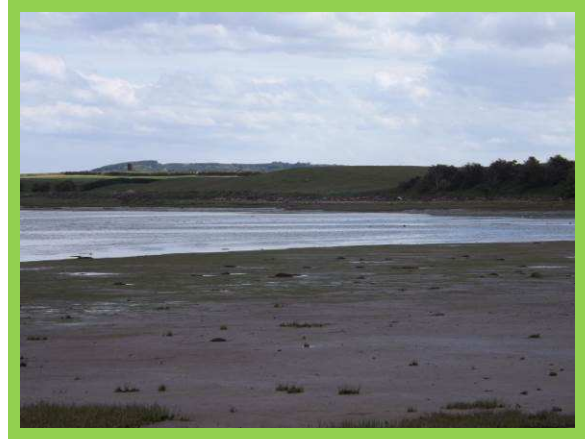
Beyond the Fenham Burn the width of saltmarsh tends to reduce. There has been minor erosion in places and again, possibly some local piling of rocks to mitigate this.

1401/ C24, Minor erosion to bank to rising land.

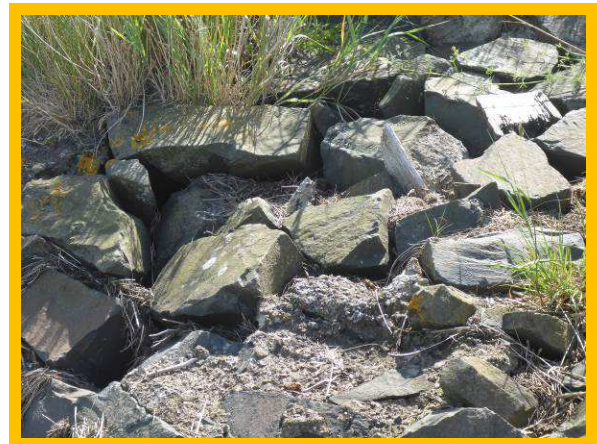
East of the bird hide at Elwick there is a flood embankment fronted by salt marsh. The embankment is protected by an asphalt and stone revetment which is generally in good condition despite being largely overgrown but locally is in poor condition where voids have opened due to loose or sunken stones. Despite this, the structure appears to continue to be effective in preventing sea flooding to a local low-lying bank of farmland across Ross. However a few areas would benefit from routine maintenance by the local landowner to infill gaps in the stones.

1401C98 – generally fair but locally poor stone-revetted embankment.

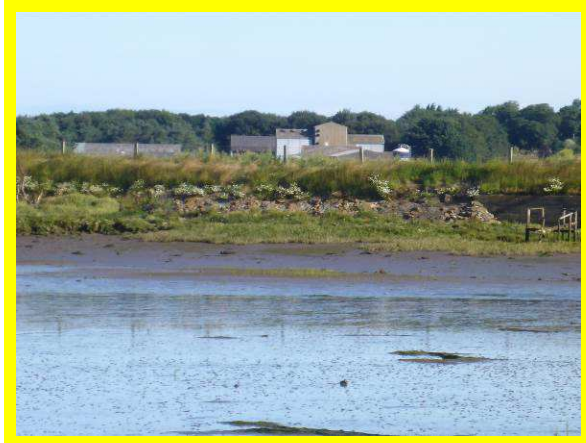
Various walls and grouted stone revetments, rip-rap and concrete retaining walls extend around Links End towards the sluice at Ross Low channel. These assets are generally in fair condition although would benefit from some maintenance by the local landowner.

1401C14 – Fair condition revetted bank, but local maintenance would be beneficial

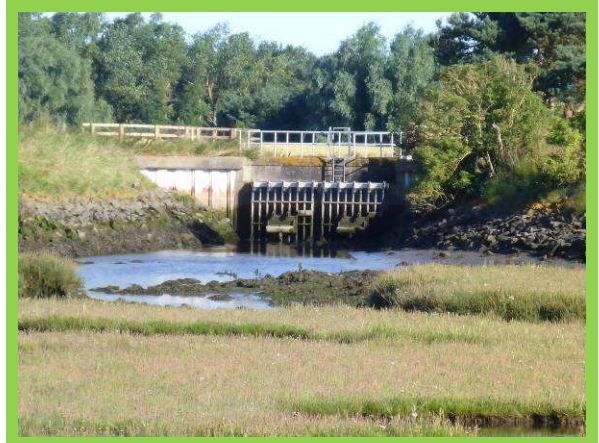
The sluice at Ross Low channel continues to be in a good state of repair with sheet piles, capping beams, hand-railings and ladders in good condition.

1401C16 – Good condition sluice at Ross Low channel

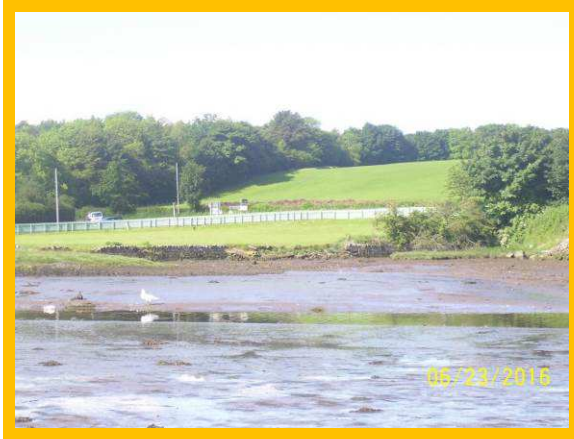
At Waren Mill, the wall fronting the private land at the head of the bay was reported as being in very poor condition during the 2014 inspections, with significant collapse along the central section of masonry. This has been repaired by the owners but remains in general poor overall condition. The revetment fronting the B1342 appears in fair condition although somewhat overgrown and in need of repointing.

1501/C02 – poor condition of masonry wall

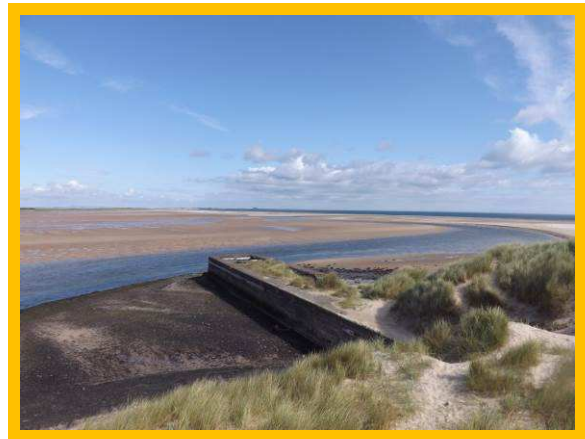
1501/C06 – south face and core of jetty

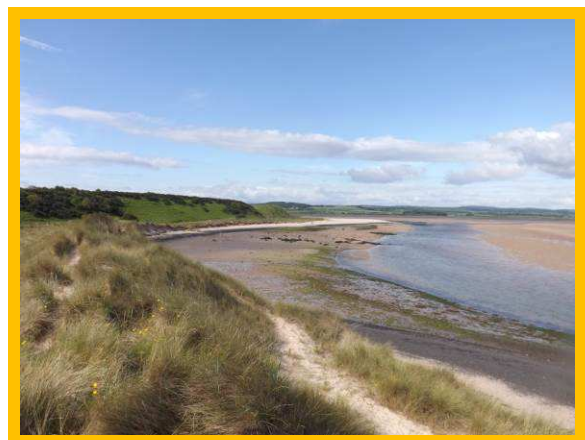
There was concern over safety with respect to the old Jetty at Heather Cottages within section 121AA901A1501C06 reported in the 2014 inspection. This has not substantially deteriorated but still might be considered a public safety hazard. There has been significant erosion to the south of the jetty, although at present this only cuts back as far as the second dune ridge shown in 2008. This is considered to be associated with the growth of the spit across Budle Bay, changing the position of the channel. The jetty does strongly influence the ability of the channel to cut further to the south.

1501/C06 – 2016 major area of erosion to south of jetty

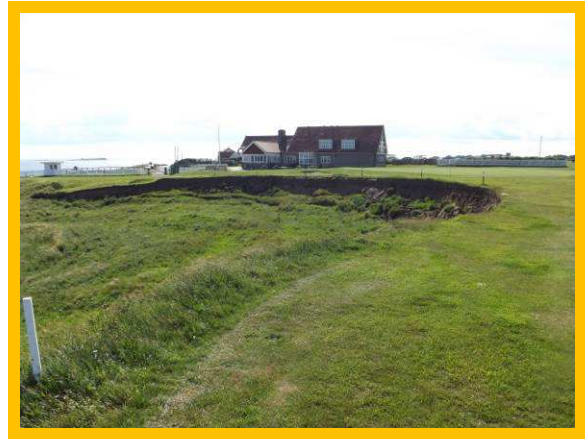
There continues to be growth of the dune head to the north of Budle Point. The dunes between Budle Point and Harkness Point continue to show areas of erosion and more general accretion, with development of embryo dunes in some places. There has been a significant land slip at the crest of the coastal slope close to the lookout point and golf club. There is no evidence of erosion at the toe of the slope and the slip is considered to be due to ground water and slope instability.

1501/C07 – significant slip at crest of slope

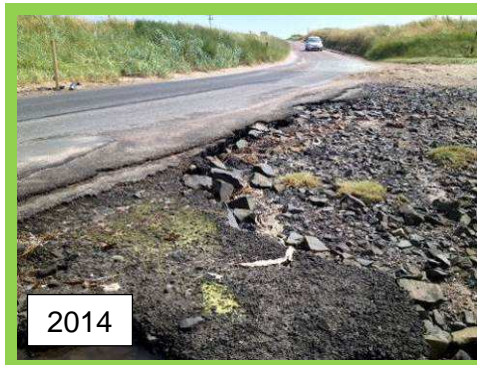
Localised erosion damage to road at Chare Ends in 2014 (4901c01)

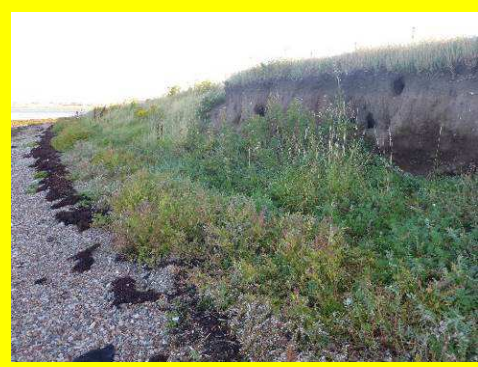
Holes from Sand Martins in exposed section of cliff at The Basin (/4901c02).

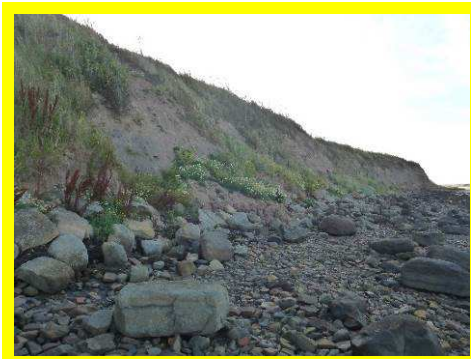
Eroding section of higher cliff (/4901c03).

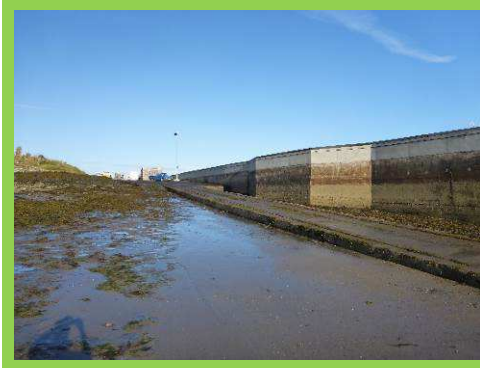
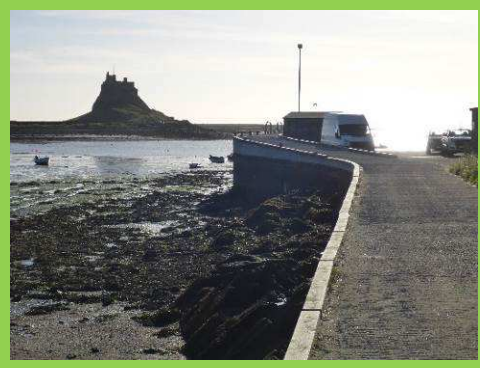
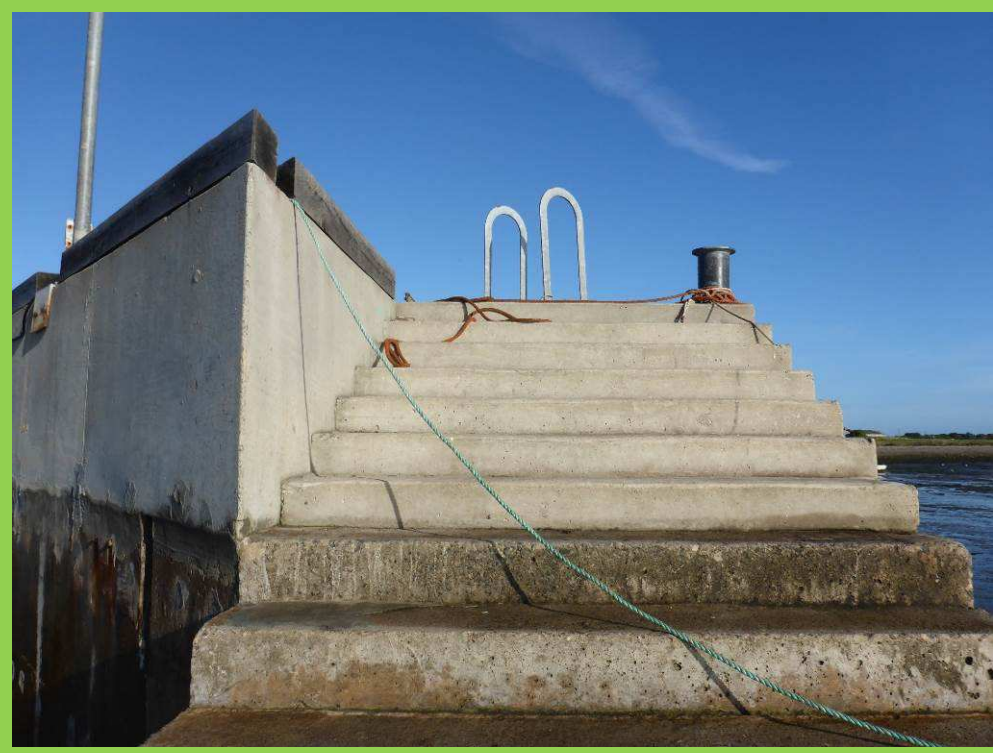
The highly fissured hard rock outcrop of Steel End provides natural sheltering to the harbour and bay to the north. Following successive inspections from 2008 onwards which reported several defects with the harbour pier, a major repair of the structure has been undertaken, with concrete encasement of upper sections. This has improved the condition of the pier to good. Problems previously noted, associated with undermining were not observed due to high beach levels at the toe.

Improvement works to harbour pier (/4901c09)

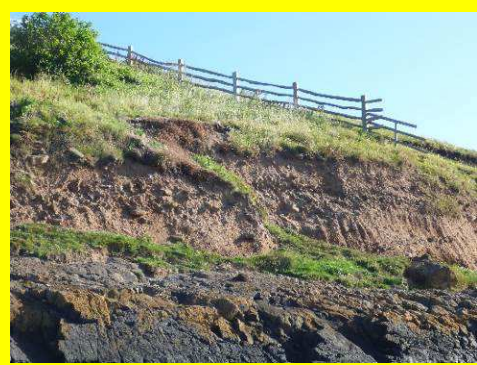
Slumps in cliff below castle east of erosion matting (/4901c12).

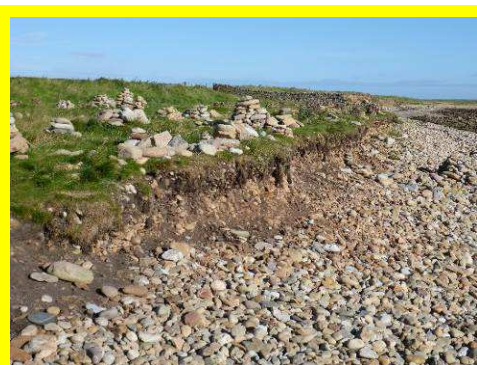
Erosion and undermining of grassed shingle on north side of ness (4901c14).

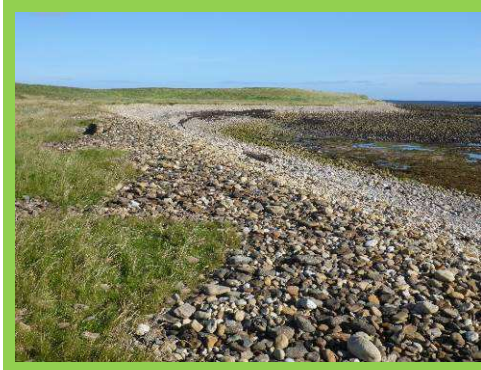
Relatively stable shingle bay near Sheldrake Pool with washover fans (/5001c03)

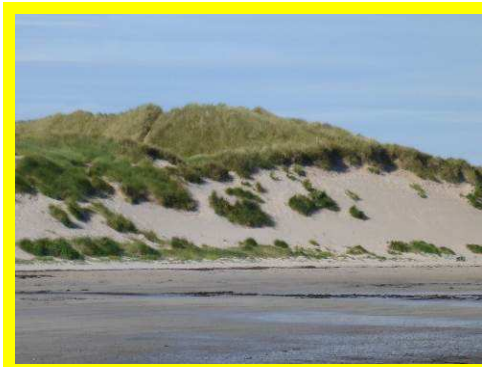
In Sandham Bay, west of Emmanuel Head, the dunes to the west and east are stable where they are protected by the cobble spit and rocky reefs of Castle Head Rocks. However, active erosion to the seaward face of higher dunes in the centre of the bay continues.

Eroding dunes in centre of Sandham Bay (/5001c06).

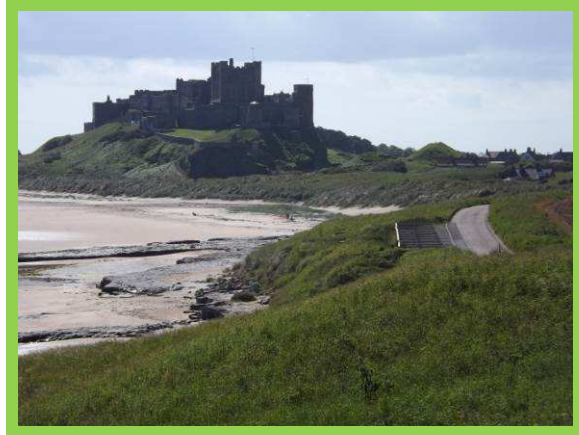
Embryo dune growth evident just north of castle and along main dune frontage 1601/ C05

Along much of the frontage down to Islestone Rocks (121AA901A1601C05) there has been recent embryo dune growth. There is slight cliffing of the dune local to Islestone Rocks.

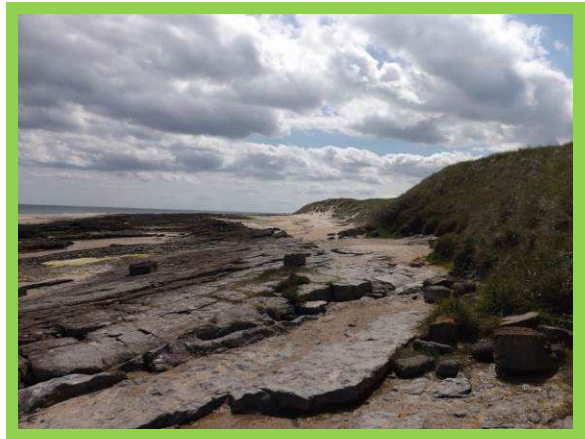
Sand to upper rock platform and embryo dune growth between rock outcrop areas 1601/ C03

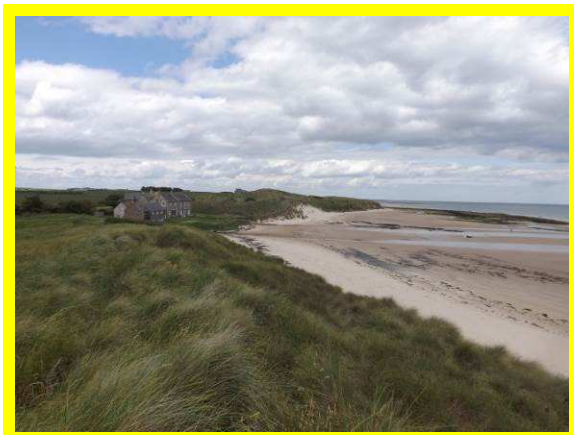
Some evidence of recent dune cliffing to the north of Monk's House but associated with subsequent of the upper beach 1601/C03

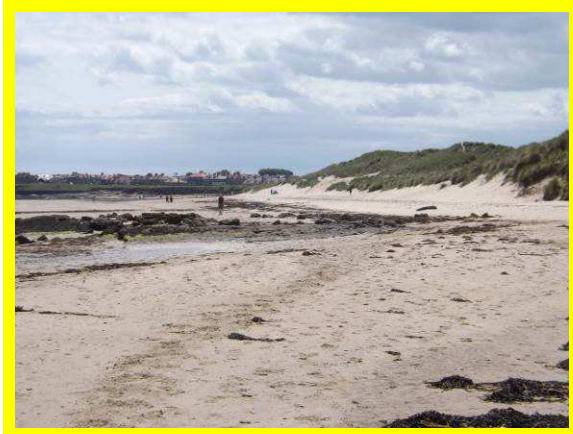
recent cliffing to St Aidan's dunes (north) and subsequent of the upper beach growth 1601/C04

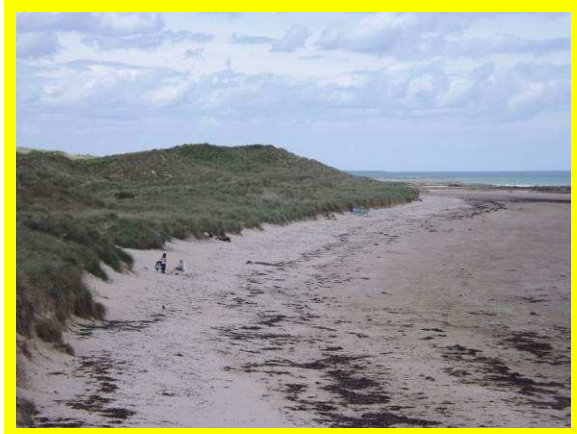
recent cliffing to St Aidan's dunes (south) and subsequent of the upper beach growth 1601/C04

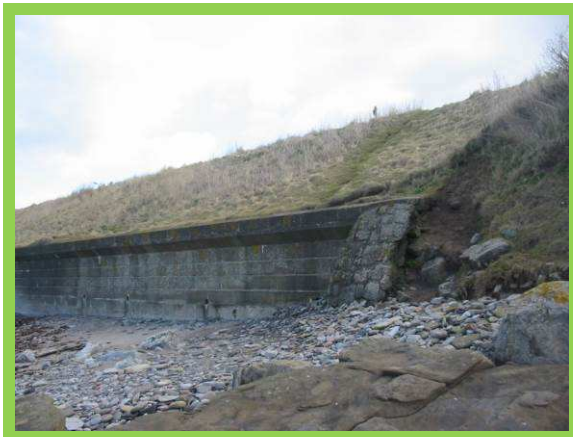
The sea wall to the south of St Aidan's dunes along Seafield Road remains in good condition. As identified in the 2014 inspection there is general separation of the coping and the upper section of the wall. However, there is no loss of coping nor displacement. While there is some outflanking to the northern end of the wall this has not significantly worsened since 2006. The slight erosion of the bank at the southern end has not significantly worsened.

Outflanking of northern end of wall 1701/C54 - 2006

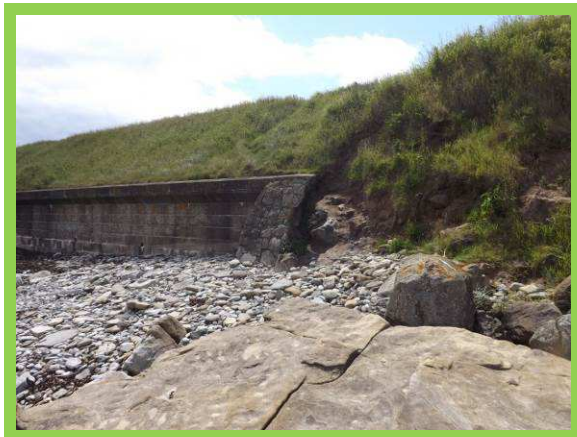
Outflanking of northern end of wall 1701/C54 - 2016

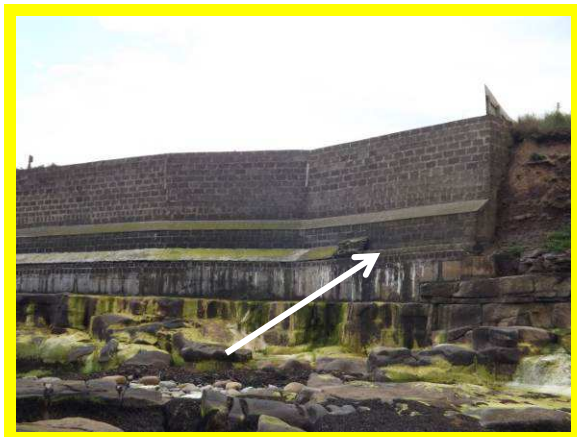
Damage of lower coping 1701/C02 - 2016

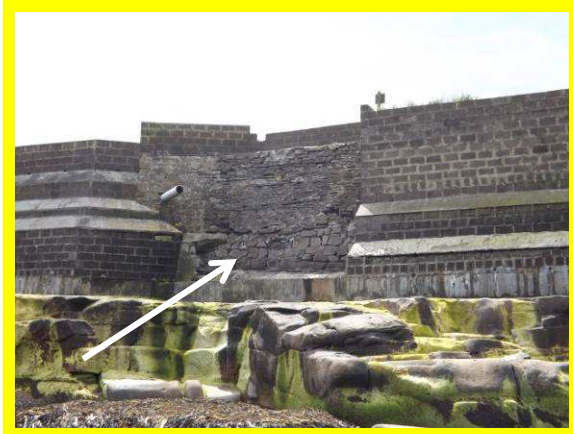
1701/C03 2016, requires repointing.

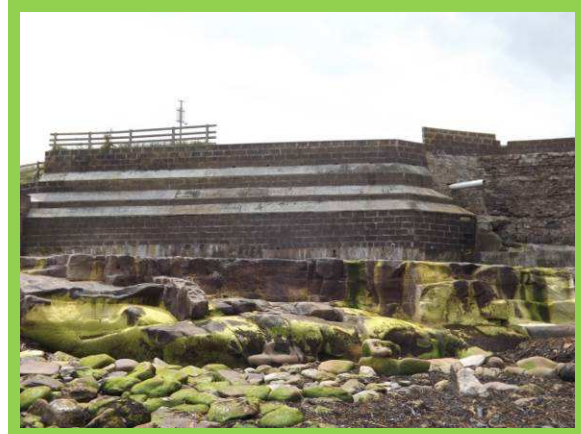
No significant damage 1701/C04 - 2016

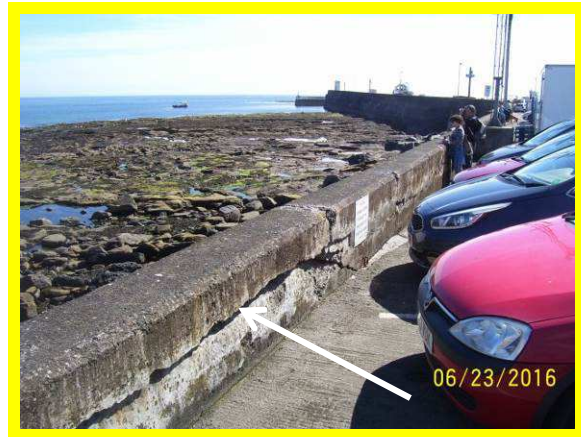
There has been no significant deterioration to the two concrete walls to storage yard and outer parking area. There are, however significant cracks to wall 121AA901A1701C06.

Old crack not noticeably worse 1701/C06

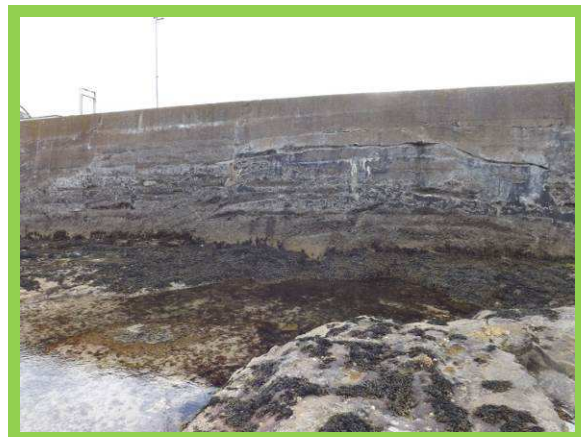
Old crack not noticeably worse 1701/C07

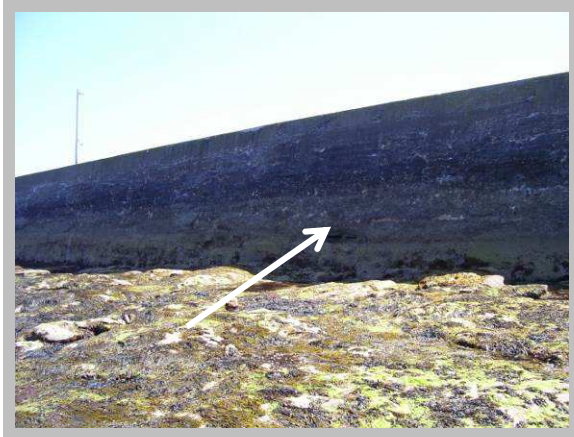
The outer the main north Pier does not appear to have worsened, except in one location towards low water. Here there has been further abrasion of an old developing hole.

Developing abrasion hole 1701/C07 2010

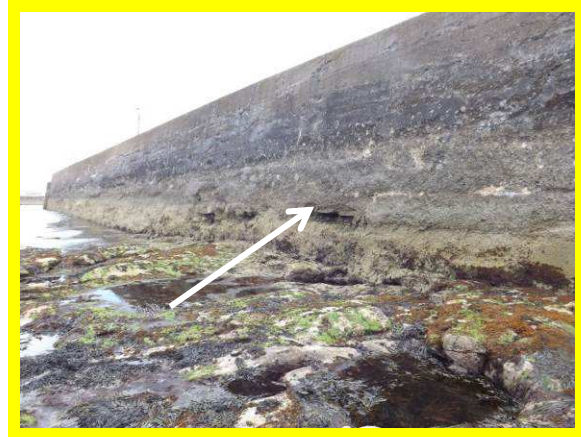
Increased depth of abrasion hole 1701/C07 2016

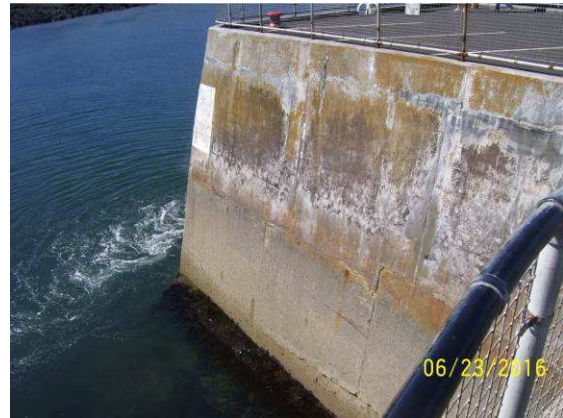
The 2014 report identified reports of undermining to the south east corner of the stub to the main pier. This has worsened to 2016 and repairs are recommended.

South East corner to stub 1701/C09
