Cell 1 Regional Coastal Monitoring Programme Walkover Inspection Surveys 2016

Northumberland County Council

Walkover Inspection Surveys 2016

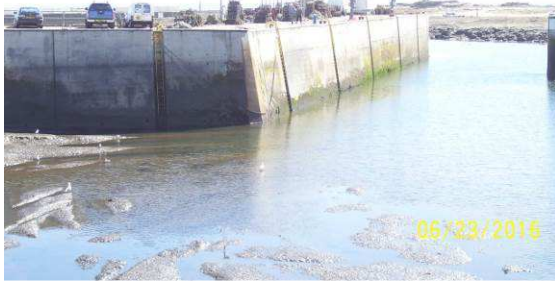
Some repairs have been undertaken to the Inner Pier, including to the encasement of the inner face of the Inner Pier.

Inner face of the Inner Pier 1701/C10

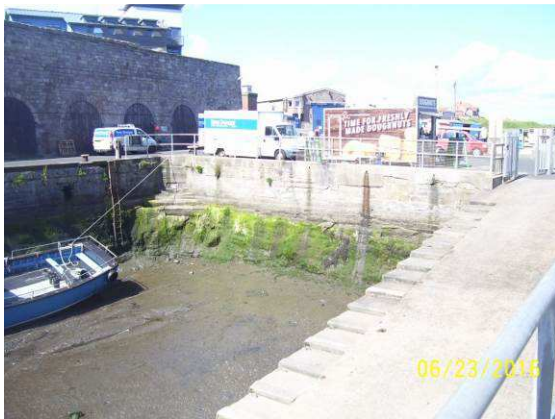
No signs of deterioration 1701/C12

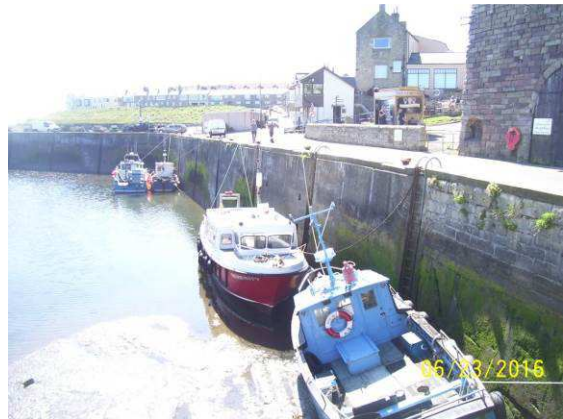
No signs of deterioration 1701/C13

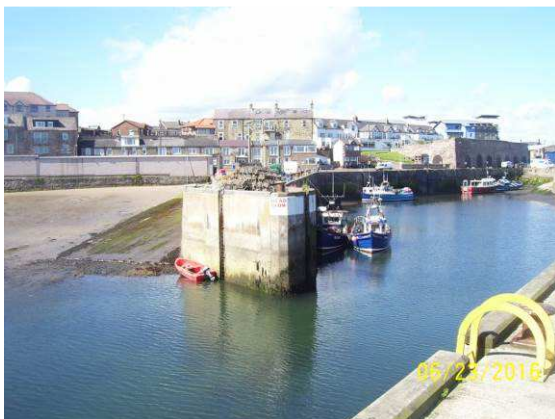
It was reported in 2014 that there might be some undermining to the head of the Main Pier, although no sign of movement was observed in 2016. To the outer face of the Main Pier there is no further sign of movement in the damaged masonry area.

No signs of undermining 1701/C14

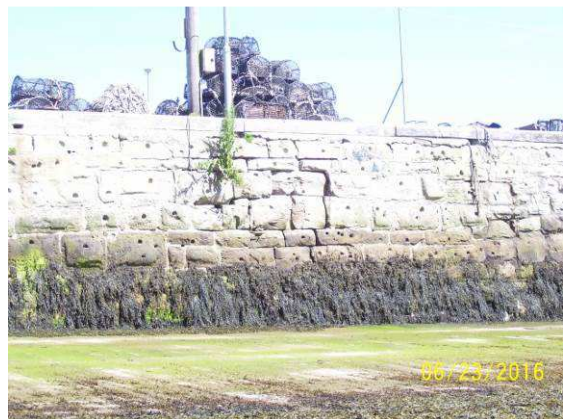
No signs of deterioration 1701/C14

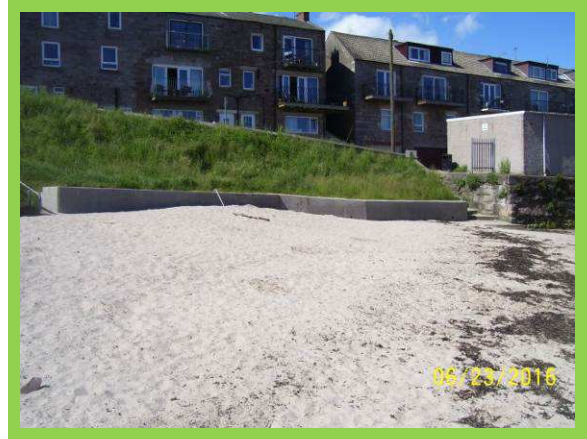
1701/c16 Good condition, no sign of undermining.

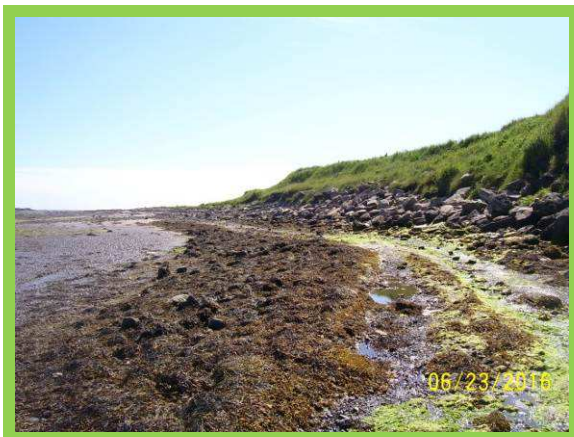
There has been slight erosion to the crest above the rock revetment to the east of the Crewe Street wall. However, this poses no significant risk at this time.

1701/C19 minor erosion above rock

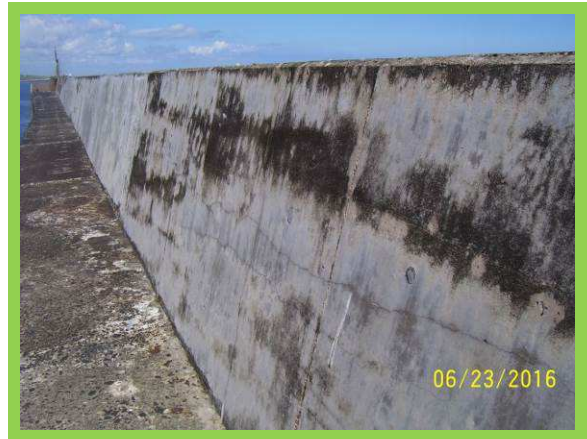
1701/C21 Good condition, some cracks in original deck but no significant damage

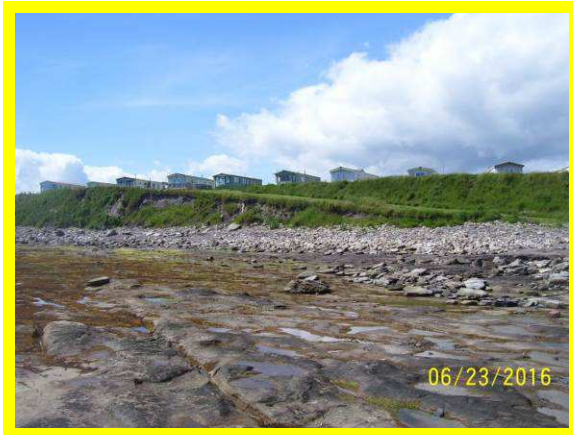
To the south of Seahouses 120AA901A1701C22 there is continued erosion to the crest of the access ramp, although this does not pose a significant risk at present. Further along the frontage there is some embryo dune development giving way to the slowly eroding cliffs around North Sunderland Point. There seems to be no immediate significant risk.

Erosion to access ramp 1701/ C22

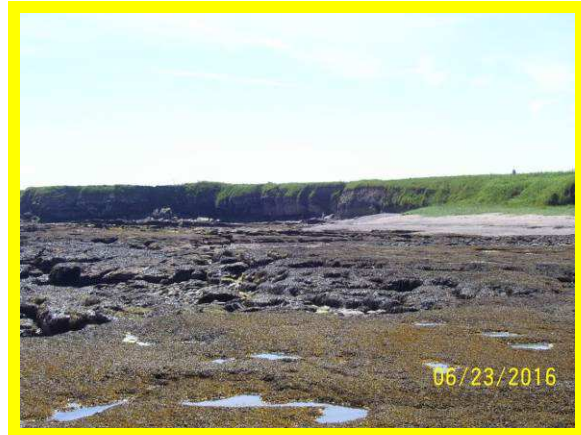
Embryo dunes within bay with slow erosion to cliffs to the south 1701/ C22

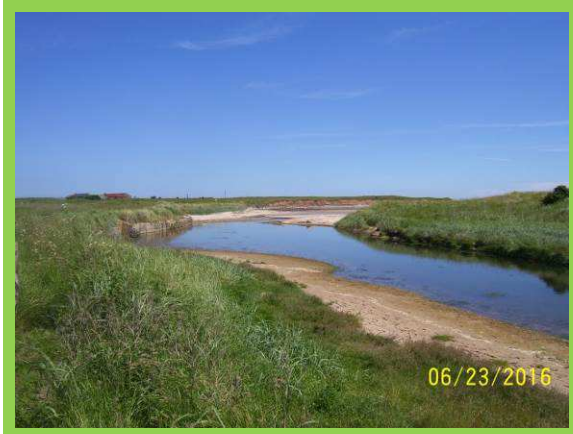
Minor areas of erosion and some areas of toe dune development to Annstaed Burn.

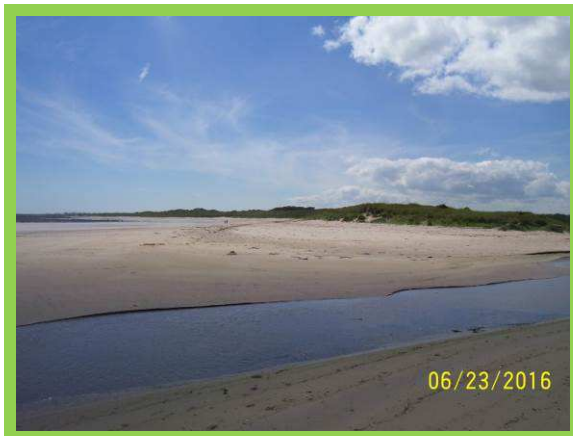
Further south along the main Annstead Dunes, there is some evidence of recent erosion but this has recovered to a degree with a build-up and vegetation to the toe of the dunes.

1701/C23 some evidence of erosion but with general recovery at the toe of the dunes.

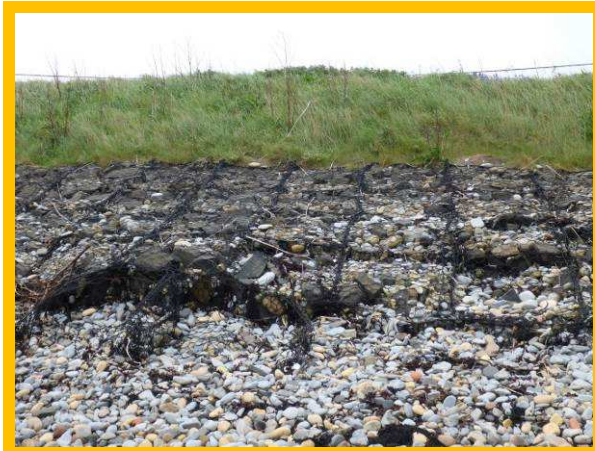
Further south at Lady's Hole, the rock-filled mattresses remains in poor condition and in need of repair with burst baskets along the toe. It is recommended that the improvement works proposed in the Beadnell North PAR (also covering Nacker's Hole) be implemented as soon as funding becomes available to prevent failure of this seawall.

Failing mattresses at Beadnell North (Lady's Hole) (/1701C40)

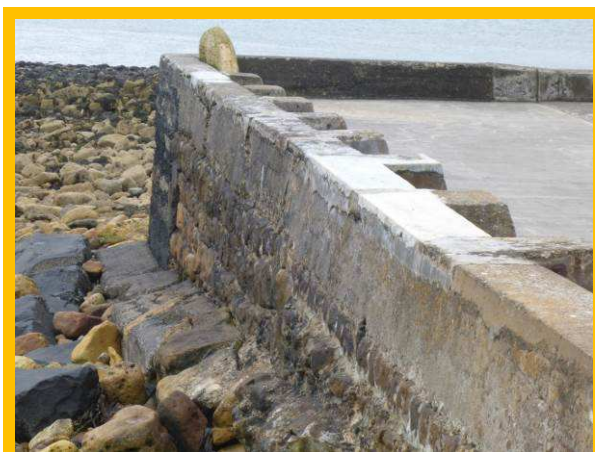
The structures at Beadnell Harbour are generally in fair to poor condition with masonry walls and concrete coping showing signs of abrasion and cracking. However, there is also evidence of toe undermining on both the outer and inner face of several of the structures. It is suggested that this situation is monitored closely, perhaps with a more detailed structural inspection and investigations, because a breach previously occurred in the harbour wall, requiring emergency repair works.

Abrasion and undermining of Beadnell Harbour wall (outer face of eastern wall) (/1701C47)

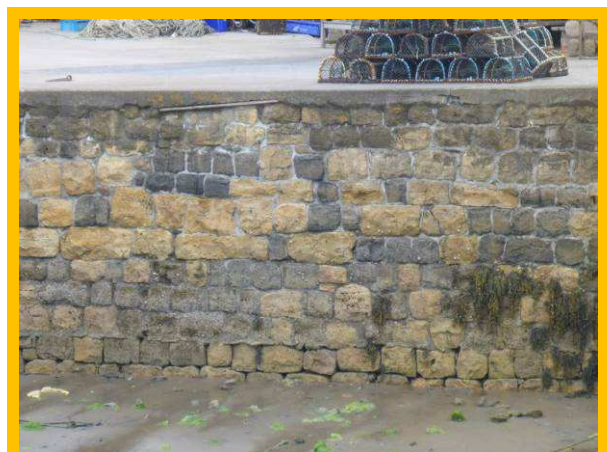
Open joints between blocks on Beadnell Harbour wall (inner face of eastern wall) (/1701C51)

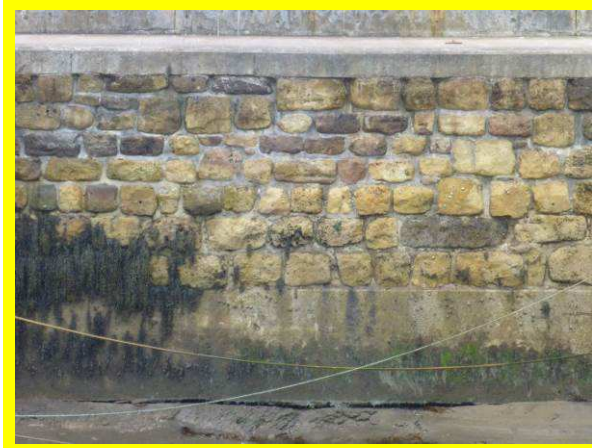
Undermining of Beadnell Harbour wall (inner face of southern wall) (/1701C51)

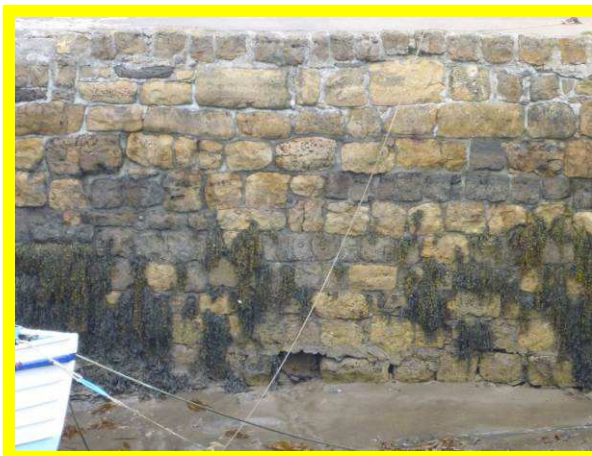
Missing block at toe of Beadnell Harbour wall (inner face of northern wall) (/1701C52)

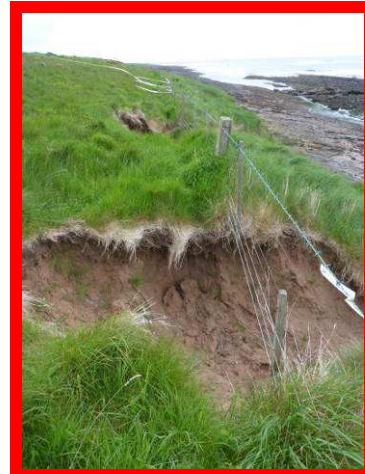
Coastal slope erosion at Newton Point headland (/2001C01)

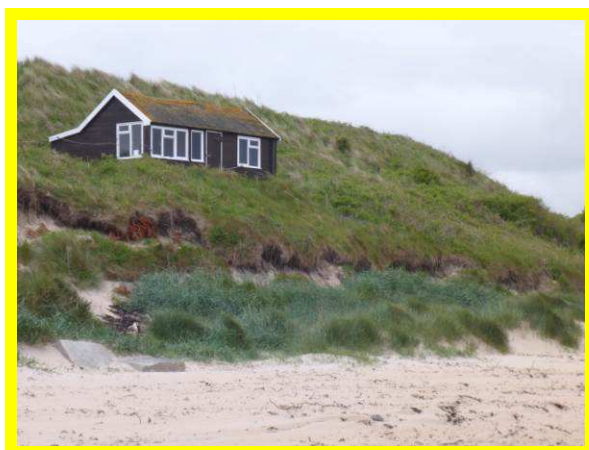
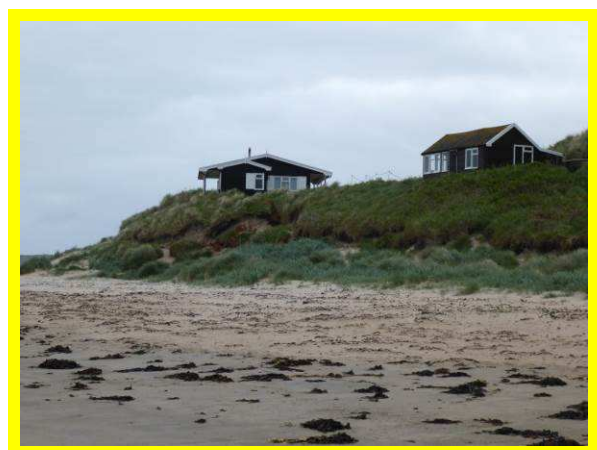
The dunes within Newton Haven appear to have experienced slumping on a measureable scale at some point since the previous inspections in 2014. However, since that damage was incurred, the dunes have recovered with currently accreting sand levels and embryonic vegetation growth at the toe. This means they are currently in fair condition once again, although remain susceptible to winter storm damage and the long term sustainability of some of the bungalows must be questioned. The most vulnerable section is at the intersection of Newton Haven and Embleton Bay where the shore protrudes seawards in the lee of Embleton Out Carr rocks and where bungalows are close to the dune crest.

Previous dune damage followed by recovery at Newton Haven (/2001C03)

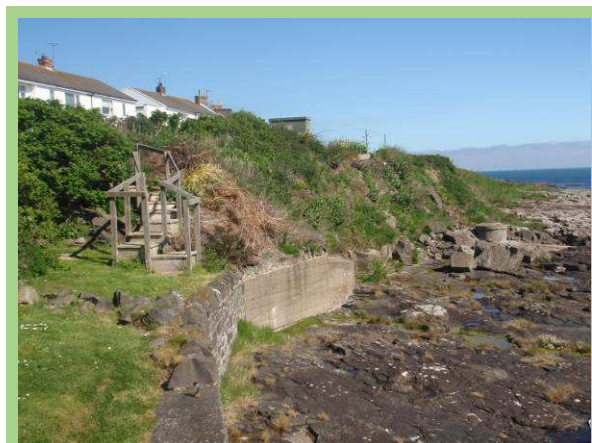
Stable slopes and masonry wall north of Craster Harbour north pier (/2201C02)

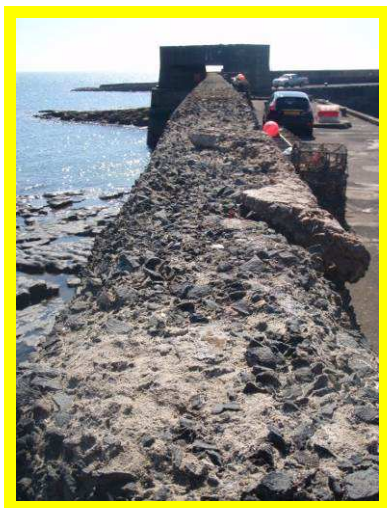
At Craster Harbour no significant change was evident since the last inspection with all structures remaining in a fair condition. The landward and seaward faces of both north and south harbour arms show noticeable signs of heavy abrasion and spalling along the crest wall. This is not unexpected for a structure which was built in 1906.

Abrasion and spalling on crest wall of north pier (/2201C03)

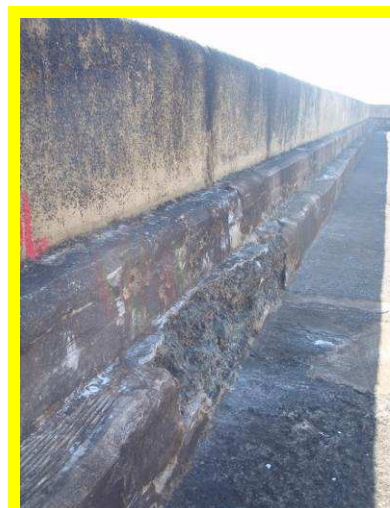
Abrasion and spalling on inner face toe of crest wall of south pier (/2201C11)

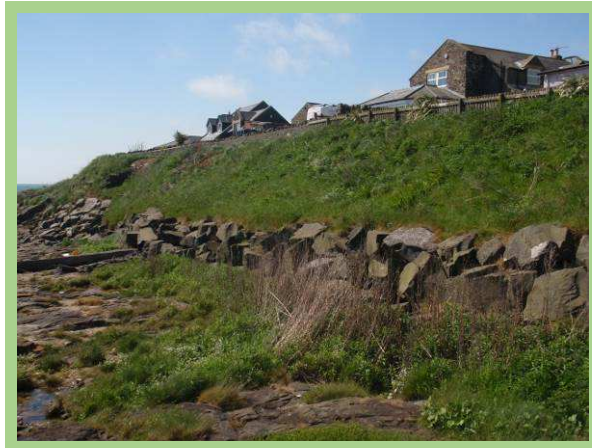
Inactive slopes with rock revetment at toe (/2201C13)

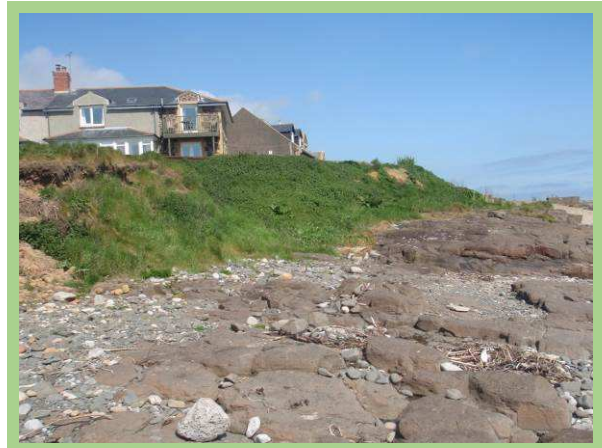
Inactive slopes with rock ledge at toe, with one minor area of slippage (/2201C14)

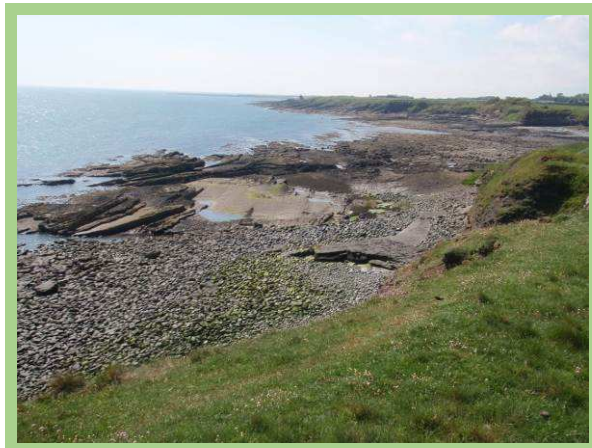
Inactive slopes with natural rock platform at toe (/2301C01)

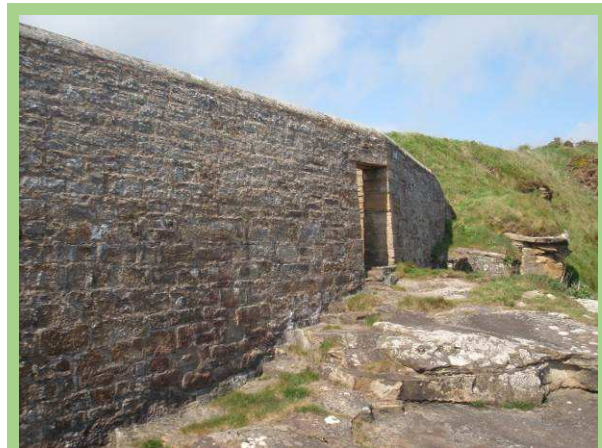
Masonry wall at The Bathing House in good condition (/2401C02)

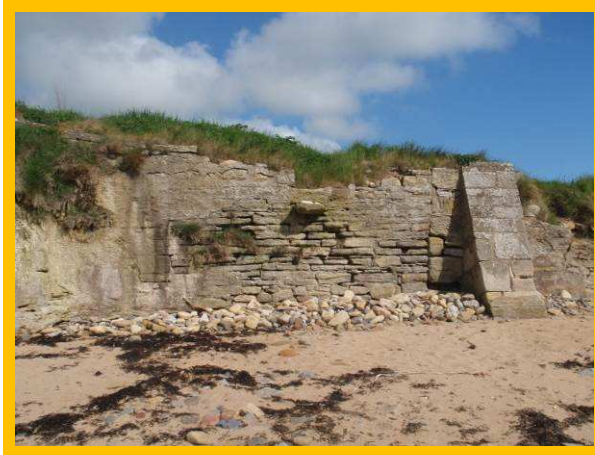
Just south of here, at Rumbling Kern, a short length of low masonry retaining wall at the back of the beach is in fair condition. Further south, at Howick Haven, there are two further short lengths of masonry retaining walls at the back of the beach; one with a set of access steps. These walls are in a poor to fair condition with weathering of blocks and loss of mortar evident.

Poor condition retaining wall (/2501C01)

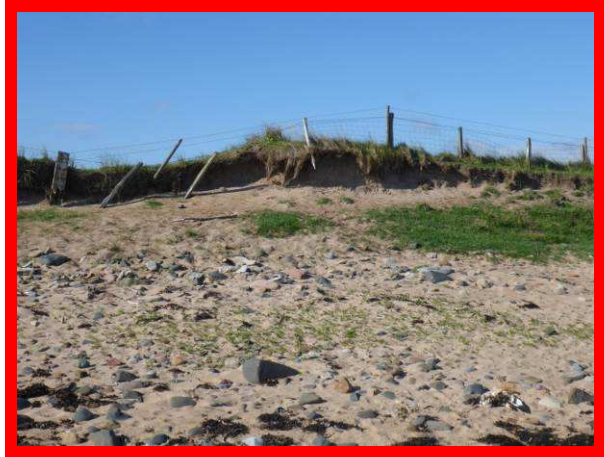
The bays of Sugar Sands and Howdiemont Sands comprise healthy sandy beaches backed by stable dunes, with mature and embryonic vegetation. The only sign of (minor) erosion is in a highly localised patch immediately south of the footbridge across the small burn which discharges at the southern end of Howdiemont Sands. This erosion is affecting the fence line which is in need of repositioning.

Local erosion affecting fence line (/2501C01)

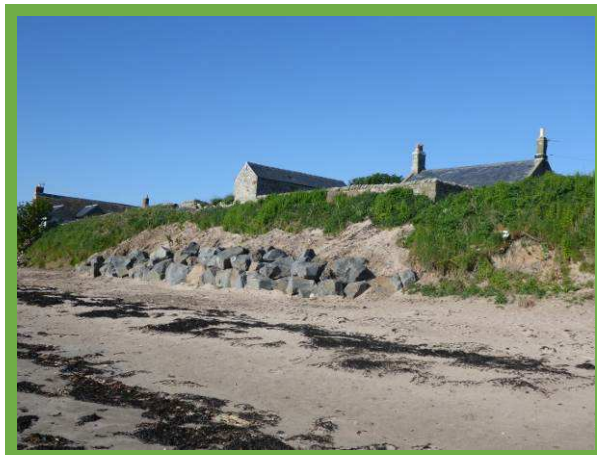
New rock revetment toe to locally protect isolated property at northern end of Boulmer village (/2601C01) – constructed May 2016

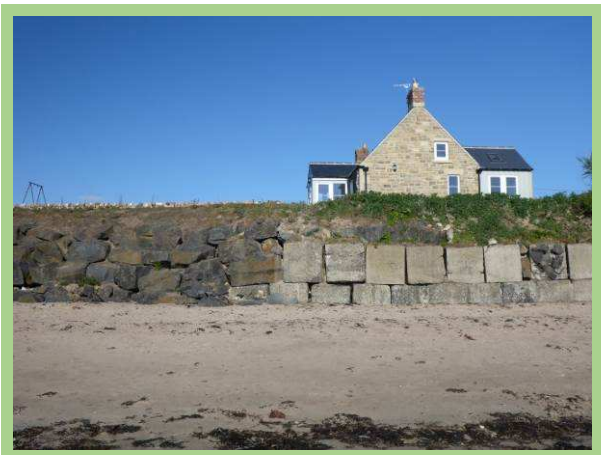
Stacked concrete blocks (original scheme) and rock revetment (emergency scheme) at northern end of Boulmer village (/2601C02)

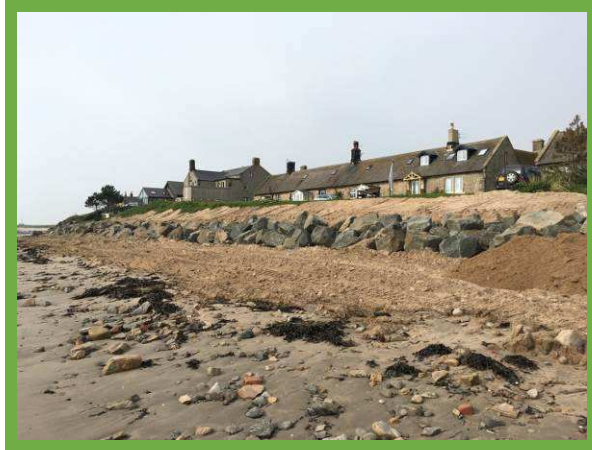
New rock revetment toe to protect previous central 'gap' at Boulmer village (/2601C03) – constructed May 2016

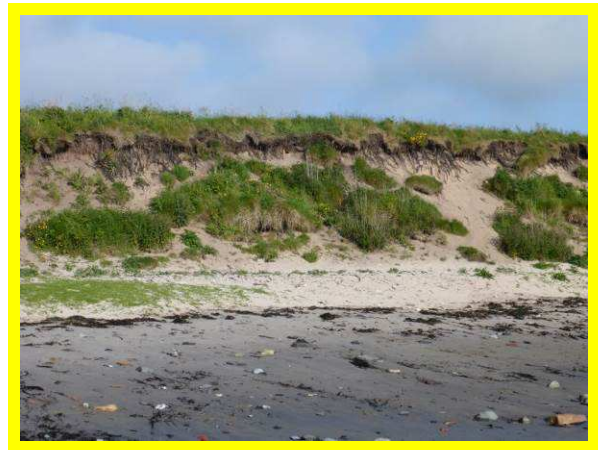
Local slumping to dunes around Seaton Point (/2601C07)

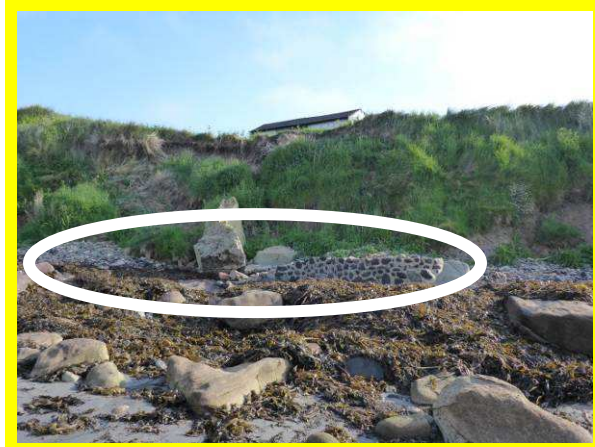
With progression around the Seaton Point headland and into the northern part of Foxtton Bay, the erosion of the cliffs increases. This is particularly linked to the absence of rock platform fronting the cliffs with progression away from the headland. In places where there are bungalows at the northern end of the bay, local attempts to slow the erosion have been made with stone built walls or timber breastwork, but these have suffered damage or are largely ineffective.

*Local stone built wall at toe of eroding cliffs
(/2601C08)*

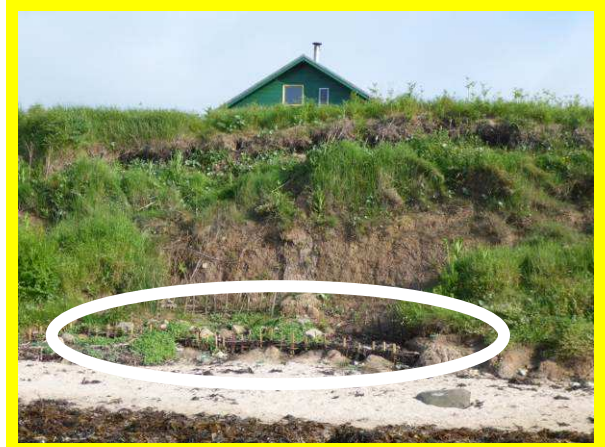
*Local timber breastwork at toe of eroding cliffs
(/2601C08)*

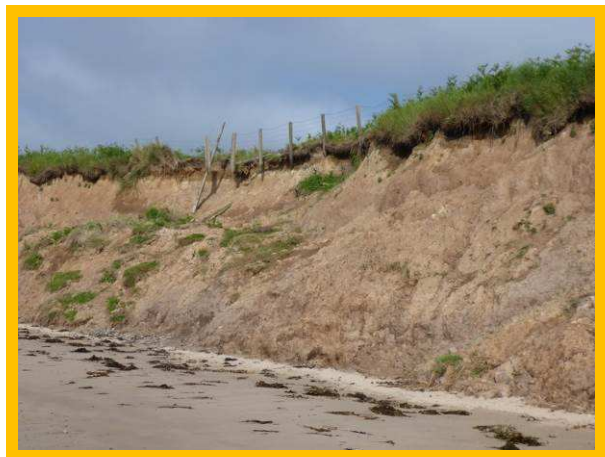
The access steps towards the northern end of Foxtton Bay are protected by rock armour but erosion of the cliffs either side continues. Just to the south of the access steps, the eroding cliffs are largely bare of vegetation on their face and sand martins are nesting in the upper sections of cliff. The ongoing erosion has caused the fence to become lost in places.

*Actively eroding cliffs causing loss of fencing
(/2701C01)*

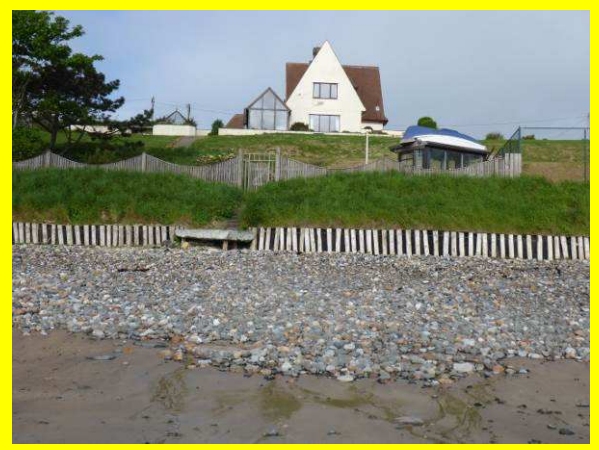
Timber breastwork fronting property (/2701C02)

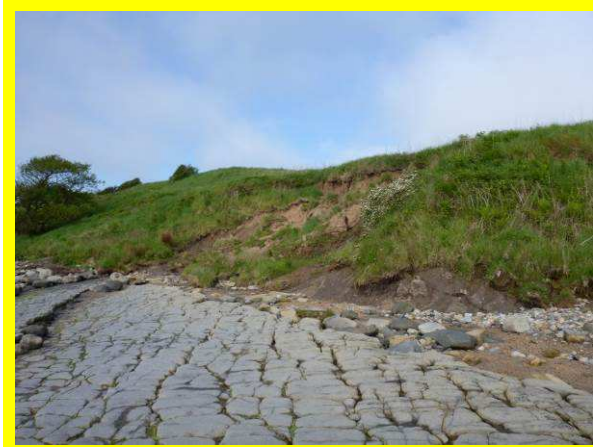
Immediately south of the breakwater style wall south of Foxton Hall, the backing slopes are well protected by foreshore boulders and rocky shore platform, although slumping has occurred locally in one place. Further around the headland is an isolated, short and mostly buried timber groyne in fair condition, with a very short section of remnant timber from another groyne structure slightly further south.

Generally stable slope protected by rocky shore platform but one area of local slumping (/2701C04)

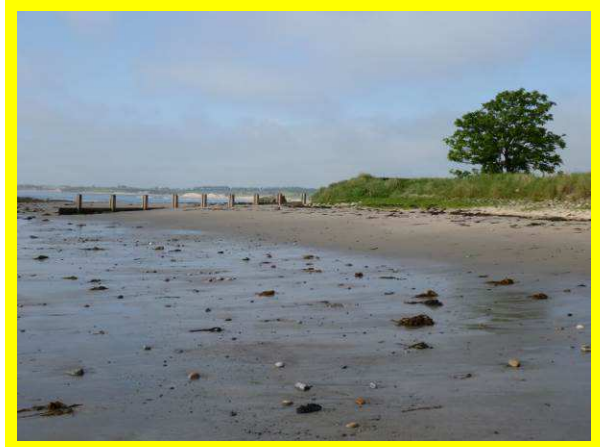
Isolated timber groyne (/2701C04)

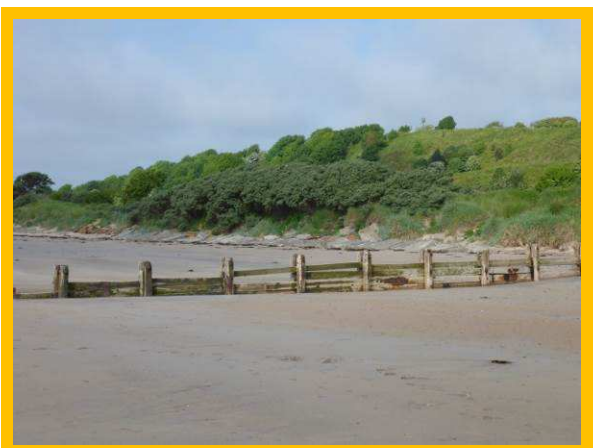
Missing timber planks on fifth (southerly) groyne in field of five groynes (/2701C05)

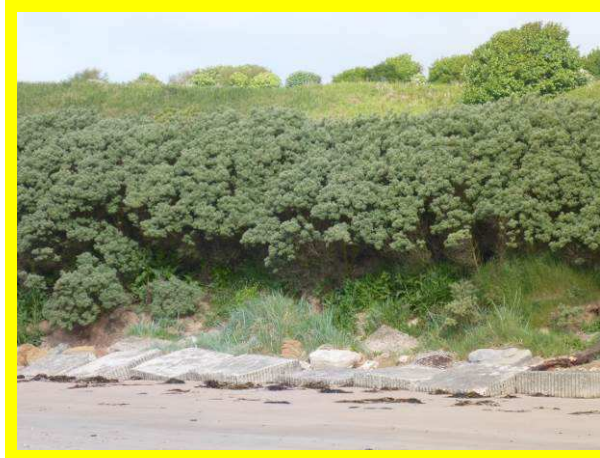
Immediately south of the last groyne, concrete blocks placed at the toe of the low dunes has helped stabilise them initially, although some minor erosion continues. To the north of the River Aln estuary, beach levels in front of the car park appear relatively stable due to the estuary channel taking a more direct route to discharge at sea, rather than running along the toe of the dunes at the present time.

Relatively stable dunes protected by concrete blocks in north of Alnmouth Bay (/2701C06)

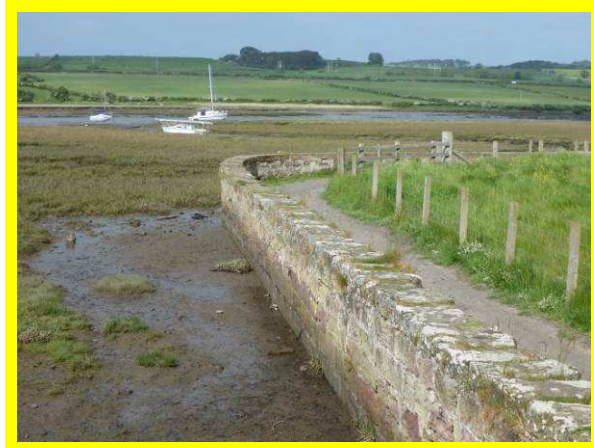
The footpath along the estuary extends away from Peases Park and is protected by an older low masonry wall which is in fair condition. A previously collapsed section of crest wall (reported during the 2014 inspections) has been repaired, but there are occasional missing blocks and the wall would generally benefit from re-pointing in many places. Salt marsh continues to front this section of wall.

Masonry wall fronted by salt marsh (/2801C06)

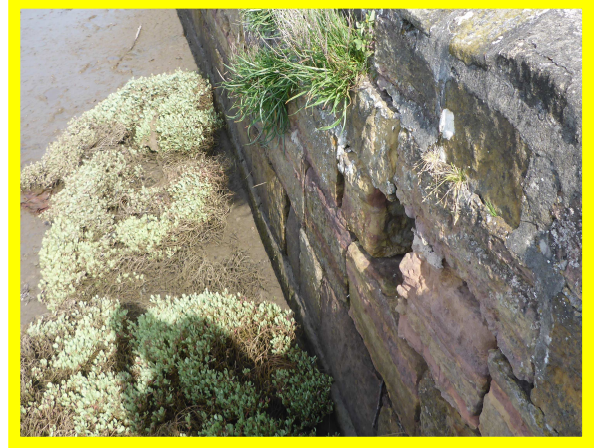
Missing block in masonry wall (/2801C06)

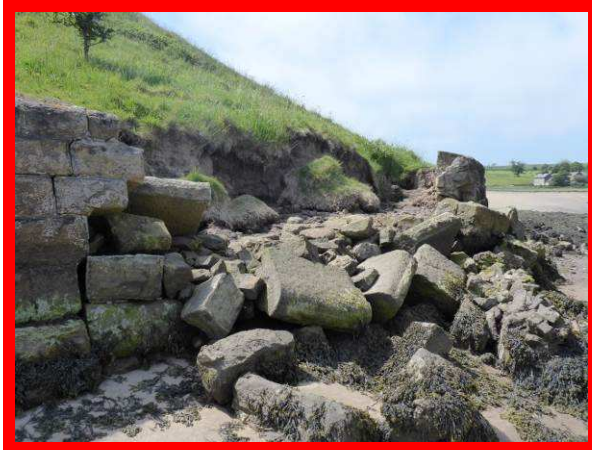
The low masonry wall around the bottom of Church Hill has collapsed along a length of approximately 10m, but it is concerning that adjacent sections are also in very poor condition and work should be undertaken to avoid a larger scale collapse that potentially could lead to slumping of Church Hill. Further around Church Hill another short section of lower wall has collapsed. The whole end-section of the wall needs rebuilding.

Collapsed section of wall at Church Hill (/2801C13)

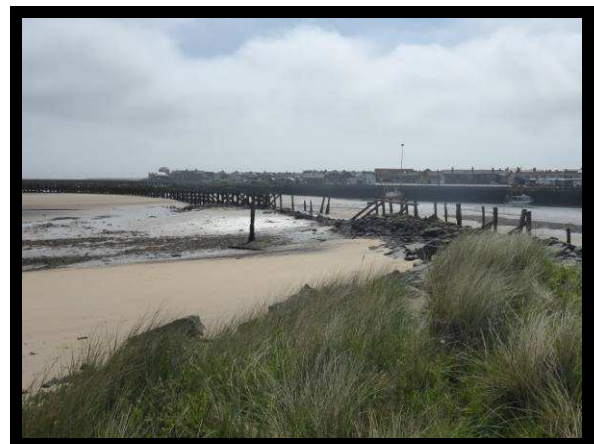
Dilapidated North Jetty (no asset reference)

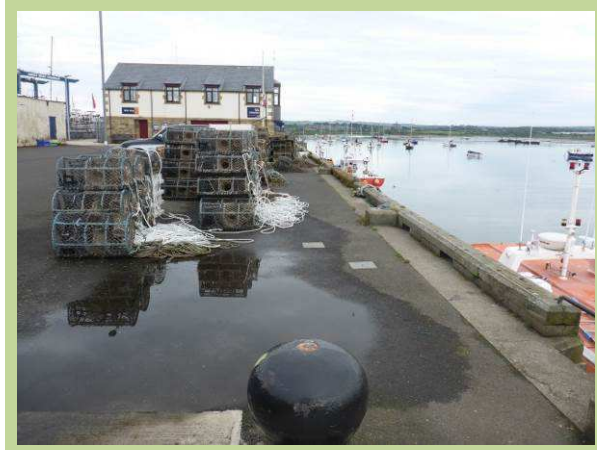
The concrete quay wall at the western end of Amble quayside (/3001C05) is generally in good condition with only minor localised cracks visible in the concrete deck. The masonry walls in the small dock basin (/3001C05 & C06) are generally in fair condition, but have several open joints between blocks which would benefit from repointing and one area of concrete spalling. At the eastern end of Amble quayside the previously repaired Broomhill Quay (/3001C05) appears in good condition with no cracking or settlement of the deck or obvious defects in the face of the wall.

Quay wall in good overall condition (/3001C05)

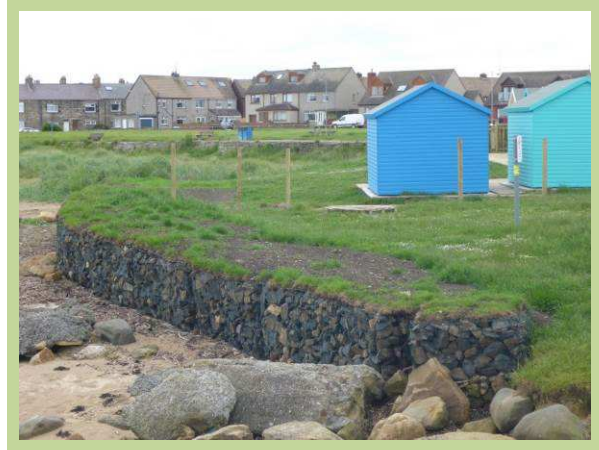
At the east end of Broomhill Quay the timber linkspan bridge erected 2008/09 is still in very good condition. Previously the low vegetated bank that was eroding at the intersection of South Jetty and Little Shore Wave Basin (/3001C07) had been protected, to a degree, by rock armour and tipped construction waste. Recently the area has been improved with the construction of some beach huts and the provision of more formalised defence in the form of gabion baskets and fronting rock armour. The area looks in good condition and is now much improved. The low masonry wall along the back of the enclosed bay is generally in good condition although one or two missing stones were noted. This wall is protected by a well vegetated area of healthy dunes/links (/3001C08 &09).

New gabions and beach huts (/3001C07)

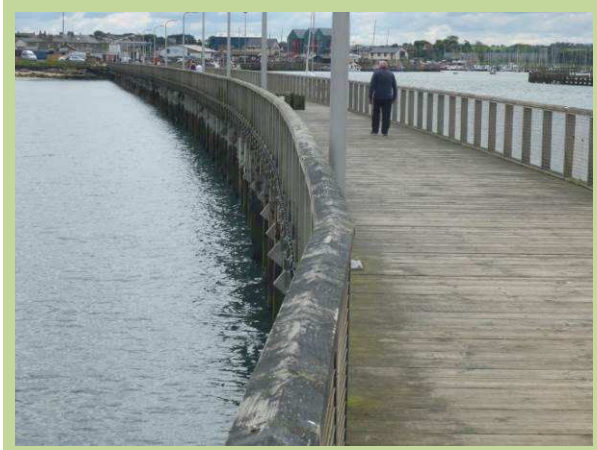
The South Jetty is in good condition along the length enclosing the Little Shore Wave Basin (/3001C11), with no gaps in the timber decks, all hand railing intact and the steel sheet piling forming the half-tide barrier remaining effective. However, the seaward end, extending to the lighthouse (/3101C01), is very heavily abraded, most notably along the base, at the access steps to the lighthouse and at the junction with the South Pier.

South Jetty in good overall condition (/3001C11)

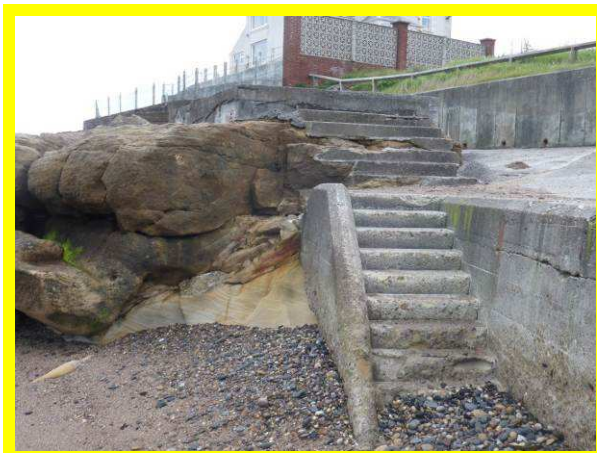
The condition of the inner face of the South Pier (/3101C02) does not appear to have changed significantly since the last inspection and remains in fair condition along most of its length, although there is abrasion and cracking at the junctions at each end, namely with the Bay View road seawall and with the South Jetty. The seaward face of the south Pier (/3101C02 & C03) is generally in fair condition with frequent horizontal cracking at the south end. The access steps at the south end of the Pier (/3101C03) are highly abraded and, as these provided the only access to the beach, present a public safety hazard. Although the concrete stub groyne is also highly abraded it still serves its current function to retain the rock armour on the north side.

Heavily abraded access steps to foreshore (/3101C02)

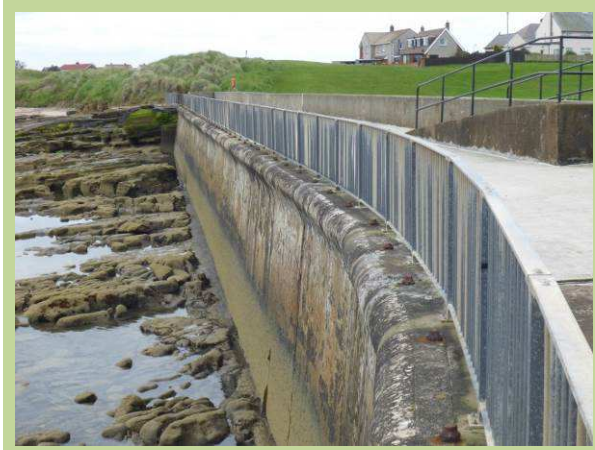
The seawall fronting Paddler's Park children's play area (/3101C05) to the south of Pan Point is generally in good to fair condition, despite being heavily stained. It shows no signs of undermining or movement. Some minor abrasion, localised cracks and spalling to the wave return wall and setback wall were noted. The previously damaged bitumen surfacing was replaced with a concrete decking a few years ago and this remains in very good condition with all joints well sealed.

Seawall in good condition despite rust-staining (/3101C05)

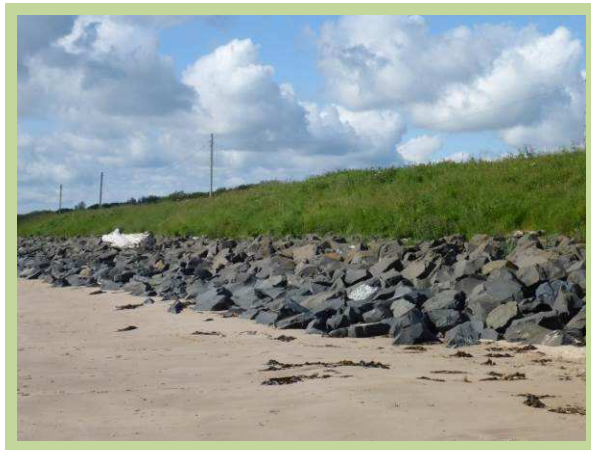
There is a short length of low, undefended dune which has received some sand accretion and is experiencing embryo vegetation growth, but immediately south of here (down to and beyond the beach access ramp) the coastal margin is protected by rock revetment in front of further properties. This is in good condition and towards its southern end forms an overlap to the subsequent concrete block revetment which extends further south. This has a number of large gaps between the blocks, with some rotational displacement apparent at the southern end. Erosion and cliffing of the low earth bank above the blocks continues, with ongoing dumping of construction waste.

Wide rock revetment in good condition (/3201C03)

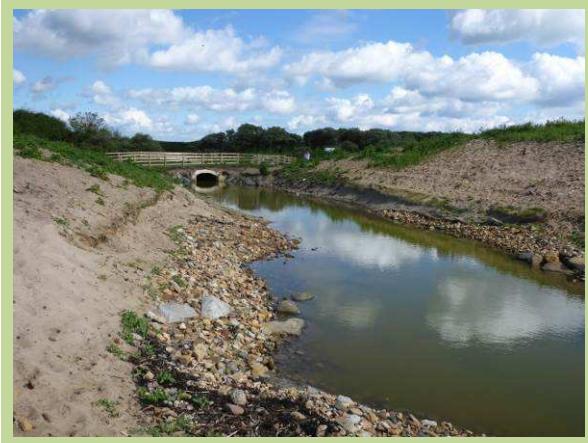
The outfall of Hauxley Nature Reserve, at the northern end of Druridge Bay, has previously been reported as being in poor condition, with concrete blocks placed to the north of the outfall to shelter the structure also showing signs of movement and cracking. Since the previous inspections, the Northumberland Wildlife Trust has 'daylighted' the majority of the drainage channel (although seaward parts of the structure and the adjacent concrete blocks remain on the beach), creating a more natural aesthetic in line with the recommendations of the *Druridge Bay Adaptation Study*. The drainage from the reserve now occurs along a natural open channel and then alongside the remnant outfall structure, across gravel, cobbles and boulders. It is understood that ultimately the remnant structural sections will be removed. At the present time, the drainage is working well, although some geotextile placed on the re-graded bank slopes of the open channel section has become exposed and would benefit from being pinned or tied so that it does not unravel and locally erode or destabilise the side slopes. There is some gravel accumulation to the north of the remnant outfall and its protective concrete blocks it is possible that this may move south to block the natural outfall if the remnant structure is removed. This will require inspection and maintenance as necessary to ensure free-flowing drainage from the reserve is unhindered.

Landward view of newly 'daylighted' open channel section of outfall from Hauxley Nature Reserve (/3201C09)

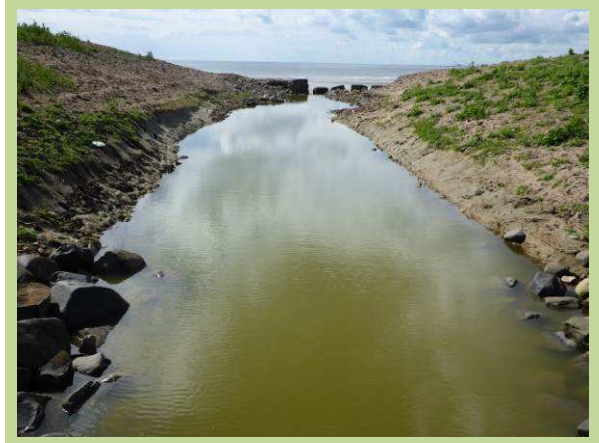
Seaward view of newly 'daylighted' open channel section of outfall from Hauxley Nature Reserve (/3201C09)

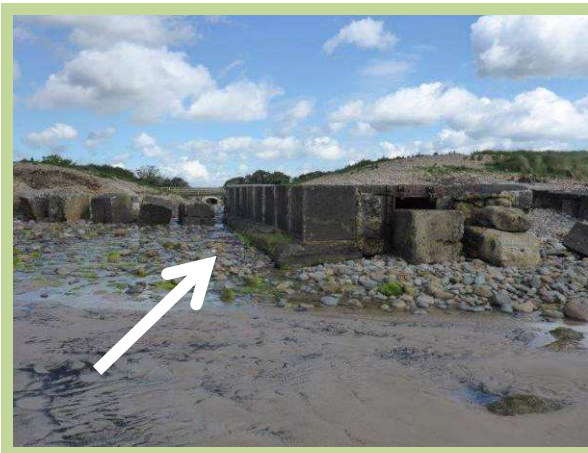
Drainage occurring alongside of remnant outfall structure through gravel, cobbles and boulders (/3201C09)

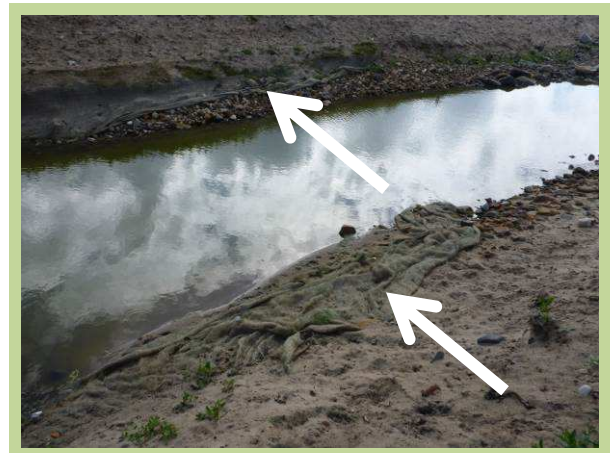
Exposure of geotextile on re-graded side slopes of newly 'daylighted' open channel section (/3201C09)

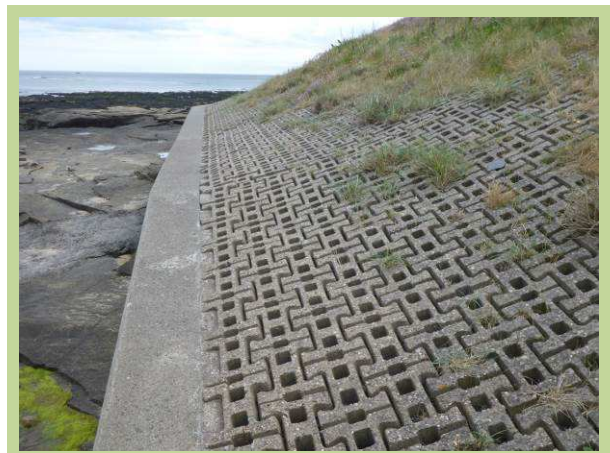
To the south of Cresswell the low concrete wall and interlocking concrete unit revetment is largely in good condition and the area of apparent settlement towards its southern end has not worsened since it was first observed.

Low concrete wall and interlocking concrete unit revetment at Cresswell (/3201C19)

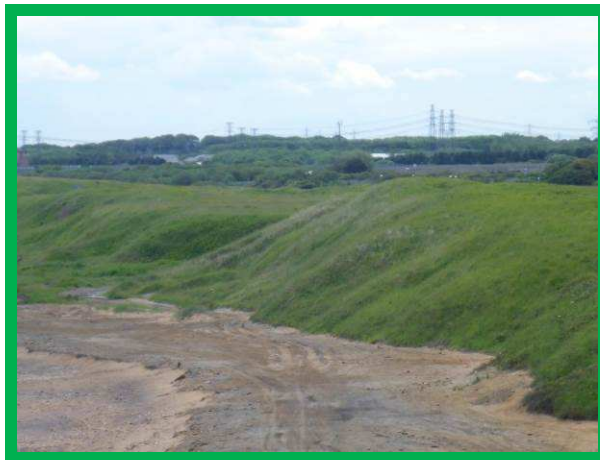
The northern section of Lynemouth Bay comprises a low rock cliff overlain with softer material. There is still evidence of local rock falls in the basal layer and slumping in the softer material, despite the presence of much vegetation on the cliff face. Further south, the protection afforded by the wide spoil beach means that the low cliffs are much more stable, adopting a shallow profile with considerable vegetation cover.

'Dormant' section of cliff protected by spoil beach (/3401C01)

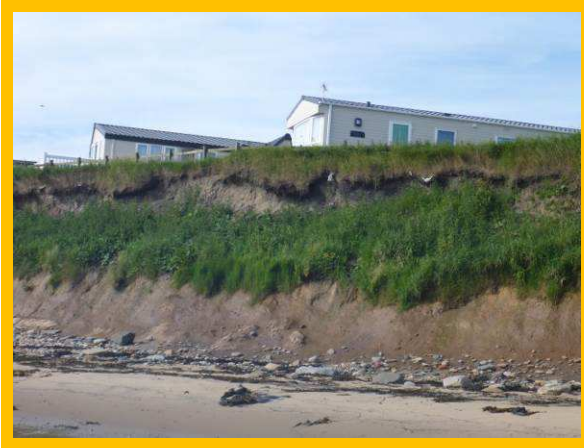
1. The northern section is unprotected by coastal defences or rock platforms and is in poor condition with active erosion continuing through a series of regular local slumps. This has prompted the Caravan Park to erect warning signs along the cliff top footpath and realign short lengths of its boundary fencing.
2. The central section is protected by concrete blocks and remains in fair condition. Despite some localised slumps having continued this section of cliff is considerably less active than the undefended section to the north.
3. The southern section is protected by a rock ledge but, despite this, frequent local slumps remain evident. Two pill boxes are located on the rock ledge and erosion of the surrounding soft cliff material has left these structures perched precariously. However, this erosion has not worsened since the previous inspection.

Active slumping at northern section fronting caravan park (/3501C05)

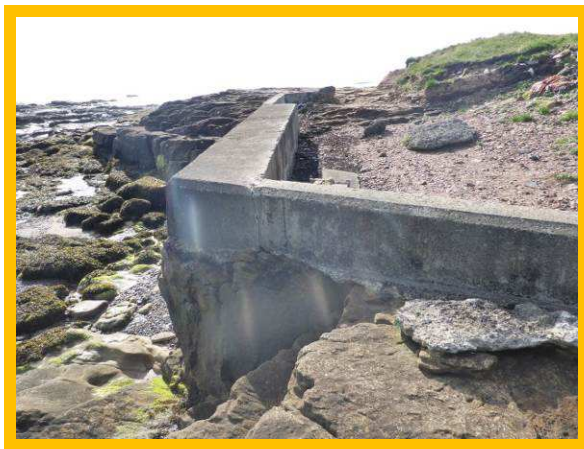
Extending between Newbiggin Point and Church Point is a continuation of the rock ledge, with overlaying softer material, interspersed with a series of ad-hoc defences to 'patch' local areas. At Beacon End a short length of concrete seawall is present which appears in fair condition on the seaward face. However abrasion and initial undermining of the toe was observed as well as undermining of the south return wall, reducing its overall condition to poor. Active erosion, cliffing and slumping of the soft cliff material behind the structure has continued since the previous inspection.

Seawall with undermining and outflanking (/3501C08)

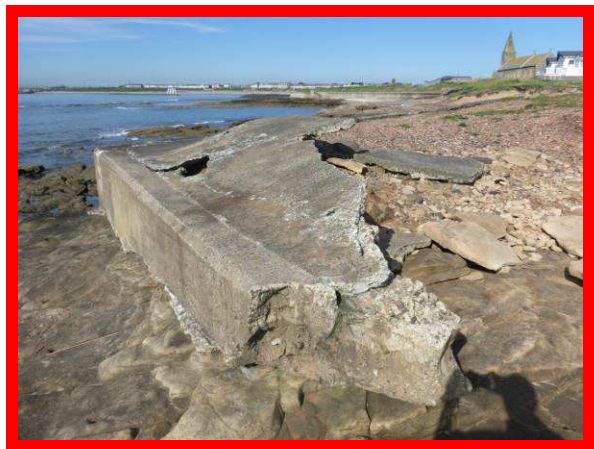
The second length of concrete wall is further south around Newbiggin Point and remains in very poor condition. The tie-in sections are actively breaking-up. Although the damage at the northern tie-in looks recent, this situation was first noted in 2008. Erosion of the soft earth cliffs behind the structure continues.

Seawall actively breaking-up since at least 2008 (/3501C10)

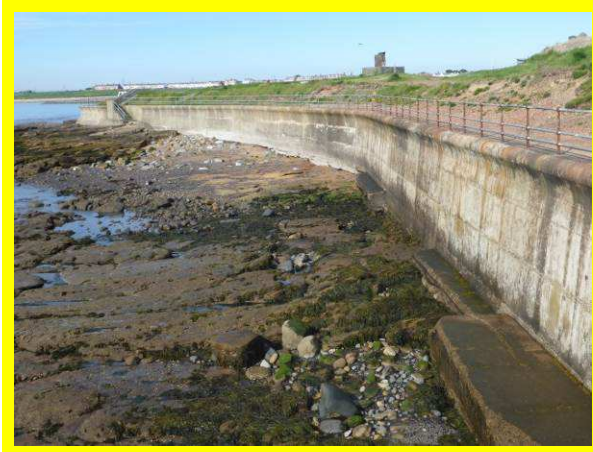
The vertical concrete seawall at Church Point remains in overall fair condition. However, there is a reasonable amount of abrasion at the toe and crest as well as signs of local undermining between the toe and rock slab. There is also erosion of the slope behind the crest and the hand railing is showing signs of corrosion.

Church Point seawall in fair overall condition (/3601C12)

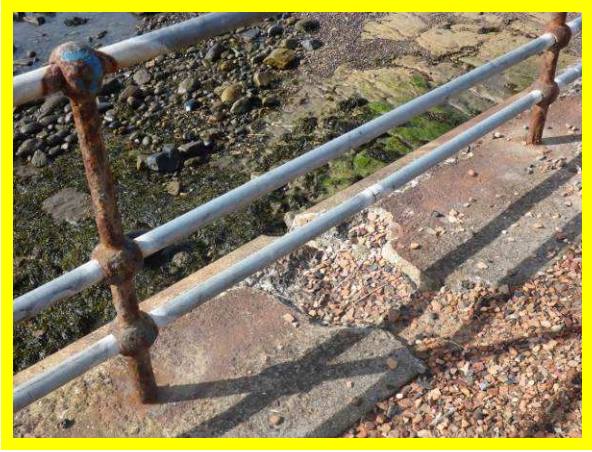
Local crest damage to Church Point seawall (/3601C12)

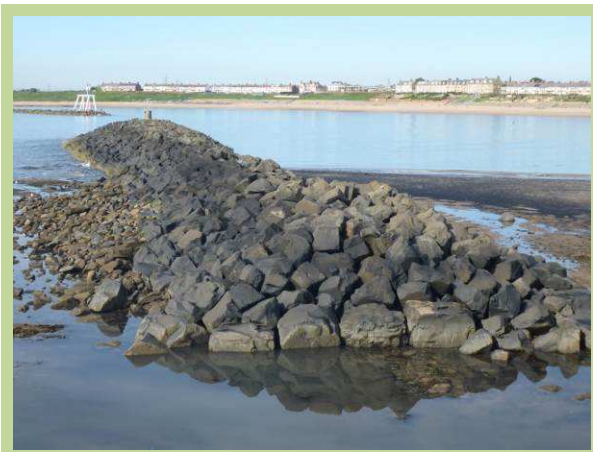
The start of Newbiggin Bay is marked by a rock armour breakwater, built along the edge of Hully Rocks and extending from just offshore of Church Point. This structure is in good condition though there are some smaller rocks displaced across the foreshore on the seaward side. The profile and crest level along the structure appears stable with no signs of displaced rock, toe erosion or settlement.

North breakwater in Newbiggin Bay in overall good condition (/3601C13)

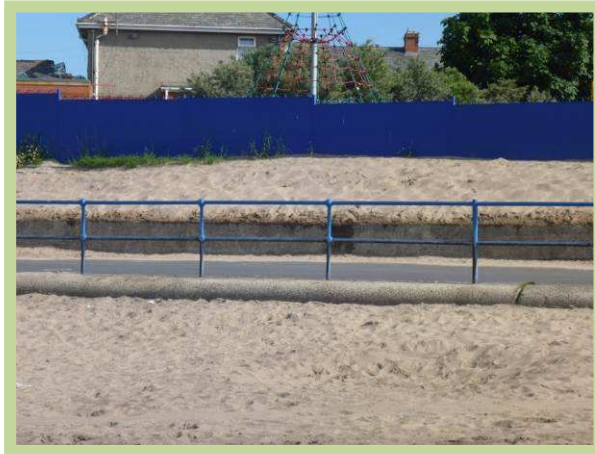
At the south end of the bay the vertical section of seawall is protected by a rock revetment. This revetment is part of the defences that were in poor condition prior to the 2007 scheme, but is now largely buried by high beach levels. Where visible this rock revetment continues to appear in good condition. High beach levels have also resulted in windblown sand on the promenade.

High beach levels and wind-blown sand to rear of promenade in northern sections of Newbiggin Bay (/3601C06)

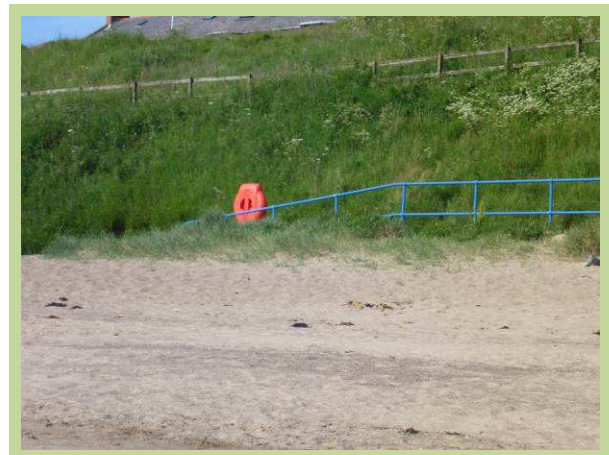
At the south end of Newbiggin Bay the soft earth slopes are largely stable and protected by a wide beach with new dune vegetation growth evident on the foreshore. At Spital Point there is no evidence of new rock falls or slips in the overlaying softer material since the previous inspection.

High beach levels and embryo dune vegetation growth at southern end of Newbiggin Bay (/3601C09)

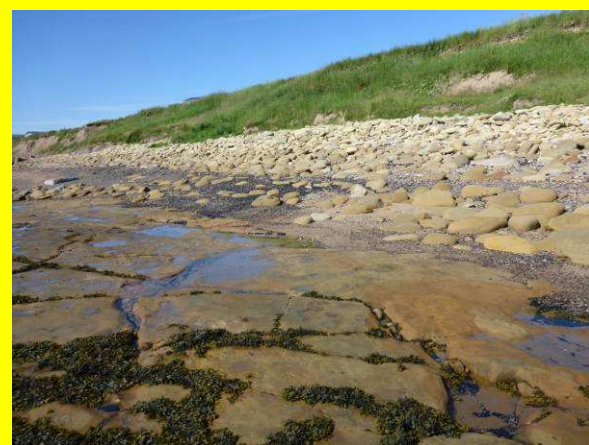
The cliffs directly fronting the northern section of Sandy Bay Caravan Park are relatively well protected by a sandstone boulder berm at their toe and here the seaward face of the slopes are well vegetated. However, further south the slopes and cliffs become more unstable and are actively eroding. In places, recession of the cliff top has occurred to within a few meters of the caravans. There are three near-shore rock breakwaters which have helped stabilise the cliffs immediately in their lee, but erosion recommences immediately to the south. Attempts to slow this using tipped rubble are ineffective and unsightly.

Slopes stabilised due to protection by sandstone boulder berm at toe (/3701C02)
