Cell 1 Regional Coastal Monitoring Programme Walkover Inspection Surveys 2016

Northumberland County Council

Walkover Inspection Surveys 2016

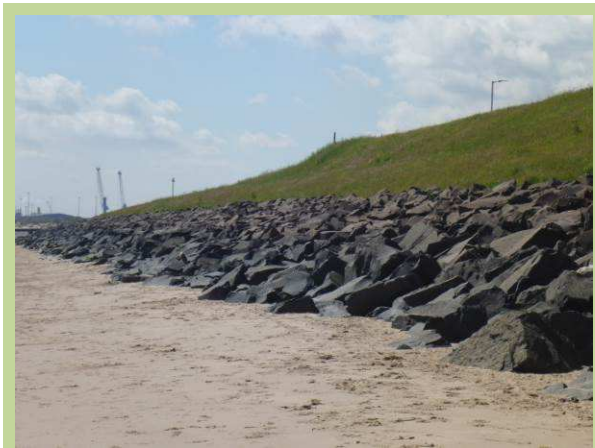
The rock revetment to the south was constructed by private industry to protect the former foundry. This structure remains largely in good condition although displacement of some rocks along the toe was noted. The well vegetated slope behind is generally stable with no signs of erosion, although it is somewhat hummocky in profile. There is a failed and disused outfall pipe across the beach at the southern end of the revetment. After this point, the low earth cliffs to the south of the revetment are experiencing terminal erosion along a length of approximately 100m and are actively slumping along most of their length.

Rock revetment protecting former foundry site (/3901C05)

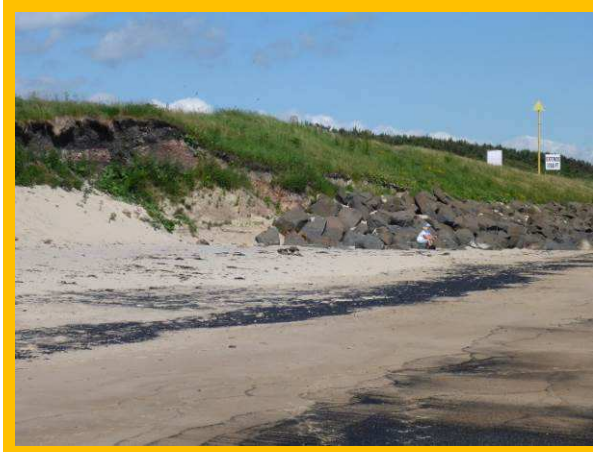
Erosion of cliffs at terminal end of rock revetment (/3901C03)

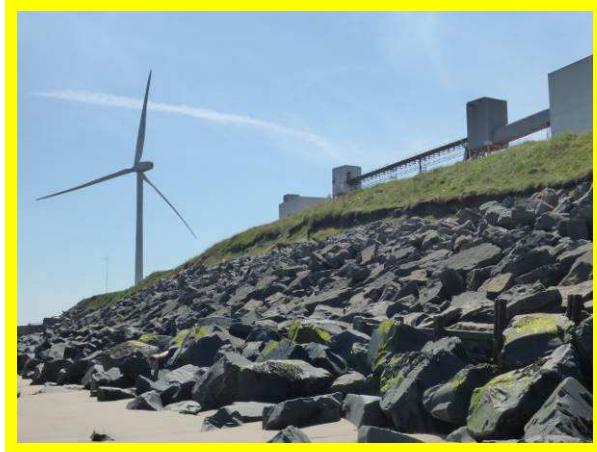
To the south, the revetment changes to a composite structure with large rock armourstone at the base separated from the smaller upper armourstone by steel breastwork. This breastwork is largely in a poor condition with extensive corrosion and numerous failed members. Some erosion and slumps are apparent in the cliffs behind the revetment crest with dumped construction waste and smaller tipped rocks at the crest in an attempt to protect these sections.

Composite defence with corroded steel breastwork (/4001C02)

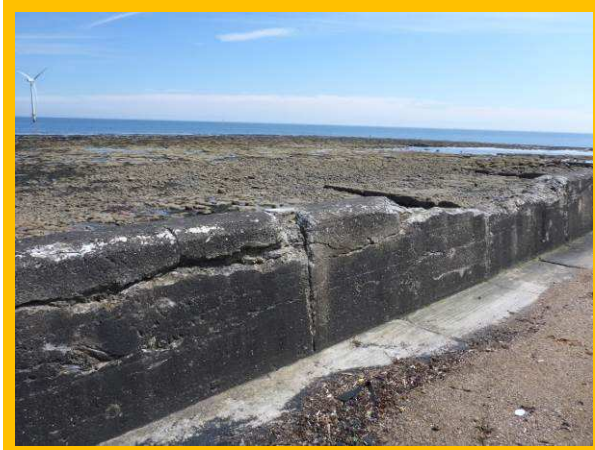
Access to the deck of the southern section of Blyth East Pier was not possible at the time of the visit so this structure was inspected solely from the foreshore as far as the tides allowed. The structure is generally in fair condition with no noticeable signs of undermining at the toe or movement in the sub structure or superstructure. However, significant corrosion was occurring to the majority of the trestle legs with concrete spalling and staining apparent. The timber decking was worn with the onset of rot around fixings of some boards and a number of boards missing. The timber edge beam was missing in one location causing collapse of one section of hand railing.

Damaged crest wall and deck of landward section of Blyth East Pier (/4001C04)

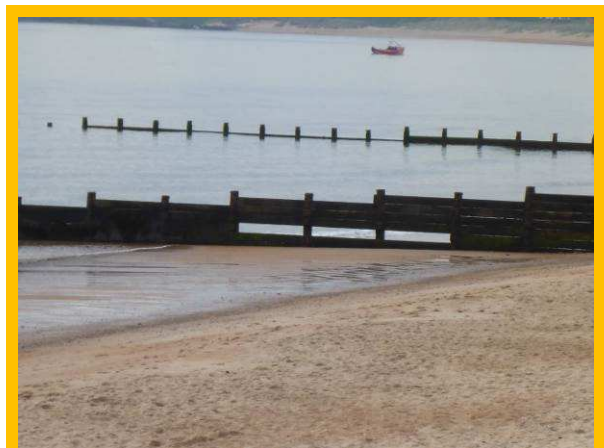
The three timber groynes remain in poor condition, with missing timber planks, arson damage and many sizeable gaps. Beach levels are relatively low in the lower and middle beach with accretion of windblown sand in the upper beach along the toe of the dunes.

Missing timber planks on groynes (/4201C07)

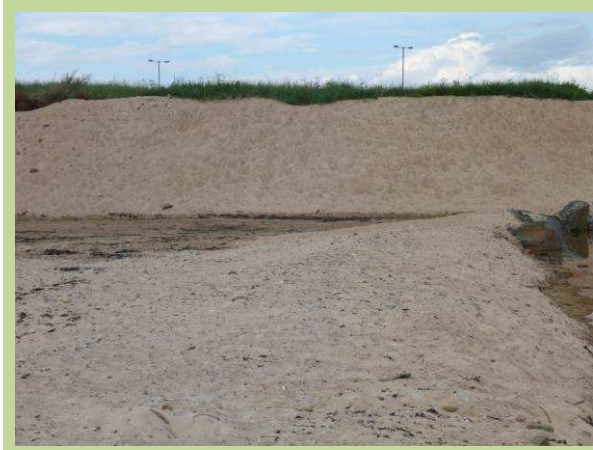
The dune stabilisation works in 2015 continue to be effective, with the sand-filled geotextile bags placed at the toe of the dunes along the south flank of Meggie's Burn remaining covered (or having been recovered) with emplaced beach sand. It is known from previous visits to the site that the course of the burn did come close to the toe of these dunes and expose some of the geotextile bags, so it is likely that some intervention has been undertaken. It is known that in 2016 some rock armourstones have been placed in attempt to train the course of the burn and keep it away from the toe of the dunes. Christmas trees have been placed just to the south of the area benefiting from the previous works in further attempt to help stabilise this section.

Stabilised, replenished and re-profiled dunes near Meggie's Burn (/4301C01)

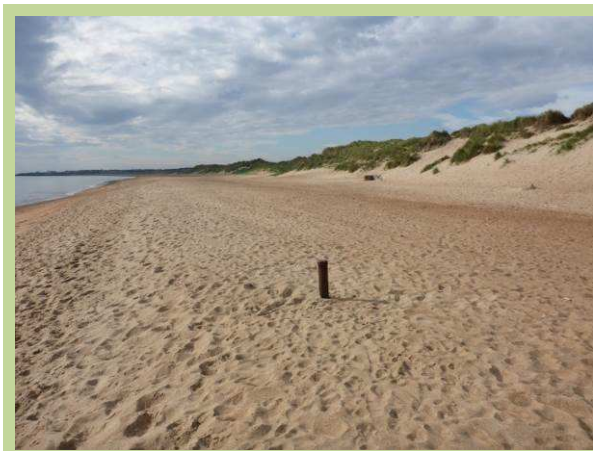
Further south at the centre of the bay, the beach remains very wide and healthy and this is to such an extent that the dunes are not affected by marine processes at the present time. Some new vegetation growth along the toe of the dunes continues. This is likely to be a natural recovery following storm damage over the winter of 2009/10. At the two areas in the centre of South Beach where sand-filled geotextile bags have been used to stabilise the dune toe there was wide, healthy beach volumes and no visible signs of dune erosion.

Very wide and healthy beach protecting dunes in centre of South Beach (/4301C02)

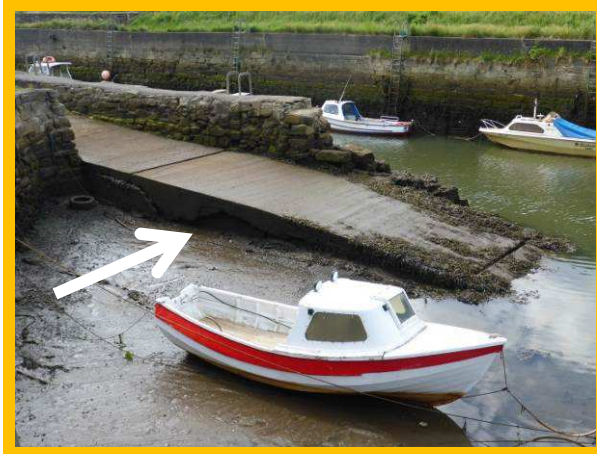
The wall along the inner north bank of the harbour includes a boat ramp. This ramp remains in poor condition with missing blocks on the outer side and some movement apparent. There are also large gaps in the joints at the top and bottom of the ramp suggesting that some settlement may be occurring and there is undermining on the inner face at the toe.

*Undermining at toe on inner face of boat ramp
(/4401C05)*

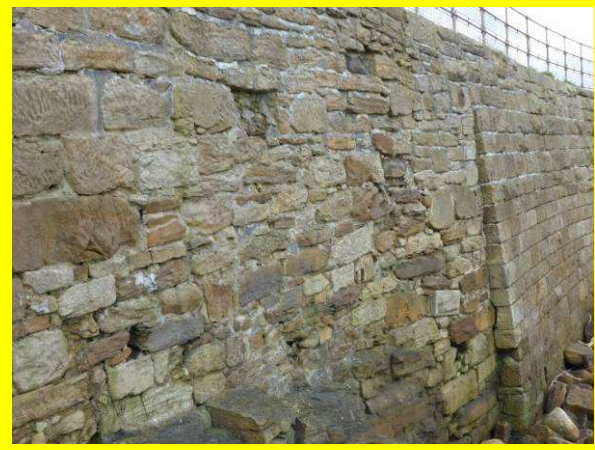
Extending eastwards from the pier, along the northern side of Rocky Island, is a length of masonry sea wall fronted by a rock platform. There is missing mortar and gaps between blocks along much of its length. In one or two areas there are missing blocks and in many locations there are abraded blocks. On the landward side of the wall the poured concrete slurry continues to break up and soil erosion of the land is continuing.

Missing mortar and gaps between blocks
(/4401C11)
