**Cell 1 Regional Coastal Monitoring Programme
Coastal Walkover Inspections 2010**

**North Tyneside Council
Final Report**

October 2010

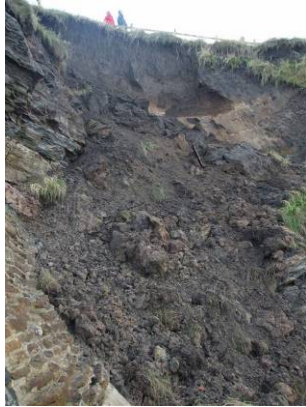
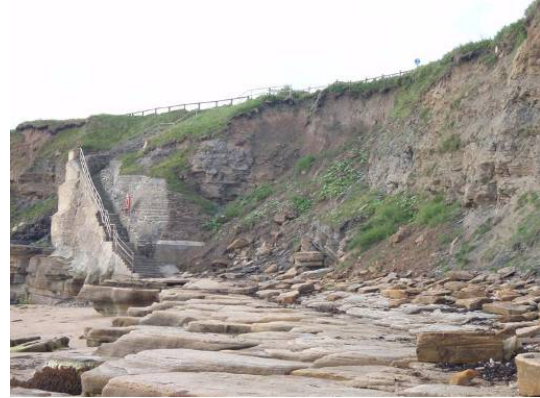
The northern boundary of North Tyneside Council's frontage is part-way along Hartley Cove. A local slump occurred in the soft material immediately adjacent to the foreshore access steps in Hartley Cove around November 2009 (below left). This affected the top edge of the footpath and resulted in some areas being temporarily fenced-off. Evidence of this slippage remained by the time of the August 2010 inspections (below right).

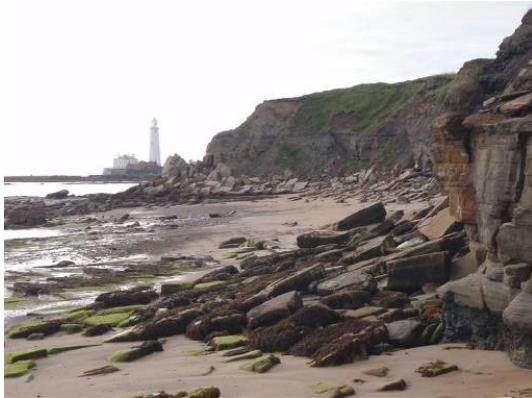
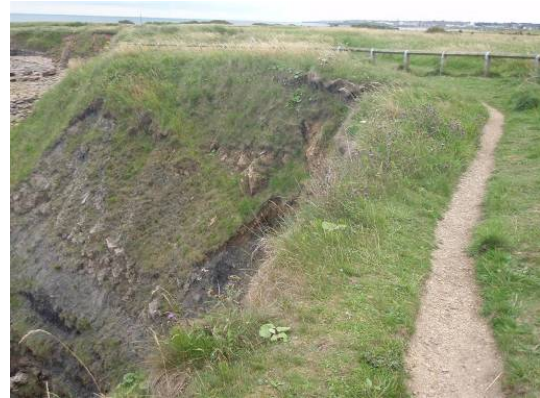
In addition, the undefended cliffs between Hartley Cove and Curry's Point are subject to both rockfalls in the harder material (below left) and slippages in the overlying softer material (below right). This has in places resulted in narrow sections of footpath being relocated inland along more defined paths and low-level fencing used to keep walkers away from the most vulnerable areas.

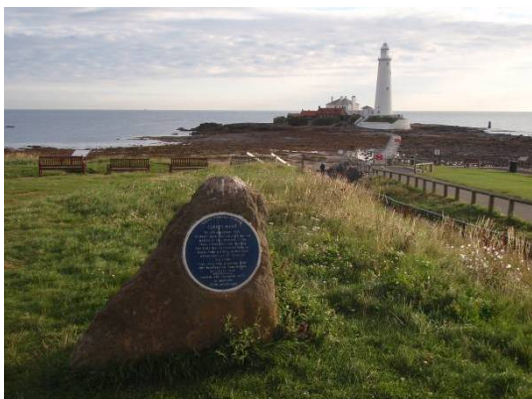
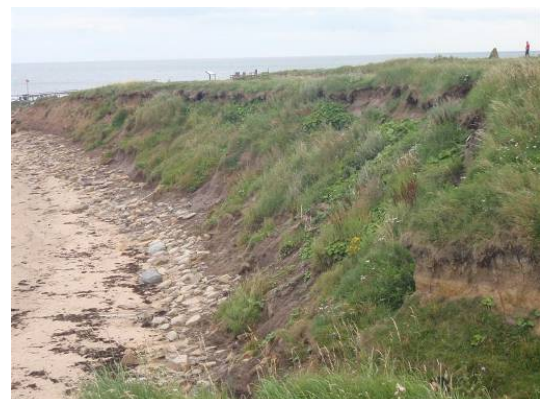
With progression south, towards Curry's Point (below left), relict slippages are evident along much of the cliff line (below right).

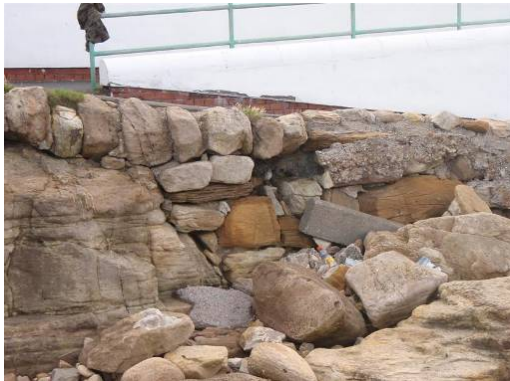
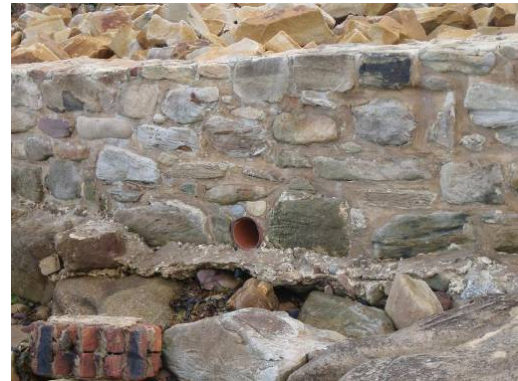
The buildings on St. Mary's Island are generally well protected by a variety of defences, although the low masonry wall on the western side, fronting the residential properties, suffers from voiding caused by loss of masonry, vegetation growth through the structure and, in places, undermining (below). Despite the loose bonding in places, the wall does not appear to have significantly deteriorated since the 2008 inspections. The set of small concrete access steps is heavily abraded and voided.

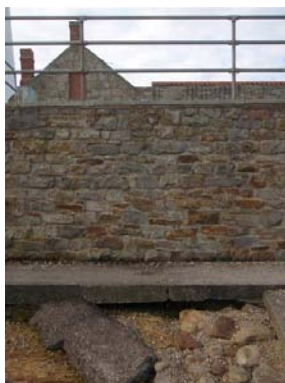
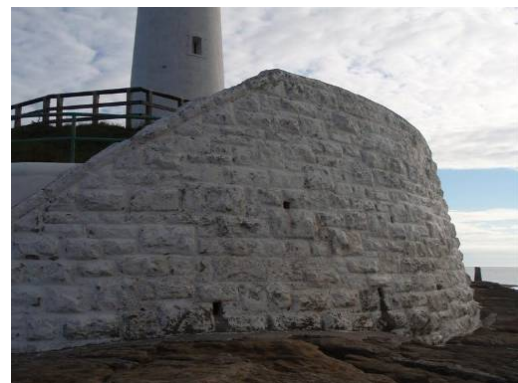
The masonry wall on the north-facing corner of the island is undermined in one place (below left), but this does not seem to have deteriorated since the 2006 inspections. There are several old, abraded, concrete outfall structures extending from the island across the rocky foreshore. The remaining walls on the island, which protect the lighthouse, remain in fair condition with no structural problems observed, although the whitewash has deteriorated since the 2008 inspections (below right).

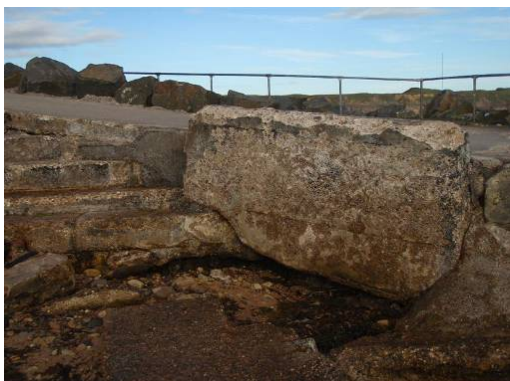
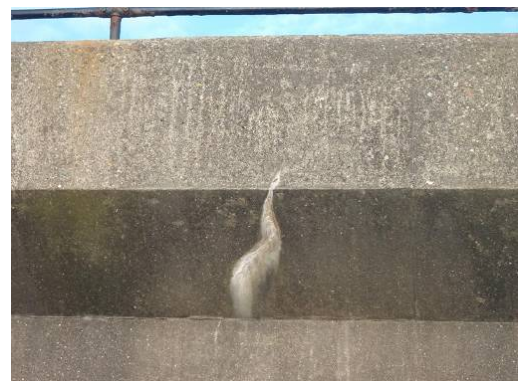
At the landward end of the causeway on its southern side, there is a set of steps joining the causeway to the Trinity Road Sea Wall. At the junction between these steps and the causeway, there is some undermining (below left), although this does not seem to have worsened since the 2008 inspections. The Trinity Road Sea Wall is generally well maintained, with evidence of previous infilling of cracks and joints (below right).

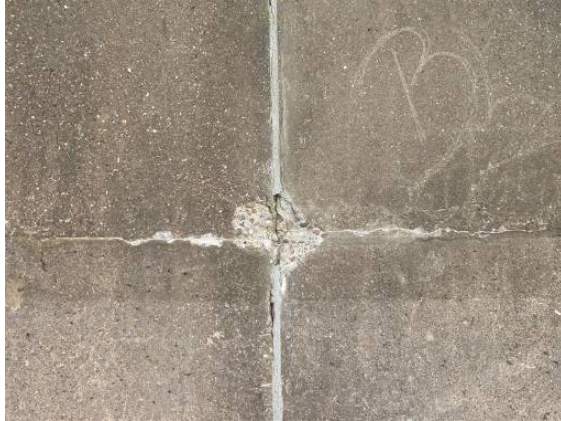
There remains some minor ongoing abrasion, especially where joint sealant has been washed-out (below left), which would benefit from ongoing routine maintenance which presently would only need to be of a minor nature. The main issue with the Trinity Road Sea Wall, however, is the continued outflanking at its southern end (below right). If the undefended cliffs to the immediate south of the wall continue to cut back behind the rock armour and seawall structure, there could be more major problems caused by outflanking and therefore a more immediate remedy to this ongoing problem is recommended.

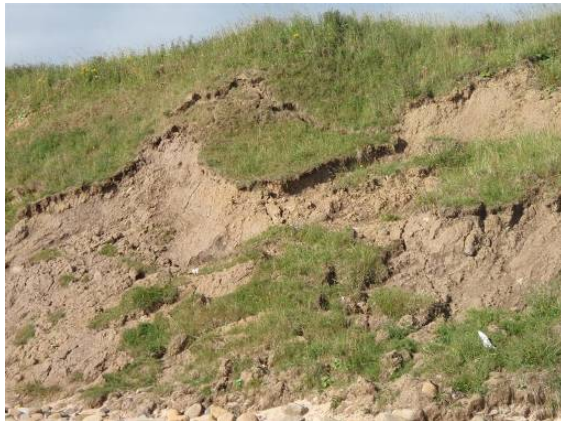
The undefended sea cliffs at the northern end of Whitley Sands are actively slumping (below left) despite the presence of a relatively high boulder beach at their toe which sits on top of the sandy foreshore. As this erosion continues, the cliffs release material, including boulders, to the foreshore (below right). This process also cuts the cliff top back, through successive slumping failures, closer to the footpath. In time, this process will start to affect the seaward edge of the Briardene Car Park and the municipal golf course. Some sections of the undefended cliff are prone to imminent slumping since the soft material is extensively cracked.

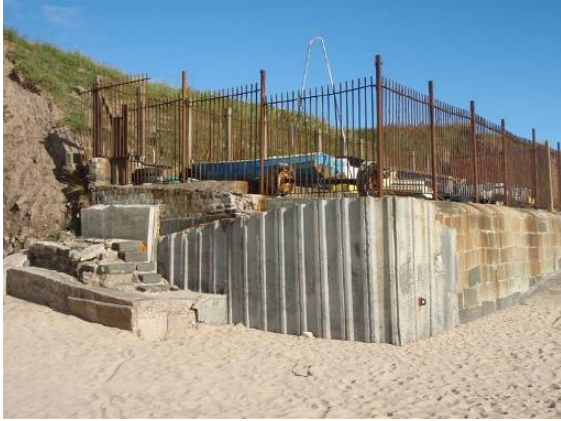
The stone blockwork wall fronting the boatyard along the otherwise undefended cliffs has received some repairs at its southern end since the last inspections in the form of concrete fill, using steel sheet piles as temporary works, following a large failure of this section (below left). Some minor unravelling of the structure continues at the southern end. In contrast to the 2008 inspections, which occurred after an intense rainfall event, the Briardene Burn was barely discharging across the foreshore at its mouth (below right). The rainfall-induced damage previously reported to the access path down the northern bank of the burn has been satisfactorily repaired, as has the previously-reported damage to the timber boardwalk.

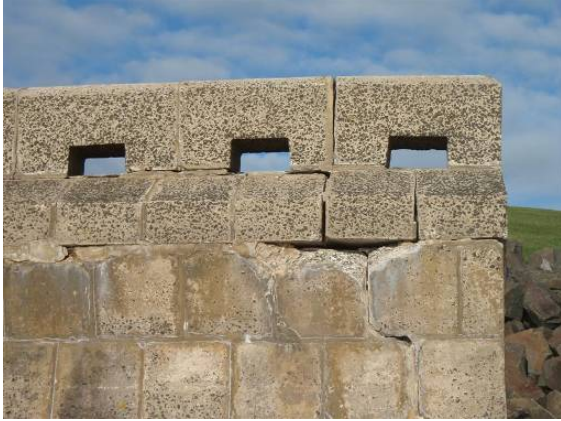
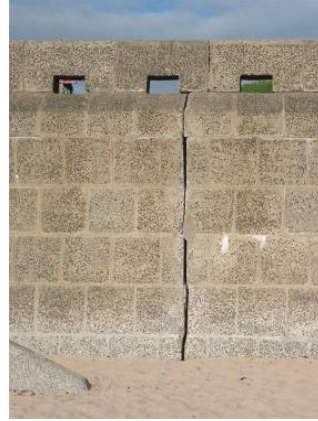
The Whitley Links Sea Wall extends in front of the Northern Promenade and whilst being in an overall fair condition, would benefit from some medium priority maintenance to infill cracks (most notably between the wall and its coping; below left), reseal gaps at vertical construction joints, and repair abrasion damage. During the present inspections, beach levels at the toe of the wall were very high, so only the upper sections of the structure could be visually inspected. Some previously-photographed defects, such as to the coping stones at the very northern end of the wall, have not been addressed since the 2008 inspections. There are also now some full-height gaps in the wall at construction joints (below right).

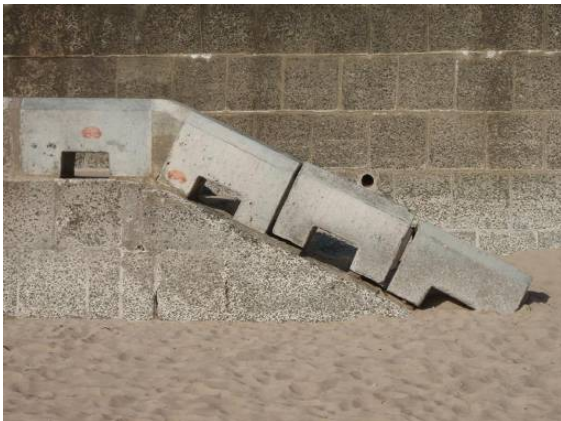
The worst affected areas are generally where there are access steps or access ramps from the promenade to the foreshore. Many of these structures have been repaired since the 2008 inspections but in some areas those repairs are now damaged (below left) and several other areas are in need of attention otherwise further failures of the coping will occur (below right).

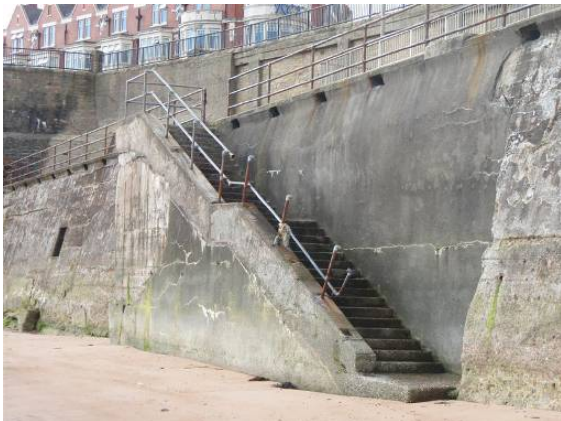
The access steps down this wall have missing handrailing (below left), and the wall crest has, in places, notable cracking (below right).

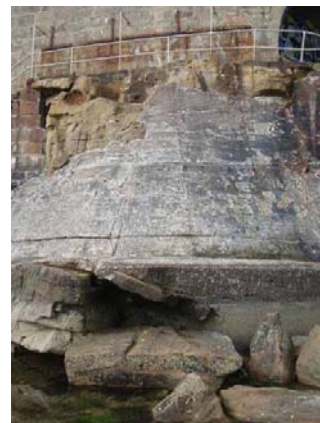
The concrete blockwork and masonry wall initially is arched (below left), with abrasion at the toe at the northern end. The bullnose is becoming undermined (below right) and the disused access steps are in a very poor condition and now fenced-off to the public.

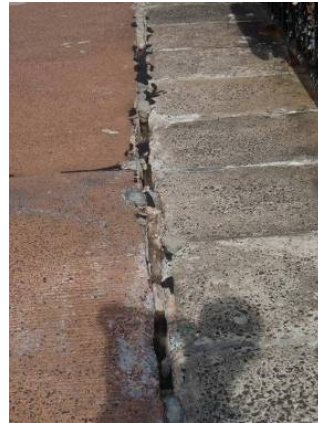
As the wall fronts the Southern Lower Promenade it is generally in fair condition (below left), although the incidences of gaps between the wall and the promenade deck increase to the southern end (below right). There are also cracks and small voids in the promenade deck, areas of damaged or missing kerbing, and one area where only temporary fencing is installed to fill a gap left by missing handrailing.

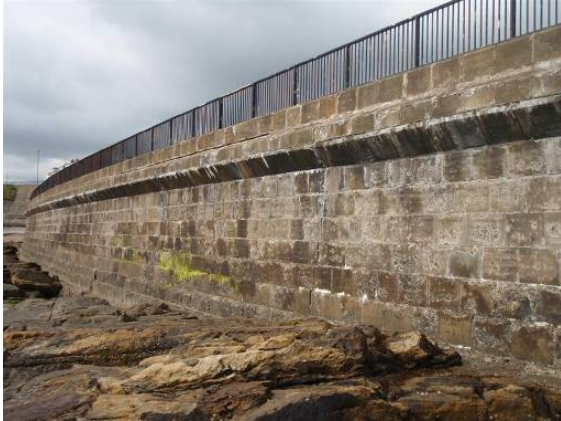
Brown's Bay has two separate sections of seawall. In the northern part of the bay, the wall is generally in fair condition (below left), although the cracks, joint gaps and abrasion around joint gaps increase in frequency to the south. The high beach levels at the time of the survey meant that the abrasion previously reported to the access steps at the southern end of this wall could not be observed. The southern wall is also generally in fair condition, although there is one area of toe undermining towards the southern end (below right). The rock netting to the cliffs behind the wall remains in good condition.

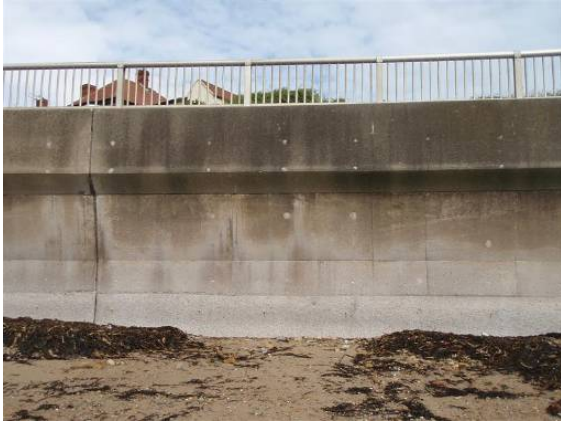
There are three sections of sea wall extending southwards to meet the North Pier of Cullercoats Bay. The first section is a concrete recurve wall in good condition (below left), although there is abrasion at the toe of the access steps. The mid section is a concrete blockwork wall which again is in overall good condition, but the poured concrete apron is being undermined in places (below right). There has been some deterioration in condition since the 2008 inspections since the toe apron is now in places breaking up, with concrete debris remaining on the foreshore and medium urgency maintenance would be beneficial.

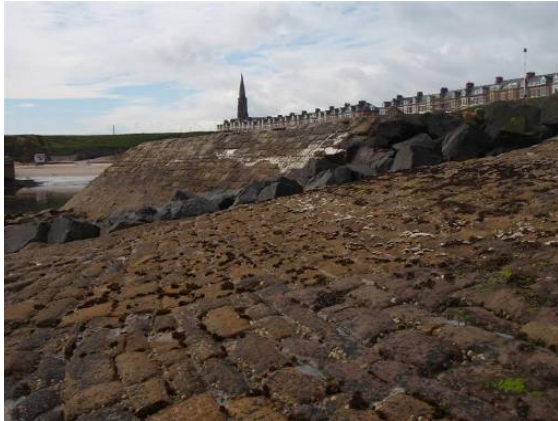
The North Pier has previously been breached during a storm, and the breach was subsequently infilled with rock armour (below left). The pier can significantly be over-washed during high spring tides that combine with storms. The concrete apron at the seaward toe is being undermined and there are several missing or settled blocks, and gaps between blocks, on the seaward face. There may be the onset of voiding adjacent to the previous rock armour repairs, part-way up the face to the northern side of the seaward-facing repair (below right). The leeward face is in better condition, although suffering from abrasion, especially around the head.

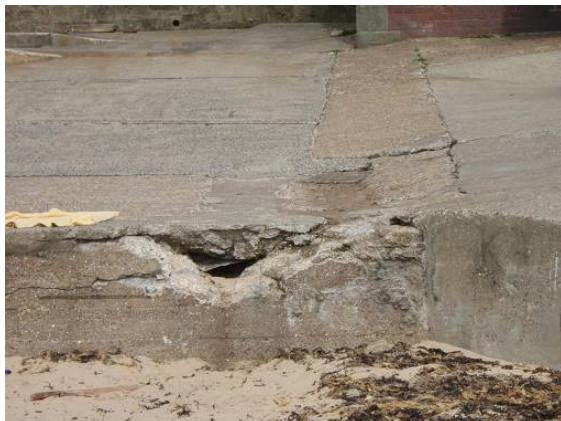
The wall fronting the lifeguard station in the north of the bay is in fair condition, but the lifeboat access ramp is starting to become abraded at the edges. The low wall fronting the sloping concrete area (below left) and the seaward end of the main pedestrian/vehicle access ramp to the bay (below right) are cracked and voided and in need of fairly urgent repair due to their continued heavy use.

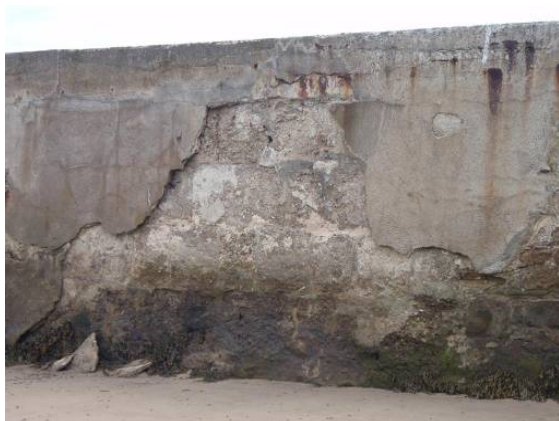
The South Pier remains in poor condition, with render breaking off the leeward face of the structure and laying on the foreshore as debris (below left). Other sections have the render 'bowing' away from the wall. In areas where the render is no longer present, the reinforcement bars are often exposed, and in one area a void has opened in the face (below right).

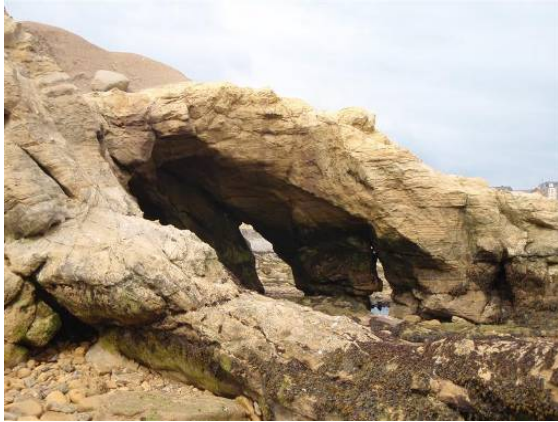
The cliffs around Tynemouth North Point have arches and caves at their base (below left). There is one area near the landward root of the headland on the southern side where there has been a minor rockfall (below right), otherwise there have been the characteristic occasional local slumps in the overlying softer material.

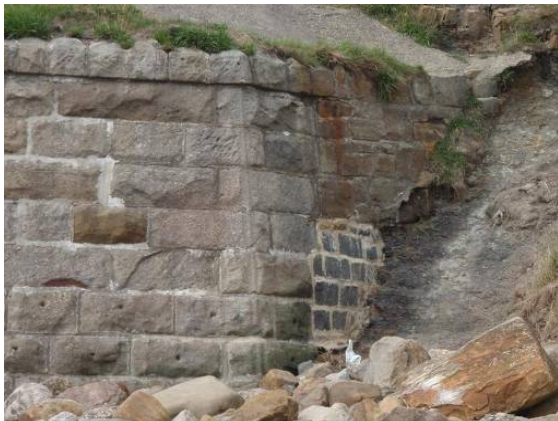
The large gap previously identified at the northern end of the masonry wall in the north of Tynemouth Longsands has been repaired (below left). There is one area, however, where part of the concrete toe apron has now broken away (below right).

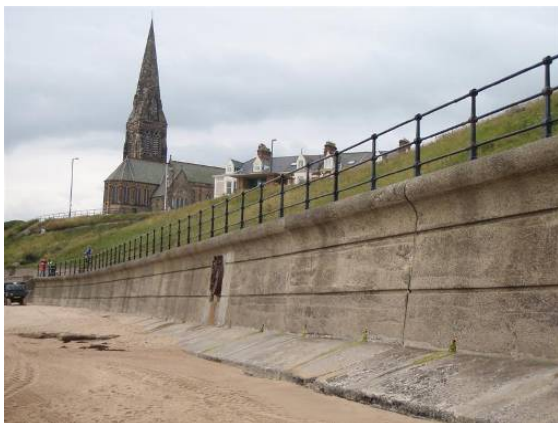
The sea wall protecting the promenade and vegetated coastal slope remains in fair condition despite some abrasion (below left). Along the neighbouring sloping blockwork revetment, there is some damage to the crest of the splash wall, although the structure overall remains in fair condition (below right).

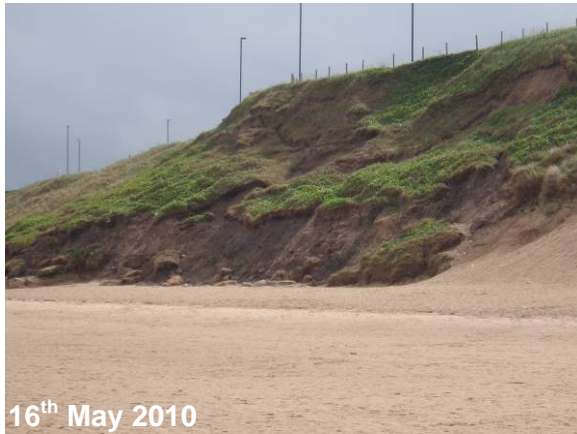
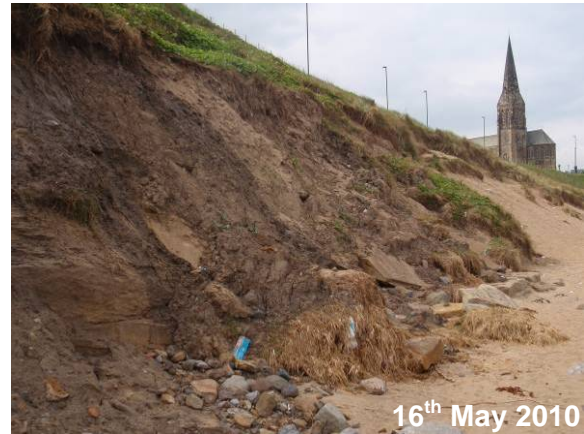
The undefended dunes along Longsands experienced notable erosion during the winter of 2009/2010, as shown in the pictures below from 16th May 2010.

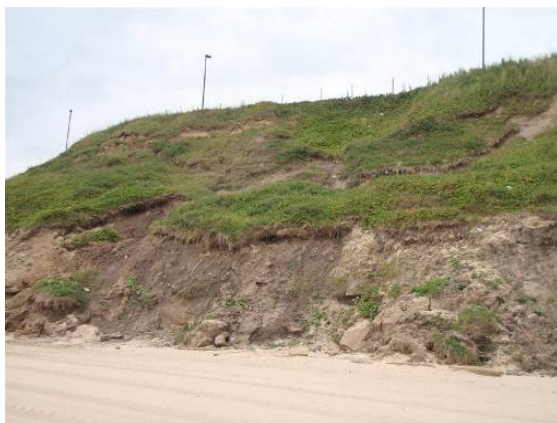
During the 2010 inspections, beach levels at the toe of the dunes were high which has helped the dunes to stabilise (below left) or recover, although in the worst affected area slumps in the face of the dune remain visible and just south of there a distinct 'clifflet' remains at the toe of the dunes (below right). The erosion that was recorded, and the subsequent general recovery, is characteristic of the interactions that occur between beaches and dunes during different seasons and is within the bounds of usual behaviour, although the erosion was particularly notable because of the severity of the winter 2009/10 storms.

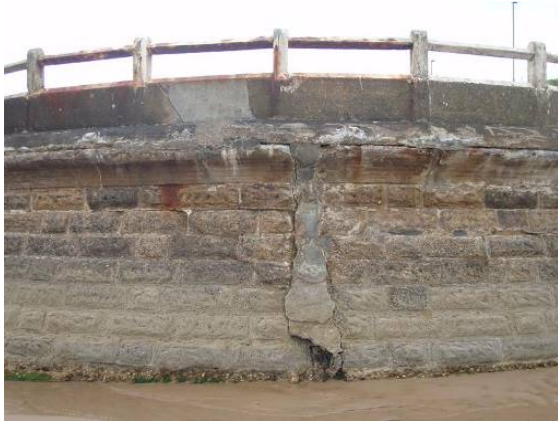
Around Tynemouth Pool, the wall on the northern-facing side has cracks and some previous repairs are now coming away. The eastern- and southern-facing walls mainly suffer from abrasion and cracks at the join between the masonry wall and the concrete wave return wall.

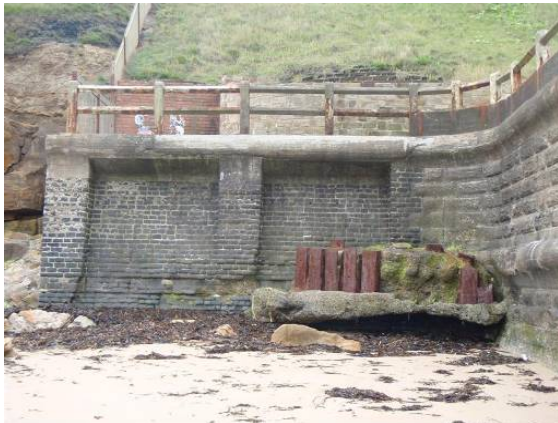
The short section of wall at the southern landward tie-in has its concrete apron cantilevered off the foreshore (below), although the wall behind appears sound.

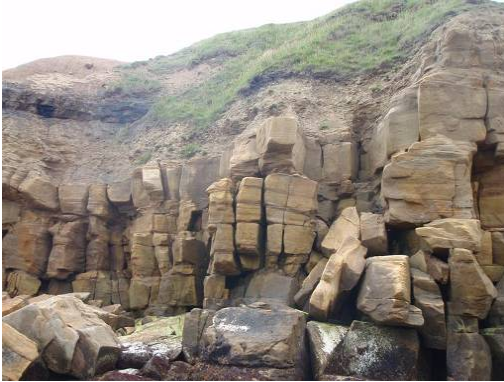
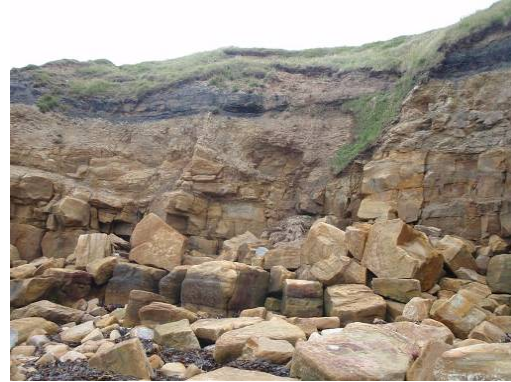
The cliffs around Sharpness Point are highly fractured and have experienced several rockfalls (below left). Some failures are known to be relatively recent due to the presence of dying vegetation in clumps of softer material which has slumped following a lower level rockfall (below right).

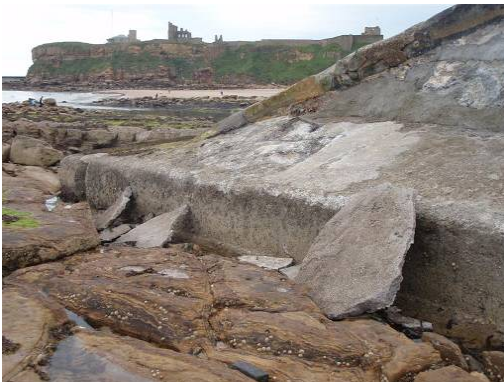
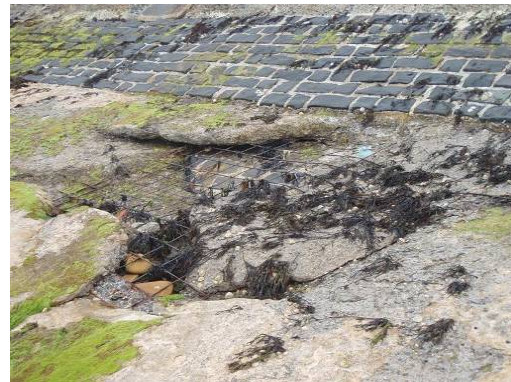
The sea wall that protects the Lower Promenade in King Edward's Bay has at its northern end a concrete apron tie-in to the cliffs of Sharpness Point. This apron has concrete breaking off in flakes and being deposited on the foreshore (below left). The main body of the wall appears to have received some patch repairs since the 2008 inspections, but there are still considerable areas of abrasion at the toe and on the sloping revetment face, in places exposing the reinforcement bars (below right). The access steps at the southern end of the wall are heavily abraded.

There is also an urgent need for maintenance to repair the failing structures at Sandy Goit, and the damaged structures in King Edward's Bay.

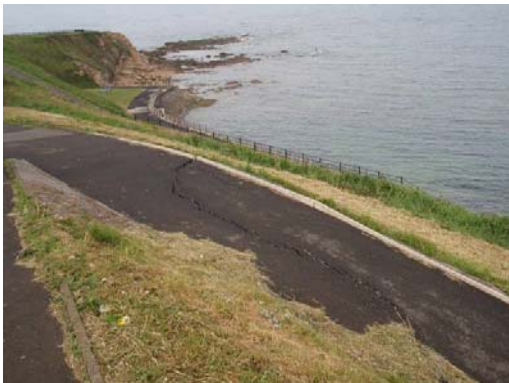
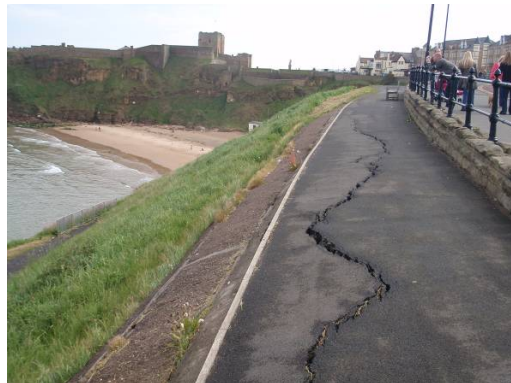
Although the backing slope appears stable, there is evidence in the pathways of cracking of the asphalt which may be indicative of some slope movement (below).

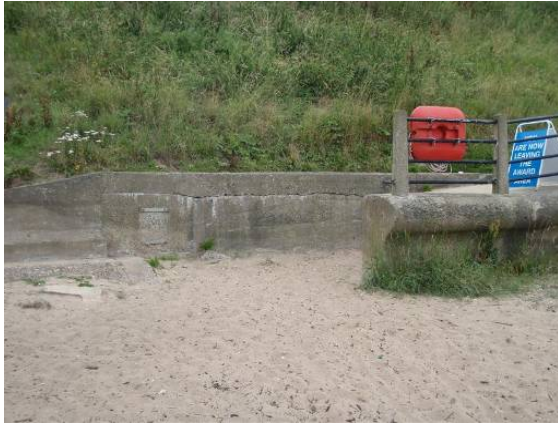
There is a longitudinal crack in the wall at the rear of the access slope near the lifeguard station (below left), and missing bricks at the short set of access steps (below right).

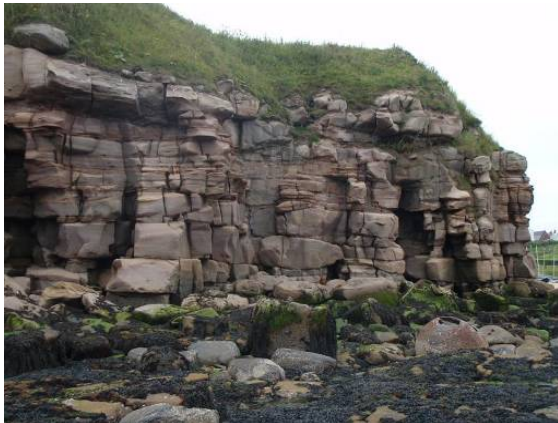
The rock headland Freestone Point is highly fractured but only experiencing occasional very local rock falls (below left). The arched retaining wall is in fair structural condition, although there is some abrasion and flaking of render (below right).

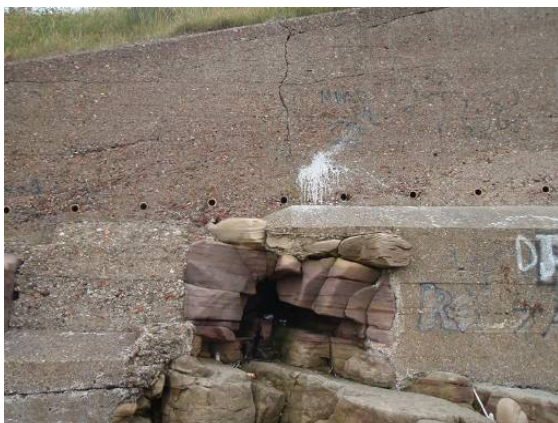
The adjacent masonry wall, however, has blocks missing from the toe (below left) and outflanking at its southern end (below right), leaving it in poor overall condition.

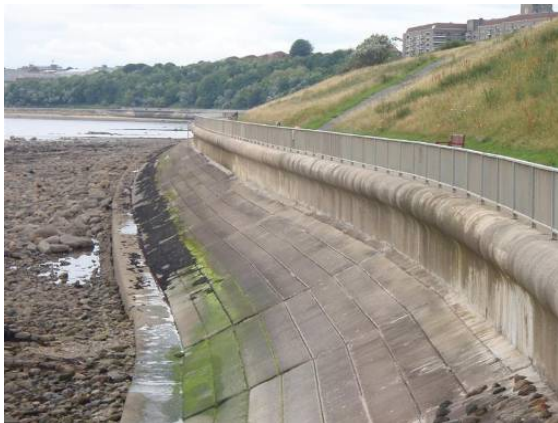
The concrete sloping revetment with a concrete toe wall (below left) that runs along the riverside towards The Flats is generally in a fair condition, although there are gaps between revetment panels along the eastern section of defence, and then increasing incidences of abrasion damage to the toe wall in particular (below right) but also the crest of the structure with progression upstream along the western section of defence.

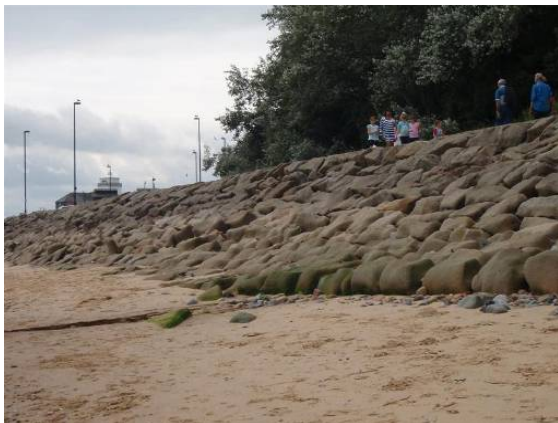
The rock revetment (below left) extending to the jetty downstream of the Fish Quay suffers from settlement of rock and in places the concrete slurry that has been poured to address this is now being undermined and in places breaking up (below right).

121AA901 A4801C10	Low Lights	Revetment	routine	2012	improve condition through maintenance	Maintenance/repairs to revetment.
