Northumberland and North Tyneside Coastal Monitoring Programme

Defence Inspection Overview 2008

September 2008
Inspection Report
9S0776

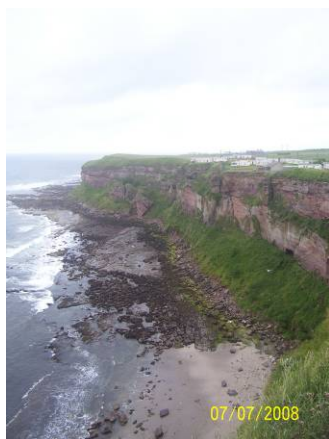
There is erosion at the toe of the cliff throughout the Needles Eye frontage and localised erosion of the soft vegetated slope on top of the rocky cliff. An outfall from the industrial estate to the north of Berwick-upon-Tweed

has been constructed in this unit. The current inspection noted no significant change, with continuing slow erosion and slips. The SMP2 highlights future possible failure due to the caving of the under-cliff. This is not anticipated to create any immediate threat to assets.

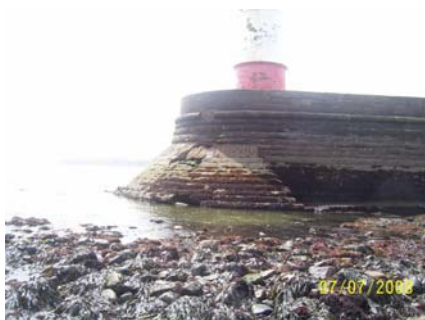
The North Tweed Breakwater is generally in moderate condition as identified in the recent Babbie study. At the head there has been actual loss of masonry with movement in other areas. Urgent action is considered necessary here to prevent more major damage over this next year. Repairs are still required to the southern face of the breakwater, particularly in the area where a previous encasement is being damaged by outflanking.

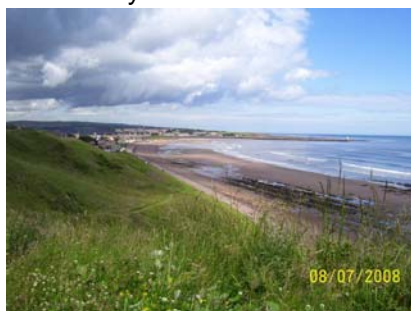
The survey data has shown continued variation in erosion and accretion along the river frontage behind Spital. This is reflected in the observed erosion of the dune line behind the point and the increased nose of sand at the head of the point. There is good evidence linking this behaviour to change in position of the channel between Sandstell Point and the North Breakwater. This influence and variation would also appear to extend over the northern half of the Spital open coast frontage.

At present the erosion to the rear of Spital does not significantly increase flood risk to the area. However, management of this in the future needs to be considered in relation to management needs over the whole section of the coast.

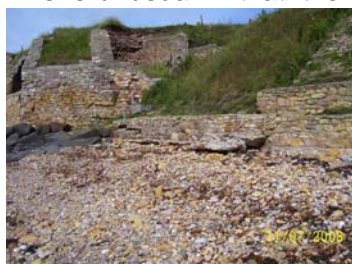
To the north of the harbour, there has been slightly greater erosion than noted in 2006. This is unusual in that it is one of very few areas of the Berwick coast that appears to have suffered more significantly. In particular in this area, just north of the harbour the small masonry wall protecting the back of the Lime Kiln has suffered undermining. This requires repair so as to prevent a more severe problem developing.

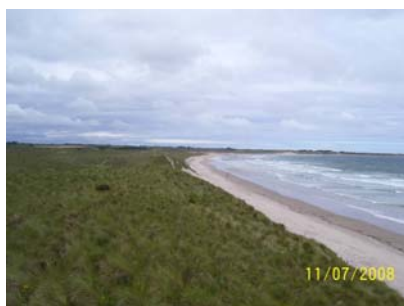
There appears to be relatively limited pedestrian damage to the dunes considering the high usage of the beach. Again, the use of fencing appears to be working well in limiting pedestrian movement through the dunes. There is evidence however of localised minor erosion and loss of vegetation at the toe of the dunes. While not fully repairing itself from the observed erosion in 2004 and 2006, the 2008 inspections show no greater erosion of the main dunes.

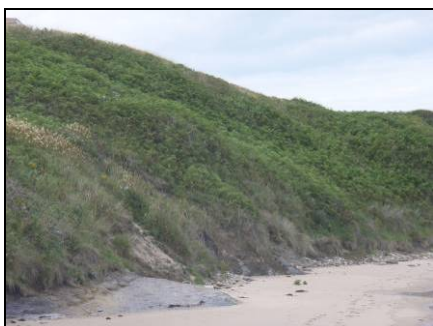
Furthest north (below left), immediately south of Birling Carrs, the first zone contains dunes that are relatively stable as indicated by their shallower seaward profile and dense vegetation. Occasional outcrops of hard rock at the toe of the dunes indicate a controlling influence on the dune toe. South of here the second zone contains dunes which are more actively eroding, with recent slumping evident (below right).

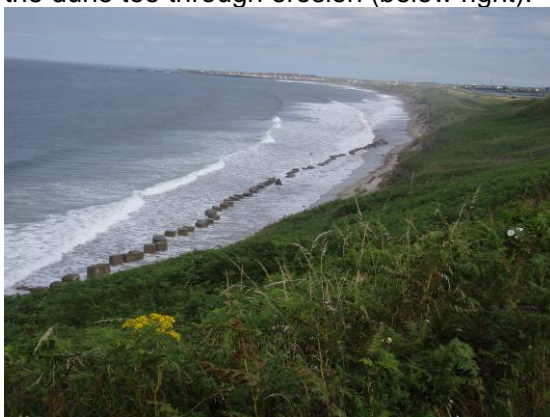
These dunes are protected to a degree by concrete anti-tank blocks along the foreshore, set away from the dune toe at their southern end and gradually tapering in towards the dune toe at the north (below left). In one location, underlying clay has been exposed at the dune toe through erosion (below right).

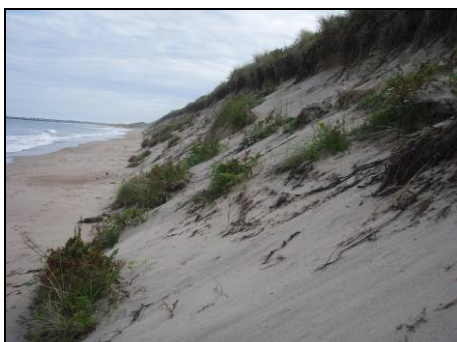
With progression south towards the southern end of the anti-tank blocks, the dunes are continuing to erode quite notably, with recent slumps evident (below left) and clear signs of erosion setting back the dune crest position, exposing bracken roots (below right).

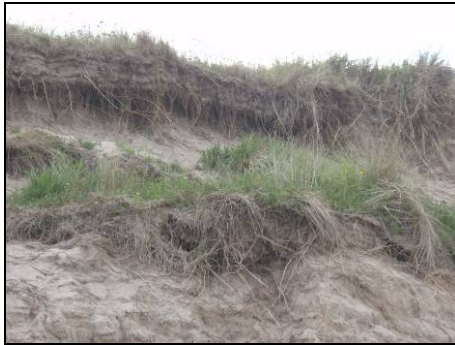
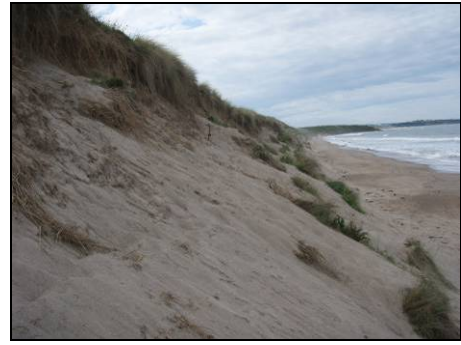
There is then a third zone unprotected by concrete anti-tank blocks where the dunes are steep, high and bare of vegetation on their seaward face, exhibiting signs of recent and ongoing erosion. Clumps are being eroded from the dune crest and sliding down the seaward face (below, left and right).

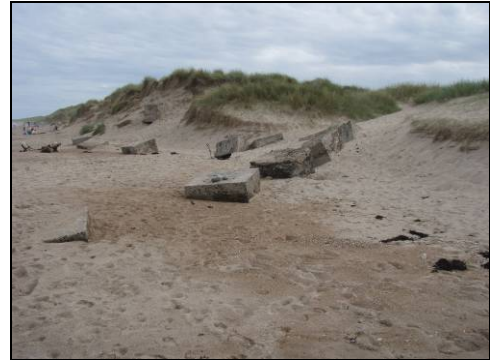
Further south, a fourth zone is characterised by notable erosion around a public beach access point. Here concrete anti-tank blocks have been placed at the dune toe (right).

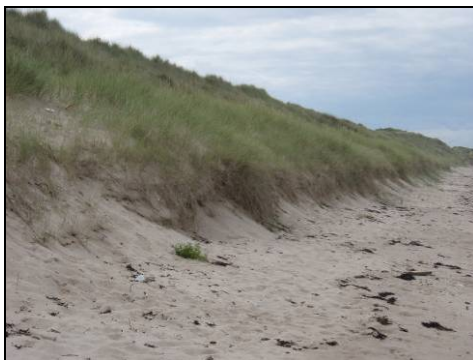
A fifth zone is then characterised by somewhat more stable dunes, although they are exhibiting some signs of undercutting and cliffing at the toe due to wave action (below left), and are also affected by erosion around informal access points (below right).

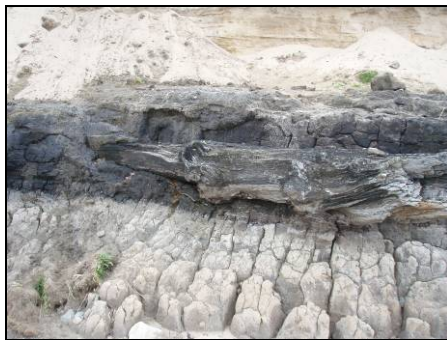
Along Togston Links to Hadston Carrs, the dunes are continuing to erode in localised sections on their seaward face through ongoing processes of slumping. This has exposed a dead animal carcass in the upper section of dune (right). The localised erosion to the immediate north and the immediate south of the piped outlet has also cut back to the access road and car park along this section in one location.

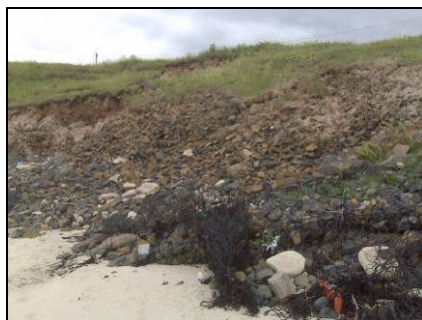
Moving south to the more natural frontages, the soft cliffs continue to exhibit signs of slumping in places and there is quite bad erosion at the southern end of the bay extending to Snab Point.

Here rock-filled gabions have been installed along some lengths but these are becoming broken-up by wave energy and losing their effectiveness.

In areas where gabions have not been constructed the soft cliffs are actively slumping. Here debris has been tipped in an attempt to counter the erosion (left).

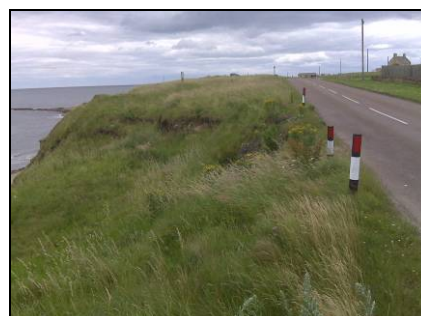
There is also evidence of relict slipping in the upper sections of soft cliff and one are in particular has a slump that has cut the cliff line back to within less than 1m of the road (right). It is recommended that efforts are made to repair and extend the gabions while investigations are made in parallel into longer-term more effective alternative solutions.

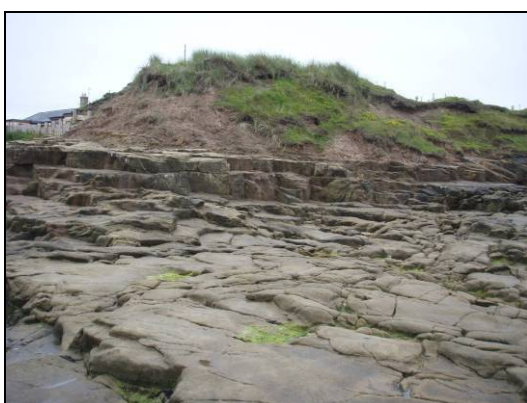
Snab Point comprises a hard rock shore platform and lower cliff section, with an overlying softer cliff (below, left). A large rock fall has occurred in the hard cliff just to the north of the pond. Around the headland itself, to the south, a new private defence has been constructed, comprising drainage pipes and timber retaining boards. This is located within a short section of cliff that has cut back between two harder rock controls and notably has no fronting shore platform, in contrast to the frontages immediately to the north and south. This leaves this short section most vulnerable to incoming wave action, leading to cliff recession events. There is ongoing discussion between Castle Morpeth Borough Council, Natural England and the landowner about the construction of this defence and it seems likely that retrospective planning permission will be required.

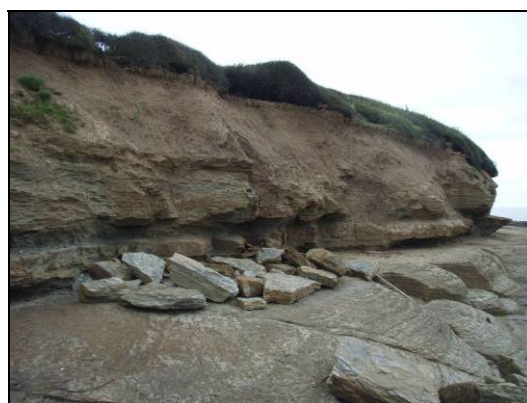
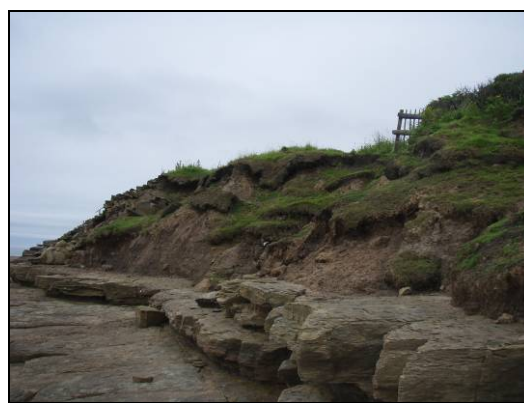
Castle Morpeth Borough Council also has responsibility for the northern section of Lynemouth Bay between Snab Point and the River Lyne. The hard rock headland in the north is experiencing both basal undercutting with associated rock falls in the lower hard rock cliffs and active slumping in the upper soft cliffs (below, right).

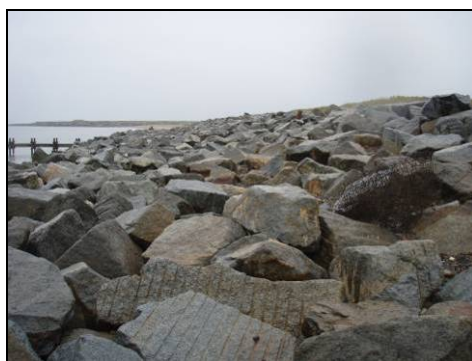
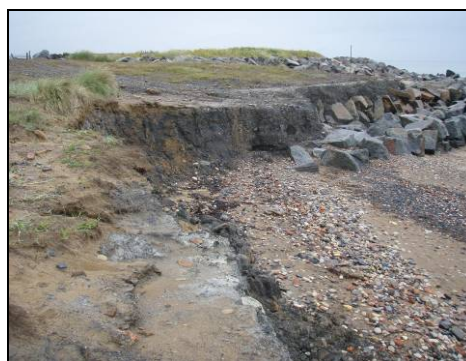
Lynemouth Power Station is protected by a robust rock revetment (below left) that was constructed in 1995. A 320m extension of this revetment was completed in April 2006. The extension encompasses the coal stocking yard area to the north of the Power Station. Both sections of revetment are in good or very good condition. This coastline has historically been protected by the tipping of colliery waste on the foreshore, however due to the closure of the local mines this practise has ceased. It is therefore expected that the undefended shoreline either side of the Power Station revetment will erode rapidly until a new equilibrium is achieved. This is now visibly occurring to the southern end of the revetment (below, right).

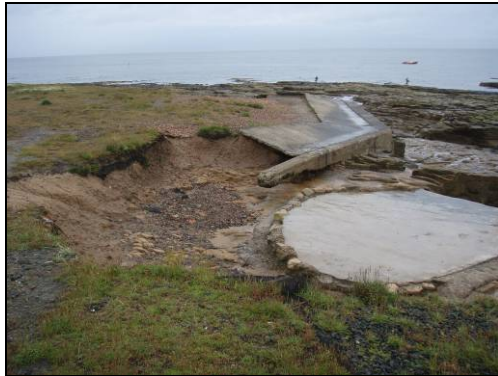
The few structures that exist around Newbiggin Point are all in a very poor state of repair due to undermining, outflanking, concrete cracking, spalling and voiding. One structure is now effectively obsolete (left) due to a combination of these defects.

Many of these structures require urgent attention to bring them back to providing a suitable standard of protection.

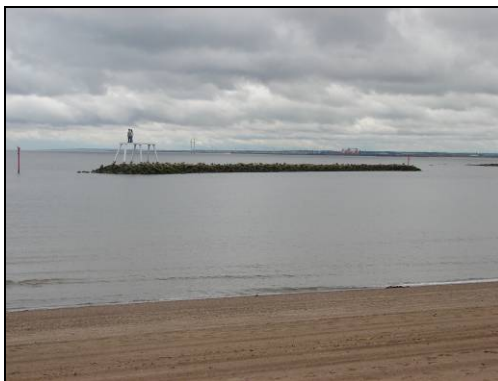
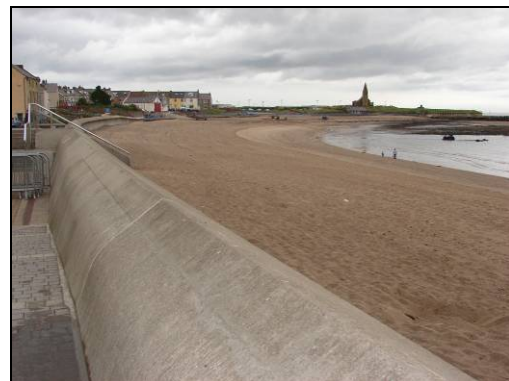
Newbiggin Bay has benefited from a capital coast protection scheme, completed in 2007, comprising the construction of a 200m long breakwater some 300m offshore (below left) and the import of sand to replenish beach volumes. The effects of this scheme on the Bay remain dramatic, with high and wide beaches still evident throughout the Bay (below right) and the onset of the formation of a salient feature in the lee of the breakwater. Previous to the scheme, there were major concerns about the beach lowering at the toe of the existing seawall defences leading to undermining of the toe and failure of the structures. With a healthy beach restored, the backing seawalls are now protected against this concern.

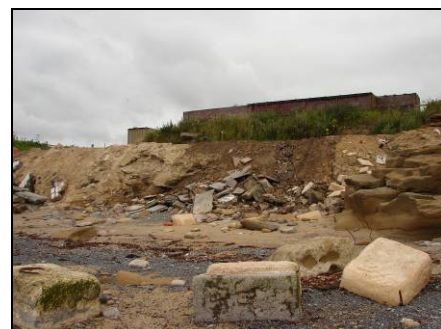
South of Spital Point, immediately south of the robust rock armour around the Northumbrian Water Storm Outfall, there is a section of soft eroding cliff sitting atop a raised rock ledge. Considerable rubble has been tipped down the soft cliff face in attempt to arrest the erosion, but this is continuing, quite severely in places.

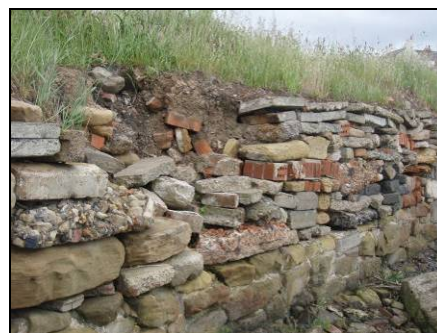
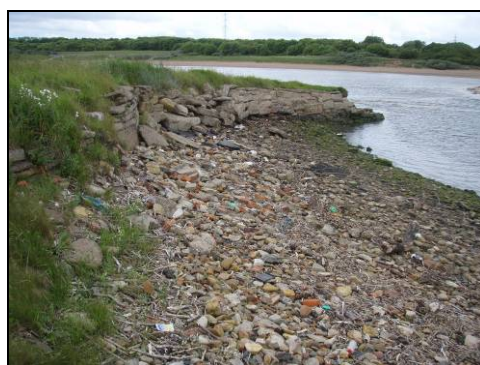
In places the stone wall has been patched-up on an ad-hoc basis with bricks but in many places these are now spilling onto the foreshore. There are several areas where substantive sections of masonry (or the replacement brickwork) are missing or where original masonry is now very loose (pictured, right).

This structure is in a very poor condition and liable to fail under heavy loading conditions. This could lead to navigational issues should debris fall into the channel.

Also the small jetty/pier (pictured, left) forms a river training function and if it were to fail the channel may migrate further towards the southern shore at the mouth.

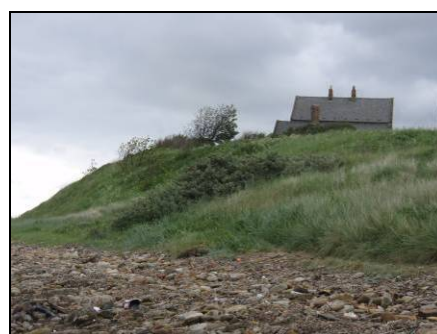
The undefended section of slope/cliff near the estuary mouth appears very stable (pictured, right).

There are no visible signs of erosion or slippage and the vegetation is dense and comprises trees and shrubs.

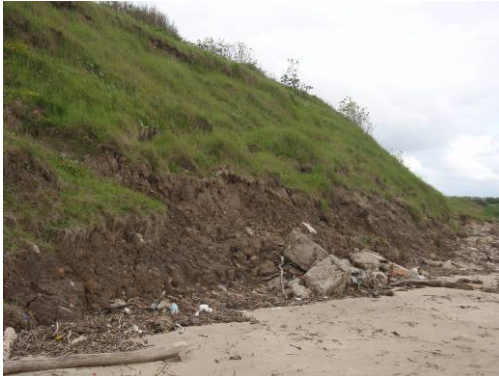
Cambois House sits atop the cliffs within this transition zone, approximately some 50m from the cliff edge. In the transition zone, the cliff top does not appear to have substantially changed in position over the past 2 years, but recent undercutting has occurred at the toe (pictured, left). It is envisaged that this will lead to slumping higher up the cliff and, soon, a step-back in the cliff top position by some 1-2 m as a consequence.

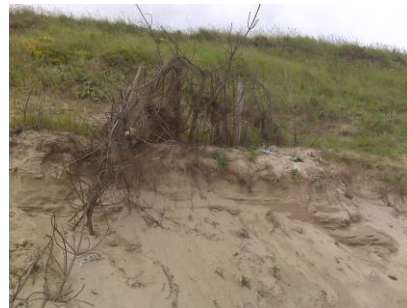
Previous attempts to stabilise the slope have been made using willow fencing, but this is now obsolete although remnants remain (pictured, right).

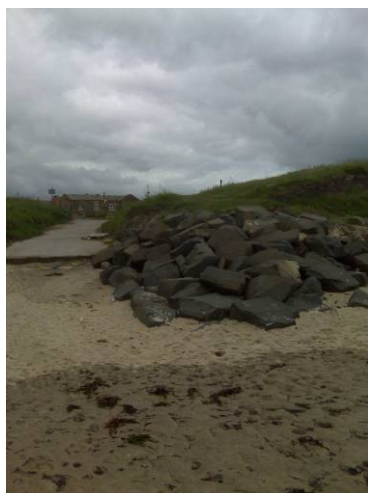
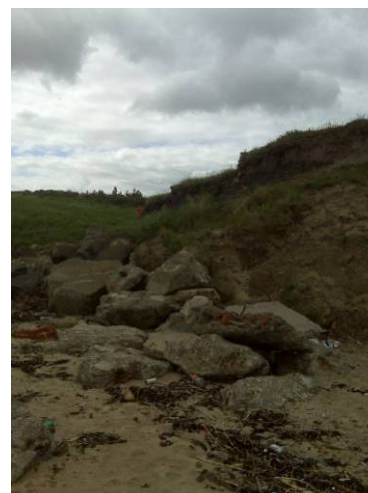
Also at the intersection with the access path from the car park, some rock armourstone (perhaps surplus from the revetment constructed further south; 39/17/01) and large rubble has been placed/tipped to prevent outflanking of the access point (pictured, below).

This appears to have had success in stabilising this immediate short length. Further to the north a pill box has been eroded from the cliff. This is now, in effect, acting as a

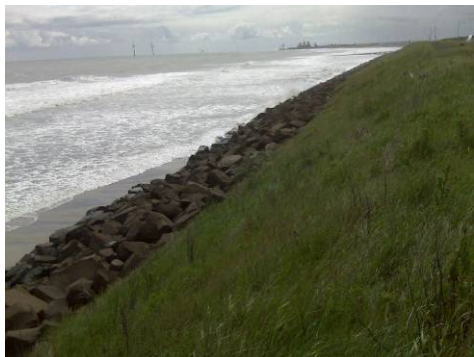
The revetted frontage itself appears to be very stable and the structure is highly effective (pictured, left).

Minor problems previously reported of displaced armourstone at the toe were not apparent on this inspection.

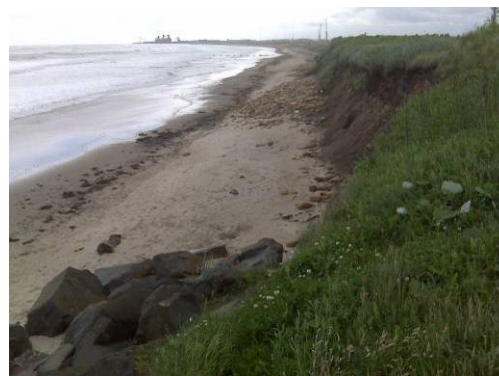
The armourstone continues around the long sea outfall, but there is notable cut back in the cliffs to the immediate south of the structure (pictured, right).

At present this does not appear to be compromising its integrity through outflanking, but the erosion here should be monitored (visual inspections).

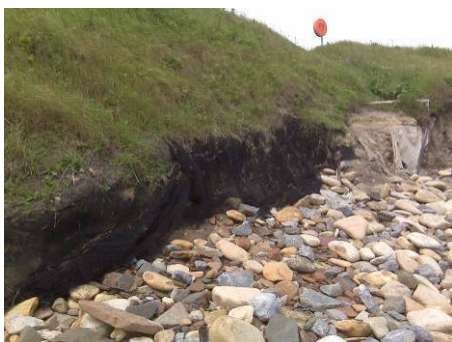
The undefended section of dunes continues to erode, particularly along a length of about 200m immediately south of the end of the rock revetment (30/17/01), between the two sea outfalls.

There is evidence of exposed netting geotextile (presumably placed to aid stabilisation; pictured, left) and ongoing slumping.

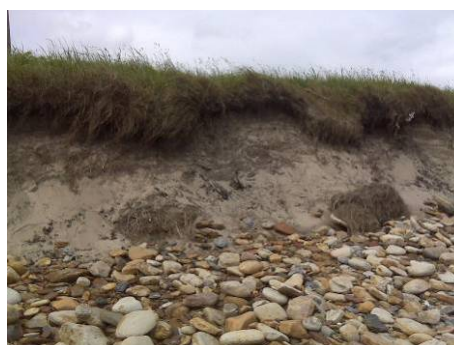
However, there are also sections where the dunes/slopes are more actively eroding and near vertical in profile, especially in the southern half of this frontage (pictured, right).

Here there are also some occasional low spots in the crest level.

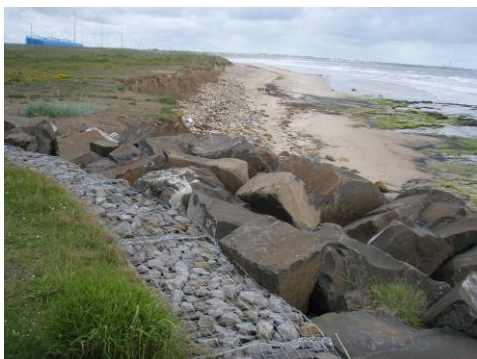
At the southern most end, there is notable cut back in the crest-line compared with the defended section to the south (pictured, left).

Attempts have been made to stop this outflanking by tipping rubble.

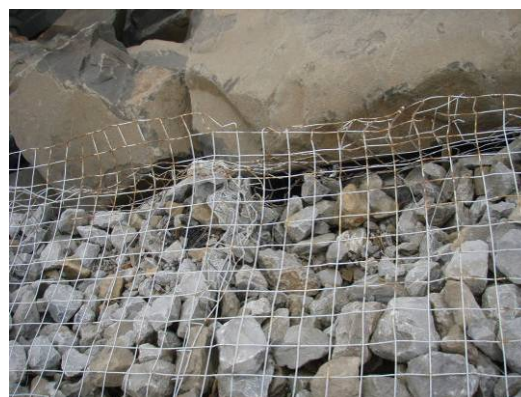
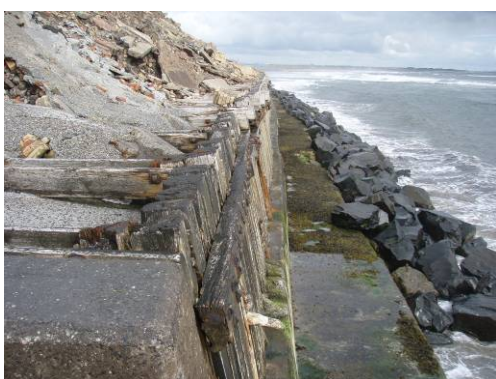
The revetment fronting the settlement of North Blyth is very uneven in profile, suggesting it was constructed by tipping, rather than placing, the boulders or that considerable settling and displacement has occurred.² The rock-filled gabions at the revetment crest are generally in reasonable condition, although they have split and leaked cobbles at three visible locations (an example is pictured, right). The gabions and revetment extend around a 90° dog-leg at the northern end.

The North Blyth Alcan facility is protected by timber breastwork fronted by a rock armoured concrete toe, and an adjacent rock revetment (pictured, left).

The upper rubble slope has been subject to wash-out of material, but remains broadly intact behind the timber. The fronting revetment has no major apparent problems although some rocks have been dislodged.

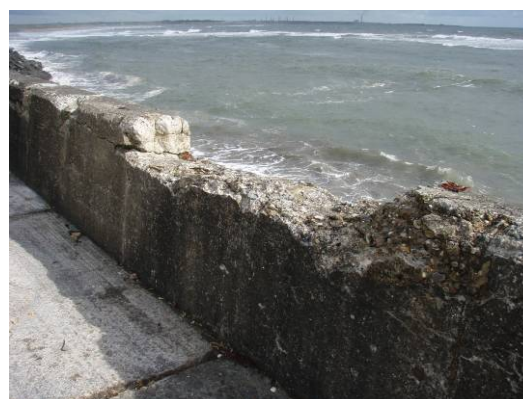
Along this section there are several cracks on the landward face and crest of the wall, as well as the walkway decking. In one particular location, there is a more significant failure of the crest (pictured, right). There are also cracks at the toe of the wall and there are several locations where there are access gaps through the wall. There are also areas of spalling and corrosion stains and general abrasion along the base of the wall.

This northern section of the Blyth East Pier is in urgent need of repair and maintenance and the situation appears to be progressively deteriorating due to inaction in response to previous recommendations.

It is recommended that the structural integrity of all of the man made structures protecting the North Blyth Alcan facility and the north end of the Blyth East Pier be assessed.

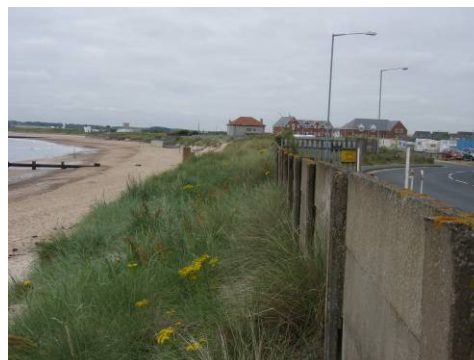
Adjacent to the Port of Blyth, the dunes are initially healthy, especially in the spending beach. A short distance south, however, the dunes become narrower in width and are more actively eroding on their seaward face. This, in places, has left only a narrow zone between the dune crest and the backing concrete wall, behind which runs to Port's access road (left).

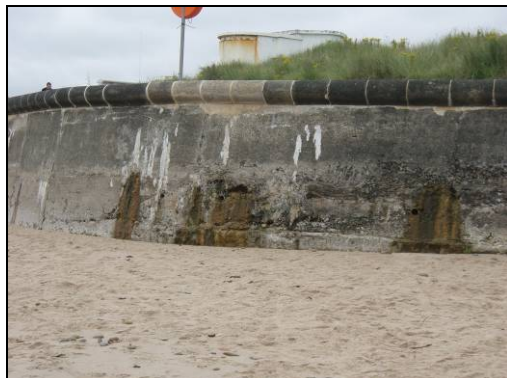
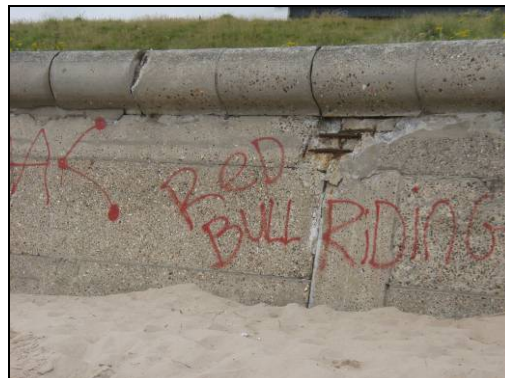
The promenade is in a poor condition at its northern end, especially around the access steps, where concrete cracking, corrosion and staining is evident around the outlet pipes (below, left). Previous repairs are evident, but they need to be extended to new areas. Along its main length, the promenade is in fair condition but with progression south the incidences of damage (cracking, spalling, etc.) increases, corresponding with increasing

exposure, and in some locations towards the southern end the reinforcement bars are exposed through concrete spalling (below, right).

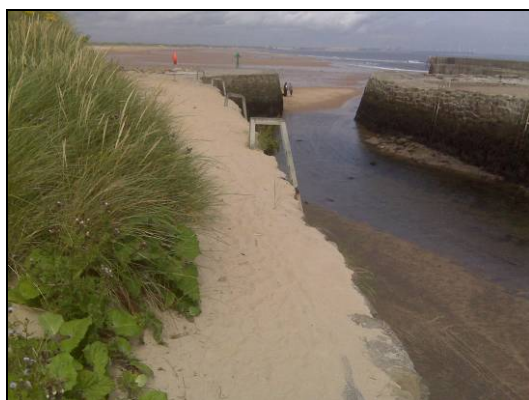
At Seaton Sluice harbour certain sections of the masonry wall are in need of repair. This mainly relates to re-pointing of joints, re-placement of blocks and infilling of voids, but in one section a major hole has been created which needs infilling. There is also considerable sand build-up on the crest of the western wall, which proves difficult and hazardous conditions along the footpath (left).

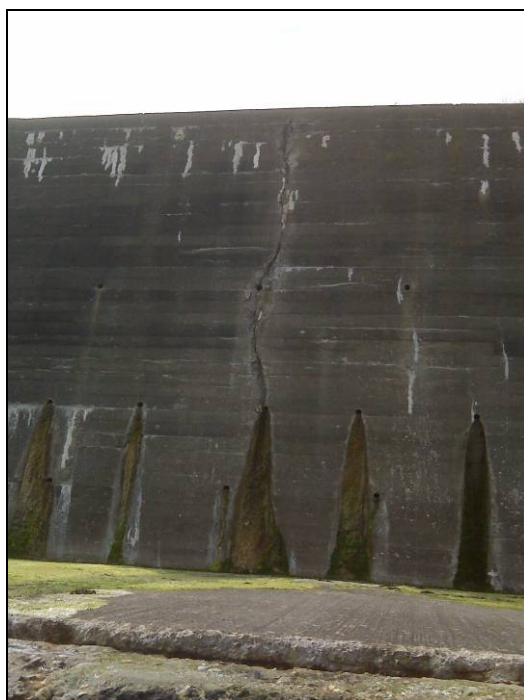
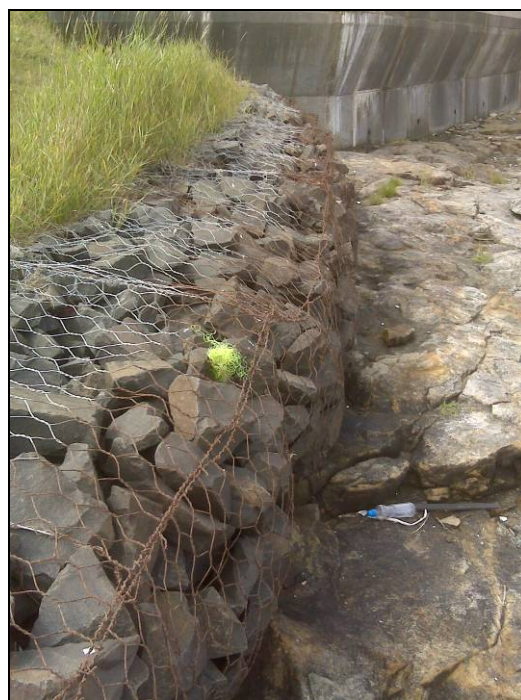
In Collywell Bay one seawall has suffered two major cracks which require re-pointing (below, left) and the gabions along the access ramp at the southern end are starting to bulge and will probably break, making the backing soft cliff vulnerable to marine erosion (below, right).

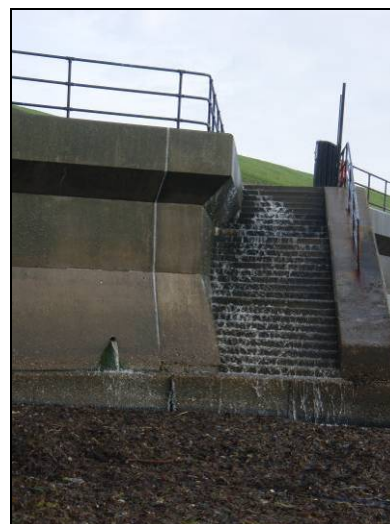
This rainfall storm caused surcharging of drains and extensive pluvial flooding in parts of North Tyneside, with burst pipes and flood water flowing down beach access steps and ramps (right). Also, drainage outfalls through seawalls and the channel of the Briardene Burn were heavily discharging flood waters, creating or exacerbating channels across the foreshore. Council workforce was present at many locations, rectifying defects and attempting to clear up flood-damaged facilities, such as public toilet facilities. The undefended section of sea cliff to the immediate south of Trinity Road seawall was expelling water through its cliff face.

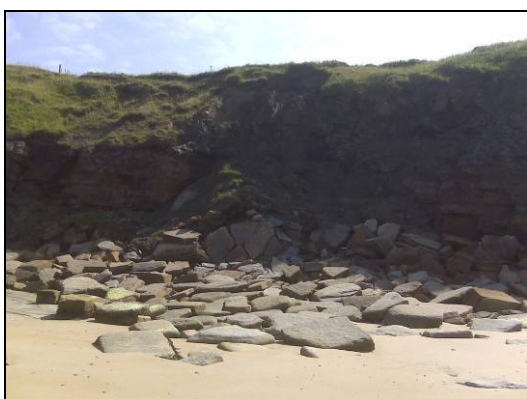
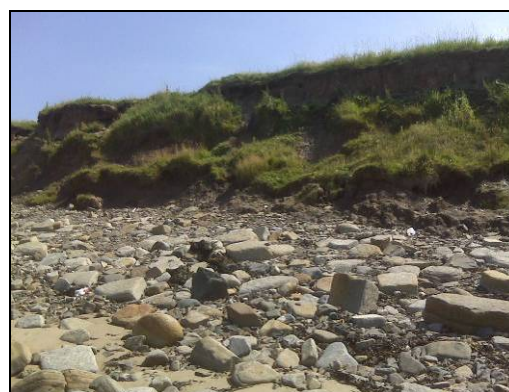
The northern end of the North Tyneside frontage starts to the south of Collywell Bay and comprises undefended rock cliffs between here and the causeway to St. Mary's Island. In the north, the soft cliff material sits on top of a harder rock base and there is evidence of rock falls, some quite notable (below, left), and slippages in the softer material, most of which are relict. To the south, the harder geology dips and the cliffs are composed solely of softer material which is where there are more frequent and more recent slippages (below, right).

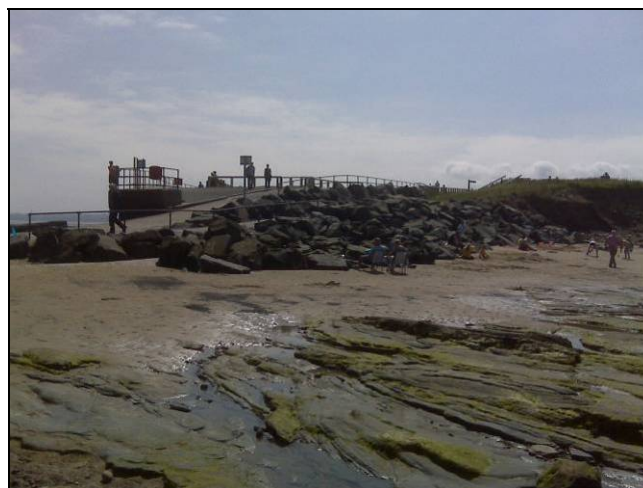
At the northern landward edge of the access ramp to the causeway, rock armour protection works have been constructed in 2006.

Erosion of the undefended cliffs to the north is continuing and this needs to be monitored to ensure outflanking does not occur.

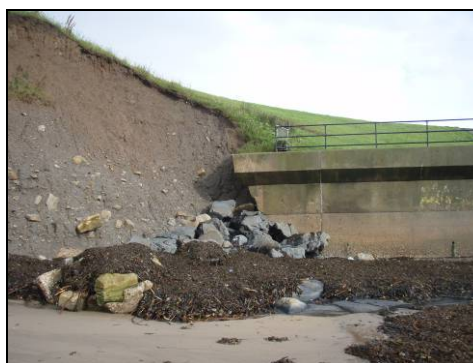
At the northern end, outflanking from the seawall is exacerbating erosion (right).

Works are recommended to address this with a degree of urgency and it is known that a Project Appraisal Report is presently underway.

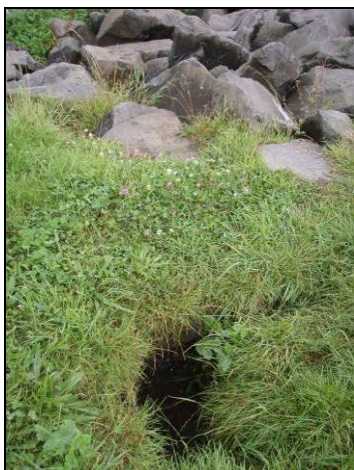
Also noted, in the grassed slope behind the revetment on the southern bank of Briardene Burn, was a sink-hole (left) which presents a public health and safety hazard. This needs filling, if it has not already been done.

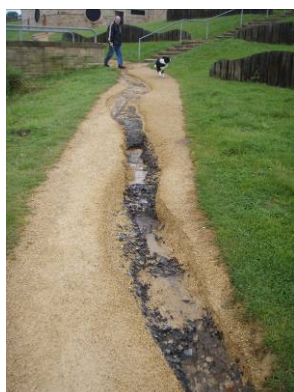
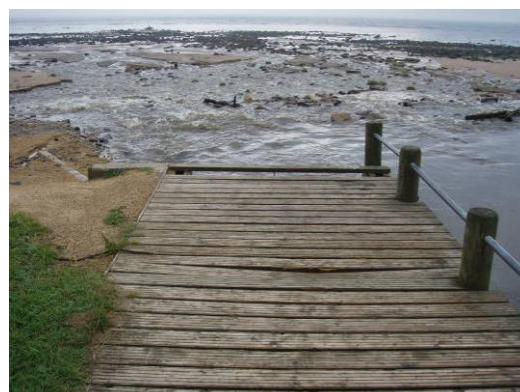
At Briardene Burn two other issues were noted. The heavy rainfall had eroded the footpath extending towards the beach from the footbridge (below, left) and a small number of boards on the timber jetty were either damaged or missing (below, right).

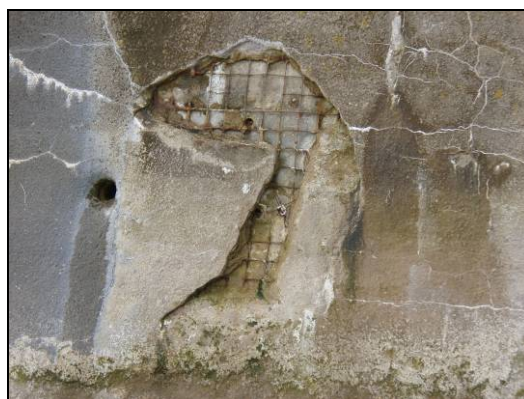
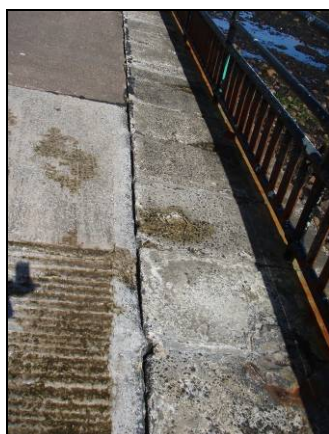
The sections of seawall at the southern end of Whitley Bay, extending south from the Beach Lifeguard Office, are probably in the worst condition of all of North Tyneside's assets, with longitudinal and vertical cracks, loss of render and exposure of reinforcement meshes (right), although repairs would be possible to maintain operable serviceability of these structures.

Along the seawall and promenade that stretches southwards towards Table Rocks there are gaps between the decking and the coping which need filling (left).

Some previous repairs here are in need of updating.

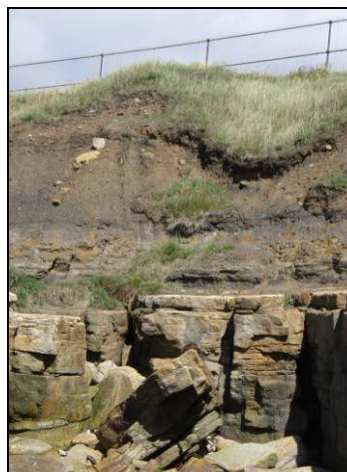
Here there is evidence of recent erosion events, including one located directly seaward of one of the properties on the cliff top. There have also been other rock falls, leading to the removal of the overlying soft material (right).

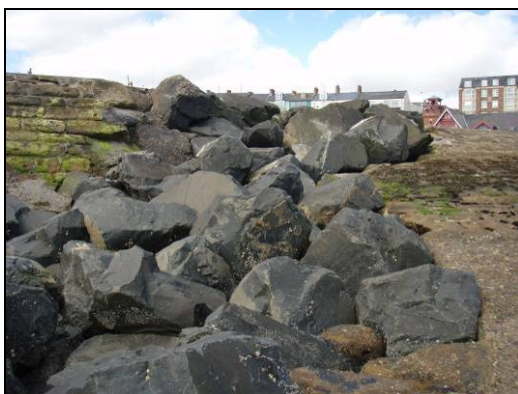
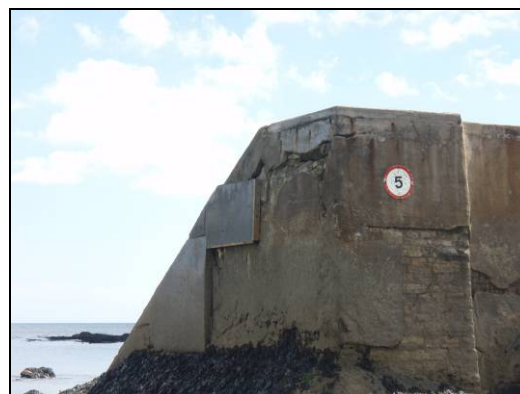
In Cullercoats Bay the seawalls, where present, are generally in good to fair condition leading southwards towards the North Pier, although a little abrasion and toe undermining is observed at the southern limit of this section. The North and South Piers appear in need of upgrade, particularly at the heads of the structures. Along the North Pier is an area of rock armour protection (below, left) that was used as emergency works to infill the hole that was punched through the pier during a storm. This is an obvious weak point in the structure, being at a narrow section of the pier and where the structure changes in both plan alignment and outer face gradient. There is significant cracking at the head of the South Pier (below, right). The inner face has suffered loss of render, including one area where an intact section of render is visibly detached from the pier as a whole. The seaward face has cracks, settle and undermining. An urgent investigation of options to upgrade the structures is recommended.

47	27	1	Cullercoats	Low	01-Aug-2008	Improve facing of the apron
47	28	1	Cullercoats	Urgent	01-Aug-2008	Investigate options to upgrade the pier structure.
47	29	1	Tynemouth	High	01-Aug-2008	Fill large gap at northern end, fill cracks, and address undermining at toe.
47	30	1	Tynemouth	High	01-Aug-2008	Consider toe works to prevent undermining.
47	31	1	Tynemouth	Low	01-Aug-2008	Repair wall crest. Fill gaps between blocks.
47	32	2	Tynemouth	Low	01-Aug-2008	Replace obsolete dune fencing.
47	33	1	Tynemouth	Low	01-Aug-2008	Repair/replace coping stone to revetment

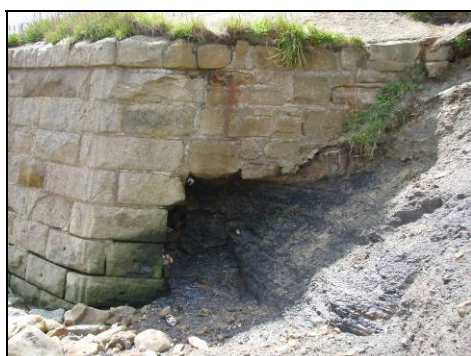
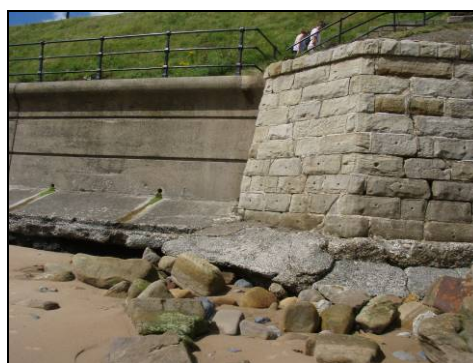
At the northern end of Longsands is a short section of masonry wall. This is in poor condition with the need to infill a gap in the masonry at the northern end (below, left), fill some cracks in the seaward face and address the undermining at the southern end, which is also affecting the concrete apron of the adjacent concrete seawall (below, right). The concrete seawall is in fair condition, with no repairs required but the undermining at the toe seems to be a worsening situation and toe works should start to be considered.

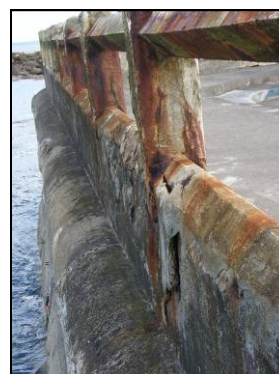
Along the concrete block revetment, there is damage to the crest wall and some cracks between the sloped revetment and the vertical wall (below left) which require repair. The dunes along Longsands are generally well vegetated and relatively stable. The main problem is associated with trampling erosion and efforts have been made to control this through fencing. Some fencing is now obsolete and in need of renewal. At the southern end of Longsands a wall extends around the now disused Outdoor Pool. The concrete coping section of this wall is rust-stained and spalling in places (below, right).

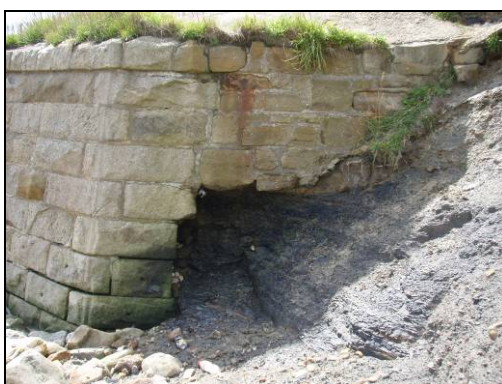
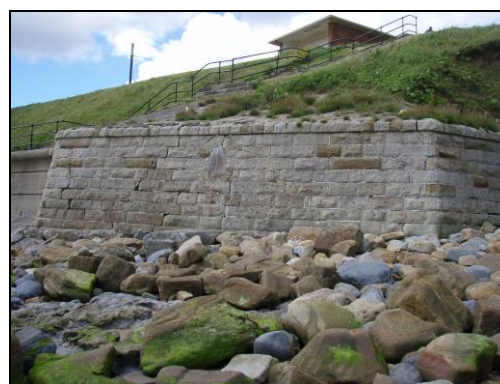
Both defended and undefended sections of Prior's Haven are stable. There is continued outflanking at the southern end of the seawall at Freestone Point (below, left) which would benefit from some local armouring protection to avoid compromising the structure. The wall at Sandy Goit is very poor (near failing) condition (below, right)
