# **NECAG Coast Protection Assets and Coastal Slope Condition Analysis**

## **South Tyneside Council Final Report**

**South Tyneside Council**

**April 2009**

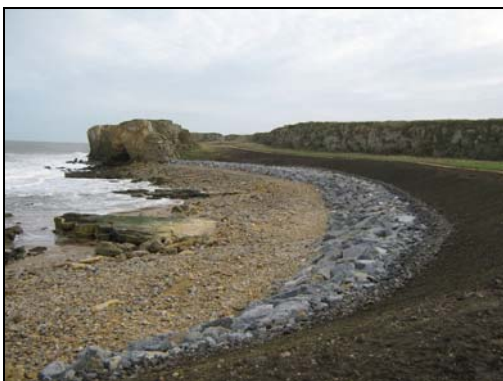
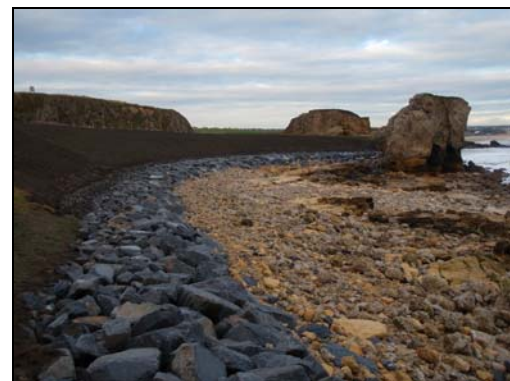
The Trow Quarry Coastal Defence Scheme was completed between August and November 2008. The scheme consists of a granite rock armour toe revetment with re-grading of the coastal slope above in the two coastal bays of Graham's Sand (pictured, below left) and Southern Bay (pictured, below right), separated by the headland of Target Rock.

The defences were in very good condition, with the beach material returned to previous levels following construction work over summer and autumn 2008. The re-graded slopes were covered with a layer of imported topsoil which was seeded with Red Fescue (*Festuca Rubra*). Only small shoots were visible due to the planting occurring late in the growing season, although the vegetation was expected to grow fully in spring 2009.

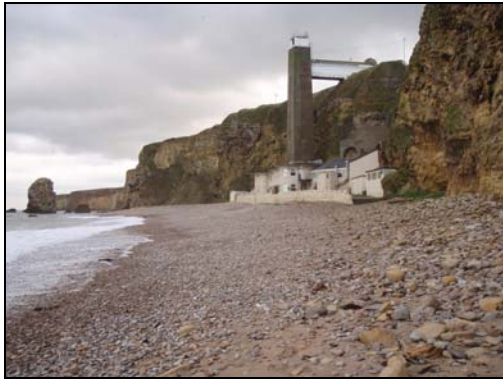
The Marsden Grotto Public House/Restaurant is situated at the foot of the cliff and is defended by a masonry wall which is in good condition (left). Access to the foreshore is via a set of wooden steps which zig-zag down from a car park on the cliff top. The previous steps were replaced in 2007 along with the addition of rock netting to prevent minor rockfalls from the concreted limestone cliff face (below). The steps and netting were in very good condition.
