**Cell 1 Regional Coastal Monitoring Programme
Coastal Walkover Inspections 2010**

**Sunderland City Council
Final Report**

October 2010

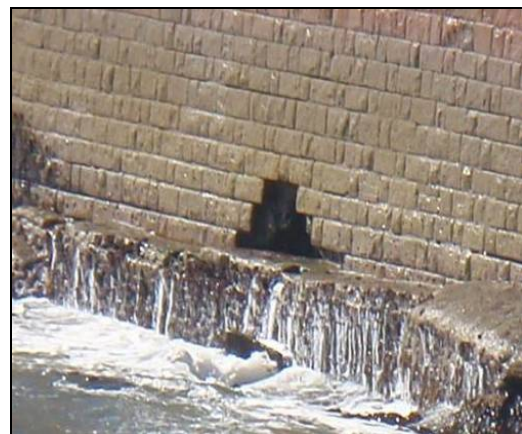
A void was visible at the base of the wall, with approximately eight masonry blocks missing from the seaward face (below, left and right). It was not possible to ascertain the depth of the void as the tide prevented access. Further investigation should be carried out and an appropriate local repair carried out urgently to prevent the void expanding.

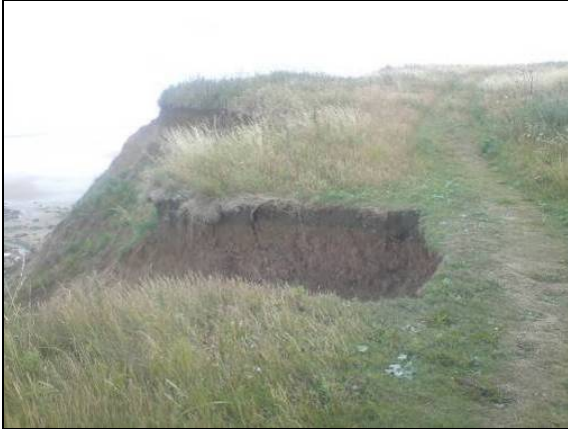
Several slope failures occurred in close proximity to the cliff top footpath, with Halliwell Banks particularly affected (below left). Signs are present to warn members of the public that the cliffs are unstable and that there is no footpath along the cliff top (below right). However, the track appeared to be well worn and on the day of inspection, several people were observed using the footpath. Recent slope failures could potentially be obscured by long grass and the proximity of the retreating cliff edge to the footpath is an ongoing public health and safety concern.

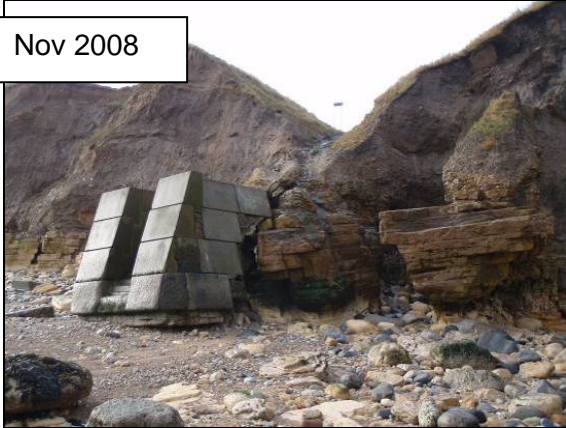
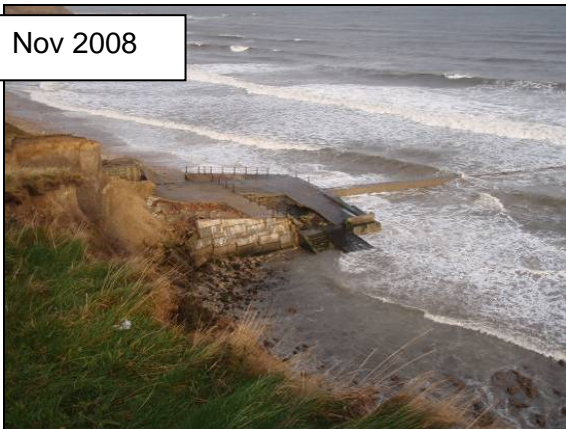
The most significant change appears to have been the removal of two failing structures along the undefended Ryhope frontage (below).

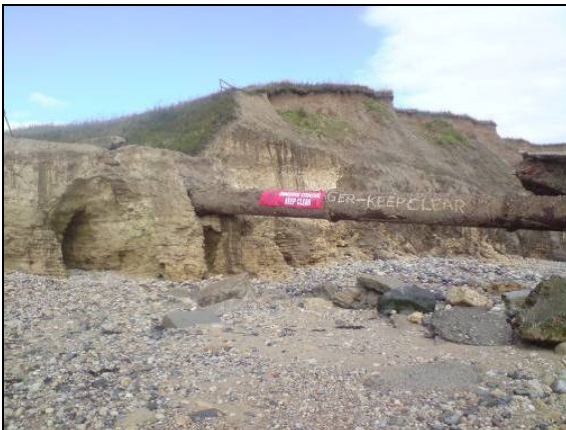
The outfall pipe at the southern outfall is still present and now spans between the cliff and the remains of the concrete structure. Northumbrian Water Limited have fixed a banner to the pipe ("DANGEROUS STRUCTURE KEEP CLEAR") (below , left and right).
