**NECAG Coast Protection Assets
and Coastal Slope Condition Analysis**

**Durham County Council
Final Report**

April 2009

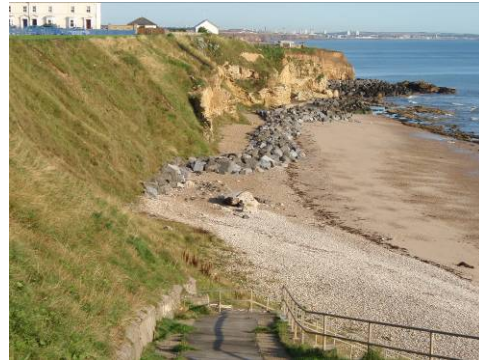
The southern-most section of protected cliff and the undefended stretch extending between the rock armouring and Seaham Harbour is subject to ongoing recession, with an area of cliff top close to a car park being fenced off to ensure public safety. Despite being well vegetated, these cliffs are at a relatively steep angle of repose and are in places slumping. A drainage pipe through the cliffs has been exposed in one area, probably due to settlement.

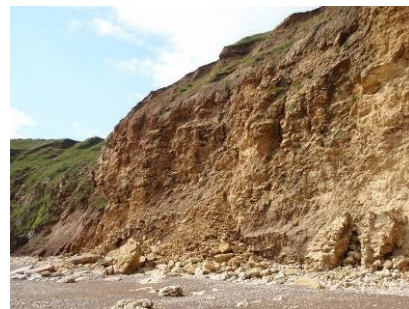
Further south from here to Gin Cave at Blackhall Rocks, behaviour is dominated by cliff geology and the presence (or absence) of a protective beach formed from colliery waste. Generally, where the form of the cliff comprises softer material overlying a harder rock base, there can be slumping in the overlying material and cracks and arches formed at the cliff base.

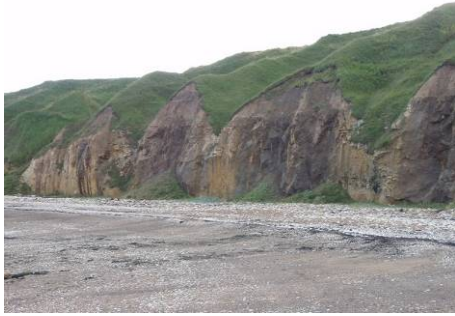
There are occasional stack formations resident on the foreshore and in one location a rock slide was observed. Elsewhere rock falls become more prevalent. Where colliery waste beaches are observed, even where they are only of moderate width, the backing sea cliffs are generally more stable. As the waste beaches become wider and higher with progression south, so the stability of the backing cliffs improves further. Two reedbed lagoons are protected by the colliery spoil towards the southern section of this frontage.
