**Cell 1 Regional Coastal Monitoring Programme  
Walk-over Visual Inspections of Assets**

**Durham County Council  
Final Report**

**September 2012**

## **Walk-over Visual Inspections of Assets**

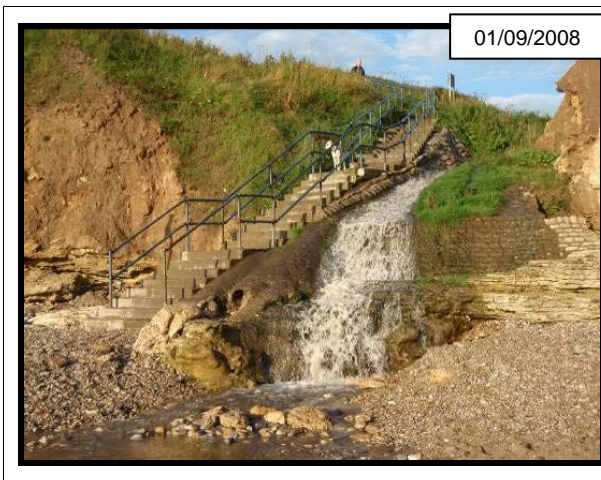
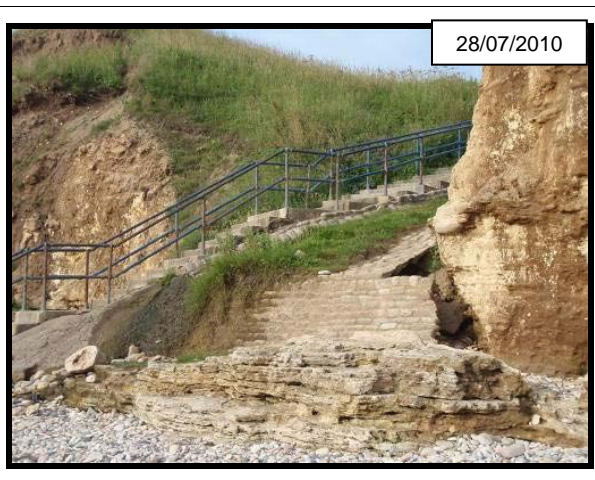
Immediately adjacent to the access steps from the picnic site car park is a stream that discharges to the foreshore. The 2008 report notes that this stream was in spate due to the heavy rainfall that preceded the inspection (below left). During the 2010 inspections, there was very little flow (below right). Despite the heavy rain at the end of September there was little flow in the beck at the time of the inspection on 4th October 2012. The outflanking noted at the short length of blockwork wall immediately to the north of the stream, appeared unchanged since 2010, see photos below and overleaf.

Outflanking at north of steps unchanged from 2010. (Asset ref. No. 121AB901B0804C01)

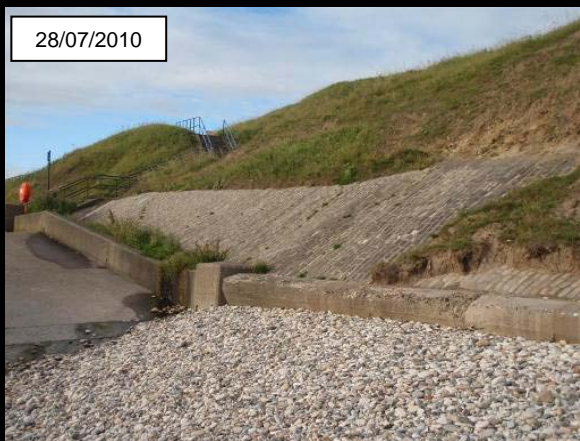
Immediately south of the car park access steps is a short undefended length of cliff, followed by a short (approximately 10m) length of low-level wall at the tie in to the main Seaham seawall to the south. As during the 2010 inspections the beach levels at the wall were quite high, offering protection to the structure (below right). Backing the southern end of this low-level wall, and continuing behind the very northern end of the Seaham sea wall is a blockwork revetment on the backing slope which remains in fair condition.

Wall at north end of Seaham. Photo from 2010 report.

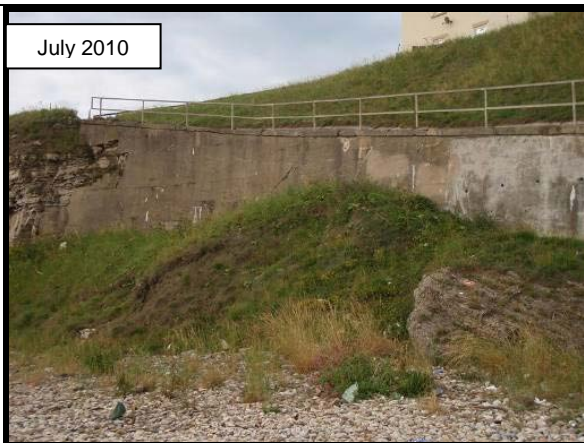
The beach access ramp and steps are supported by a vertical concrete wall, below left that has a large diagonal crack through the full height. The crack is also present on the photo from in 2010 so the situation does not seem to have significantly worsened. There was also minor cracking to retaining wall at toe of slope to rear of ramp.

Photo from 2010 report  
(Asset Ref. No. 121AC901C0103C07)

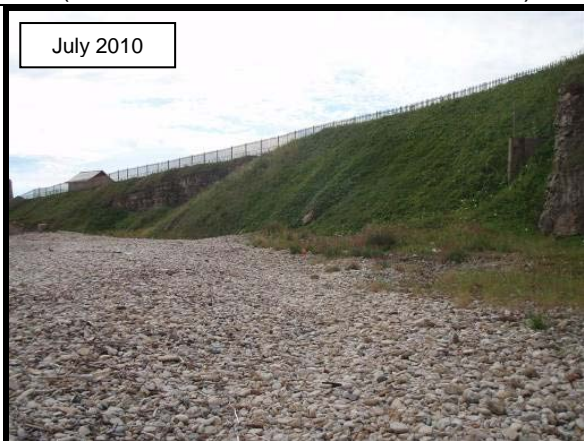
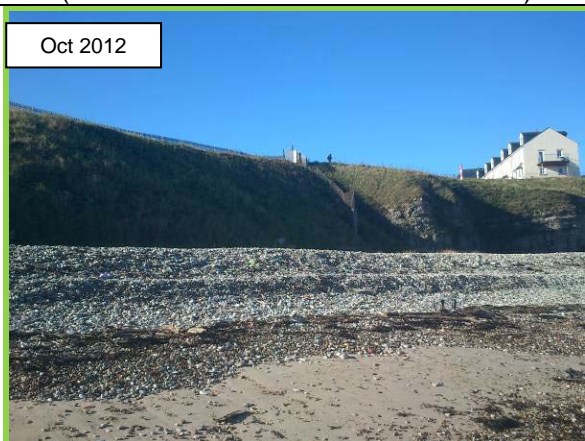
Undefended length south of beach ramp.  
(Asset Ref. No. 121AC901C0103C05)

There was a high cobble beach running from north of the access steps through the bay to the northern extent of Seaham Harbour. This gives a high degree of protection to the cliff

toe, see above right. There was evidence of former movement at several locations in the cliff vegetation, but the cliff was vegetated and appeared stable at the time of the inspection.

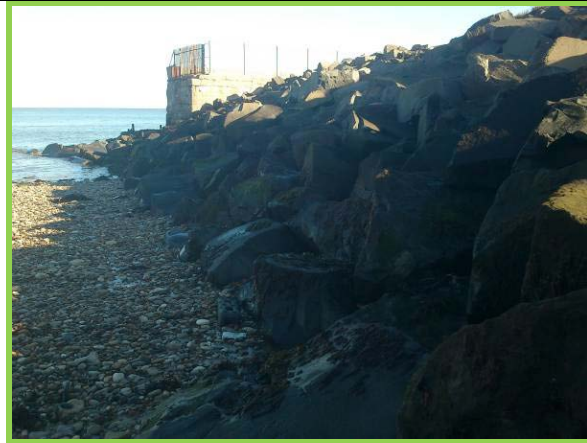
At the south end of the bay there is a rock armour revetment, asset 121AC901C0104C02, which is in good condition, see photos below. This defence forms the link to the root of the North Pier of Seaham Harbour and in a protected location where there had previously been outflanking of the North Pier.

Rock armour in good condition  
(Asset Ref. No. 121AC901C0104C02)

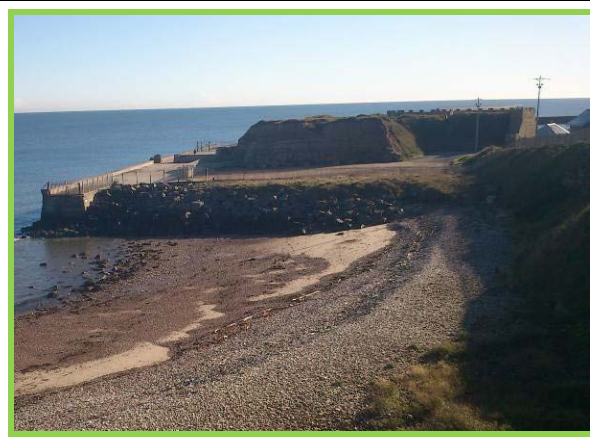
Rock armour at rear of harbour reclamation.  
(Asset Ref. No. 121AC901C0104C02)

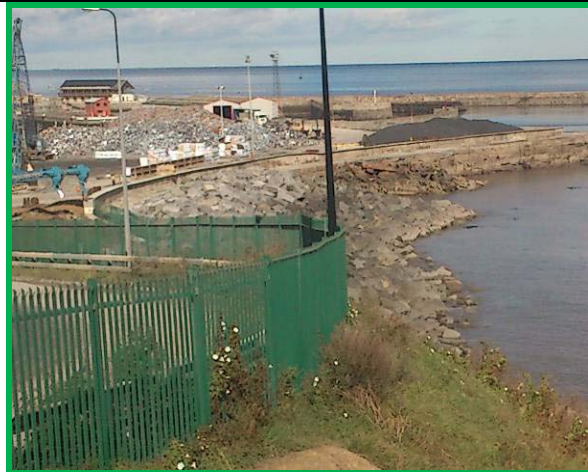
The South Pier was only inspected from a distance as it is within the port operational area, see photos below. The main pier appeared to be in fair overall condition, although there are visible areas of damage seaward of the rock armour. At the root of the pier rock armour has been placed at the tie in to the coast, below right as part of a previous phase of regeneration. The armour continues to the south protecting the port access road and appeared to be in very good condition.

Rock armour at root of South Pier.  
(Asset Ref. No. 121AC901C0104C01)

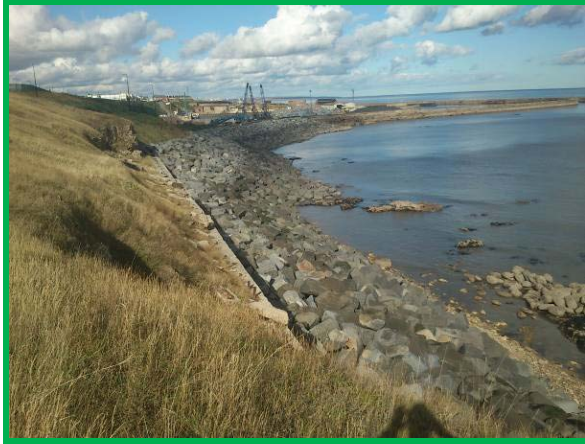
The frontage between Seaham Harbour South Pier and Seaham Fleet Rock is protected by a continuation of the rock armour revetment extending southwards from the South Pier. In the north the armour is against the cliff toe, where there is evidence of a former vertical wall (below left), whilst in the south it is placed as a bund slightly seaward of the near vertical cliff, below right. The rock armour is in very good condition. There was some evidence of localised surface slumping in the vegetated slopes between the rock armour and the road.

Rock armour south of port  
(Asset Ref. No. 121AC901C0105C01)

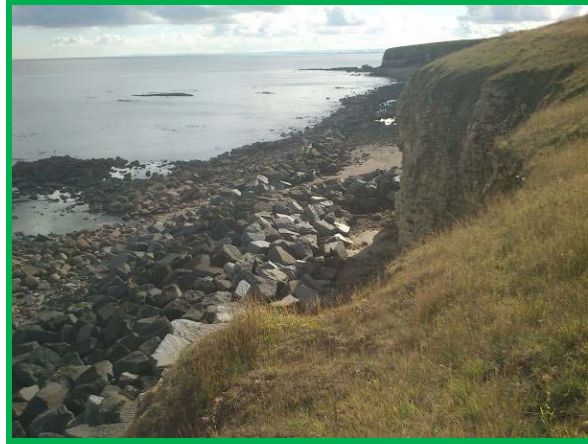
Rock armour bund seaward of cliff  
(Asset Ref. No. 121AC901C0105C01)

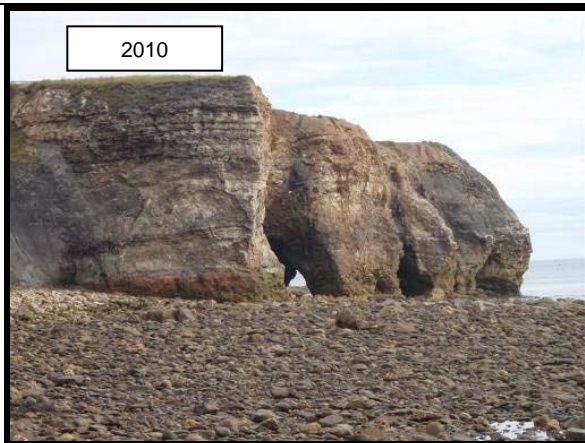
At Nose's Point headland, the cliffs characteristically have caves and arches formed at their base (below left). The headland appears relatively stable and exerts a control on both the Dawdon frontage to its north and Blast Beach to the south.

Caves and arches at Nose's Point from 2010 report. (Asset Ref. No. 121AC901C0107C01)

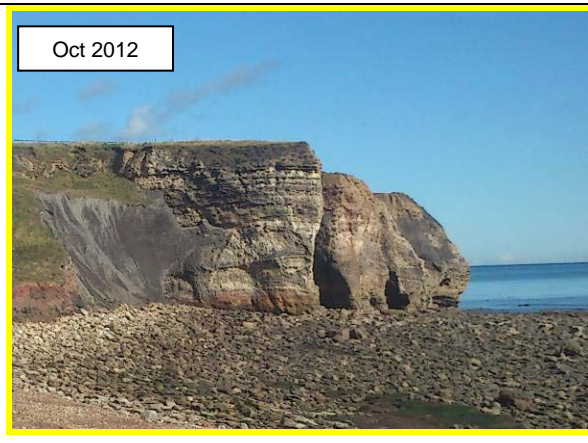
Cliffs with caves at Nose's Point  
(Asset Ref. No. 121AC901C0107C01)

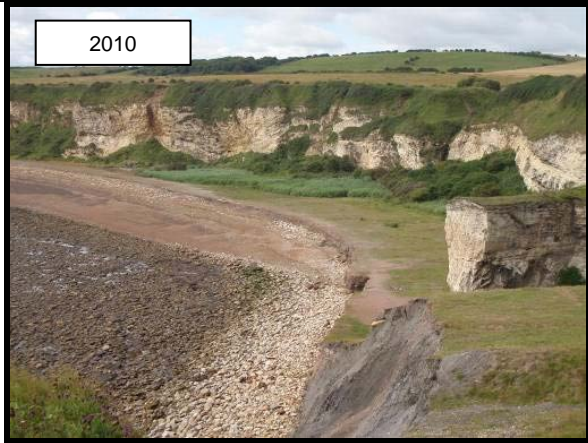
Photo of Blast beach from 2010 report  
(Asset Ref. No. 121AC901C0107C01)

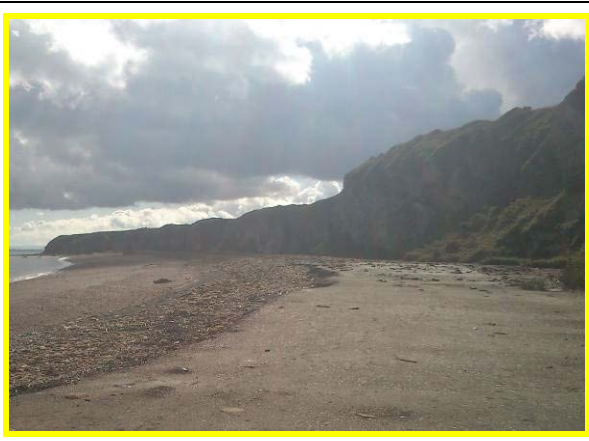
Blast beach looking south to Chourdon Point  
(Asset Ref. No. 121AC901C0107C01)

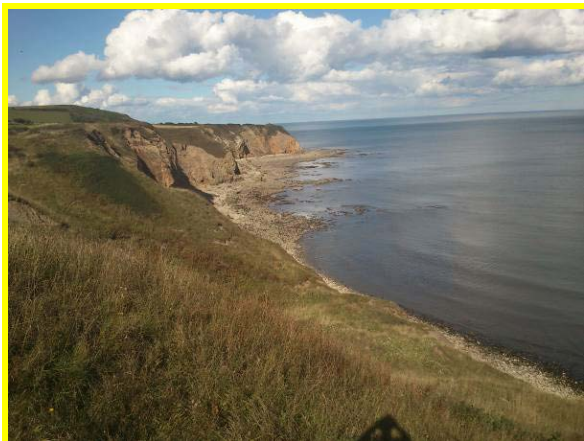
The coast between Chourdon Point in the north and Horden Point in the South consists of a single NFCDD asset reference 121AC901C0107C01. This unit has been classed as "locally Active" and includes the bays of Hawthorne Hive and Shippersea, which both contain artificial beaches of eroding colliery spoil at the base of the natural cliffs. Further south the artificial beach is narrow or almost completely eroded.

Where there is no colliery waste beach the cliffs are subject to cave and arch formation at their base, with local rockfalls occasionally occurring and slumping in the upper till layers.

View looking north to Shippersea Point  
(Asset Ref. No. 121AC901C0201C01)

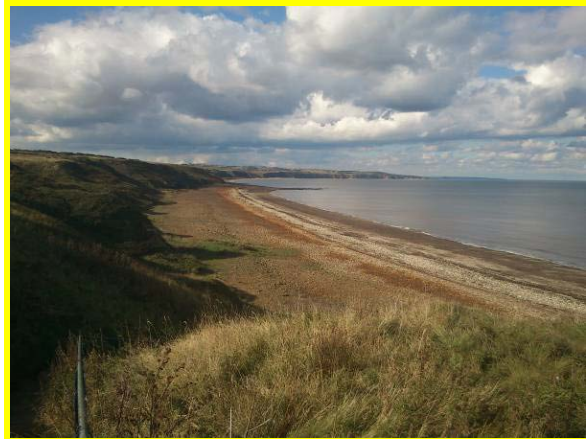
View of artificial beach looking north from  
Blackhall Nature Reserve  
(Asset Ref. No. 121AC901C0201C02)

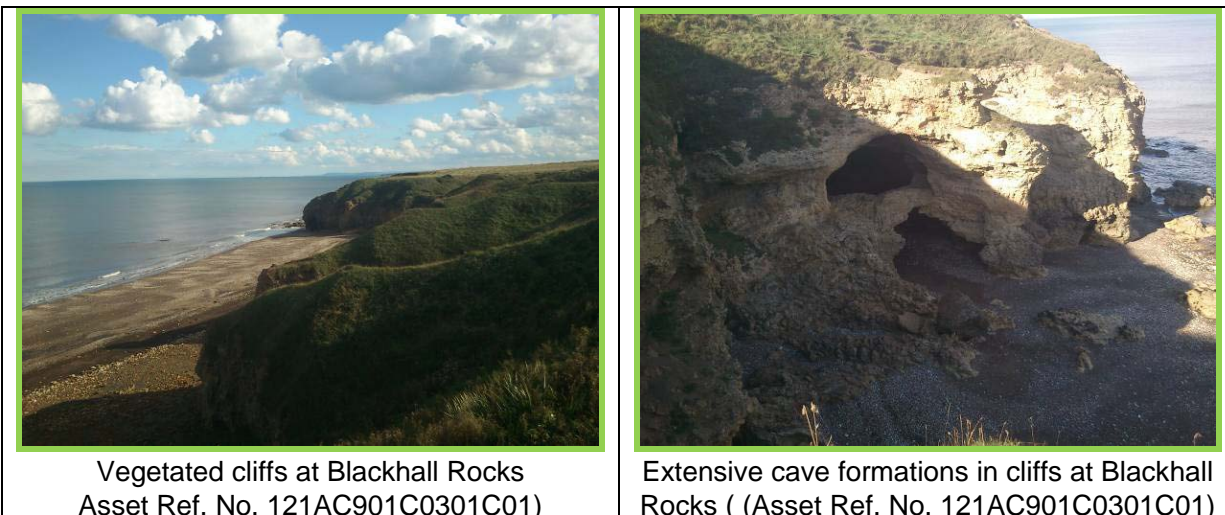
At Blackhall Rocks there is an extensive rocky outcrop on the foreshore (below left), and the backing cliffs have extensive cave formation at their base (below right).

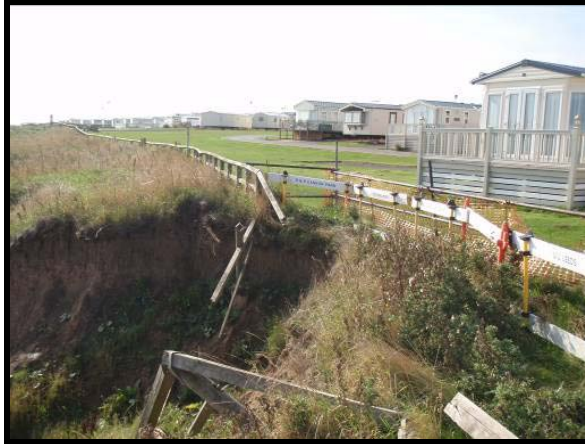
Near the north end of the caravan park, between Limekiln Gill and the caravan park access steps there are extensive cliff slumps and cliff failures. The 2010 report noted that a 10m length of the caravan park fence had been damaged, see left photo overleaf. As the cliff is expected to continue to erode the fence should be regularly relocated as required.

Cliff failure near north end of caravan park.  
Photo from 2010 report.  
(Asset Ref. No. 121AC901C0301C01)

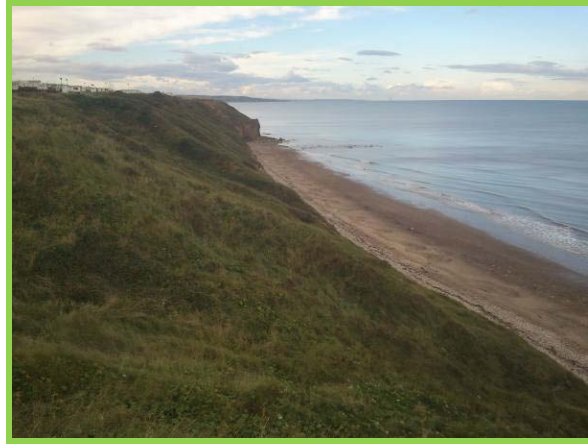
Vegetated cliff slopes adjacent to caravan park  
(Asset Ref. No. 121AC901C0301C01)

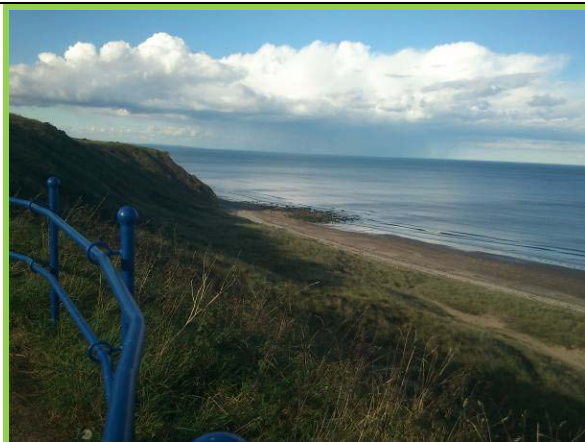
From Crimdon Park Caravan Site to the southern limit of the Durham coast at the boundary with Hartlepool at Crimdon Beck, the frontage comprises of extensive dunes (below left and right). There is a wide sandy beach that has formed in the bay controlled by the resistant rocks of Hartlepool headland to the south. This has encouraged the growth of the dune system, which before development was continuous through to the headland.

North end of dune system near caravan park  
(Asset Ref. No. 121AC901C0301C01)

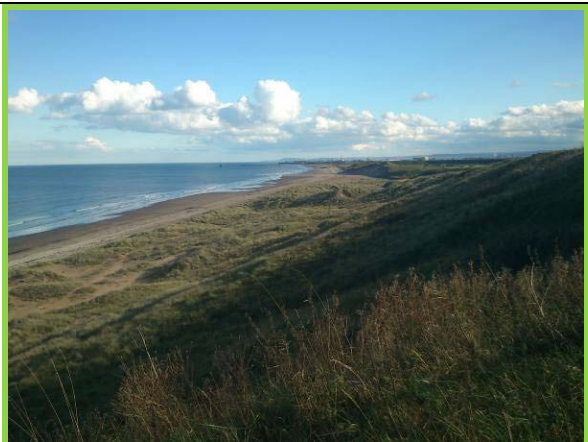
View of dune system looking south from  
caravan park, showing paths through dunes  
(Asset Ref. No. 121AC901C0301C01)

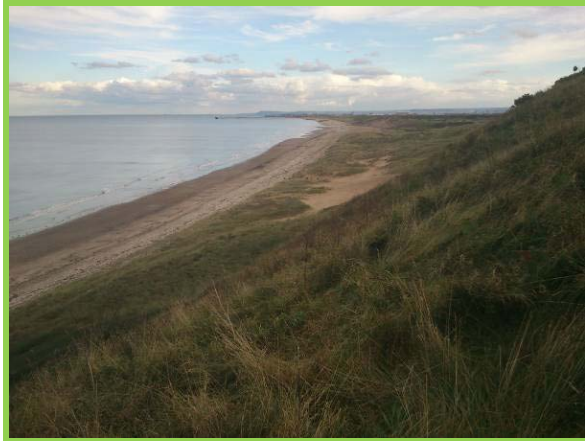
Sand dunes north of Crimdon Beck  
(Asset Ref. No. 121AC901C0301C01)
