Cell 1 Regional Coastal Monitoring Programme Walkover Inspection Surveys 2022

Durham County Council

June 2022

Walkover Inspection Surveys 2022

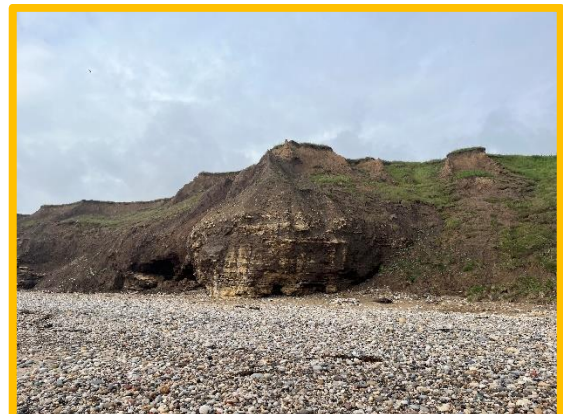
Further towards the southern end of the frontage length, the harder Magnesian Limestone base is more prominent. There are frequent caves and arches formed in the limestone rock at the base of the cliffs caused by differential erosion by waves. The caves did not appear to have significantly worsened since 2020. At these locations, there is again evidence of recent local slumping in the upper till cliff.

Localised slumping of upper till within the cliffs (/0804C01)

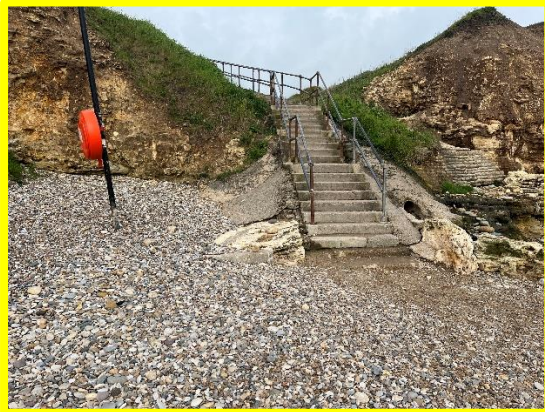
Within this asset length is a set of access steps from the picnic site car park near Seaham Hall with a small stream discharging to the foreshore over an adjacent stone revetment. The stone revetment is heavily overgrown and continues to be outflanked to its north. The fill material below the revetment has been notably washed out putting the revetment at risk of immediate collapse. There is also a small diameter pipe encased in concrete running alongside the steps. Neither the stream nor the pipe was discharging at the time of the inspection.

Access steps adjacent stone revetment (/0804C01)

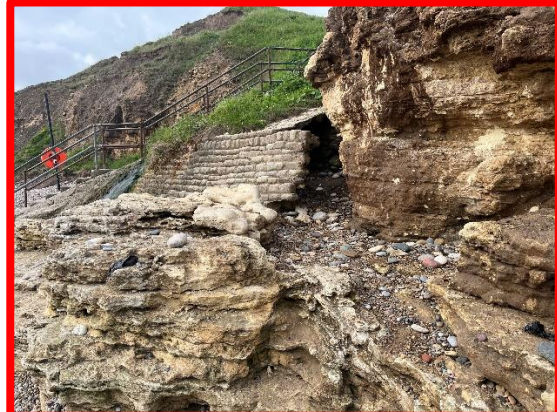
- **Seaham Hall picnic site** – The fill material has been washed out from the revetment adjacent to the beach access steps, leaving the revetment at risk of immediate failure. The outflanking has not worsened.

Outflanking of revetment causing washout of fill (/0804C01)

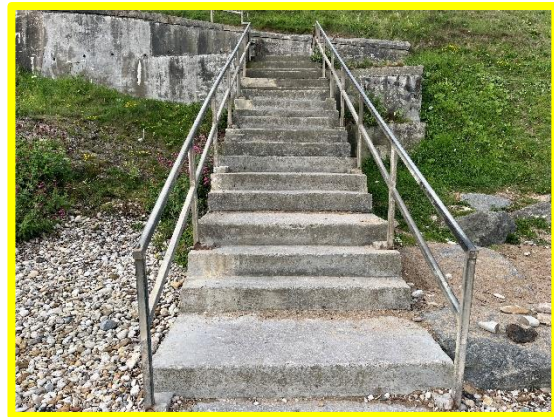
Access ramp and steps (/0103C07)

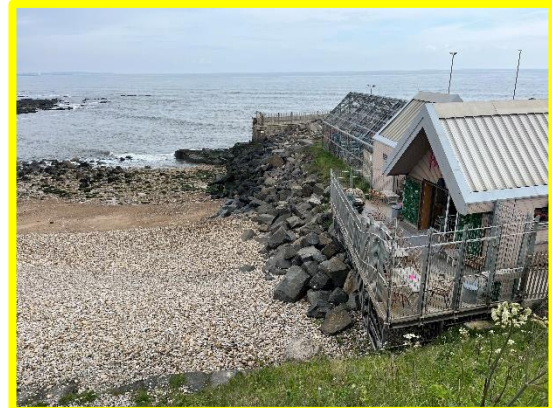
*Revetment preventing outflanking of the North
Pier(/0104C02)*

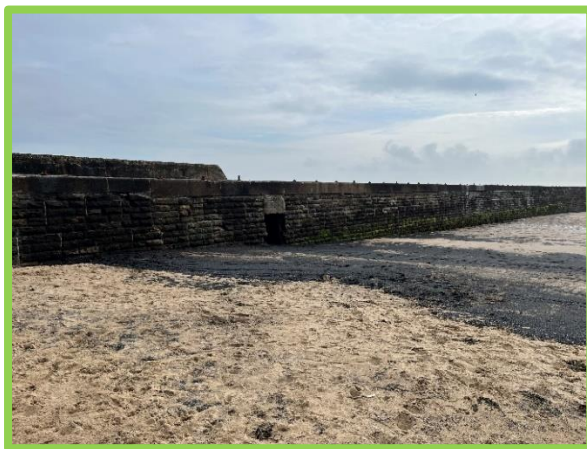
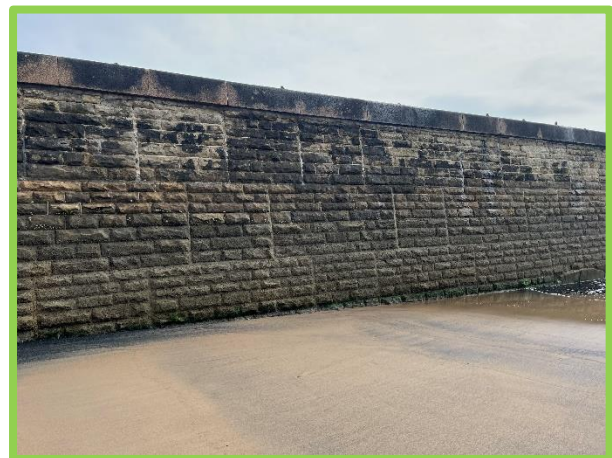
Repointing repairs to previously-reported defects to the deck and both coping and upper sections of the inner face were noted beyond the access gate, but these could not be inspected in detail. The inner face was inspected from the beach at low tide and appeared unchanged from 2020, thus it remains in fair condition. It is recommended that, if not already in place, more detailed vessel-based and underwater inspections are undertaken by the Dock Company and if not already in progress a maintenance programme should be put in place.

*Seaham Harbour North Pier Inner Face
(/0104C03)*

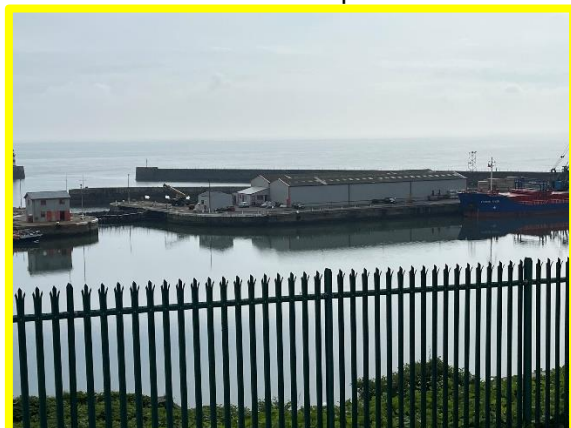
Access to South Pier and South Dock is prohibited due to port-related activity and so the structures could only be inspected from a distance on the adjacent A182 road. As per previous inspections, the South Pier appeared from afar to have significant damage to sections of the crest and outer face, particular apparent at the pier root outer face. An ununiform profile along this section potentially suggests settlement issues, although it was difficult to establish from afar whether this had worsened since 2020.

No Access - Seaham Harbour South Pier (/0104C17)

At the root of the pier, rock armour has been placed at the tie-in to the coast as part of a previous phase of regeneration. There is an area of tipped rubble in front of the rock armour. The armour continues to the south protecting the port access road and appeared to be in good condition. It is recommended a detailed inspection is carried out to assess the damage.

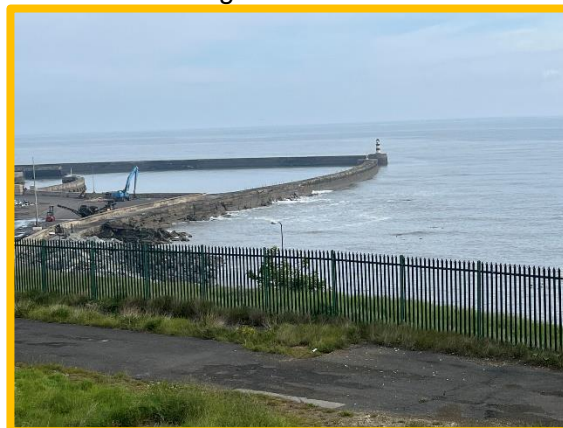
No Access - Tipped rubble (/0104C16) and rock revetment (/0104C01)

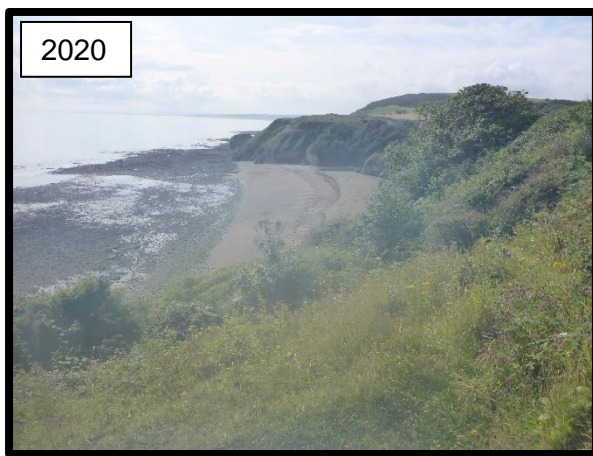
Residual spoil beach at Hawthorne Hive – 2020 (/0201C01)

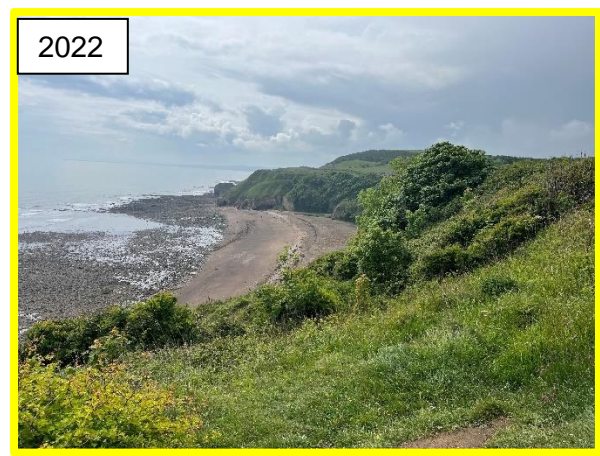
Residual spoil beach at Hawthorne Hive – 2022 (/0201C01)

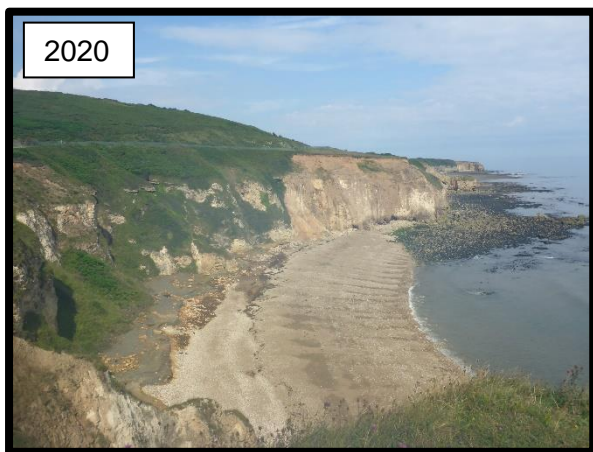
Residual spoil at Shippersea Bay – 2020 (/0201C01)

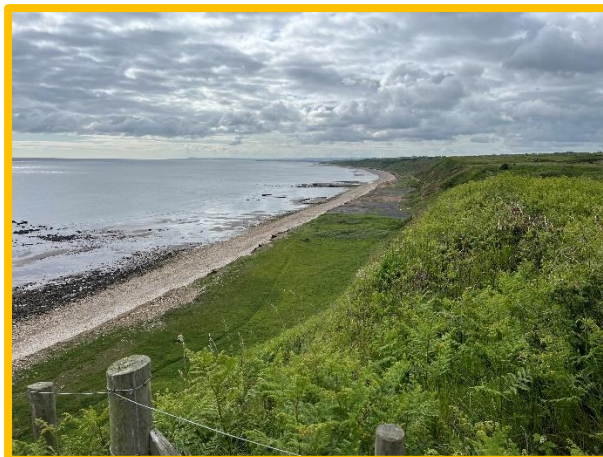
Despite the protection afforded by the foreshore and spoil beach, there remains occasional local shallow slumping in the backing slopes, especially in the centre of the frontage.

Looking southwards from Horden Point (/0201C02)

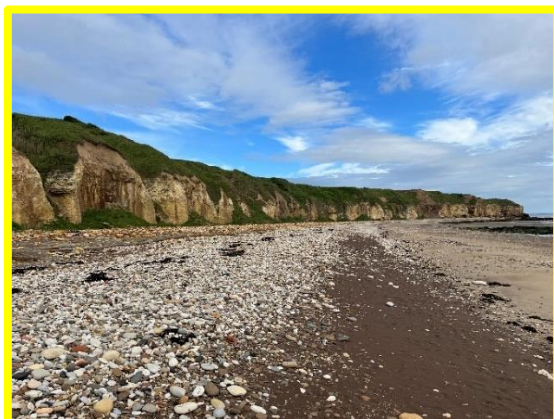
Less active cliffs to the north, protection by the residual colliery spoil (/0301C01)
