NECAG Coast Protection Assets and Coastal Slope Condition Analysis

The assessment of coastal protection assets and slopes along the Hartlepool Borough Council frontage was carried out by a team of asset inspectors and structural engineers during September and October 2008. All assets were graded based on their condition, residual life and urgency of repair work. Observations were photographed and all data were stored in the National Flood and Coastal Defence Database (NFCDD).

Hartlepool Borough Council's frontage extends from Crimdon Beck in the north to the North Gare Breakwater in the south. It comprises natural dunes, towns defended by sea walls and revetments, and key maritime structures such as port or harbour breakwaters.

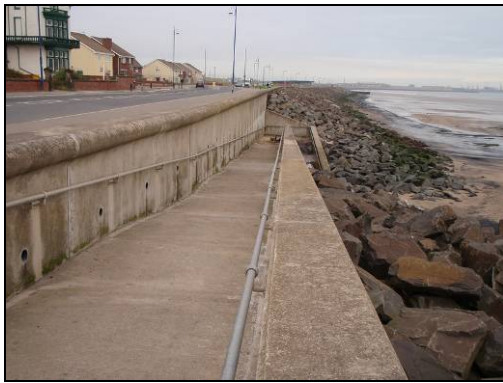
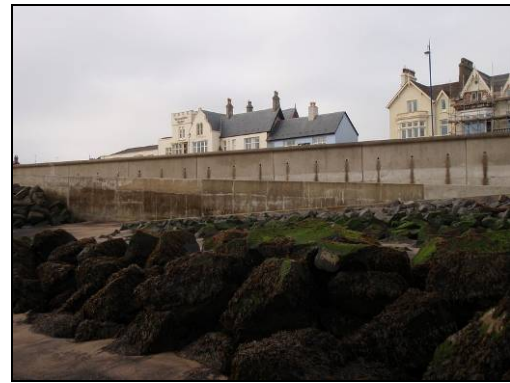
Seaton Carew

Inland of the Little Scar outcrop, a concrete ramp provides access to the foreshore through a reduced rock revetment. The seawall and ramp structure is in good condition. Some minor cracks were visible around construction joints with evidence of previous repairs. The concrete surface is stained beneath the drainage outlets and minor deterioration of the surface is beginning to occur. The reduced rock armour revetment is in good condition.
