**Cell 1 Regional Coastal Monitoring Programme
Coastal Walkover Inspections 2010**

The present report is **Coastal Walkover Inspections 2010** and provides a summary of the main findings from the walkover inspections of Hartlepool Borough Council’s frontage that are undertaken once every 2 years.

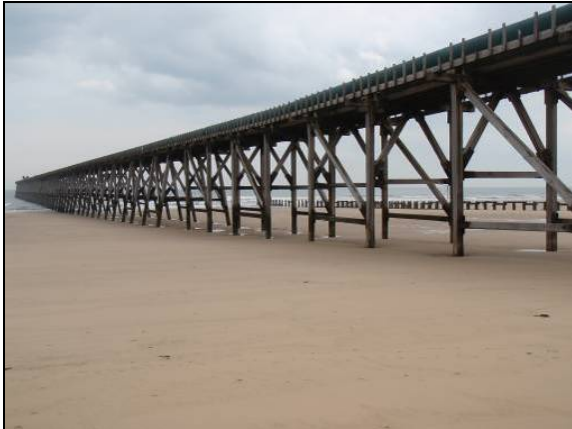
The timber pier carrying a disused (assumed) outlet pipe from the former works was generally in fair condition (below left). Minor scour was evident around the timber standards of the structure and metal elements appeared severely corroded. South of the timber pier, the dunes fronting the cemetery had greater vegetation coverage with minor erosion locally due to trampling as people have crossed the dunes to access the beach (below right).

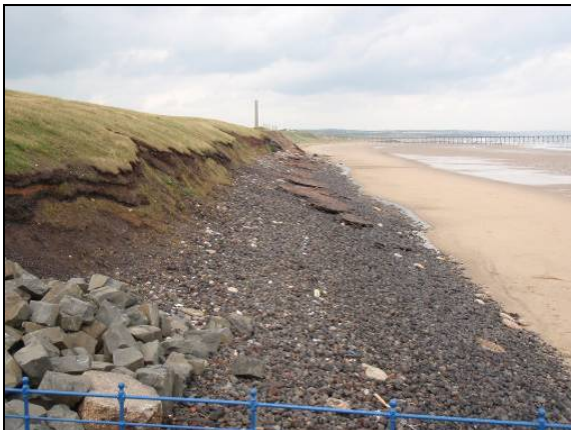
The slag and rubble embankment to the north of Marine Drive appeared to be effectively protecting the steeper vegetated embankment to the rear (below left). Historic slope failures were visible throughout the seaward face of the embankment with a more recent slip observed towards the north (below right). Further south, the rubble mixes with a cobble-sized stone revetment which appeared more uniform in size and distribution and the backing slopes appeared more stable. The majority of the frontage had a coverage of vegetation (with the exception of the steepest sections). Large pieces of broken slag were present on the surface and within the rubble revetment.

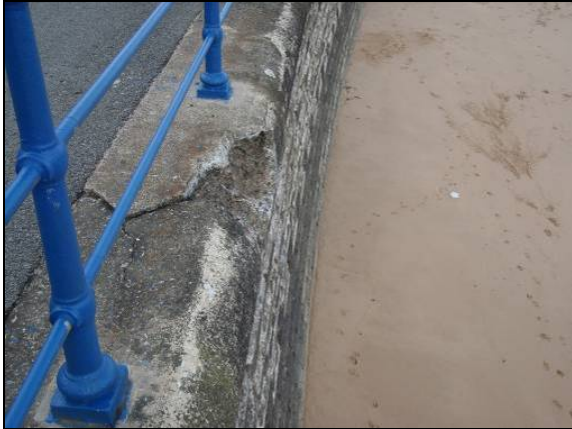
The seawall fronting Marine Drive was cracking and spalling locally with the crest particularly affected (below left). Previous patch repairs had been carried out and generally appeared to be performing well. No significant voids were observed in the masonry wall and defects were noted as minor loss of mortar and surface deterioration as abrasion to the concrete facing was evident throughout (below right).

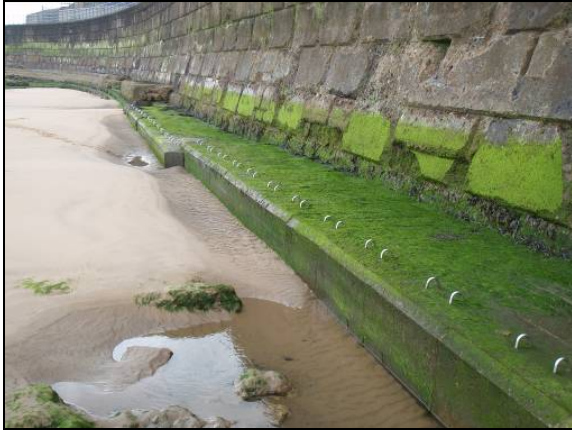
A concrete toe is present along the majority of the length of seawall. The concrete appeared to have been added in several stages, consisting of a variety of older stepped concrete profiles to more recent massive concrete blocks and was in good condition throughout. The most recently placed sections were in very good condition, with lifting eyes visible (below left). Where new concrete units were not present at the toe, the older (original?) toe was beginning to be undercut locally (below right).

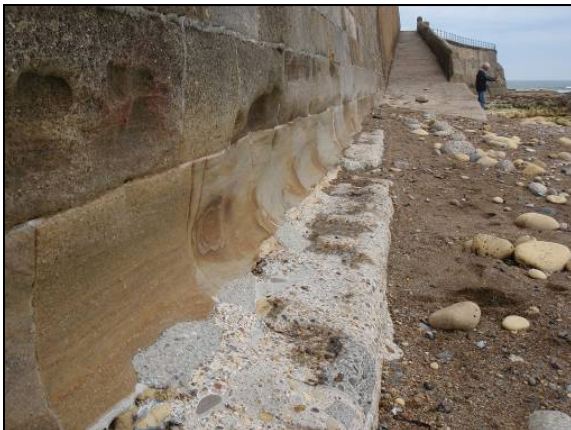
The masonry seawall fronting the access ramp was generally in fair condition. Erosion of masonry in the lowest visible courses and a lowering of the beach level was evident (below left) although no undercutting or void formation was observed. Several smaller masonry units had been lost and the abraded surface of the concrete was providing a key for vegetation growth on the wall at the tie in with the Heugh Breakwater (below right).

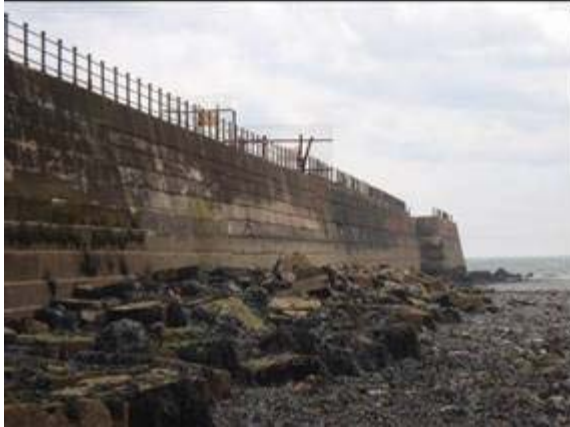
The Heugh Breakwater (left) is not accessible to members of the public and fencing and signage was present at approximately mid-length. Viewed from the foreshore, the structure generally appeared in fair condition with no significant displacement of material or undercutting and only minor mortar loss and abrasion. Local repairs were evident in the form of concrete deck repairs and local infilling of voids. It is understood that a collapse of the seaward end of the structure had occurred.

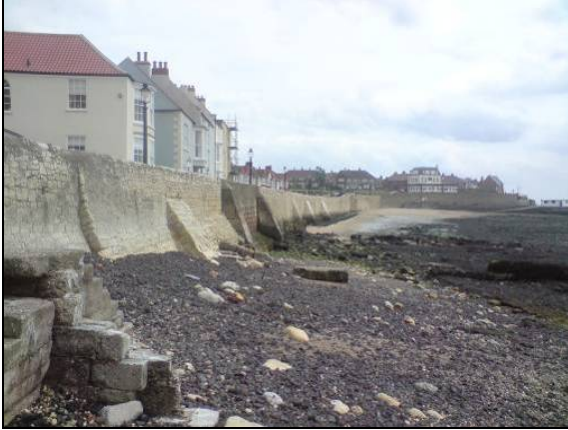
Beach levels increased leeward of the four dilapidated groyne structures and the apron and toe of the wall were buried up to the end of the length of seawall accessible to the public (below, left & right). The visible portion of the wall generally appeared to be in fair condition although local bulges were evident which should continue to be monitored. The paving stones and highway retained to the rear of the seawall appeared to be in very good condition with no evidence of movement of the structure.

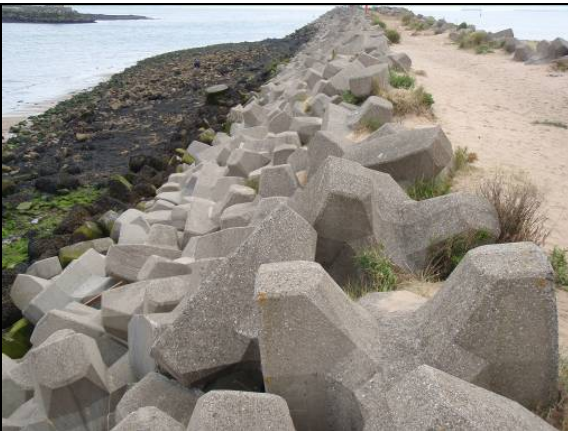
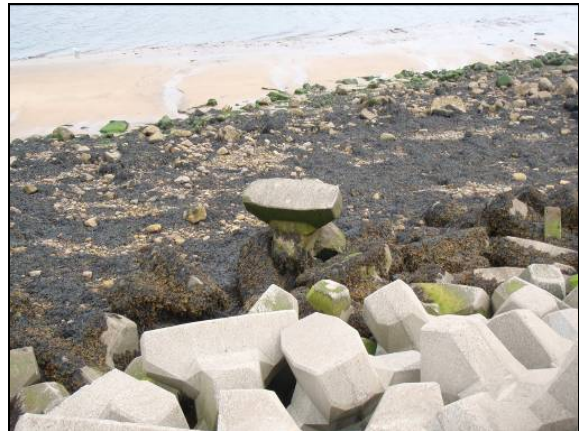
The concrete accropodes of Middleton Jetty appeared to have a very good interlock, with only a single unit apparently displaced from the structure (below, left & right).

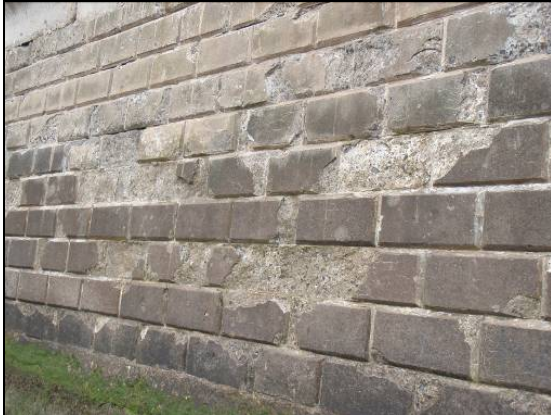
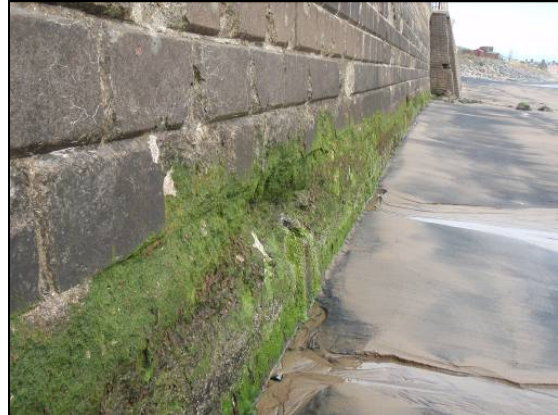
The concrete block wall to the south had extensive abrasion of the blockwork facing (below left) and where occurring in the lower courses had provided a key for vegetation growth (below right). Cracking of the concrete coping was also observed.

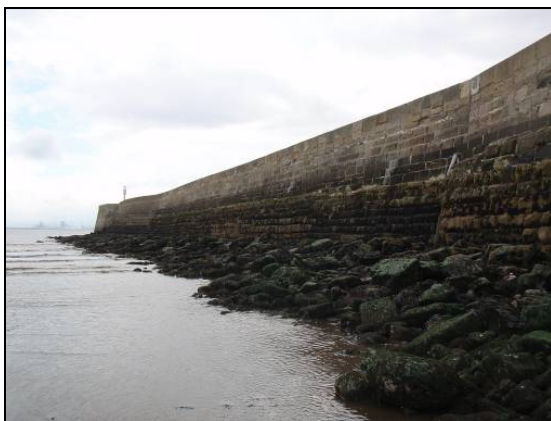
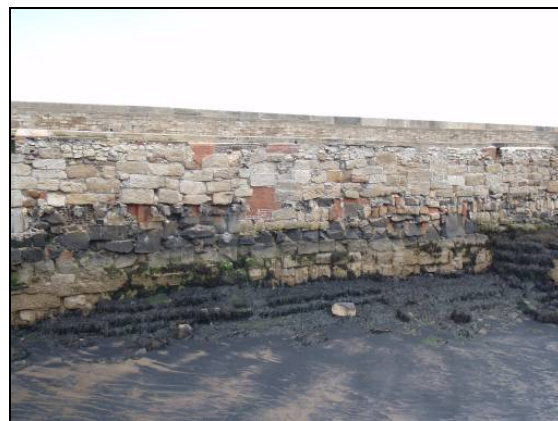
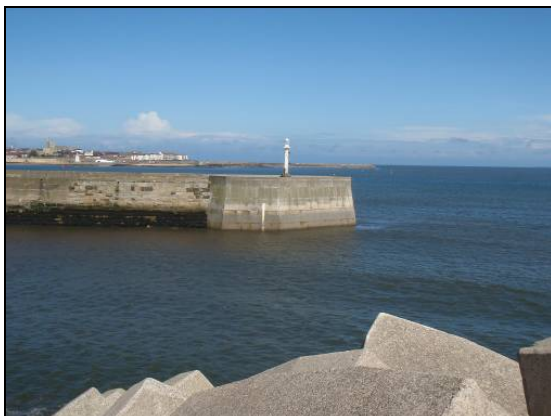
The outside face of the structure appeared in fair condition from the landward end (below left). The inside face of the structure appeared in poor condition with significant areas of masonry loss, extensive patchwork repairs and several large concrete repairs (below right). The seaward end of the structure is encased in concrete which could not be inspected although when viewed from the South Pier, appeared in fair condition (below left).

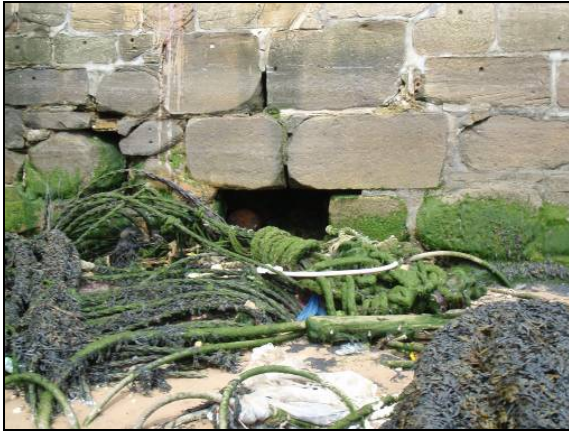
The seawall fronting the Navigation Point development was generally in fair condition although voids and missing mortar were observed locally in the masonry elements (below, left & right). Extensive seaweed coverage of the lower wall prevented inspection although there was no evidence of undercutting at the toe of the wall and no global movement or distress to the structure which suggests that the foundations were performing satisfactorily.

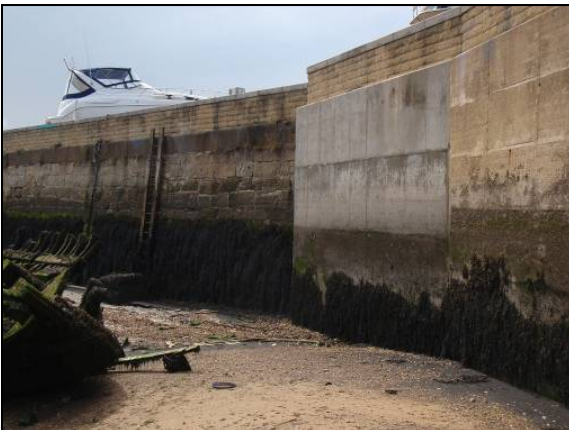
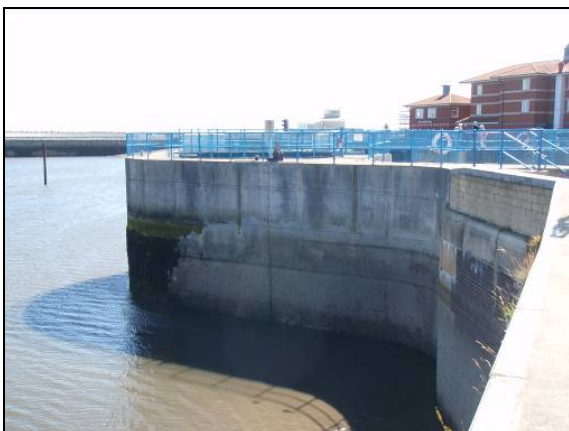
The concrete elements of the wall were in good condition with minor spalling evident to the upper edge (below, left & right). The masonry parapet wall was in very good condition throughout. The concrete structures forming the lock entrance were in good condition although water level prevented the inspection of the lower section of the walls (below left).

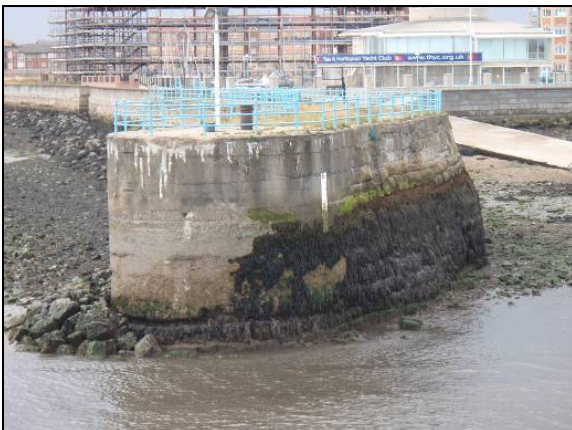
The concrete head of Middle Pier appeared to be in fair condition (below left). The masonry body of the structure ties into a masonry seawall which was in good condition. In areas where beach material was lower, mortar loss had occurred between the lower courses of masonry. Previous repointing works were evident in the upper courses but this did not appear to extend into the lower courses (below right).

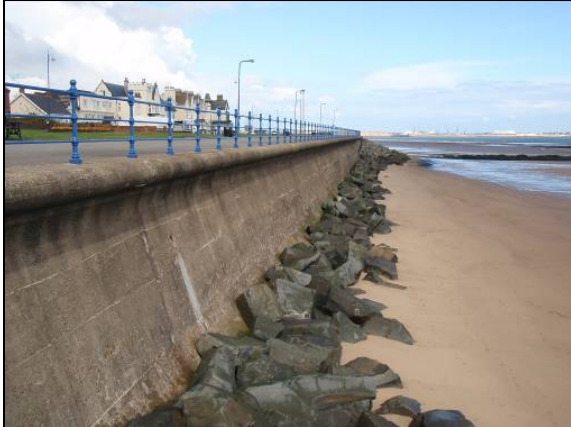
The structures along the Seaton Carew frontage consist of various concrete and masonry structures with toe rock armour units locally (below, left). There was no global movement or distress noted to any of the defence assets and therefore it was assumed that the foundations were performing satisfactorily and that no significant deterioration had taken place below the beach level. The structures were generally in fair condition with predominantly aesthetic defects which were previously recorded in the 2008 inspections (below right).

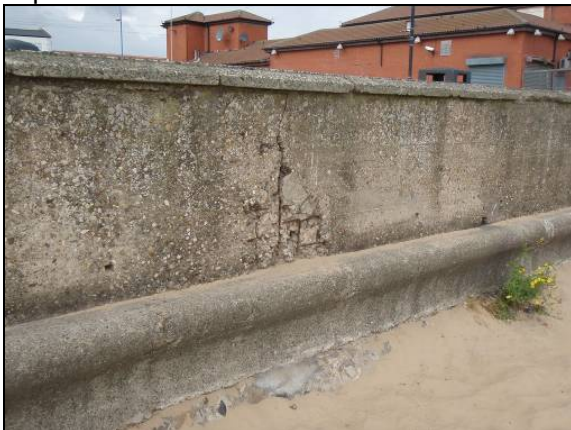
Defects included abrasion of concrete exposing aggregate and reinforcement locally (below left) and spalling of concrete (particularly copings and surrounding impact damage) (below right). Some mortar loss from the grouted masonry revetment was visible in areas with lower beach level such as access points although this did not appear to have worsened since the 2008 inspections.

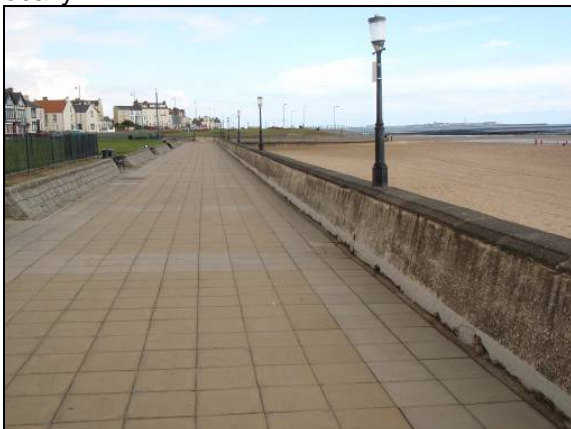
Abrasion and minor spalling was evident along the base of the wall on the promenade side (below, left & right). This erosion was most likely caused by wind blow sand and water draining from the promenade and previous patch repairs were evident although these were also eroded locally.

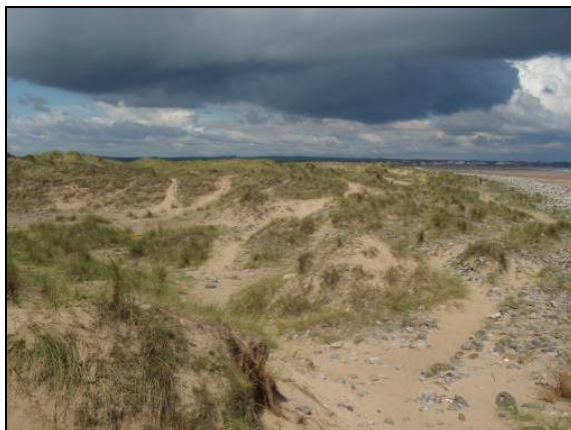
South of the sewage pumping station, the frontage is undefended and comprises of a relatively stable dune system forming the Seaton Dunes Nature Reserve (below left). The dunes were well established and had a good coverage of vegetation. Local erosion was evident due to trampling from members of the public walking through the dunes, with a lowering of the crest of the most seaward dune in several locations. Local cliffing was observed towards the south in close proximity to the North Gare breakwater (below right). The level of the dune crests generally increases to the south and a healthy beach is maintained along Seaton Sands by the North Gare breakwater.

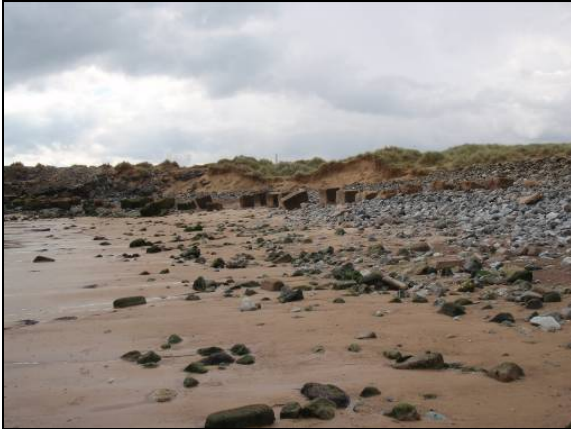
A stone/rubble revetment is present to the south of the dunes tying into the North Gare Breakwater (left). Concrete armour units are also present to prevent outflanking. The revetment appeared to be effective with a consistent profile and only minor displacement of blocks.
